Fish and Fish Habitat Technical Data Report

Mackenzie Valley Highway Project Technical Data Report—Fish and Fish Habitat

Government of the Northwest Territories

K'alo-Stantec Limited

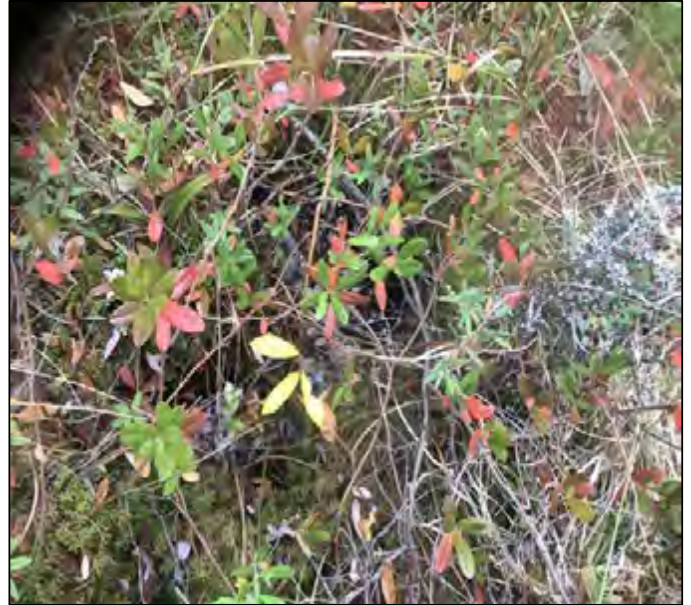
Photo 2. Subsurface flows to east of existing winter road

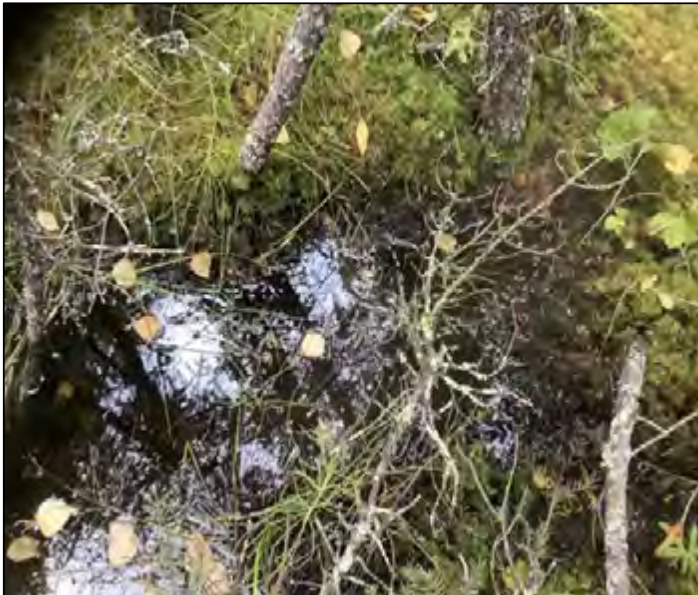
Photo 3. Water with subsurface flow to west of existing winter road

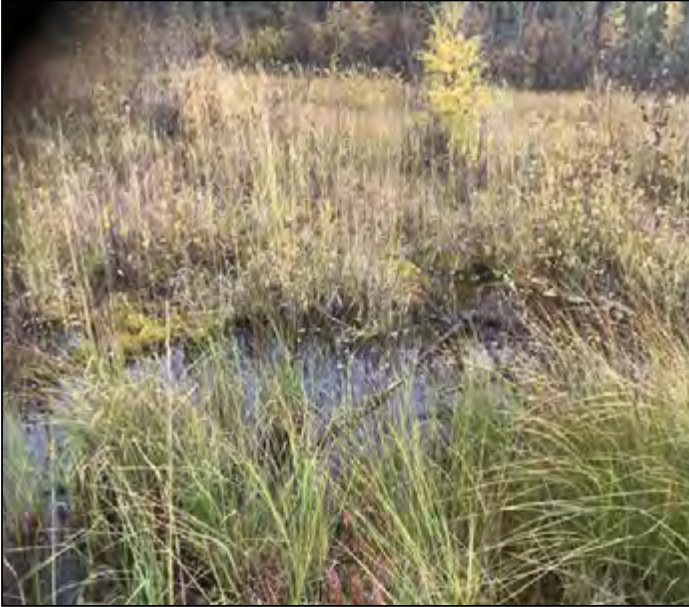
Photo 1. Showing outlet, an ephemeral drainage

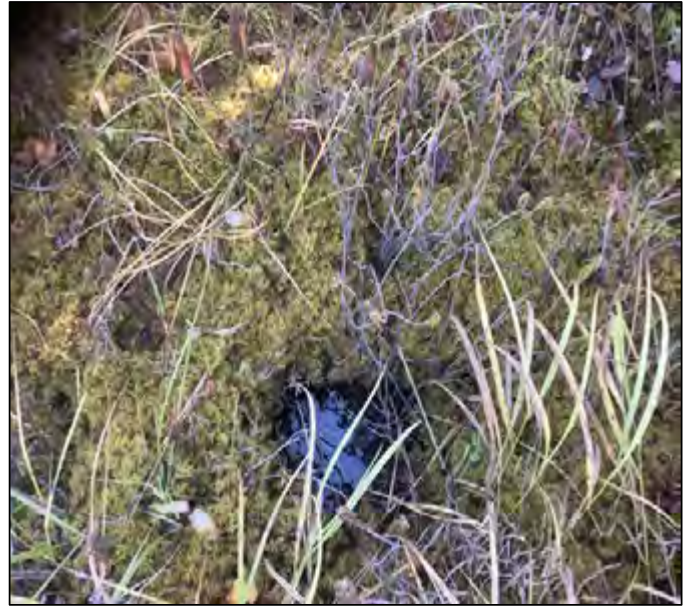
Photo 2. No channelization 40 m east of existing winter road

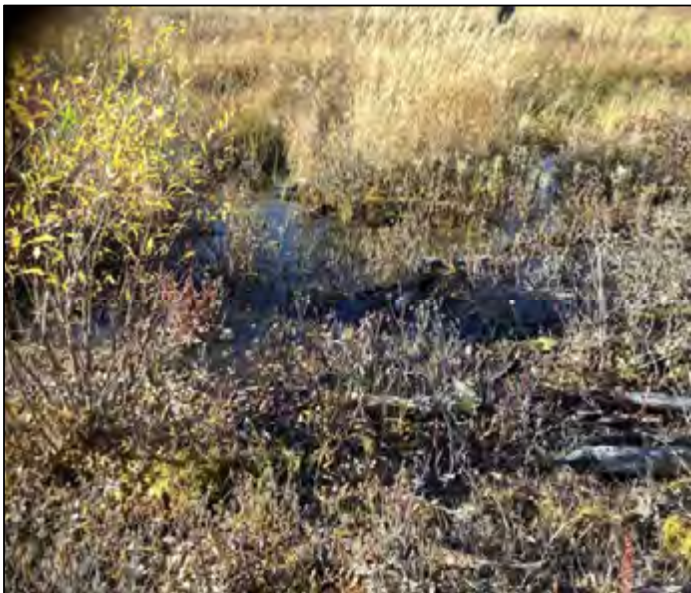
Photo 3. Standing water on west side of existing winter road

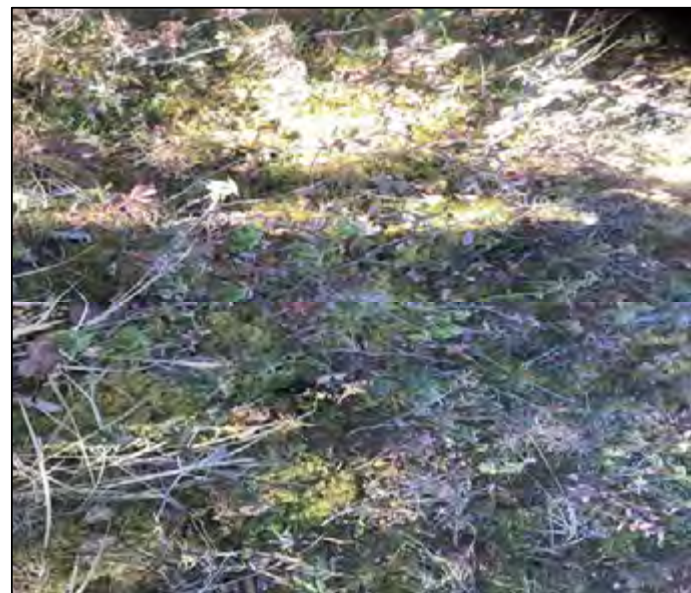
Photo 4. No channelization 50 m east of existing winter road

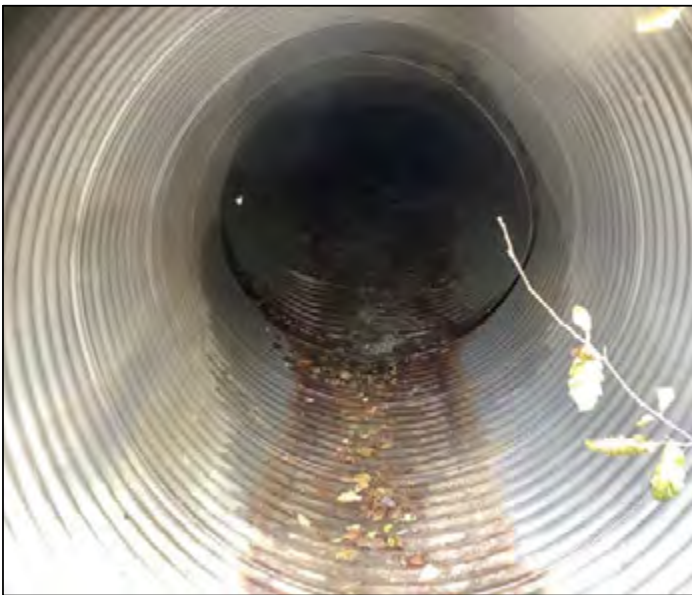
Photo 3. Facing upstream showing damaged culvert

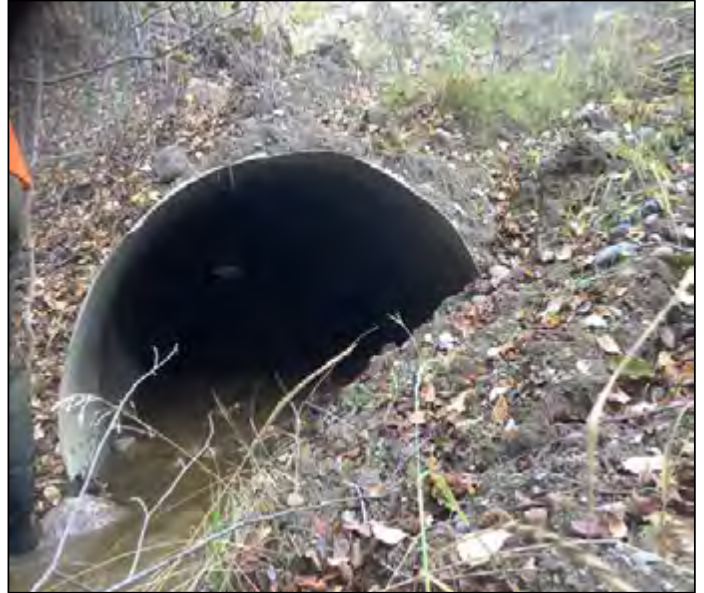
Photo 4. Culvert outlet

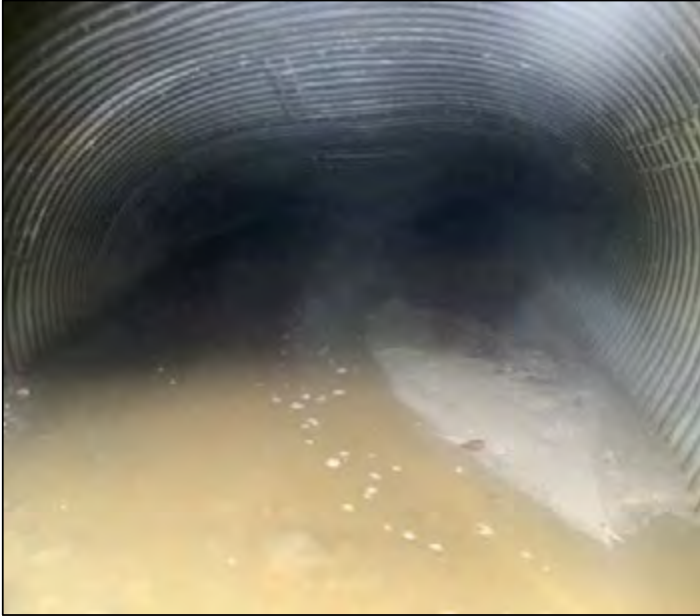
Photo 1. Facing outlet, culvert collapsed in centre

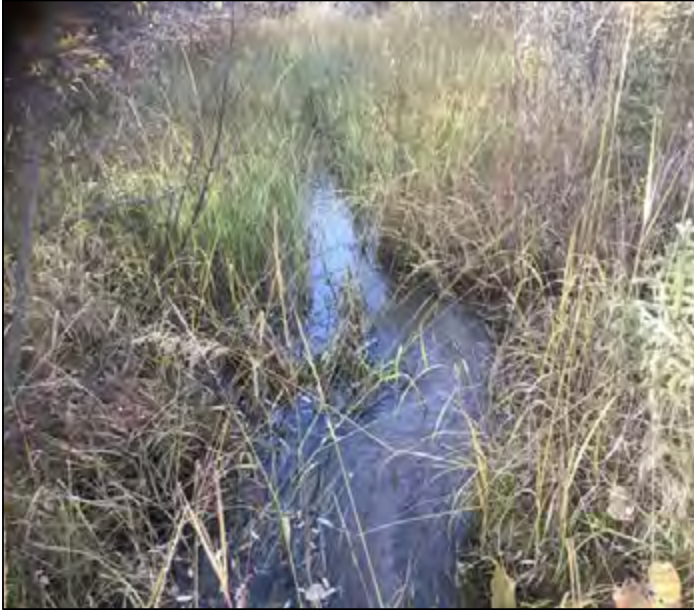
Photo 1. Flow through grasses and sedges 70 m west of winter road

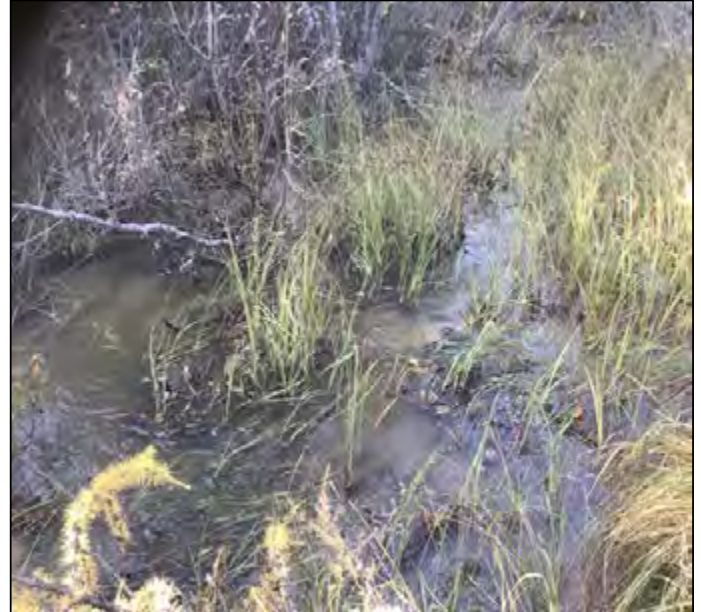
Photo 2. No defined bed or banks 35 m west of winter road

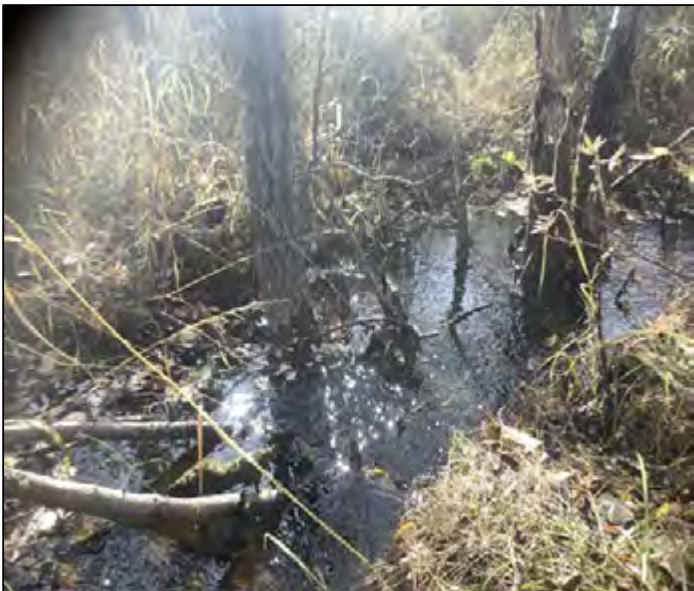
Photo 3. Section of intermittent channelization, 50 m east of winter road

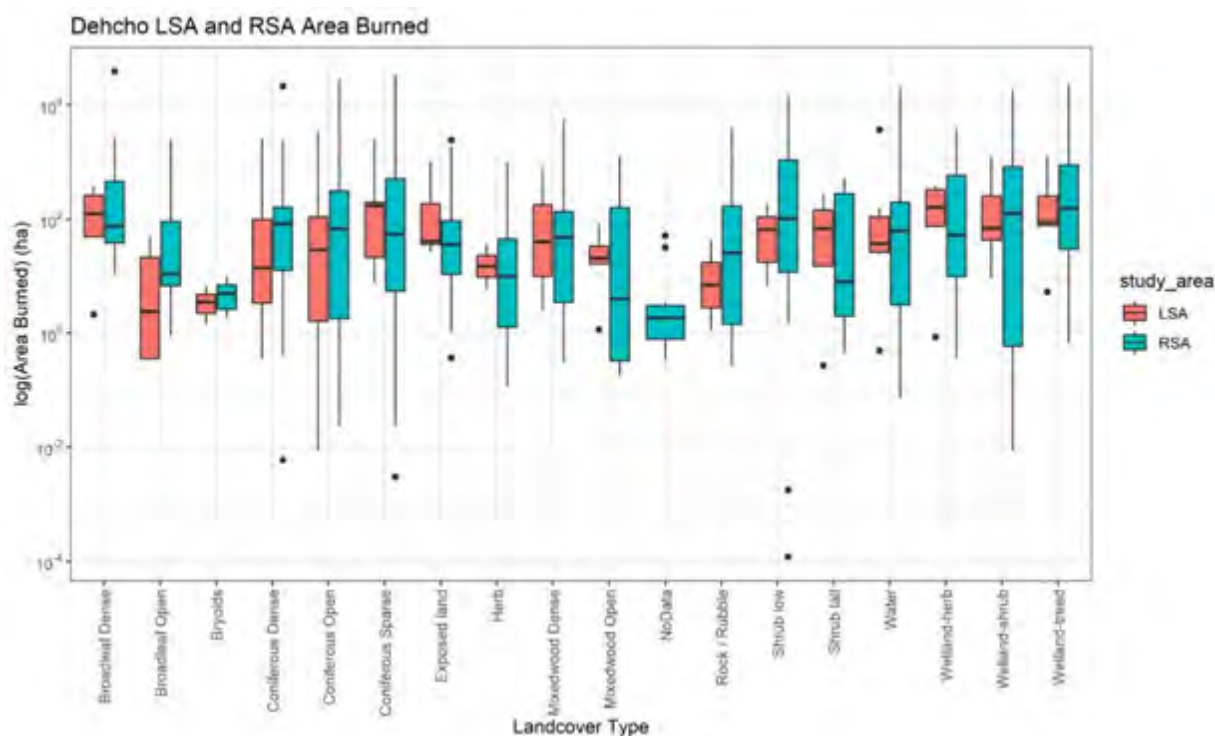
Figure 3.5 Area Burned by Landcover/Plant Assemblage Type from 1960 to 2019 in the LSA and RSA – Dehcho Region

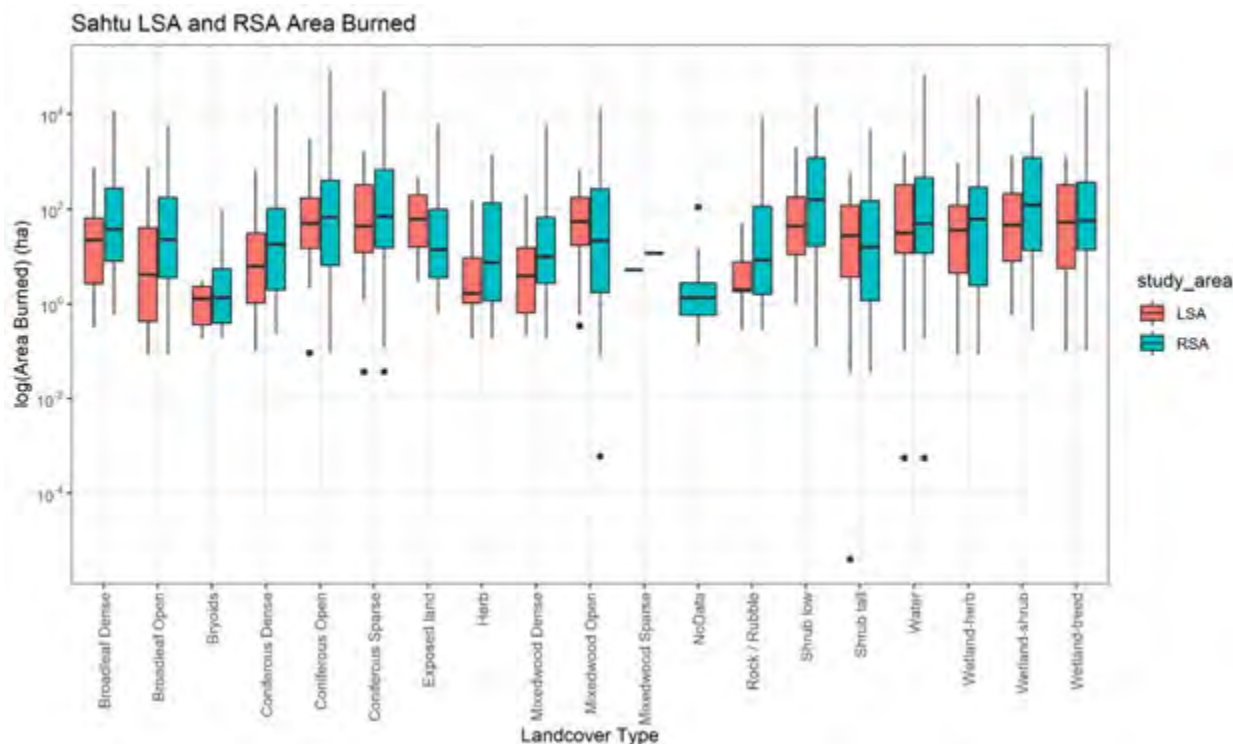
Figure 3.10 Area Burned by Landcover/Assemblage Type from 1960 to 2019 in the LSA and RSA – Sahtu Region
