River Action Plan for Gynudup Brook and Tren Creek

River Action Plan for the Gynudup Brook and Tren Creek

Prepared for the Capel Land Conservation District Committee and the
Geographe Catchment Council (GeoCatch).

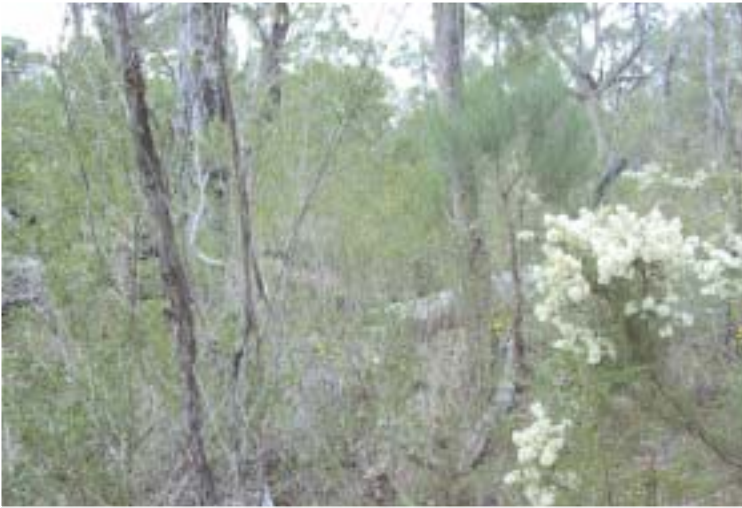
A Grade foreshore of the very upper reaches of Gynudup Brook in the State Forest. Although there is minimal flow in this section, the fringing vegetation provides habitat and shades the waterway.

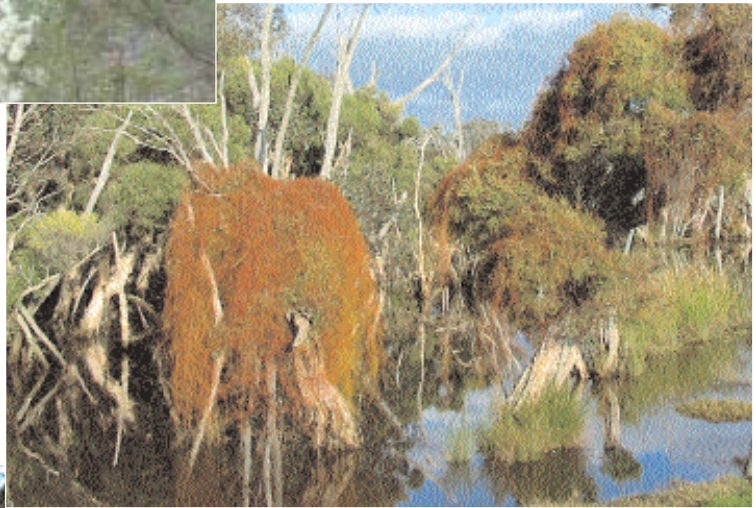
B Grade foreshore on Gynudup Brook near Capel River. Some understorey (mainly rushes and sedges) remains and helps to retard erosion, but there is significant weed growth.

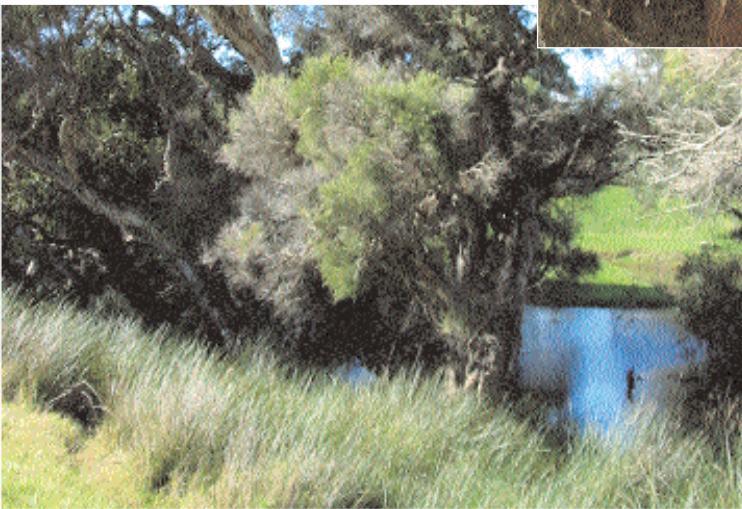
B Grade foreshore on Gynudup Brook. Note the very thin strip of native vegetation. Such a narrow strip is very sensitive to disturbance and degradation. A wider strip would be more resilient and trap sediments and nutrients entering the brook. The opposite bank is C1/C2.

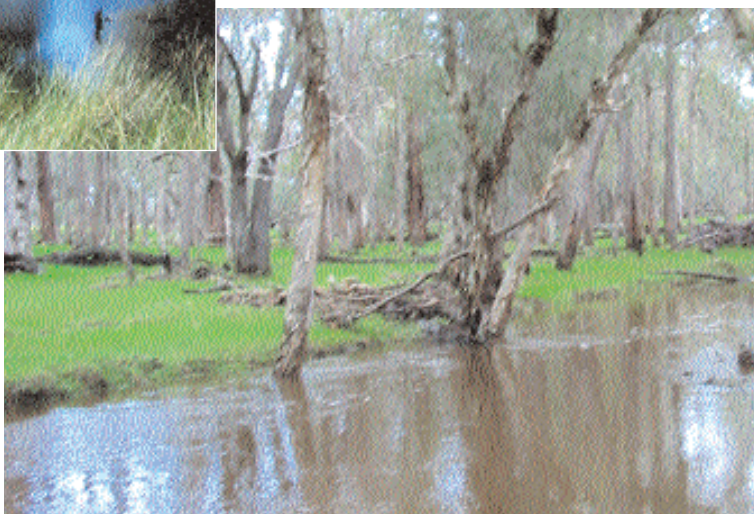
C1 Grade foreshore on Gynudup Brook. Note mature trees only, no exposed soil, and complete invasion by weeds, particularly grasses such as Kikuyu. This foreshore is very vulnerable to disturbance such as stock grazing and trampling. The grasses serve to hold the bank together slightly, but not as effectively as a variety of native species.

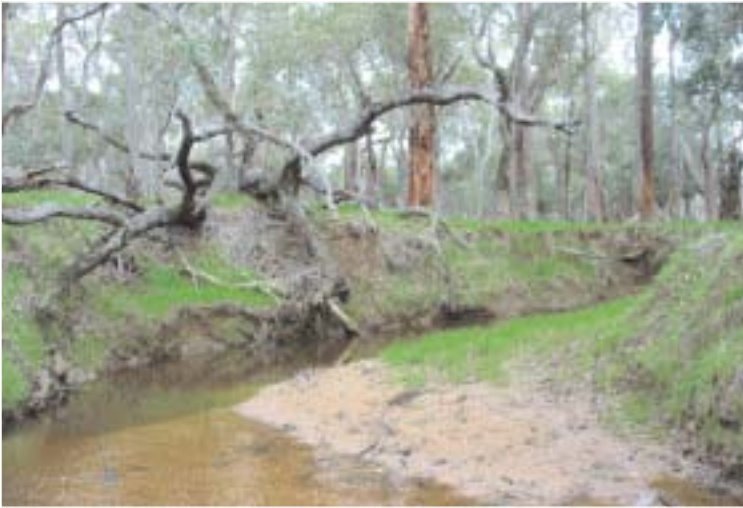
C2 Grade foreshore on Gynudup Brook. Some erosion and sedimentation (point bar formation) is occurring, especially on bends. This is due to a lack of native understorey vegetation that serves to dissipate flows and hold the bank together.

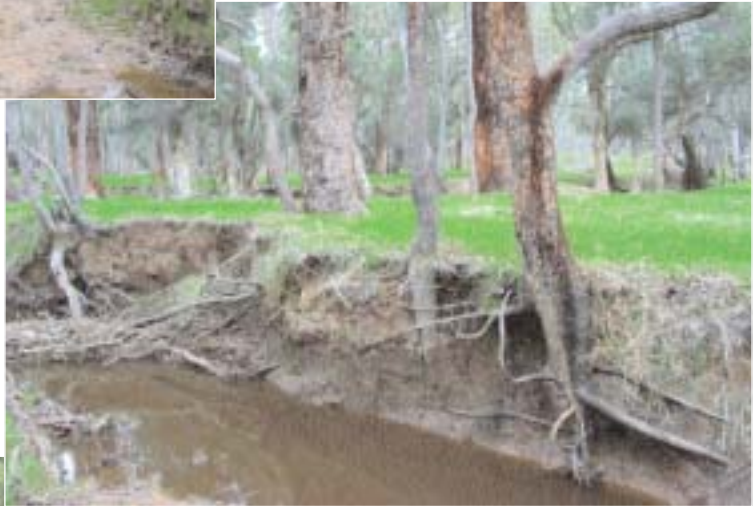
C3 Grade foreshore. Tree roots are barely holding bank in place, with undercutting and subsidence apparent. Only mature trees remain, with no regeneration of local species, as a result of stock access and weeds. These trees are all doomed to be undermined eventually unless supported by revegetation projects using a variety of local species.

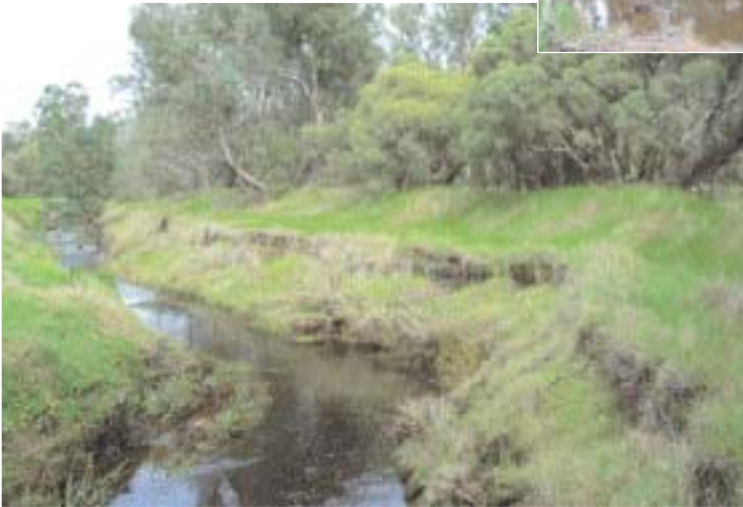
D1 Grade foreshore on Tren Creek/Elgin Drain. Very little fringing vegetation apart from isolated mature trees and grassy weeds. Banks are subsiding with a large amount of sediment being transported downstream.

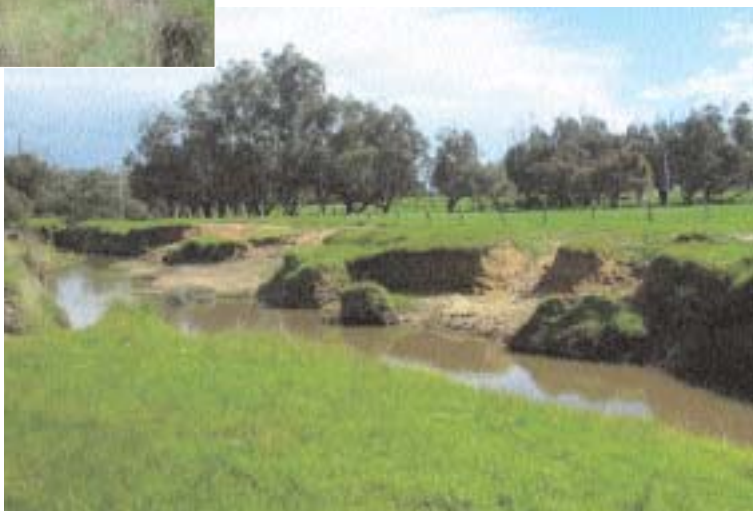
D2 Grade foreshore. No fringing vegetation remains and banks are freely eroding, resulting in massive sediment transport downstream, loss of productive land and serious downstream water quality issues.

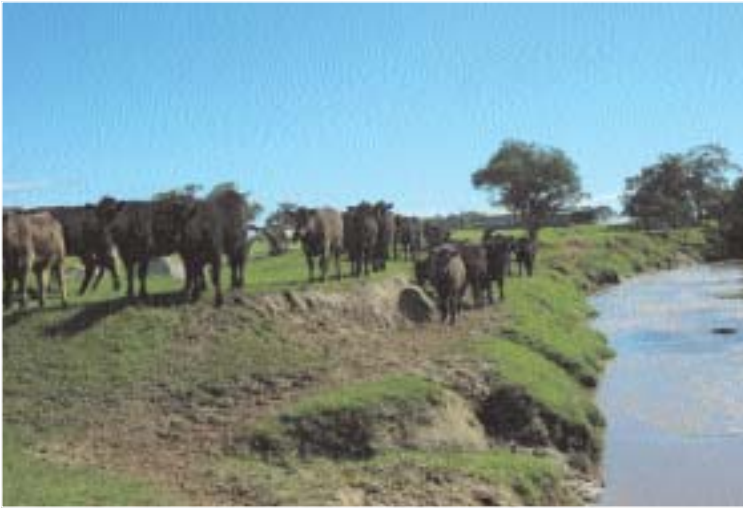
D2 Grade foreshore, showing a major cause of problems in the catchment – unrestricted stock access.

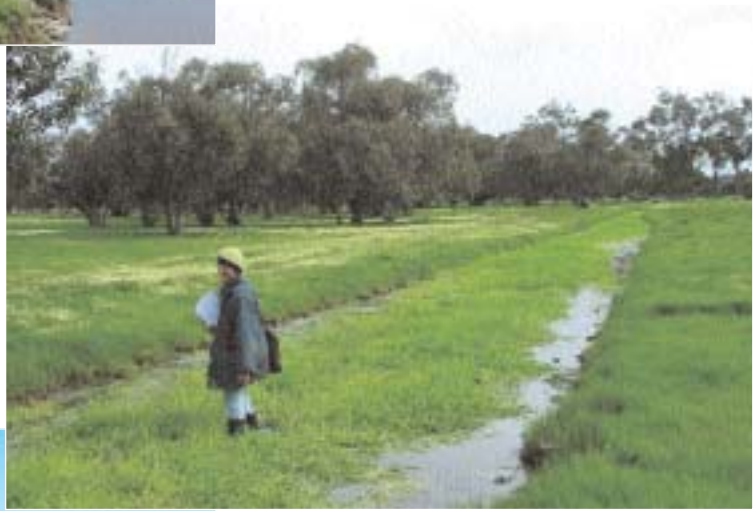
D3 grade foreshore. This drain has no remaining fringing vegetation, and is heavily infested with exotic species. The banks are stable however, and erosion is not a significant issue in this part. It is important to ensure invasive weeds are well managed to minimise potential problems downstream.

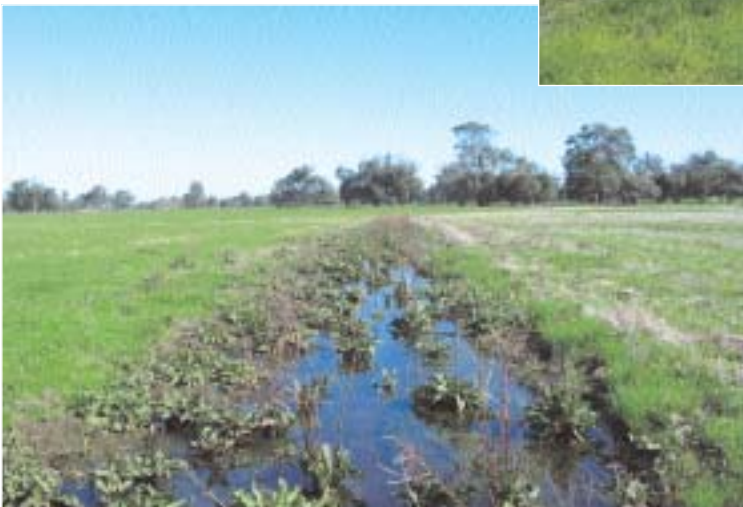
D3 grade foreshore. This drain is approximately 1 metre wide, with very low flows. Due to the low flows, the grasses and clovers are able to hold the bank together and there is little erosion occurring,
