GOD'S WINDOW SKYWALK Wetland Assessment

SEF Reference No: 505201

August 2014

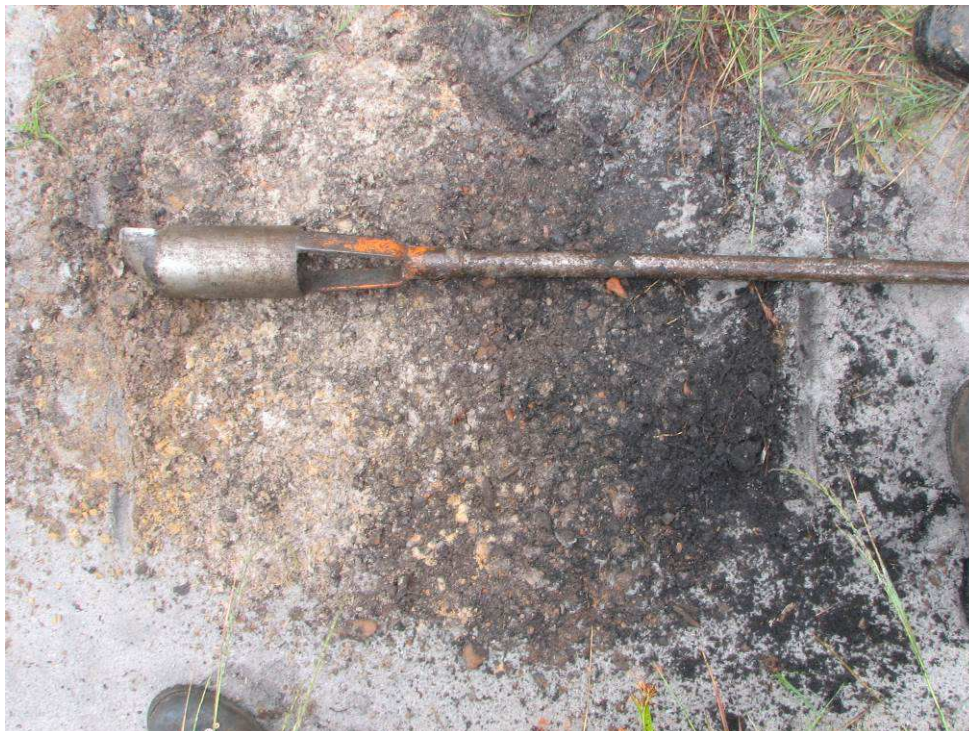
Photograph 1: Augered Cartref soil form with three distinct horizons displayed, including lithocutanic on the left, lighter coloured E-horizon in centre and an organic rich orthic A horizon towards the right

Temporary and seasonal wetland zones within the vicinity and within the study area contained Kroonstad, Longlands, Cartref (Photograph 1), Westleigh, Fernwood and Pinedene soil forms. Hydric soil forms sampled within permanent wetland habitat included Champagne and Katspruit soil forms. Terrestrial habitat within the wetland's catchment was dominated by Mispah soil forms.

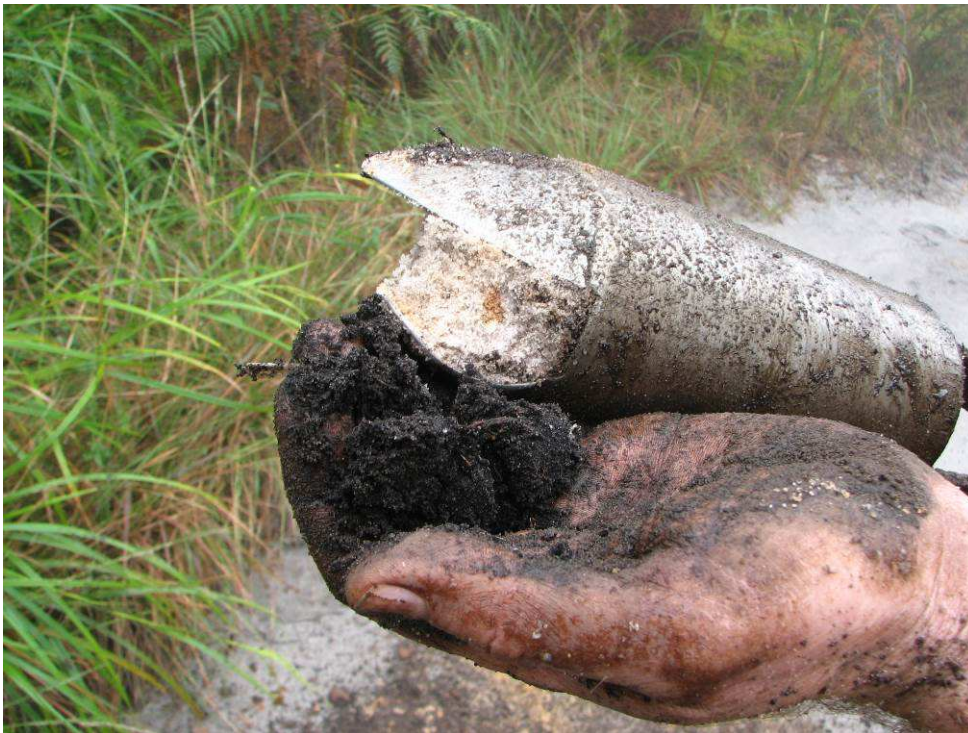
Photograph 2: Dark organic rich topsoil in contrast to augered bleached E-horizon which has lost colouring materials such as iron oxides, organic matter and clay particles due to reduction

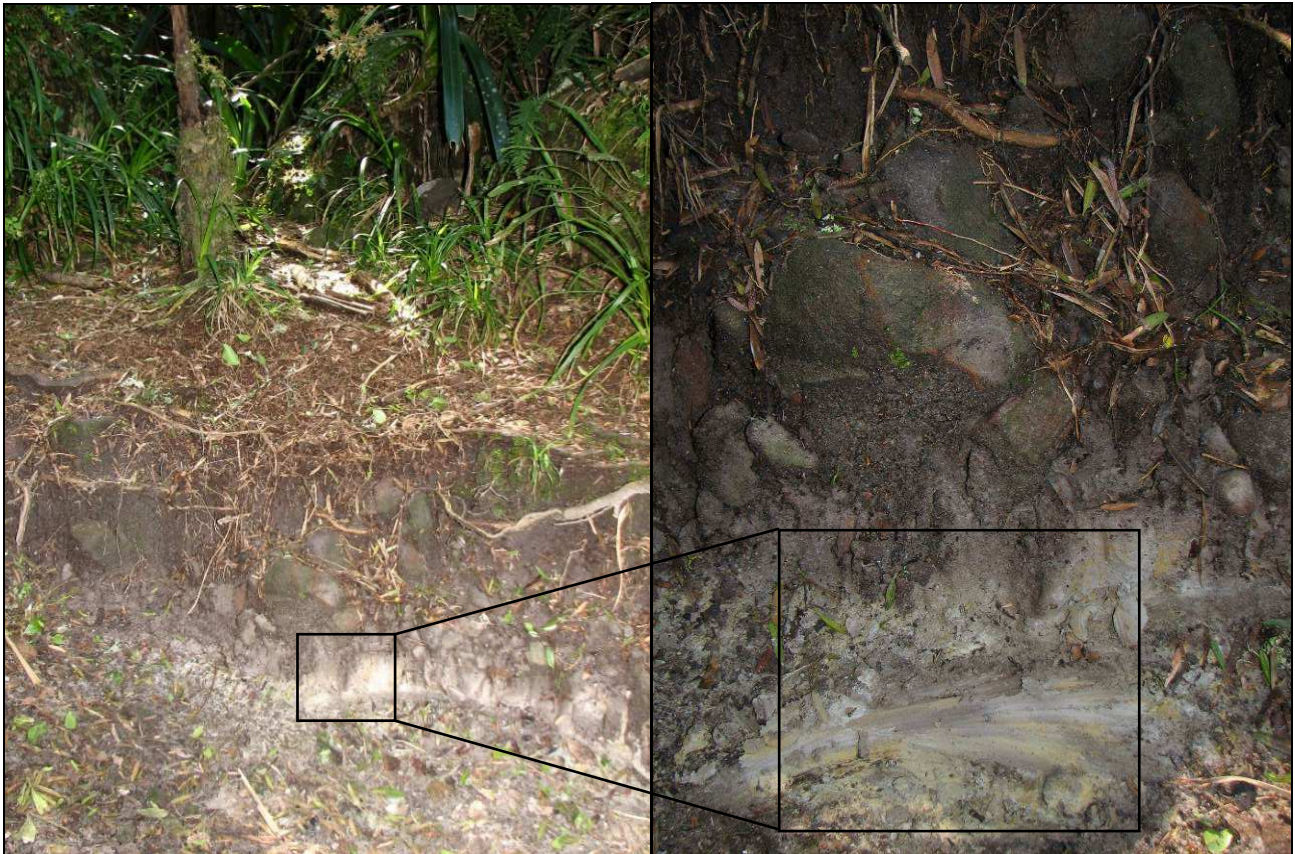
Photograph 3: Grey gleyed horizon within mistbelt forest that is indicative of permanent wet conditions. Complete soil profile (left) and zoomed in section of gleyed material (right)

Soils associated with the mistbelt forest just north of the study area contained organic rich topsoils with faint red mottling and rhizospheres as well as gleyed subsoils (Photograph 3) which are likely indicative of permanent wet conditions within the mistbelt forest clumps along the escarpment. Cliff faces below the mistbelt forest contained overhangs and cave formations (Photograph 4) which were groundwater-supported developed potential peat soils from mosses and ferns (Photograph 5). However, these soils' organic content needs to be determined in a laboratory in order to qualify as peat.

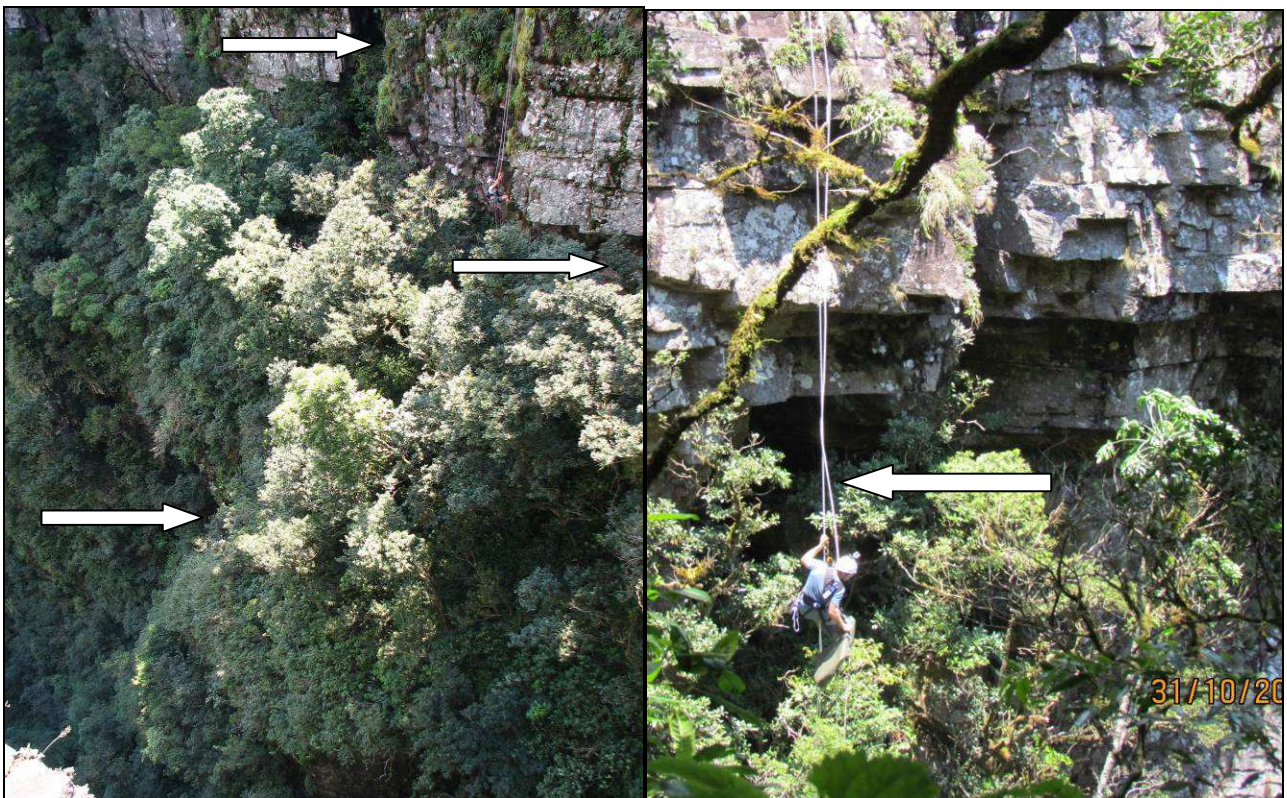
Photograph 4: Examples of hydrologically-supported caves and overhangs on cliff faces indicated by multiple arrows (left) and single large cave formation (right).

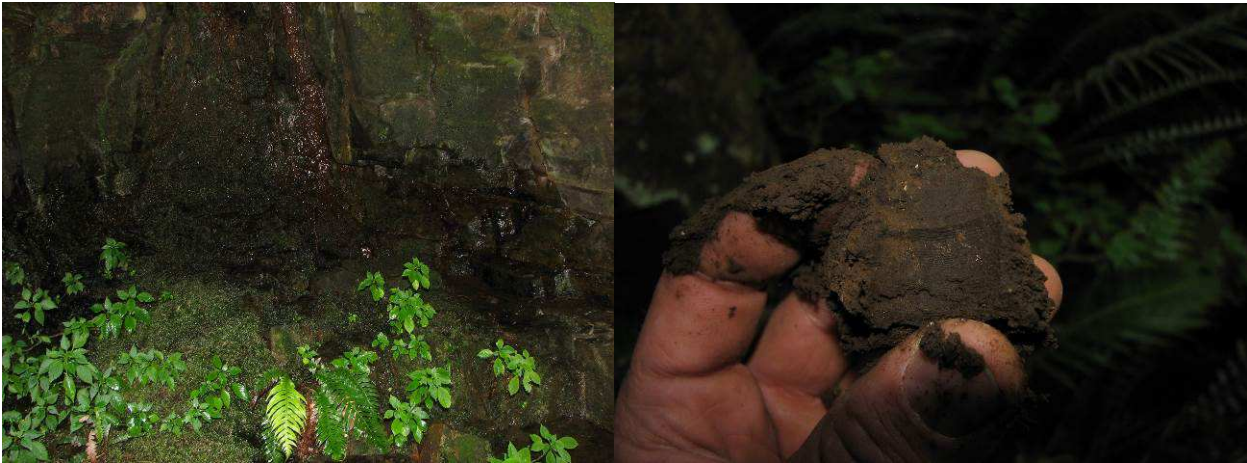
Photograph 5: Hydrologically-supported cave formation (left) developing potential peat soils derived mostly from mosses and ferns (right)

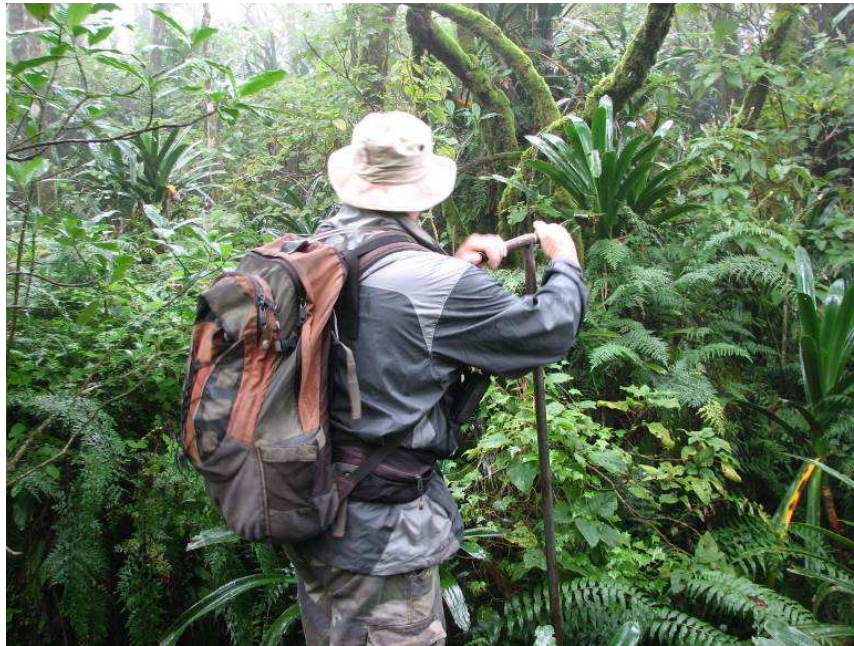
Photograph 6: Mistbelt forest section with multi-layered vegetation structure exhibiting permanent signs of wetness within the soil profile at various localities.

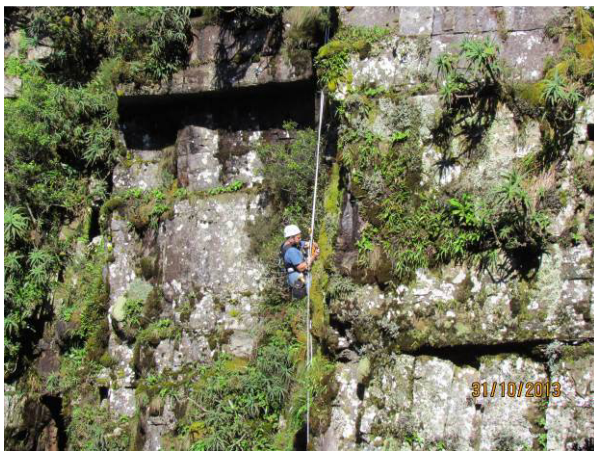
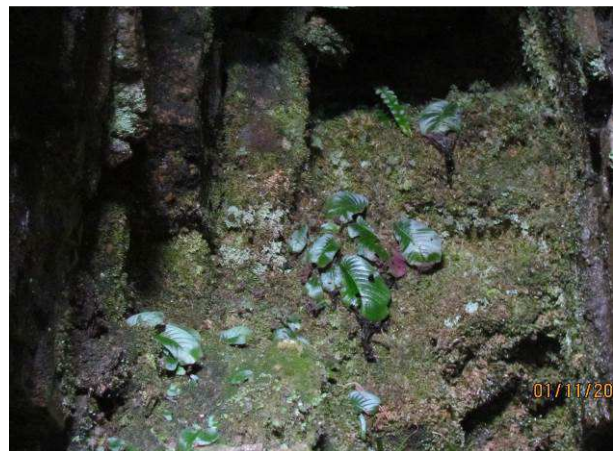
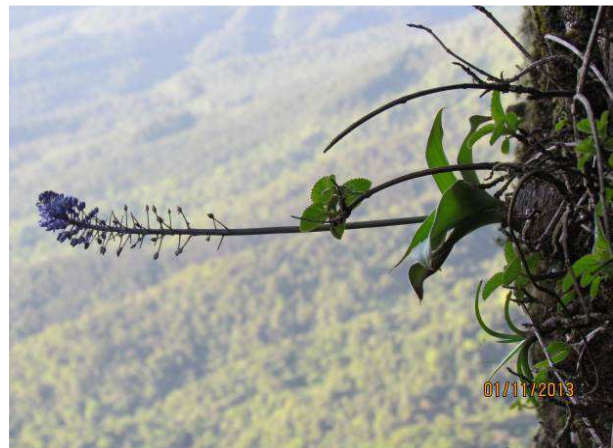
Photograph 7: Sheer cliffs in the study area (top left) providing habitat for specially adapted species such as *Streptocarpus* (top right) the extremely rare *Schizochilus lilacinus* (bottom left) and *Mervilla plumbea* (bottom right)

A cliff is defined as a high, steep or overhanging face of rock and due to the extreme nature of cliffs, these habitats have rarely been investigated from an ecological viewpoint. The biotic communities living on vertical cliffs are usually highly adapted to cope with temperature extremes and various moisture regimes (usually very wet or completely dry). The cliffs at God’s Window form part of the Drakensberg escarpment range which includes over 250km of cliffs. Numerous rare, provincially protected as well as species of conservation concern were recorded on the cliff face within the study area and included *Schizochilus lilacinus* (Extremely Rare), *Monopsis kowynensis* (Vulnerable), *Aloe nubigena* (provincially protected), *Streptocarpus fenestra-dei* (Rare), *Clivia caulescens* (Near Threatened and provincially protected) as well as large populations of *Merwillia plumbea* (nationally protected and Declining) (Photograph 7). Many of the above mentioned species as well as numerous unidentified ferns and mosses were supported by groundwater discharging at various localities on the cliff faces, fissures, overhangs and cave formations within the study area. Table 6 summarises the species recorded on the vertical cliffs that were associated with wet conditions. It should be noted that many of these species were also associated with terrestrial habitat within the study area.

Dominant species at the time of the survey:	<p><u>Herbs:</u></p> <p><i>Helichrysum galpinii</i></p> <p><i>Clivia caulescens</i></p> <p><i>Monopsis kowynensis</i></p> <p><i>Passerine montana</i></p> <p><i>Merwillia plumbea</i></p> <p><u>Trees and shrubs:</u></p> <p>None</p>
Plants of conservation concern confirmed to occur:	<p><i>Monopsis kowynensis</i> (VU)</p> <p><i>Clivia caulescens</i> (NT)</p>

<i>Merwillia plumbea</i> (Declining) <i>Streptocarpus fenestra-dei</i> (Rare) <i>Schizochilus lilacinus</i> (Extremely Rare)
Plants of conservation concern for which suitable habitat was observed:	<i>Hesperanthera brevicaulis</i> (Rare) <i>Gladiolus saxatilis</i> (Rare)
Provincially protected plants confirmed to occur:	All species of conservation concern are also provincially protected as well as the following additional species: <i>Aloe nubigena</i>
Provincially protected plants for which suitable habitat was found:	<i>Gladiolus saxatilis</i>
Nationally protected species confirmed:	<i>Merwillia plumbea</i>
Alien species:	<i>Pinus</i> sp.

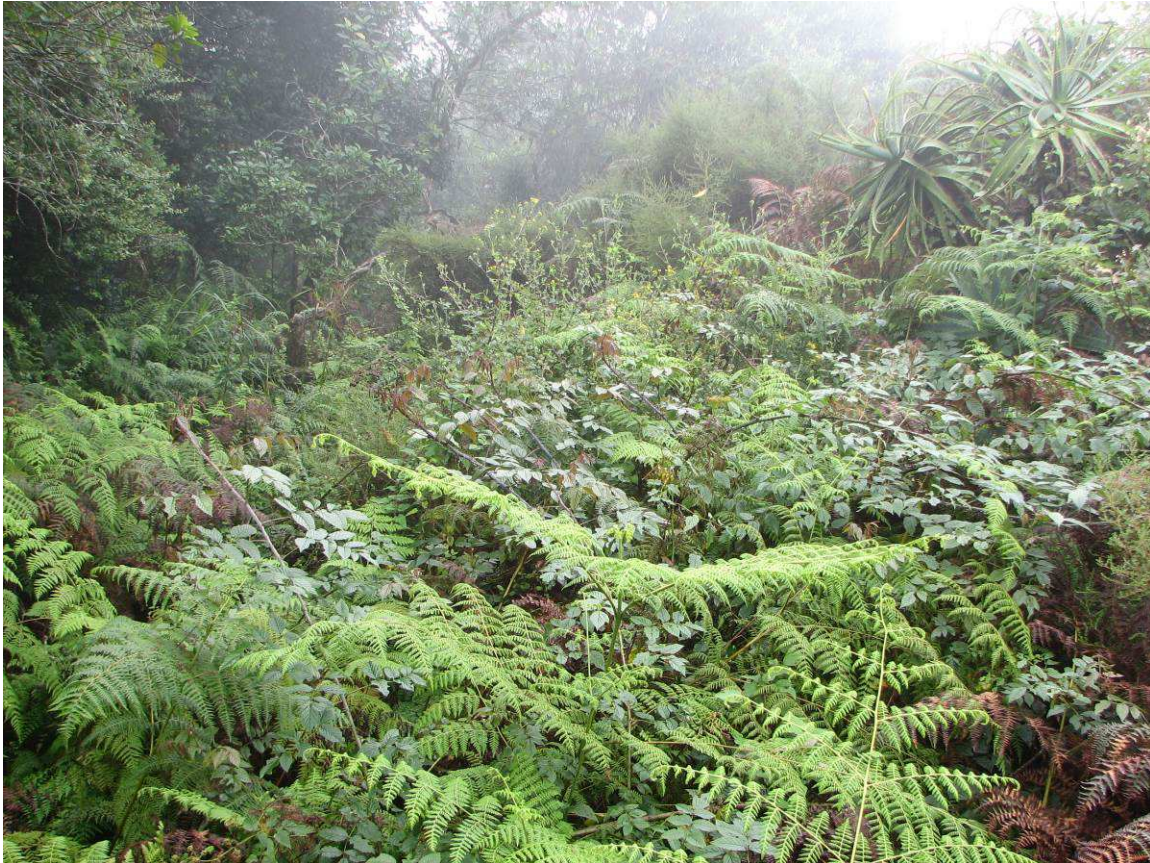
Photograph 8: Fern dominated seepage area close to escarpment edge

Seepage areas on top of the escarpment towards the south of the study area below the current parking lot and ablution facilities contained dense stands of *Pteridium* sp. (Bracken fern) ferns including invasive *Rubus* sp. on shallow organic rich soils (Photograph 8). These seepage areas also extended up to the cliff edge. According to SEF (2013), the edges of the cliffs were dominated by large stands of *Aloe arborescens* which provided suitable habitat for *Clivia caulescens*, currently listed as Near Threatened (Photograph 9). Cliff edges were high in species diversity and supported more tree species than the adjacent *Passerine montana*/*Pteridium aquilinum* scrubveld. Tree

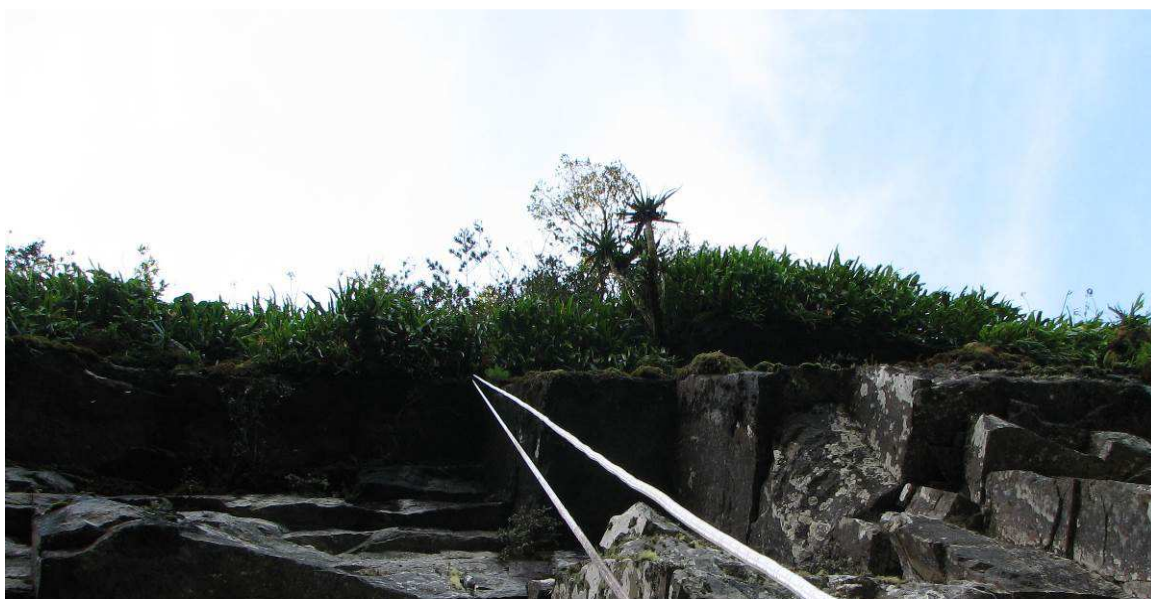
Photograph 9: *Aloe aborescens/Clivia caulescens* dominated cliff edge

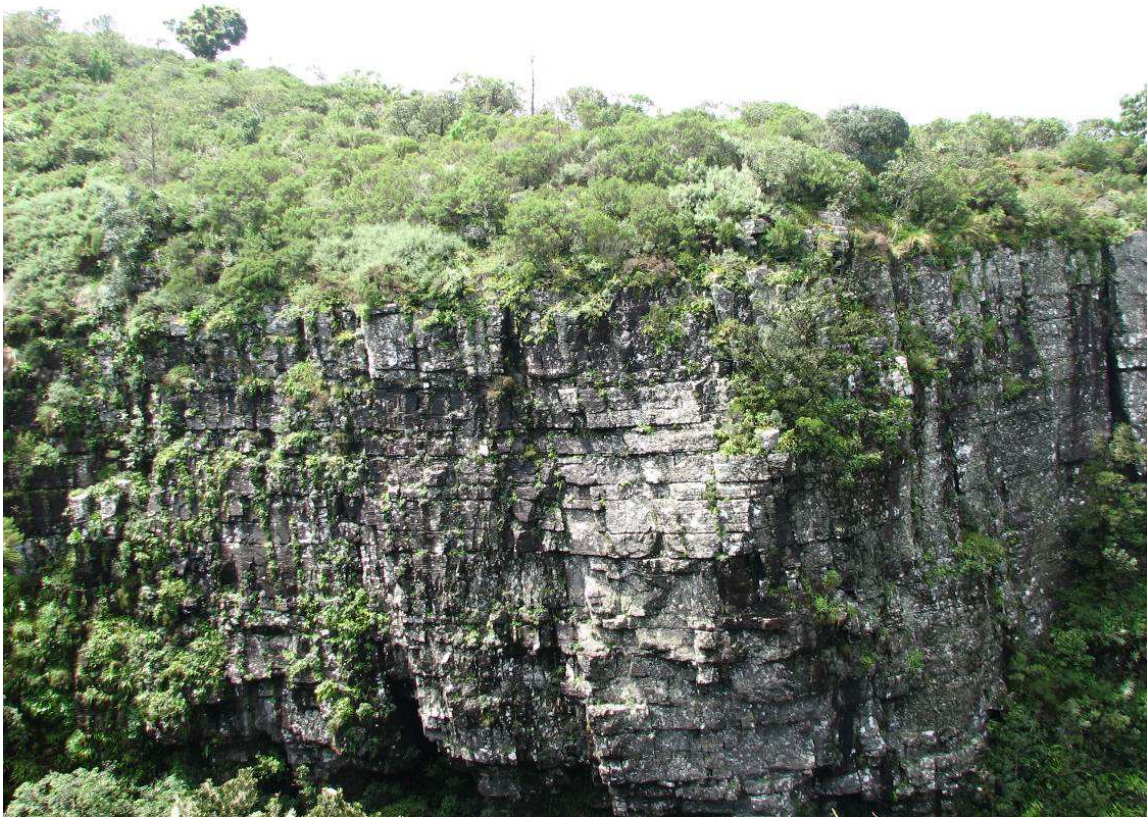
Photograph 10: Horizontal plain of sedimentary quartzite that dominate the study area

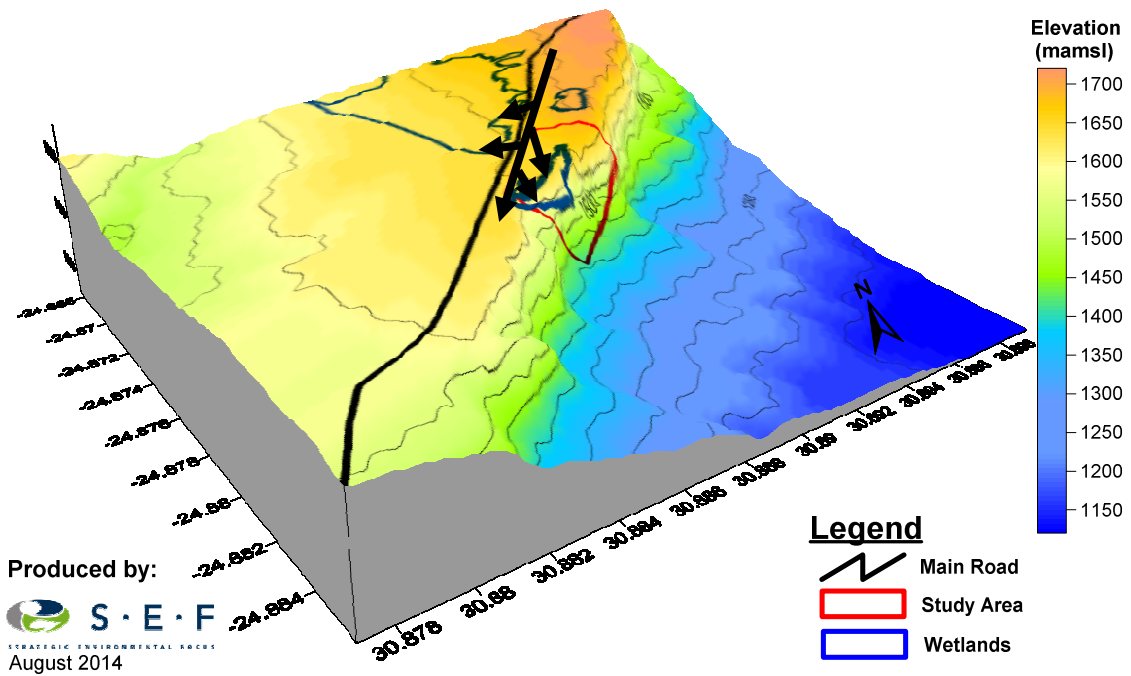
Figure 3: Digital Elevation Model illustrating potential geo-hydrological flowpaths as indicated by black arrows within study area and surroundings

The hydrology of the area seems interconnected and important in terms of regulating different moisture regimes in different areas, many of these areas serving as habitat harbouring a multitude of species of conservation concern. Lateral water movement seems likely to be an important component of the geohydrology of the area with groundwater-fed seeps occurring in several locations within and surrounding the study area. Lateral water movement is highly likely as a result of the horizontal plain of the sedimentary quartzite that dominates the site (Photograph 10). Figure 3 indicates potential flow paths as deduced from topography, geology and a multitude of observed springs and wetlands in the area.

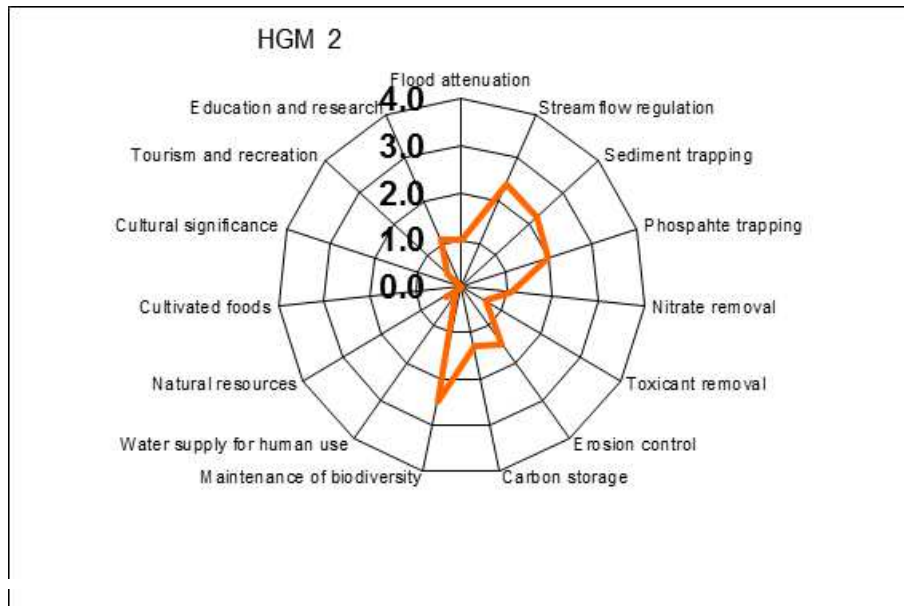
Figure 6: Spiderweb diagram depicting results for Wet-EcoServices assessment for HGM 2

This relatively small hillslope seepage system highest scoring eco-services attributes were maintenance of biodiversity and streamflow regulation (Figure 6). It is likely that this hydro-geomorphic unit occurs on underlying geology with strong surface-groundwater linkages as water percolates through crevices on cliff faces situated directly below this HGM unit. These cliff faces contained various species of conservation concern that utilises groundwater discharges which are probably linked to HGM 2. The shallow soils and relatively small size of the hillslope seep reduced the opportunity for other ecosystem services to attain high scores.

HGM 2 was determined to be moderately modified with some loss of natural habitats (PES Category C; Table 7). Modifications to this system include possible changes to the hydrology of the system as a result of the existing parking lot and ablution facilities directly below the parking lot. The parking lot would have likely increased peakflows that the wetland would receive during and shortly after precipitation events which could potentially had an impact on the geomorphology of the wetland through a loss of soil. This was supported by the presence of an invasive *Rubus* sp. as well as the dominance of *Pteridium* sp. (Bracken fern) within this unit indicating species composition changes that has taken place in the past. The ablution facilities septic tanks which is located in close proximity to HGM 2 could potentially have a negative impact on the water quality of the wetland.

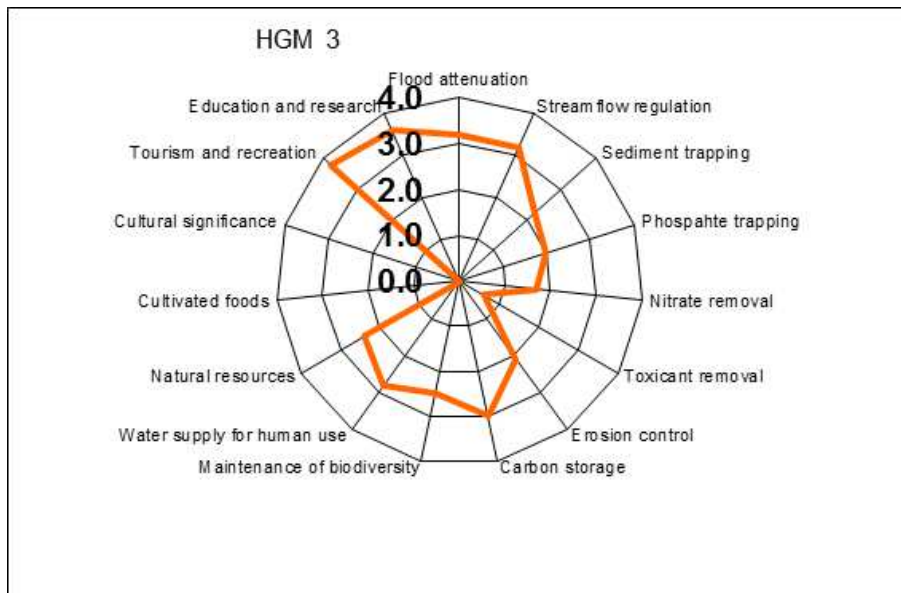
Figure 7: Spiderweb diagram depicting results for Wet-EcoServices assessment for HGM 3

From a functional perspective HGM 3 scored well for several ecosystem services such as maintenance of biodiversity, carbon storage, water supply and tourism (Figure 7). The habitat provided by the associated mistbelt forest contain a multitude species of conservation concern and the lush multilayered growth structure with near permanent wet conditions increases the carbon storage potential. The very high surface roughness of the forest floor increases the systems'propensity for flood attenuation and allow water to recharge the underlying geology which helps to facilitate streamflow regulation. Water supply to the local tourism industry is from a fountain derived just below HGM 3 and supplies water throughout the year. The uniqueness of this understudied system combined with the location affords tourism potential and various education opportunities.

HGM 3 was determined to be largely unmodified (PES Category A; Table 8). The only modifications to this system include the existing tourism walkway, most of which is elevated boardwalks and a viewpoint which resulted in some limited vegetation clearing.
