ENVIRONMENTAL IMPACT ASSESSMENT FOR THE PROPOSED LETSOAI CSP 2

SOLAR POWER PLANT:

FAUNA & FLORA SPECIALIST ASSESSMENT

January 2017

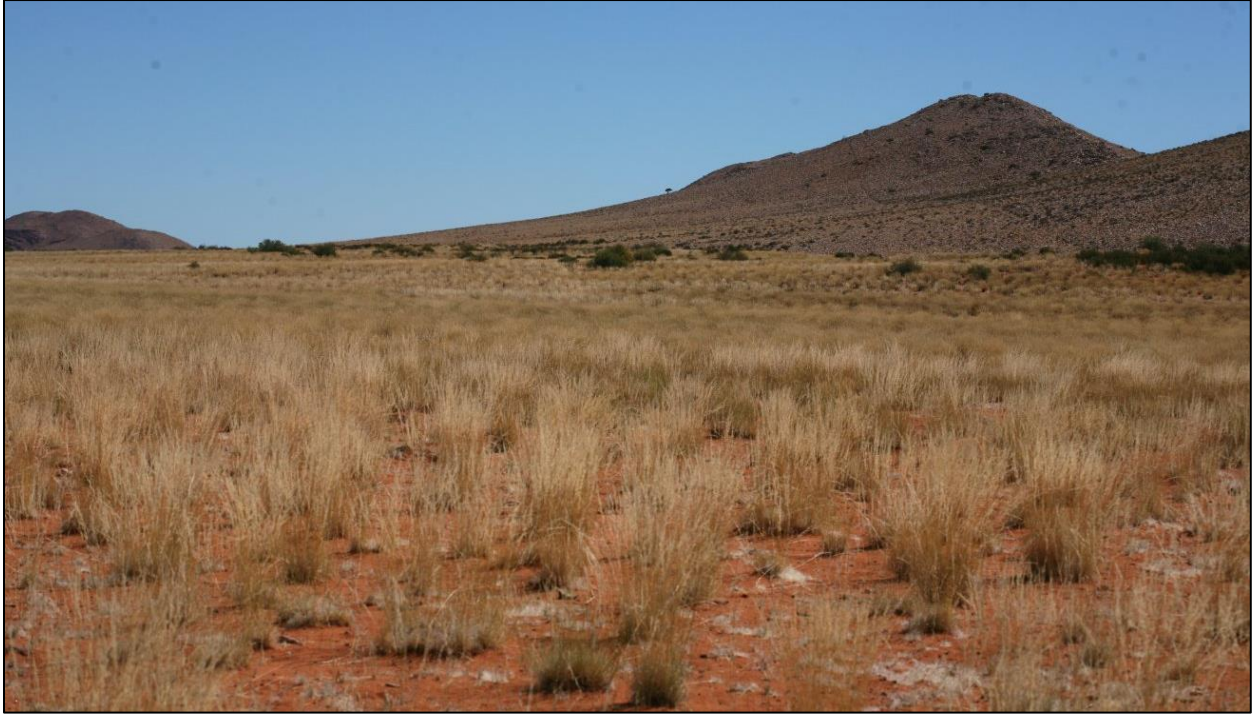
Deeper Aeolian soils within the CSP 2 site are dominated by various *Stipagrostis* grasses with occasional clumps of shrubs, largely *Rhigozum trichotomum*.

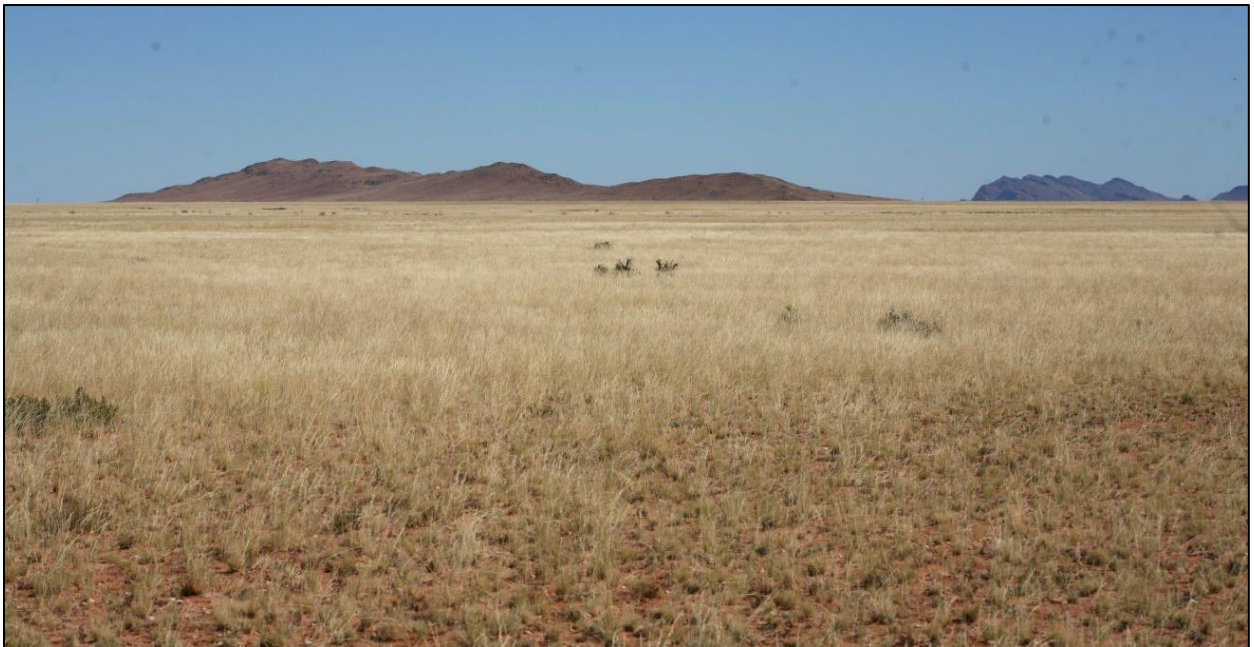
Looking northwest over the CSP 2 site, showing the extensive flat plain the site is located on and the homogenous nature of the vegetation and the lack of features within the development areas. The hill in the distance is outside of the development footprint.

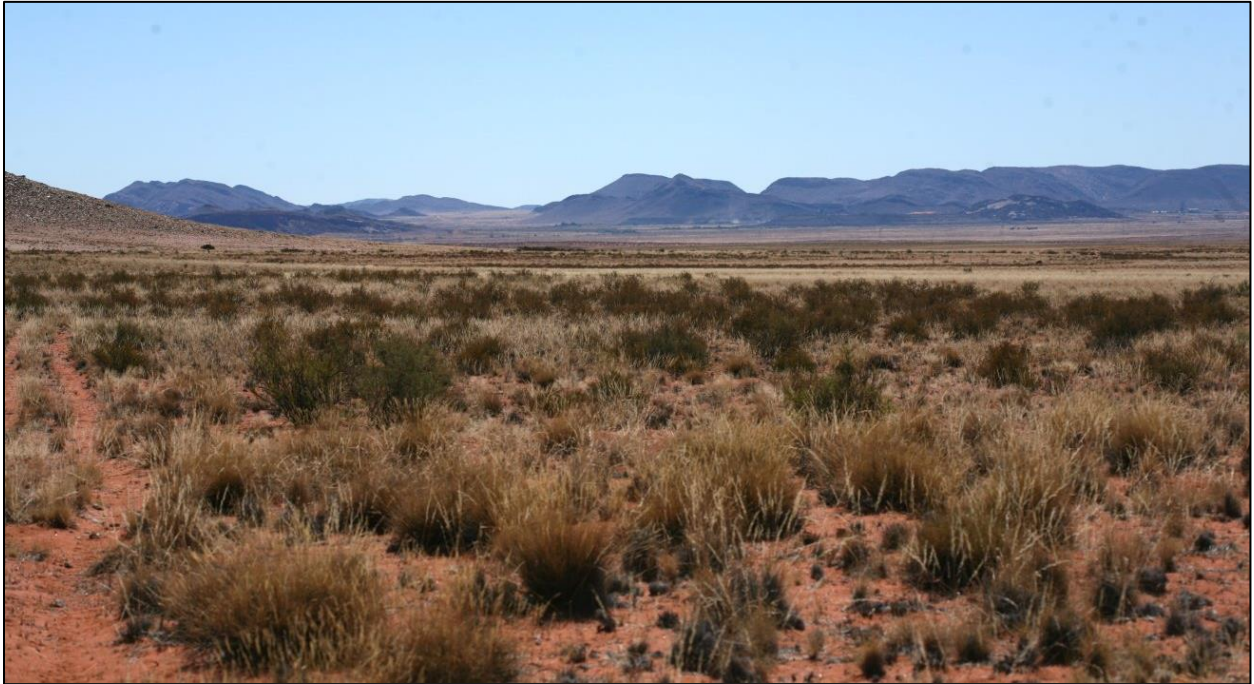
Looking along the alignment of Pipeline 1 and 3 from the site, towards Black Mountain which is visible in the distance. The vegetation is dominated by *Stipagrostis brevifolia* and *S.ciliata* with the shrubs being mostly *Rhigozum trichotomum*. The abundance of species and features of conservation concern in this area is low and it is not considered highly sensitive.

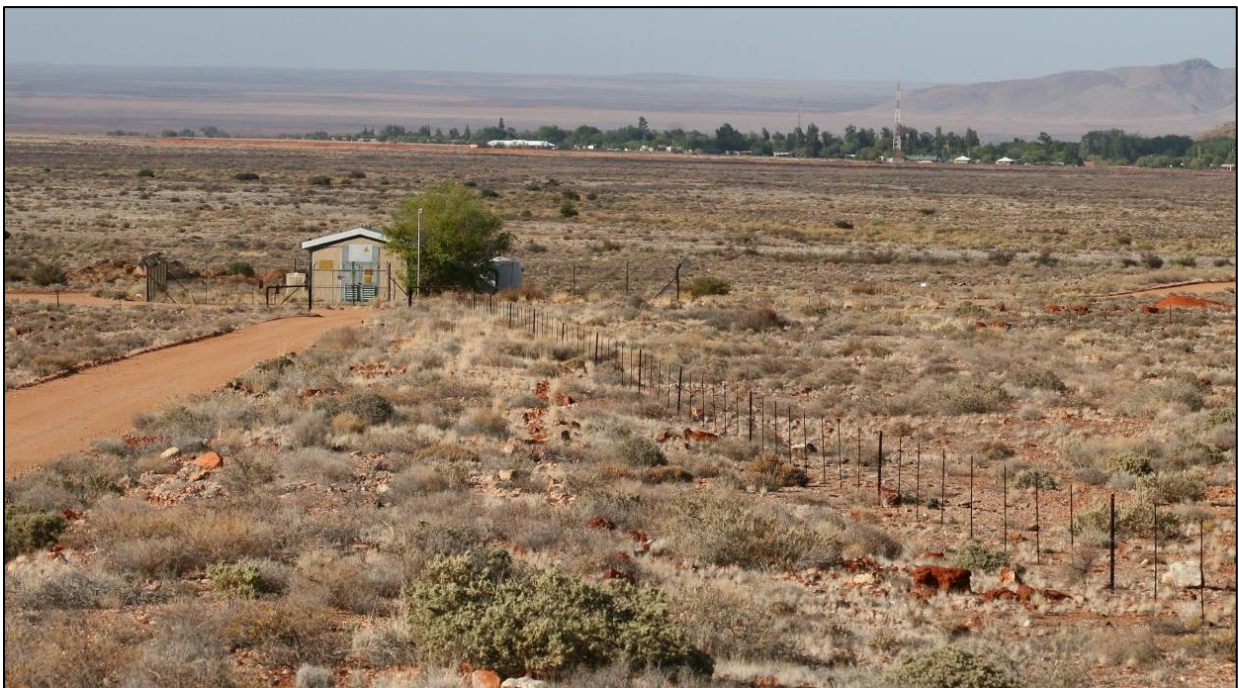
Looking back towards the Letsoai site from the water storage reservoir on Black Mountain Mine, showing the final alignment of Pipeline Option 1 and Option 2. This area is considered moderately sensitive on account of the presence of species and habitats of concern on the plains in this area, where quartz patches are present.

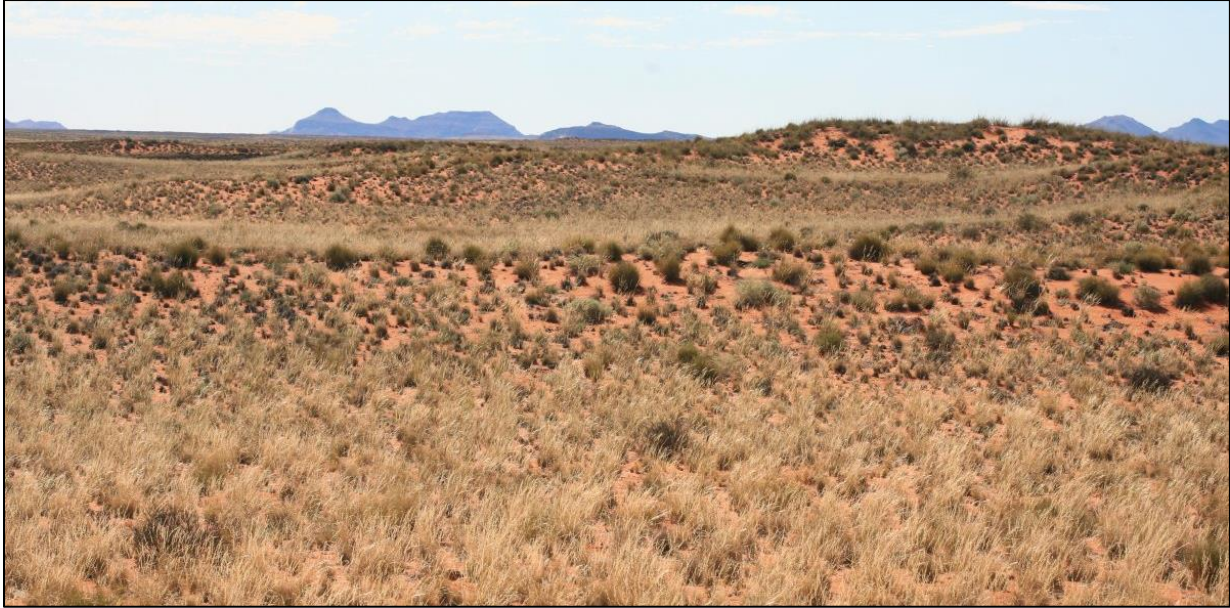
Pipeline Alternative 2 traverses the red dunes of the Koa River valley, which although it does not contain an abundance of listed species, is vulnerable to disturbance due to the mobile sands. Dominant and common species include grasses such as *Stipagrostis ciliata*, *S.brevifolia*, *S.amabilis*, *Centropodia glauca* and *Cladoraphis spinescens* as well as shrubs such as *Requienia sphaerosperma*, *Hermannia tomentosa*, *Monechma incanum*, *Lebeckia spinescens*, *Lycium bosciifolium* and *Crotalaria spartioides*.

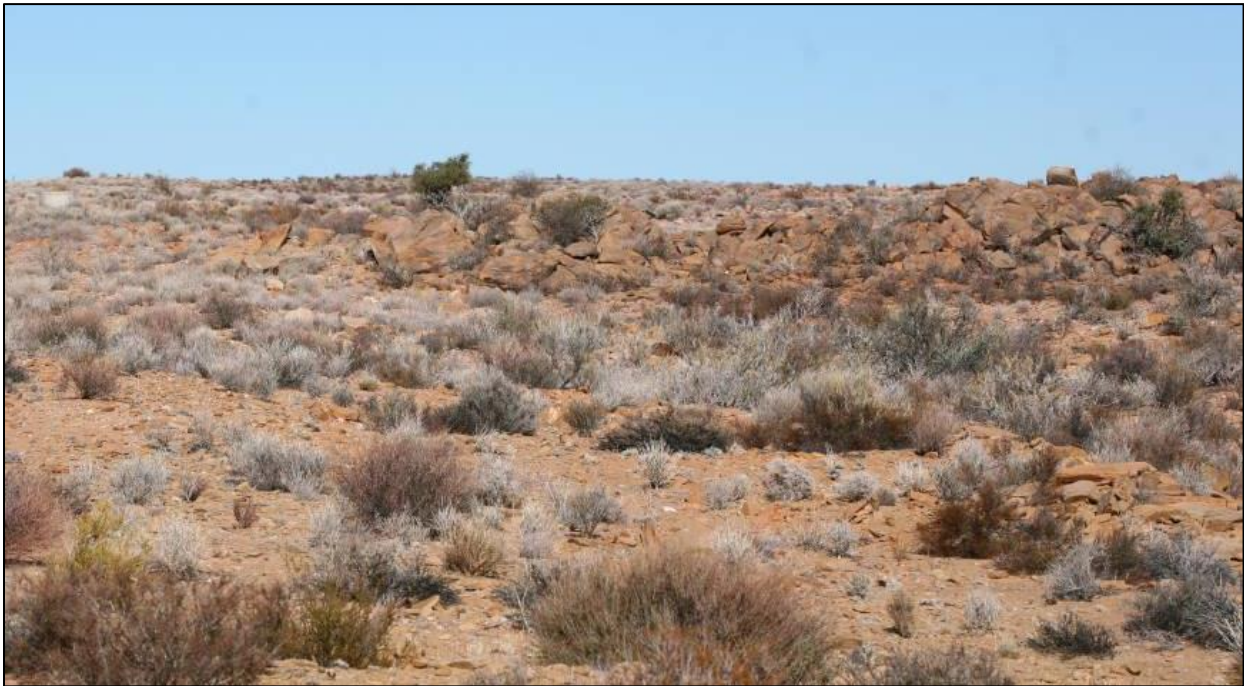
Typical rocky plains habitat along the Pipeline Option 3, between Pella and Aggeneys. The areas of rocky outcrops and shallow gravel soils along this section of the route are typically sensitive with an abundance of listed and endemic species including habitat specialists such as *Titanopsis* and *Lithops*.

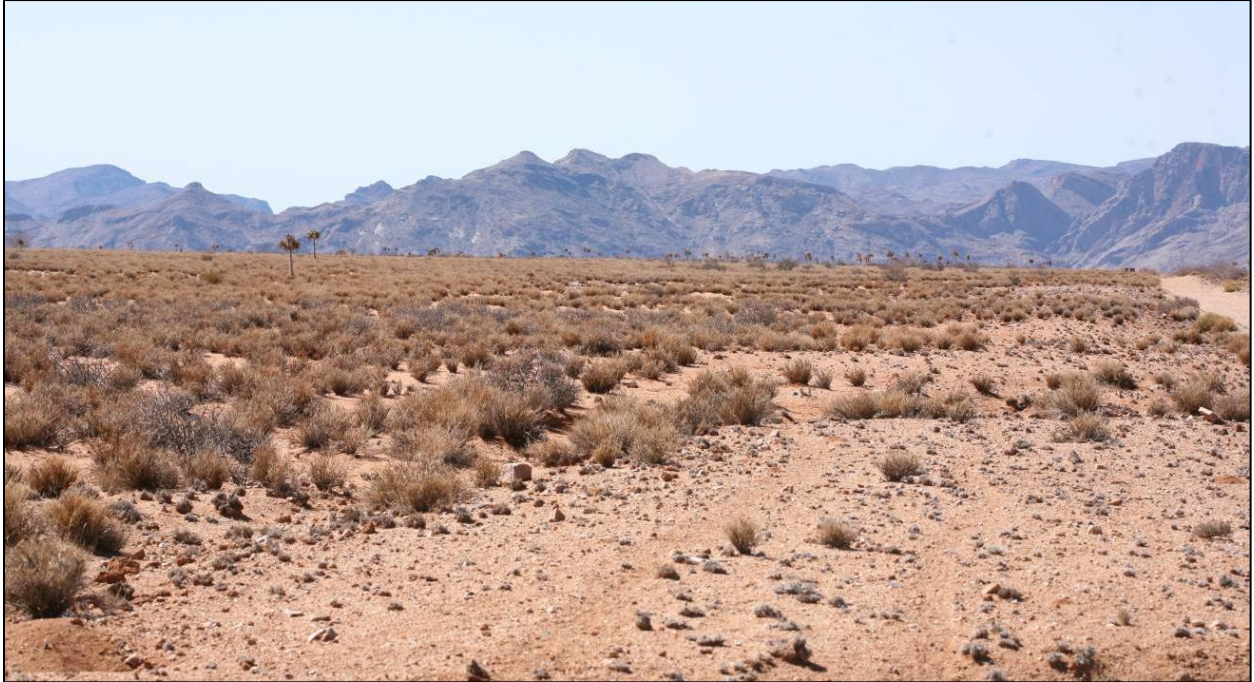
The sandy plains towards Pella, with numerous *Aloe dichotoma* and the mountains along the Orange River visible in the distance. Apart from the *Aloe dichotoma*, there are also several other listed and protected species present in this area and it is considered moderately sensitive.

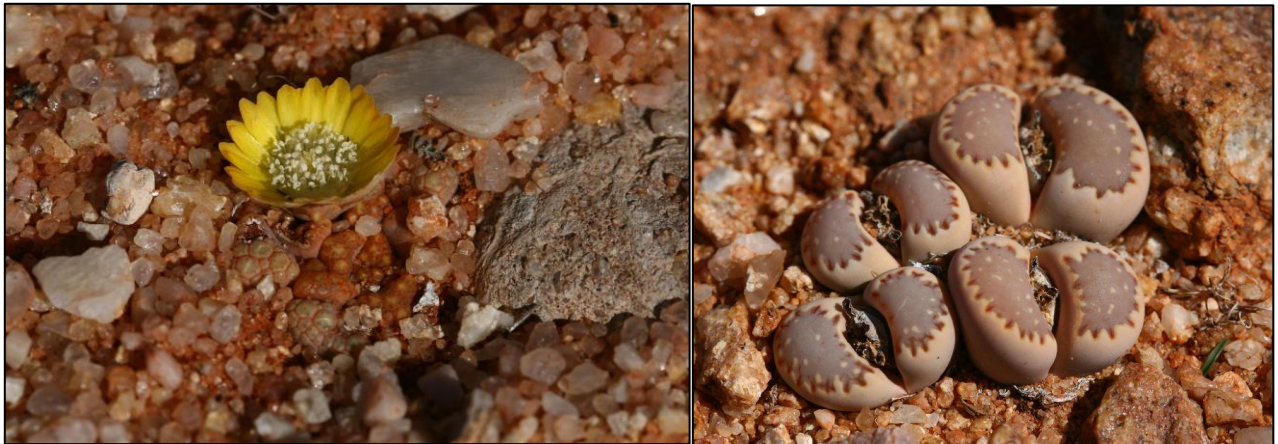
Habitat specialists such as *Titanopsis* and *Lithops* are confirmed present along Pipeline Option 3 between Pella and Aggeneys and although there is already an existing pipeline along the alignment, the new pipeline would extend the current footprint and would be highly likely to affect species of conservation concern.

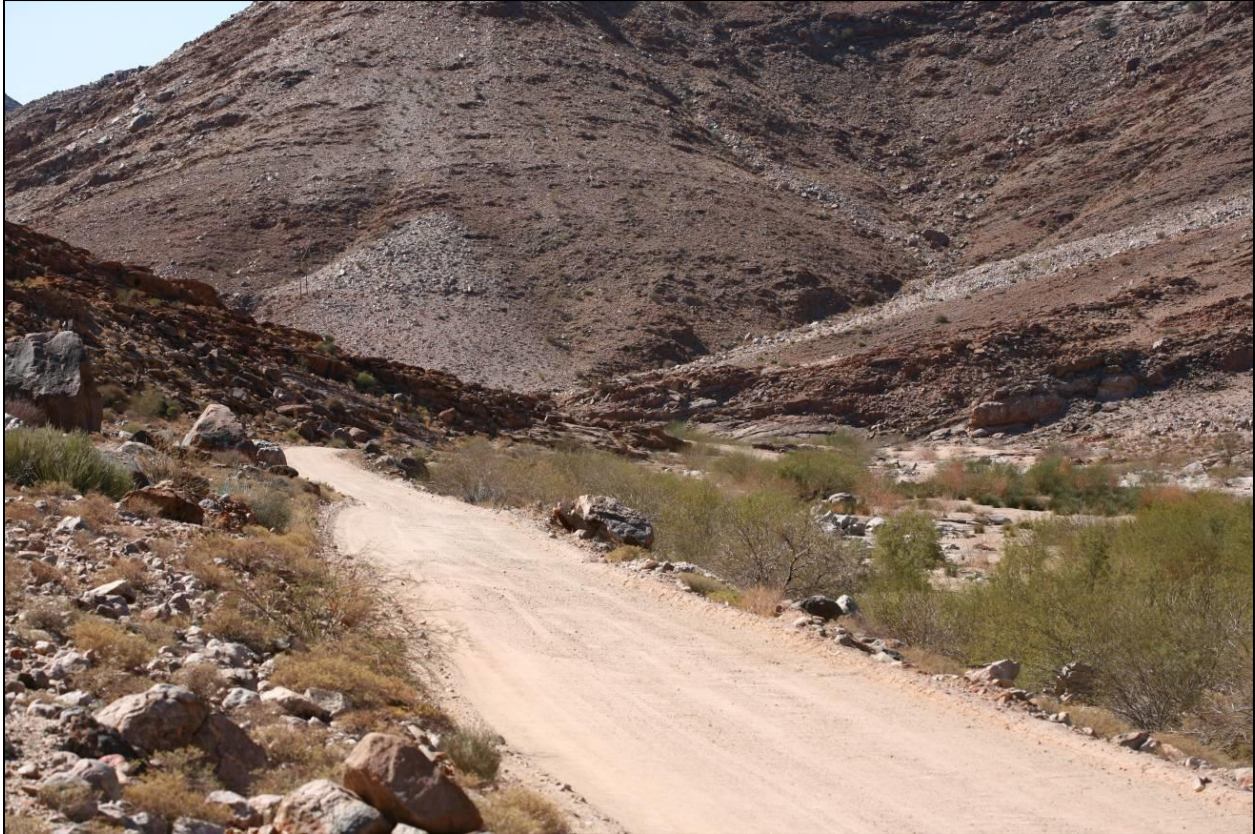
Although there is already a pumpstation at the Orange River at the extraction point, the access to the river is through a narrow gorge and it is difficult to see how an additional pipeline can be accommodated through this section without significant additional disturbance as the existing pipelines will need to be avoided and they have already occupied the most favourable route.
