DRIEFONTEIN PIPE LINE: VEGETATION ASSESSMENT OF THE PROPOSED ALIGNMENT

ECOLOGICAL AND VEGETATION ASSESSMENT OF THE PROPOSED DRIEFONTEIN WATER PIPE LINE AND ANCILLARY INFRASTRUCTURE, EXTENDING FROM LADYSMITH (EMNAMBITHI LOCAL MUNICIPALITY) TO EKUVUKHENI (INDAKA LOCAL MUNICIPALITY)

Proposed Driefontein Water Pipe Line from Ladysmith to Ekuvukheni

**CULTURAL HERITAGE IMPACT ASSESSMENT OF
THE PROPOSED DRIEFONTEIN PIPELINE
DEVELOPMENT, EMNAMBITHI/LADYSMITH
LOCAL MUNICIPALITY**

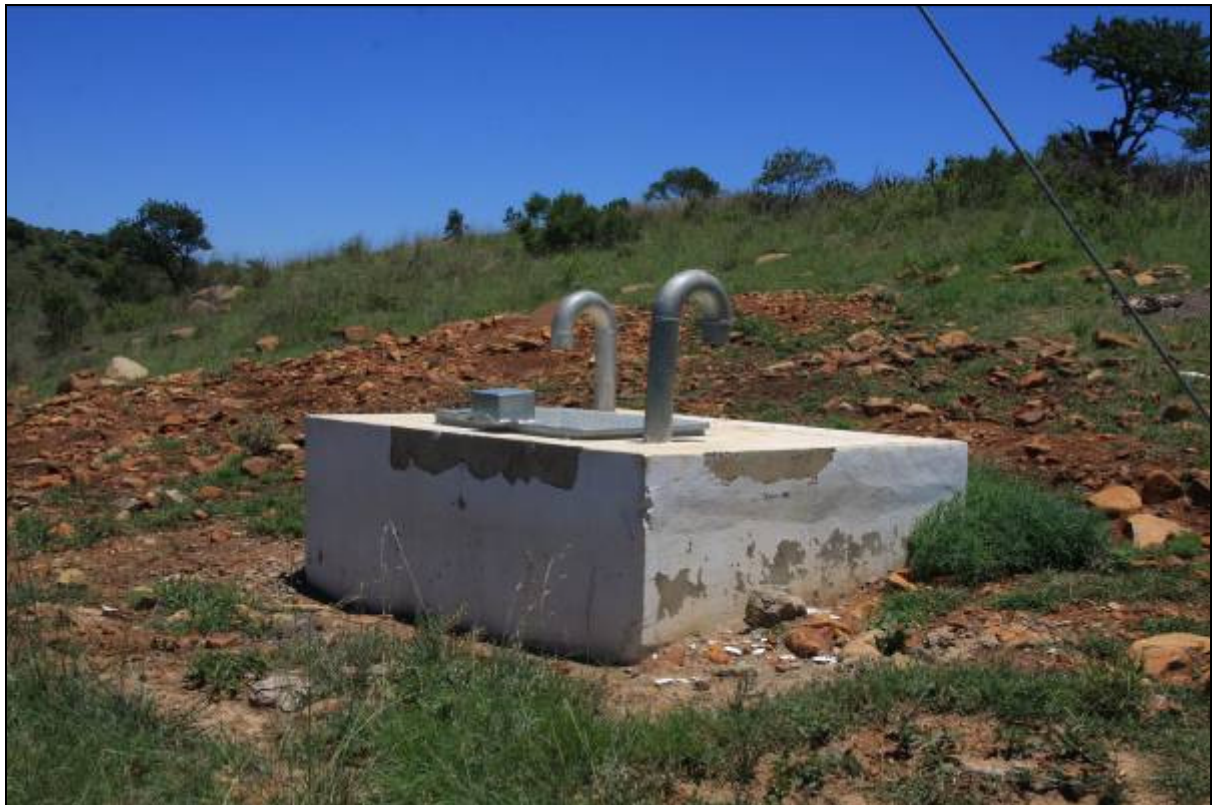
Plate 6. Air valve chamber on an existing pipe line. These will be required at certain positions along the entire length of pipe line.

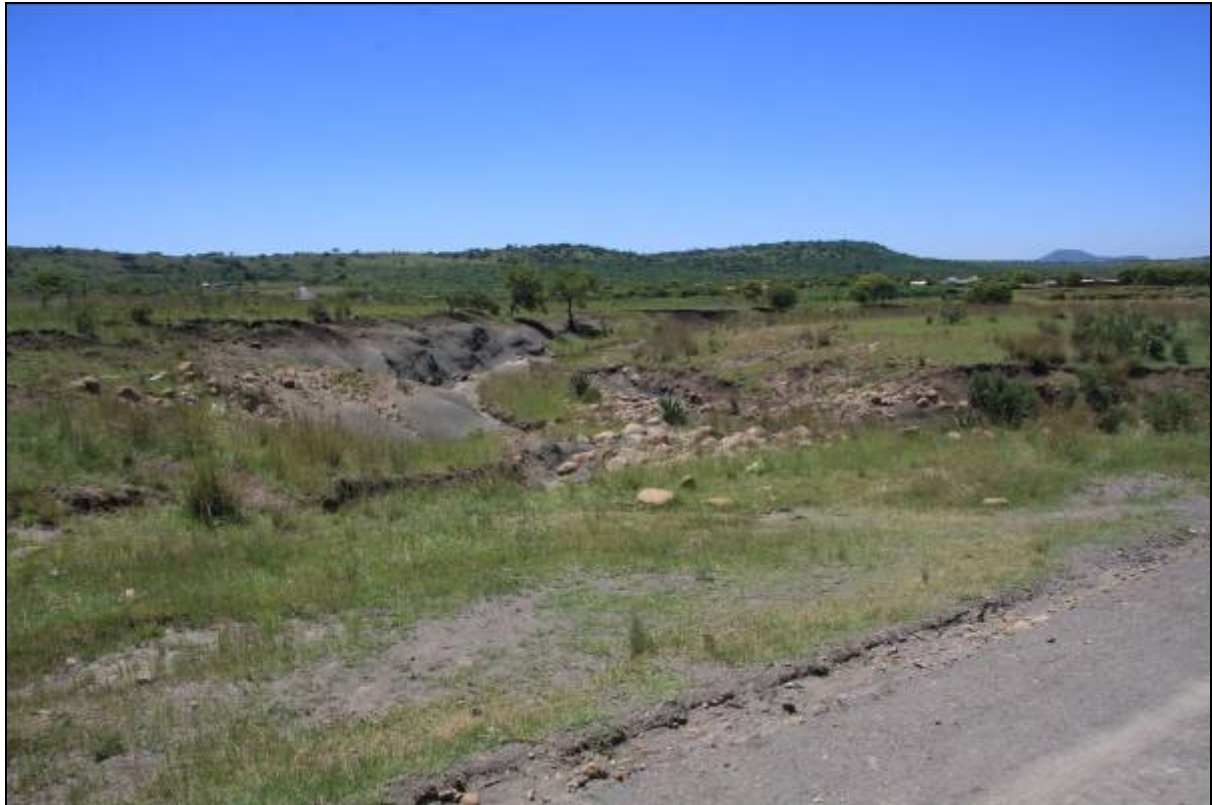
Plate 7. Messianic soils which are common along the SadersFarm / Hobsland portion of the pipe line. These soils are extremely erodible and very unstable and will make pipe placement in water courses difficult.

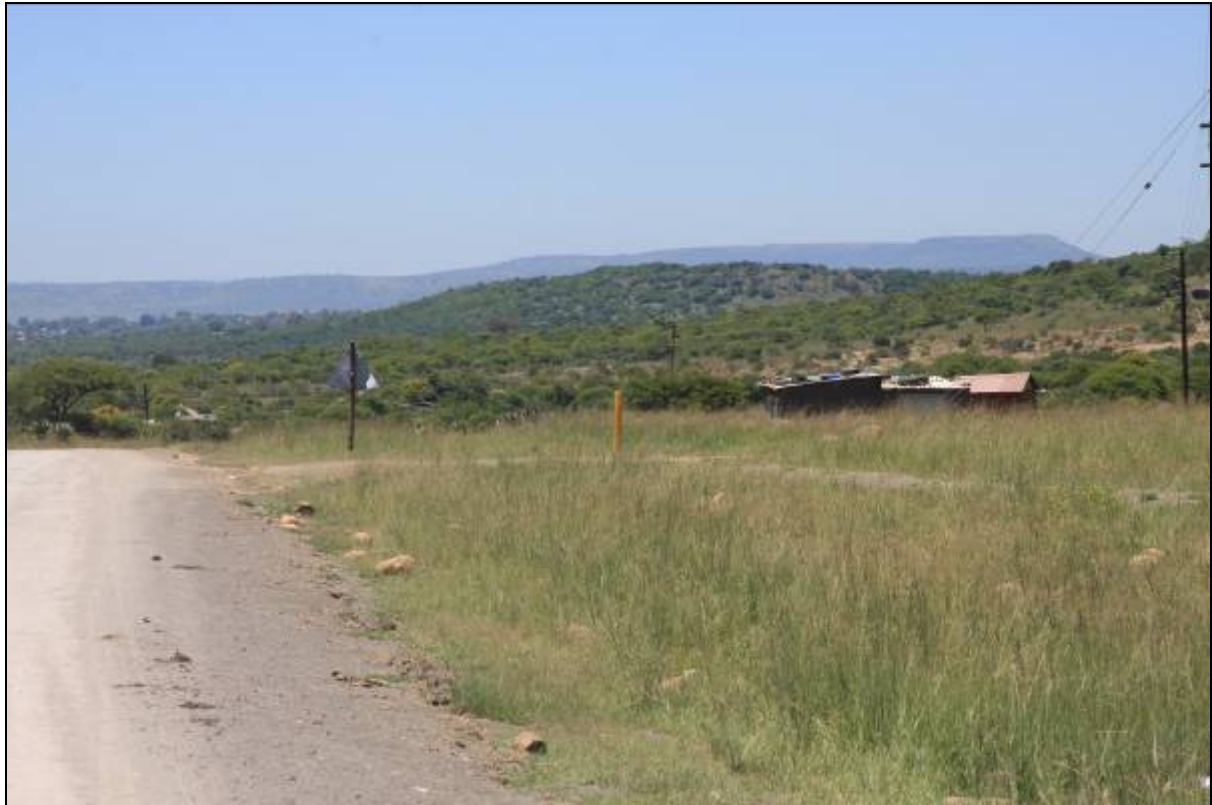
Plate 9. Existing pipe line infrastructure (yellow marker beacon).

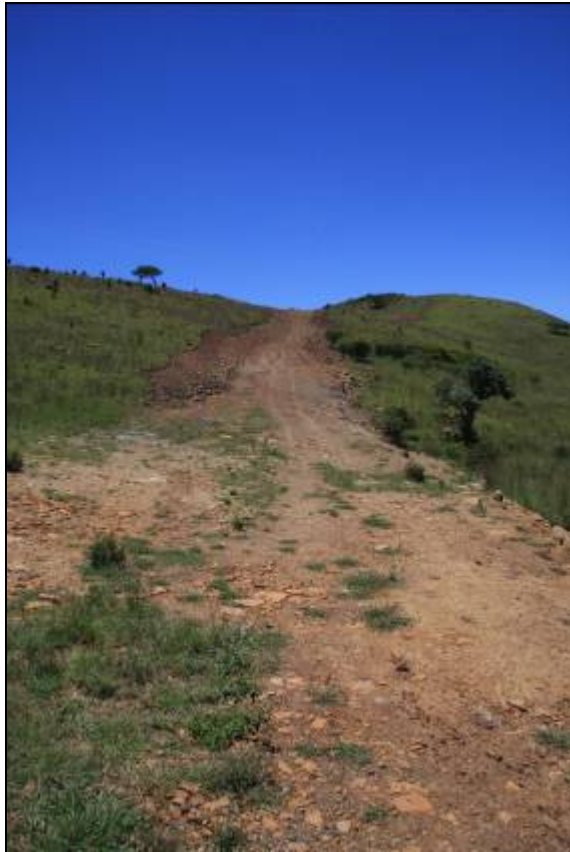
Plate 11. Existing pipe line and alignment to be followed

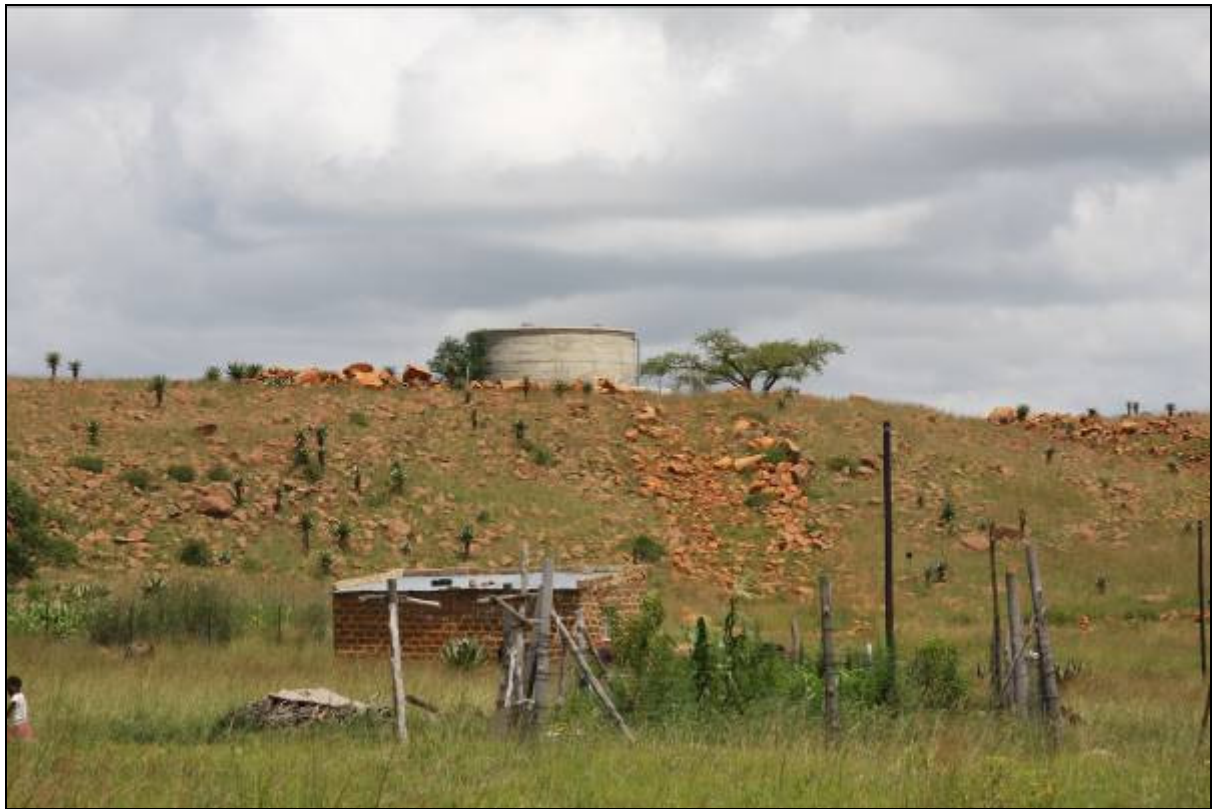
Plate 15. Wasbank Reservoir already constructed and awaiting bulk water supply feed.

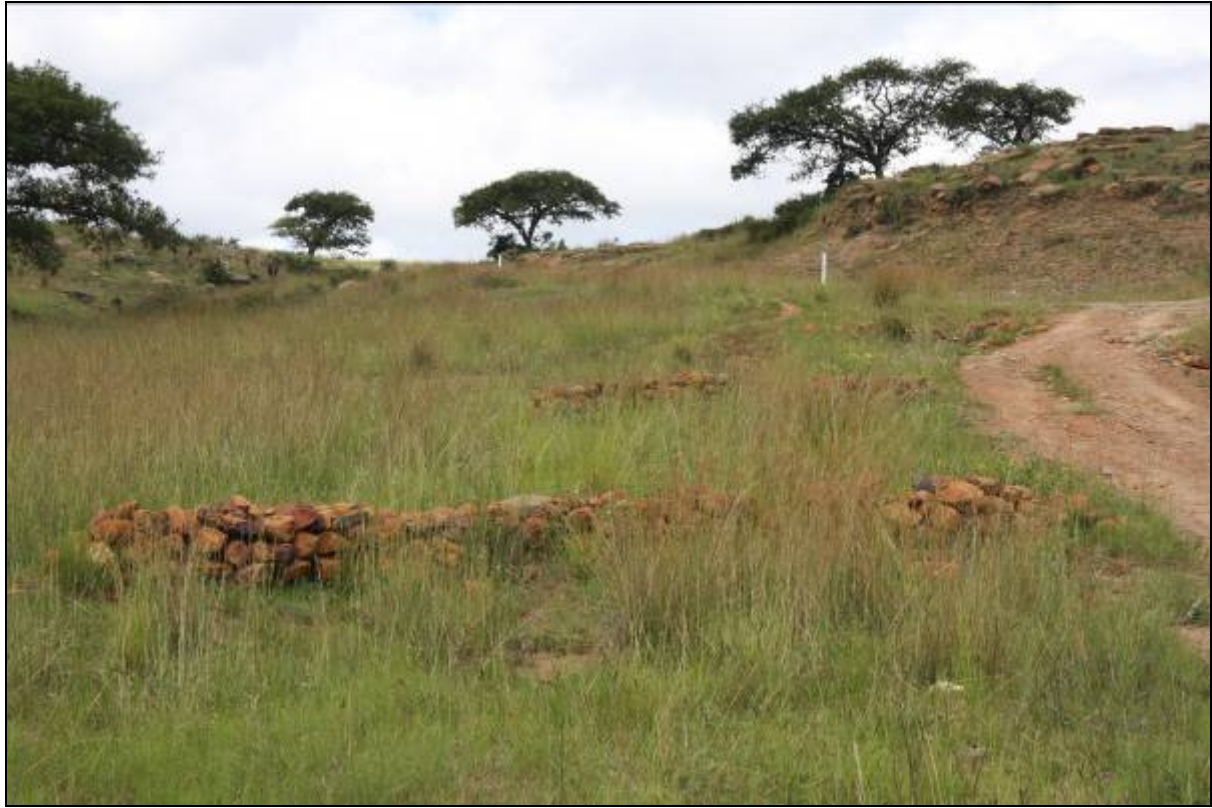
Plate 16. Erosion control measures used to reduce erosion risks on steep slopes

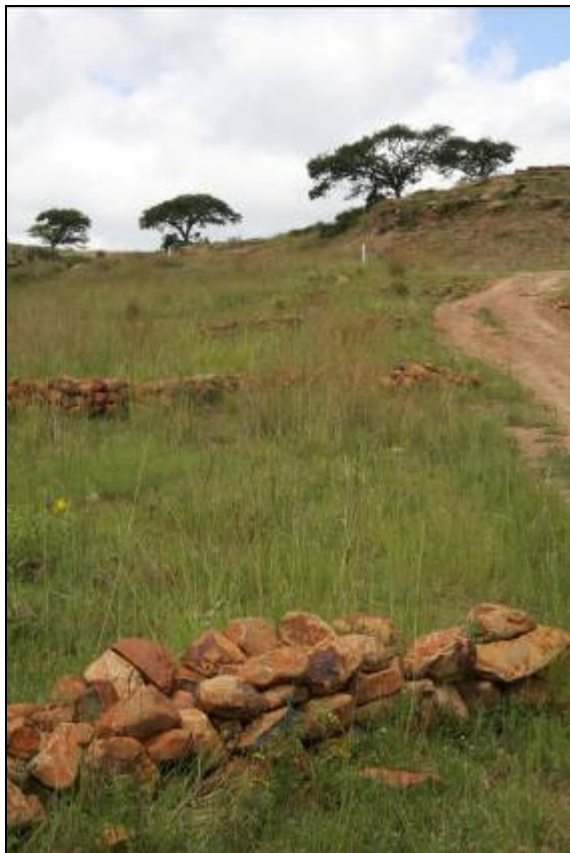
Plate 23. Erosion control measures

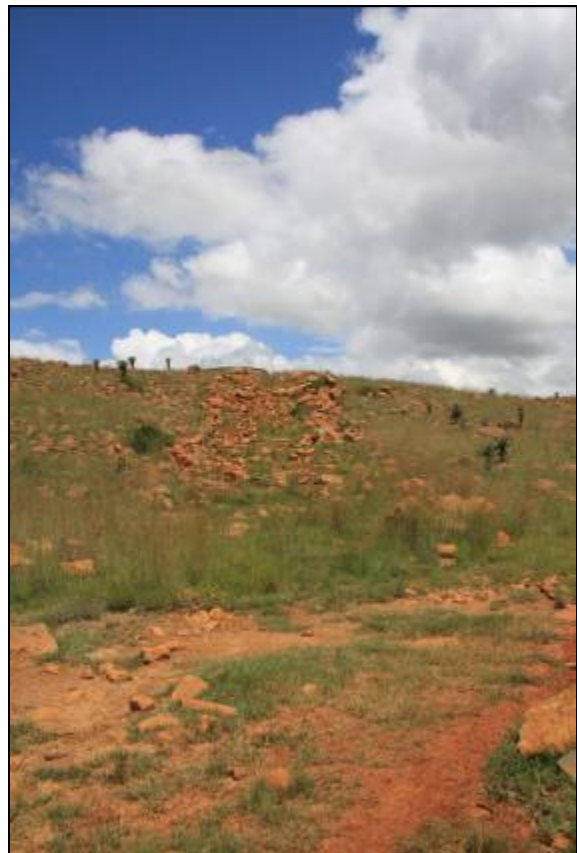
Plate 24. Pipe line excavations that are recovering.

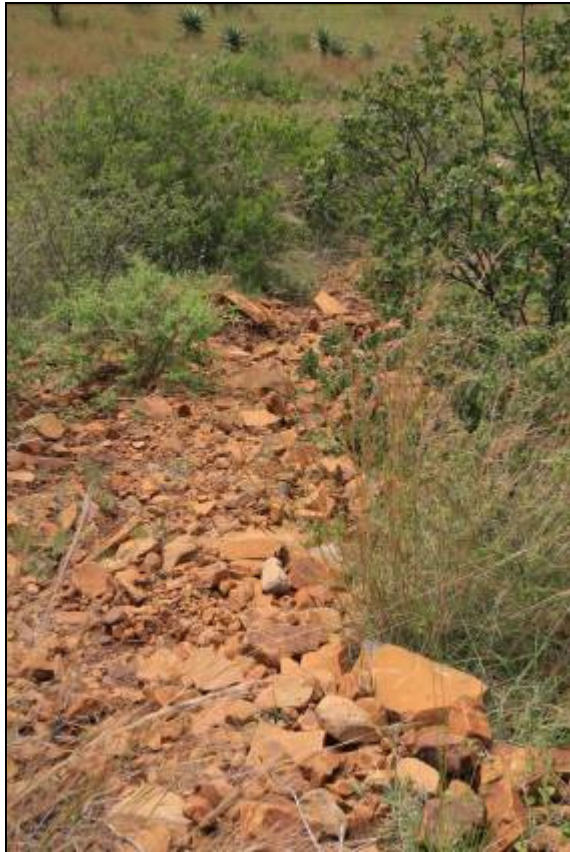
Plate 25. Excavations for a pipe line that has not undergone rehabilitation and is exposed to significant erosion.

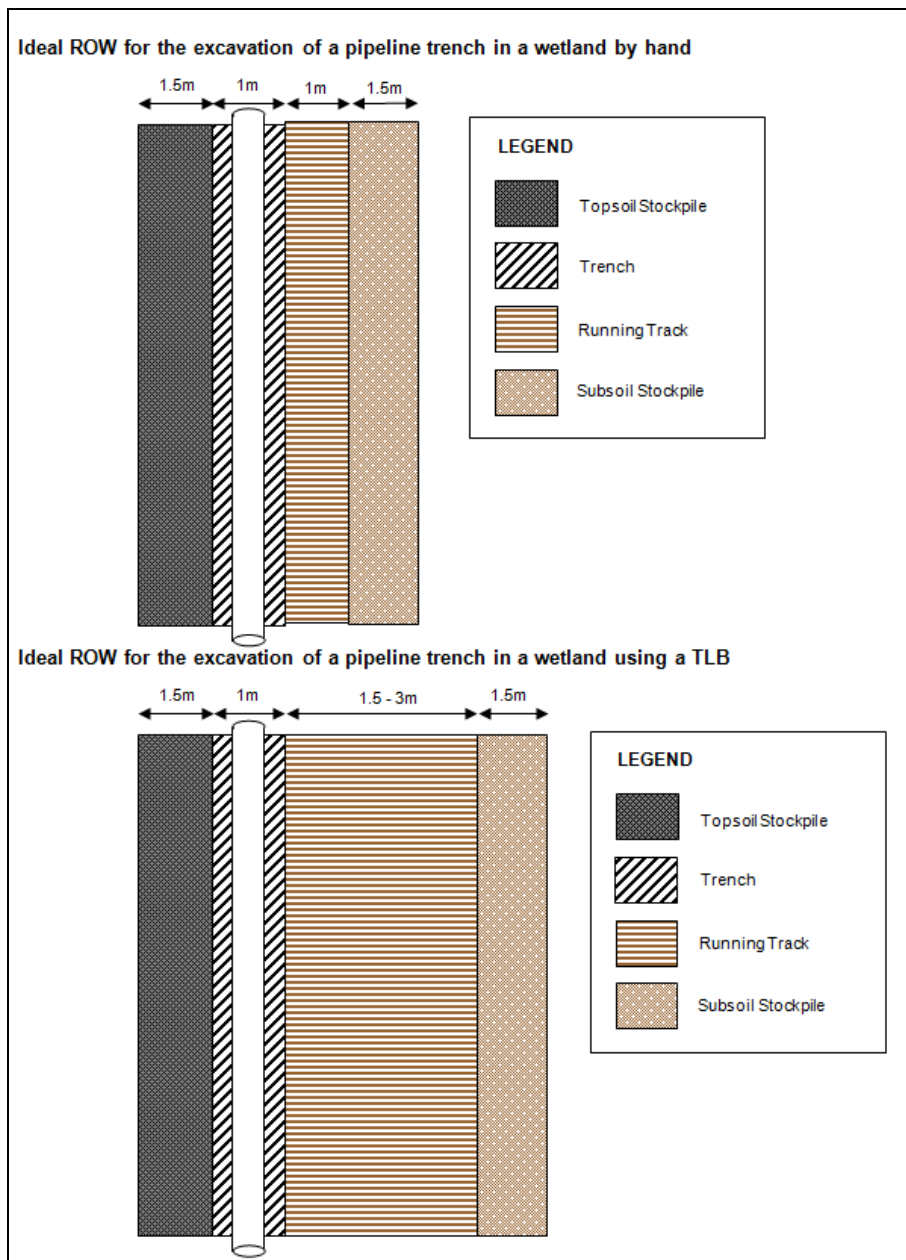
Figure 10: Recommended trenching diagrams
