## CHAPTER SEVEN: SPECIALIST AQUATIC IMPACT ASSESSMENT

The provisional development proposal entails the development of an additional approximately 300 hectares on the Remainder of Farm 82 Wolve Kop (~908 ha), Portion 1 of Farm 77 Wellshaven (~22ha) and Portion 3 of Farm 77 Honeyvale (~128ha) for agricultural purposes. The expansion of the agricultural infrastructure of the farm will include the clearing of indigenous vegetation, landscaping and levelling the site for citrus orchards, installation of water reticulation and irrigation infrastructure, construction of a balancing dam, the establishment of unpaved access roads and the establishment of windbreaks (Detail in Chapter 2).

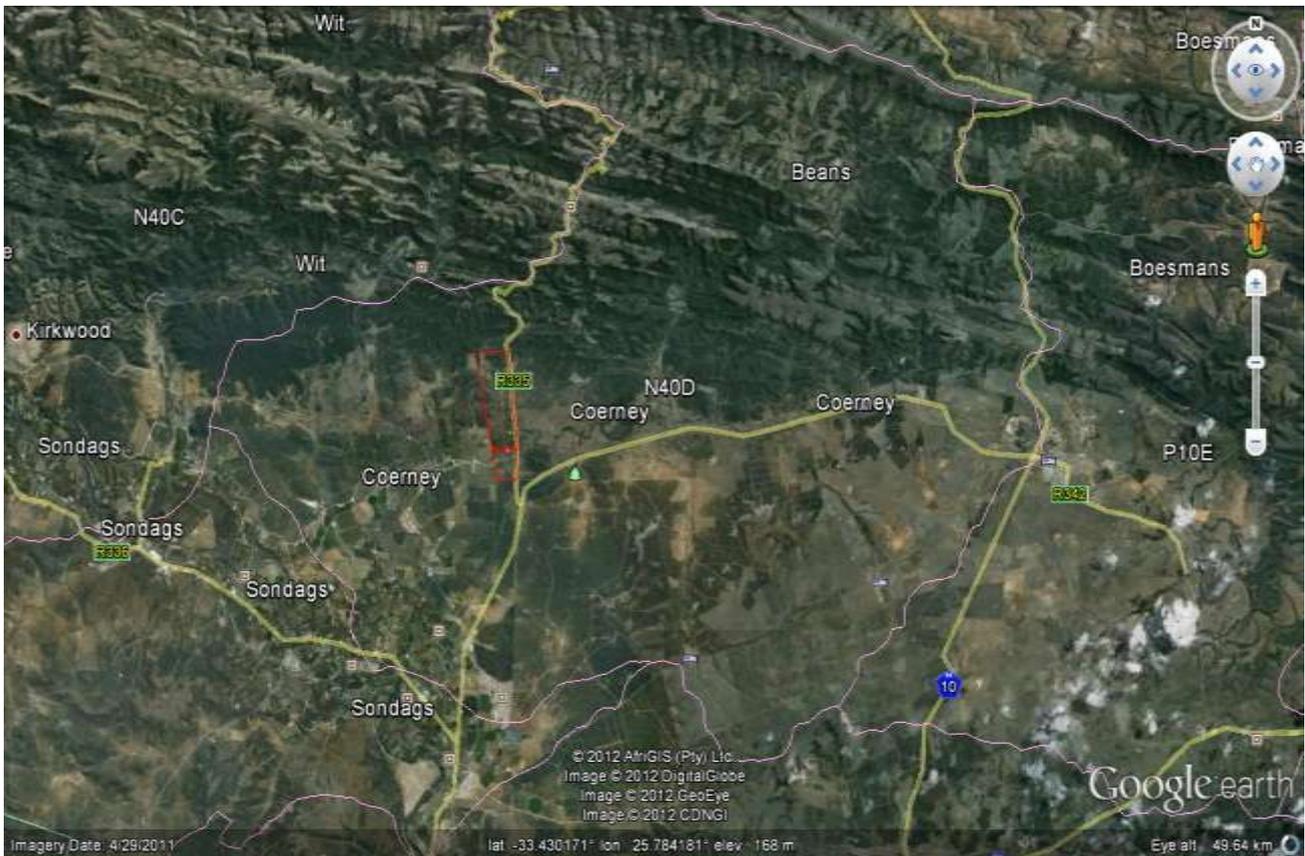
Figure 7.1: Google Earth image of the study area indicating study locality in red and regional quaternary catchments

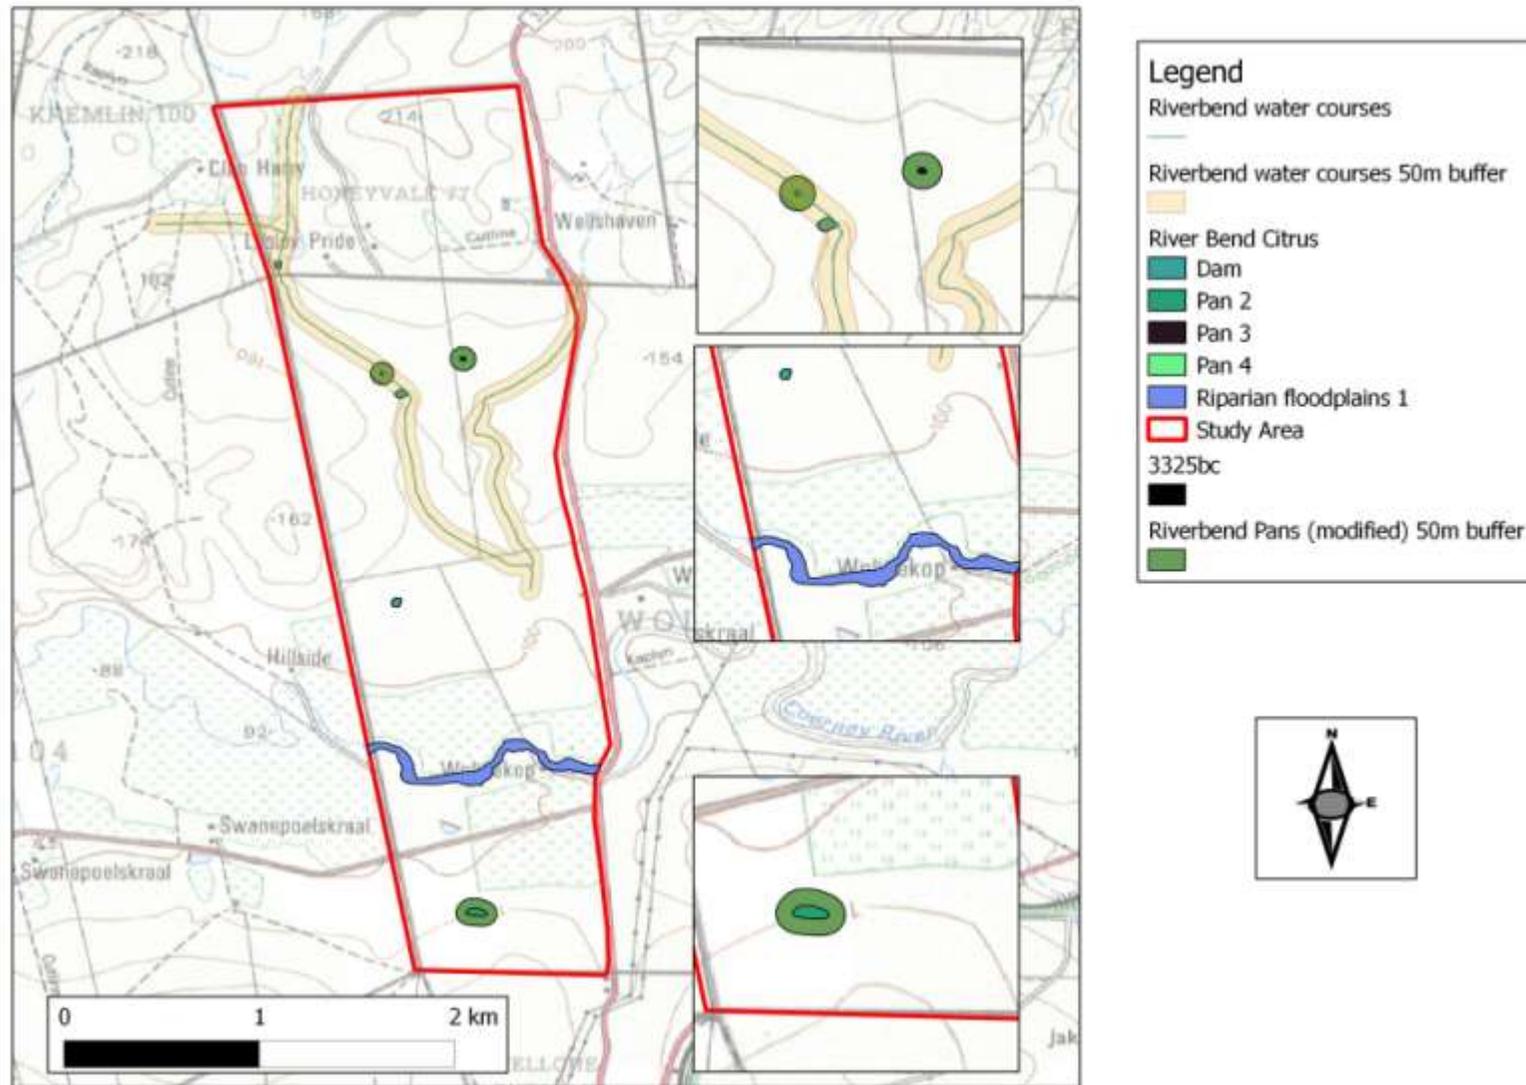
Figure 7.2 below maps the respective natural and near natural water bodies found within the study area.

Figure 7.2: The respective natural and near natural water bodies found within the study area

The study area hydrology was characterised by typical Zuurberg foothill water courses found to the north of the Coerney River (Figure 7.2). The Coerney drains in a westerly direction and then flows into the Sundays River. The site is found in the N40D quaternary catchment. Surface flows in the proposed development site would be limited to periods with high rainfall only.

With regards to the observed wetlands, these six areas (Figure 7.2) were defined as endorheic pans, of which only three remain partly functional as pans / depressions. These pans can further be defined by the National Wetland Classification system as endorheic systems based on the following definitions:

With regard the wetland areas, only two facultative hydrophilic plants species were evident namely *Juncus effuses* and *Cyperus spp* (grazed, thus no identification could be made). These species were found in areas with permanent inundation. Therefore these area form unique habitats within the landscape and the EIS of the three remaining pans (Figure 7.2) would be rated as **MODERATE**.

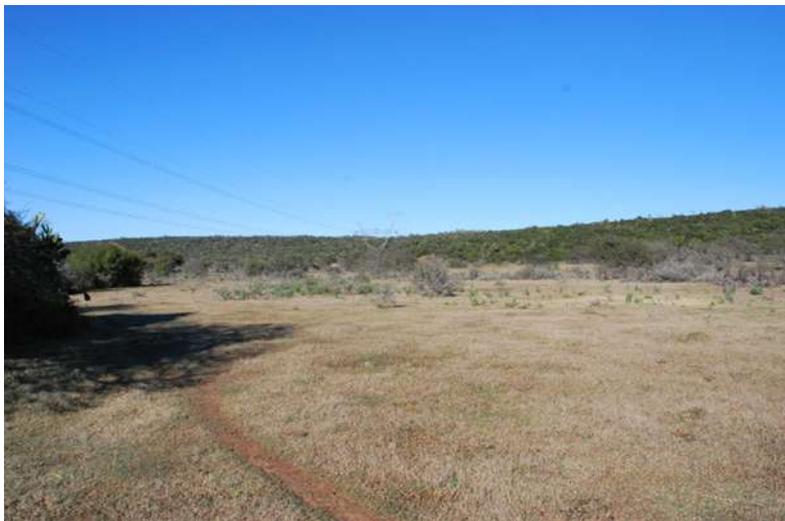
Photo 7.1: Example of cleared areas historically used for the cultivation of wheat.

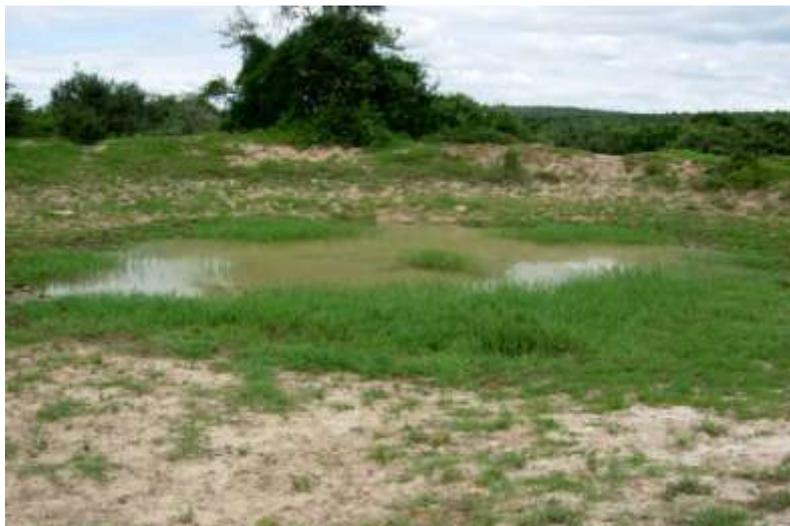
Photo 7.2: The typical scenario within the region, where the natural depression has been altered by increasing its catchment depth, through excavation of the pan floor.

Photo 7.2 indicates the typical scenario within the region, where the natural depression has been altered by increasing its catchment depth, through excavation of the pan floor. The area however still functions as a pan and several wetland plant and animals species still make use of the available habitat. Therefore although modified these three pans would be considered wetlands due to the functional role they play within the landscape.
