# COASTAL ZONE ASSESSMENT SURVEY FIRTH OF CLYDE & ISLE OF BUTE

Report No. 876

Commissioned by  
The SCAPE Trust & Firth of Clyde Forum  
on behalf of Historic Scotland

August 2004

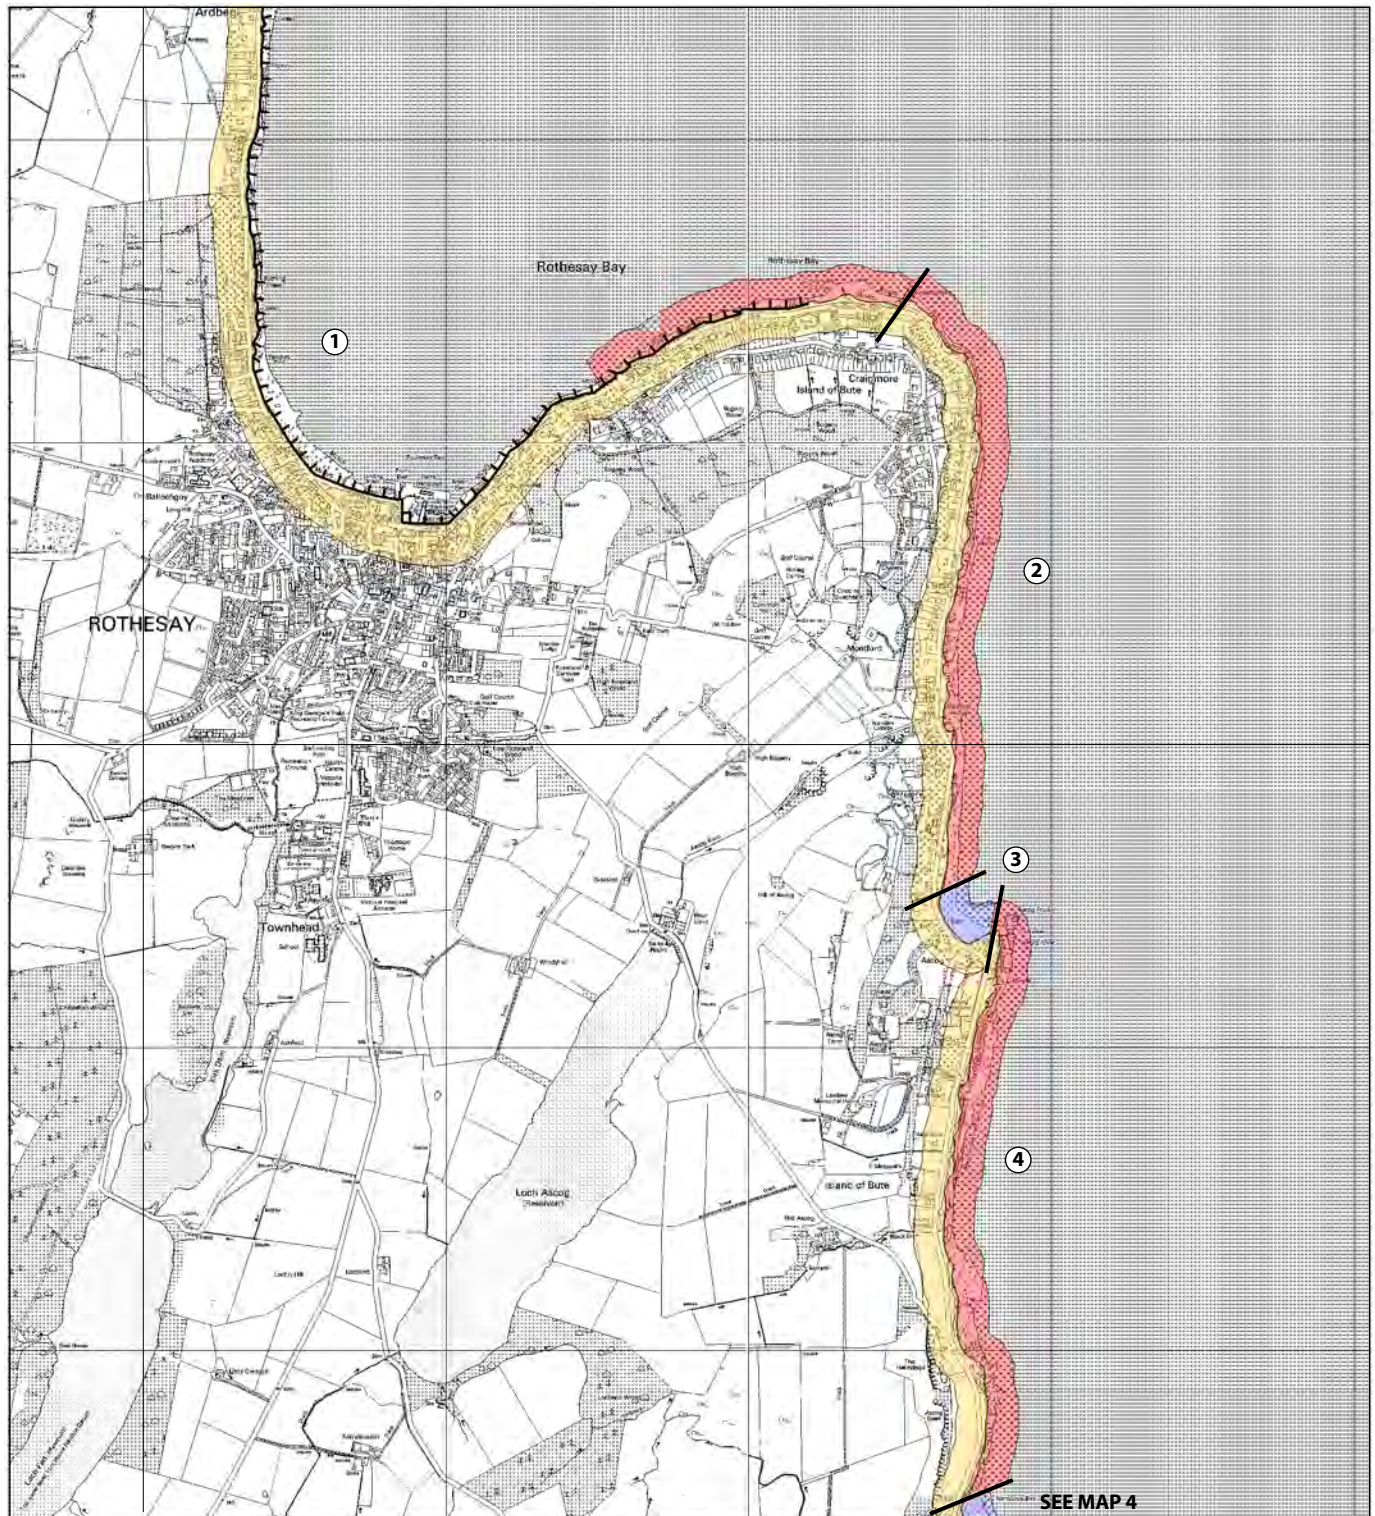
This section of coastline is uniform comprising low rock abrasion platforms interspersed by boulders and shingle. Outcropping Tertiary dykes are exposed on the shoreline. The hinterland consists of marine deposits.

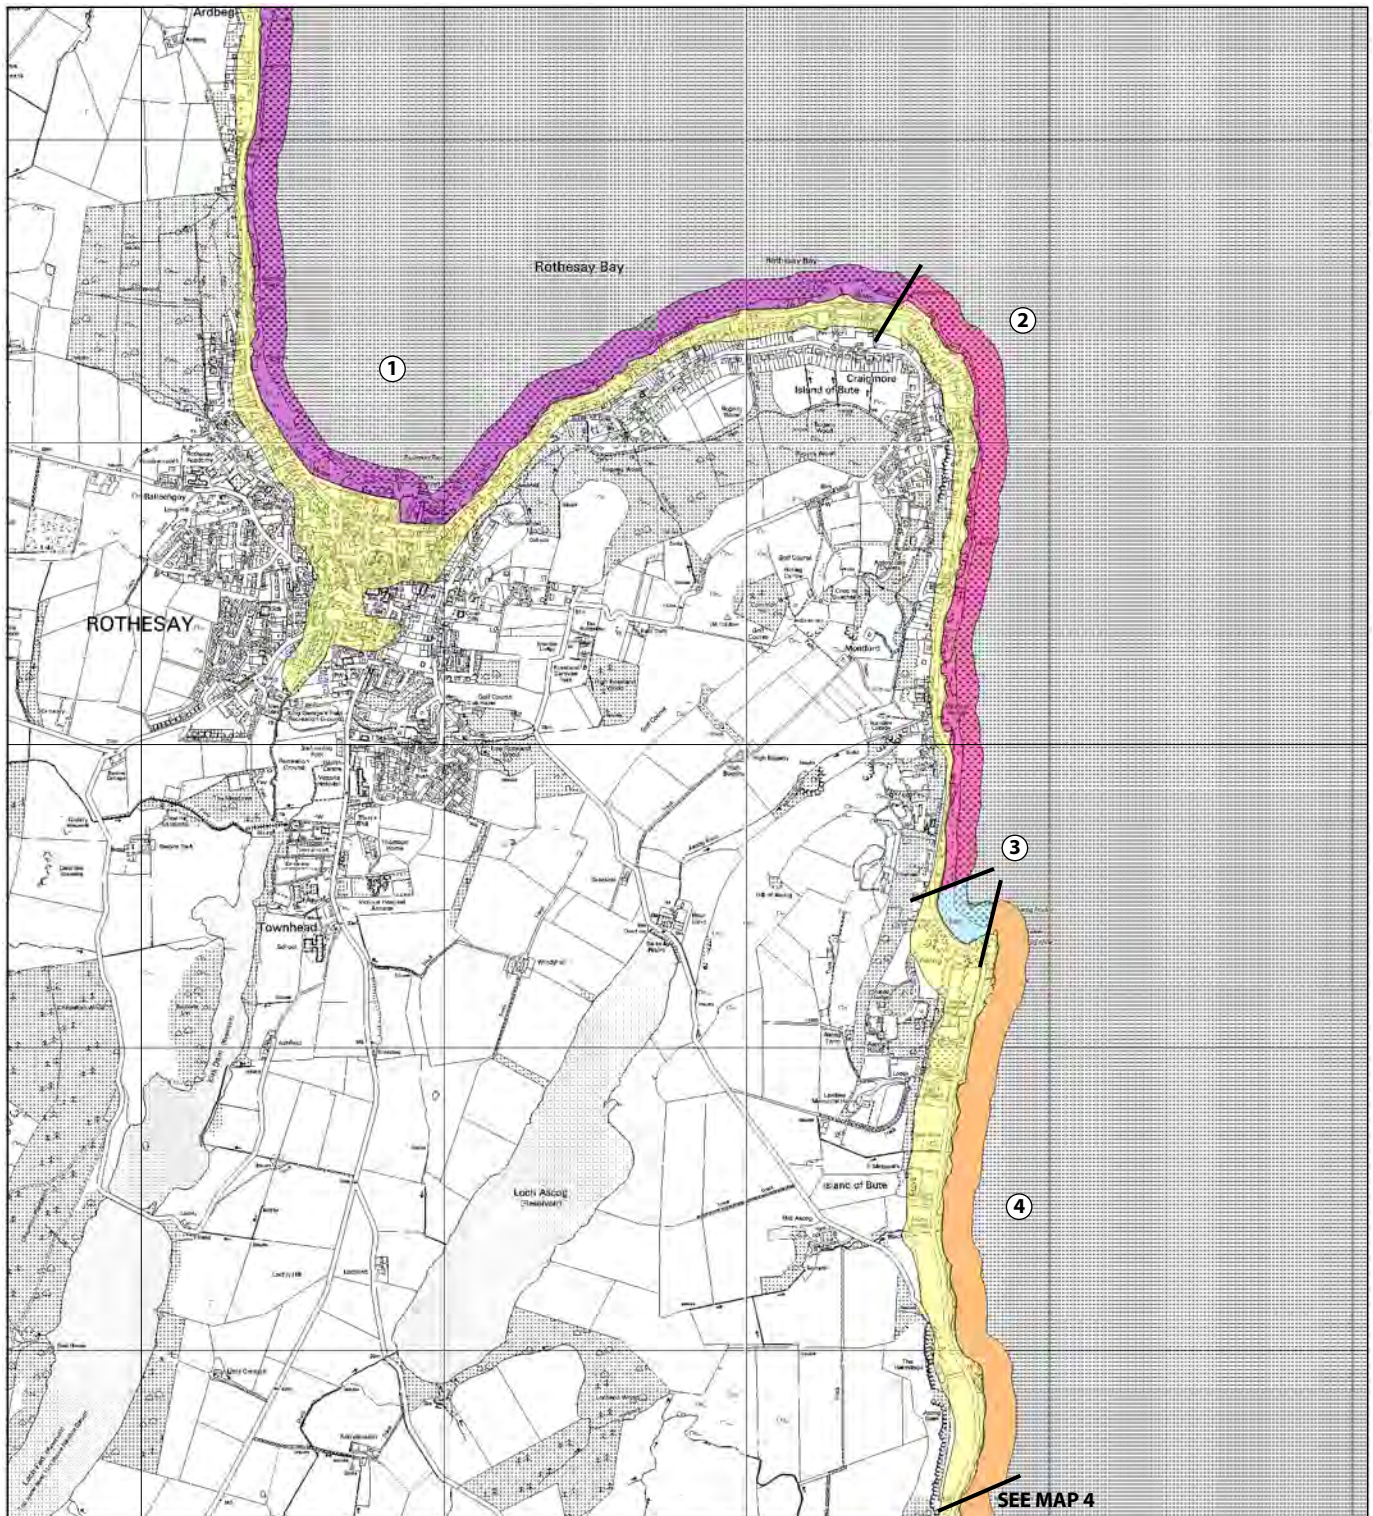
Both accreting and eroding

This section of coastline is experiencing both accretion and erosion. The low abrasion platforms are being scoured during storm conditions and shingle is being banked up at the HWMS mark.

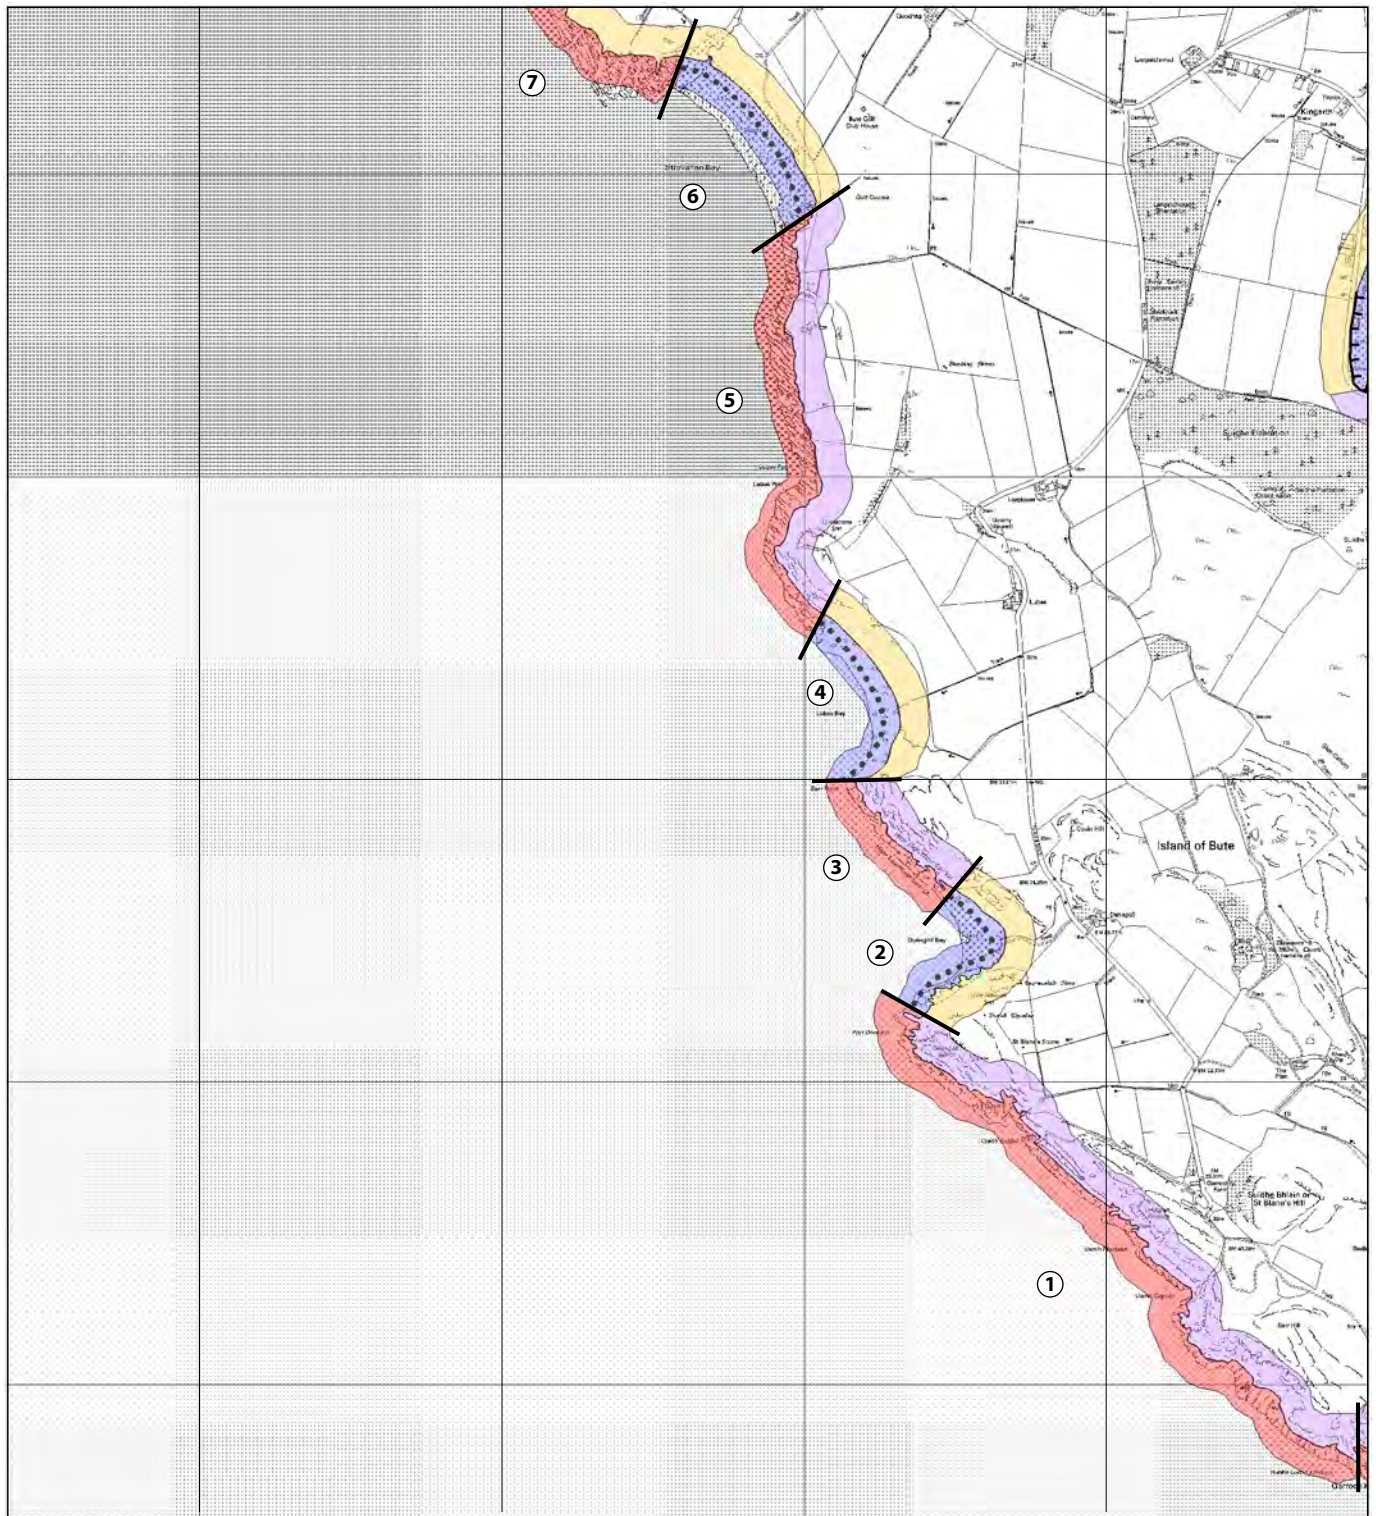
This section of coastline, as with the previous one, is subjected to the full fetch of south westerly gales. Abrasion platforms dominate the shoreline. The hinterland consists of boulder clay over outcropping bedrock.

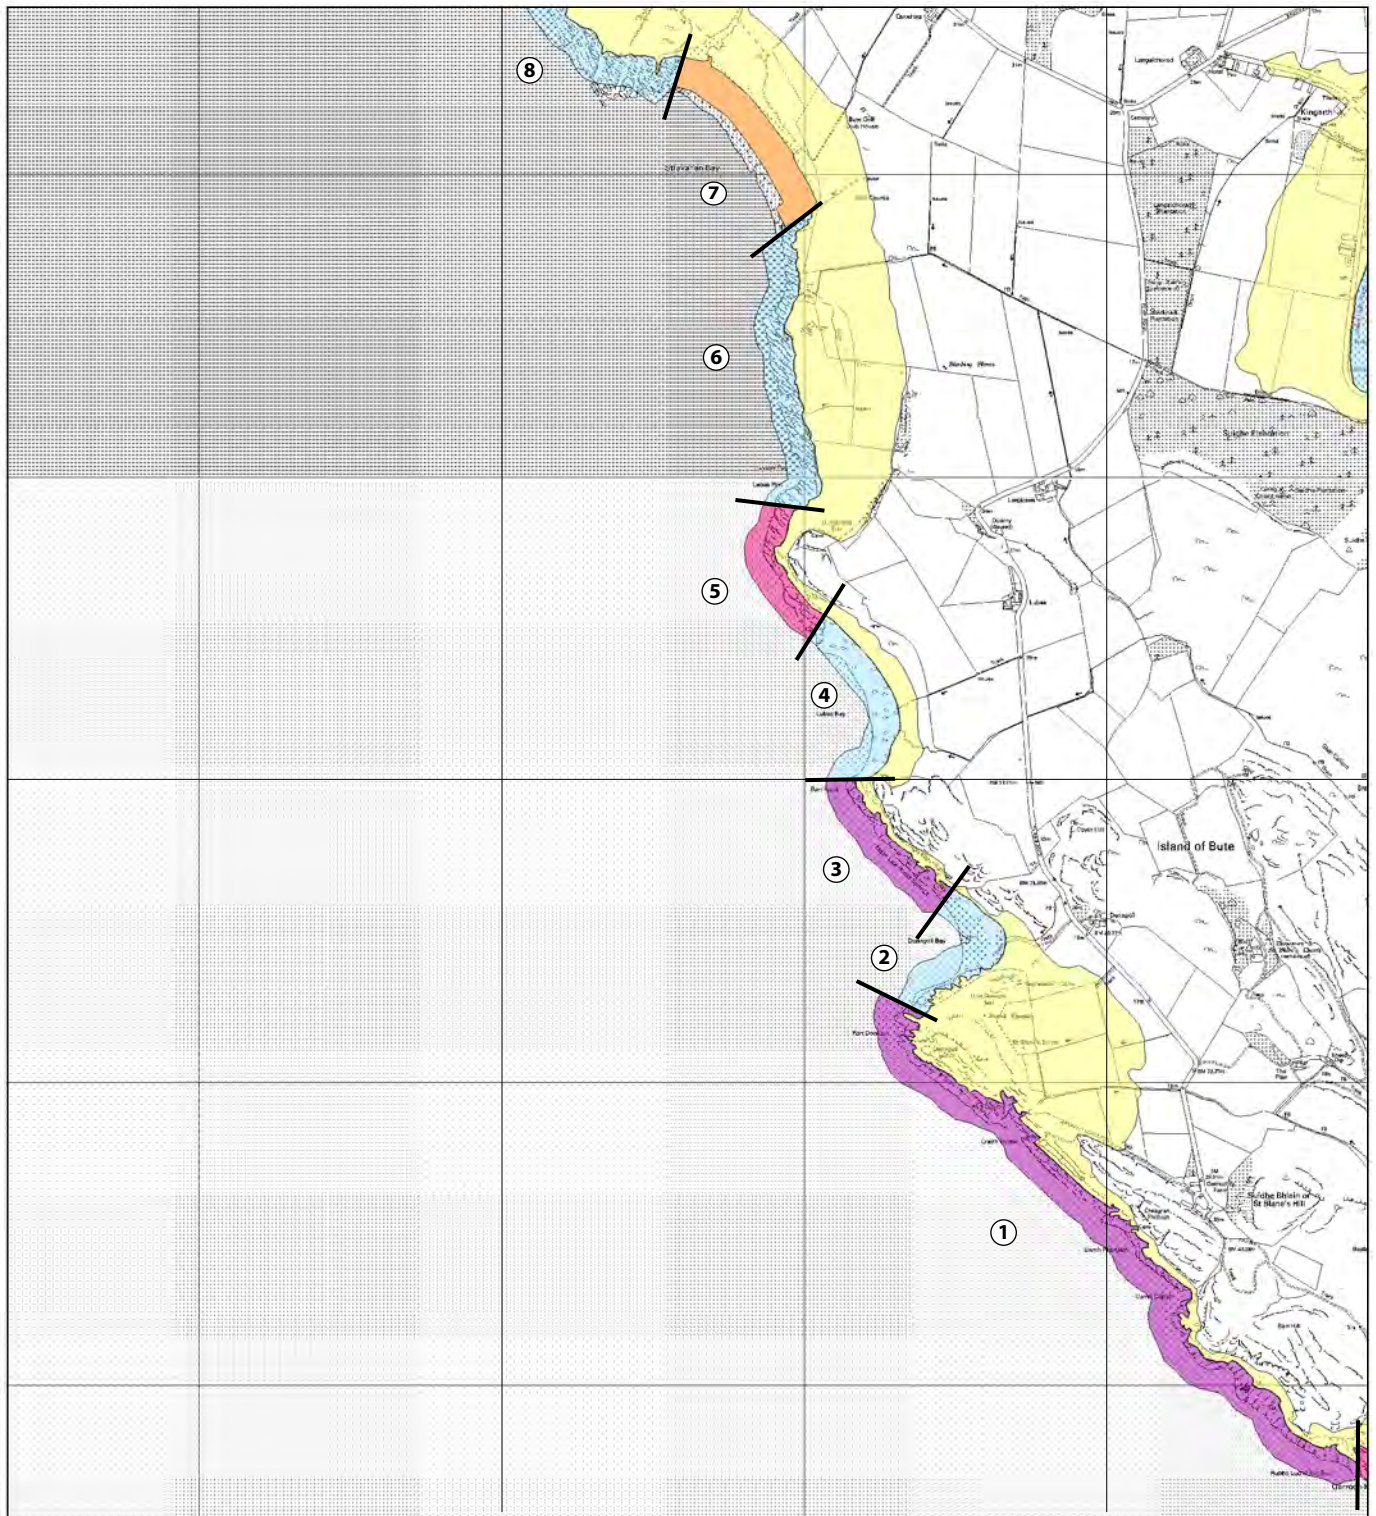
Definitely eroding

Rock abrasion platform is exposed and being eroded by scouring. Raised beach fronted by fossil shoreline. Irregular cliff overlooking a promontory with exposed rock platforms. At Gullachan Bay has a shingle beach flanked by rock platform.

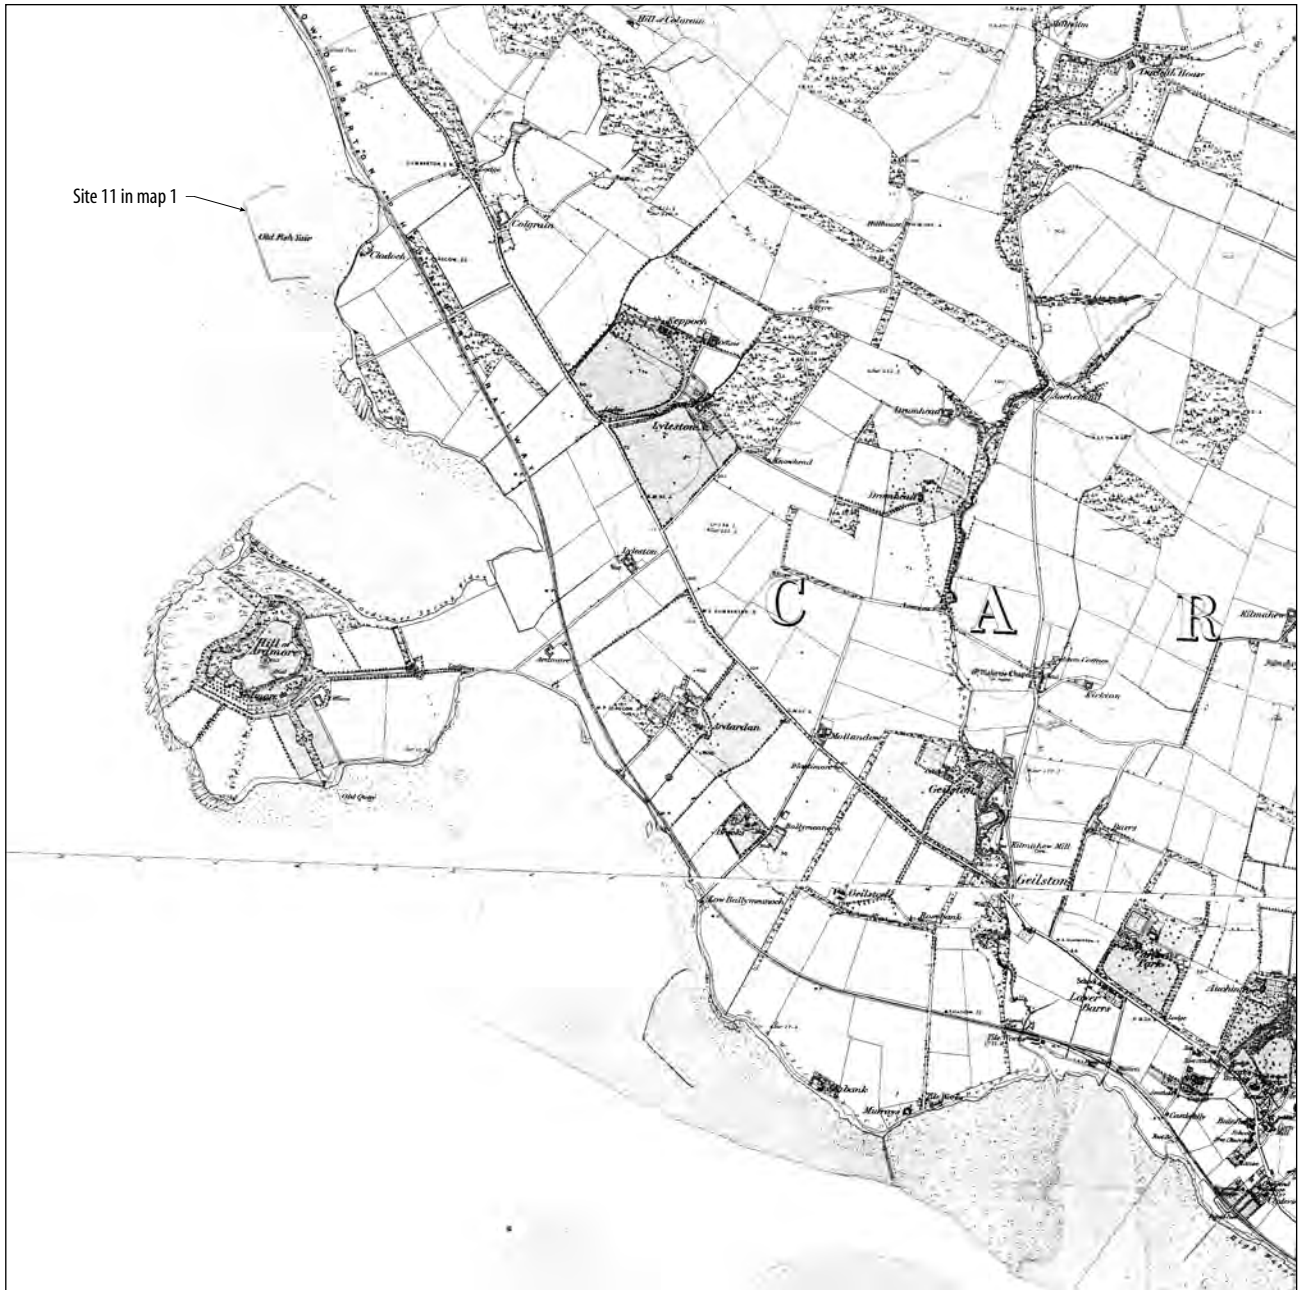
Fig.15 - 1864 First Edition Ordnance Survey map showing the positions of three fishtraps, disused in the case study.

- 9.3.2 On the north side of Hill of Ardmore (NGR: NS 3160 7920) another fish-trap was recorded during the recent survey (Fig 15). This survives as a long curvilinear mound of boulders. At its terminus a line of small wooden stakes was found strongly suggesting that these were associated with a stake net that was positioned well within the sheltered bay. Again, as with the previously mentioned fish-traps, this one appeared to also hold water to a depth of about 0.4m well after the tide had receded. Accretion of estuarine sediment and the displaced nature of the boulders do not allow for a true estimate of the actual depth of water that would have been trapped behind the walls when the trap was in operation.

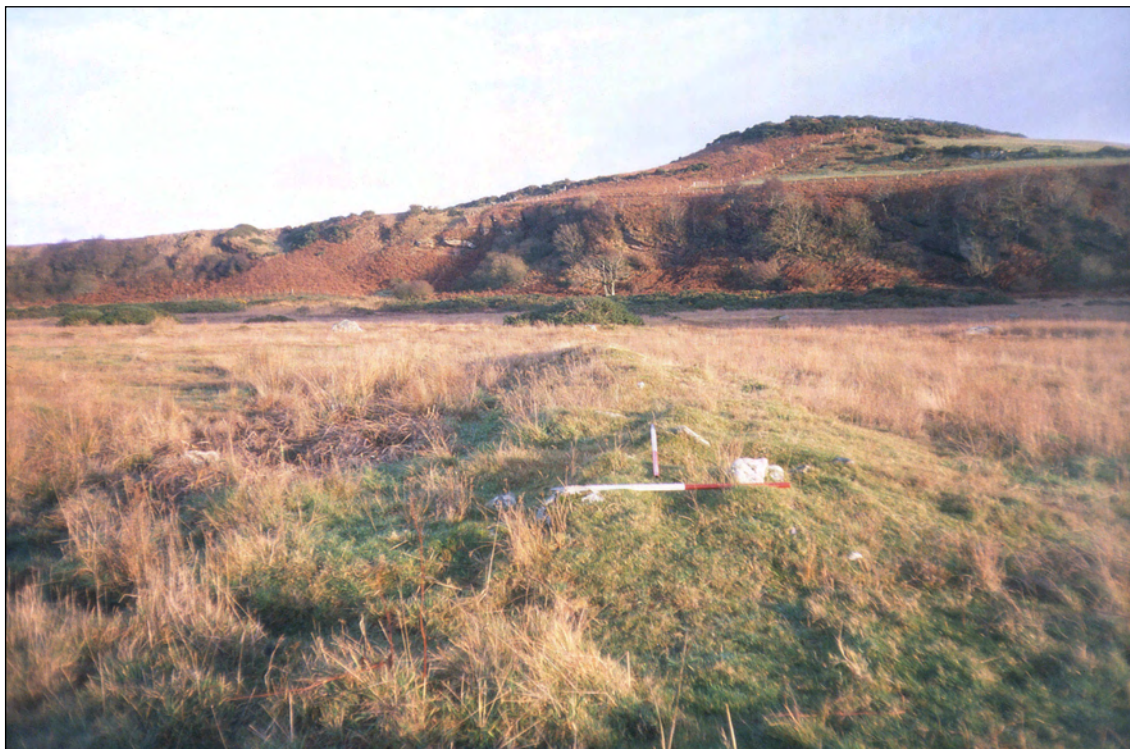
Plate 1 - Mound of stones near Dunagoil with raised beach behind.  
(Site 102, *Built Heritage and Archaeology, Bute Map 6*)

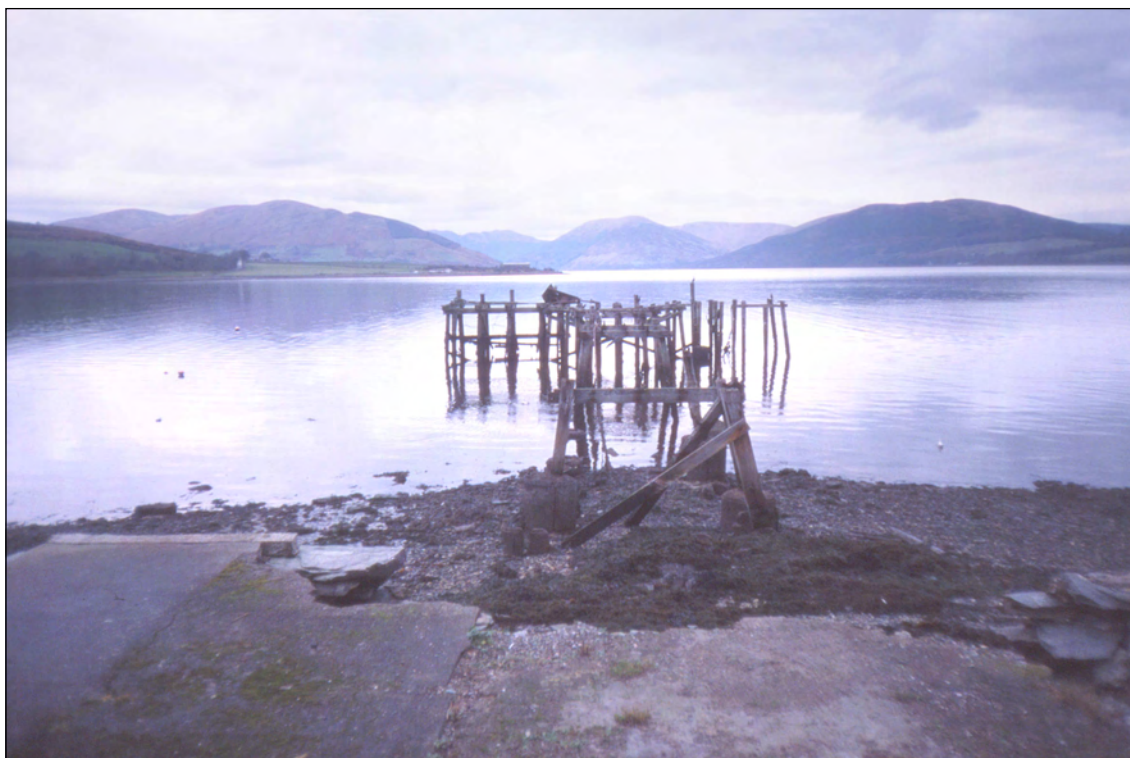
Plate 3 - Derilict wooden pier at Port Bannatyne, NE Bute.  
(Site 28, *Built Heritage and Archaeology, Bute Map 2*)

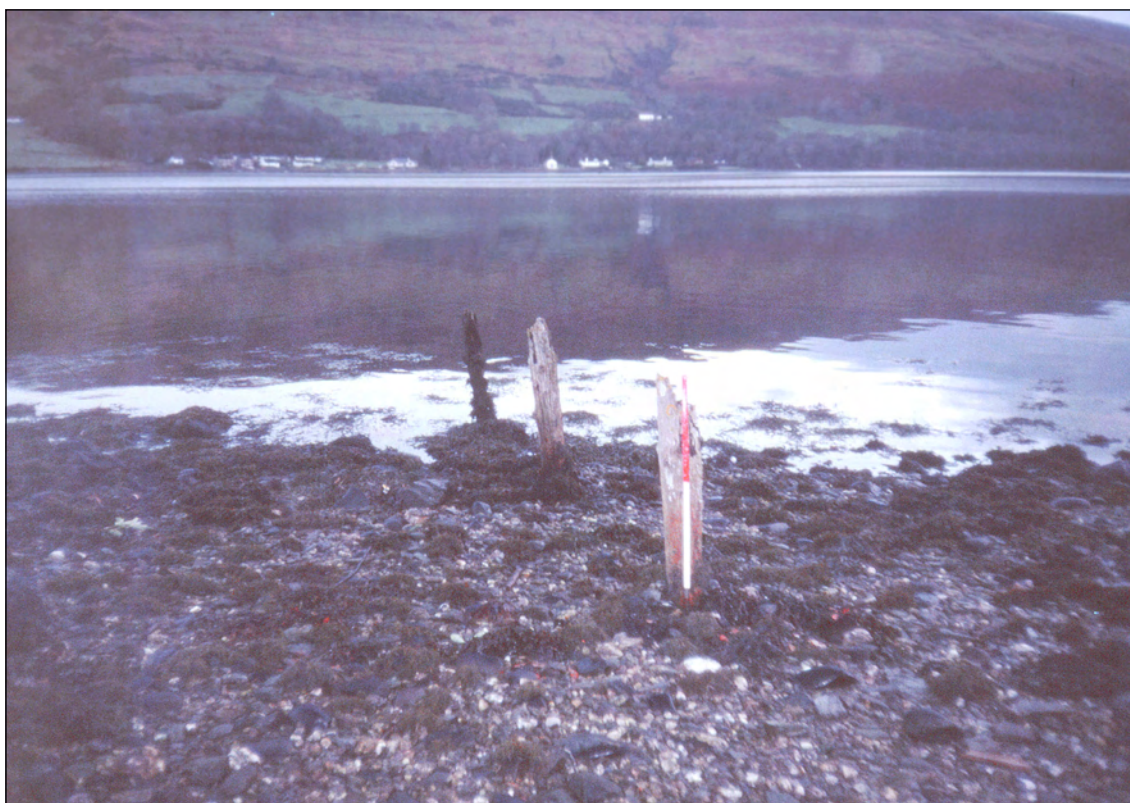
Plate 4 - Possible fish-trap or long-line stakes at Balnakally Bay, NE Bute.  
(Site 5, *Built Heritage and Archaeology, Bute Map 1*)

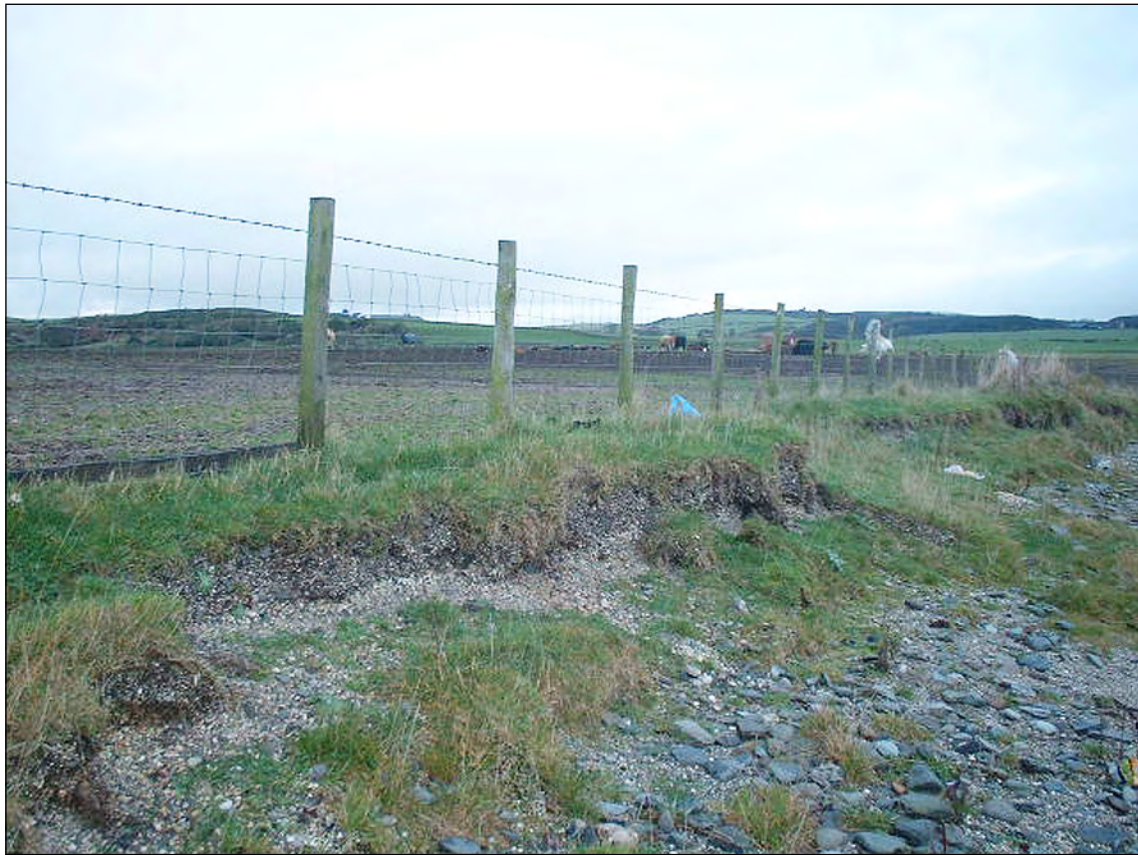
Plate 5 - Eroding marine deposits at St Ninian's Bay on the west coast of Bute.  
(Unit 2, Erosion Class, Bute Map 8)

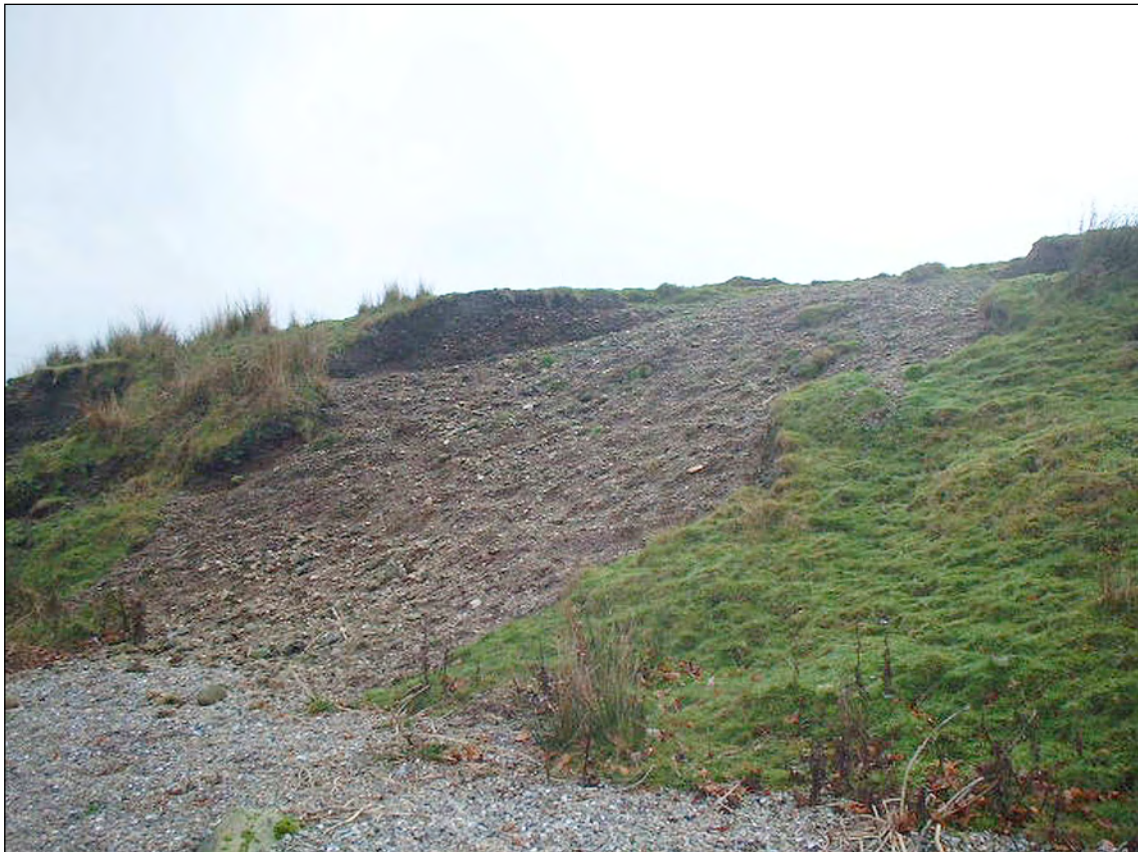
Plate 6 - Eroding raised beach at Balnakilly Bay, NE Bute.  
(Unit 2, Erosion Class, Bute Map 1)

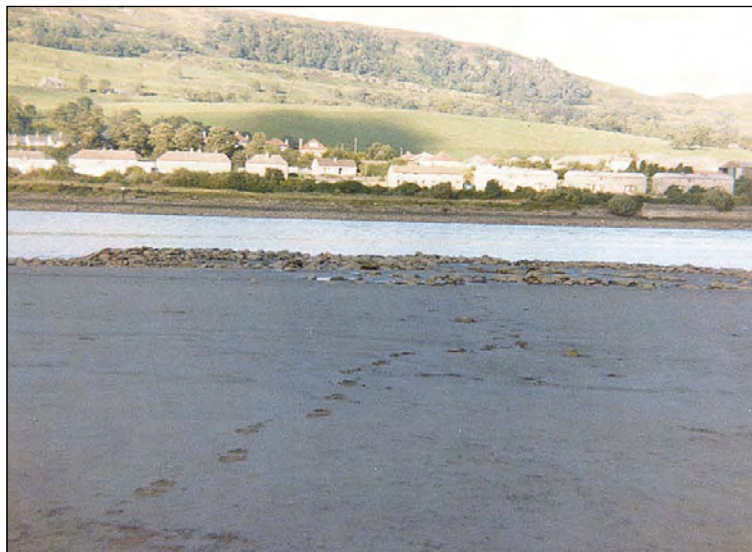
Plate 7 - Distance shot of Erskine Crannog 1986.  
(*Site 153, Built Heritage and Archaeology, Clyde Map 6*)

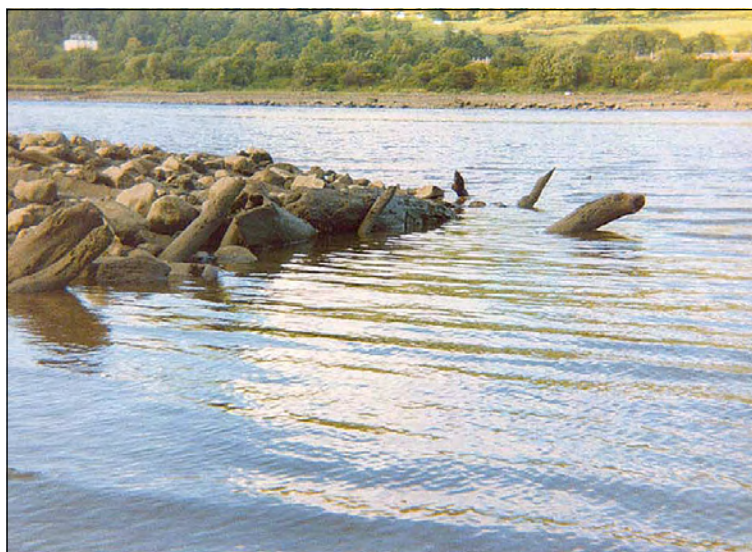
Plate 8 - Close up of piles at Erskine Crannog in 1986.  
(*Site 153, Built Heritage and Archaeology, Clyde Map 6*)

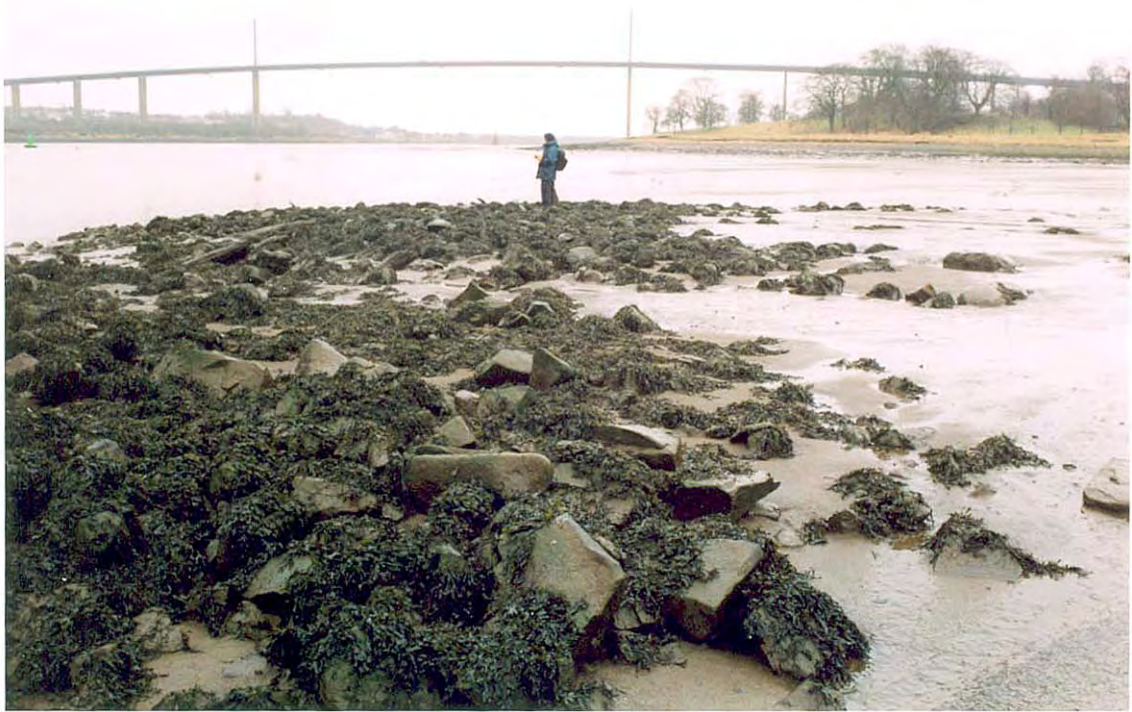
Plate 10 - Erskine Crannog at the low water mark with accreting sediment in the foreground.  
(*Site 153, Built Heritage and Archaeology, Clyde Map 6*)  
Courtesy of Renfrewshire Shorewatch Group

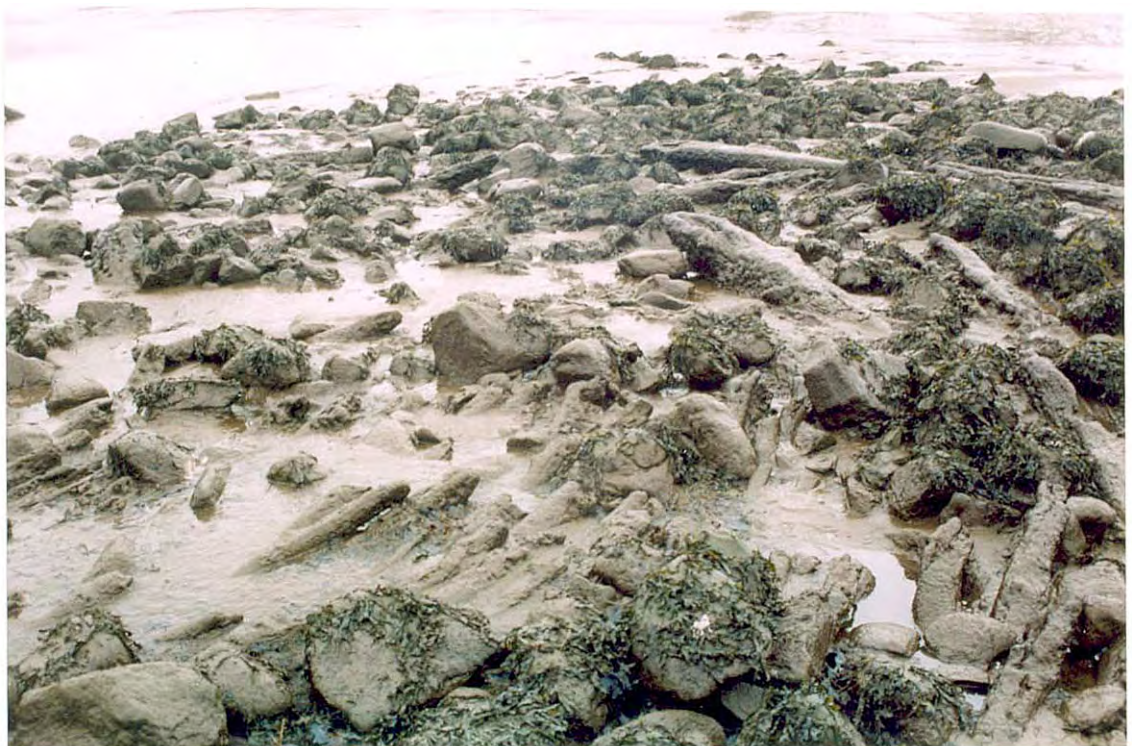
Plate 11 - Exposed timber piles at Erskine Crannog  
(*Site 153, Built Heritage and Archaeology, Clyde Map 6*)  
Courtesy of the Renfrewshire Shorewatch Group.

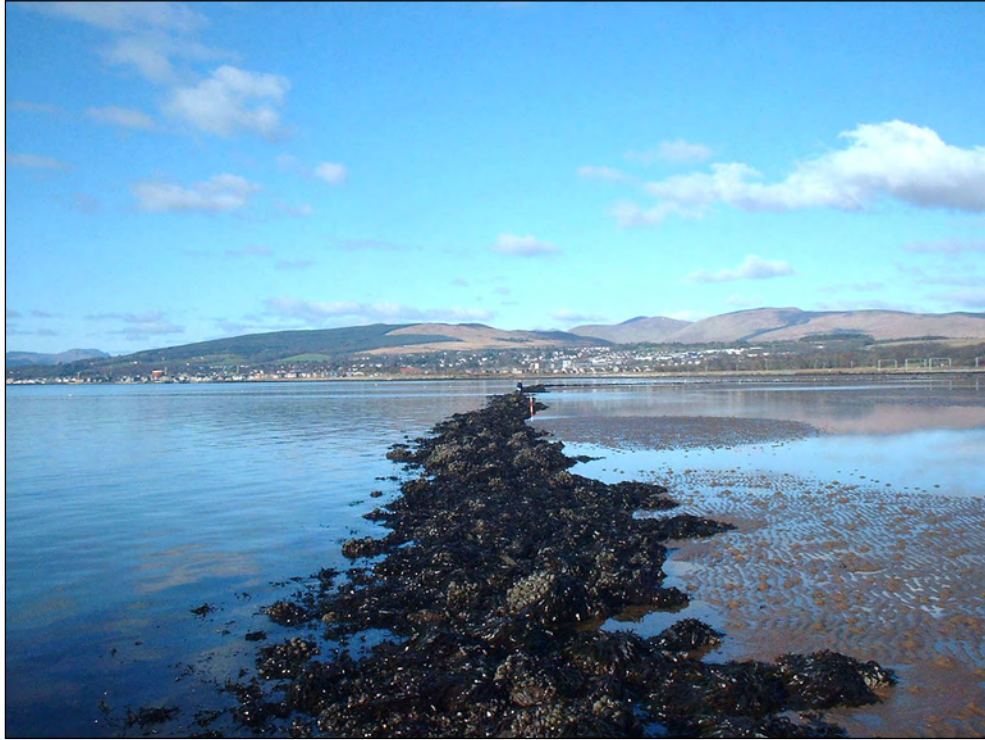
Plate 12 - The remains of a stone-built fishtrap east of Craigendoran.  
*(Site 11, Built Heritage and Archaeology, Clyde Map 1)*

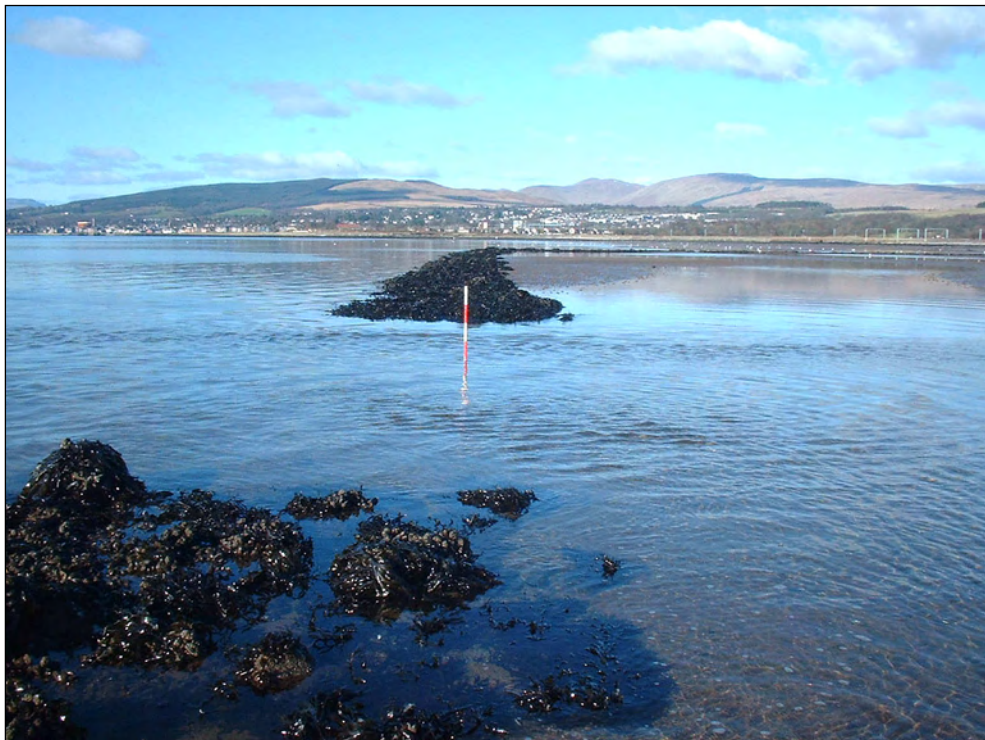
Plate 13 - Entrance to the fish-trap above - note the outflow of water.  
*(Site 11, Built Heritage and Archaeology, Clyde Map 1).*

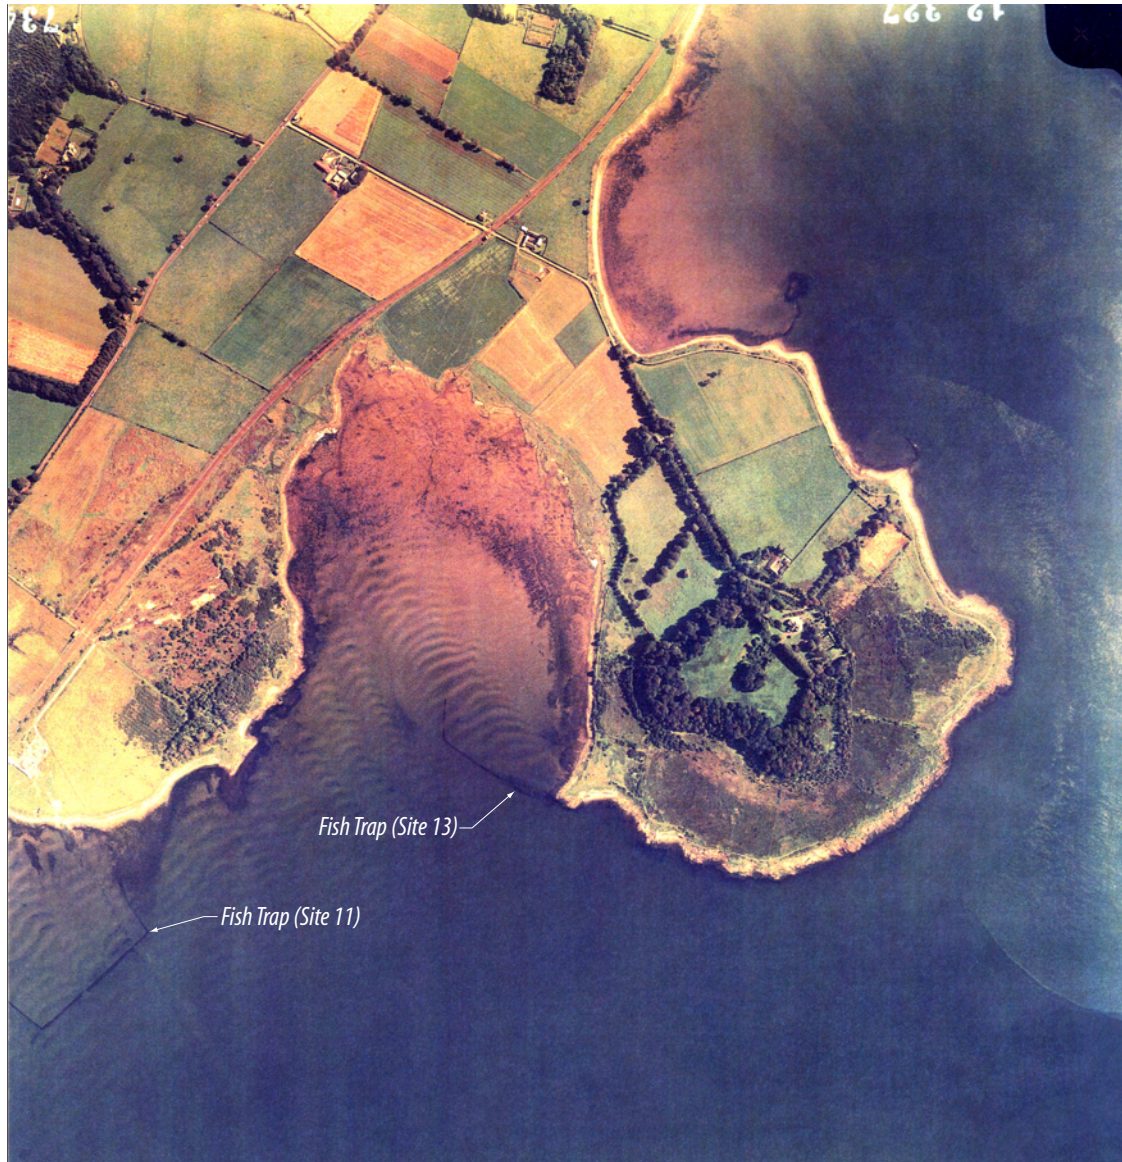
Plate 14 - Vertical aerial view of the Hill of Ardmore showing the positions of two fishtraps.  
(Sites 11 & 13, *Built Heritage and Archaeology, Clyde Map 1*)

- 9.3.1 The north side of the Inner Firth of Clyde has a collection of fish-traps that fall into the category of yairs. Two are depicted on the 1864 First Edition Ordnance Survey (Fig 15) map as '*Old Fish Yair*' and are highly visible on aerial photographs (Plate 14). The largest fish-trap is situated to the north of Ardmore Hill at NGR NS 3170 8010 and is rectangular in shape and at least 300m in length. The structure consists of a line of boulders approximately 3m wide. An inlet channel is present approximately in the middle of the feature. There has been a great deal of accretion of estuarine mud within the fish-trap and during a recent Shorewatch survey it was found that sea water was still retained within the feature for quite some time after the tide had receded. This is demonstrated in Plate 2 that clearly shows rapid flowing water running out of the entrance of the trap. It seems logical that a gill net could be placed across the entrance just before the turn of the tide. Fish trapped within the stone enclosure would naturally swim with the greatest flow of water through the central channel and into the net (Hale pers comm). It is estimated that the trap walls would have stood to a height of about half a metre, and these were certainly of sufficient height for a person to walk along and draw a net across the entrance by hand. It is further surmised that migrating Spring and Autumn salmon running up to the Rivers Clyde and Leven were the main fish exploited. Dabs and flounders were also likely to have been caught.

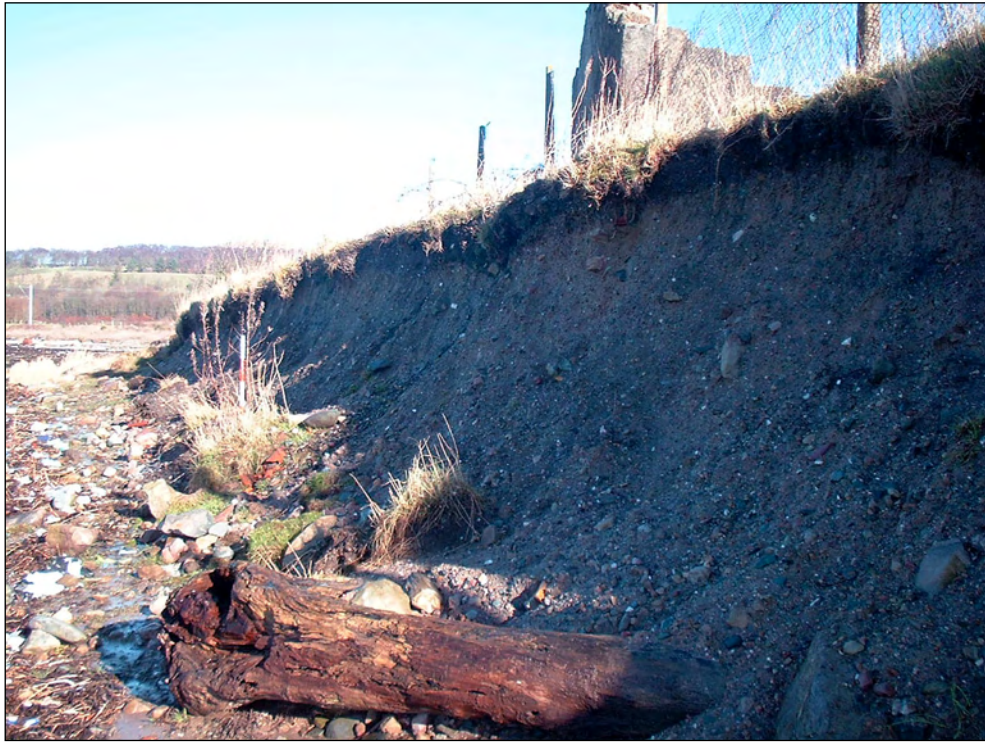
Plate 15- Eroding cliff east of Craighendoran.  
(Unit 2, Erosion Class, Clyde Map 1)

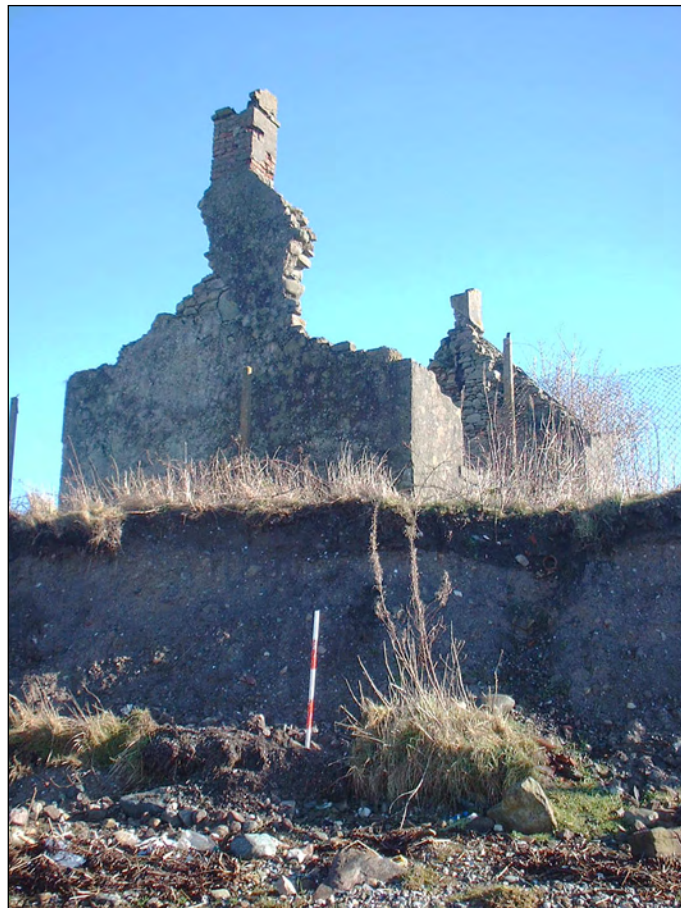
Plate 16 - Ruined farmhouse above eroding cliff, east of Craighendoran  
Since this photograph was taken this section of the cliff has been supported by dump sea-defences.  
(Unit 2, Erosion Class, Clyde Map 1)
