**Re: GE-Pittsfield/Housatonic River Site
1½-Mile Reach of the Housatonic River (GECD820)
2017 Annual Monitoring Report**

2017 ANNUAL MONITORING REPORT

1½-Mile Reach of the Housatonic River

Arcadis U.S., Inc.
110 West Fayette St, Suite 300
Syracuse
New York 13202
Tel 315 446 9120
Fax 315 449 0017

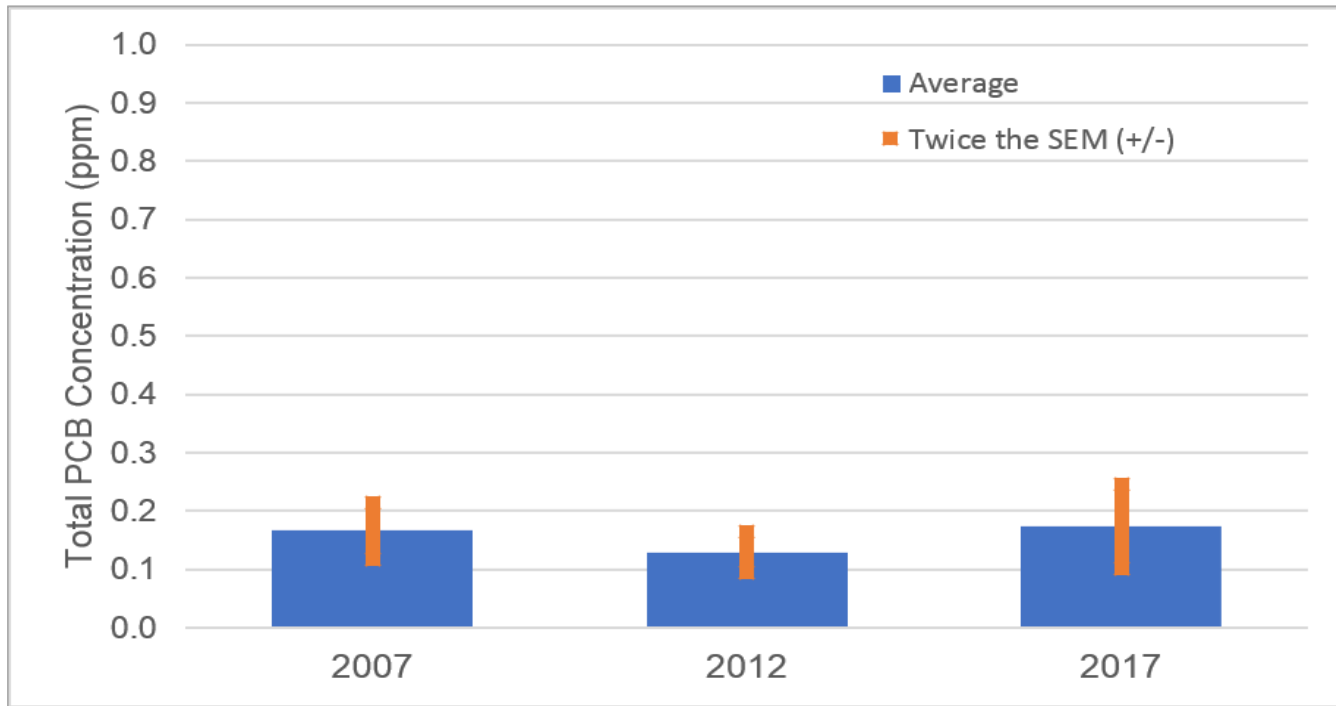
Design & Consultancy for natural and built assets
FIGURE 8-1

GENERAL ELECTRIC COMPANY PITTSFIELD, MASSACHUSETTS	
1 1/2-MILE REACH OF THE HOUSATONIC RIVER	
AVERAGE TOTAL PCB CONCENTRATION AND SEM FOR 2007, 2012, AND 2017

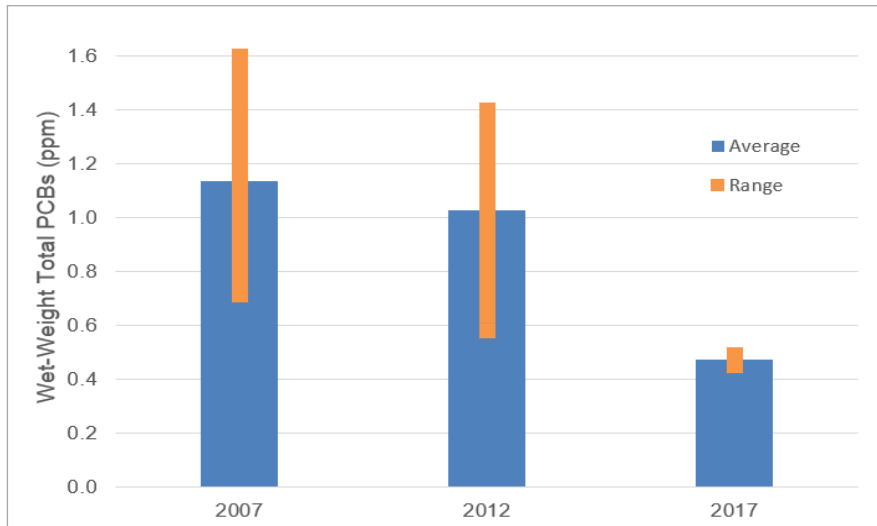
Figure 8-2A:

from 2000 (when tissue samples for PCB analysis were collected from only one transect, T-134) showed a total PCB concentration of 336 ppm, and the results from 2012 showed total PCB concentrations ranging from 0.58 ppm to 1.4 ppm, with an average PCB concentration of 1.0 ppm. The 2017 samples have lower total PCB concentrations (on a wet-weight basis) to those from 2007 and 2012, with a decrease in concentration observed at all three transects. The total PCB concentrations on a wet-weight basis for 2007, 2012 and 2017 are presented in Figure 8-2A.
