Metal Bank NPL Site

**Metal Bank NPL Site
Remediation Project**

**Remedial Action Report/
Engineer's Report**

March 2013

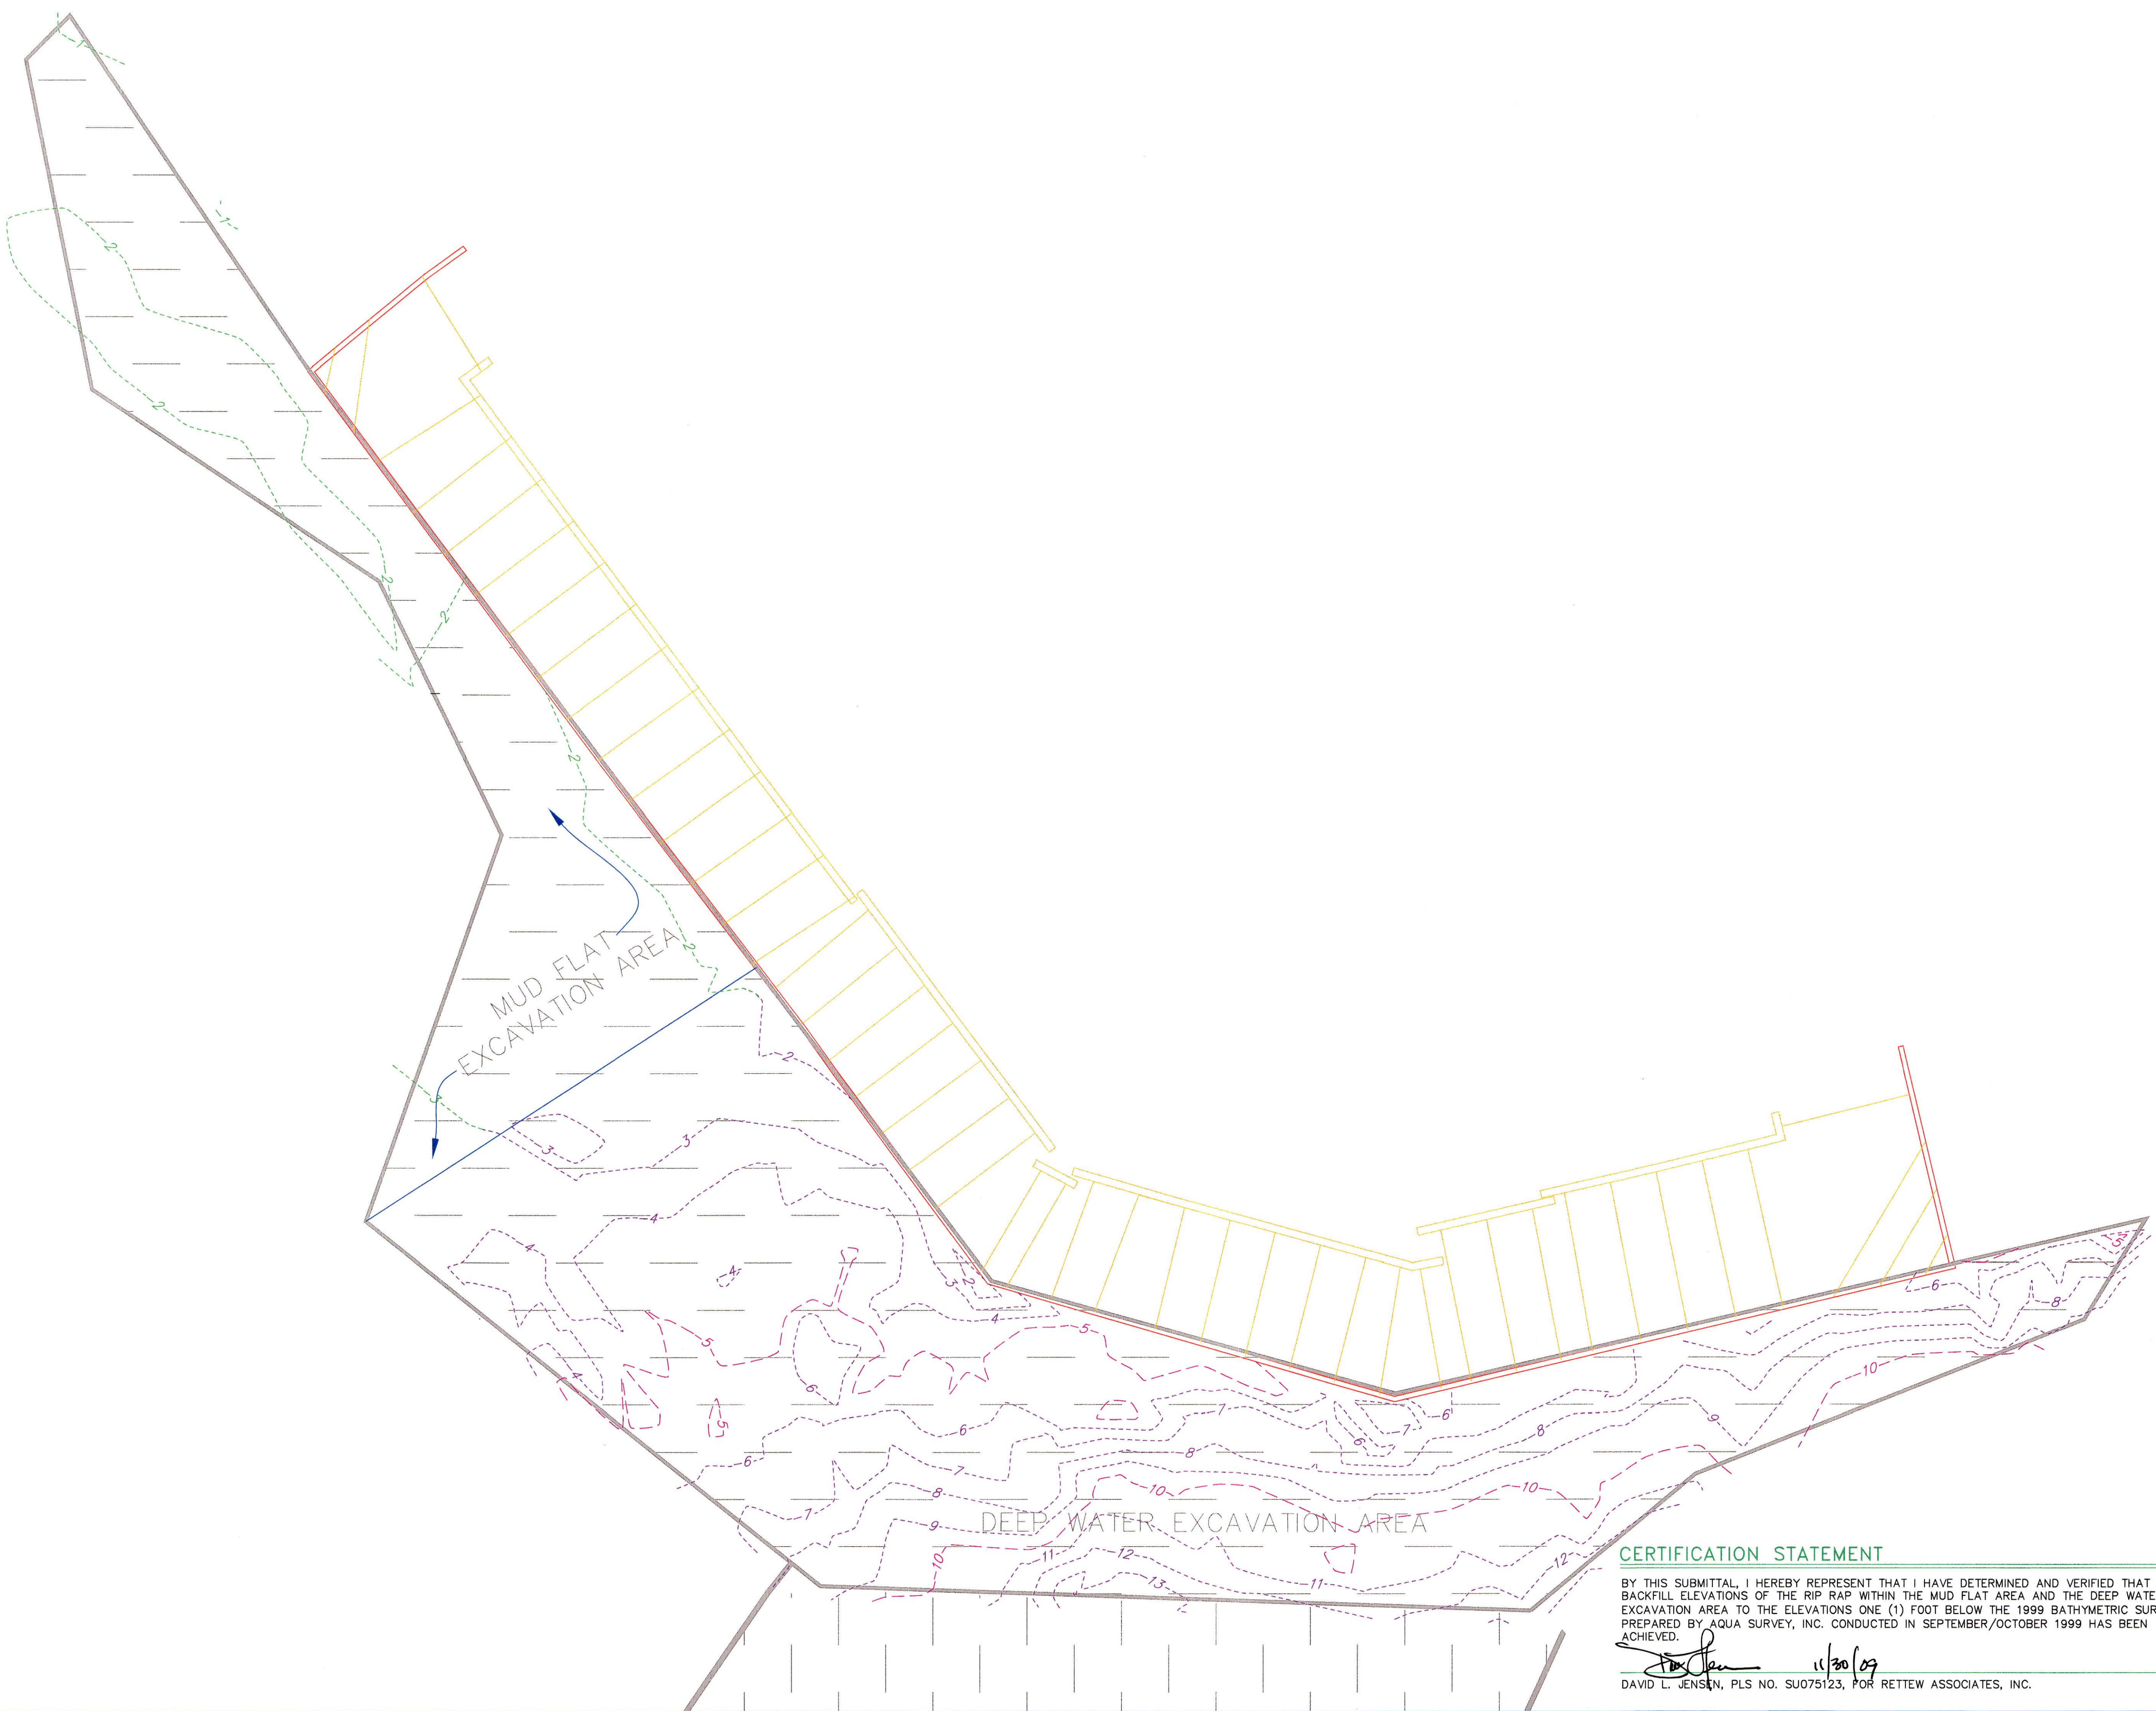
FINAL AS-BUILT SURVEY
 RIP RAP COVER (SEDIMENT EXCAVATION)
 NOV 13 & 24, 2009
 METAL BANK NPL SITE
 PHILADELPHIA PENNSYLVANIA

BY THIS SUBMITTAL, I HEREBY REPRESENT THAT I HAVE DETERMINED AND VERIFIED THAT THE BACKFILL ELEVATIONS OF THE RIP RAP WITHIN THE MUD FLAT AREA AND THE DEEP WATER EXCAVATION AREA TO THE ELEVATIONS ONE (1) FOOT BELOW THE 1999 BATHYMETRIC SURVEY PREPARED BY AQUA SURVEY, INC. CONDUCTED IN SEPTEMBER/OCTOBER 1999 HAS BEEN ACHIEVED.

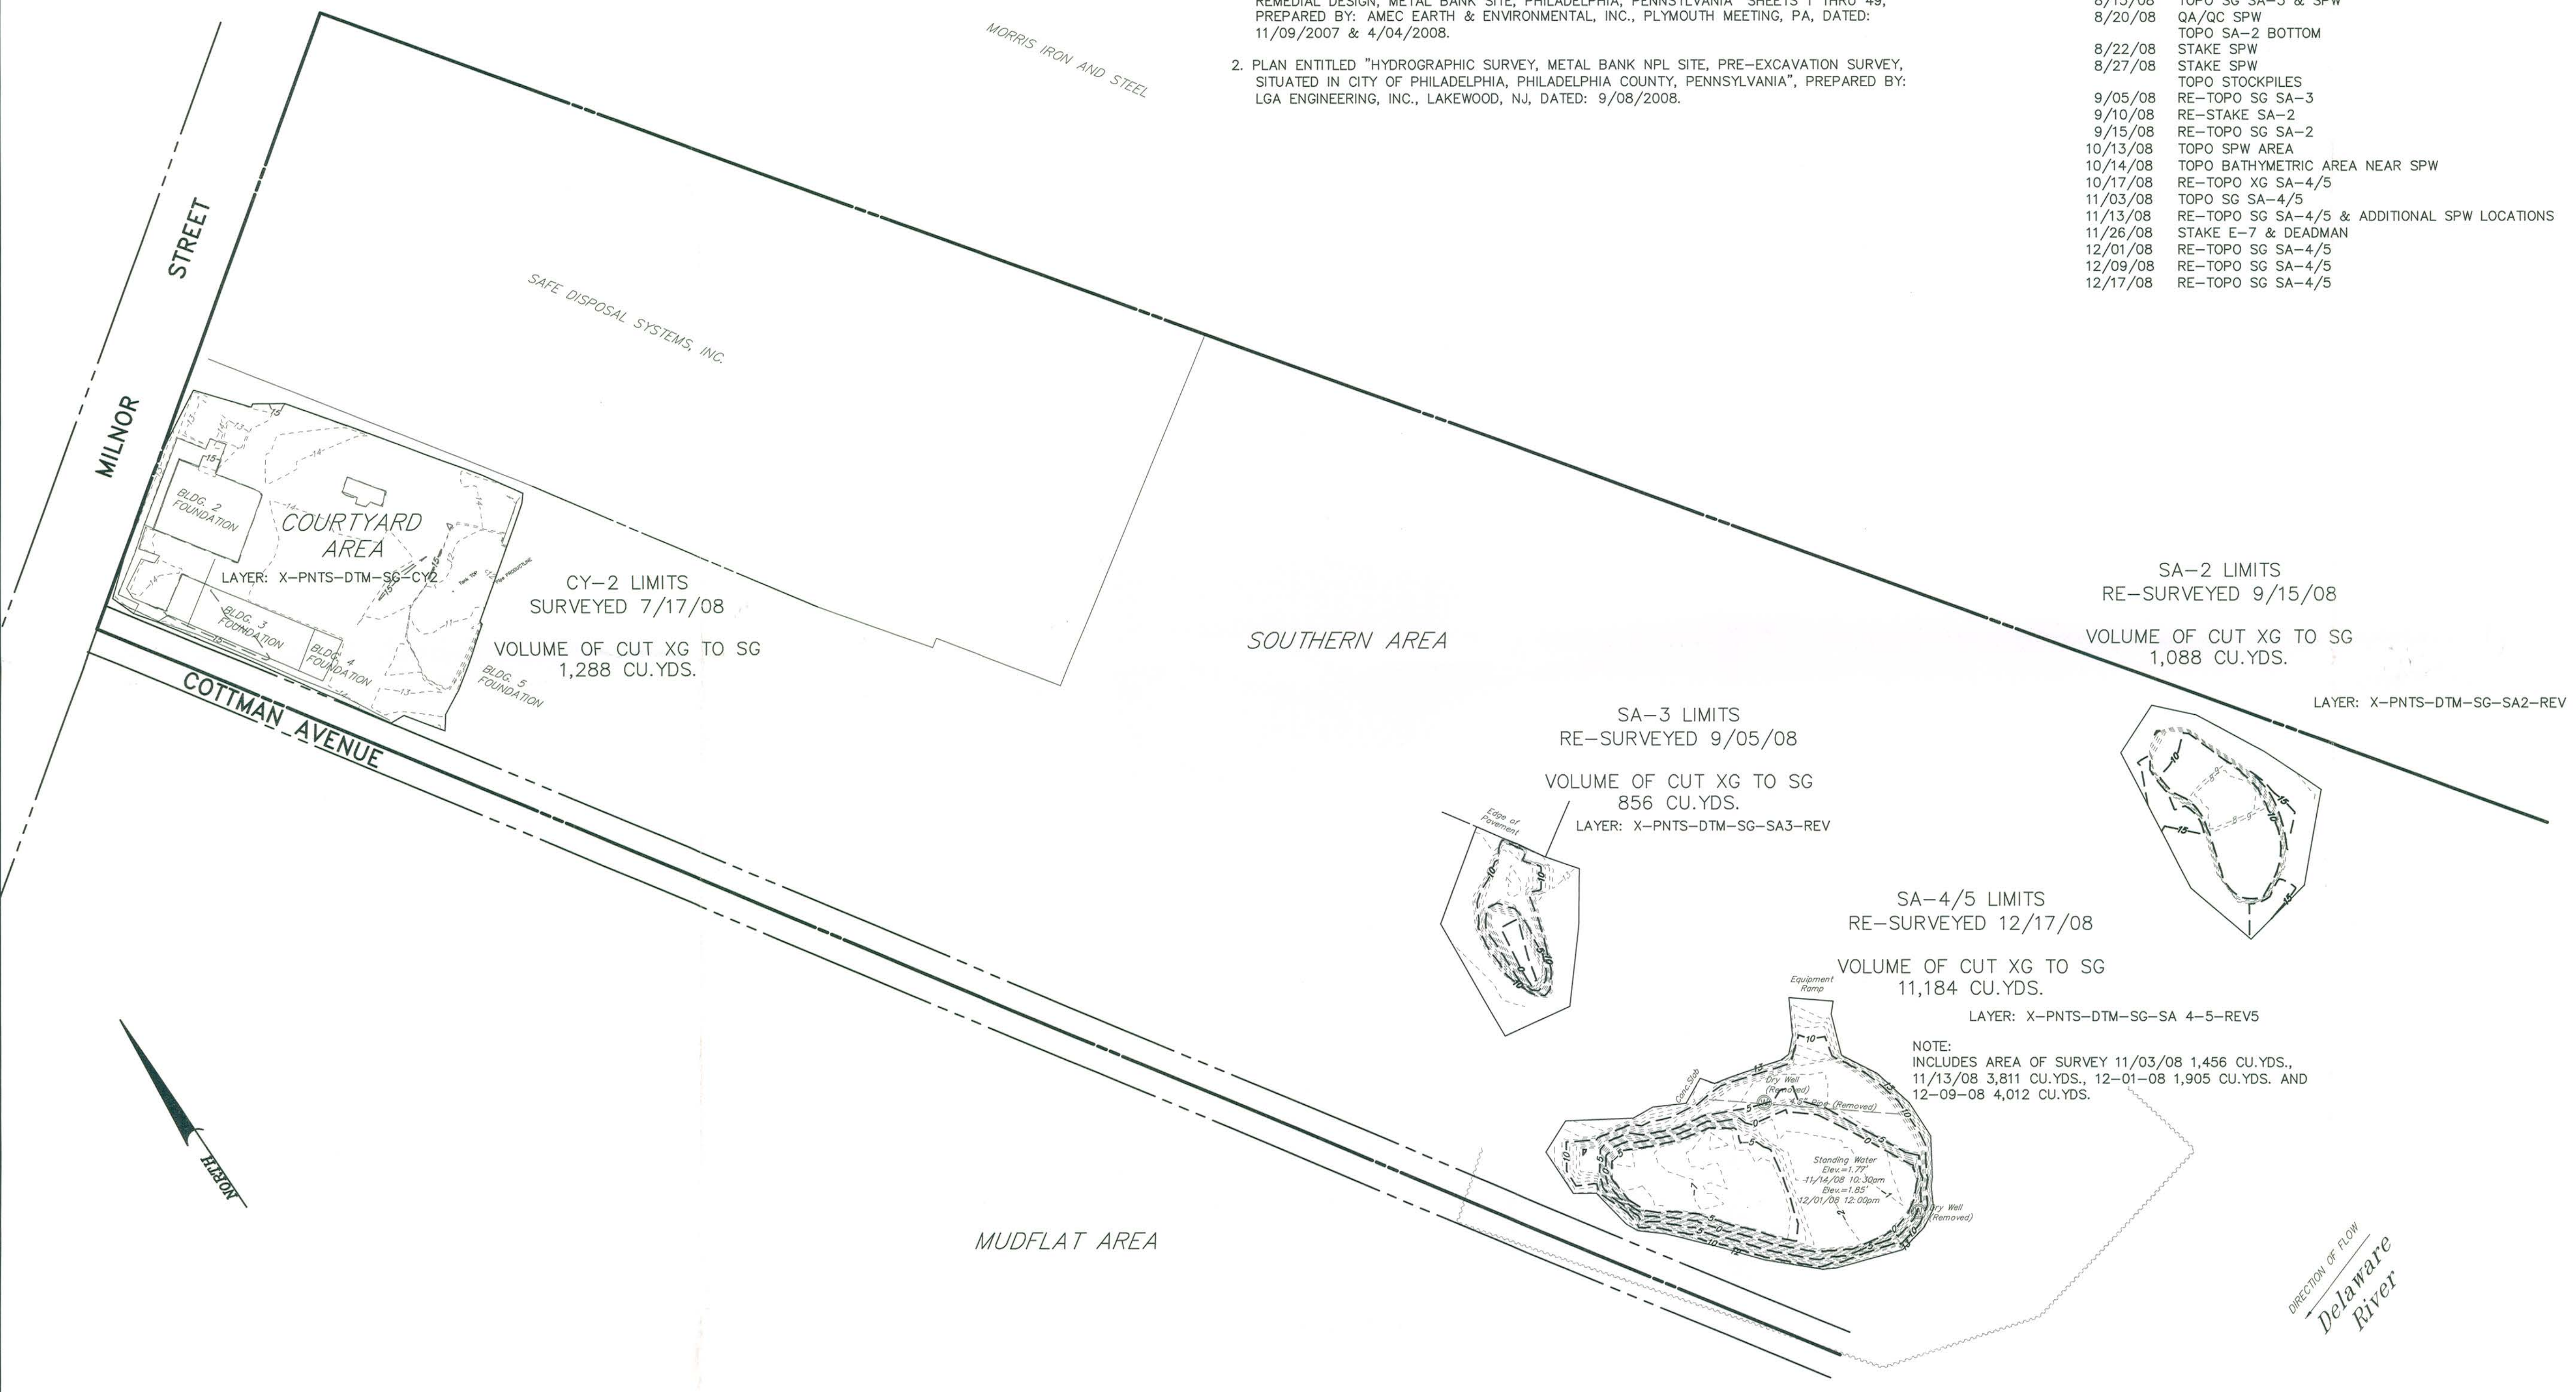
TOPOGRAPHIC SURVEY
SUB-GRADE
AFTER EXCAVATION
METAL BANK NPL SITE
PHILADELPHIA
PENNSYLVANIA

CY-2 LIMITS
SURVEYED 7/17/08
VOLUME OF CUT XG TO SG
1,288 CU.YDS.

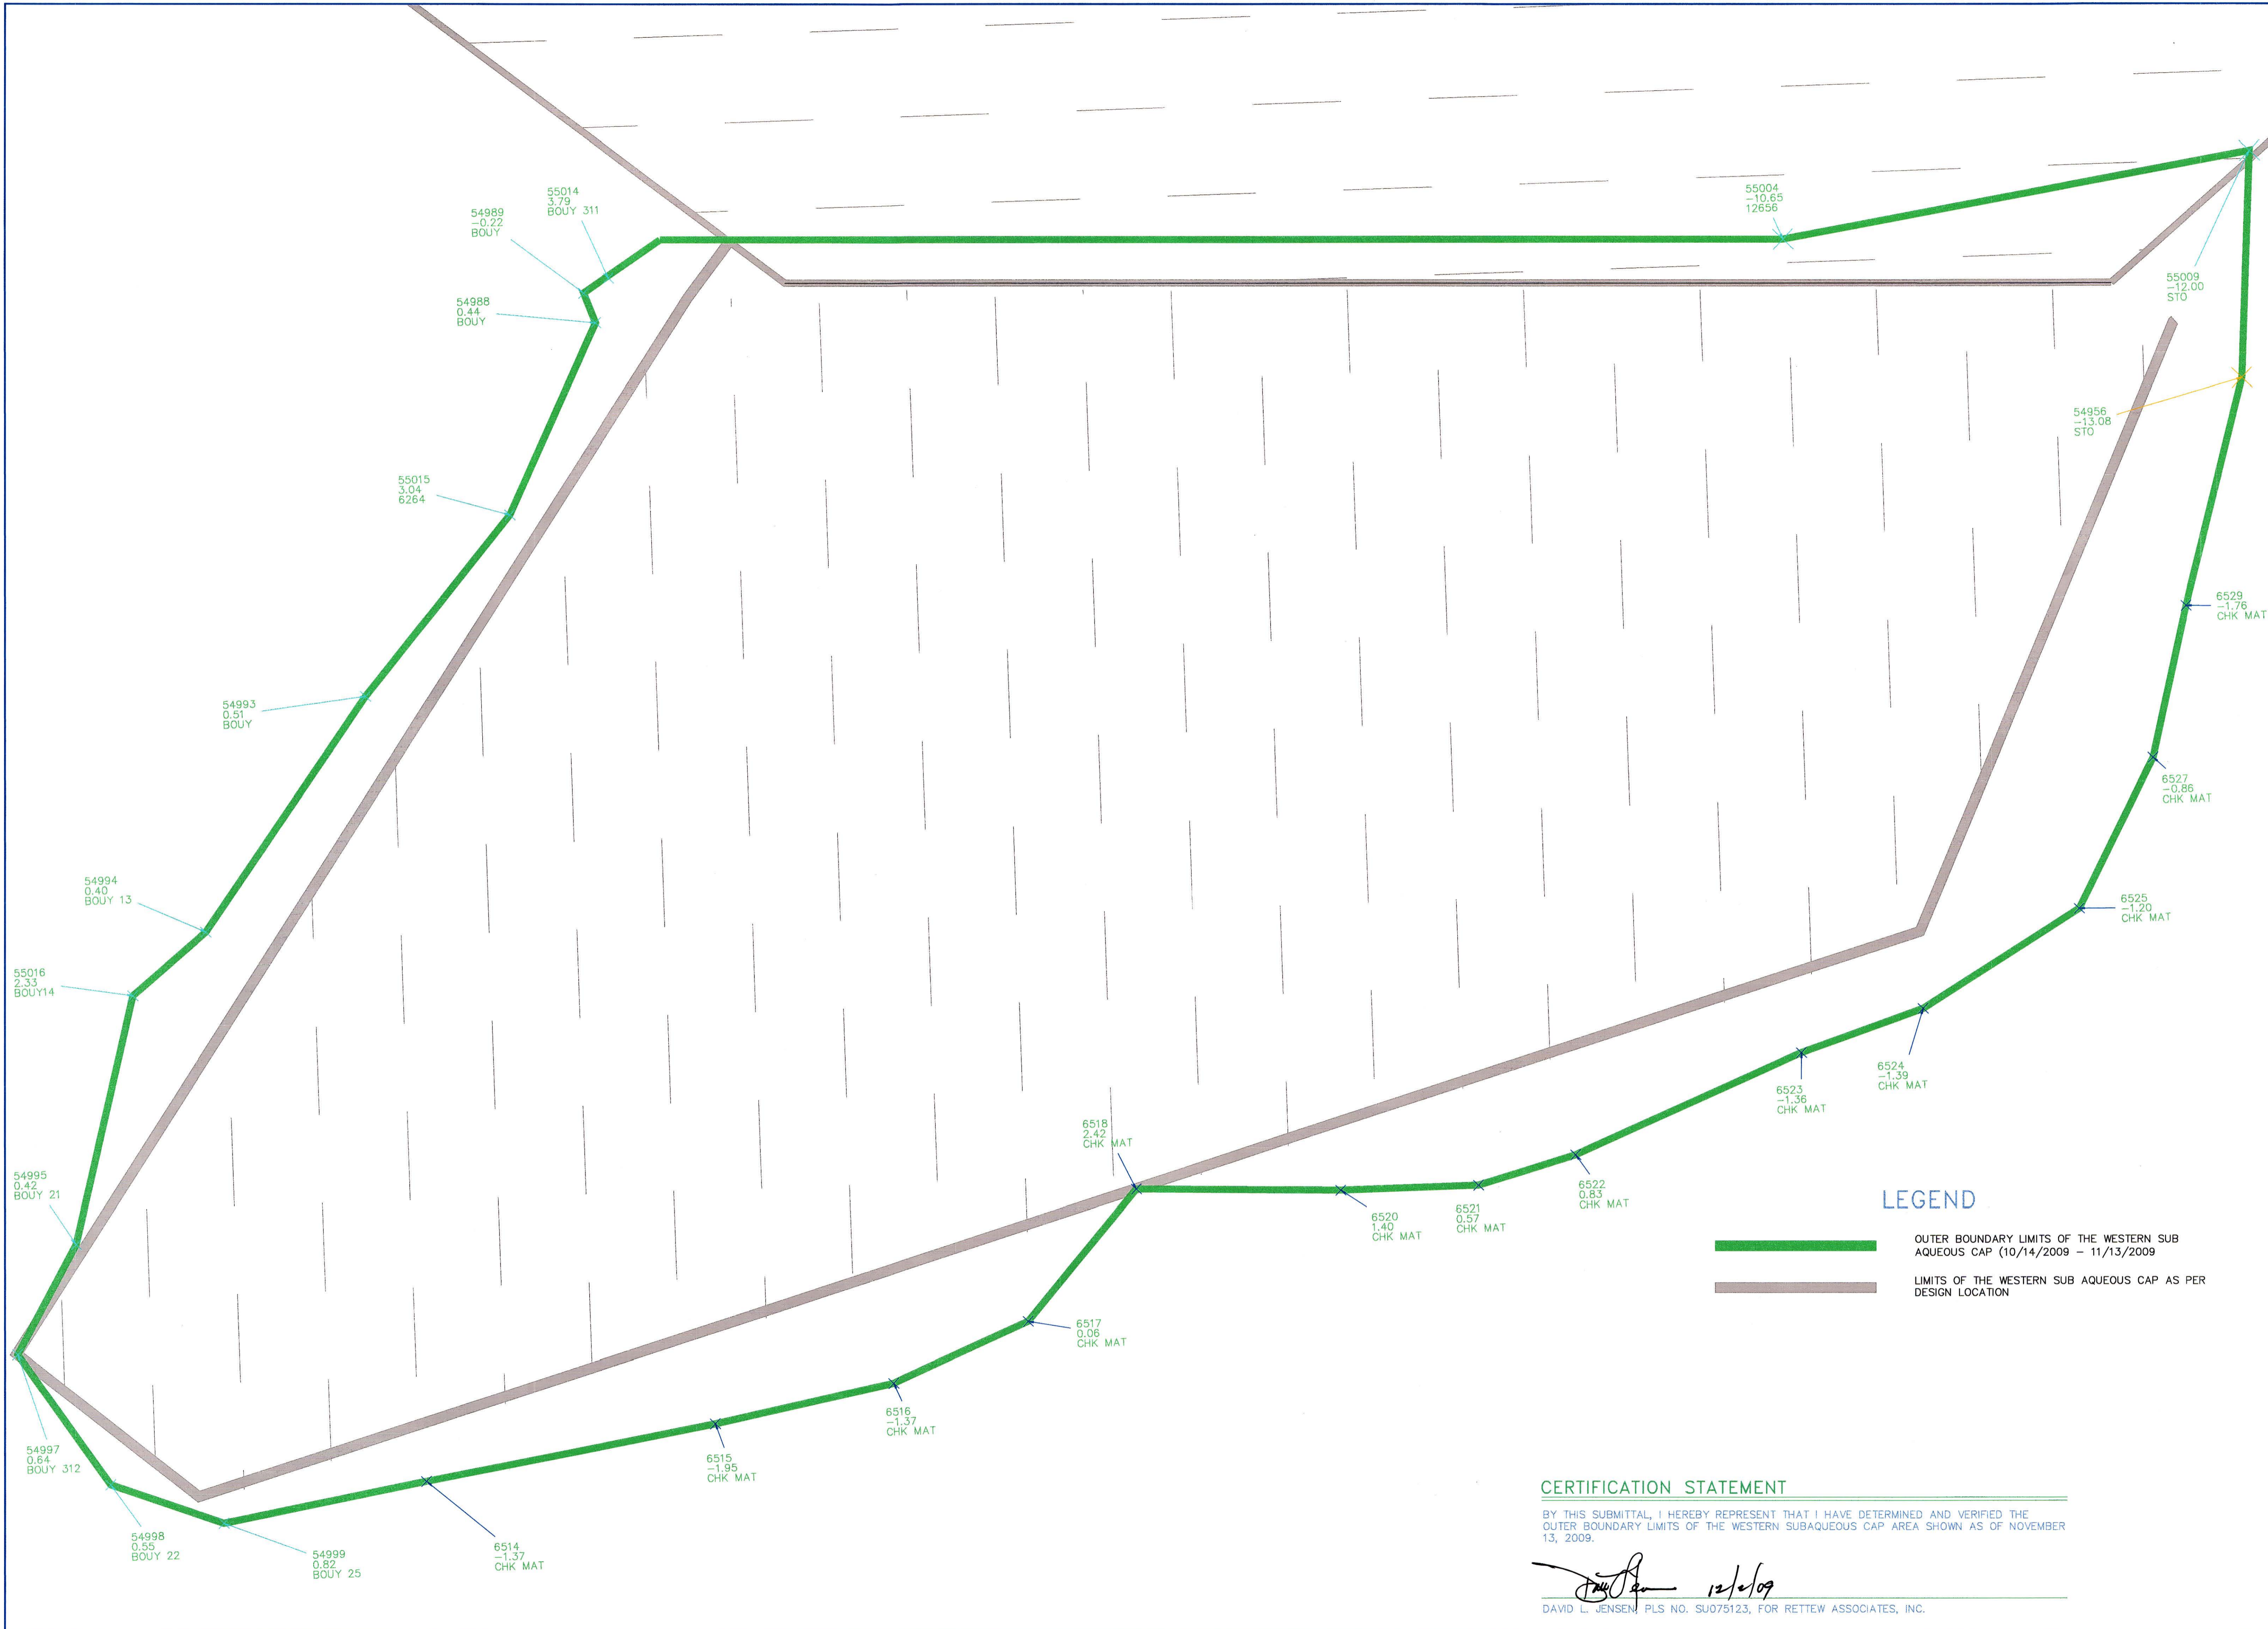
FOR RETTEW ASSOCIATES BY:	
CLIENT: Sevenson Environmental Services, Inc. 2749 Lockport Road Niagara Falls, NY 14305	REFERENCE: MANAGER: DJL DESIGN BY: DJL SURV. CHIEF: MBS DRAWN BY: JDC
DRAWING REFERENCE: H: 09-08-0871-001 (Upstream Subaqueous Buttress)	
SCALE: 1" = 20' 0' 10' 20' 40' 60'	
OUTLINE BOUNDARY OF EASTERN SUBAQUEOUS CAP BUTTRESS DECEMBER 9, 2009 METAL BANK NPL SITE PHILADELPHIA, PENNSYLVANIA	
DATE: 12-10-2009 SHEET NO. 1 OF 1 DWG. NO. 09-08711-001
