**Subject      Removal Action Report**  
**Chemical Commodities Incorporated, Olathe, Kansas**  
**U S EPA Region 7 START, Contract No 68-S7-01-41, Task Order No 0141**  
**Task Monitor Paul E Doherty, On-Scene Coordinator**

**REMOVAL ACTION REPORT**  
**CHEMICAL COMMODITIES INCORPORATED, OLATHE, KANSAS**

**Superfund Technical Assessment and Response Team (START) Contract**

**Contract No 68 S7-01-41, Task Order 0141**

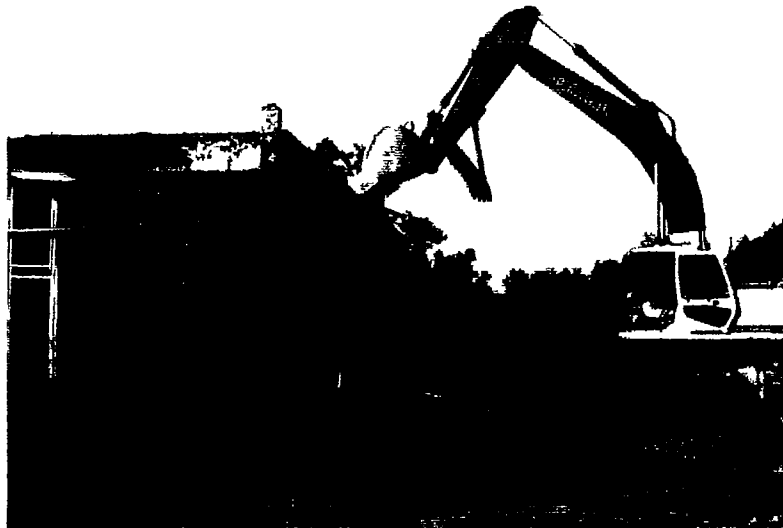
TETRA TECH PROJECT NO G9011 03 0141 00  Direction S	DESCRIPTION	Demolition activities initiated on the northern side of the CCI warehouse	5
	CLIENT	U S Environmental Protection Agency Region 7	Date
	PHOTOGRAPHER	Nicholas Godfrey	6/10/2003

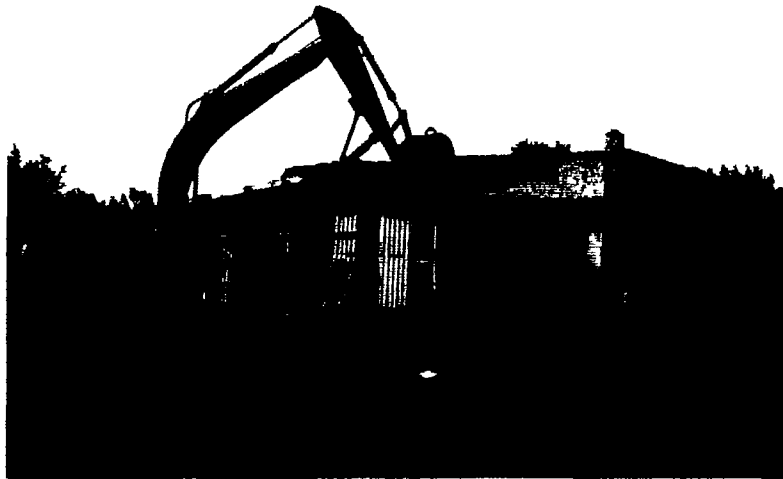
TETRA TECH PROJECT NO G9011 03 0141 00  Direction SE	DESCRIPTION	ER demolishing office additions at the northern end of the warehouse	6
	CLIENT	U S Environmental Protection Agency Region 7	Date
	PHOTOGRAPHER	Nicholas Godfrey	6/10/2003

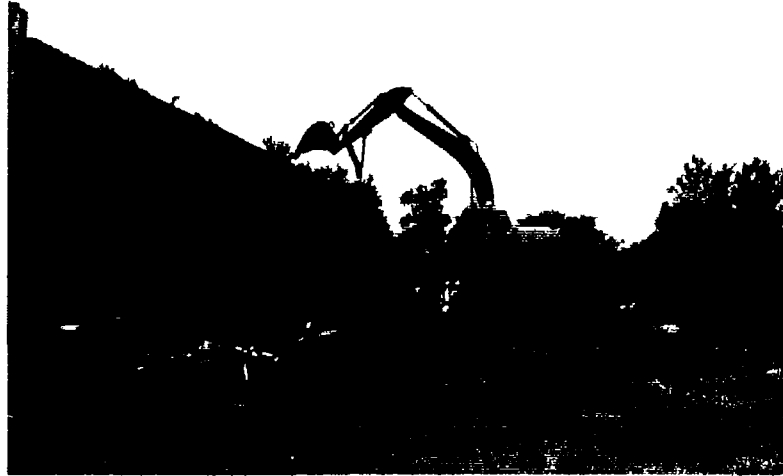
<b>TETRA TECH PROJECT NO G9011 03 0141 00</b>  Direction S	<b>DESCRIPTION</b>	ER beginning to demolish the original portion of the warehouse	9
	<b>CLIENT</b>	U S Environmental Protection Agency Region 7	Date
	<b>PHOTOGRAPHER</b>	Nicholas Godfrey	6/10/2003

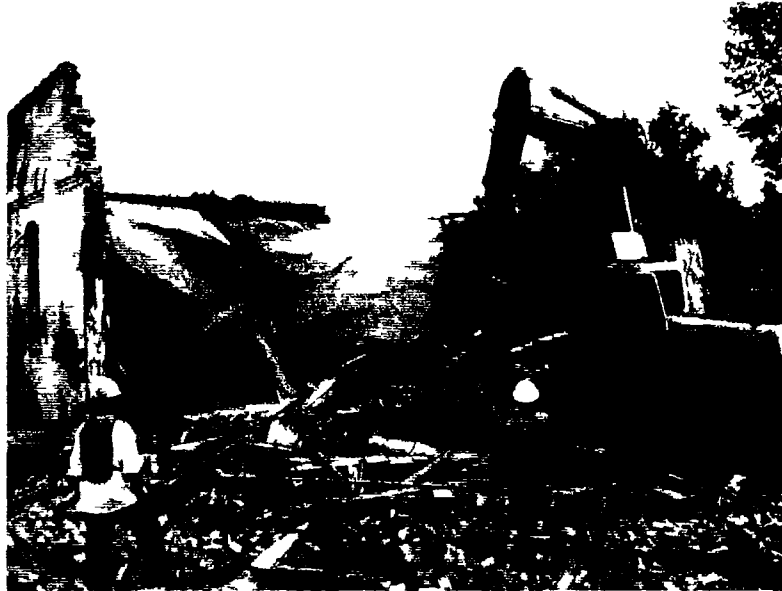
<b>TETRA TECH PROJECT NO G9011 03 0141 00</b>  Direction NE	<b>DESCRIPTION</b>	The central portion of the warehouse being demolished by ER	11
	<b>CLIENT</b>	U S Environmental Protection Agency Region 7	Date
	<b>PHOTOGRAPHER</b>	Nicholas Godfrey	6/10/2003

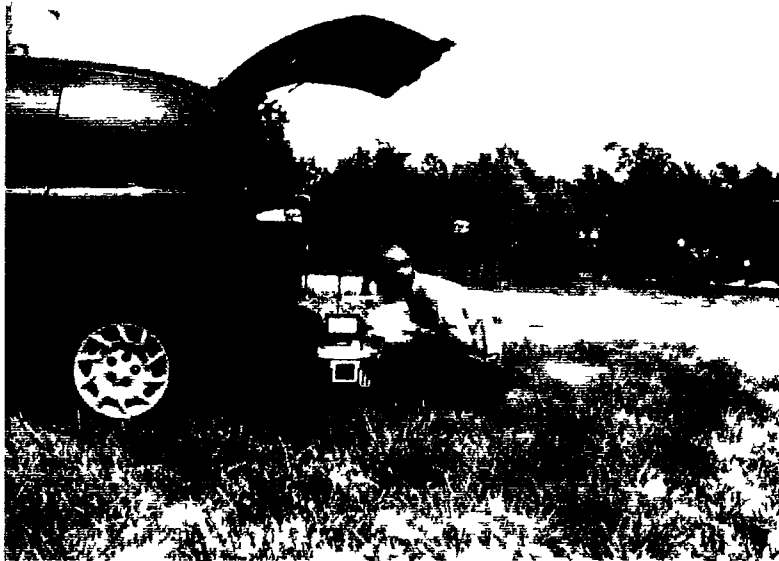
TETRA TECH PROJECT NO G9011 03 0141 00  Direction E	DESCRIPTION	Project Manager (PM) Nicholas Godfrey recording hourly particulate readings using a DataRam® particulate monitor	13
	CLIENT	U S Environmental Protection Agency Region 7	Date
	PHOTOGRAPHER	Lynn Parman	6/10/2003

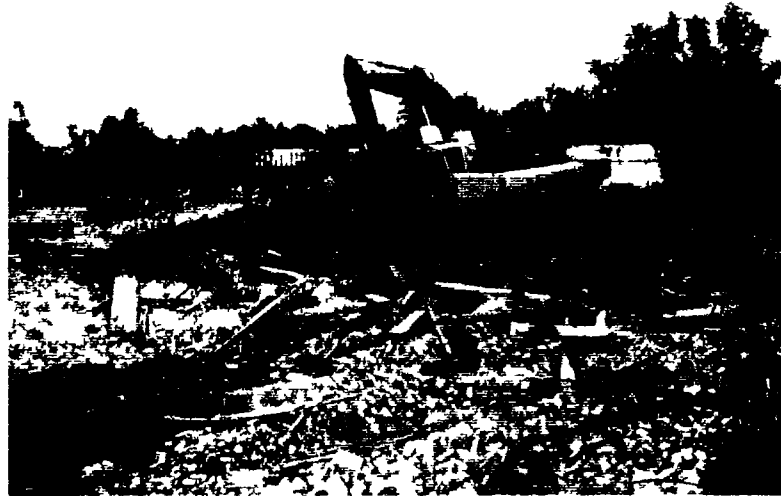
<b>TETRA TECH PROJECT NO G9011 03 0141 00</b>  Direction NE	<b>DESCRIPTION</b>	This picture shows the CCI warehouse following the completion of demolition activities	15
	<b>CLIENT</b>	U S Environmental Protection Agency Region 7	Date
	<b>PHOTOGRAPHER</b>	Nicholas Godfrey	6/11/2003

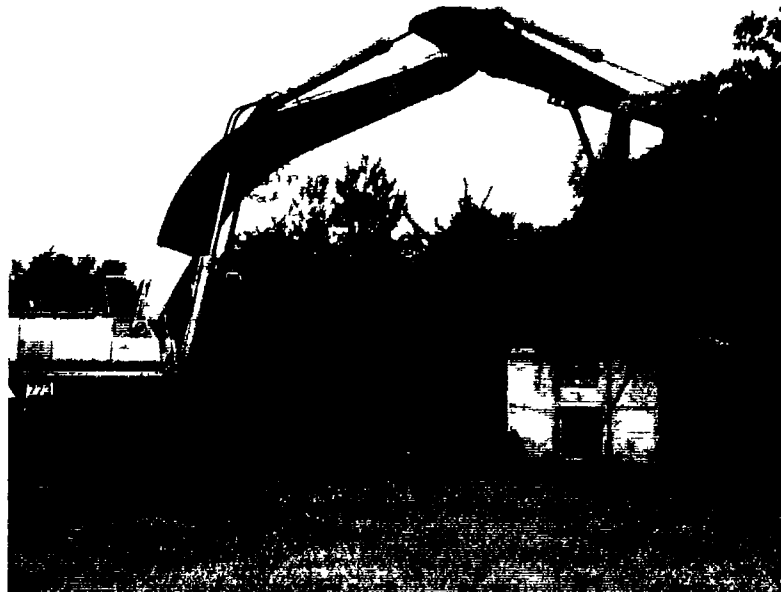
<b>TETRA TECH PROJECT NO G9011 03 0141 00</b>  Direction SW	<b>DESCRIPTION</b>	ER placing metal pieces into a 20 foot roll off storage unit	16
	<b>CLIENT</b>	U S Environmental Protection Agency Region 7	Date
	<b>PHOTOGRAPHER</b>	Nicholas Godfrey	6/11/2003

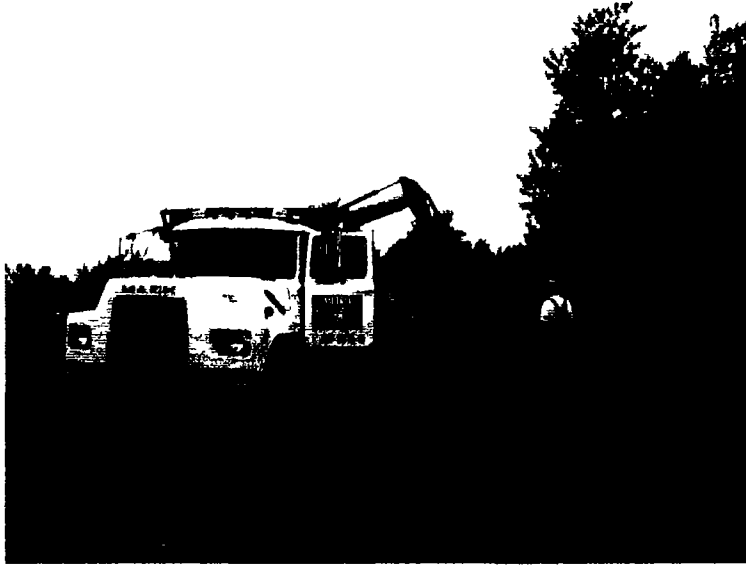
<b>TETRA TECH PROJECT NO G9011 03 0141 00</b>  Direction SW	<b>DESCRIPTION</b>	Metro Recycling Incorporated from Kansas City Missouri retrieving recyclable items from the facility	17
	<b>CLIENT</b>	U S Environmental Protection Agency Region 7	Date
	<b>PHOTOGRAPHER</b>	Nicholas Godfrey	6/11/2003

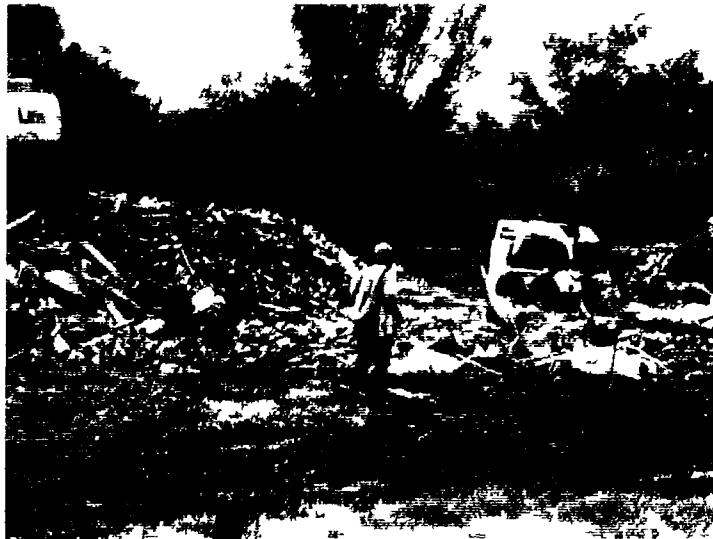
<b>TETRA TECH PROJECT NO G9011 03 0141 00</b>  Direction SE	<b>DESCRIPTION</b>	This picture shows START PM Nicholas Godfrey screening the excavation site for VOCs with a TVA 1000 <sup>®</sup> dual photoionization detector (PID)/ flame ionization detector (FID)	18
	<b>CLIENT</b>	U S Environmental Protection Agency Region 7	Date
	<b>PHOTOGRAPHER</b>	Scott Allen (ER)	6/11/2003

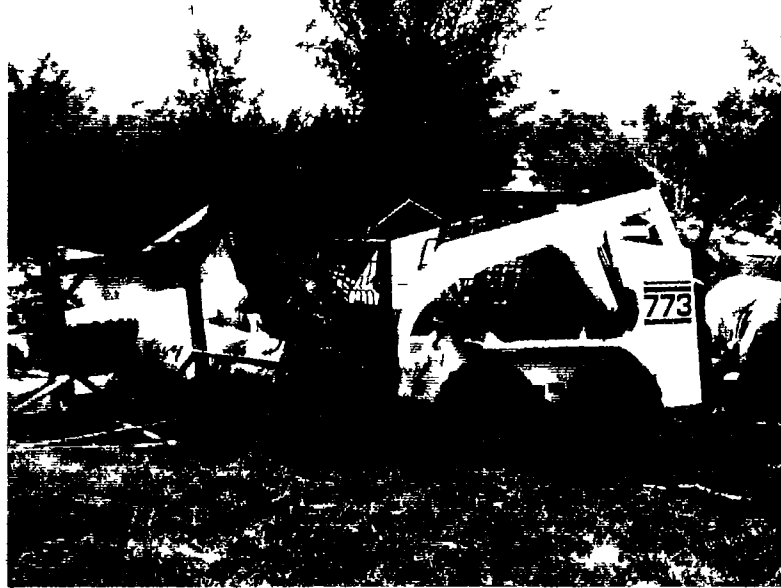
TETRA TECH PROJECT NO G9011 03 0141 00  Direction E	DESCRIPTION	A Bobcat® forklift being used to segregate metal and other recyclable materials	19
	CLIENT	U S Environmental Protection Agency Region 7	Date
	PHOTOGRAPHER	Nicholas Godfrey	6/12/2003

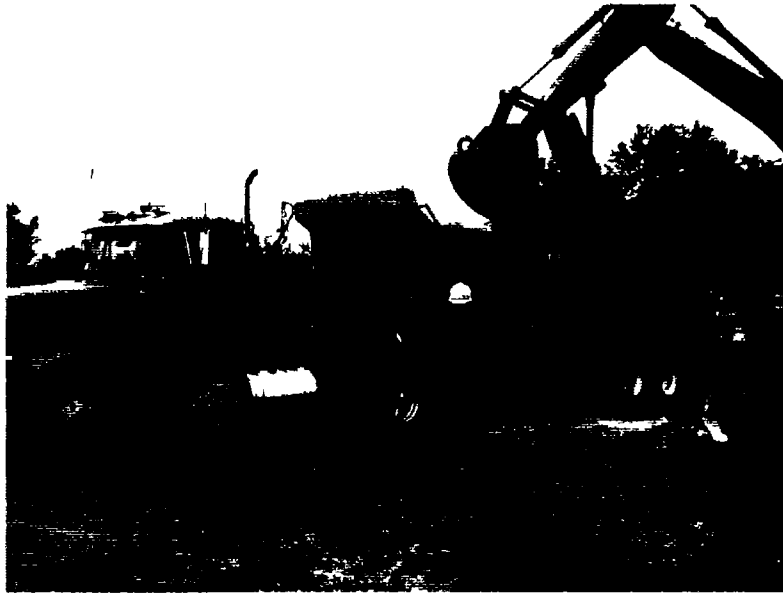
TETRA TECH PROJECT NO G9011 03 0141 00  Direction SE	DESCRIPTION	R Vickers truck being loaded to haul debris to the Deffenbaugh waste disposal facility in Shawnee Kansas	20
	CLIENT	U S Environmental Protection Agency Region 7	Date
	PHOTOGRAPHER	Nicholas Godfrey	6/12/2003

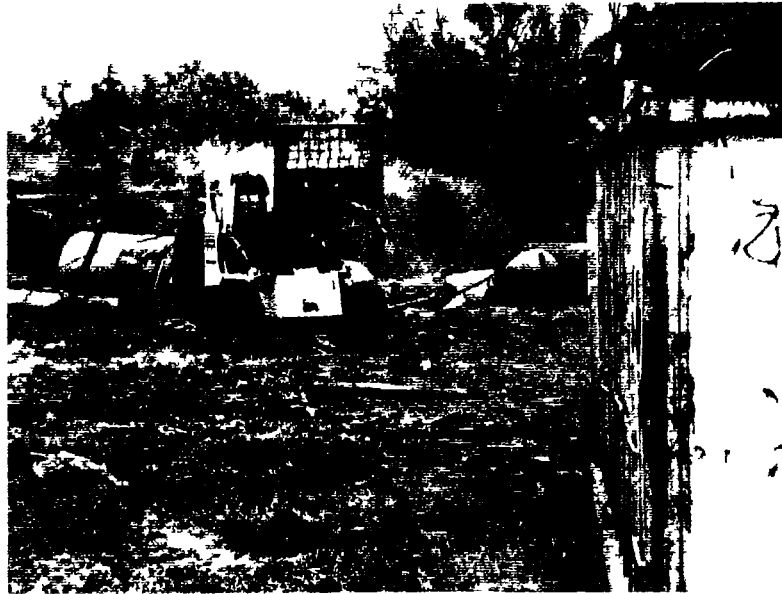
TETRA TECH PROJECT NO G9011 03 0141 00  Direction S	DESCRIPTION	ER hauling scrap metal and other recyclables to a roll off unit	21
	CLIENT	U S Environmental Protection Agency Region 7	Date
	PHOTOGRAPHER	Nicholas Godfrey	6/12/2003

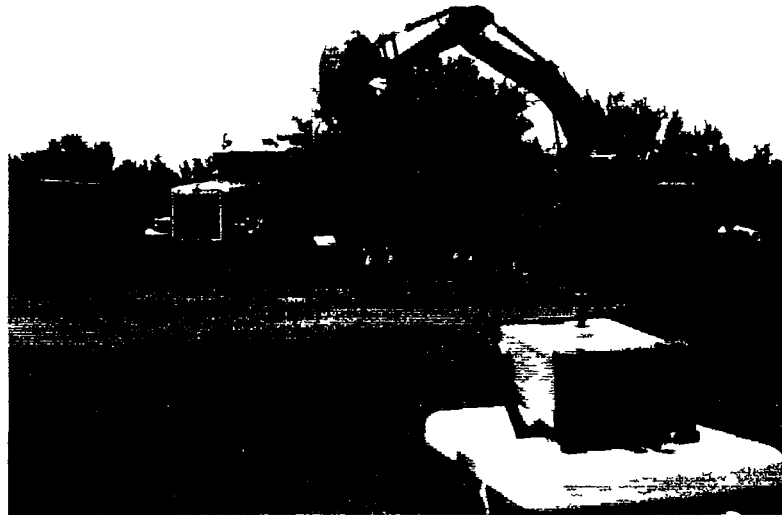
TETRA TECH PROJECT NO G9011 03 0141 00  Direction SE	DESCRIPTION	This picture shows the DataRam <sup>®</sup> particulate monitor downwind from loading and excavation activities	22
	CLIENT	U S Environmental Protection Agency Region 7	Date
	PHOTOGRAPHER	Nicholas Godfrey	6/12/2003

None of the particulate monitoring results surpassed the NAAQS of  $150 \mu\text{g}/\text{m}^3$ . The highest observed reading of  $41.0 \mu\text{g}/\text{m}^3$  was recorded during the first day of demolition/excavation on June 10, 2003.

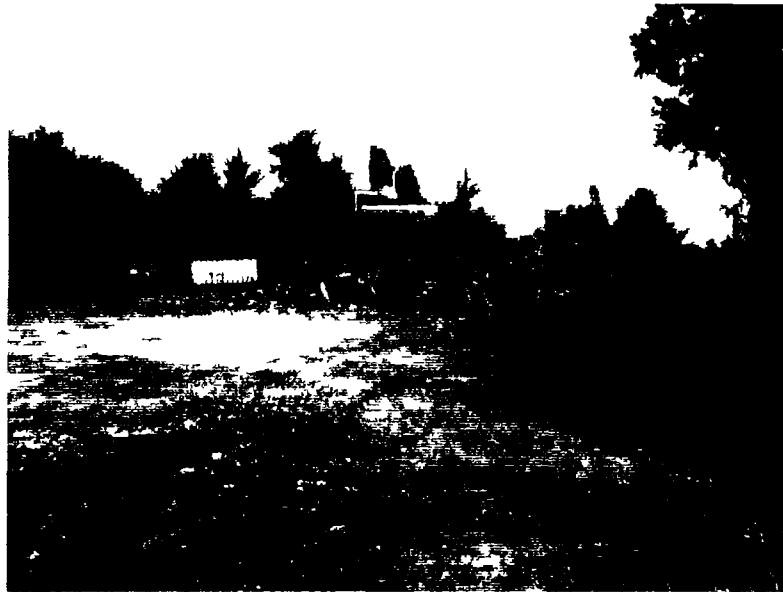
<b>TETRA TECH PROJECT NO G9011 03 0141 00</b>  Direction N	<b>DESCRIPTION</b>	This picture shows the concrete warehouse foundation following demolition and segregation activities	24
	<b>CLIENT</b>	U S Environmental Protection Agency Region 7	Date
	<b>PHOTOGRAPHER</b>	Nicholas Godfrey	6/12/2003

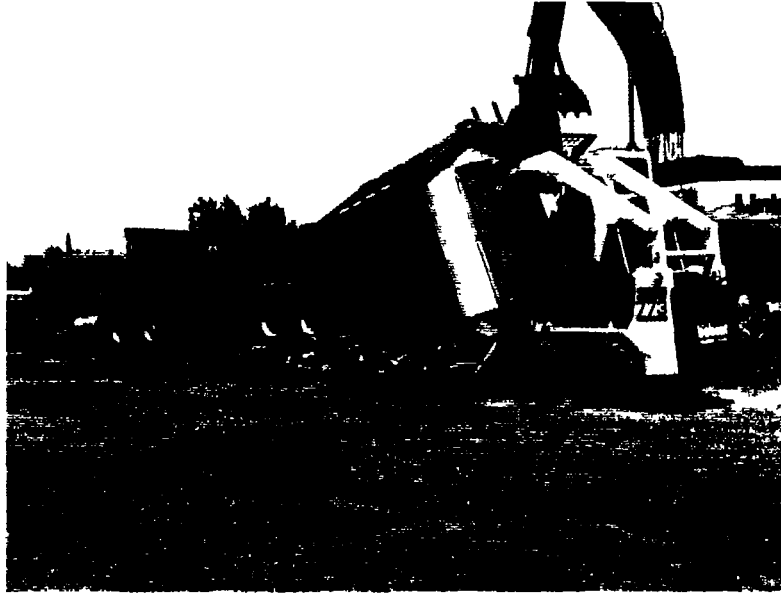
<b>TETRA TECH PROJECT NO G9011 03 0141 00</b>  Direction NE	<b>DESCRIPTION</b>	An aluminum shed that housed the facility's natural gas line connections being removed	25
	<b>CLIENT</b>	U S Environmental Protection Agency Region 7	Date
	<b>PHOTOGRAPHER</b>	Nicholas Godfrey	6/12/2003

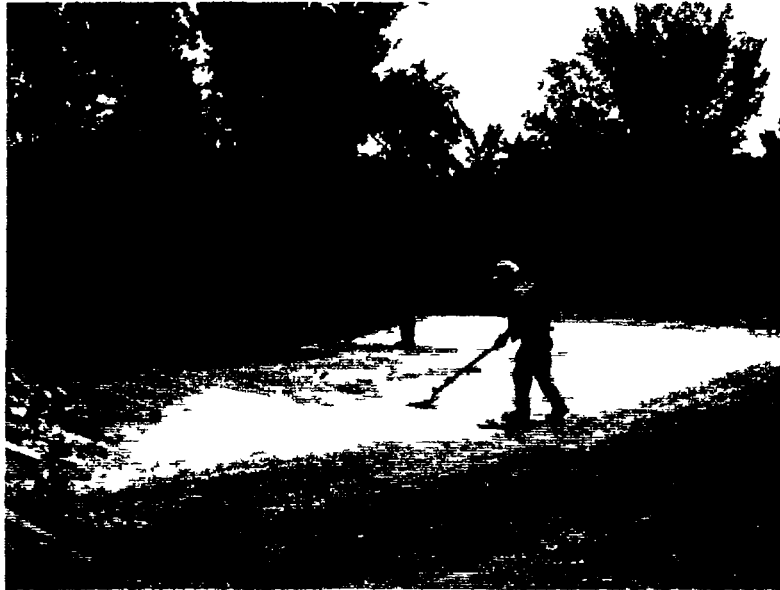
<b>TETRA TECH PROJECT NO G9011 03 0141 00</b>  Direction SE	<b>DESCRIPTION</b>	This picture shows ER contractors cleaning the concrete surface of the warehouse foundation	26
	<b>CLIENT</b>	U S Environmental Protection Agency Region 7	Date
	<b>PHOTOGRAPHER</b>	Nicholas Godfrey	6/13/2003

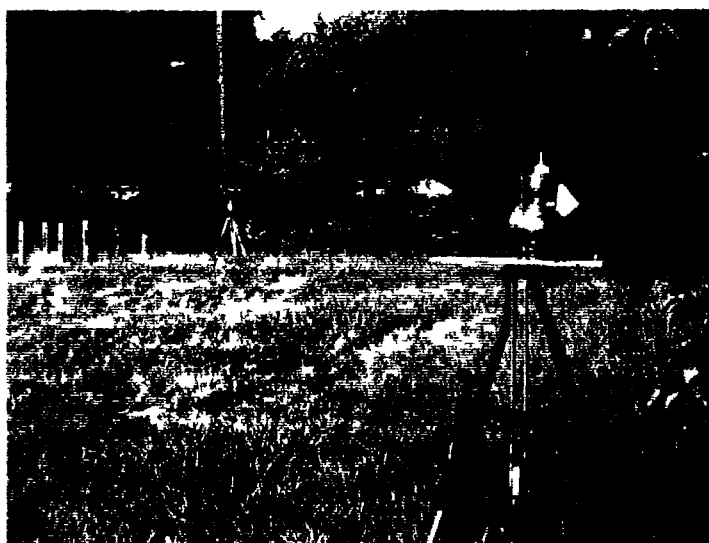
<b>TETRA TECH PROJECT NO G9011 03 0141 00</b>  Direction SW	<b>DESCRIPTION</b>	This picture shows summa air samples A 3 and A 4 located on the western border of the property	28
	<b>CLIENT</b>	U S Environmental Protection Agency Region 7	Date
	<b>PHOTOGRAPHER</b>	Nicholas Godfrey	6/16/2003

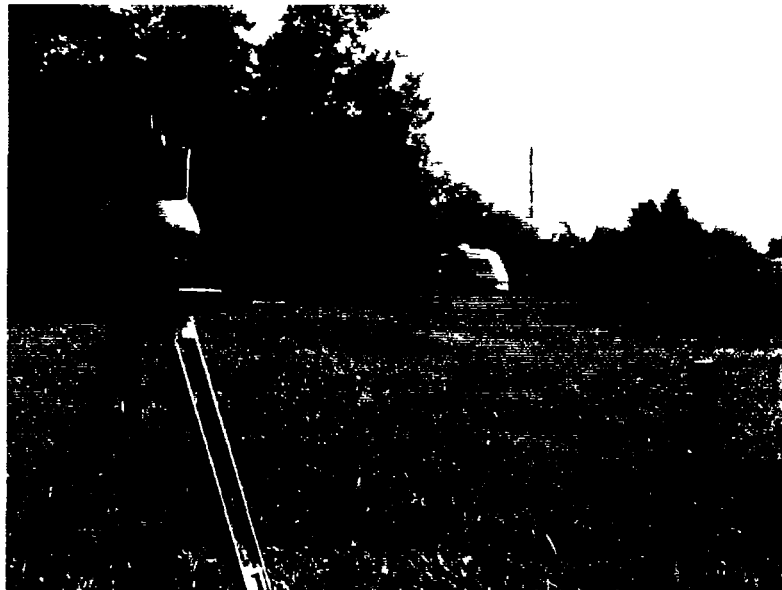
<b>TETRA TECH PROJECT NO G9011 03 0141 00</b>  Direction NE	<b>DESCRIPTION</b>	This picture shows summa canisters A 3 A 4 and A 1	30
	<b>CLIENT</b>	U S Environmental Protection Agency Region 7	Date
	<b>PHOTOGRAPHER</b>	Nicholas Godfrey	6/16/2003

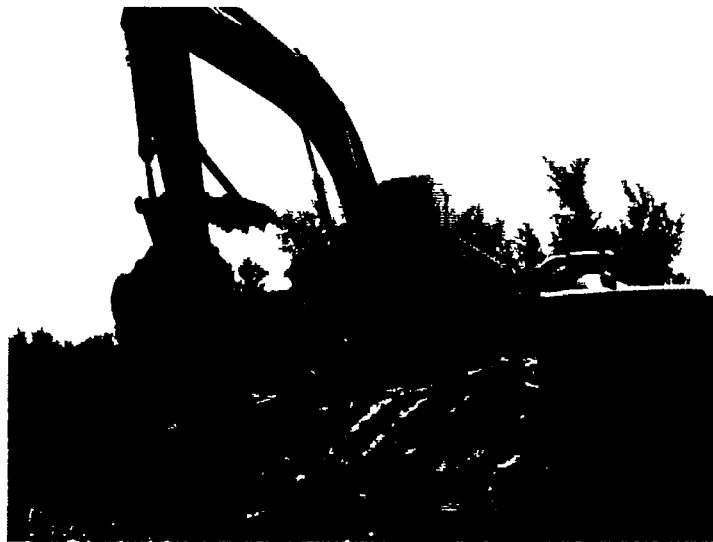
TETRA TECH PROJECT NO G9011 03 0141 00  Direction F	DESCRIPTION	START PM Godfrey using the TVA 1000 dual PID/FID to monitor for volatile organic compounds in the air during the excavation of the contaminated soil pile	32
	CLIENT	U S Environmental Protection Agency Region 7	Date
	PHOTOGRAPHER	Nicholas Godfrey	6/16/2003

Upon ER's removal of the contaminated soil pile, readings of 6 ppm and 8.8 ppm were noted on June 16, 2003. On June 17, 2003, air monitoring results peaked at 38 ppm within the area of excavation and 10 ppm around the site perimeter. Air monitoring conducted outside of the site perimeter indicated peak results between background (0 ppm) and 1 ppm. All readings and results exceeding the health and safety action level were noted in the log book and reported to OSC Doherty.

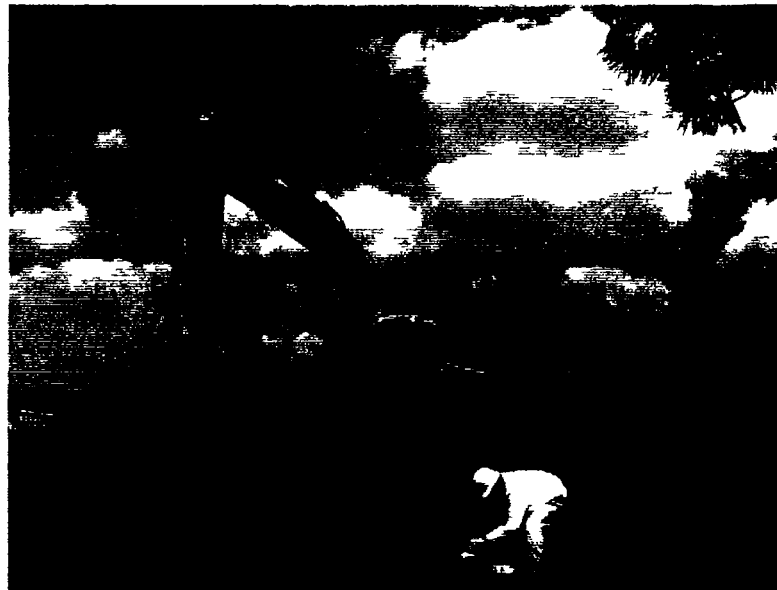
TETRA TECH PROJECT NO G9011 03 0141 00  Direction E	DESCRIPTION	Tetra Tech START PM Godfrey taking composite samples underneath the second capped layer of contaminated soil. Samples were labeled S 1 S 2 and S 3	34
	CLIENT	U S Environmental Protection Agency Region 7	Date
	PHOTOGRAPHER	Lynn Parman	6/17/2003

The samples were labeled S-1, S-2, and S-3. Soil aliquots were collected from material retrieved by ER with an excavator from a depth of 2 to 3 inches (in) bgs, using a stainless steel spoon and disposable pie pan. The aliquots were homogenized and transferred to the appropriate sample containers (except for the sample to be analyzed for VOCs, which was not homogenized). The samples were stored in a cooler pending submittal to AML Laboratories in Overland Park, Kansas, on June 17, 2003, for analysis of volatile organic compounds, semi-volatile organic compounds, pesticides, and herbicides. A soil sample summary is available in Appendix D, Table 3. A chain of custody form is provided in Appendix E. Pertinent data, including sample time, analyses to be performed, and exact sample locations, were included on the field sheets provided in Appendix F.

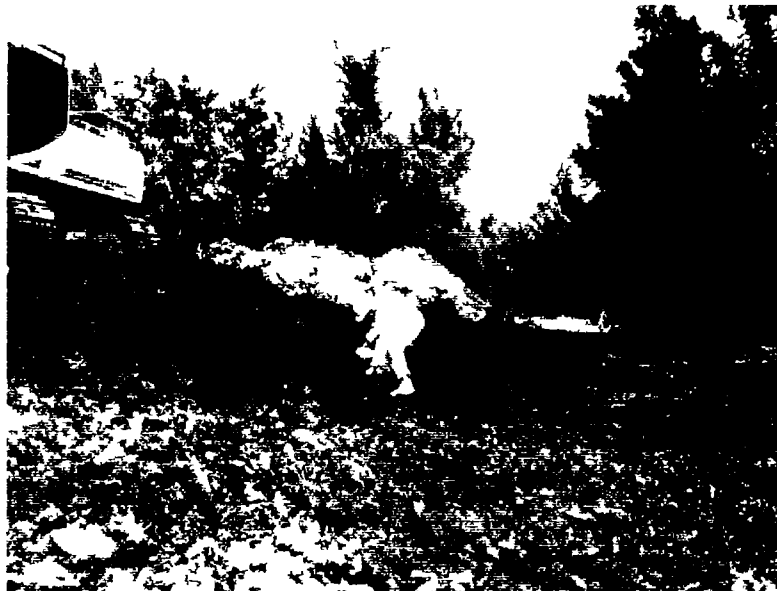
TETRA TECH PROJECT NO G9011 03 0141 00  Direction E	DESCRIPTION	This picture shows Godfrey collecting samples of soil retrieved with an excavator from a depth of 2 to 3 feet below ground surface	35
	CLIENT	U S Environmental Protection Agency Region 7	Date
	PHOTOGRAPHER	Nicholas Godfrey	6/17/2003

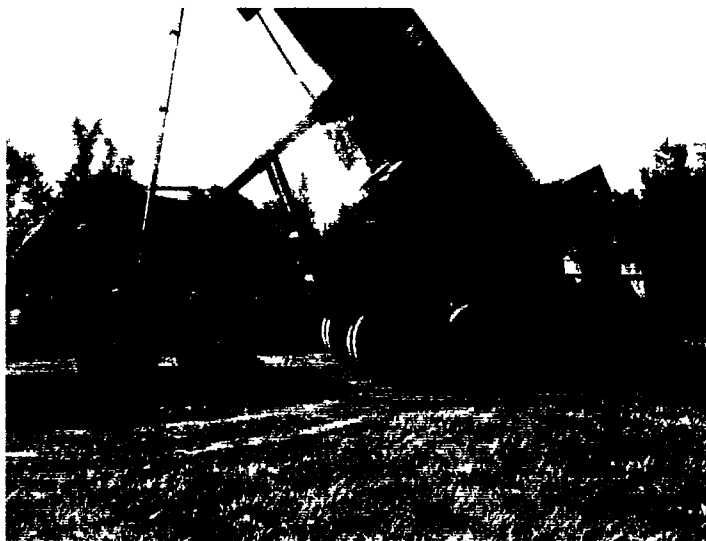
TETRA TECH PROJECT NO G9011 03 0141 00  Direction E	DESCRIPTION	R Vickers trucking company transporting clean fill to the site assisting with site restoration activities	36
	CLIENT	U S Environmental Protection Agency Region 7	Date
	PHOTOGRAPHER	Nicholas Godfrey	6/18/2003

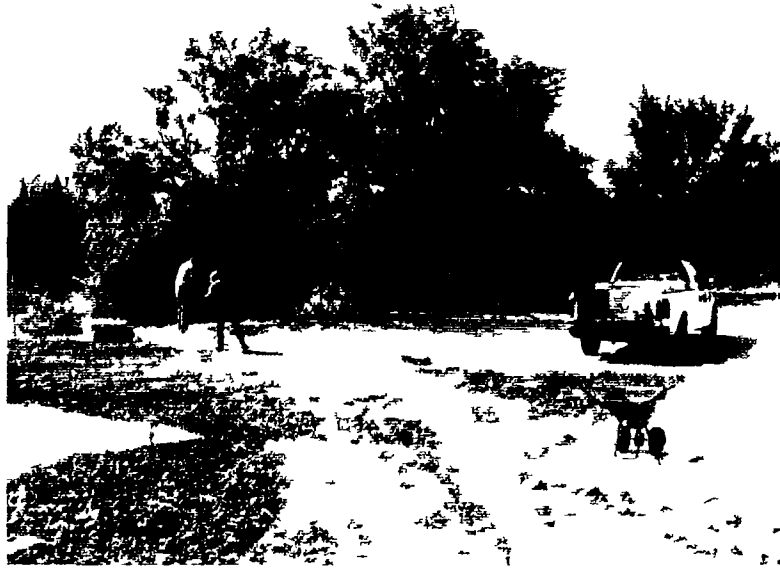
<b>TETRA TECH PROJECT NO G9011 03 0141 00</b>  Direction S	<b>DESCRIPTION</b>	Contractors spreading hay on the excavated areas of the property	39
	<b>CLIENT</b>	U S Environmental Protection Agency Region 7	Date
	<b>PHOTOGRAPHER</b>	Nicholas Godfrey	6/18/2003

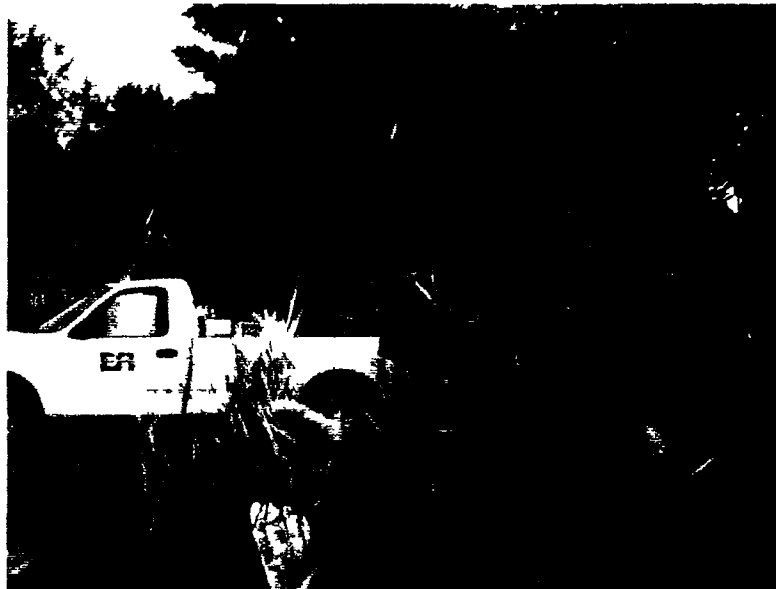
<b>TETRA TECH PROJECT NO G9011 03 0141 00</b>  Direction W	<b>DESCRIPTION</b>	This picture shows ER contractors spreading hay to retain water in newly seeded areas	40
	<b>CLIENT</b>	U S Environmental Protection Agency Region 7	Date
	<b>PHOTOGRAPHER</b>	Nicholas Godfrey	6/18/2003
