Sonoma Resource Conservation District

# Maacama and Upper Mark West Creek Integrated Watershed Management Plan

March 2015

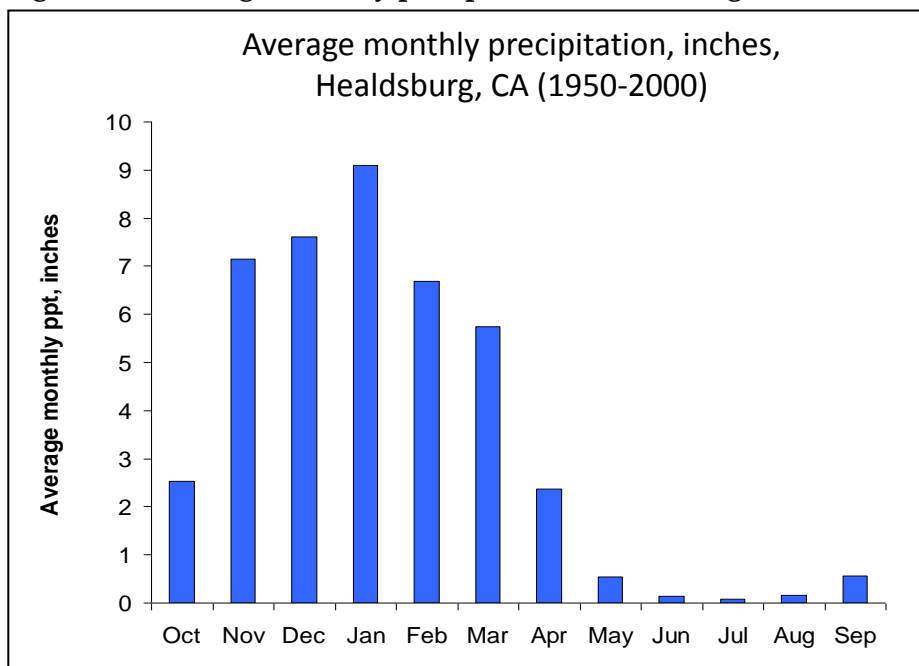
**Figure 2.11 Average monthly precipitation, Healdsburg, California**

The climate patterns of the Maacama and Upper Mark West watersheds are characteristically Mediterranean with cool to warm, dry summers and cool, moist winters. Precipitation occurs almost exclusively as rainfall (i.e., snowfall is very rare) and mostly during wet winters. On average, 95% of annual precipitation falls in October through April, with only 5% falling in May through September (see Figure 2.11 below).
