# Mill Creek Watershed Management Plan

Needs Assessment and Action Plan: A Living Document

**Sonoma Resource Conservation District  
2015**

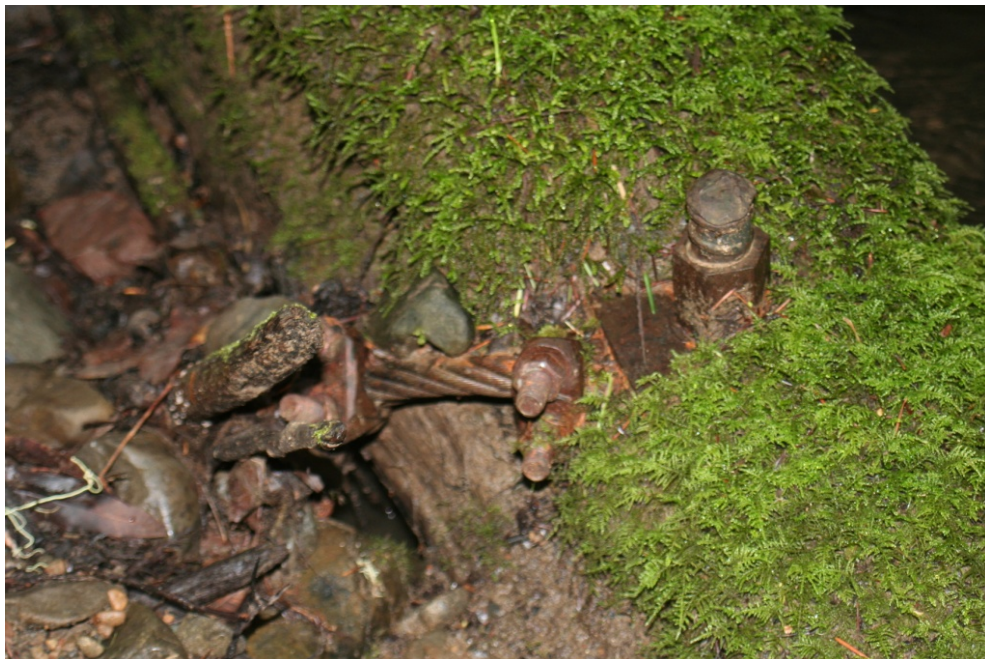
**Figure 1: Attachment cable and bolts identifying CDFW-installed LWM.**

The assessment focused on salmonid habitat in the low-flow dry period, the season prior to consistent winter rains typical of Northern California climate. Naturally occurring pieces of wood touching low-flow creek water were measured and counted. Pieces suspended above low-flow creek water were not assessed, with the exception of all previously installed LWM. Assessment of the CDFW/SCWA-installed LWM, involved recording current functioning status, and length and diameter measurements of each piece. All previously installed LWM structures were assessed within the selected reaches regardless of placement and/or designed as low-flow or high-flow structures. Large wood installed by CDFW/SCWA was identified by the use of attachment cables and bolts (Figure 1 in Appendix G) and by metal identification tags secured to living trees on either bank.

This project specifically assessed juvenile coho habitat in the low-flow dry period, the season prior to consistent winter rains typical of Northern California climate. Naturally occurring pieces of wood touching low-flow creek water were measured and counted. Pieces suspended above low-flow creek water were not assessed. However, as part of the study was to assess the current functioning status of CDFW-installed LWM, all installed pieces were measured, regardless of placement and whether they were designed as low-flow or high-flow structures. Large wood installed by CDFW was identified by the use of attachment cables and bolts (Figure 1) and by metal identification tags secured to living trees on either bank.

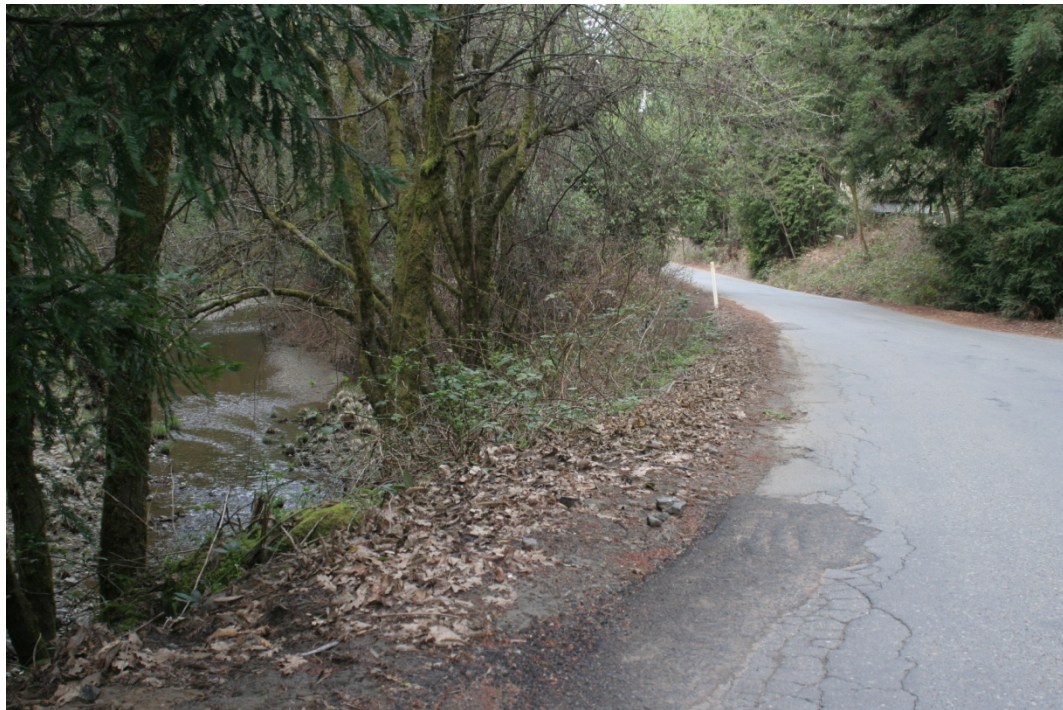
**Figure 2: The close proximity of Mill Creek Road to Mill Creek influencing LWM recruitment.**

likely to be removed to maintain accessibility. As the road runs very close to the creek, recruitment potential may be reduced by as much as 50% (Figure 2).

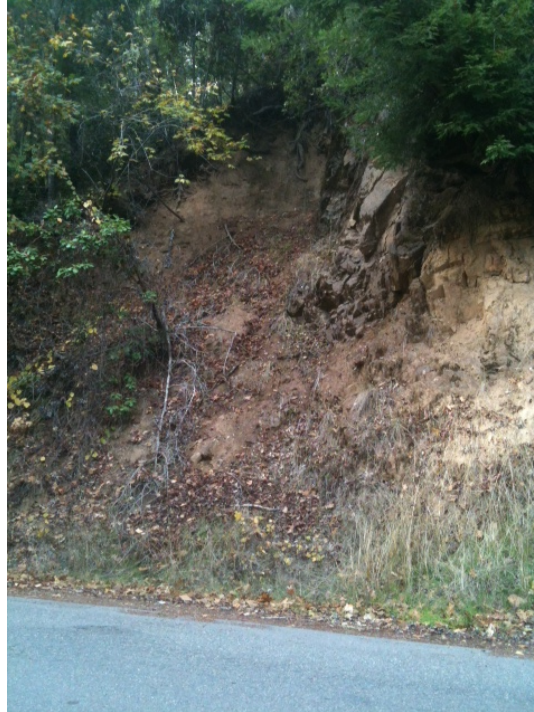
**Figure 3: Evidence of potential LWM recruitment from landslides above Mill Creek Road.**

Current recruitment appears to be exclusively from the opposite bank and beyond. Landslides are recruitment events resulting in the deposition of LWM into creeks. Evidence of landslides above Mill Creek Road suggests recruitment potential, but it is doubtful any large wood from the slide would enter the creek as it would probably be cleared off the road (Figure 3).

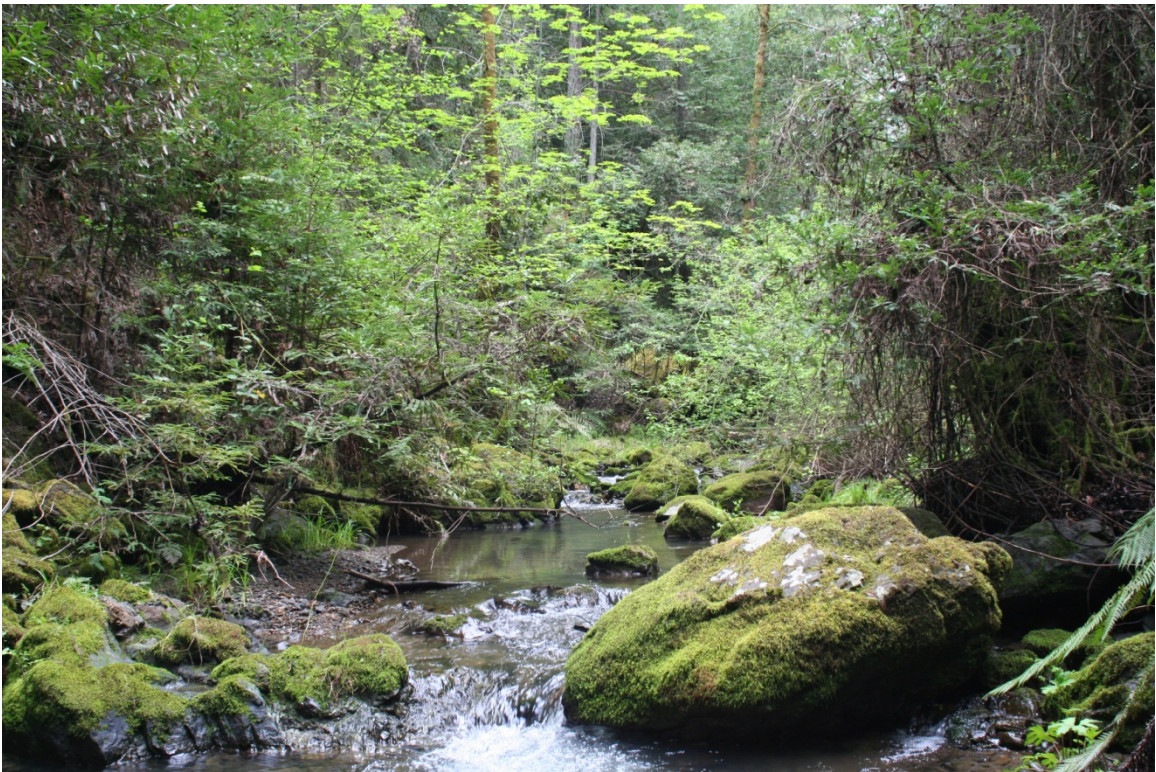
Figure 3: Palmer Creek. Note the very large bedrock and boulders in foreground.

Palmer Creek is characterized by steep banks, several very large in-stream boulders and a recruitment zone consisting predominantly of mixed hardwood and conifer cover (Figure 3). The only road impacting the creek is a dirt/gravel fire control access roads constructed and maintained by the landowner. Unlike Mill Creek, this fire/access road only

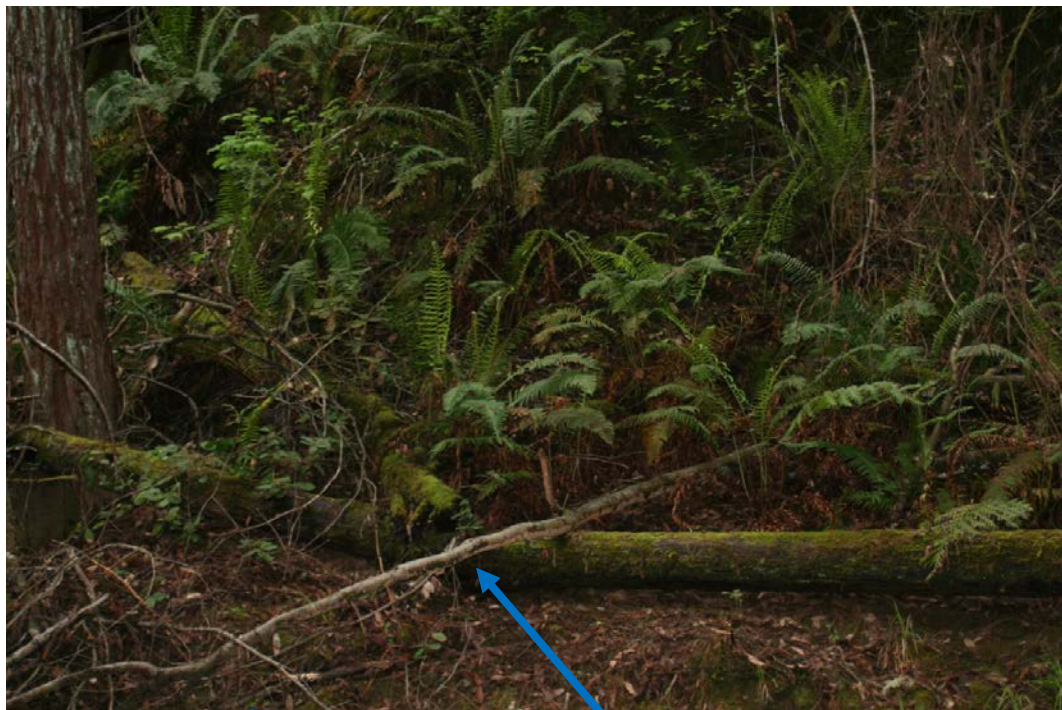
Figure 4: Broken piece of CDFW LWM. Break point located at tip of arrow.

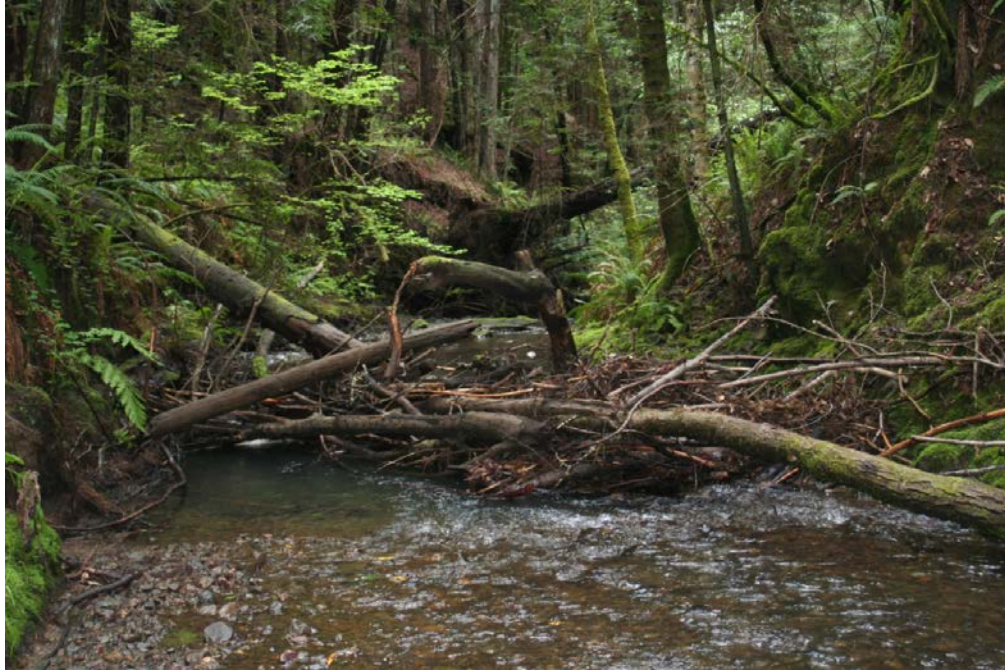
Figure 51: Log jam in Palmer Creek.

Creek-bed material consisted of several very large boulders, bedrock and gravel of assorted sizes. The lack of silt may be attributable to the effectiveness of the debris jams. Visual assessment confirmed that silt had been trapped upstream of the jams. Pool formation was bedrock-, boulder- and log-enhanced. Most boulders were natural and were consistently located throughout the sample reach.

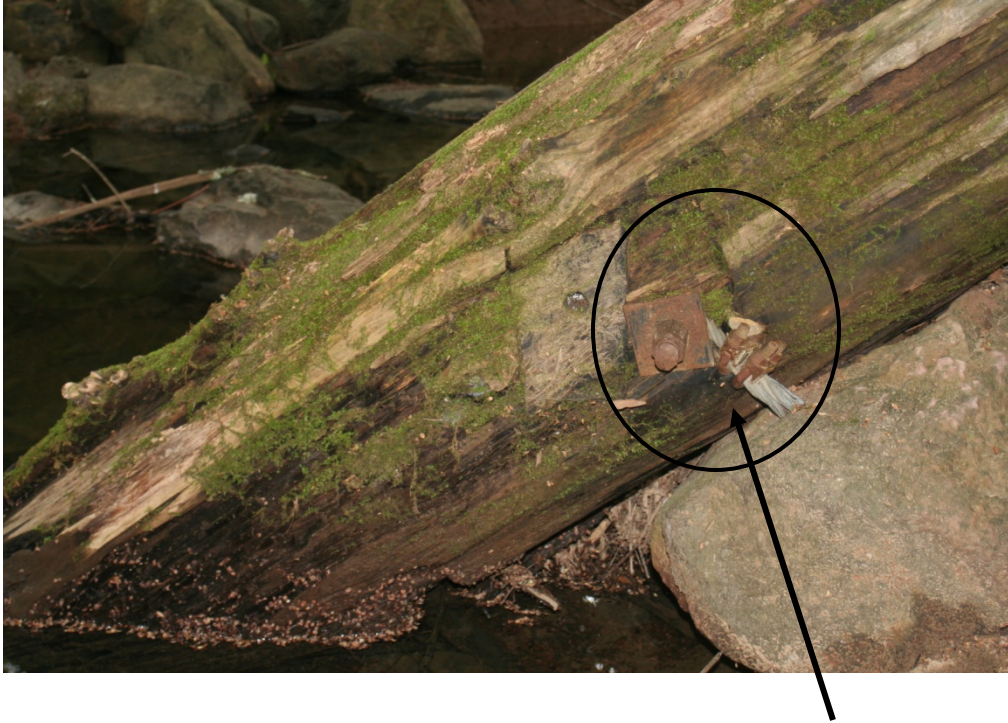
**Figure 7: Felta Creek (F1b): an example of LWM attachment to boulder using bolts and cable**

The California Department of Fish and Wildlife installed several large in-stream boulder weirs and combination LWM-boulder weirs. These structures were connected to each other using a series of bolts and cables (Figure 7). Some boulder clusters contained more than 20 large boulders spanning low-flow creek water levels. Several of these structures are no longer functioning as designed as bolts and connecting cables have separated (Figure 8).

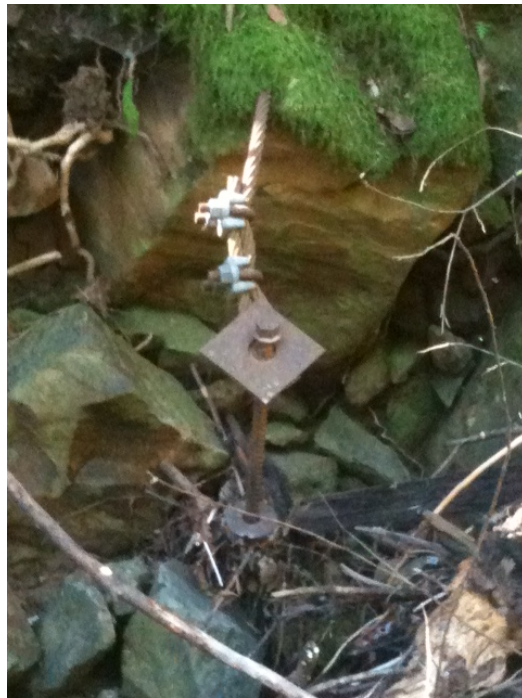
**Figure 8: A disconnected bolt from CDFW LWM.**

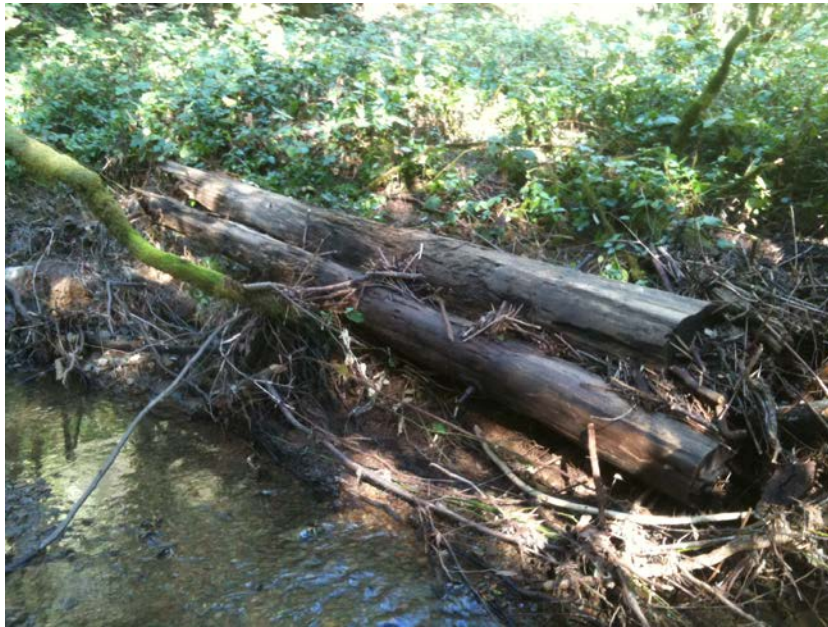
**Figure 9: Two attached pieces of CDFW LWM that has broken apart from original anchoring. These pieces are loose and will likely move in periods of high flow.**

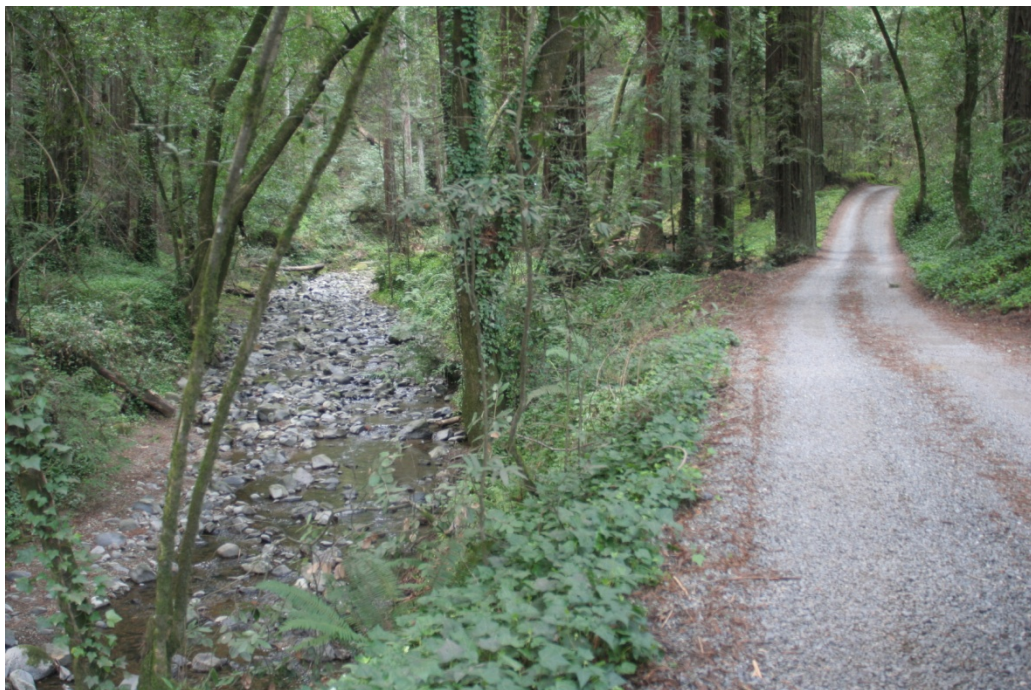
**Figure 10: Felta Creek Road and its potential influence on LWM recruitment.**

The upper reaches of the sample section are characterized by mixed hardwood forest (Figure 11), the lower portion by vineyards and fields cleared for agriculture. The banks of the creek are moderately sloped with recruitment coming largely from bank undercut. Privately-owned properties of varying size are located on both sides of creek. Access to this section of Felta Creek commences at the junction of Felta Creek Road and Felta Road. Felta Creek Road, a single-lane dirt and gravel road, follows the creek on the left bank of the sample reach (Figure 10). Periodically, where the road and creek are in close proximity, vehicle traffic is both audible and visible. The access road is maintained by, and predominantly used by, homeowners. Despite such light traffic, it has an effect on LWM recruitment. It is the major access artery into the watershed and it is likely that any large wood falling on the road is cut and hauled out immediately, maintaining access. The road acts as a buffer for large woody material from entering the stream, reducing actual and potential recruitment by as much as 50%.
