**Countries:** CANADA, UNITED STATES **Document ID:** IK1201242  
**Availability:** ISIS, FleetISIS, IsSIR **Revision:** 3  
**Major System:** ENGINES **Created:** 11/20/2014  
**Current Language:** English **Last Modified:** 9/20/2016  
**Other Languages:** [Español](#), **Author:** Dominic Venice  
**Viewed:** 9918

**Title:** Big Bore 13L HP Turbocharger Center Section Replacement Procedure

**Applies To:** EPA 10 MaxxForce 13L and N13 Engines

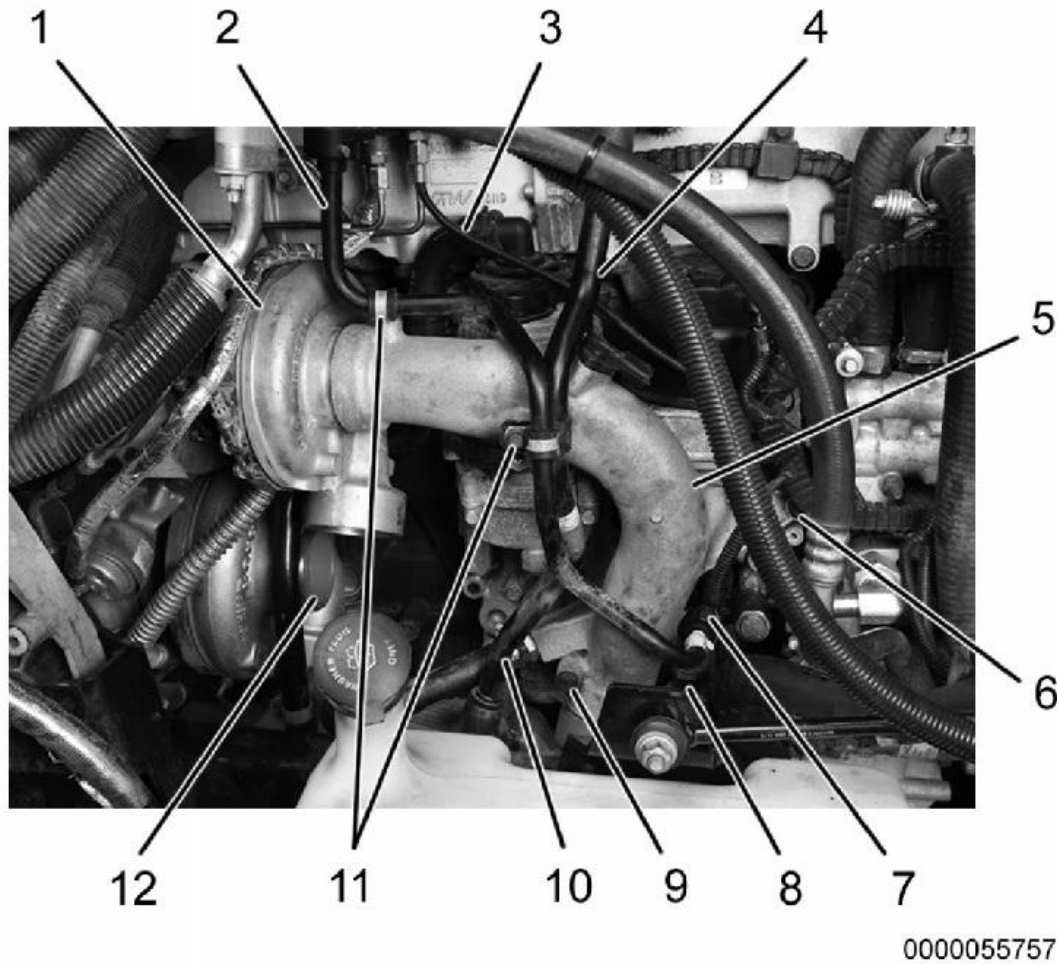
**Figure 2: HP Turbocharger and Connections.**

1. HP turbocharger
2. Cab heater coolant return pipe
3. Air supply line to ACV
4. LPCAC coolant supply pipe
5. HP turbocharger air inlet duct
6. M10 x 200 bolt
7. Cab heater coolant return pipe bolt
8. Coolant return hose
9. M10 x 200 bolt
10. Coolant hose
11. M8 x 20 bolt (2)
12. Cap

11. Remove Low-Pressure (LP) turbocharger air inlet duct (Figure 1, Item 7) and cover LP turbocharger with cap (Figure 2, Item 12). Discard LP turbocharger air inlet duct O-ring.

12. Disconnect air supply line (Figure 2, Item 3) from Air Control Valve (ACV) and secure out of the way.

13. Remove two bolts (Figure 2, Item 11) securing cab heater coolant return pipe (Figure 2, Item 2) and Low-Pressure Charge Air Cooler (LPCAC) coolant supply pipe (Figure 2, Item 4).
14. Remove bolt (Figure 2, Item 7) and position cab heater coolant return pipe (Figure 2, Item 2) out of the way.
15. Remove two clamps and LPCAC coolant supply pipe (Figure 2, Item 4) from vehicle.
16. Disconnect coolant return hose (Figure 2, Item 8) from HP turbocharger air inlet duct (Figure 2, Item 5).
17. Disconnect coolant hose (Figure 2, Item 10) from HP turbocharger air inlet duct (Figure 2, Item 5).

18. Remove two mounting bolts (Figure 2, Items 6 and 9) from HP turbocharger air inlet duct (Figure 2, Item 5).

7. While pulling out on HP turbocharger, mate HP turbocharger air inlet duct to HP turbocharger air inlet (Figure 8), then insert HP turbocharger back into turbine housing.
8. Align and fully seat HP turbocharger on dowels of turbine housing.
9. Install and torque new V-band clamp (Figure 3, Item 1) to 110 lb-in (12.4 N·m).
10. Install and torque HP turbocharger air inlet duct mounting bolts (Figure 2, Items 6 and 9) to 45 lb-ft (62 N·m).

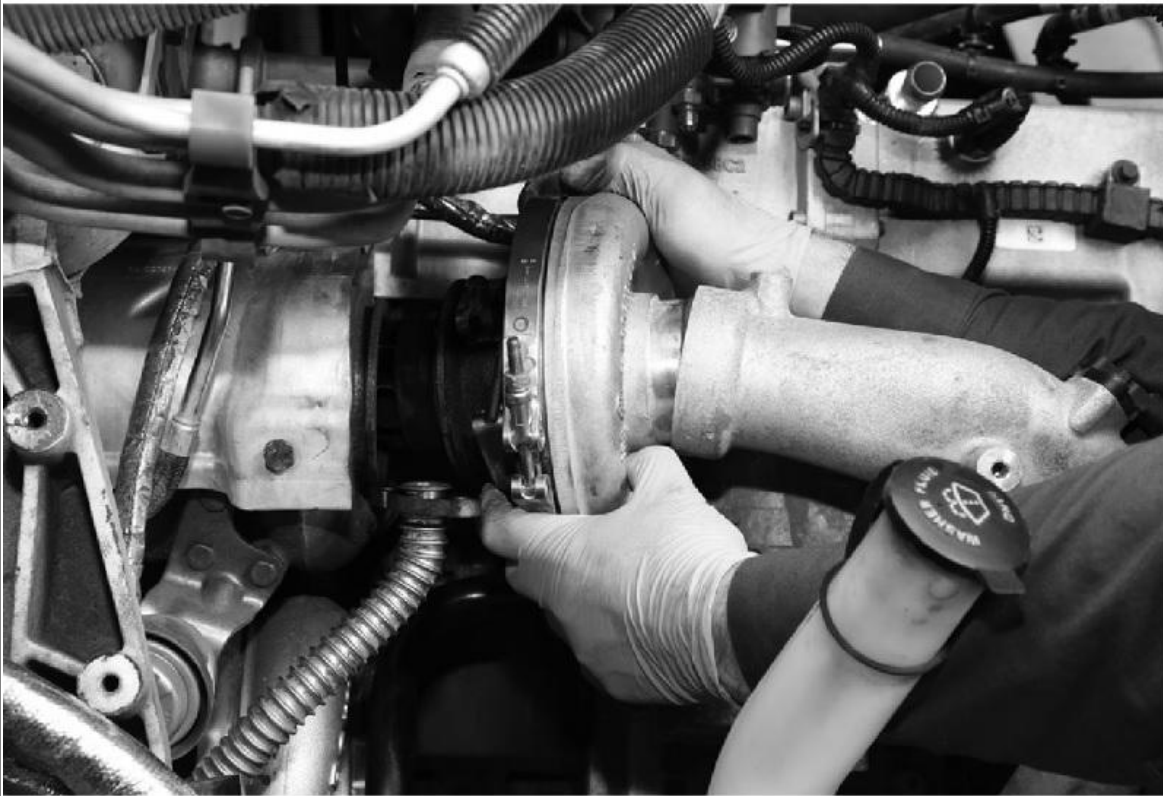
**Figure 4: HP Turbocharger Removal**

23. While pulling on HP turbocharger center cartridge, maneuver it straight out until turbine wheel is free from turbine housing (Figure 4).
24. Separate HP turbocharger and HP turbocharger air inlet duct once free from turbine housing. Discard HP turbocharger air inlet duct tube seal.
25. If HPCAC is internally contaminated with oil, clean using CAC Cleaning Kit, 09-925-01.
