Bulletin No.: PIT5317D
Published date: 08/25/2021

PIT5317D Rear Body Fuse Block Loose Fuse Connection

Brand:	Model:	Model Years:	VIN:		Engine:	Transmissions:
			from	to		
Cadillac	Escalade Models	2015 - 2020	All	All	All	All
Chevrolet	Suburban	2015 - 2020	All	All	All	All
Chevrolet	Tahoe	2015 - 2020	All	All	All	All
GMC	Yukon Models	2015 - 2020	All	All	All	All

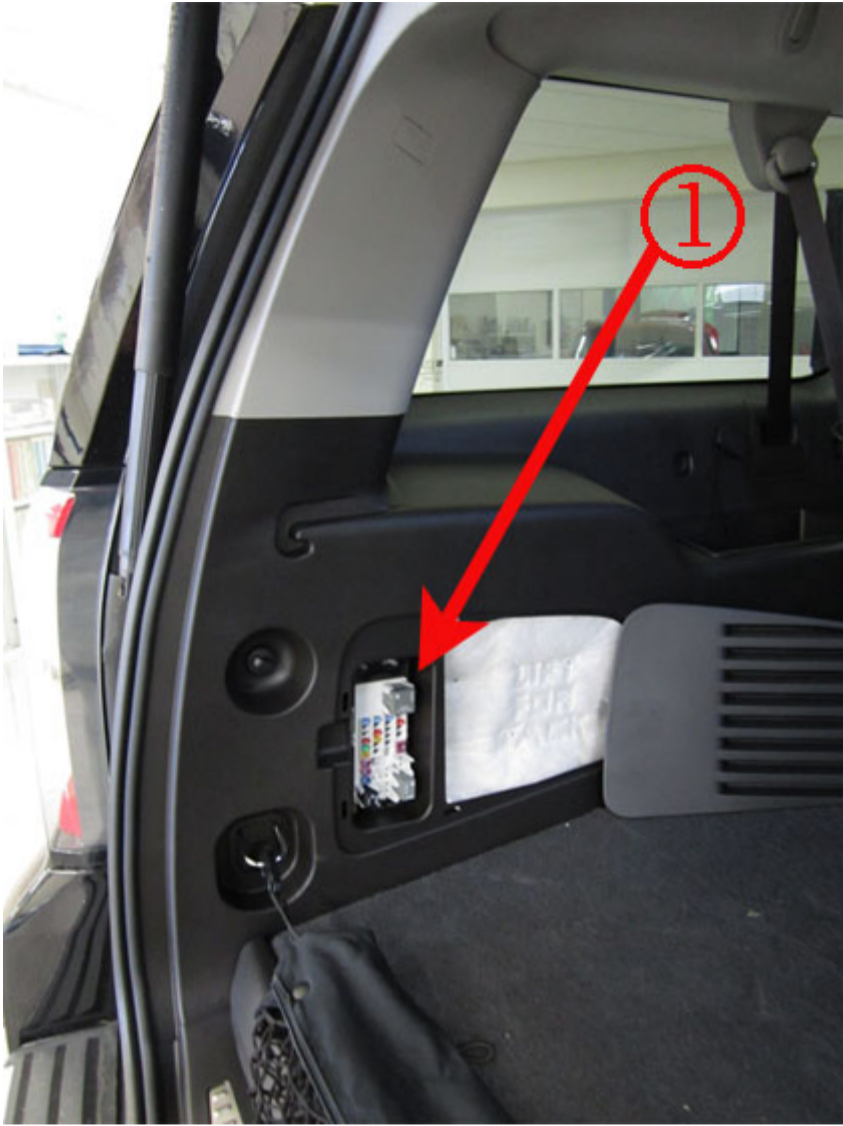
When working on any of the systems listed below that receive power from the rear body fuse block (1), inspect for loose fuse connections inside the fuse block itself. In some cases, the fuse has poor terminal tension and may cause intermittent or completely inoperative conditions for these systems:

- Liftglass release
- Liftgate release
- Power liftgate
- Rear HVAC blower
- 2nd row power flip and fold seats
- Heated outside mirrors
- Rear heated seats
- Rear wiper

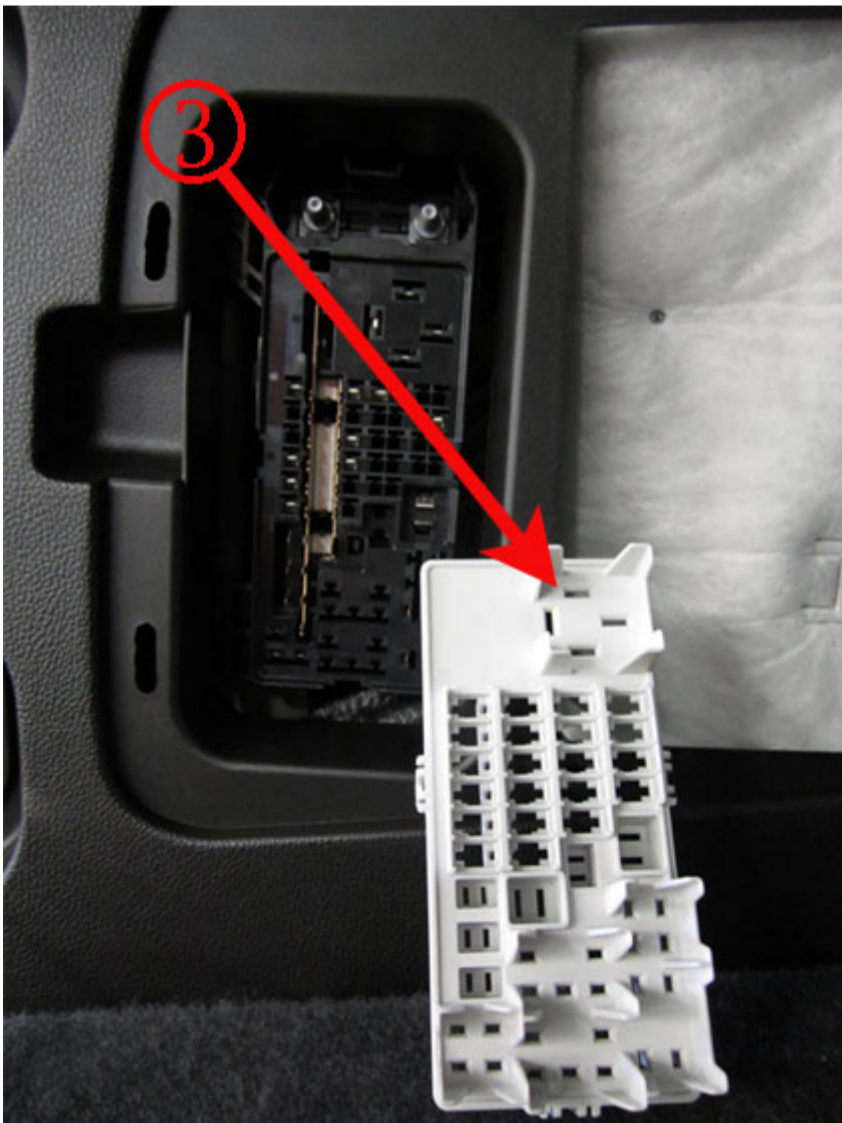
If poor terminal tension is found, first remove all the fuses and relays from the fuse block. Then, remove the white cover from the rear body fuse block (3) by releasing the three retainers on the sides and bottom.
