1. Report No.	2. Government Accession No.	3. Recipient's Catalog No.
FHWA/TX-14/0-6792-1		
4. Title and Subtitle		5. Report Date
GEOSYNTHETIC REINFORCED	STEEP SLOPES	Published: March 2016
		6. Performing Organization Code
7. Author(s)		8. Performing Organization Report No.
Yoo Jae Kim, Jiong Hu, Soon Jae L	ee, Ashley Russell Kotwal, and	Report 0-6792-1
Justin Wayne Dickey		
9. Performing Organization Name and Address	10. Work Unit No. (TRAIS)	
Texas State University		
Department of Engineering Technol	11. Contract or Grant No.	
601 University Drive	Project 0-6792	
San Marcos, Texas 78666		
12. Sponsoring Agency Name and Address		13. Type of Report and Period Covered
Texas Department of Transportation	Technical Report:	
Research and Technology Implemen	September 2012–November 2013	
125 E. 11 <sup>th</sup> Street	14. Sponsoring Agency Code	
Austin, Texas 78701-2483

# GEOSYNTHETIC REINFORCED STEEP SLOPES

Report 0-6792-1 Project 0-6792 Project Title: Synthesis on Geosynthetic Reinforced Steep Slopes

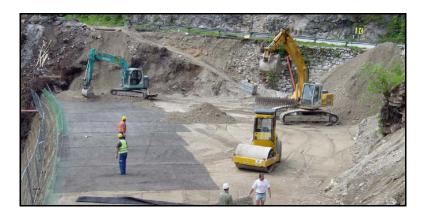
Figure 25. Placement of Geosynthetic Reinforcement for Steep Slope Construction.

The reinforcement is then placed with the principal strength direction perpendicular to the face of the slope, pulled taut, and secured with retaining pins to prevent movement during fill placement as per Figure 25. The geosynthetic materials should extend back from the slope face to the specified embedment distance at the elevations shown on the drawings. Adjacent reinforcement must also be butted together side by side without overlap unless specified (Holtz et al., 1998).

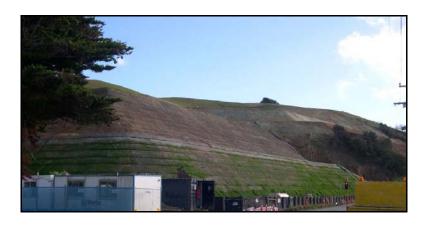
Figure 26. Vegetative Cover of Geosynthetic Reinforced Steep Slope.

Constructing a slope with vegetative cover can protect the reinforcing elements from ultraviolet light as per Figure 26. Face wrap is usually not required for slopes up to 1H:1V; however, if slope facing is required to prevent erosion, the reinforcement at the face is turned up and returned a minimum of 3 ft into the embankment below the next reinforcement layer. Steep slopes may also require formwork to support the face during construction. Field inspections should be performed by trained personnel to ensure that the reinforcement is not damaged and that the construction sequence and specifications are followed (Holtz et al., 1998).

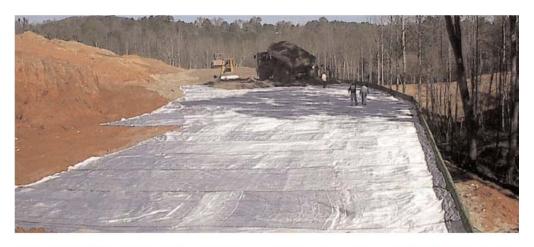
Above: The HS400PP and HS800PP high strength geotextiles were embedded between 4.5-6m (15-20ft) in length.
