Purpose: To conduct annual wetland maintenance activities to protect and enhance Suisun Marsh managed wetlands.

Typical Cross Sections

No scale
Datum: MLLW
Location: Suisun Marsh – near Suisun City, Solano County, State of California
At: Individually owned State and private properties

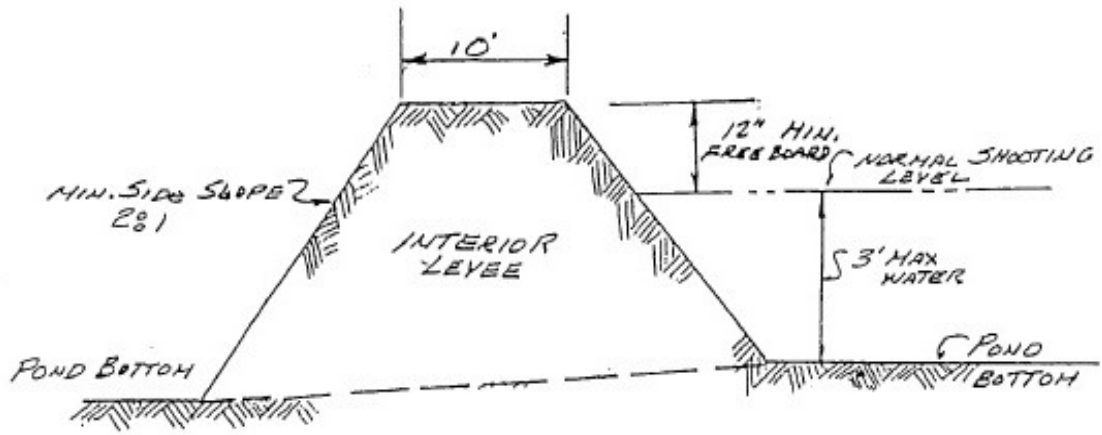
SECTION
INTERIOR LEVEE
NO SCALE

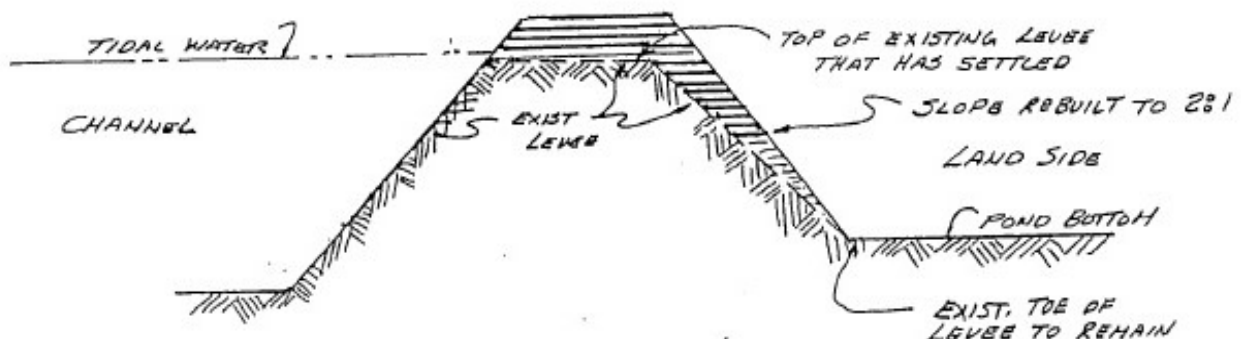
TOPPING OF EXIST. LEVEE
AND REPAIRING SIDE SLOPES
NO SCALE
WITH SETTLEMENT & EROSION

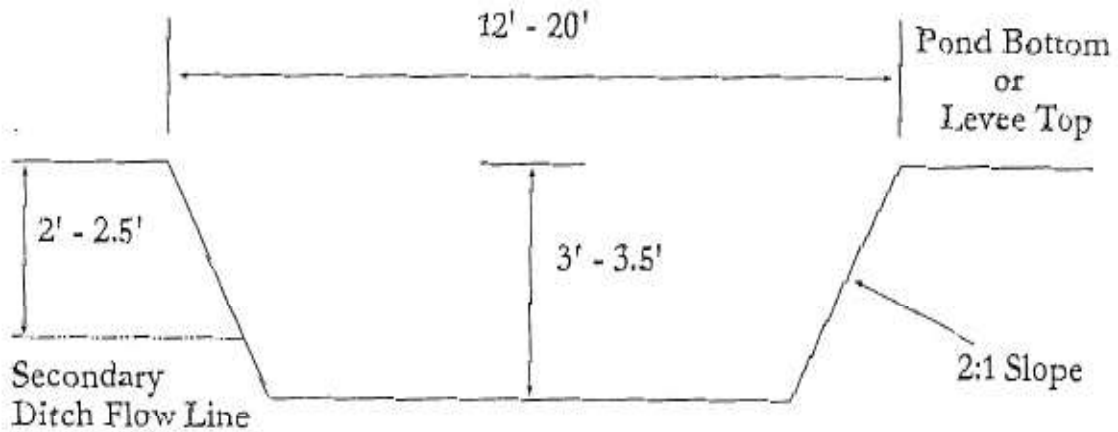
Cross Section of Primary Ditch

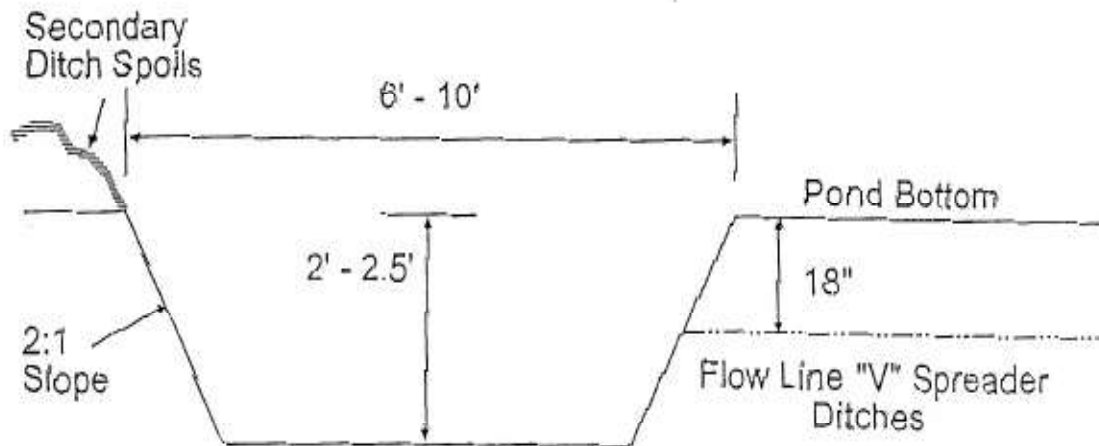
Cross Section of Secondary Ditch

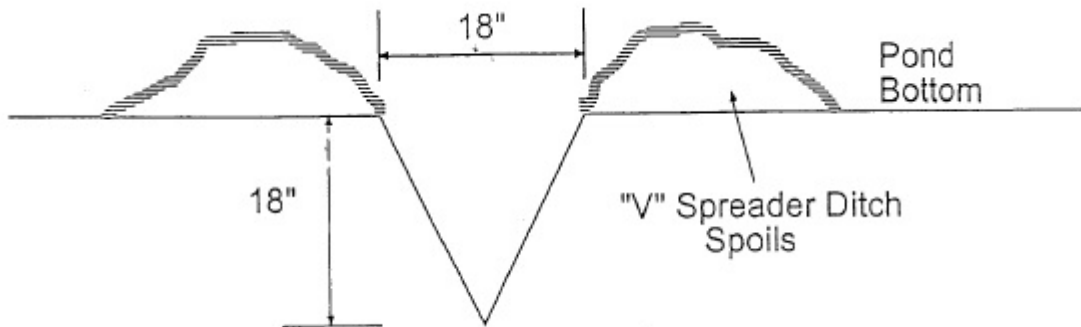
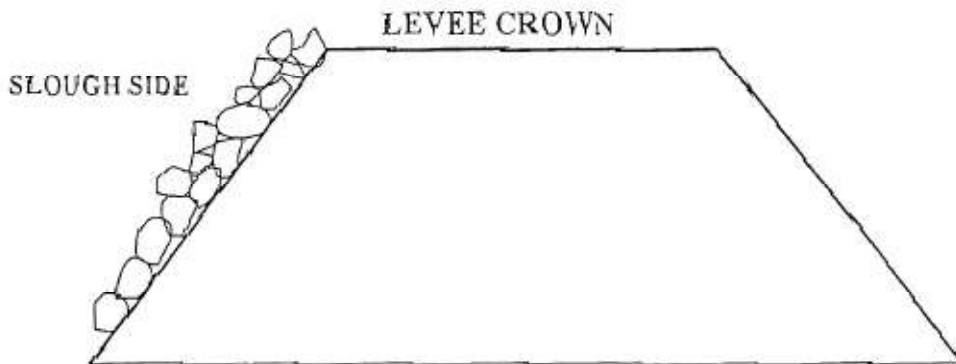
Typical Levee Section For the Replacement of Rip-Rap

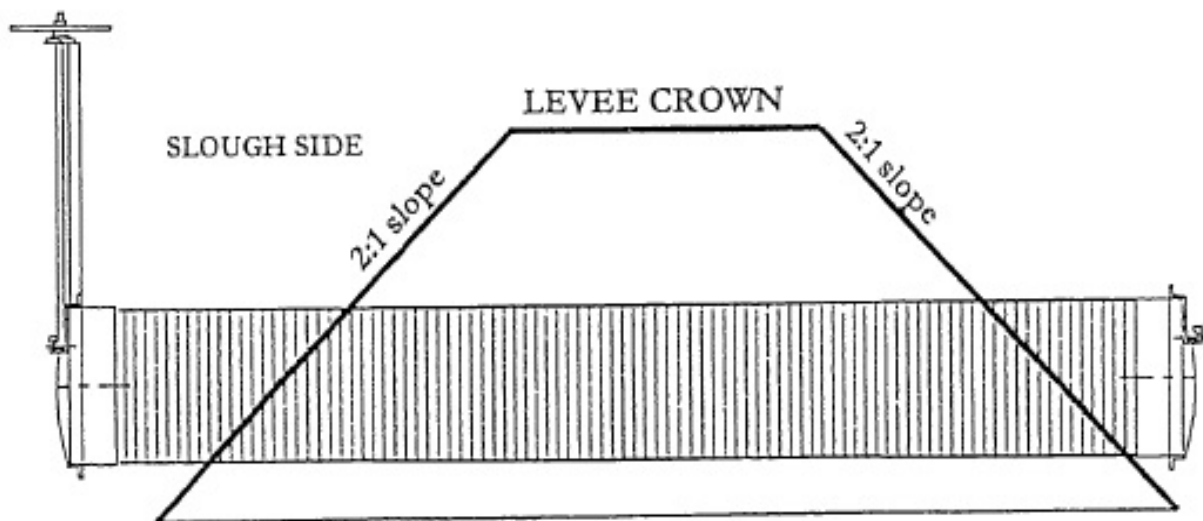
Typical Levee Section For a Flood Gate

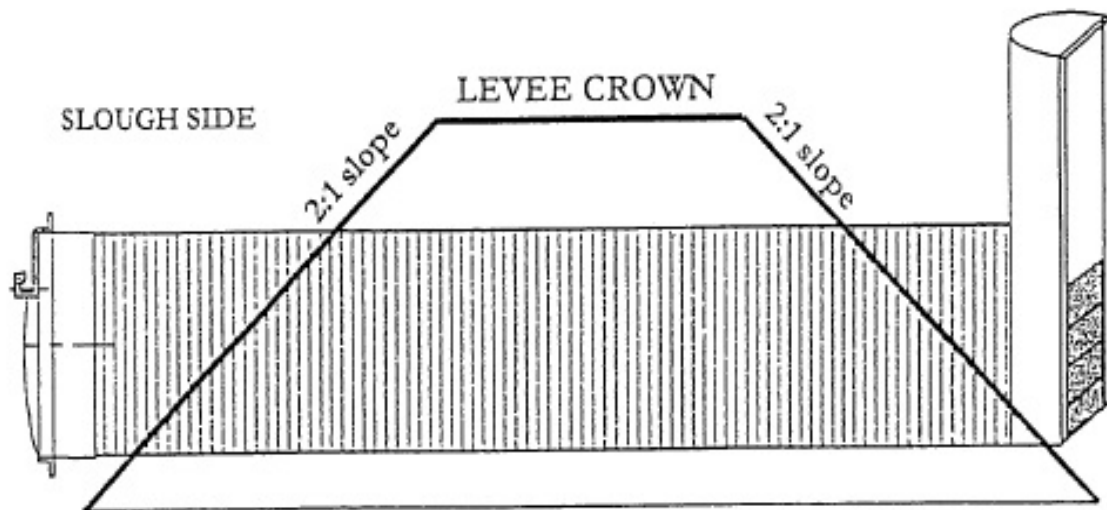
Typical Levee Section For a Drain Gate
