RURAL SETTLEMENT IN THE SCOTTISH HIGHLANDS, 1750-1850:

A COMPARATIVE STUDY OF LOCHTAYSIDE AND ASSYNT

VOLUME 3

PLATES

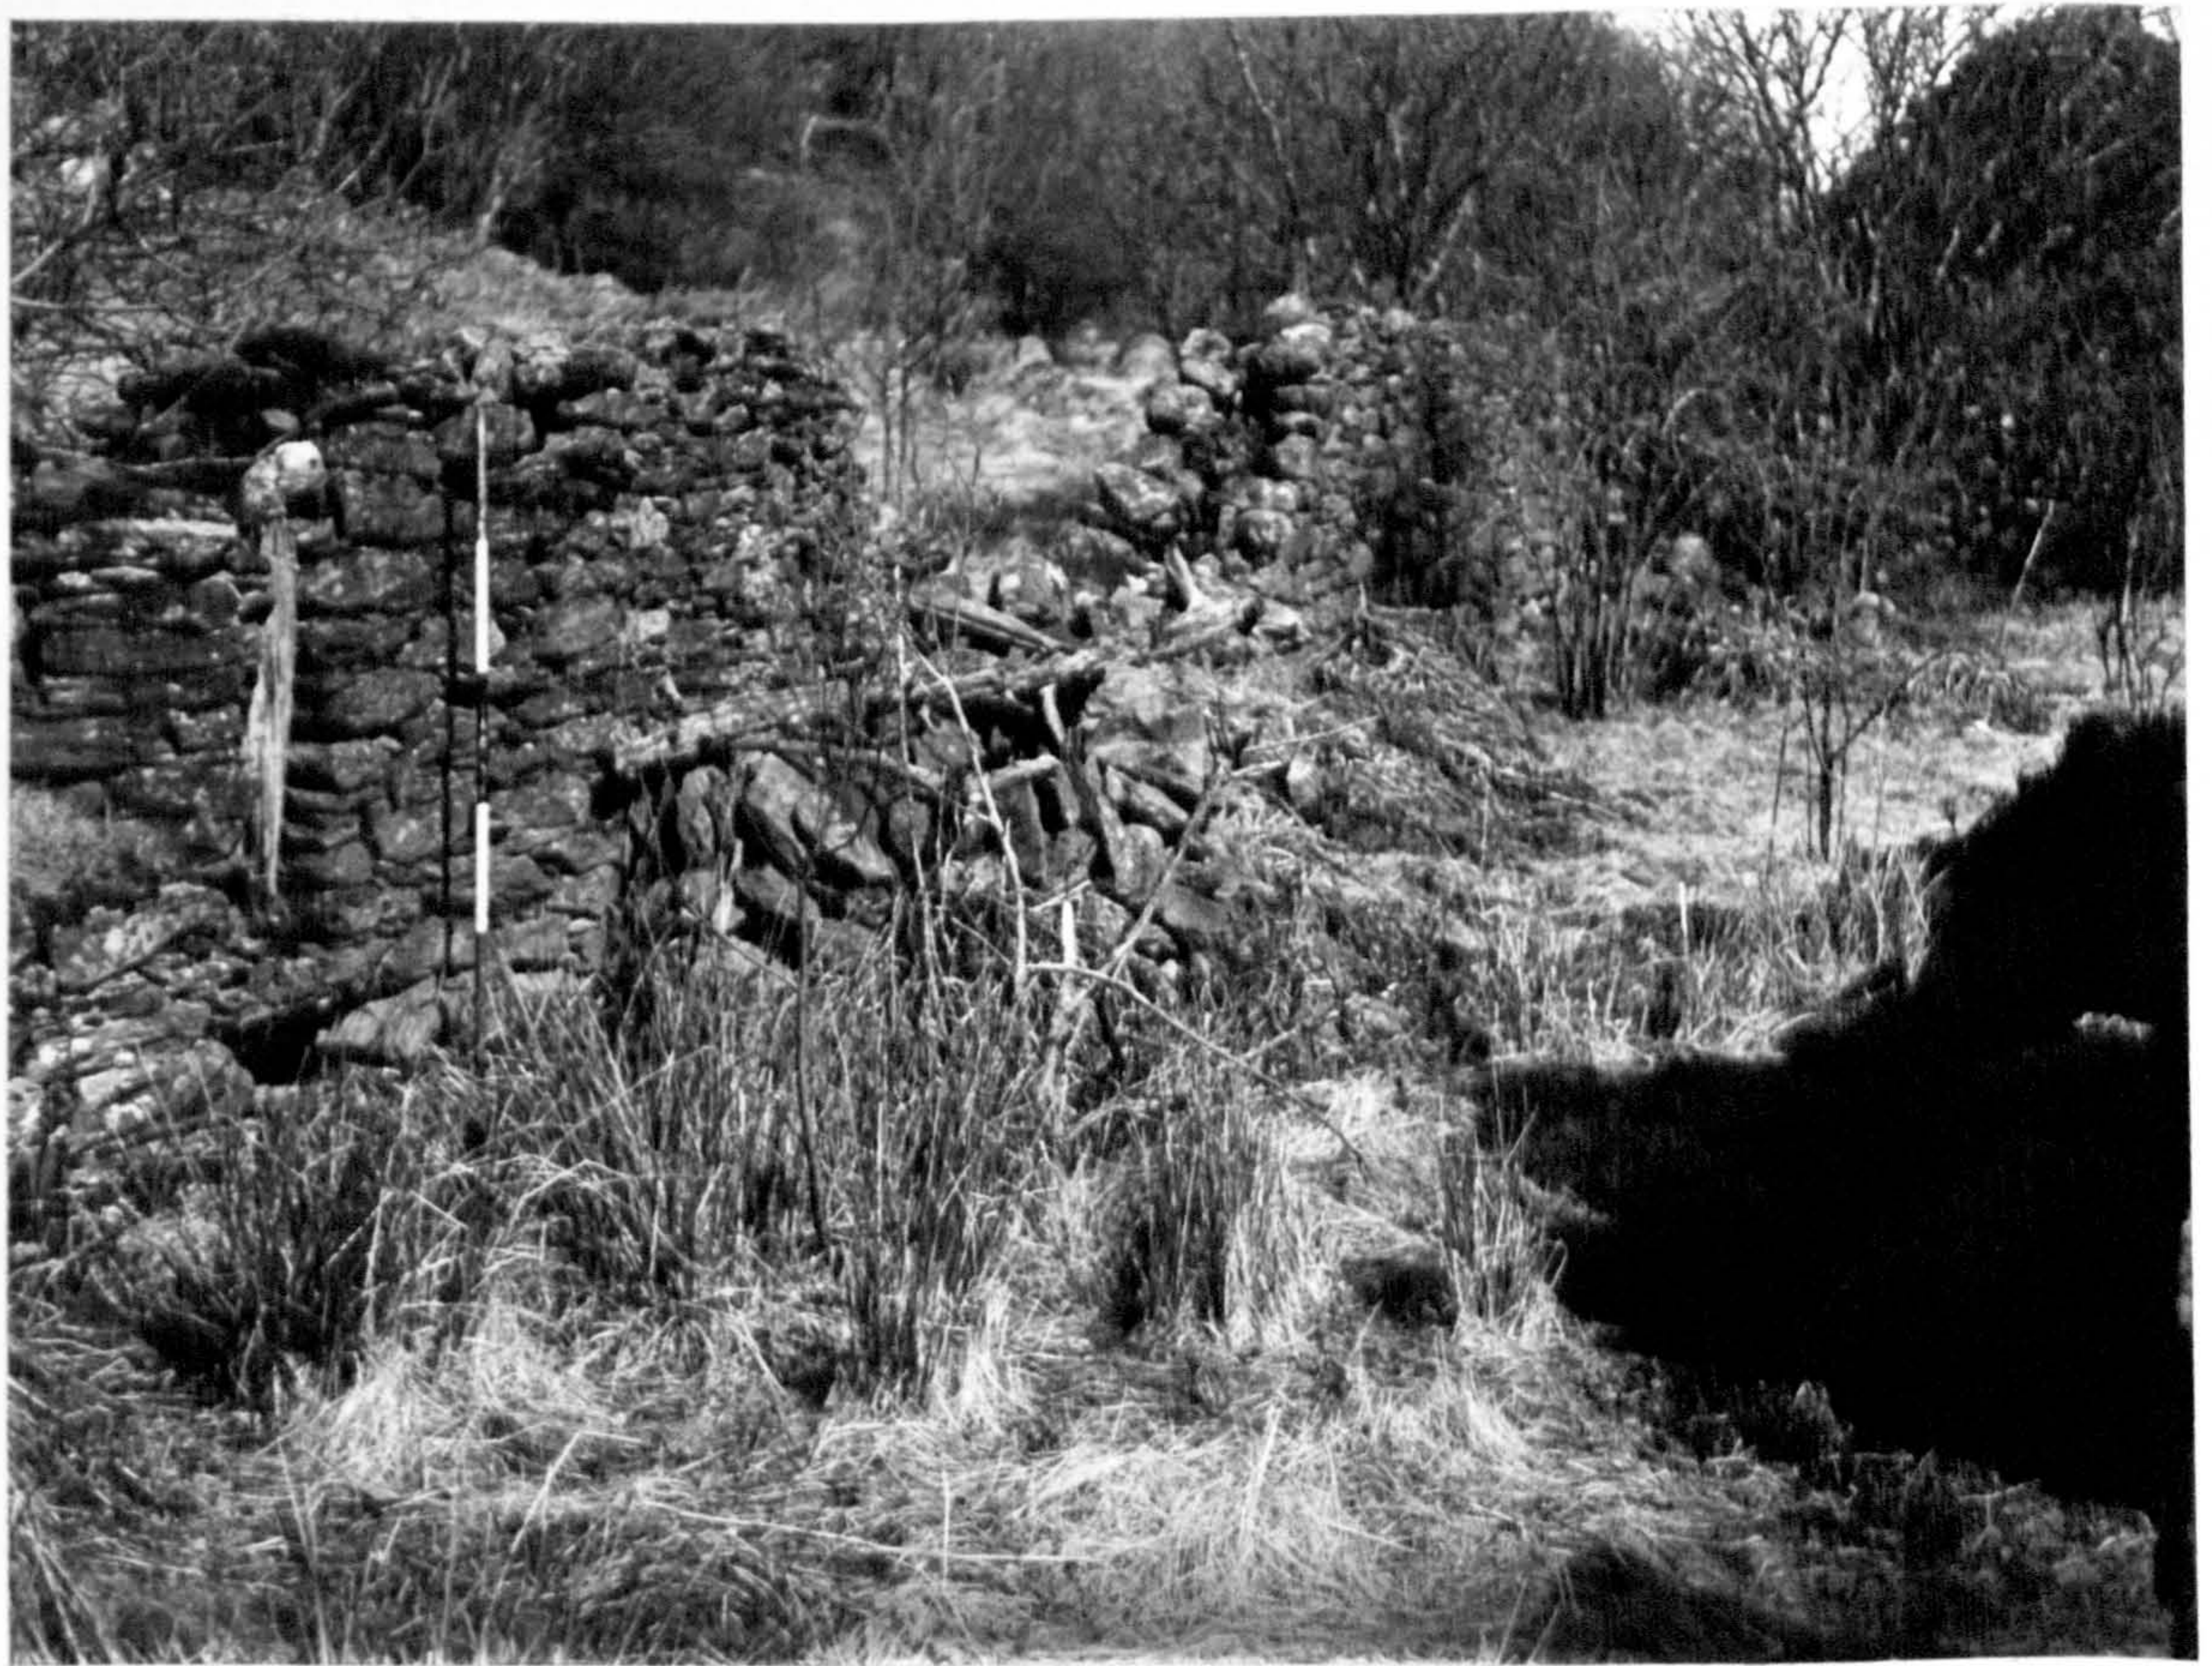
Plate 11. Remains of Building A in Cluster B on Wester Kuilturie. The ranging rod (in feet) stands beside the surviving lower part of a cruck couple.

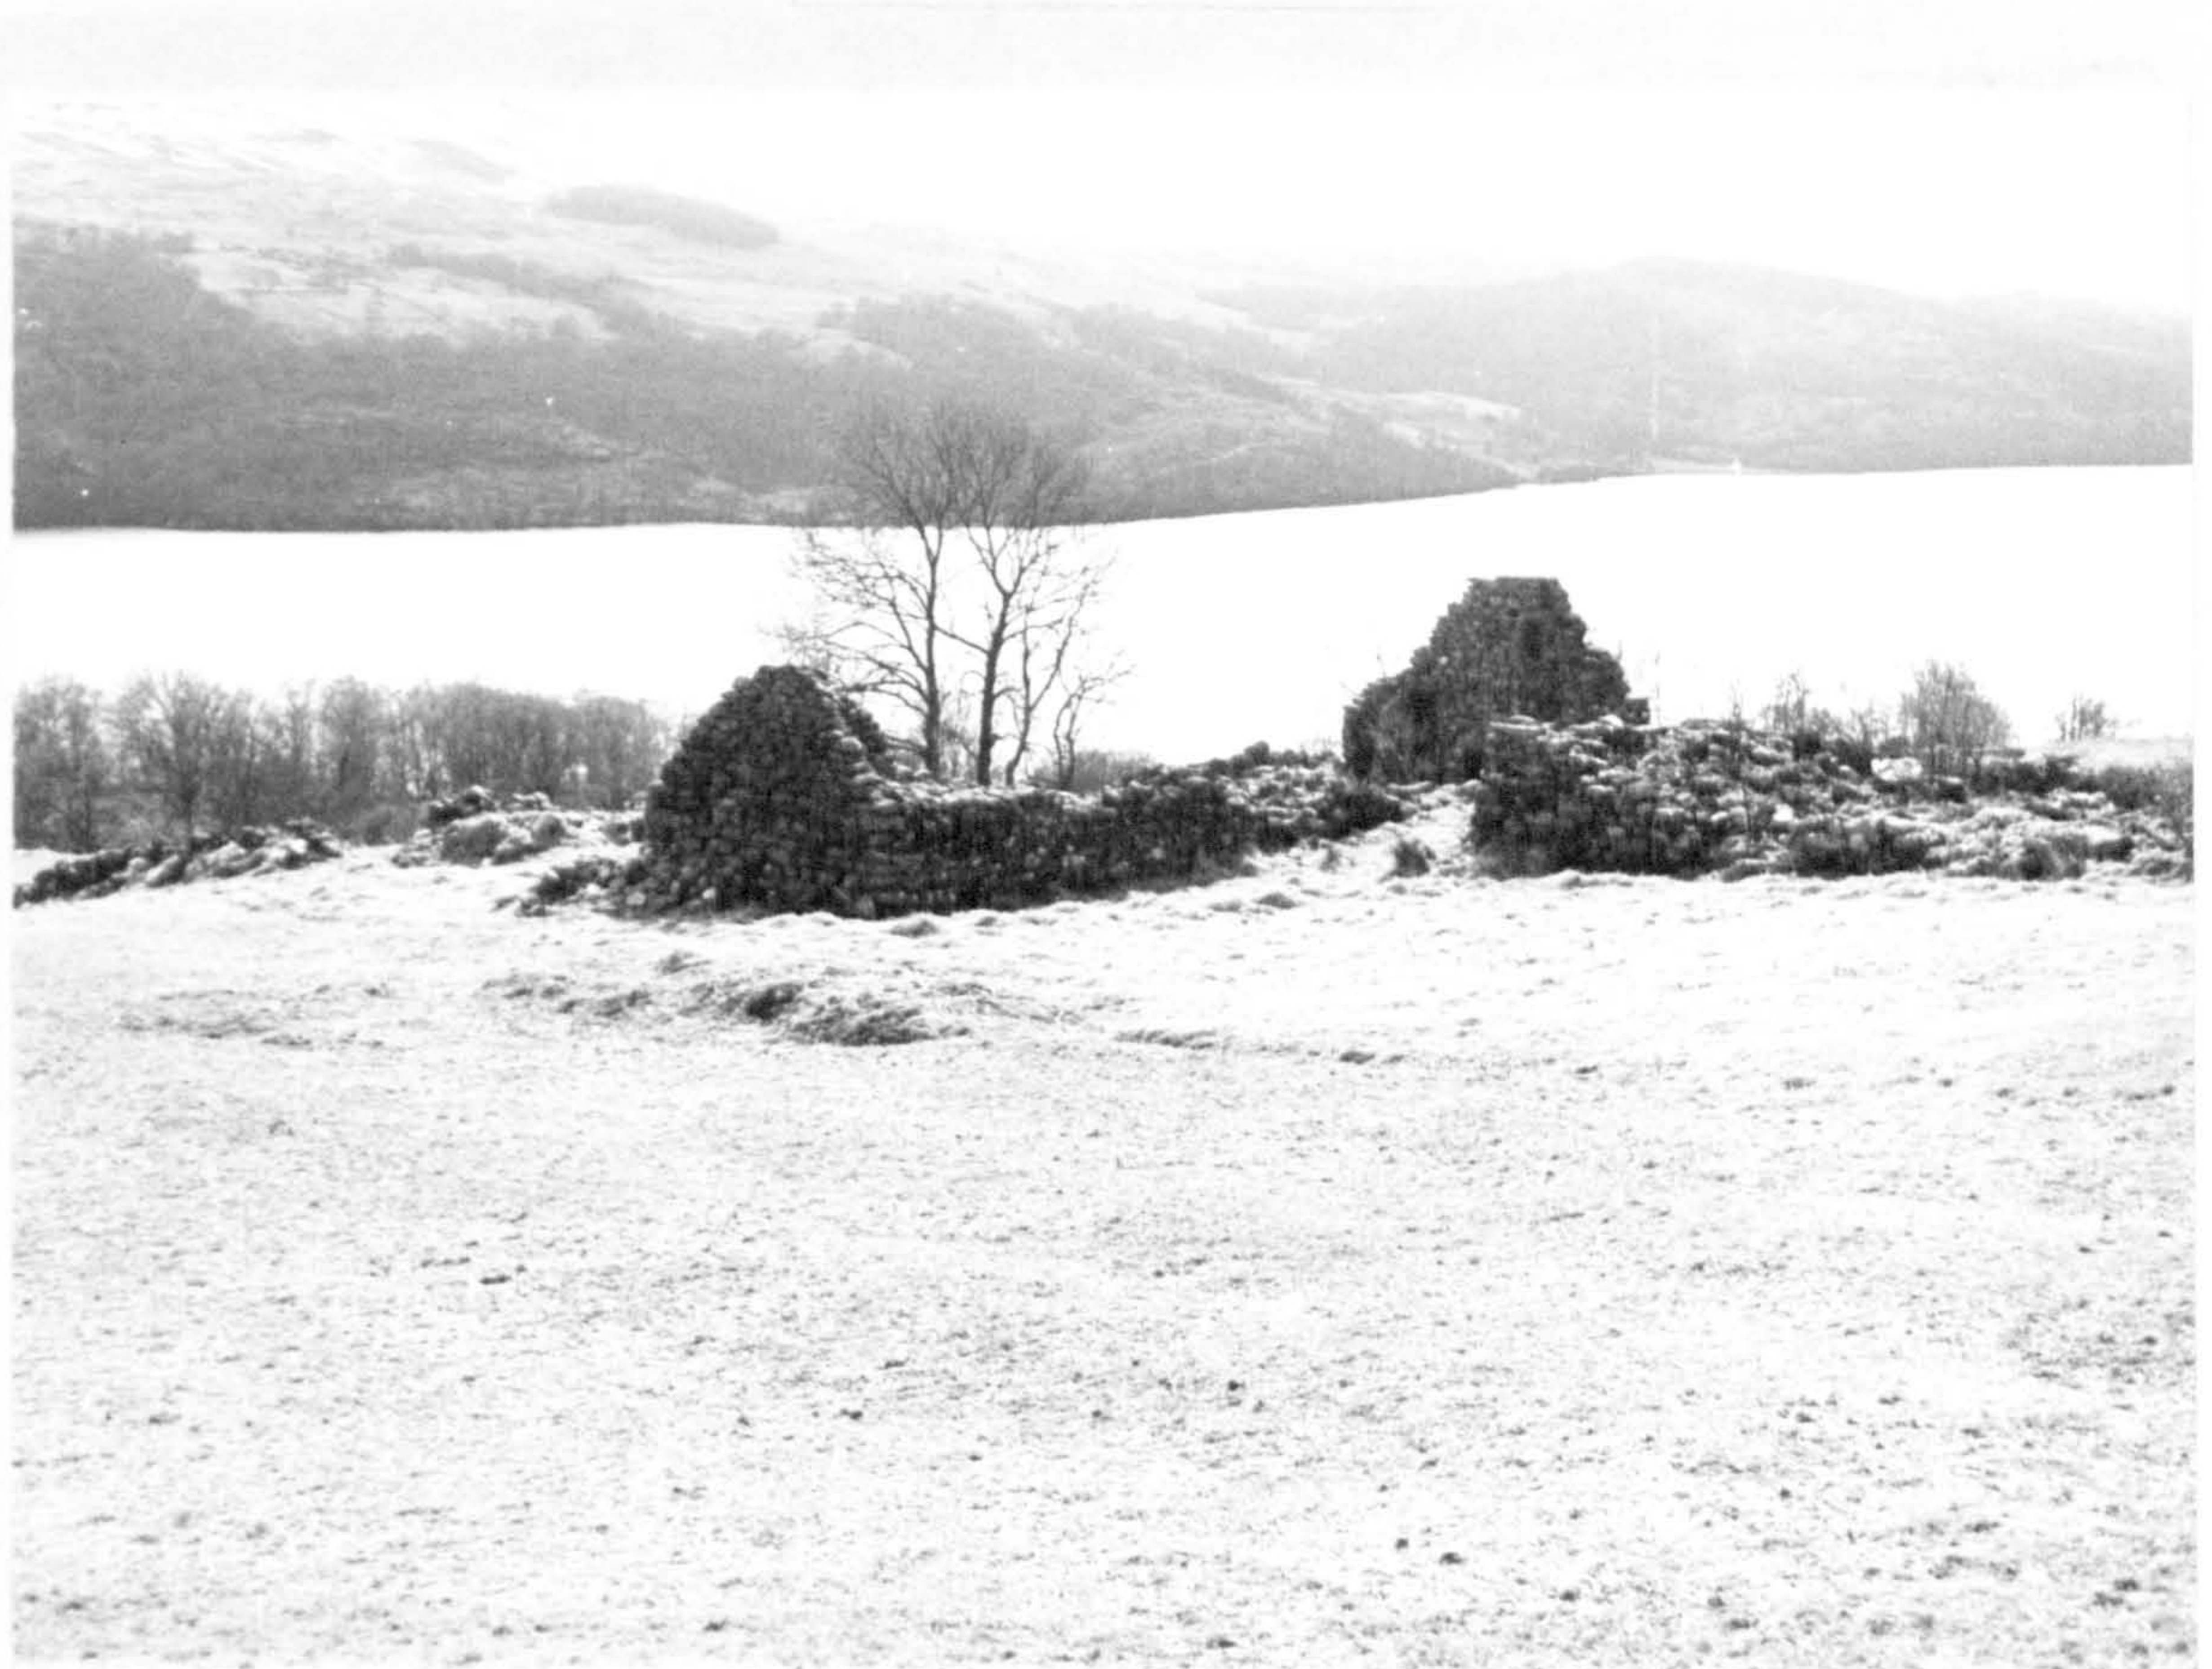
Plate 12. Cluster A on Easter Kuilturie. In Building C (centre), the gable fireplace and loft window can be seen on the western interior wall.

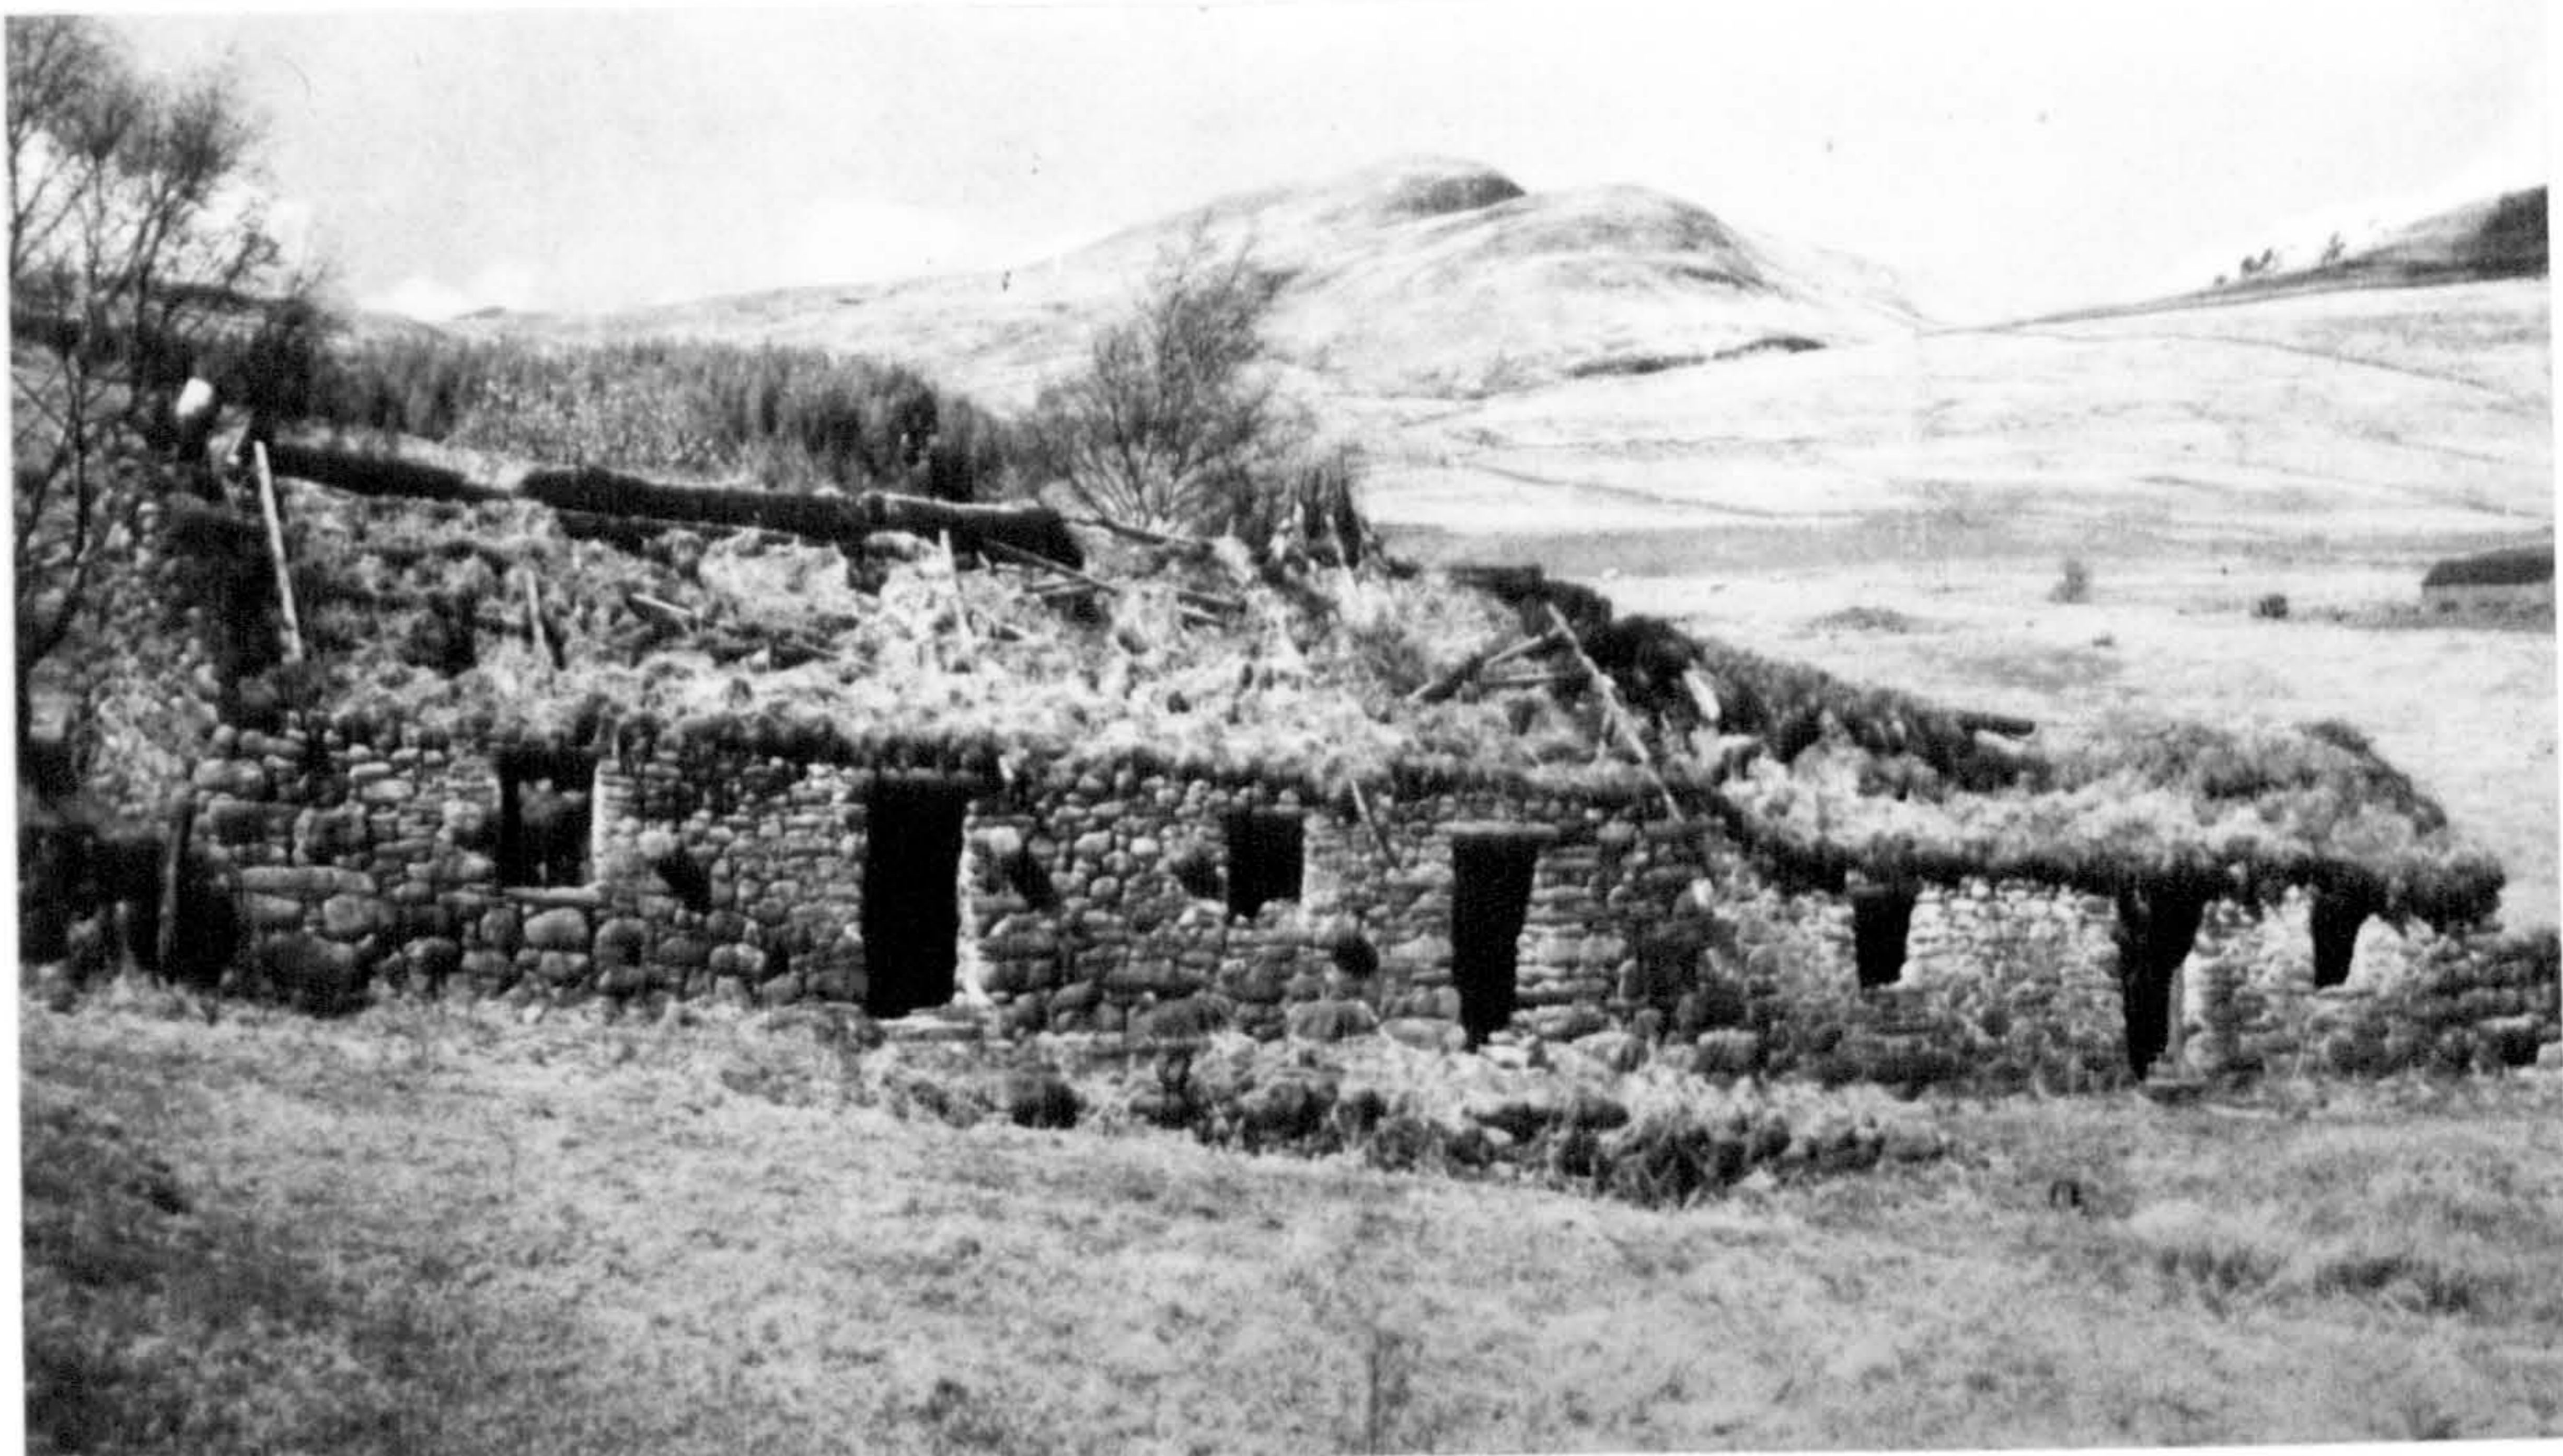
Plate 21. Building A in Cluster B on Cuiltirannich (Figure 31) in c. late 1950's. The doors and window frames have gone, the roof covering has deteriorated and the rafters and crucks are showing through, but some of the of the suspended stones which secured the earlier thatch have survived in situ. (Dunbar, 1966).

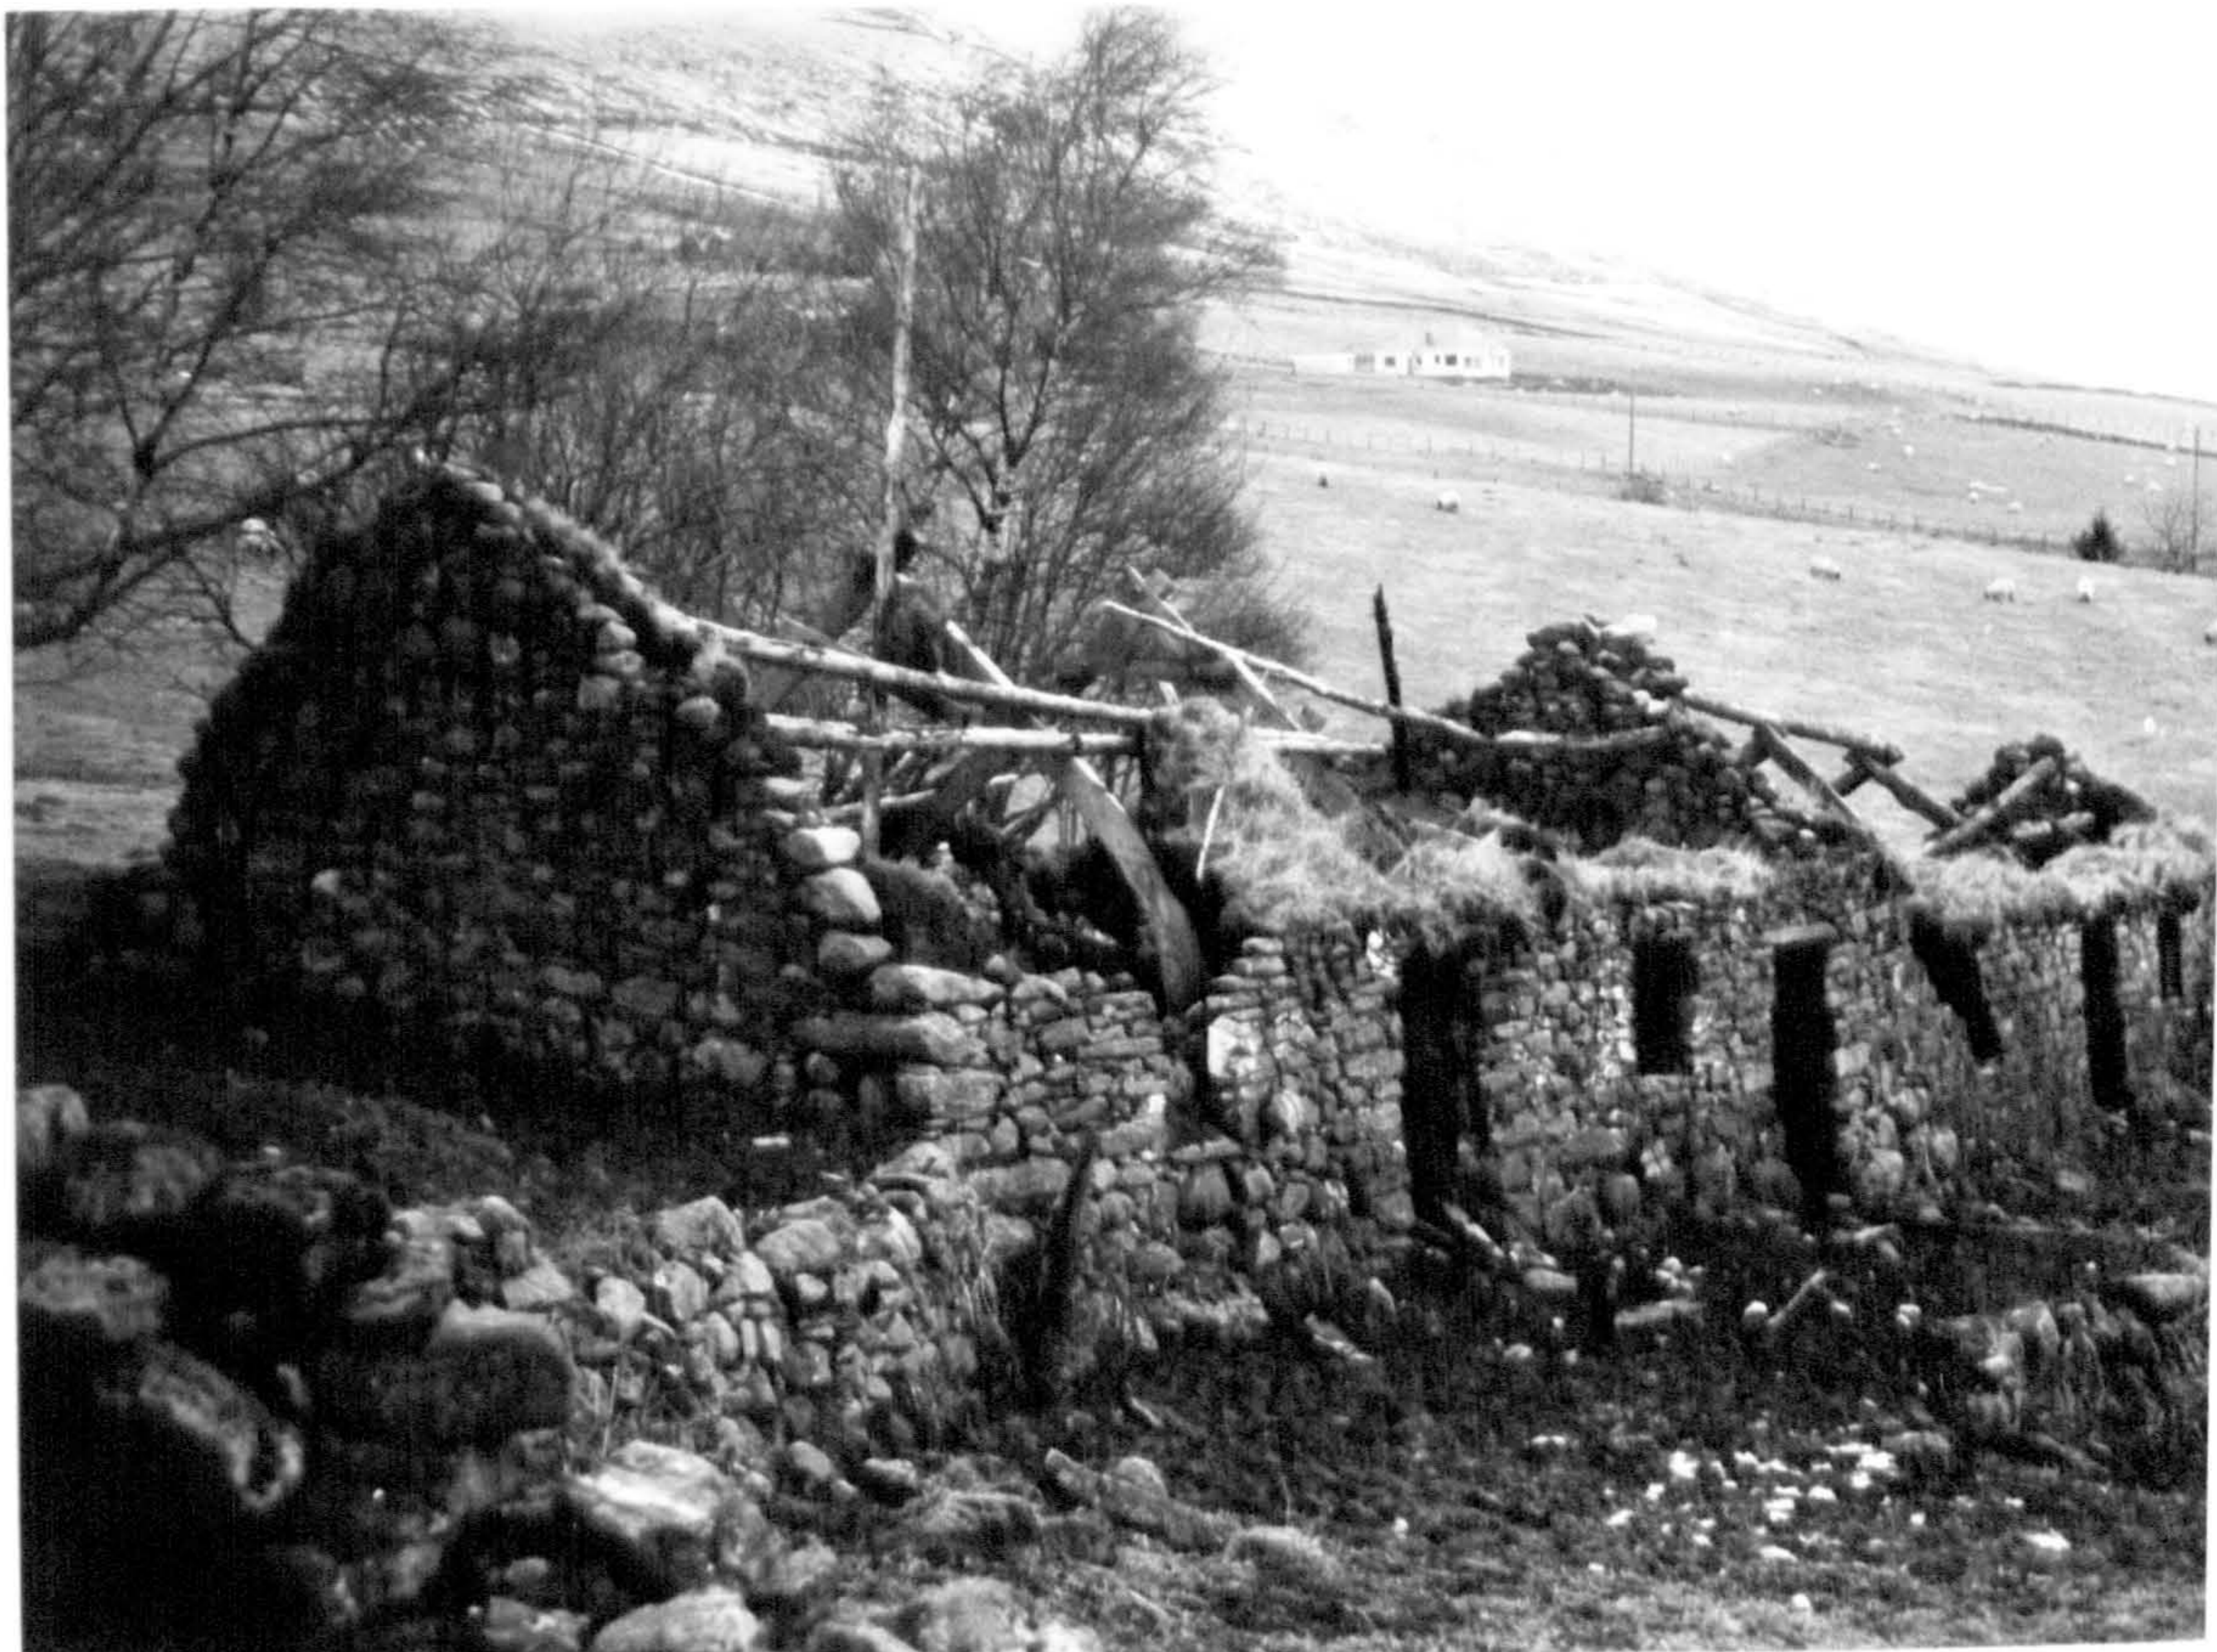
Plate 22. Building A in Cluster B, Cuiltirannich in 1966. The roof covering, now almost completely disappeared, had probably been turf under straw thatch (sgrathan). The upper crucks still carry remnants of purlins and the roof tree.

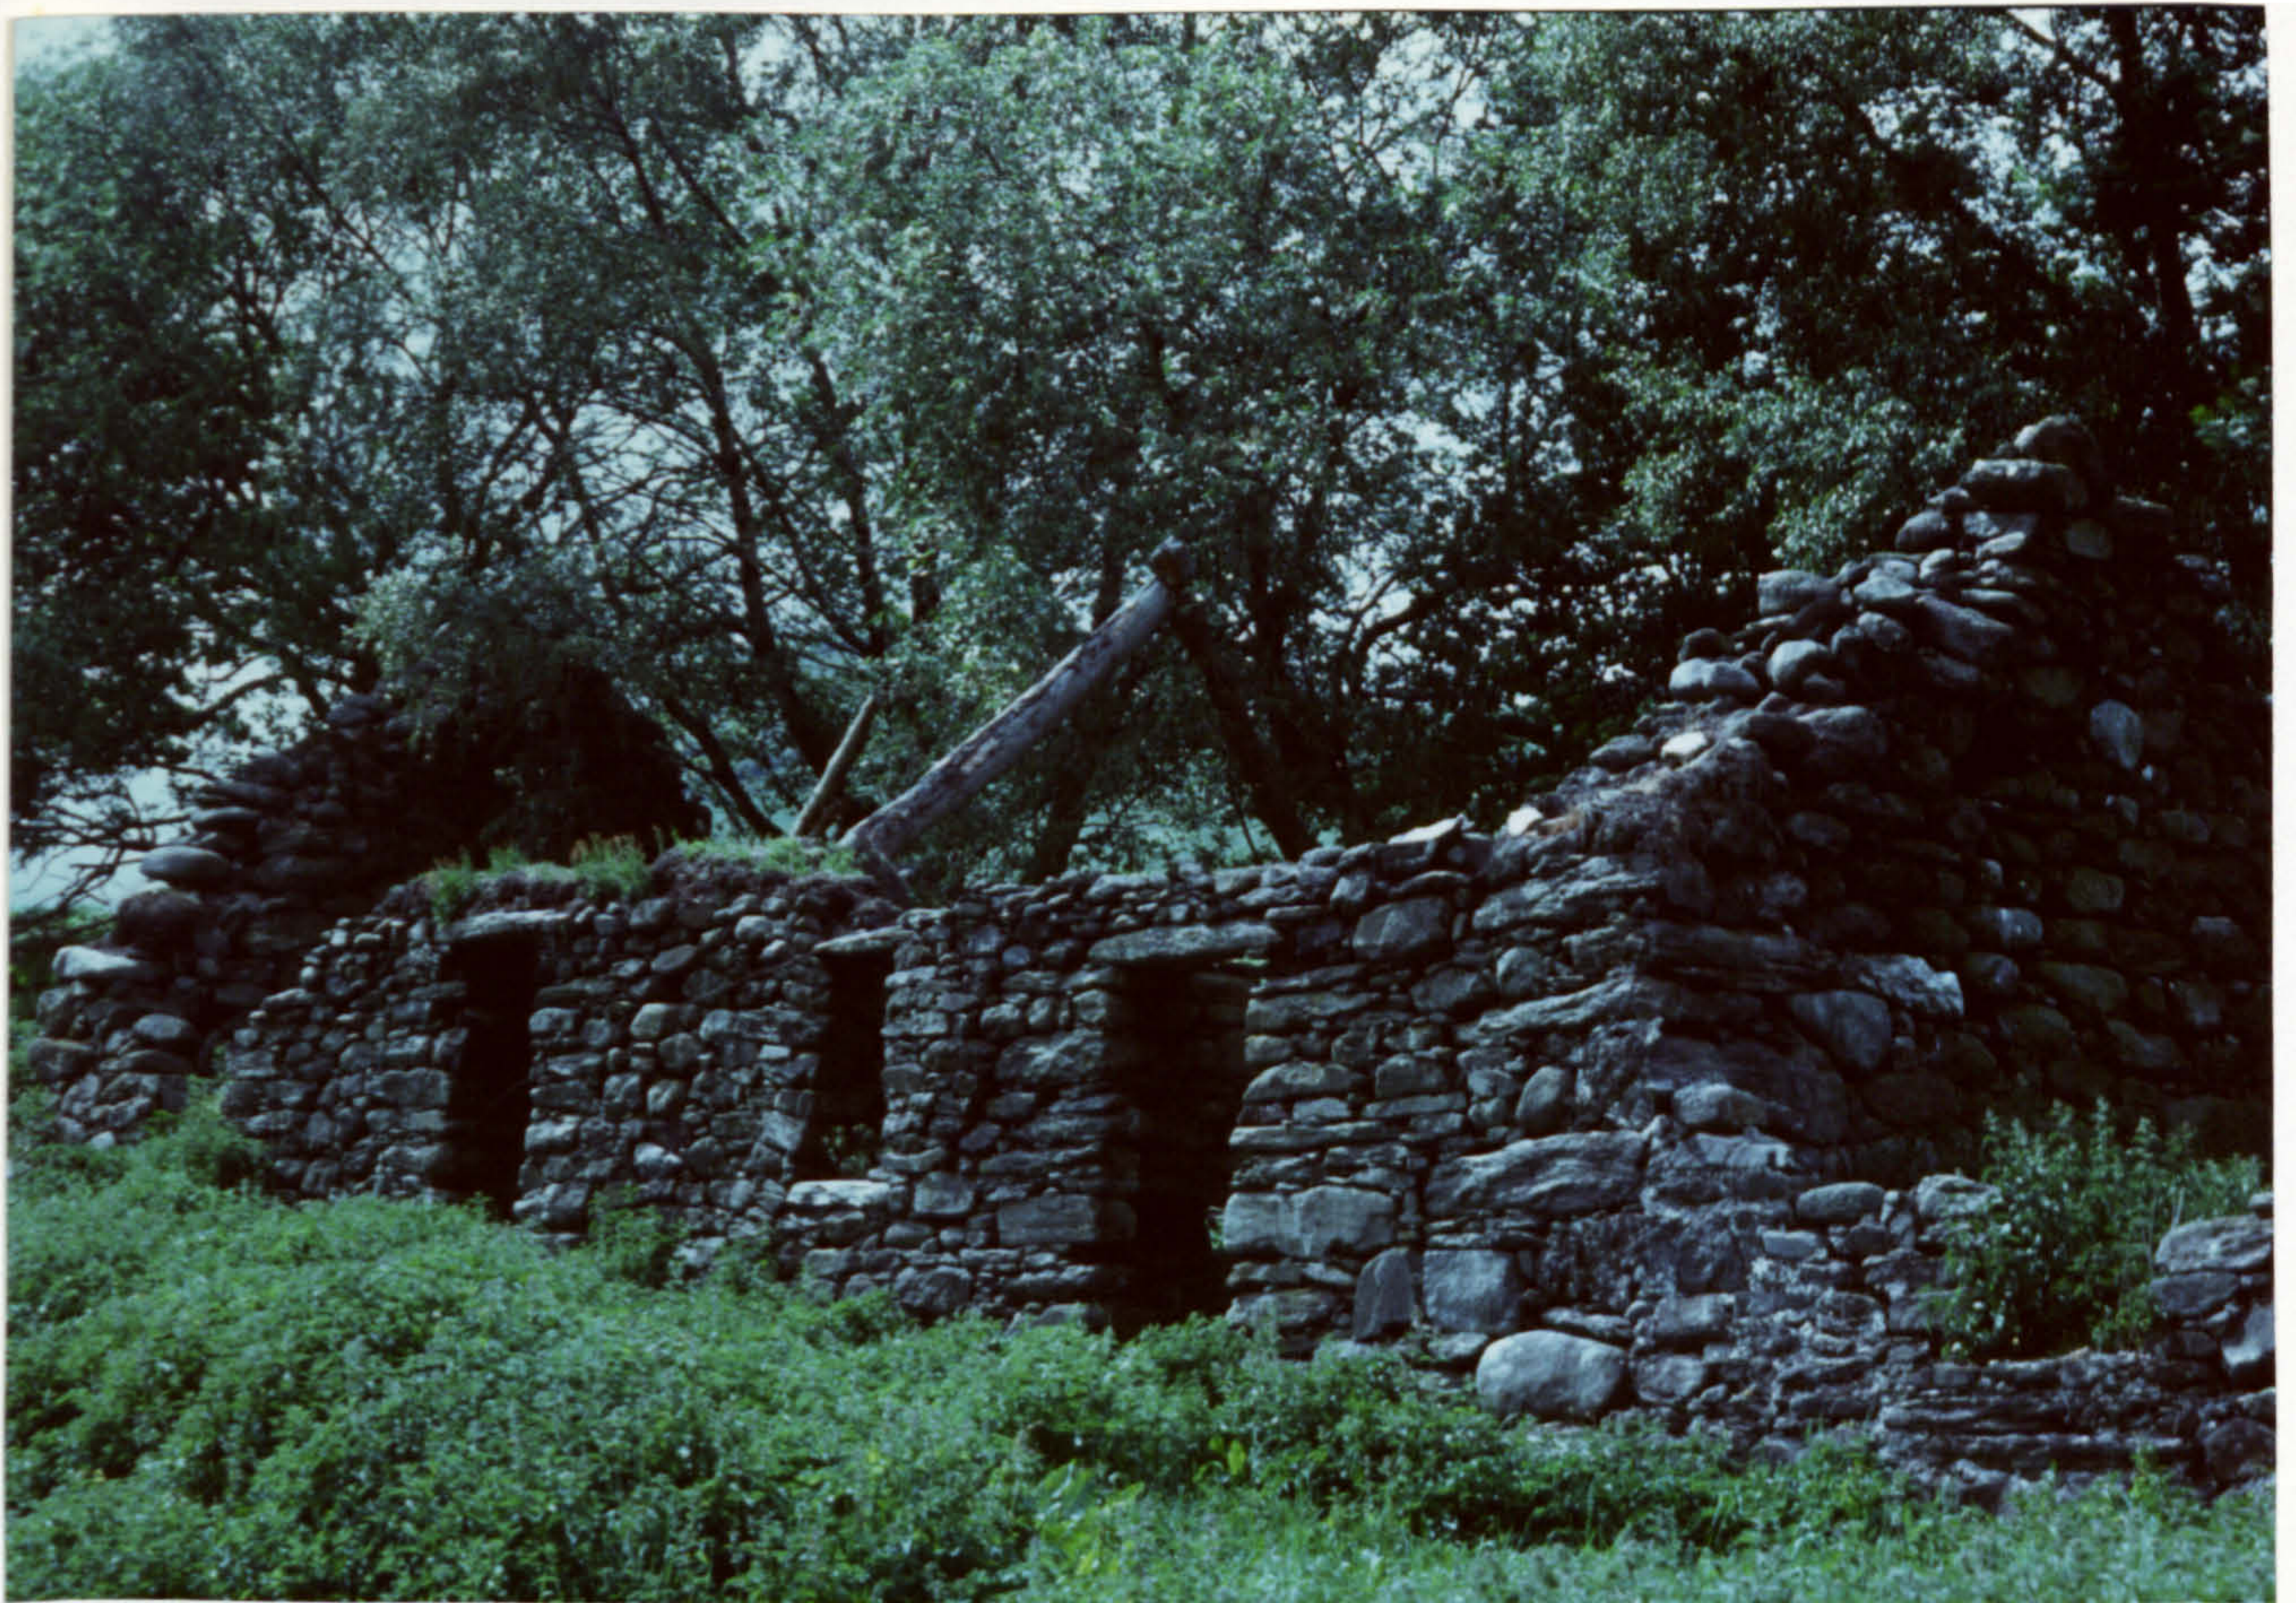
Plate 23. Building A in Cluster B on Cuiltrannich in 1978. Only one cruck couple still remains in position, the roof is entirely gone and the walls of section A₂ (Figure 31) have almost completely collapsed.

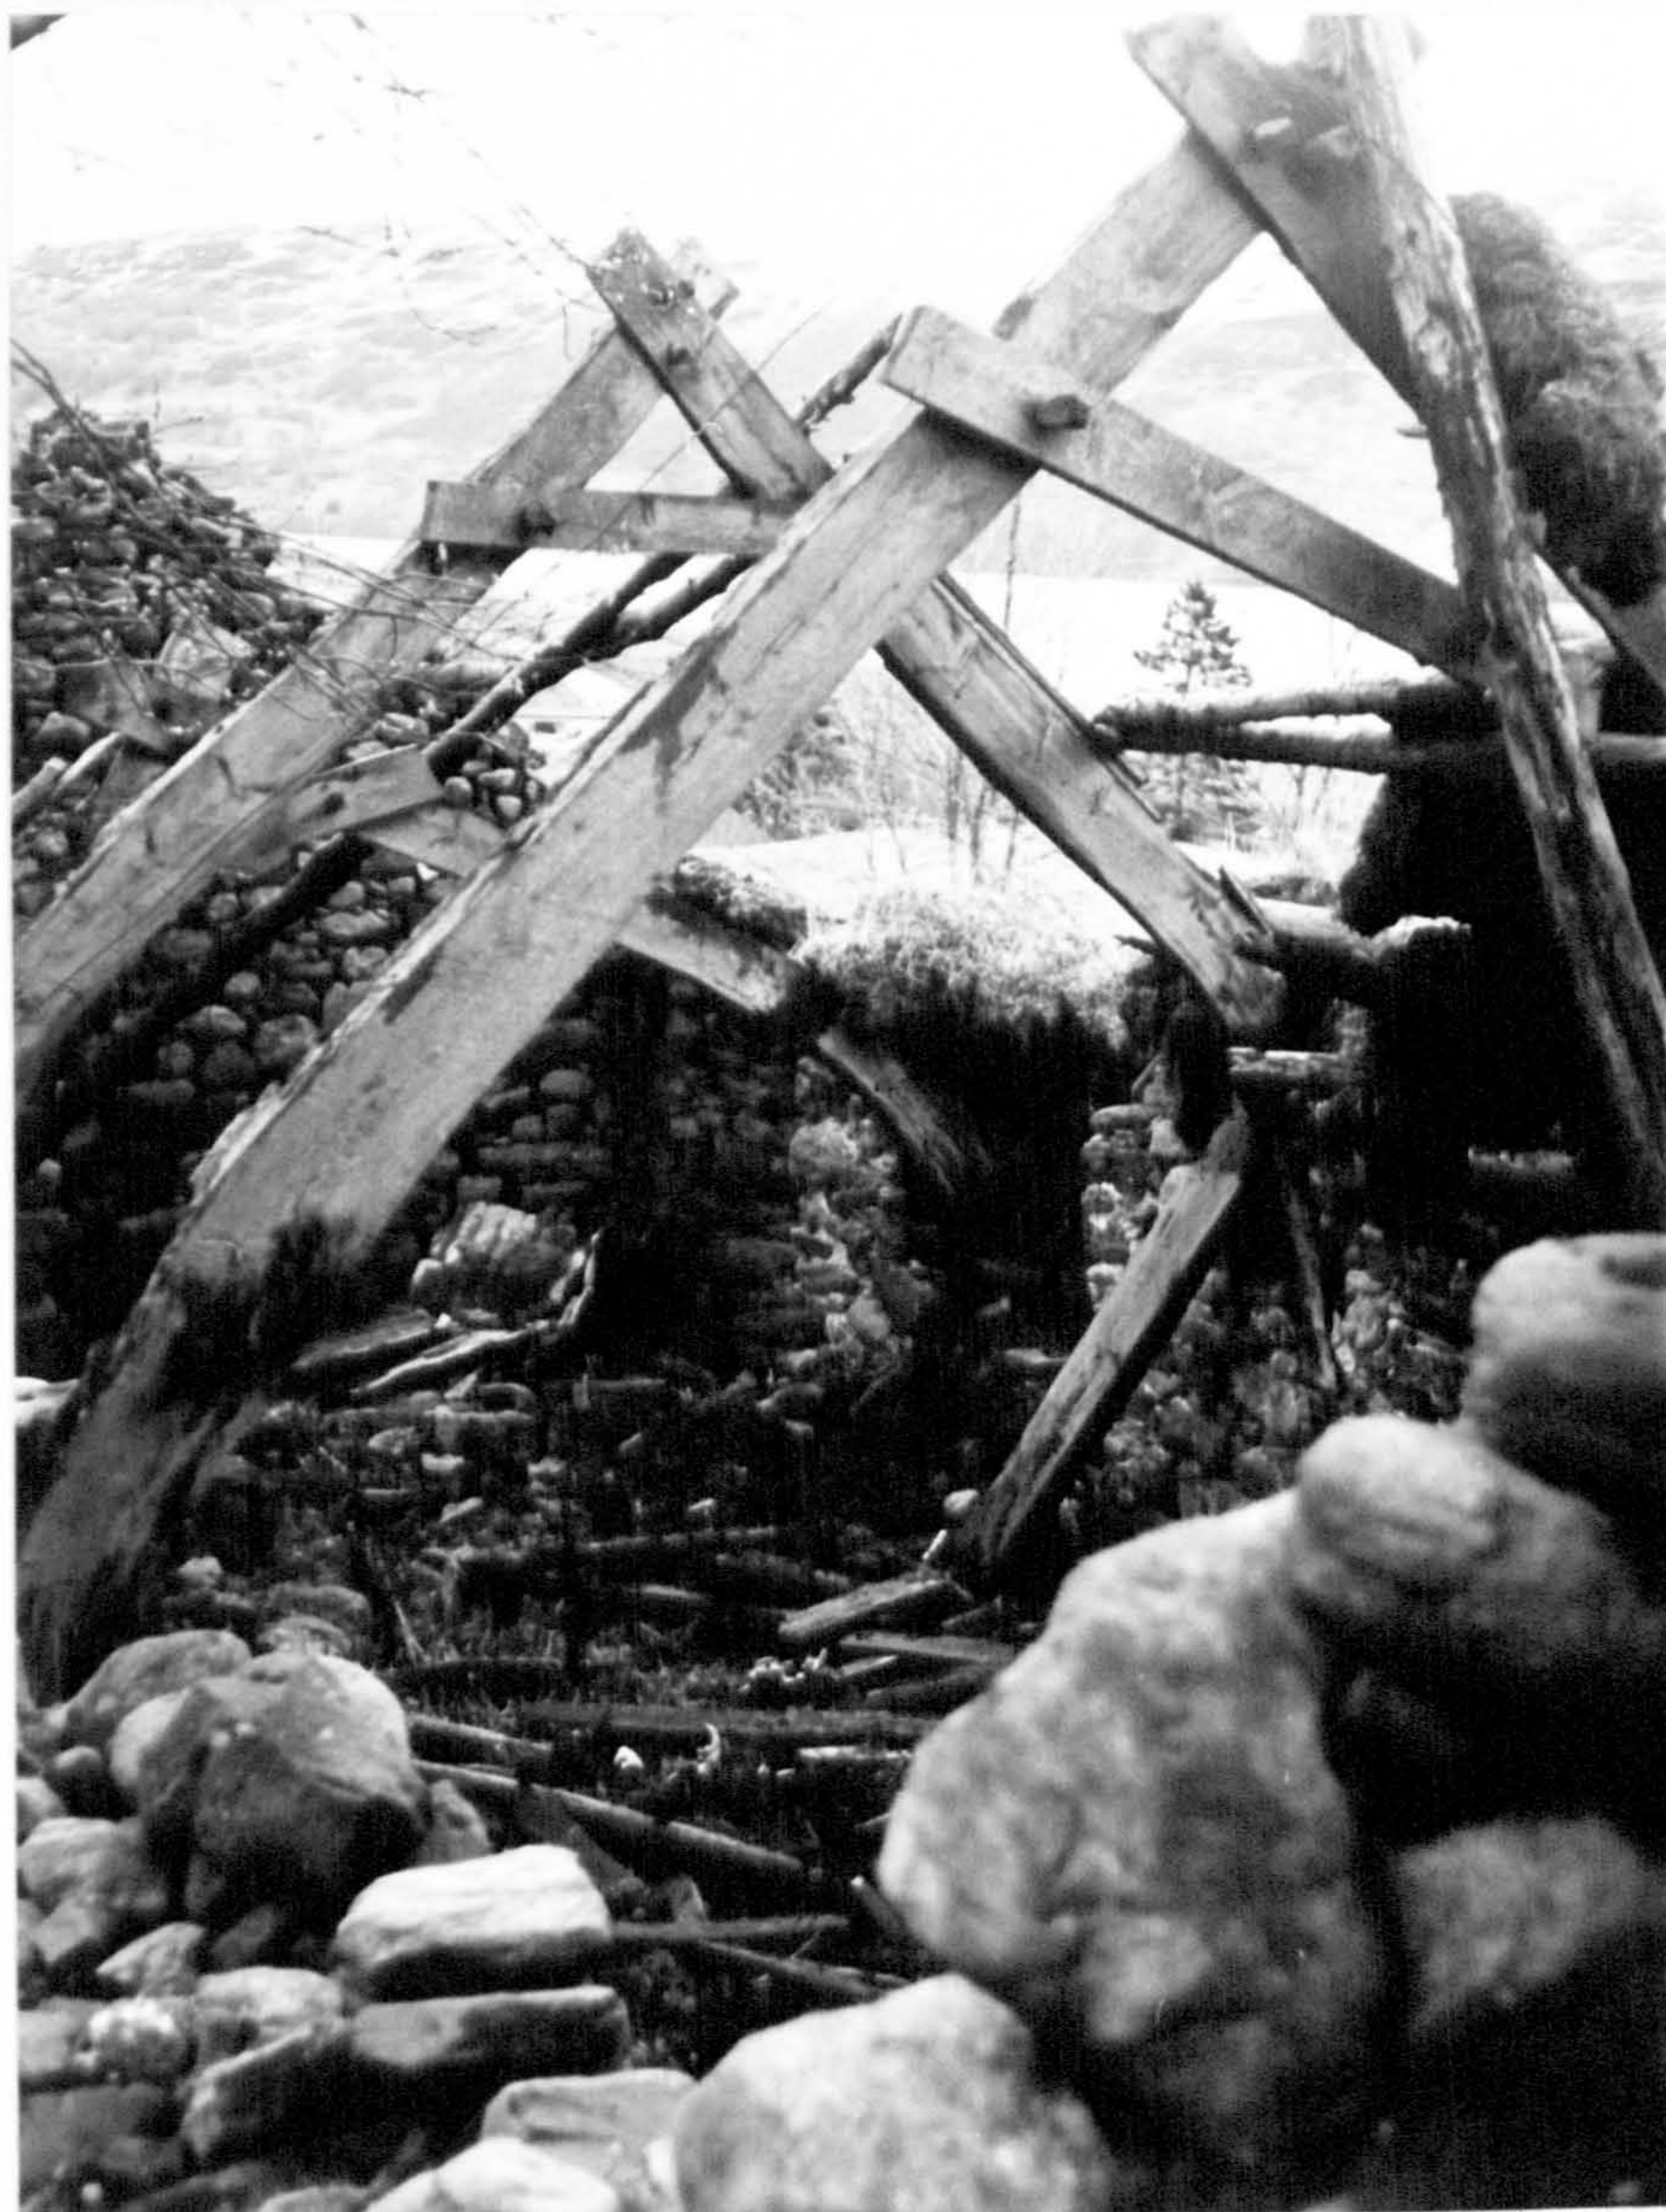
Plate 25. Interior of Building A in Cluster B on Cuiltrannich in 1966, looking east (Section A₁ in Figure 31). Three cruck couples are still in position although the rearmost has slumped from one of its wall slots. The collar beams or ties and crossed couples are secured with wooden pegs.
