RURAL SETTLEMENT IN THE SCOTTISH HIGHLANDS, 1750-1850:

A COMPARATIVE STUDY OF LOCHTAYSIDE AND ASSYNT

VOLUME 3

PLATES

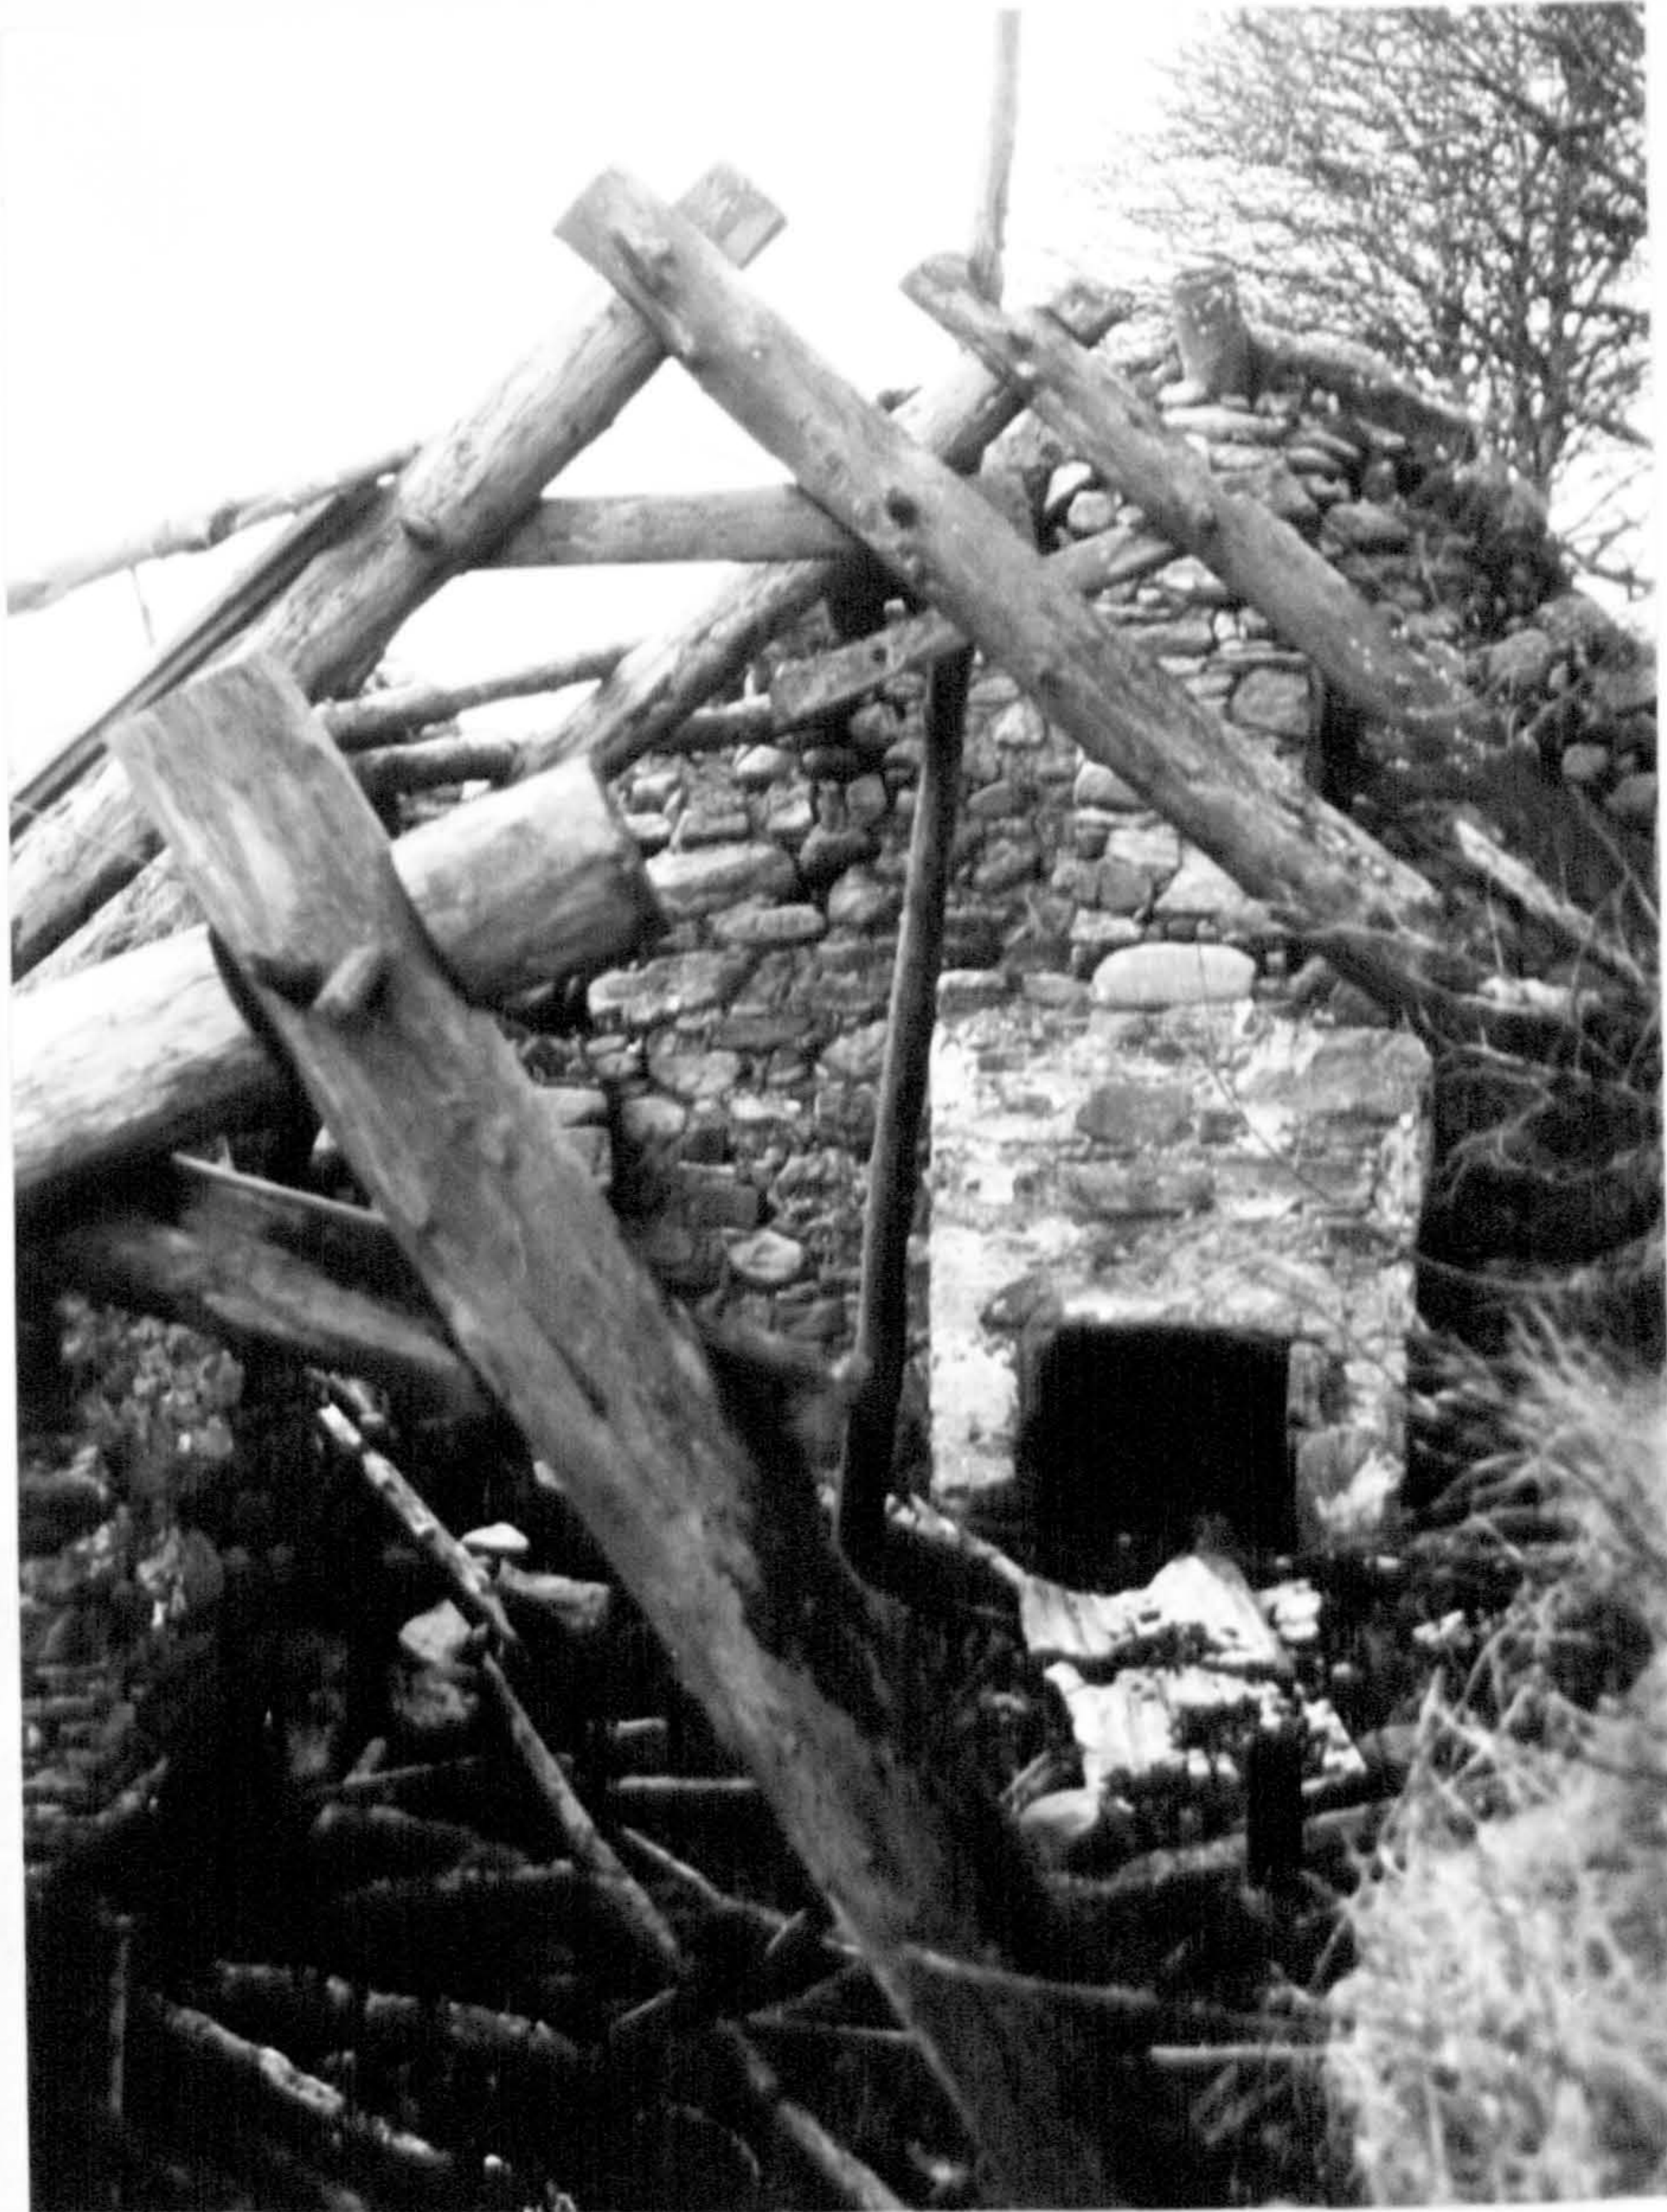
Plate 26. Interior of Building A in Cluster B on Cuiltrannich in 1966, looking west. The outer, rounded side of the cruck couples can be seen from this direction. This section of the original byre-dwelling had a hearth located just off the photograph in the foreground, with smoke going out through a probable 'hanging lum', the outer aperture of which can be seen in Plate 20. The gable-end fireplace is a secondary structure, 'added on' to the wall face with a chimney and chimney pot still visible. A fallen ridge-pole or purlin is standing upright in front of the fireplace.

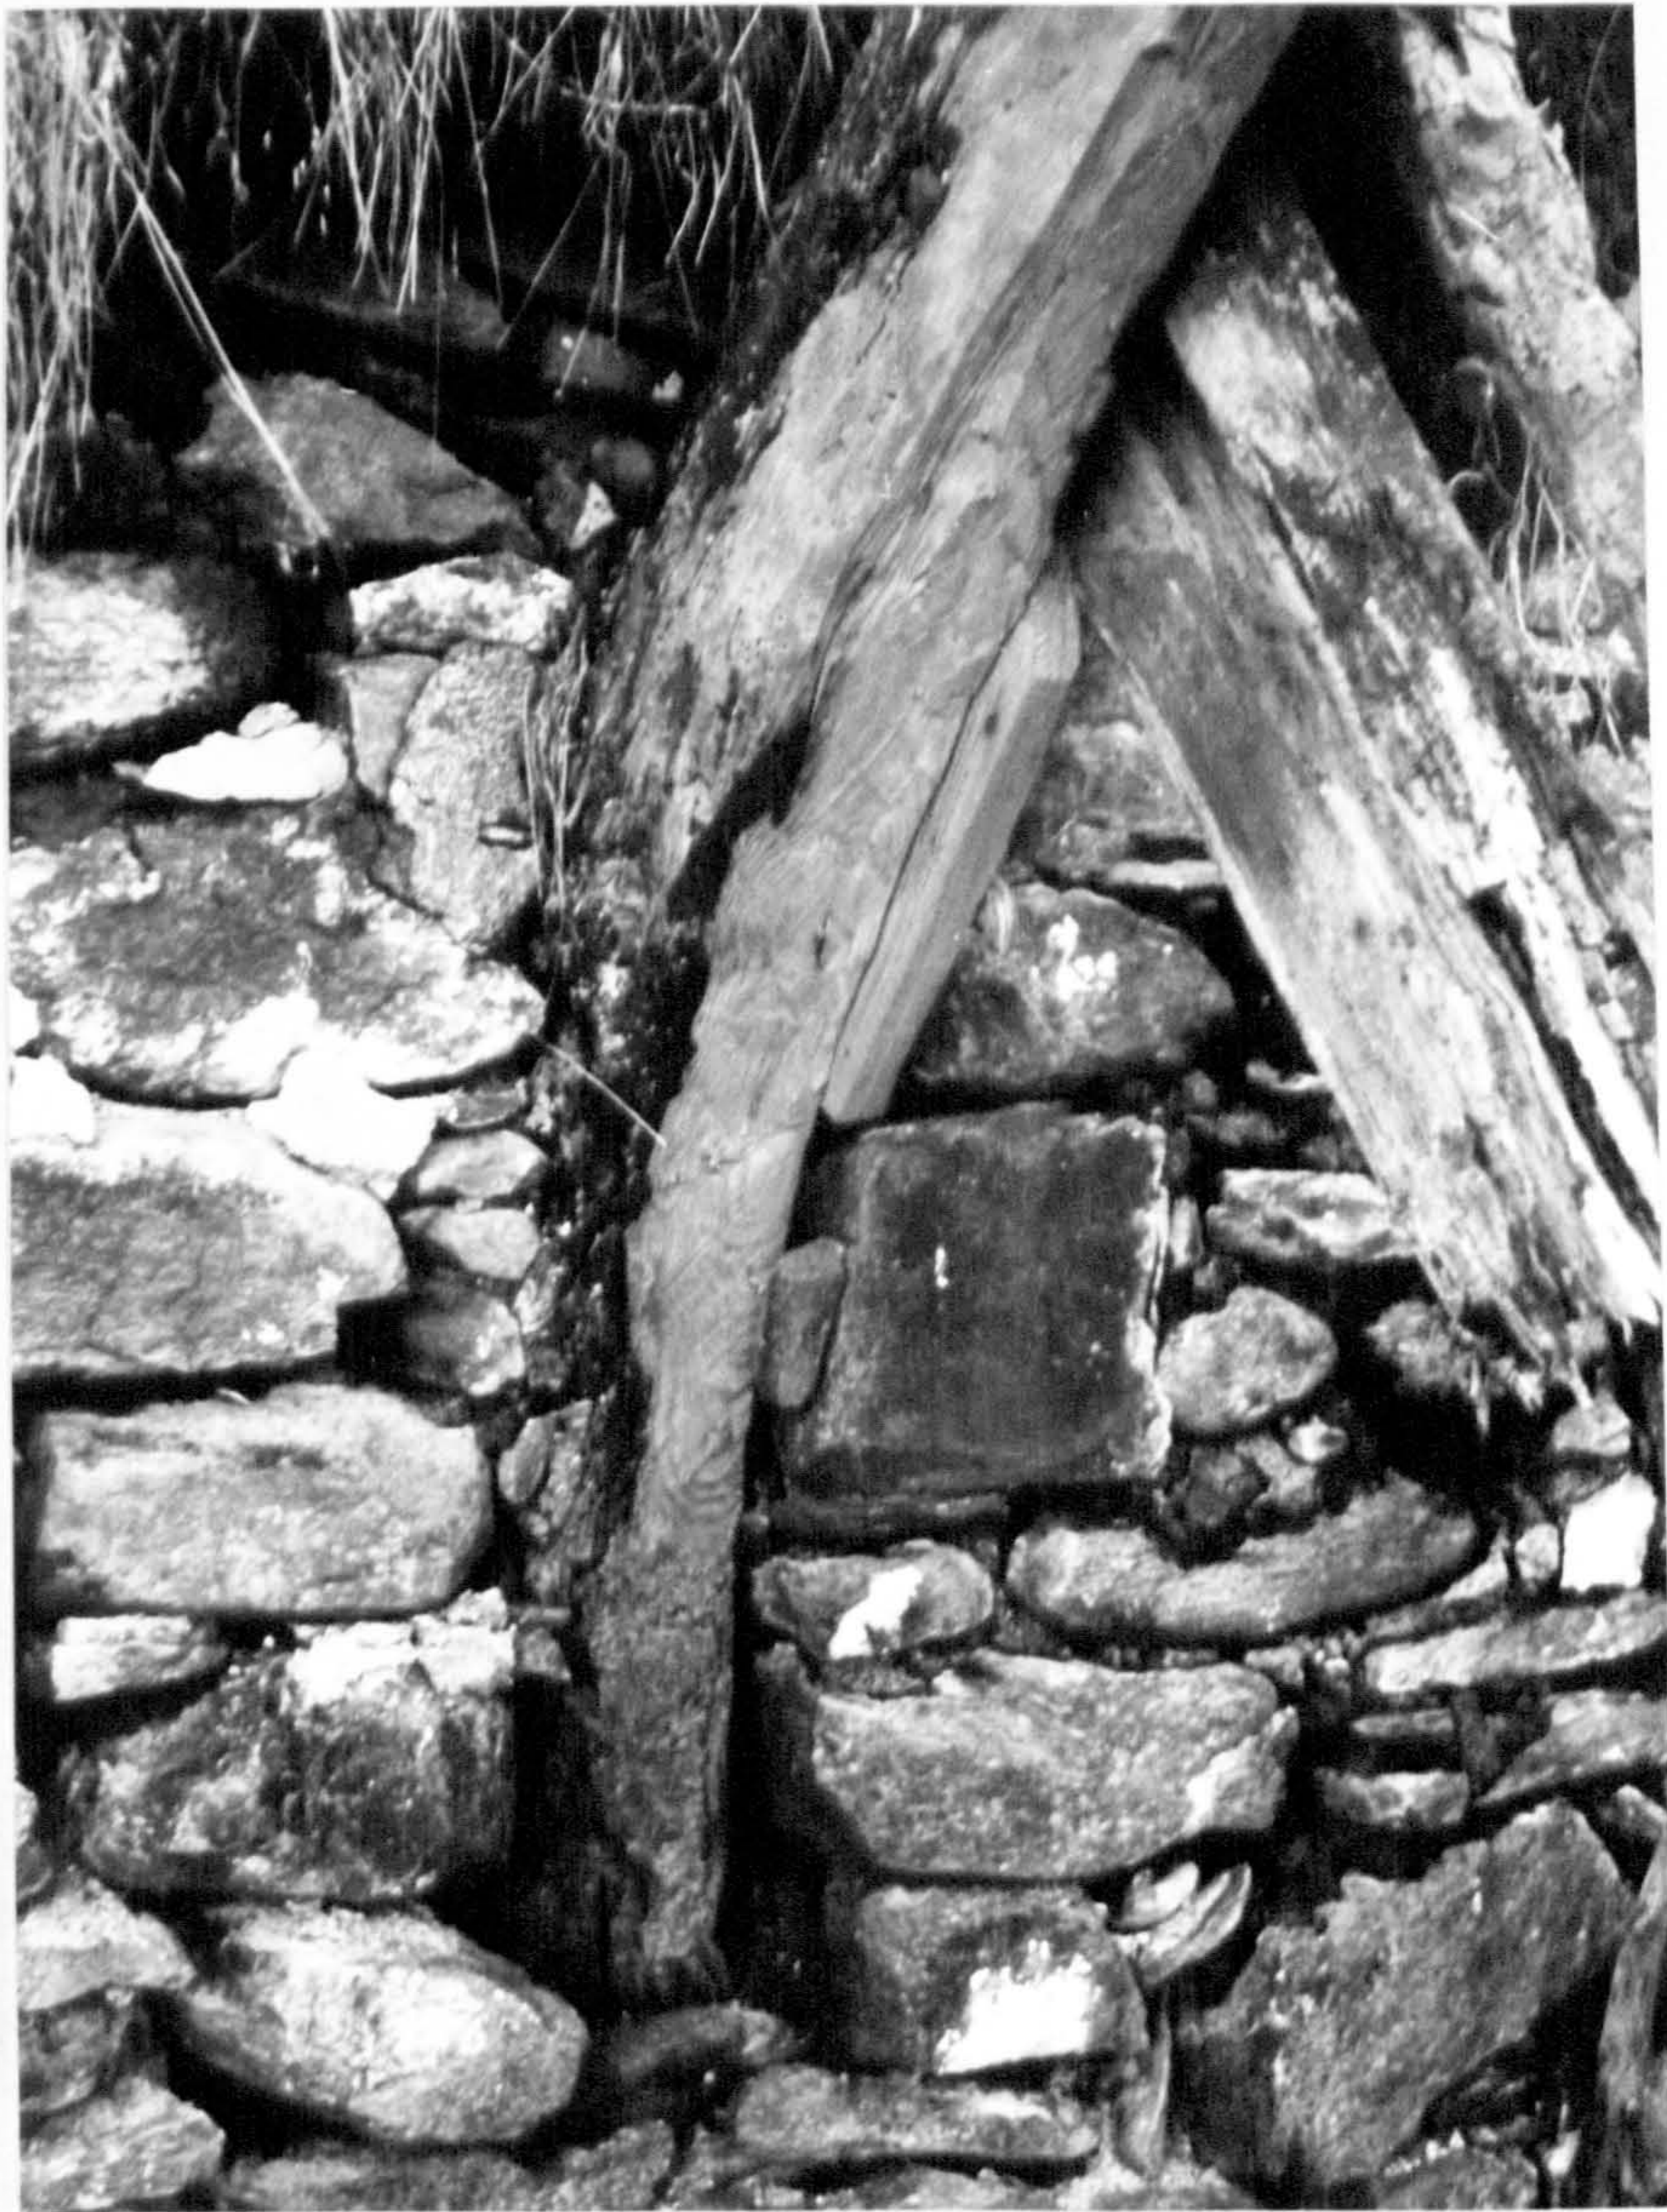
Plate 28. Foot of cruck in wall slot, central cruck, south wall of Section A₁, Building A in Cluster B on Cuiltrannich, 1966.

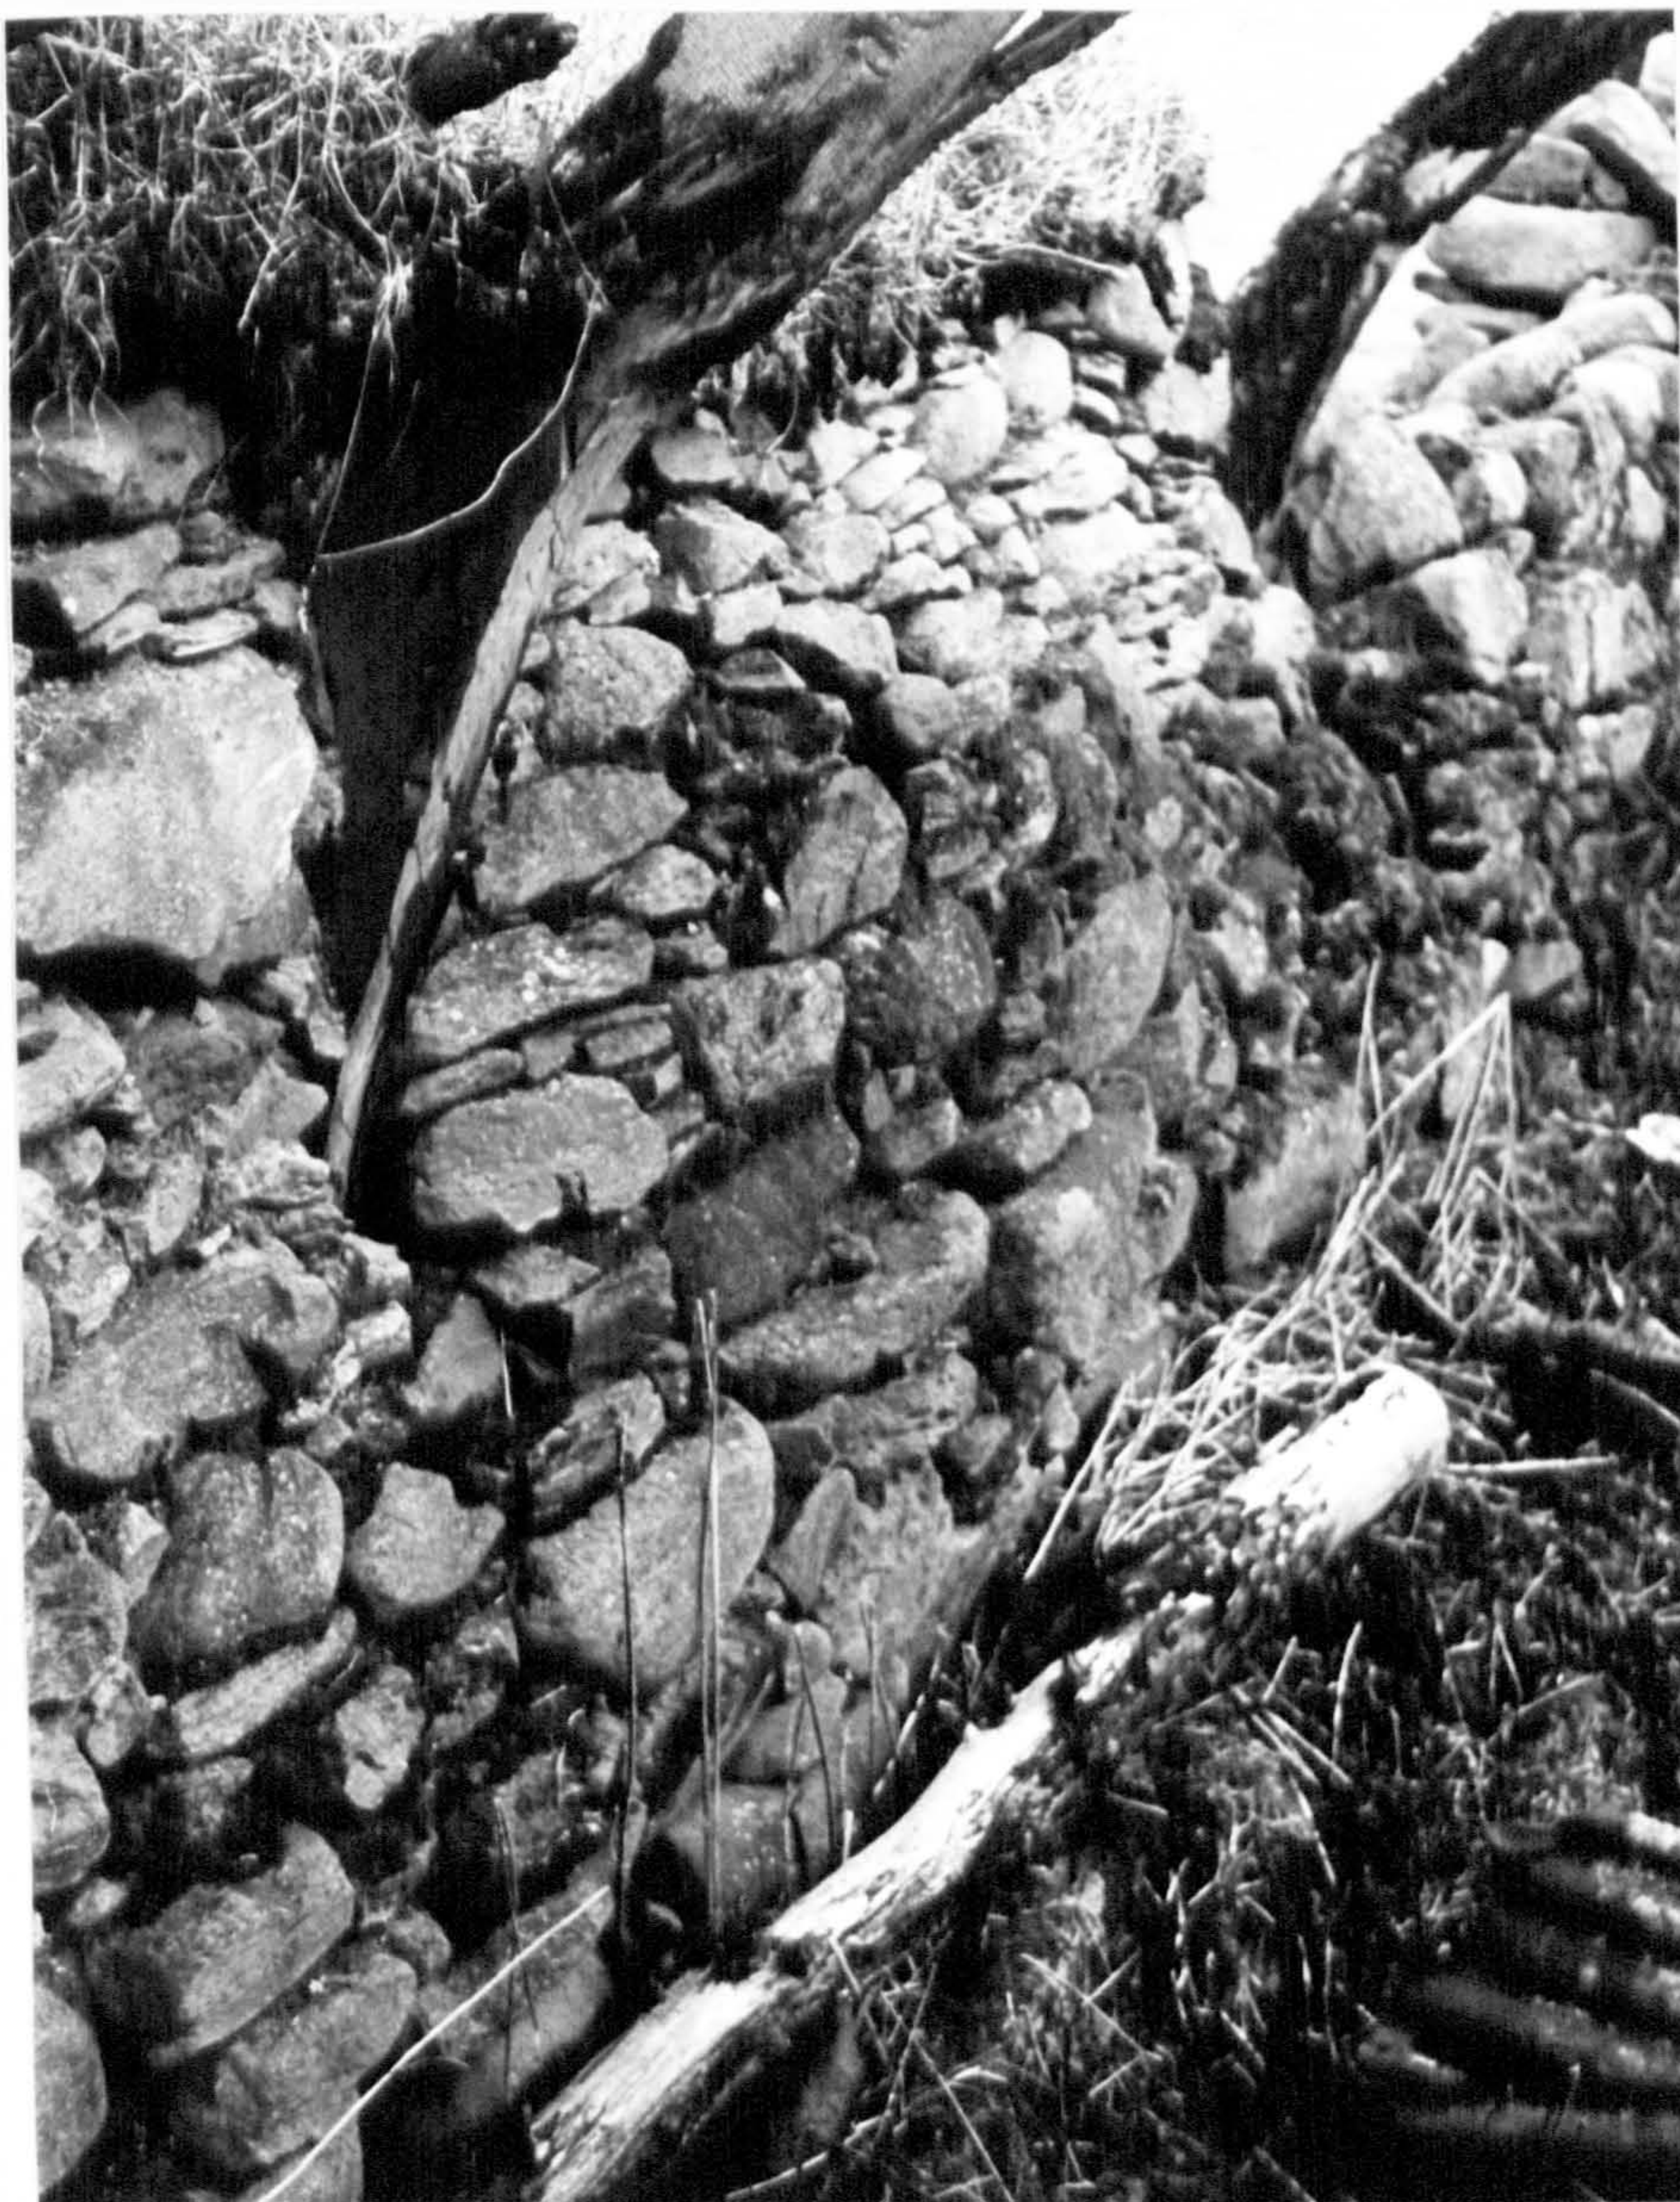
Plate 29. Feet of crucks in wall slots, west and central crucks,
North wall of Section A₁, Building A in Cluster B on Cuiltrannich,
1966 (Figure 31).

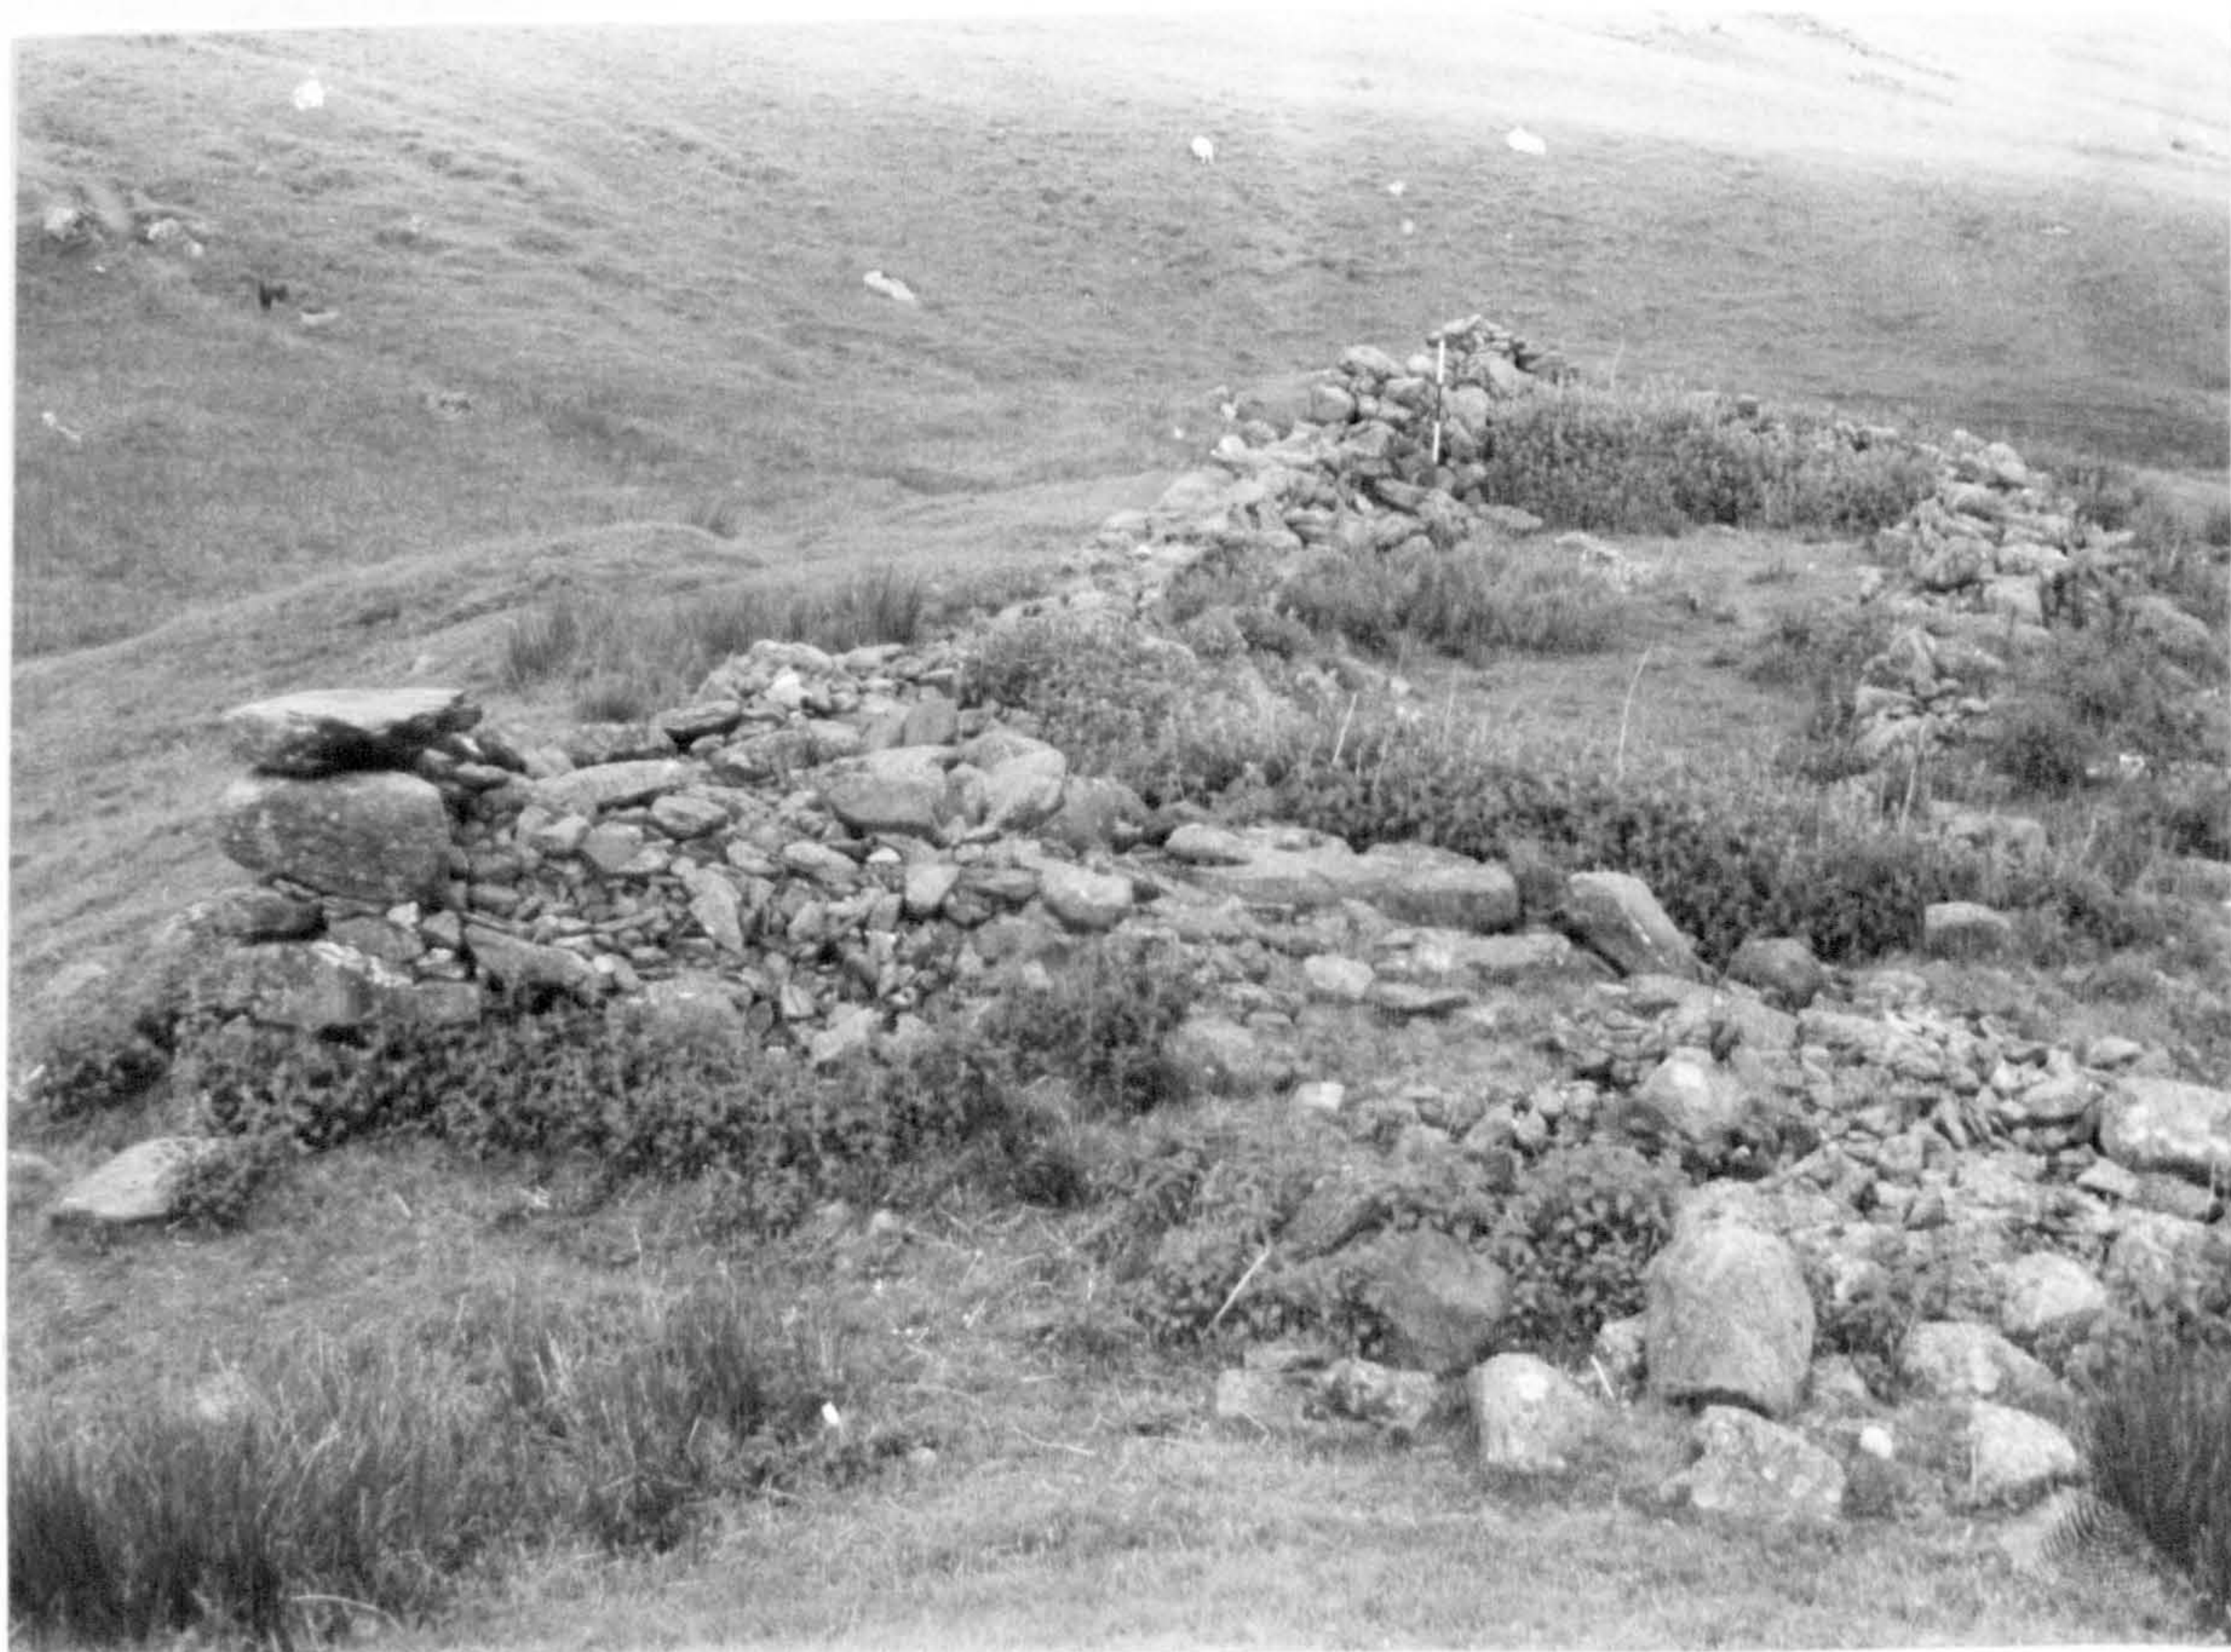
Plate 42. Remains of long house, Building A in Cluster A on Newton Farm (Figure 39). 80 x 20 feet (24 x 6 m). Ranging pole in feet.

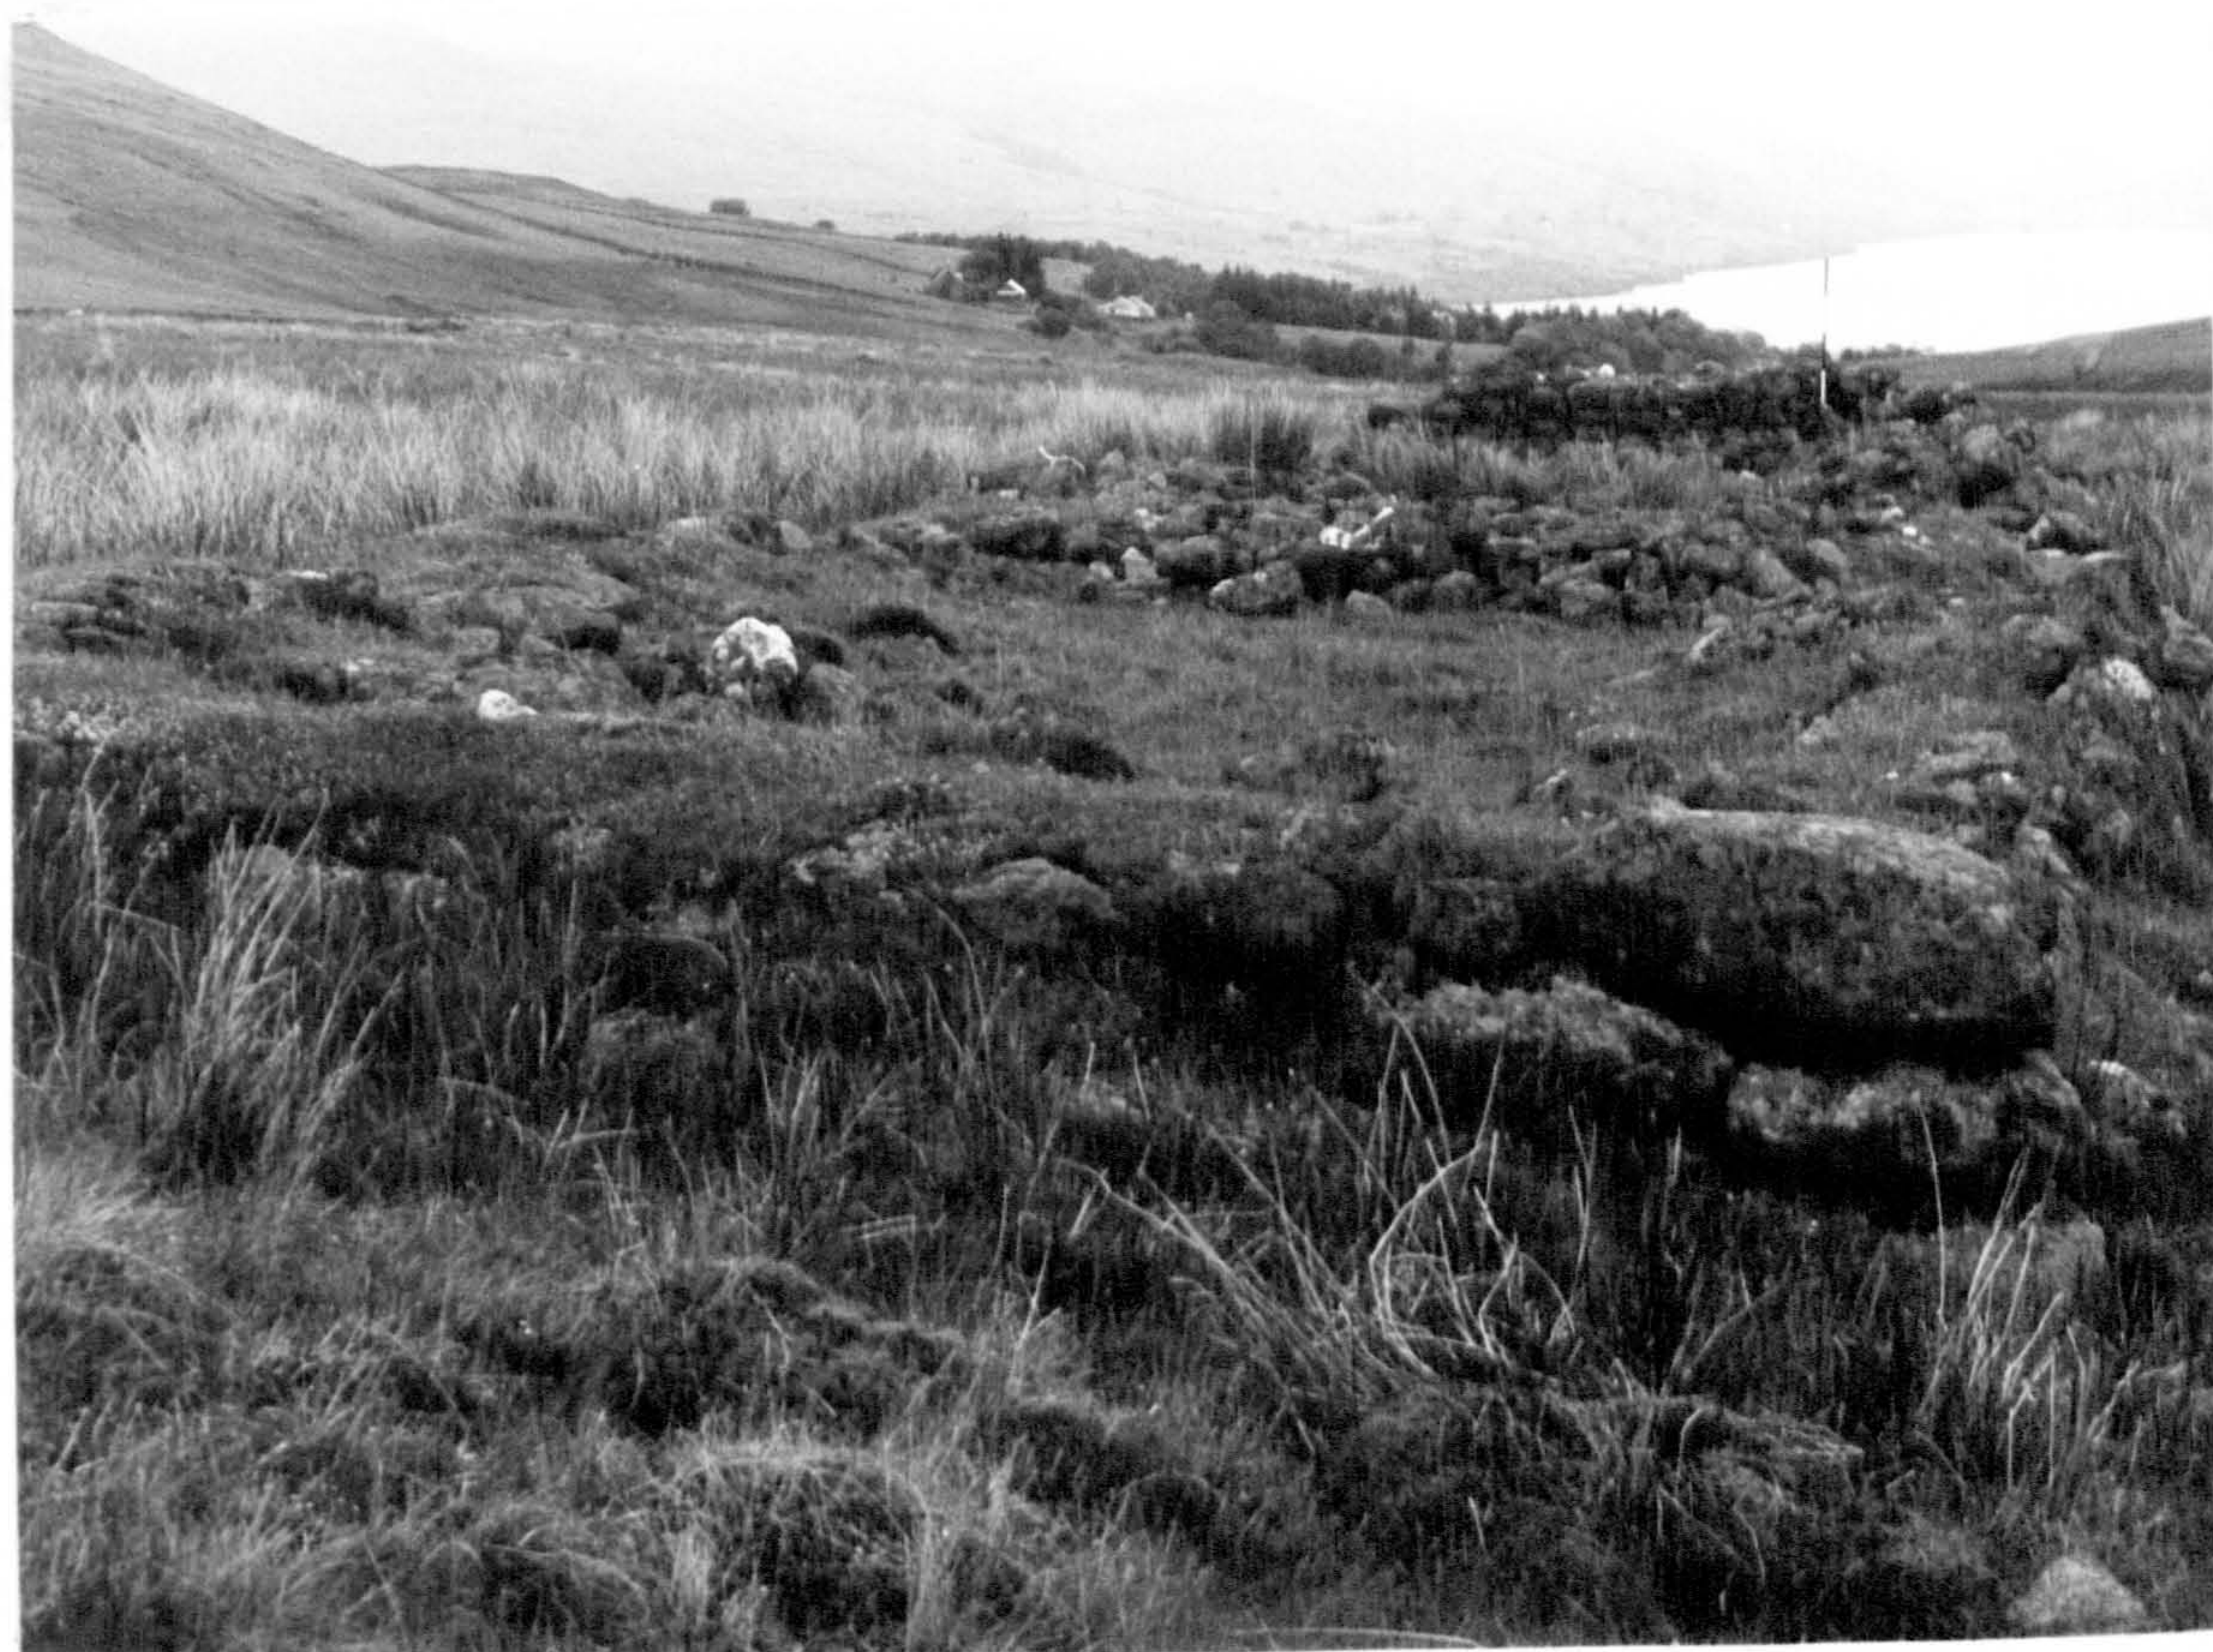
Plate 43. Remains of long house, Building A in Cluster B on Newton Farm (Figure 40). 70 x 17 feet (21 x 5 m). Newton was a 2-tenant, 2-cluster farm where the remains show the same numbers and orientations of buildings as on the 1769 plans.

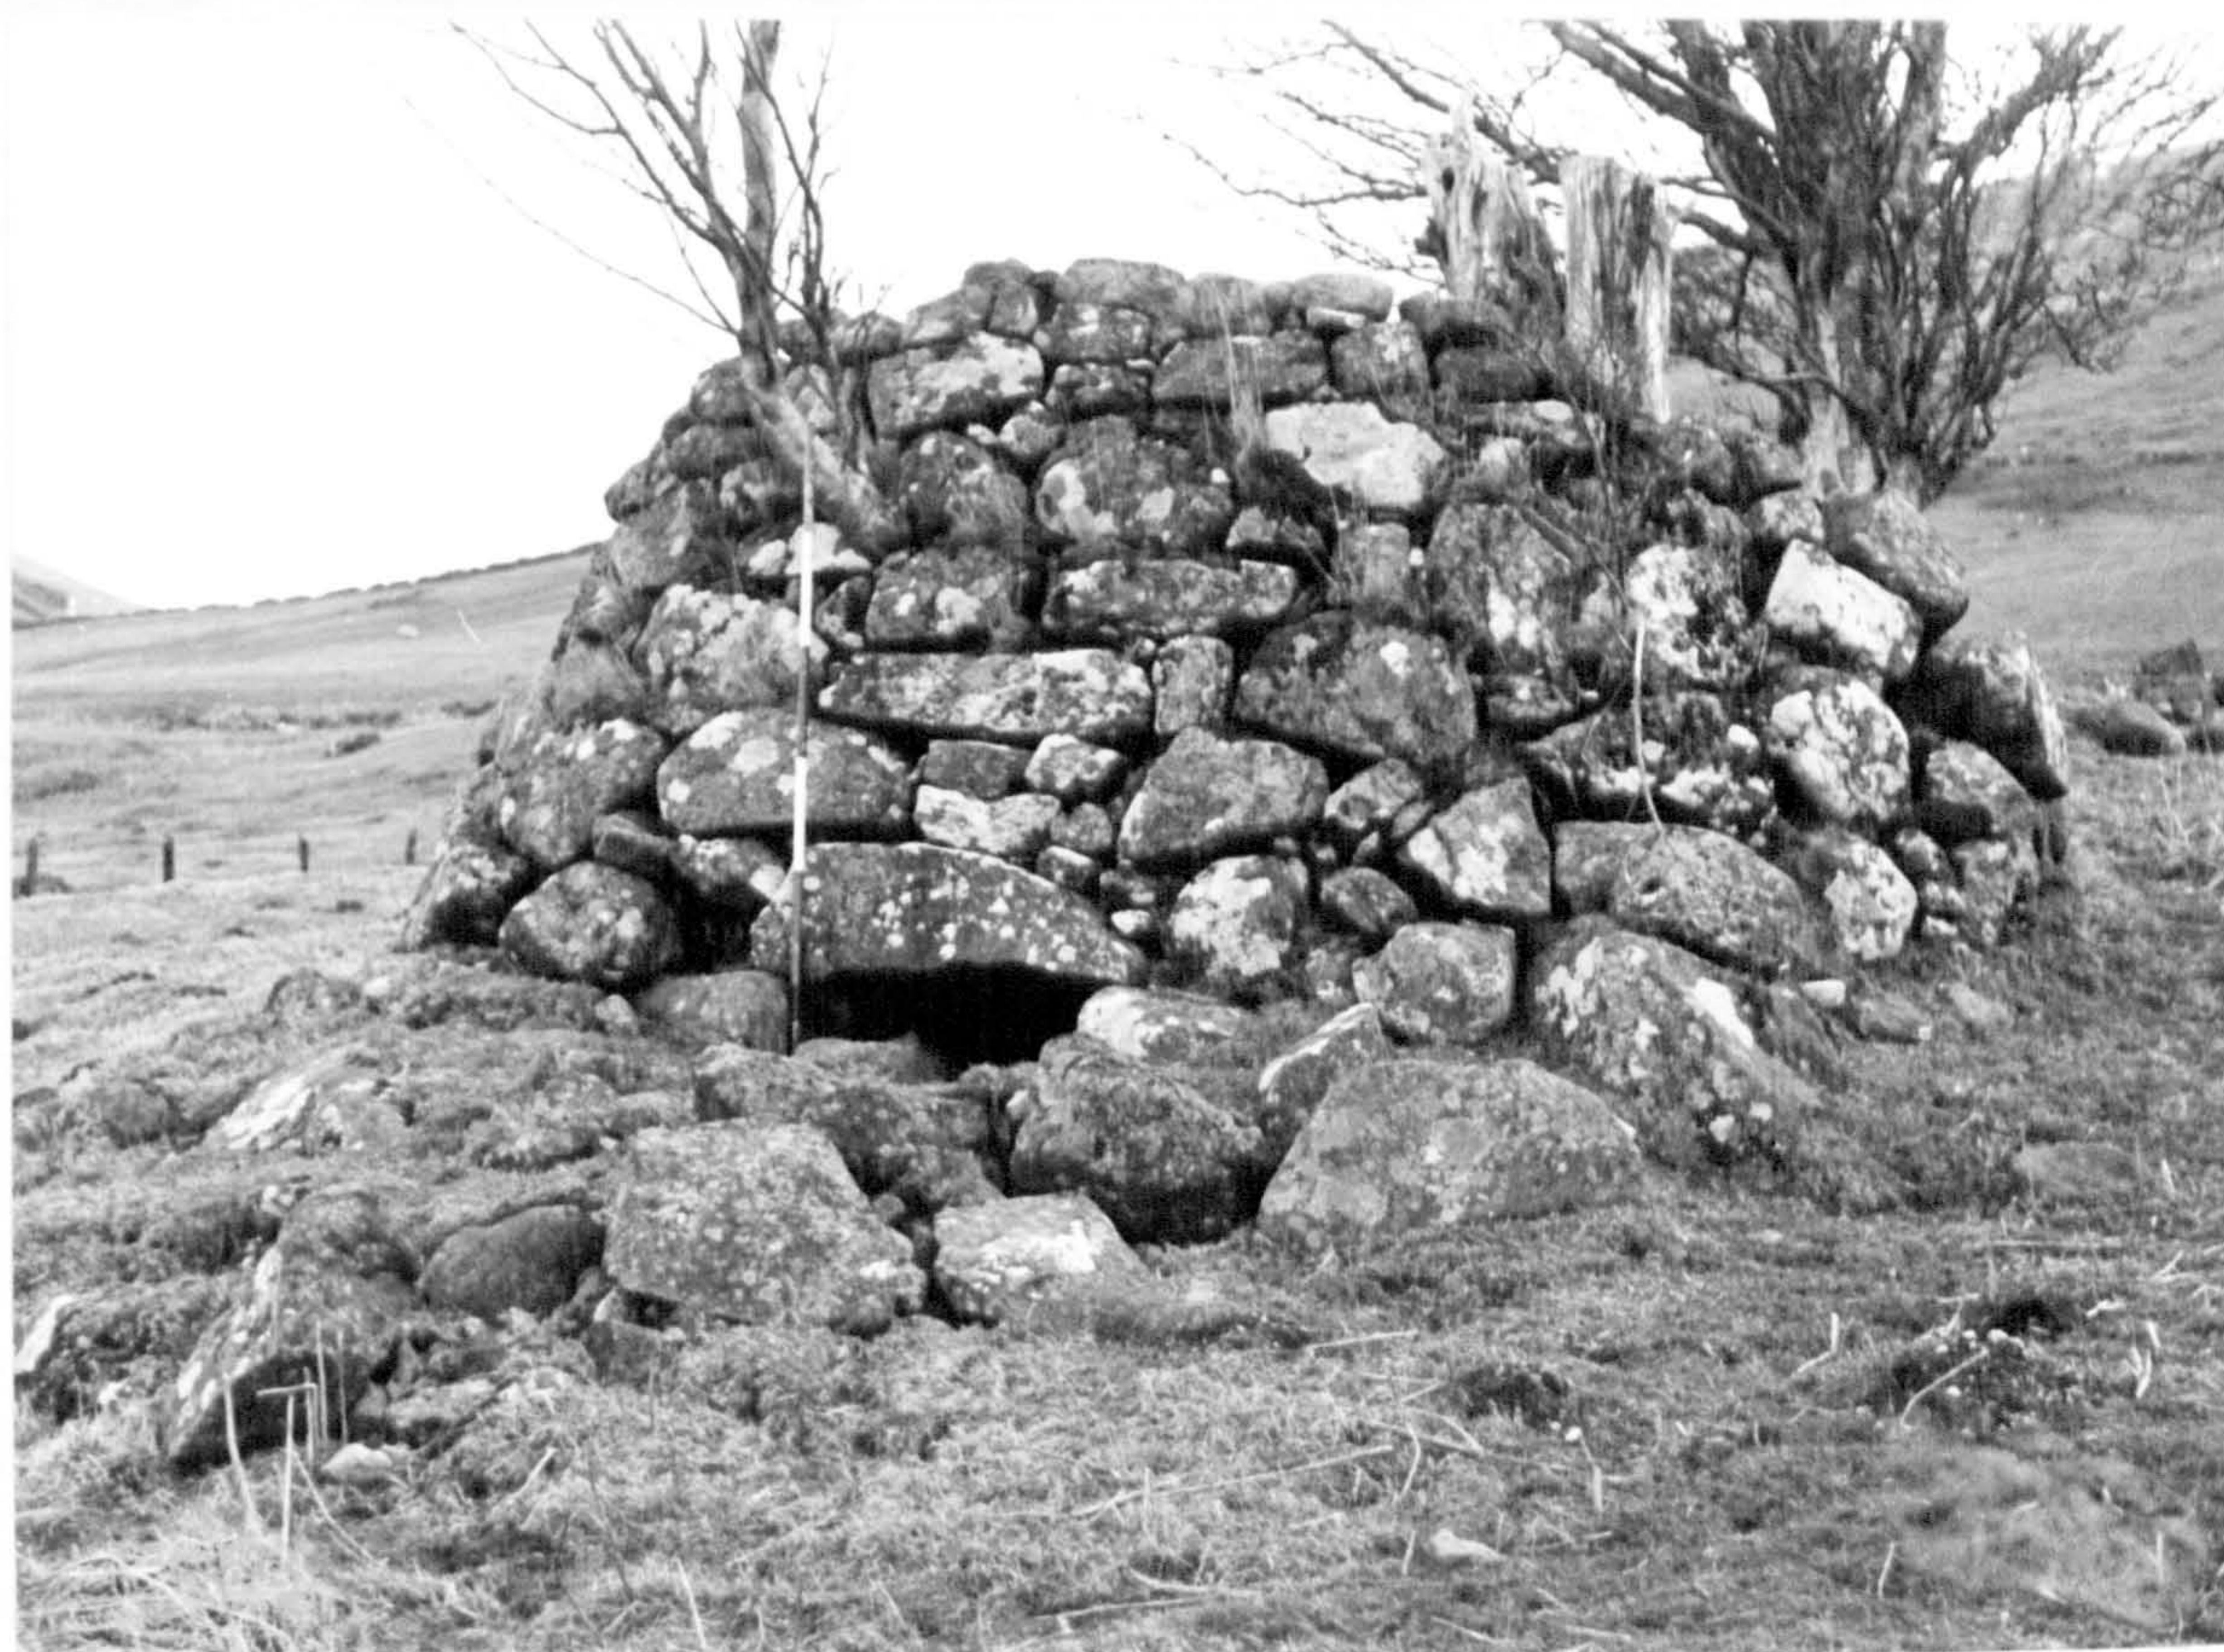
Plate 49. NW end of Building D on Craig Farm (Figure 46). Long house 64 x 17½ feet at NW end which has corn-drying kiln.. Ranging pole in feet.
