RURAL SETTLEMENT IN THE SCOTTISH HIGHLANDS, 1750-1850:

A COMPARATIVE STUDY OF LOCHTAYSIDE AND ASSYNT

VOLUME 3

PLATES

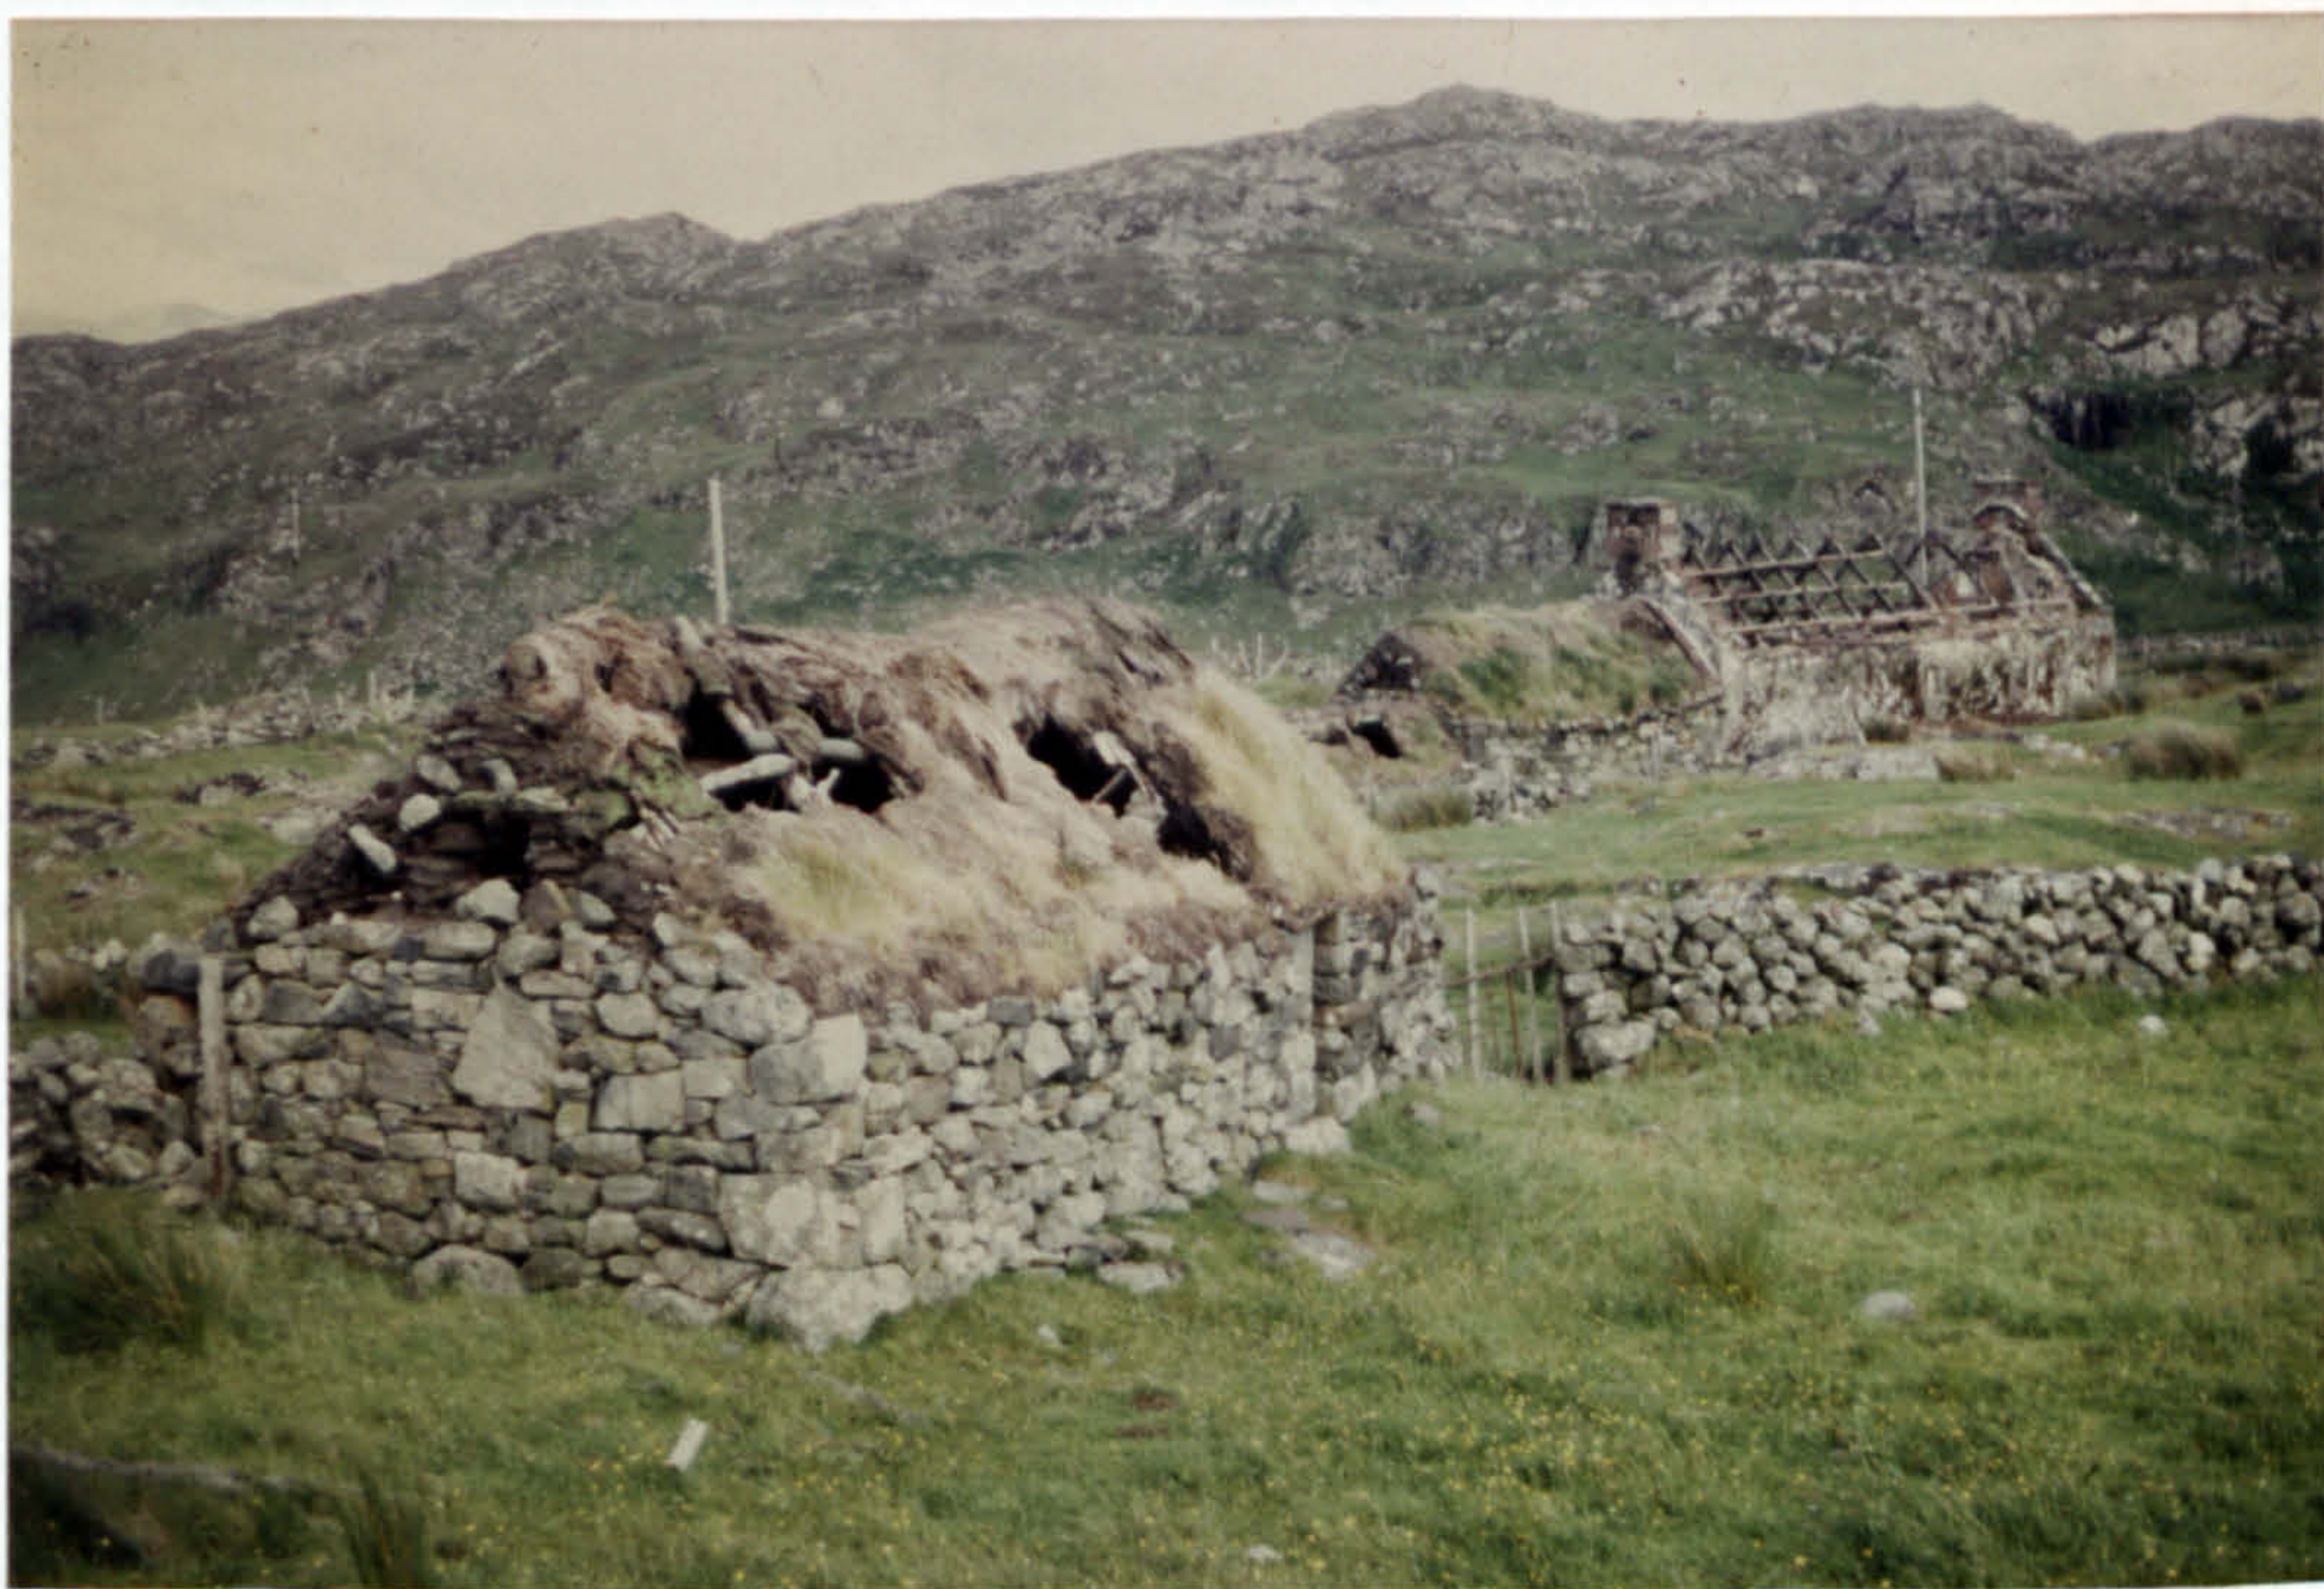
Plate 58. Building A on Clashnessie (Figure 60). An old style of construction with the upper part of the gable ends and the roof made of turf. The roof is supported on crucks (see Plate 59) unlike the later unroofed house in the background which has normal rafters resting on the wall heads.

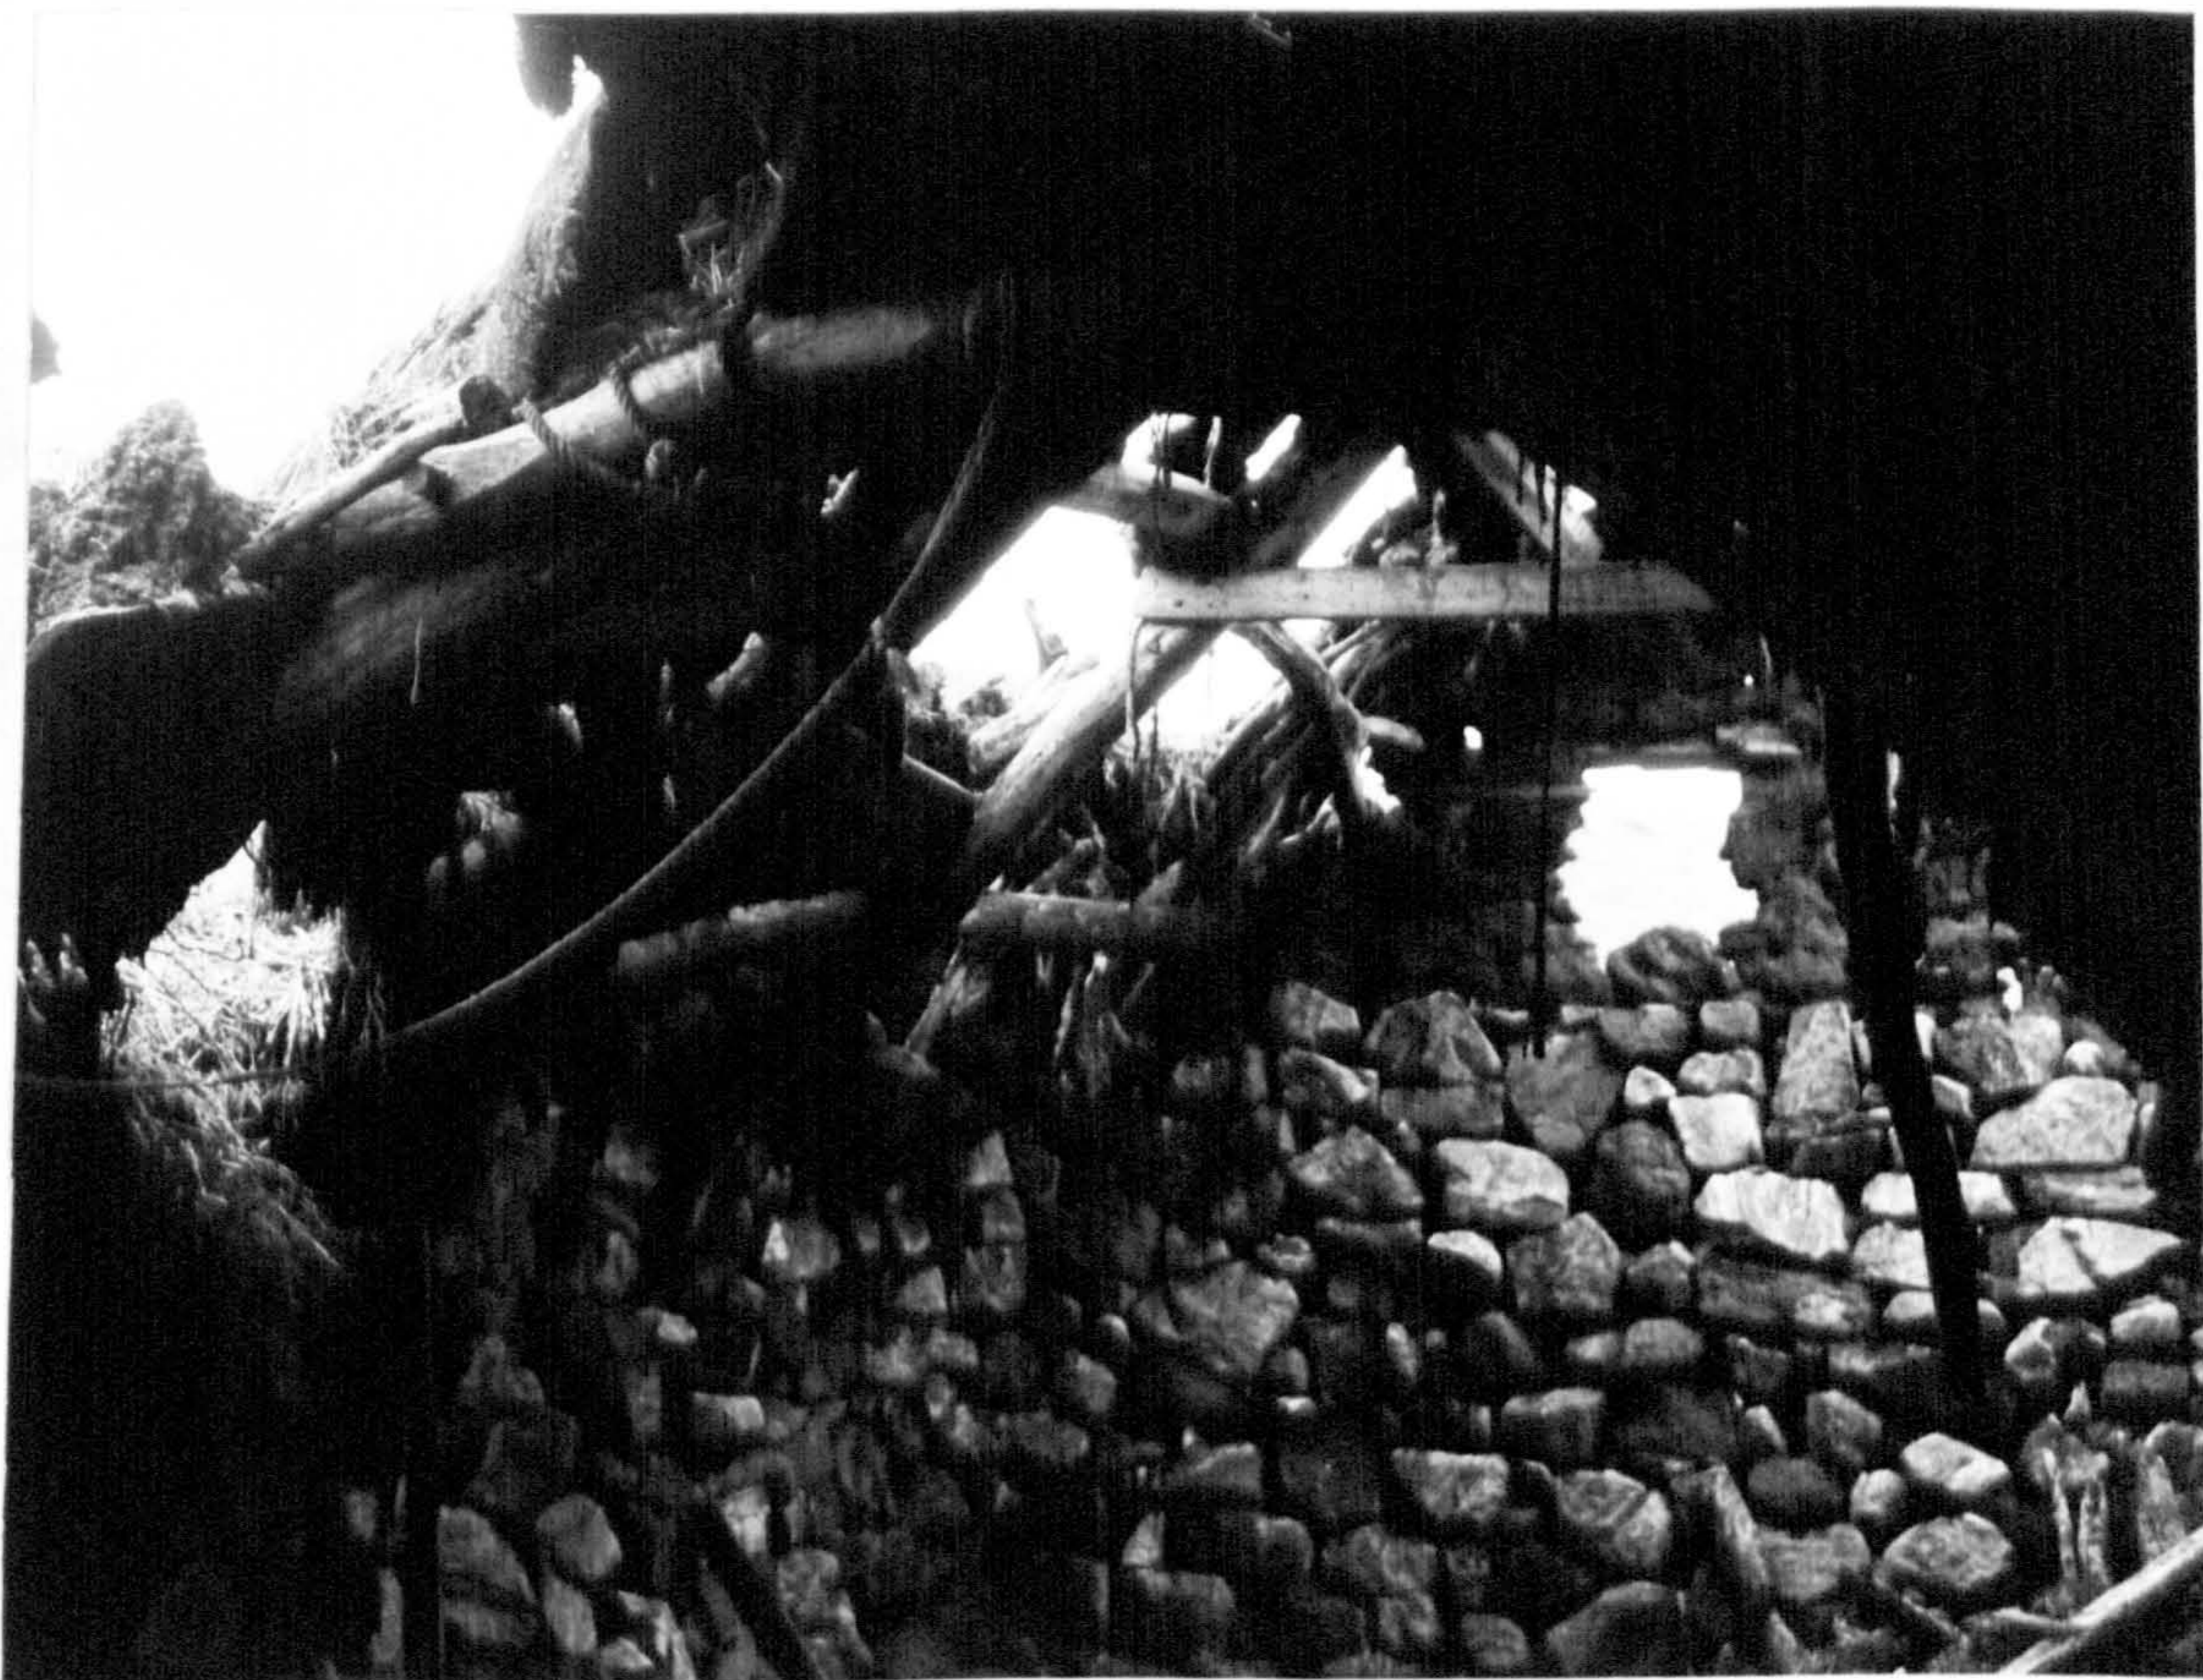
Plate 59. Interior of Building A on Clashnessie (Plate 58). The crucks are in a somewhat dilapidated condition, but at least one collar beam is still in place. Turf upper gable in background.

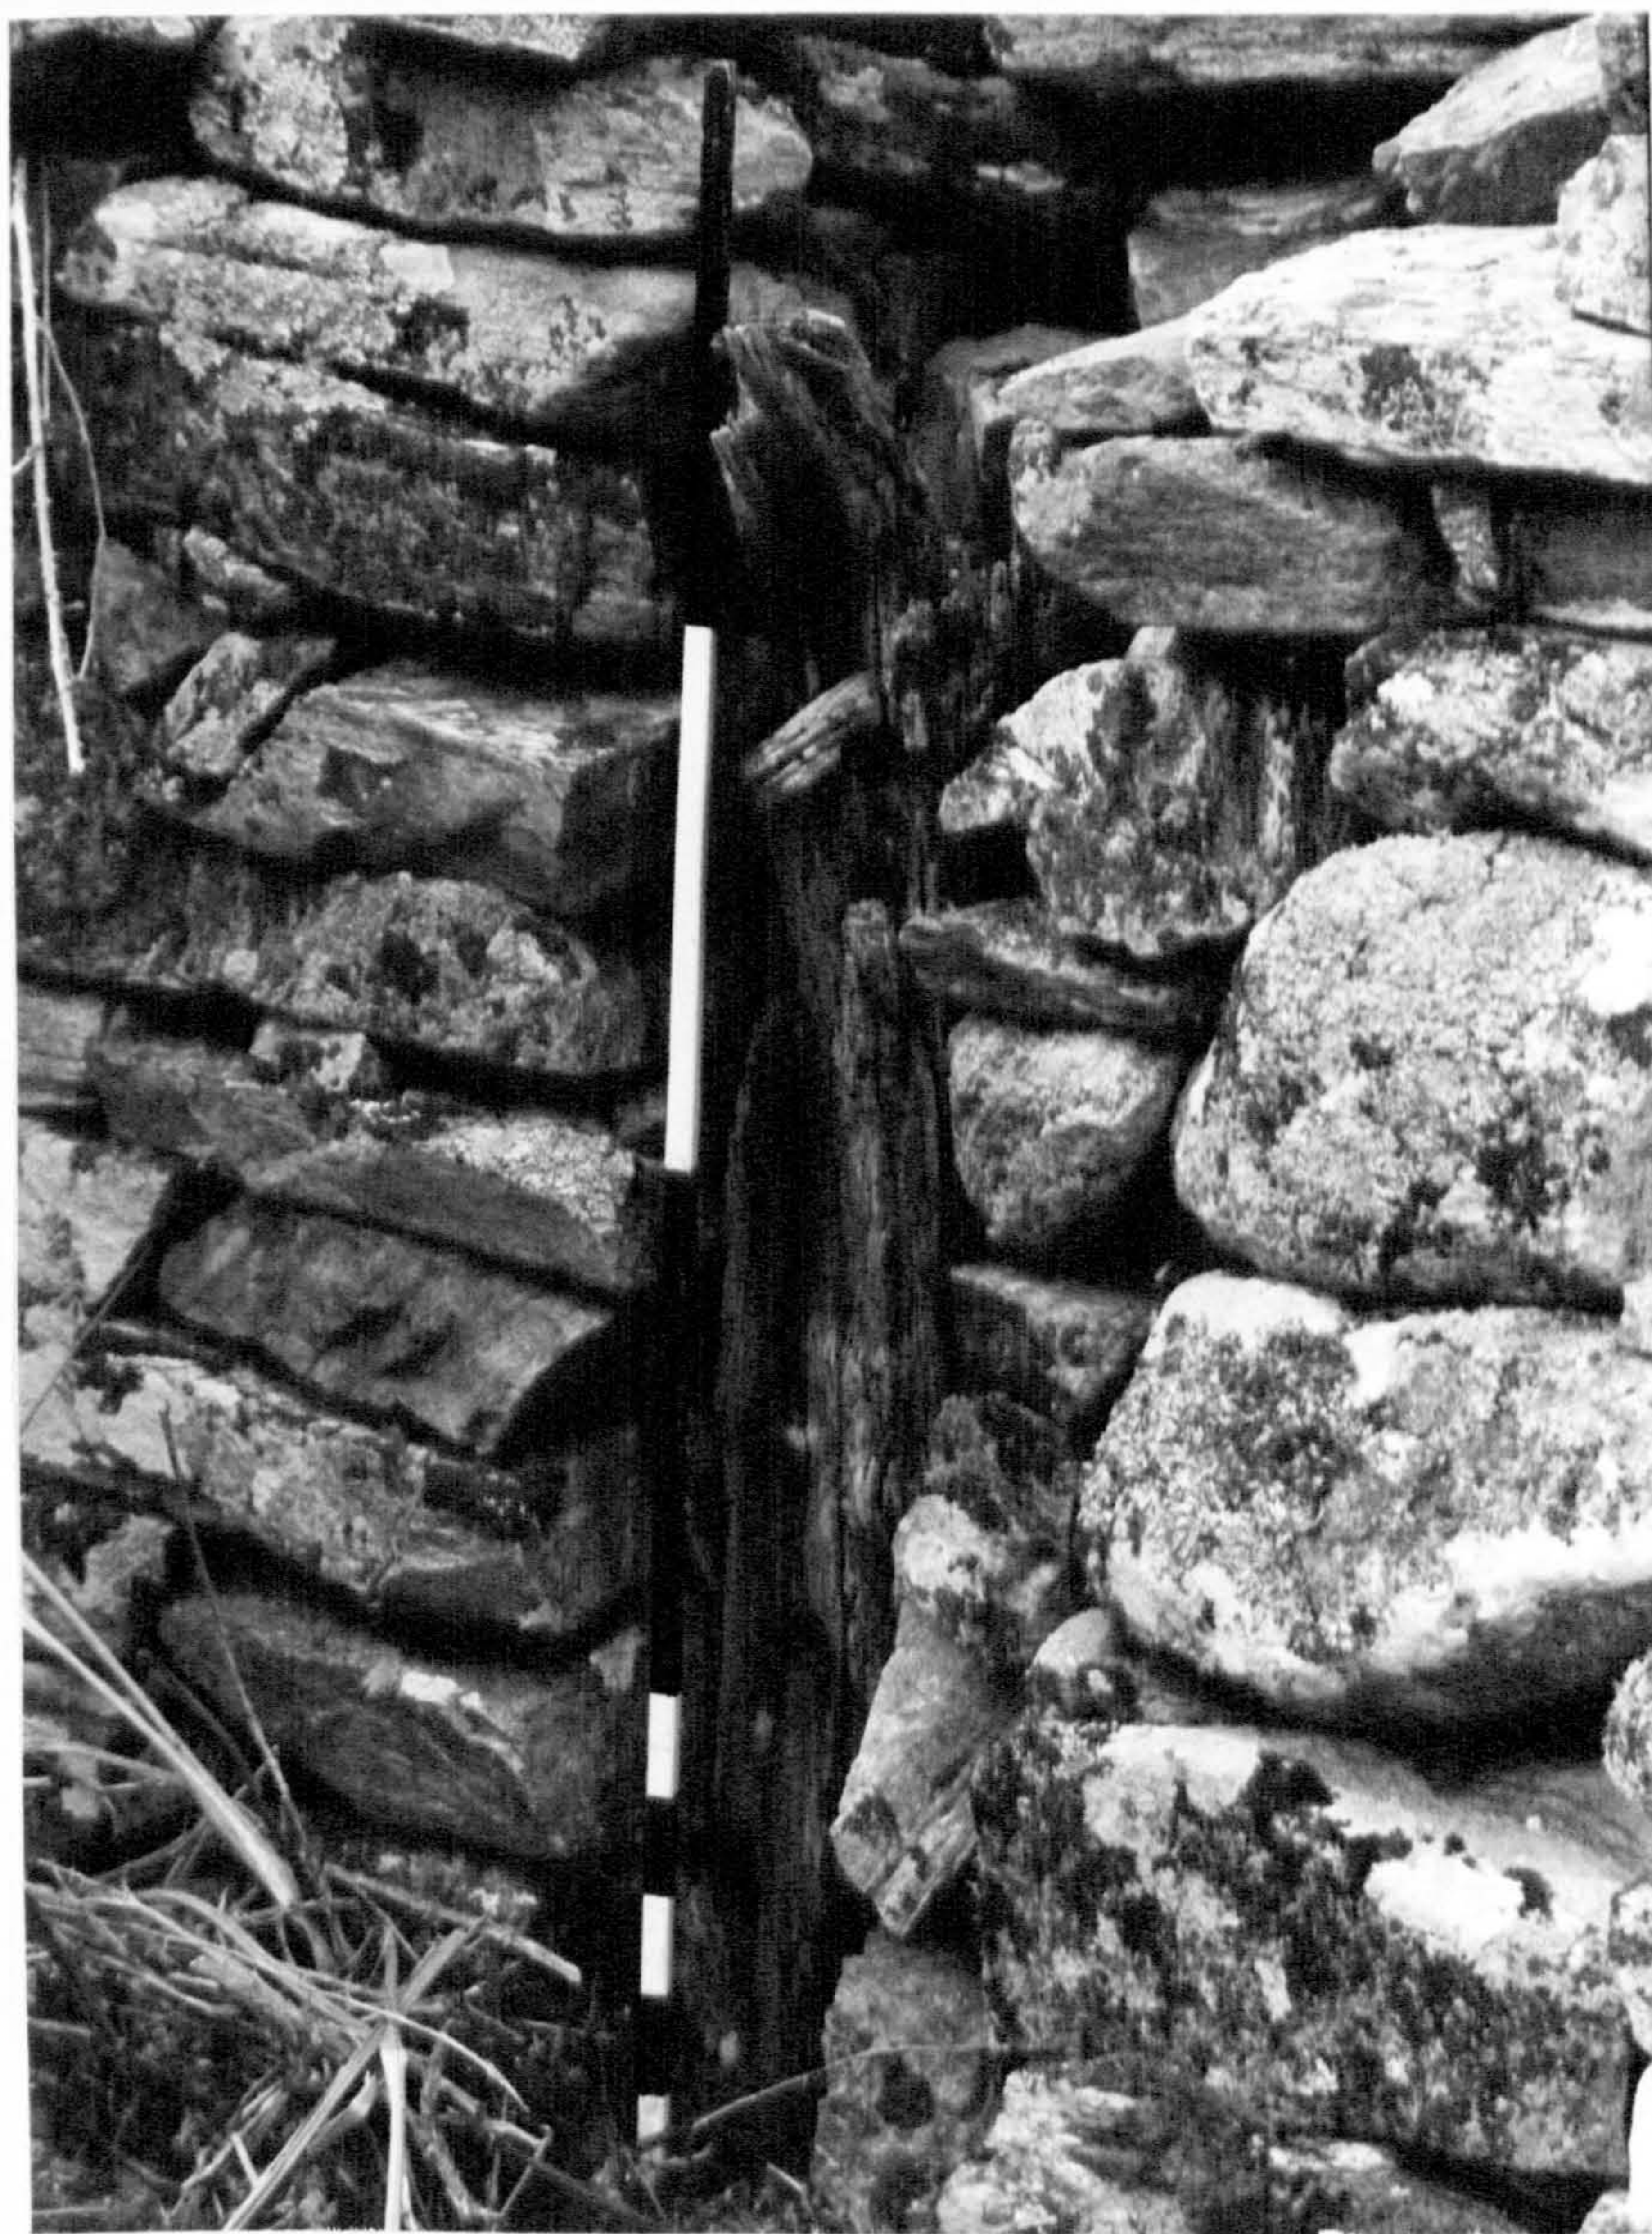
Plate 84. Remains of lower part of cruck in wall slot of NW wall of Building E, Glananter sheeling. Scale has 50 cm and 10 cm divisions.

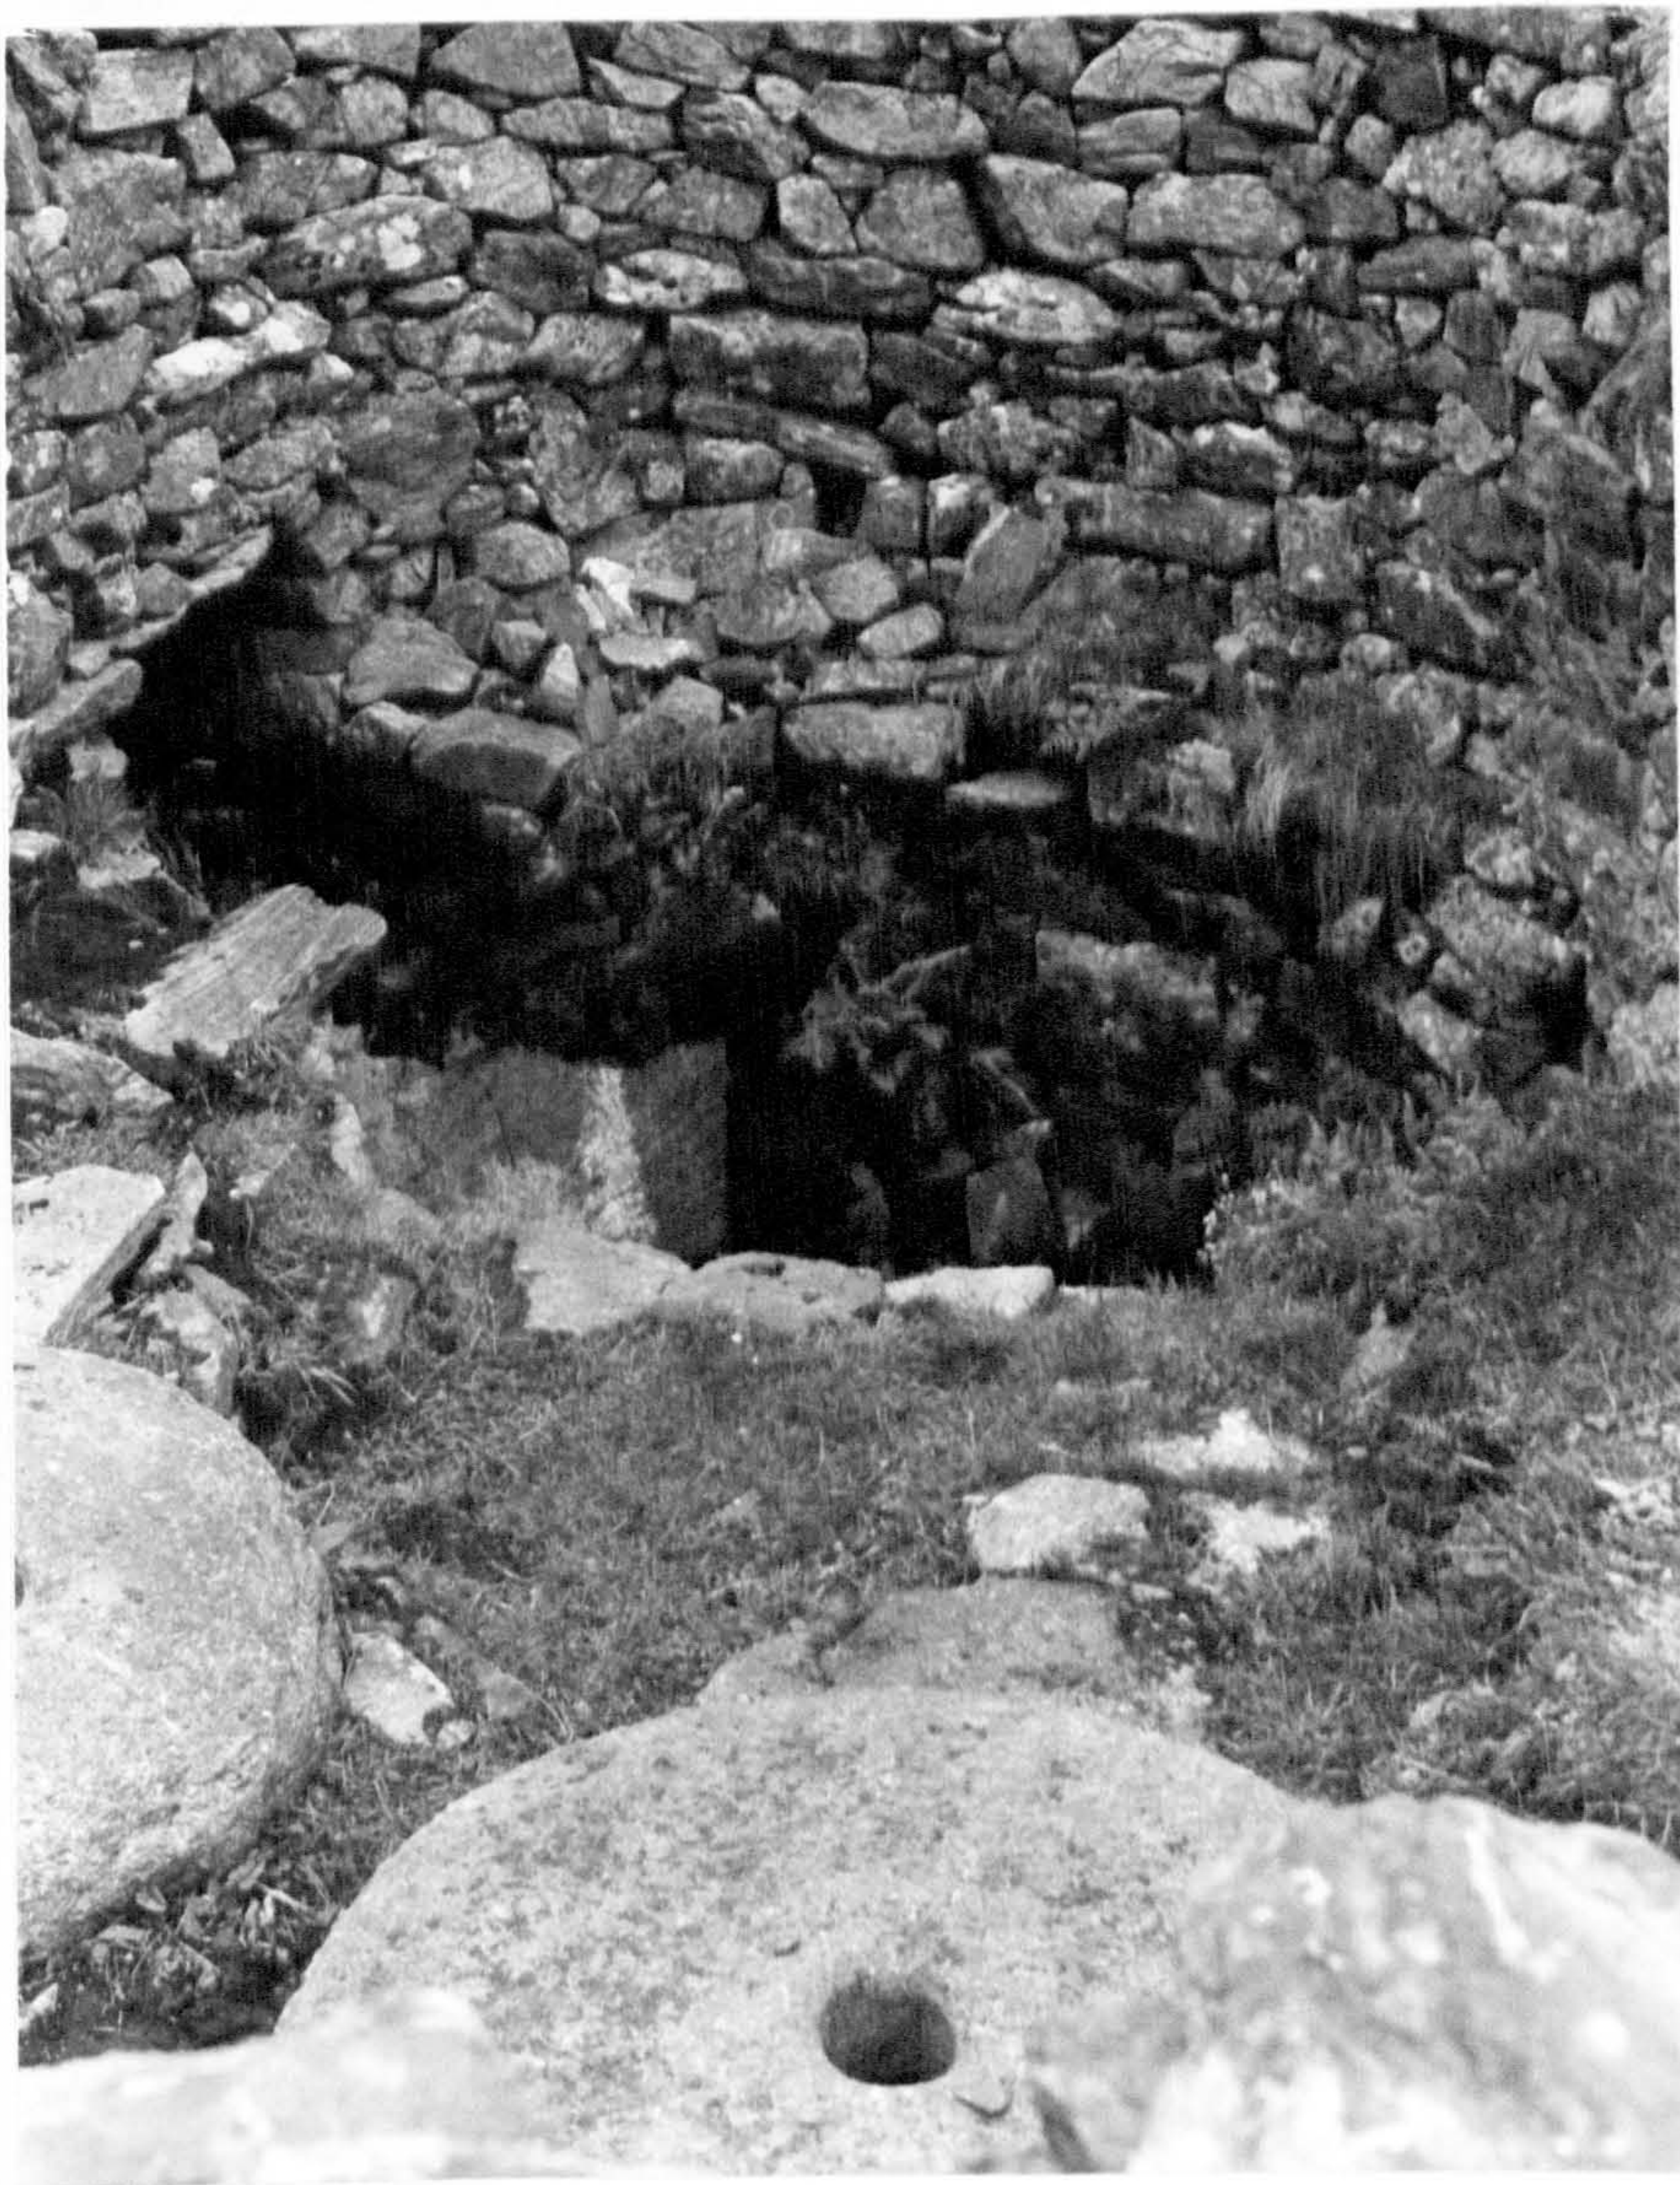
Plate 97. Basin for horizontal mill-paddle, interior of ruined mill on Alltanabradhan Burn.

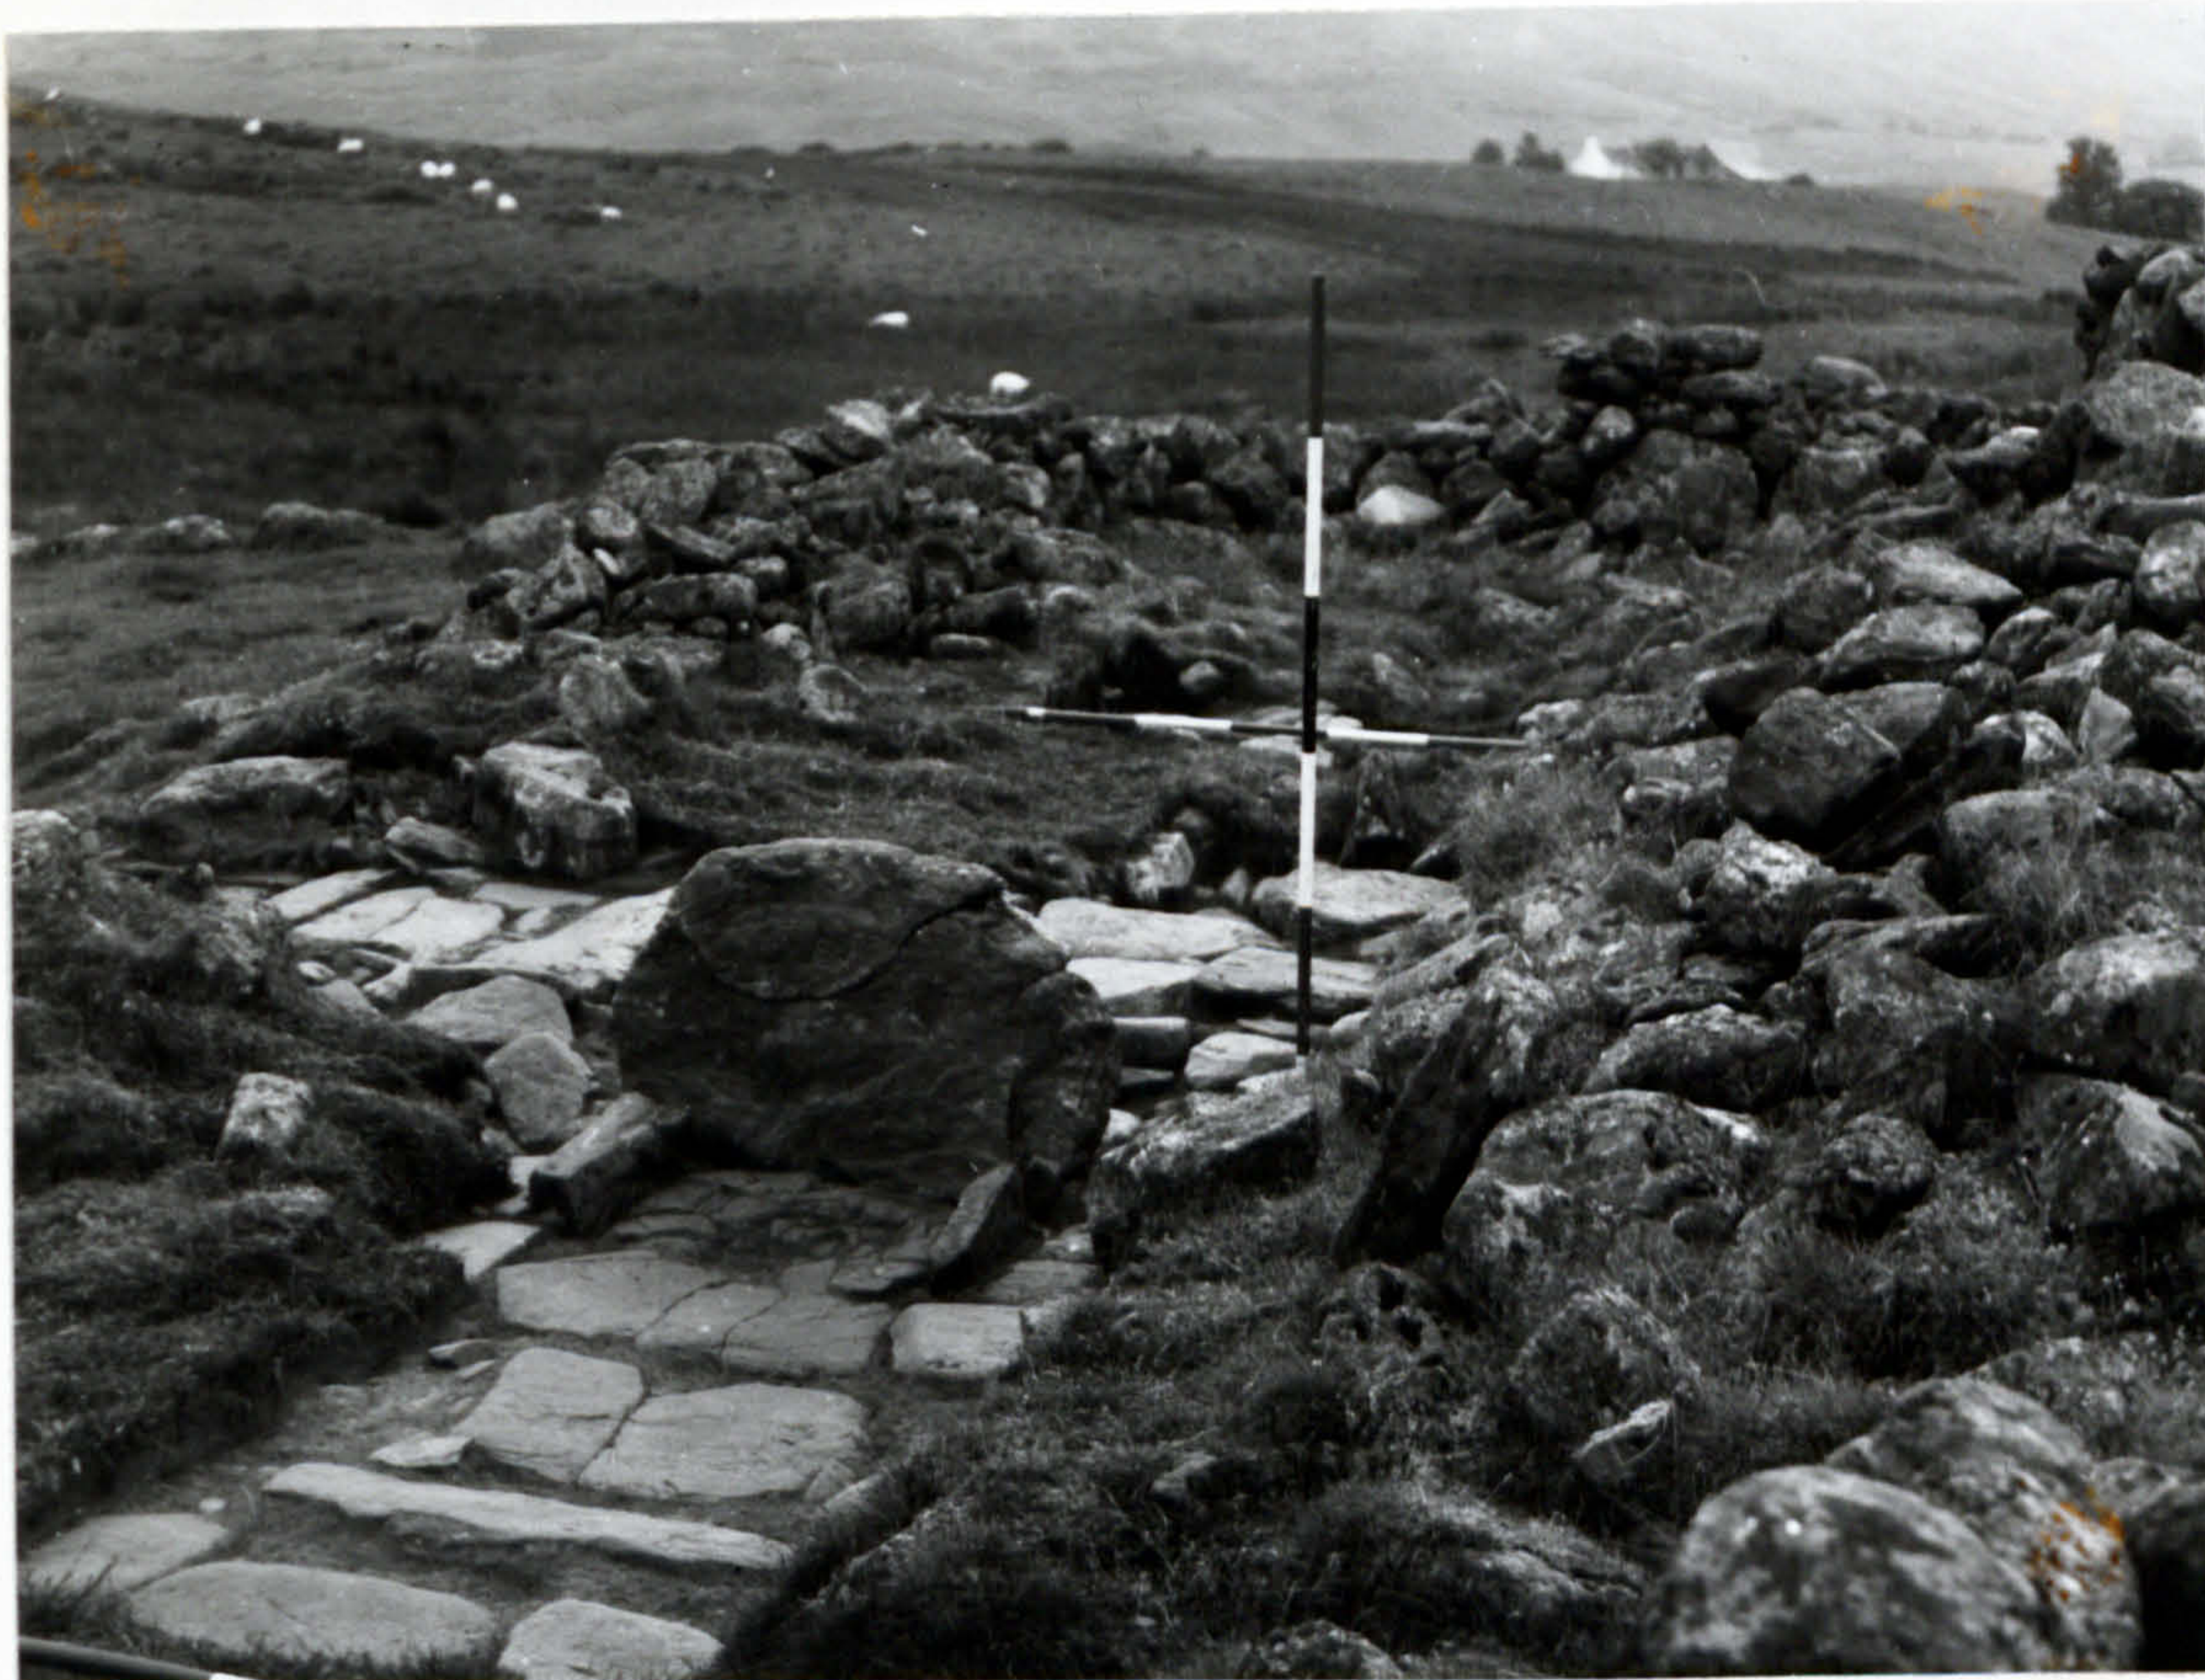
Plate 101. Excavation of byre dwelling House G in Cluster EL/III at East Lix (Figure 88), showing living area in foreground with hearth and backing stone, and byre drain behind vertical ranging pole (in feet).

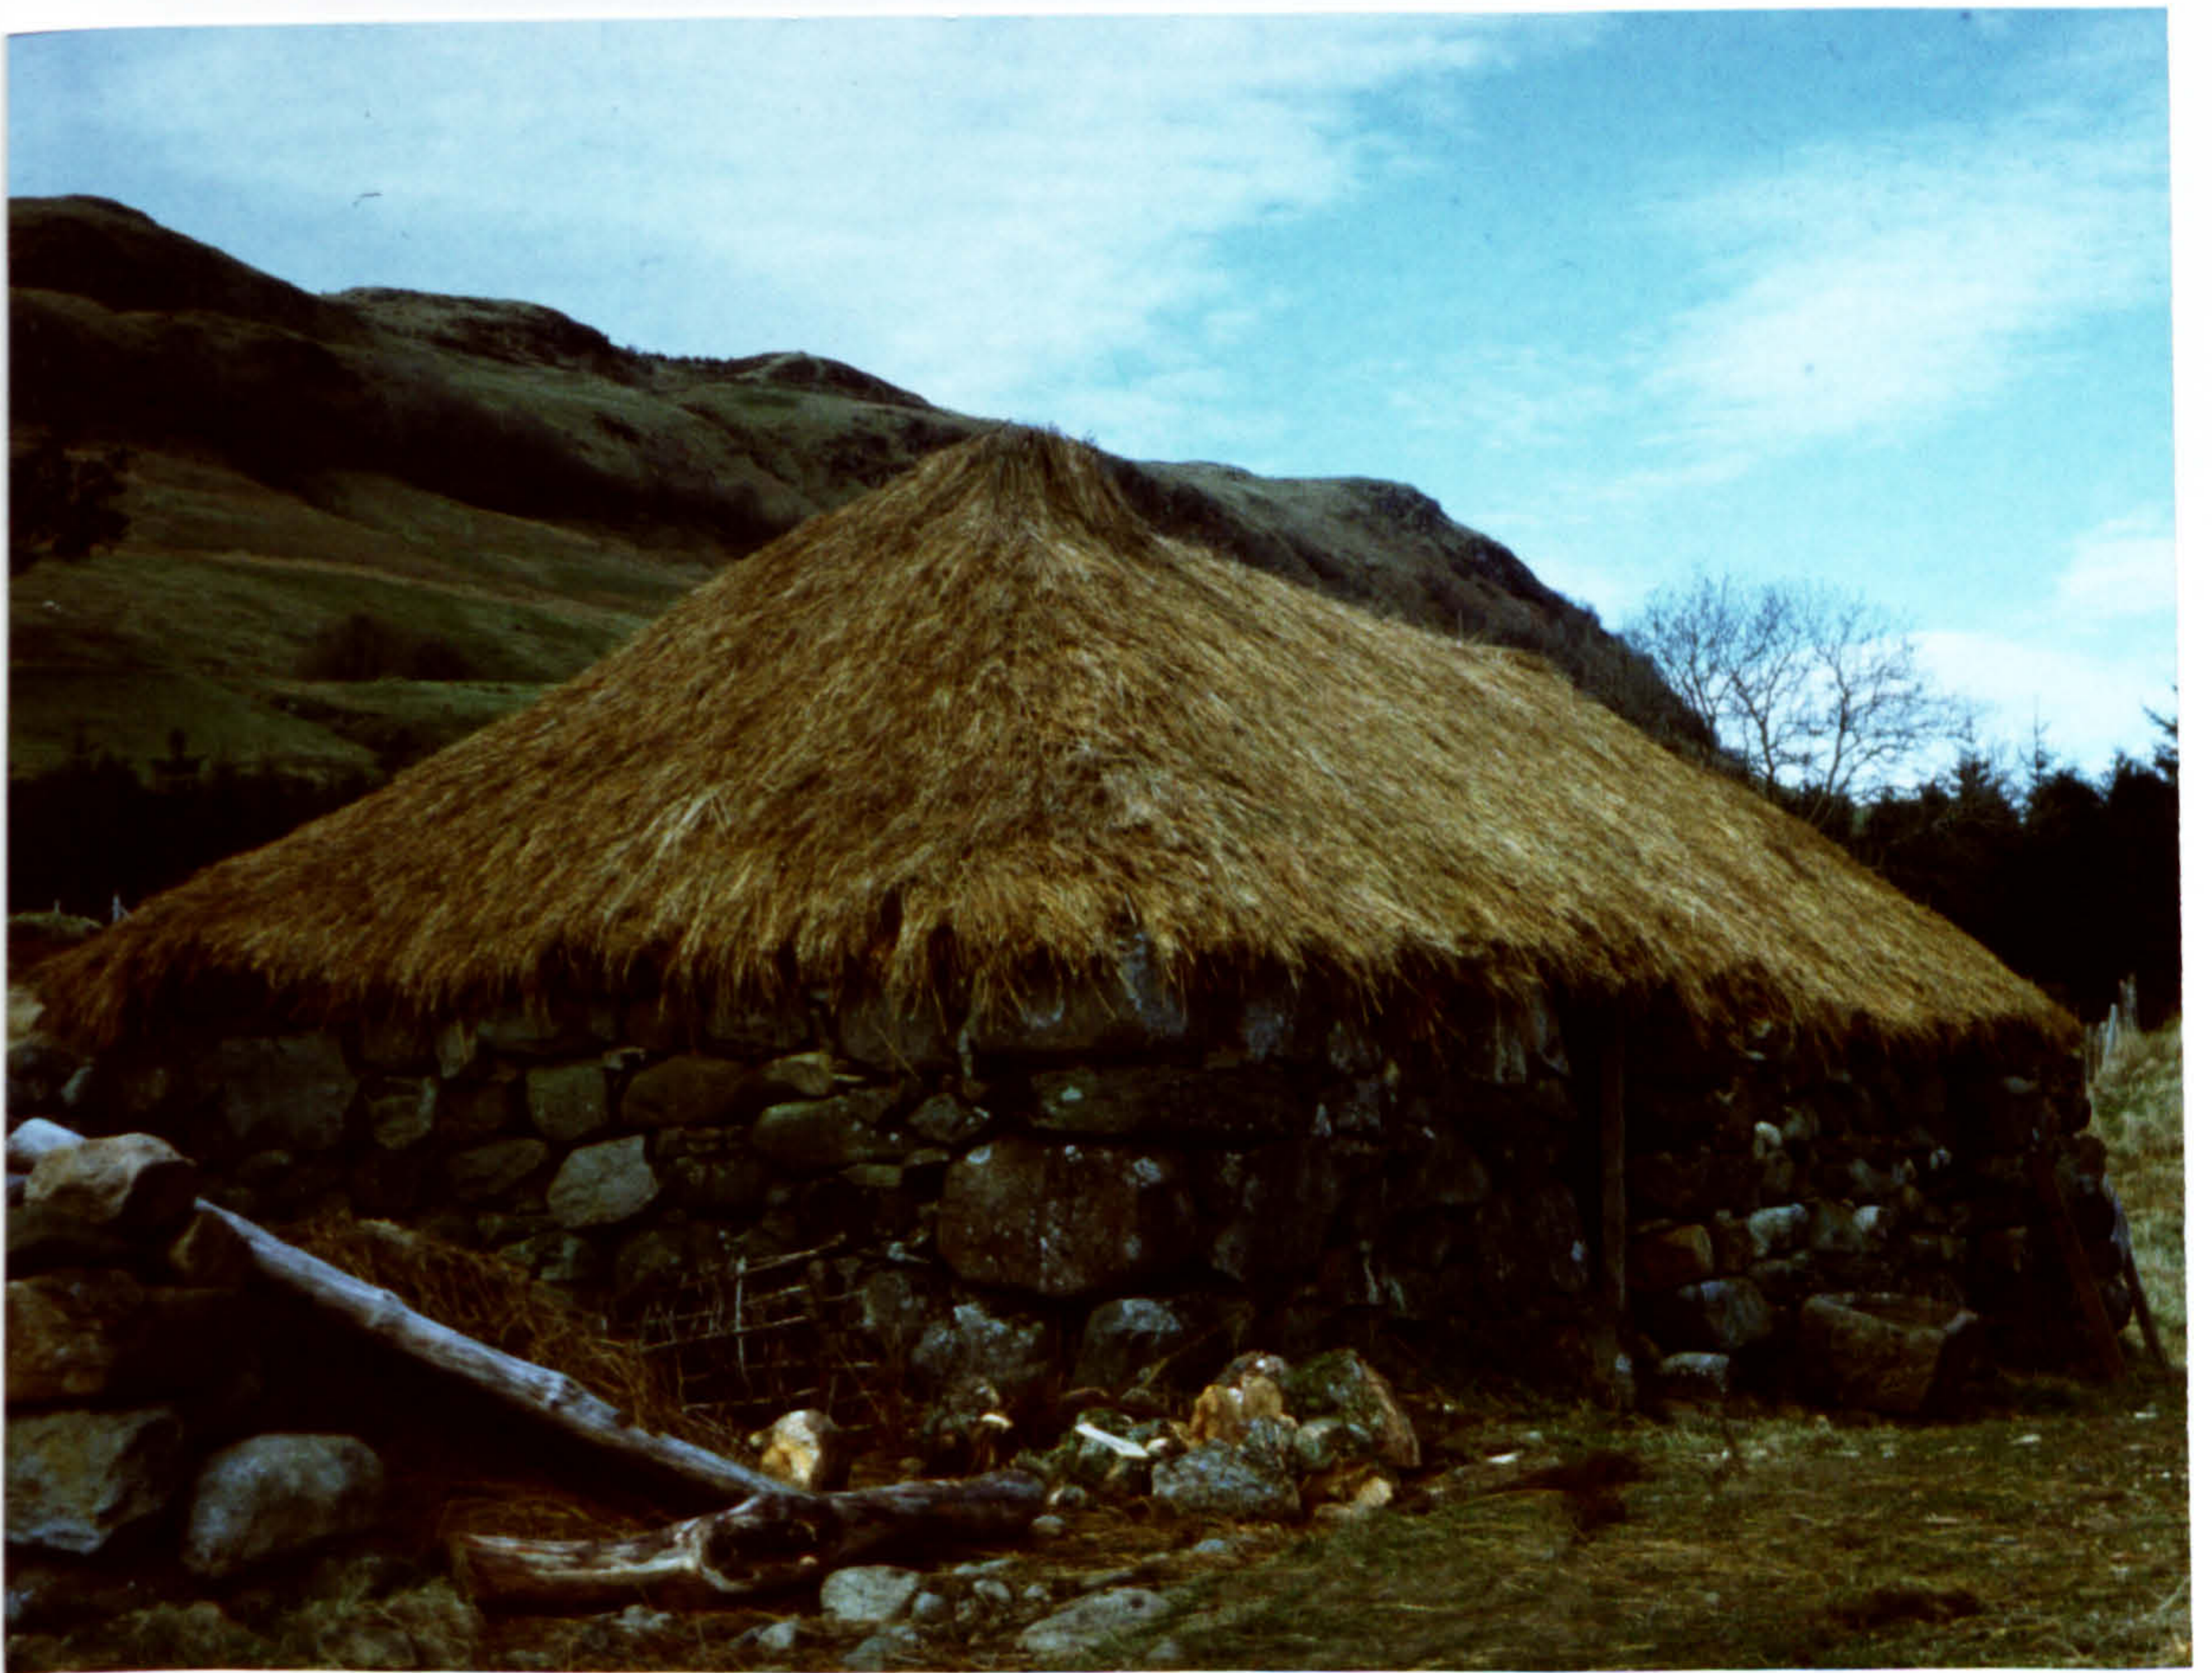
Plate 106. Building G at Auchindrain, reconstructed with hipped roof, crucks and central hearth. Thatched with straw on heather.
