# Uncompahgre River Corridor

*Ecological Assessment and Recommendations Report*

TOWN OF RIDGWAY, COLORADO

DHM DESIGN

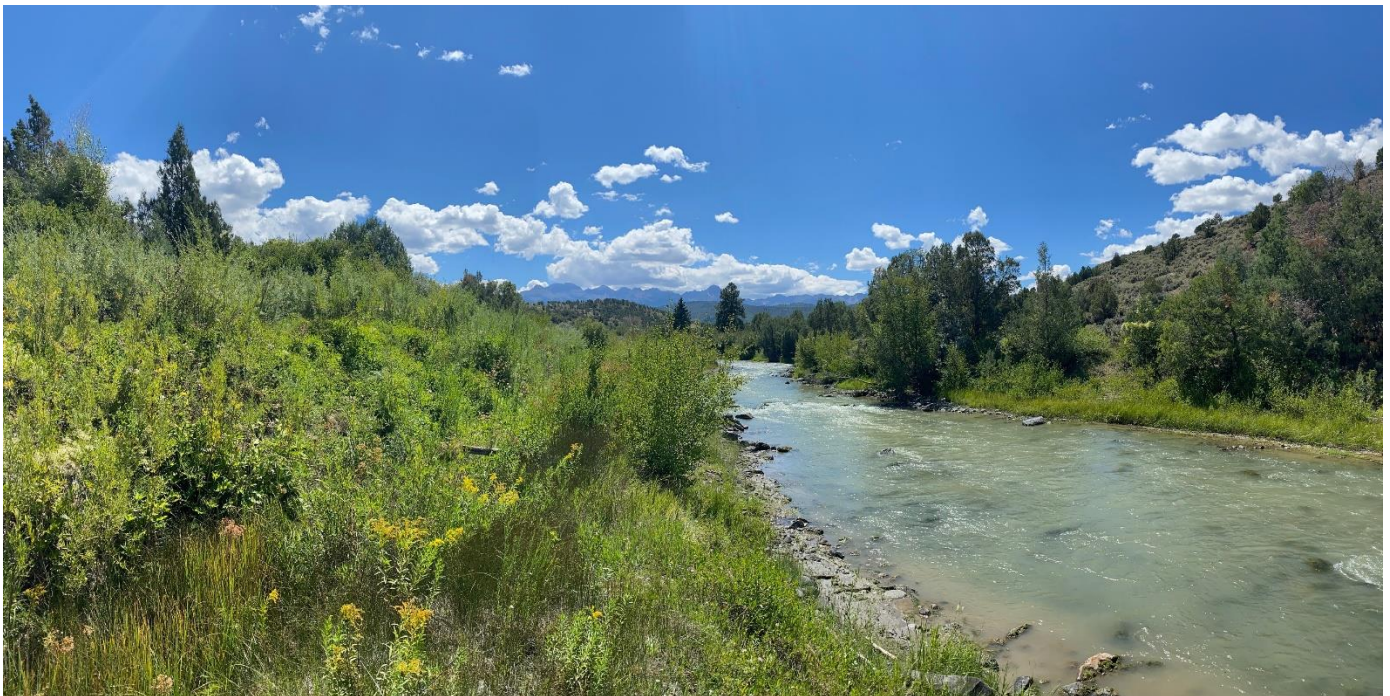
*Figure 1 - View looking south at Uncompahgre River corridor. High quality riparian habitat with good species diversity.*

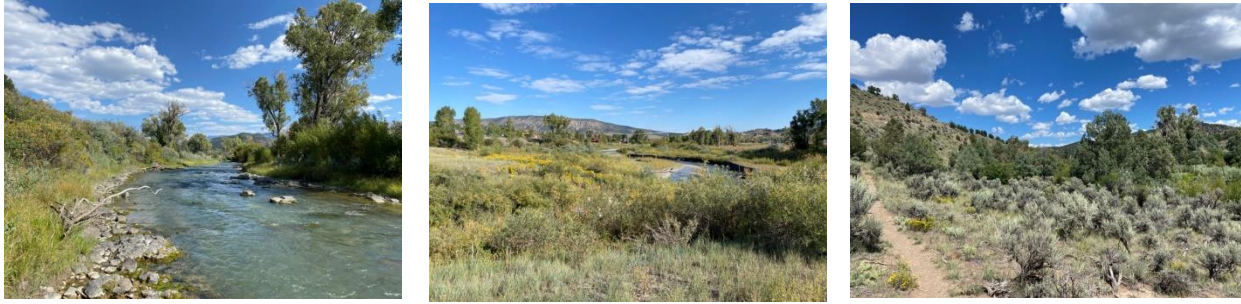
Figure 4 - Ecological communities within the Project Assessment Area.

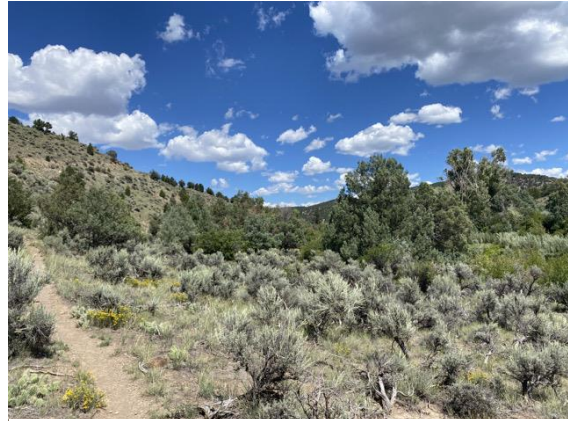
This vegetation community is found outside of the riparian zone. This shrub-steppe vegetation is dominated by species of sagebrush with Colorado pinyon and Rocky Mountain juniper. Several shrubby species of sagebrush are found along the assessment area and each have their own ecological requirements. Big sagebrush (*Artemisia tridentata*) occupies deep soils and is a frequent component of a tall shrub community with greasewood, spearleaf and rubber rabbitbrushes. Mountain big sage tends to grow at slightly higher elevations with pinyon-juniper and mountain shrub communities. It is frequent on the slopes on the northern portion of the reach. Native species observed with the sagebrush community included rabbitbrush (*Chrysothamnus spp.*), broom snakeweed (*Gutierrezia sarothrae*), winterfat (*Krascheninnikovia lanata*), prickly pear cactus (*Opuntia spp.*), western wheatgrass (*Pascopyrum smithii*) and several bunch grasses, including Indian rice grass (*Oryzopsis hymenoides*), needle and thread (*Hesperostipa comate*), and Sandberg bluegrass (*P. secunda*) these species are less prevalent and found in scattered, low densities. Sagebrush areas have been identified by the CDOW as critical deer and elk winter habitat.

Figure 6 - View looking south at xeric shrubland, sagebrush Pinyon Juniper Steppe vegetative community.

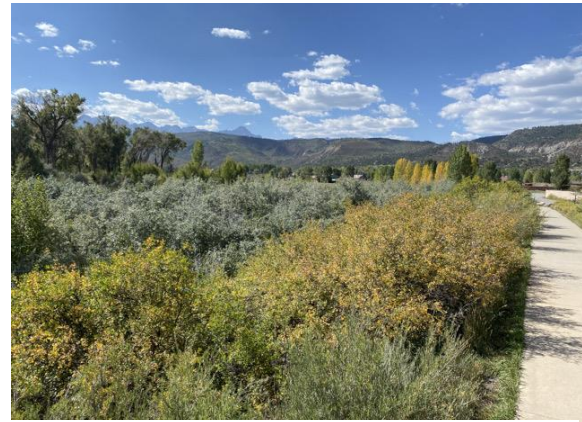
This vegetation community forms a narrow riparian corridor, consisting of patchy shrub stands and cottonwood woodlands throughout the project area. The shrubland areas are distinguishable by the presence of hydrophytic shrub species including Coyote willow (*Salix exigua*), thinleaf alder (*Alnus incana*), and silver buffaloberry (*Shepherdia argentea*) and whitestem gooseberry (*Ribes inerme*). The understory vegetation is comprised of a diversity of herbaceous forbs and graminoids, including tall fleabane (*Erigeron elatior*), cow parsnip (*Heracleum maximum*), Columbian monkshood (*Aconitum columbianum*), watercress (*Nasturtium officinale*), fringed willowherb (*Epilobium ciliatum*), reed canary grass (*Phalaris arundinacea*), horsetail (*Equisetum spp.*) sedges (*Carex spp.*) and rushes (*Juncus spp.*).

Figure 7 - View looking south along lower montane riparian woodland and shrubland vegetative community.

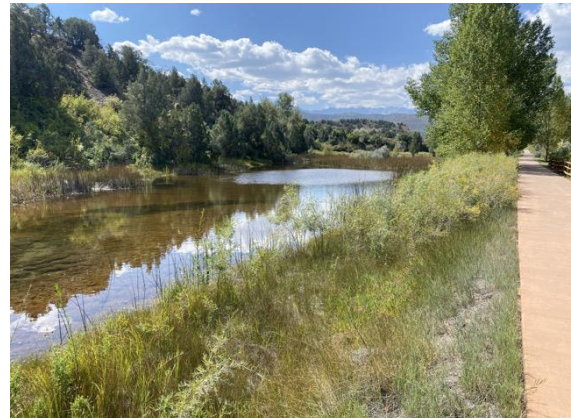
The Western North American Emergent Marsh system includes wetlands with permanent to semi-permanent standing water that support aquatic, submerged, and coarse emergent plants. Natural marshes may occur in depressions (impounded ponds or kettle ponds), on lake fringes, or within riparian and floodplain areas as beaver ponds, backwater channels, oxbows, or sloughs. Marshes are frequently or continually inundated, with water depths up to 2 m. Water levels may be stable, or may fluctuate 1 m or more over the course of the growing season. Hydrologic inputs include direct precipitation, surface water inflows, and groundwater discharge. Marshes have distinctive soil characteristics that result from long periods of anaerobic conditions in the soils (e.g., gleyed soils, high organic content, redoximorphic features). The vegetation is characterized by herbaceous plants that are adapted to saturated soil conditions. Common emergent and floating vegetation includes species of bulrush (*Scirpus* and/or *Schoenoplectus*), cattail (*Typha*), rush (*Juncus*), pondweed (*Potamogeton*), smartweed (*Polygonum*), pondlily (*Nuphar*), and canarygrass (*Phalaris*). There are two (2) locations within the Assessment Area including a transitional backwater channel on the southeastern end of the reach where beaver dams have aided the development of this ecosystem. A created marsh wetland exists on the BLM parcel in the middle section of the reach.

Figure 8 - View looking south at western emergent marsh habitat within Project Assessment Area.

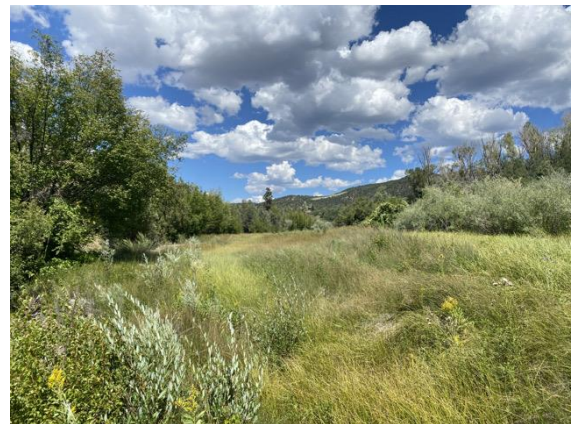
The palustrine emergent wetlands are typically located in areas adjacent to the Uncompahgre River and other hydrologic features and drainages, where the hydrology and morphology of the stream channel permits the establishment emergent wetland vegetation. The extent of these wetlands is strongly reliant on the morphology of the Uncompahgre River and other associated hydrological sources, and vary conditionally based upon the vegetative composition, often times being formed in depressional swales within the floodplain or abandon oxbows. The distribution of these wetlands is widespread, being found on both the eastern and western banks of the Uncompahgre River throughout the project extent. Characteristic emergent vegetation consists of a diversity of hydrophytic graminoid species, including: swordleaf rush (*Juncus ensifolius*), Nebraska sedge (*Carex nebrascensis*), common threesquare (*Schoenoplectus pungens*), hardstem bulrush (*Schoenoplectus acutus*), bluejoint reedgrass (*Calamagrostis canadensis*) cattails (*Typha* sp.), and horsetails (*Equisetum* spp.).

Figure 9 - Palustrine Emergent Wetland located within the floodplain of the Uncompahgre River.

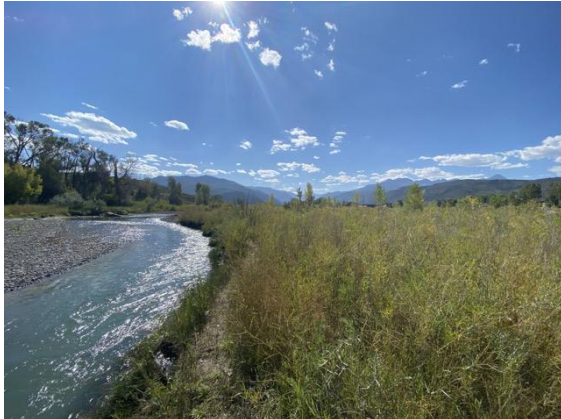
Figure 10 - Palustrine Scrub Shrub Wetland situated on broad floodplain shelf along the mid-reach of the Uncompahgre River.

The palustrine scrub shrub communities are distinguishable by the dominance of willow (*Salix* spp.), with coyote willow (*Salix exigua*) and Rocky Mountain willow (*Salix monticola*) being the primary species found. A secondary shrub species, that may be co-dominant at times include thinleaf alder (*Alnus incana*). Typically found along the banks of the Uncompahgre River, landform and hydrology are the main factors dictating the distribution of these communities. Point bars on large inside bends and broad, flat floodplain shelves that are regularly inundated and close to the water table of the Uncompahgre River are common features supporting these scrub shrub communities. Hydrology of the site is the main characteristic distinguishing the scrub-shrub wetland communities from the riparian shrubland communities.

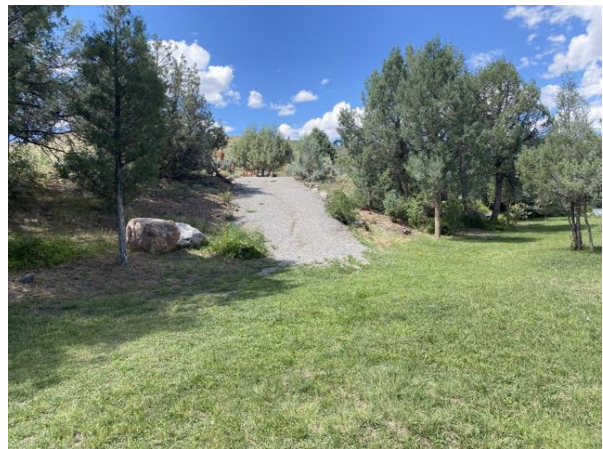
This vegetative community is used to distinguish the expansive recreational and open space influenced areas with a more park like or naturally maintained herbaceous vegetation community. They are found within the BLM parcels and park areas found along this stretch of the Uncompahgre River and are distinguishable by established herbaceous vegetation, primarily consisting of both native and non-native graminoid species. The influence of human activity is observable and attributes to the condition of these vegetated zones.

Figure 11 - Herbaceous vegetation found within Dennis Weaver Memorial Park

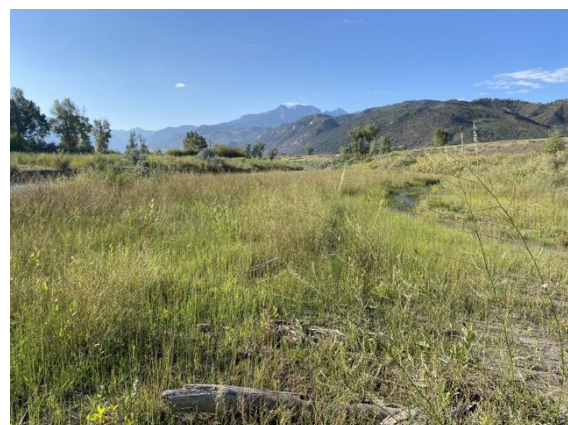
*Figure 13 - View looking south at emergent wetland with infestation of white sweet clover.*

The biennial forb species found on site consist of common burdock, plumeless thistle, poison hemlock, and sweet clover. These species reproduce solely by seed and are considered aggressive due to their high seed production rates. The key to control for these species is to suppress seed production and to eliminate the seed bank. Targeting first year plant growth in the early rosette stage, and second year plant growth as it starts to bolt in the late spring/early summer with repeated applications of herbicide or mechanical control are strategies to manage these species. Specifically, management efforts for these species will utilize a hybrid option of mechanical and chemical treatments, targeting spring and fall rosettes with chemical spot spray treatments and mechanical removal of any flowering plants before they go to seed.

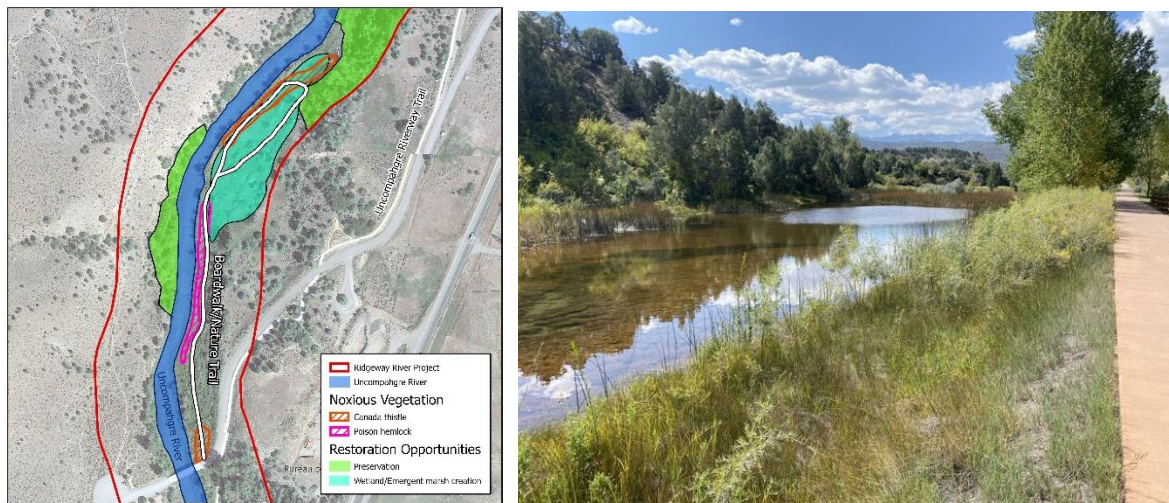
There is a unique opportunity for wetland marsh creation on the north end of the project reach. This area is located on Town of Ridgway Property north of Dennis Weaver Park on the east side of the Uncompahgre river (Figure 15 below). The photo on the right is an image of an existing wetland marsh habitat created on the BLM parcel. This recommended location exists on a large wetland bench outside of the floodway and exhibits existing hydrology and wetland vegetation. Wetland vegetation that exists today is of good quality but minor earthwork improvements would allow for succession of the existing emergent wetland to an emergent wetland marsh. These open water habitats provide excellent opportunity for increased biodiversity of plant species and wildlife utilization. Waterfowl nesting platforms could be installed to promote nesting. Additionally, this location in proximity to the existing Uncompahgre Riverway Trail is ideal for an expansion boardwalk loop trail segment through and or around the wetlands. There is what appears to be an historic ditch alignment in this location, further investigation of the ditch and current utilization would be necessary. Interpretive/educational opportunities could also be tied in with any improvements to this location.

Figure 15 - Potential location for wetland creation (left). Existing created wetland marsh on BLM Property (right).

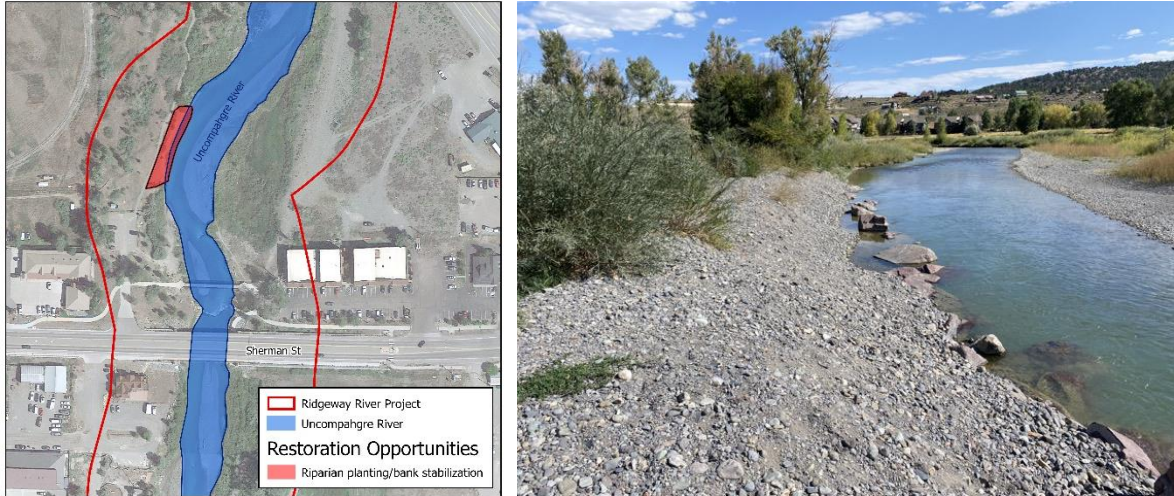
Figure 16 - Potential bank stabilization/vegetative restoration location (left). Current condition of bank, loose small aggregate materials.

There are numerous locations for potential bank stabilization to protect existing and future infrastructure using natural design techniques that incorporate bioengineering methods using natural materials such as large woody debris or root wads. If installed properly, these techniques can be effective over the long term. Incorporating longitudinal bank lowering and wetland benching can be effective in stabilizing eroding banks. Further studies and prioritization of bank stabilization locations should be considered as part of future planning activities for the Project Assessment Area. DHM identified a location north of Sherman Street in Rollans Park (Figure 16 Below). Large rock material has been placed within the river channel in this location and the bank consists of small diameter cobble and gravel. There is a high likely hood that this material would wash away during a high water event. Reconfiguring the bank design and materials in this location along with vegetative plantings could provide significant improvements to the longevity of the existing bank/river improvements as well as overall aesthetics. Other opportunities for bank stabilization and riparian planting includes the east side of the river along the newly approved Riverfront Village development. Specific locations for bank stabilization and restoration planting should be carefully evaluated as part of the trail design and installation.

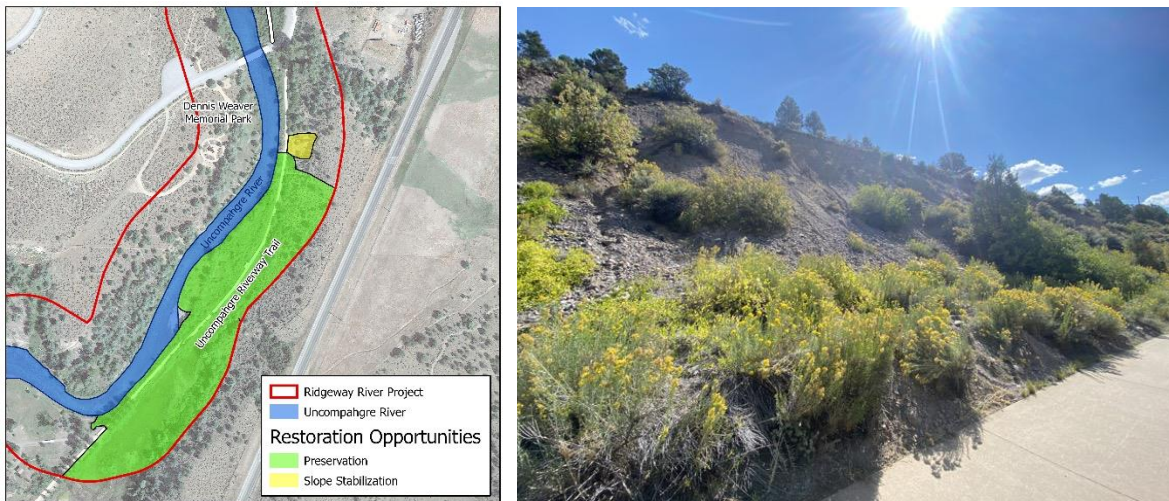
Figure 17 - Potential slope stabilization location east of Dennis Weaver Park (left). Steep slope with active erosion occurring. Revegetation recommended to stabilize slope.

There are a number of areas located along the Uncompahgre River Trail where slope stabilization through vegetative planting and seeding could be beneficial to protect infrastructure and reduce potential for sediment input into the Uncompahgre River. One of these locations is on the east side of the River across from Dennis Weaver Park (Figure 17 Below). The development of a restoration planting and seeding plan for this area that incorporates erosion control materials such as straw wattles could significantly reduce active erosion and allow for establishment of native vegetation along the slope.

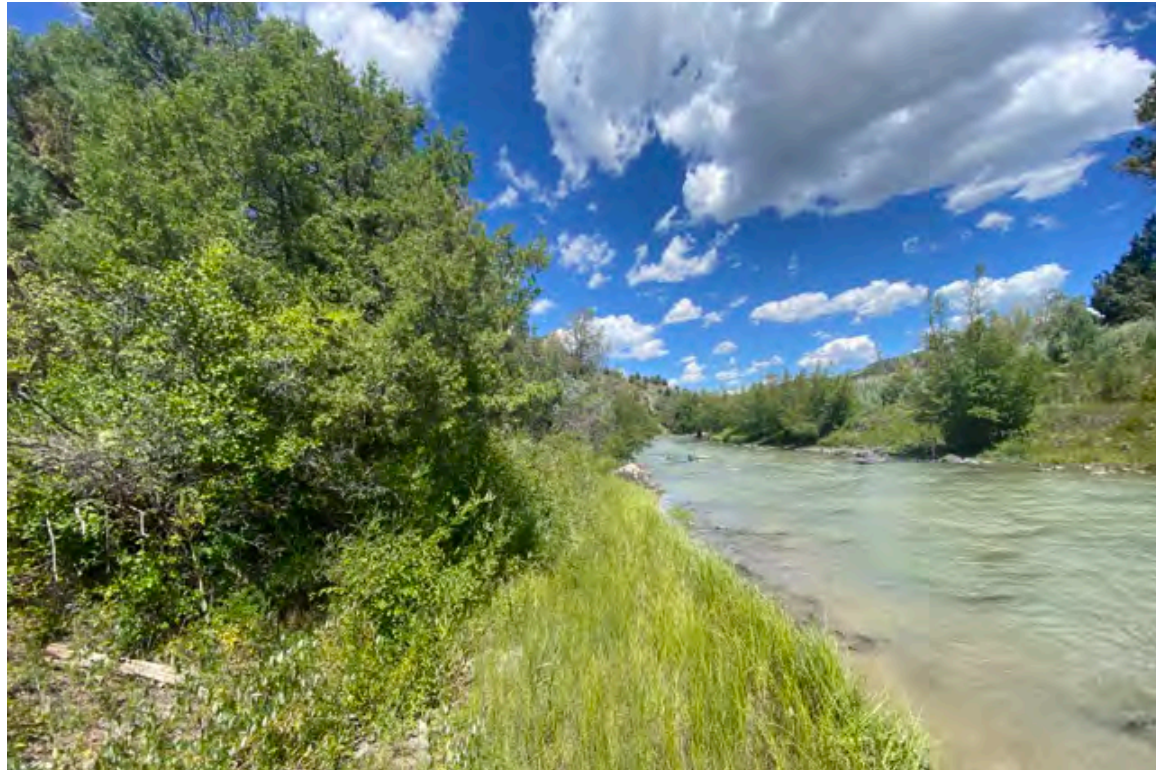
**Photo 1:** High quality riparian habitat. Good native species diversity and distribution. Minimum nuisance or noxious vegetation observed.

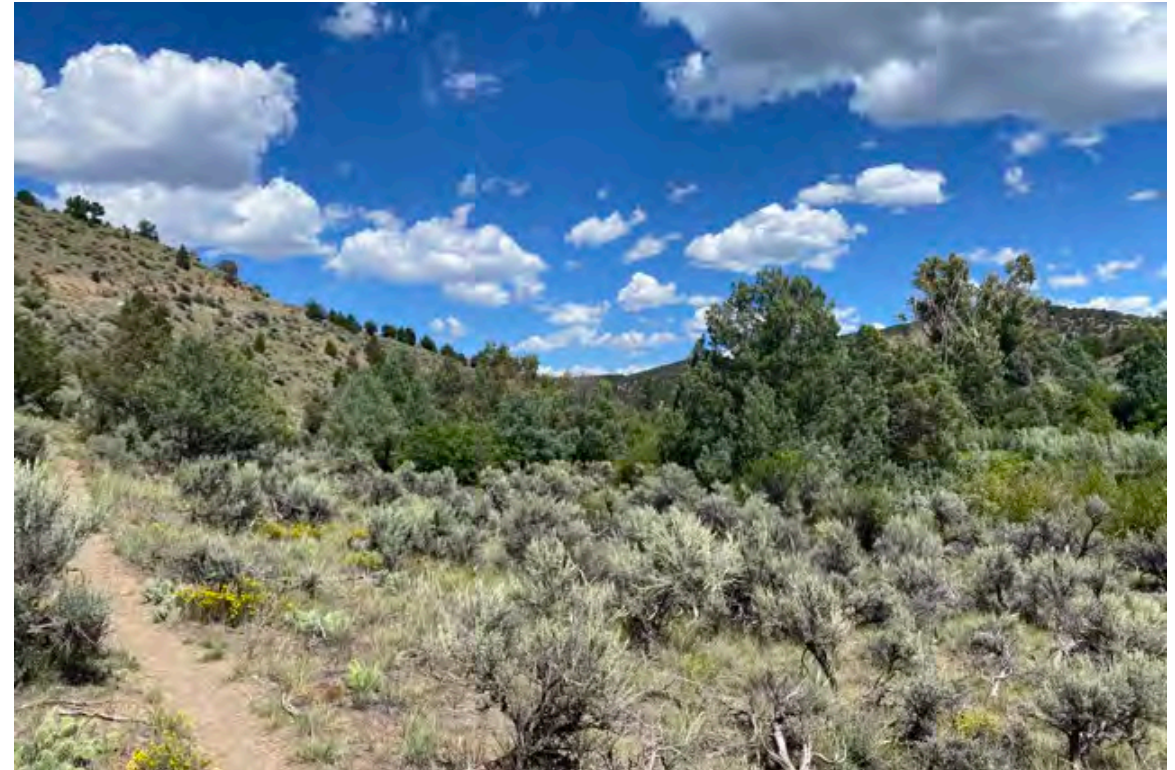
**Photo 2:** View looking south at Sagebrush stepp, Pinyon juniper steppe vegetative community. High value wildlife habitat.

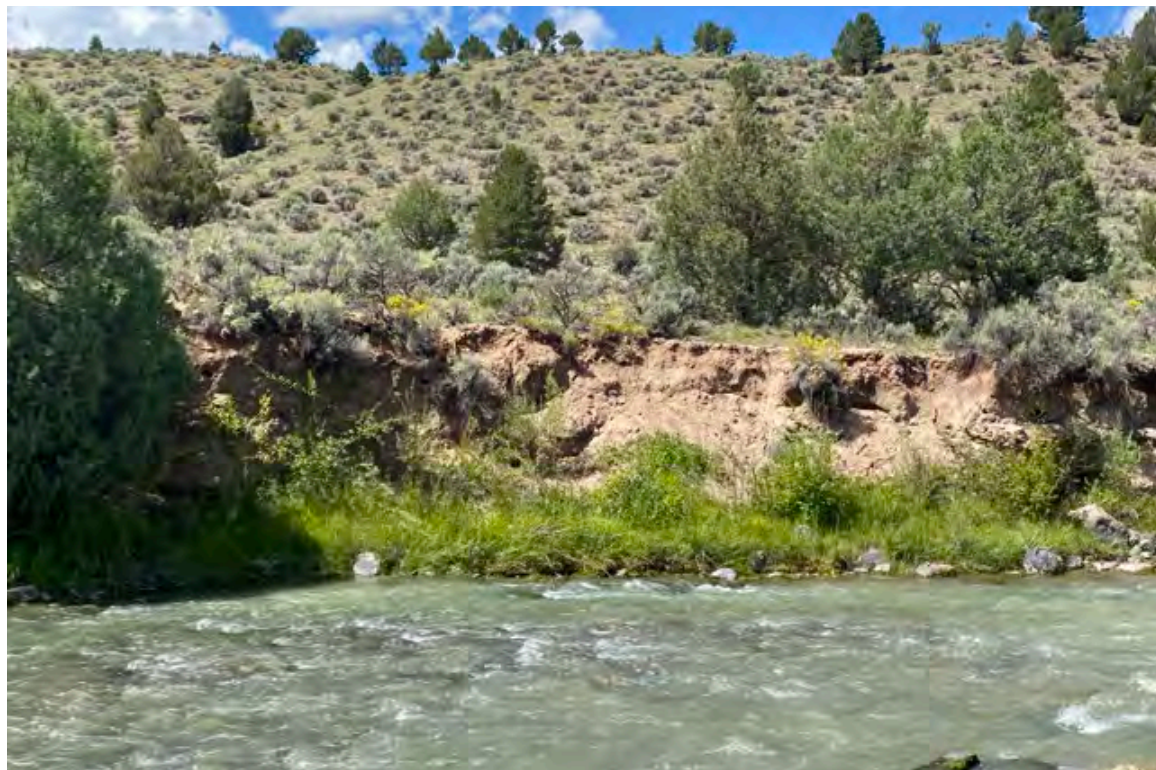
**Photo 3:** View looking at active bank erosion.

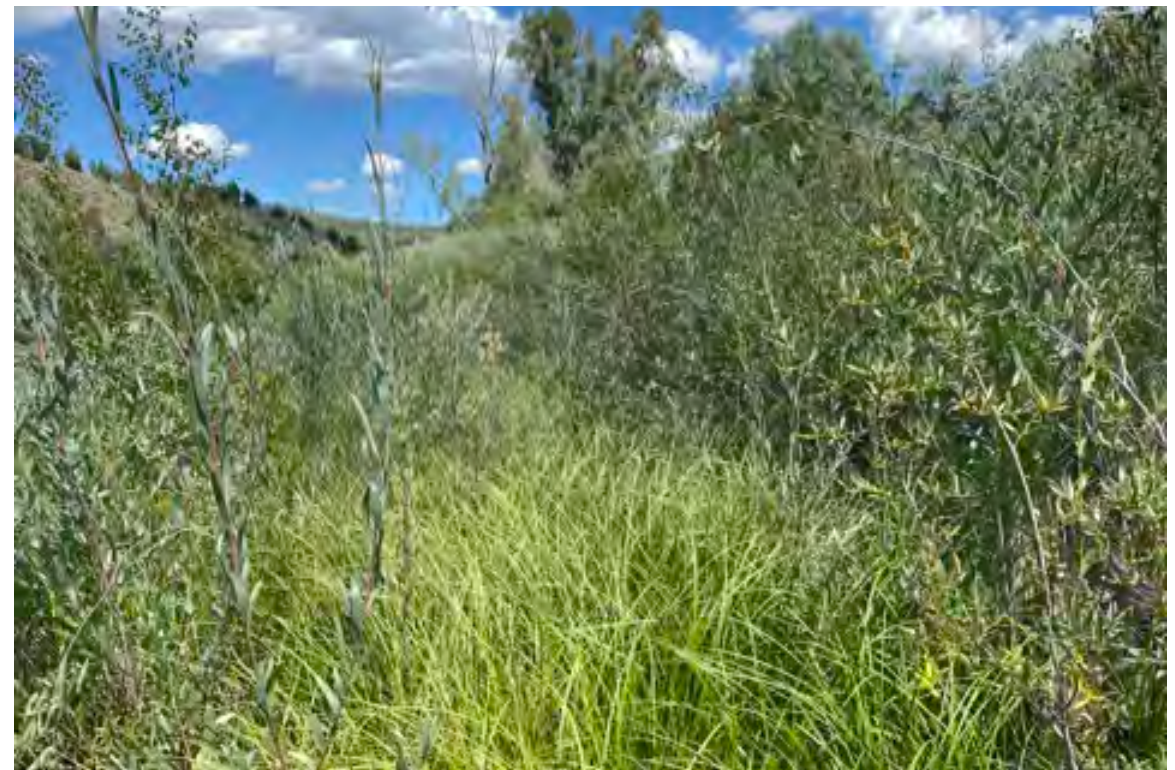
**Photo 4:** View looking south along historic ditch and emergent wetland. Coyote willow adjacent to wetland.

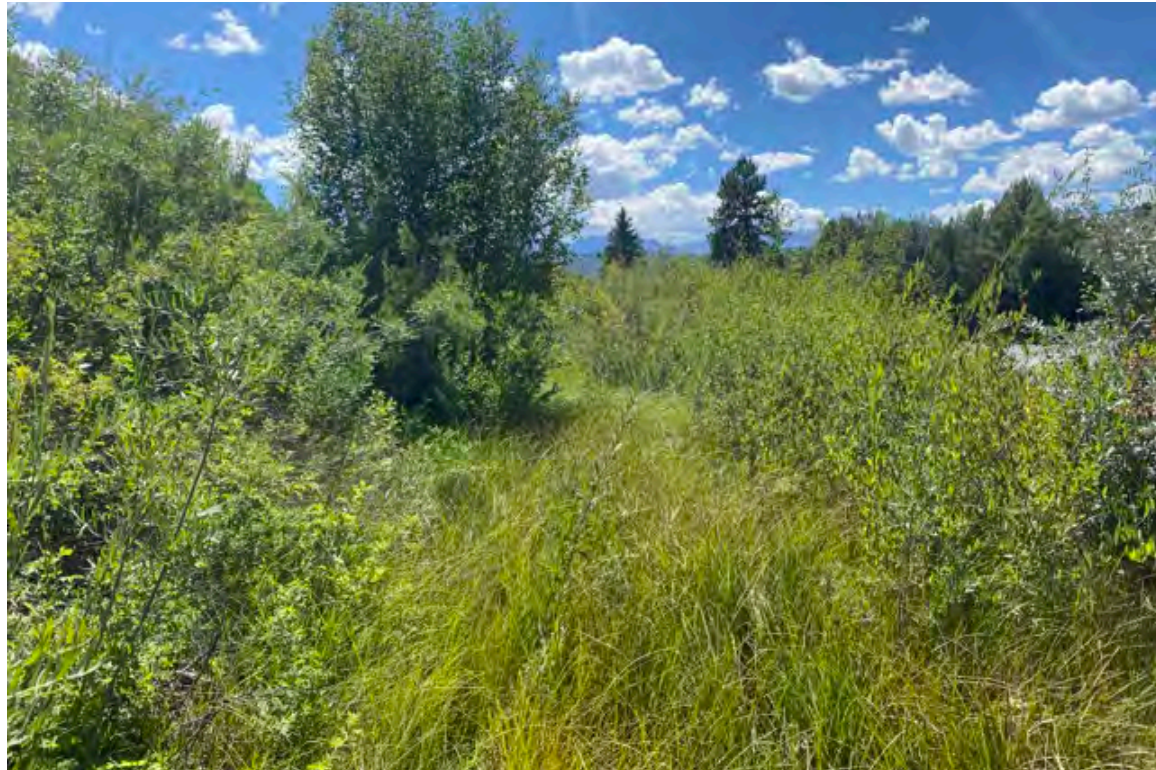
**Photo 5:** View looking south along riparian emergent and scrub shrub wetland type.

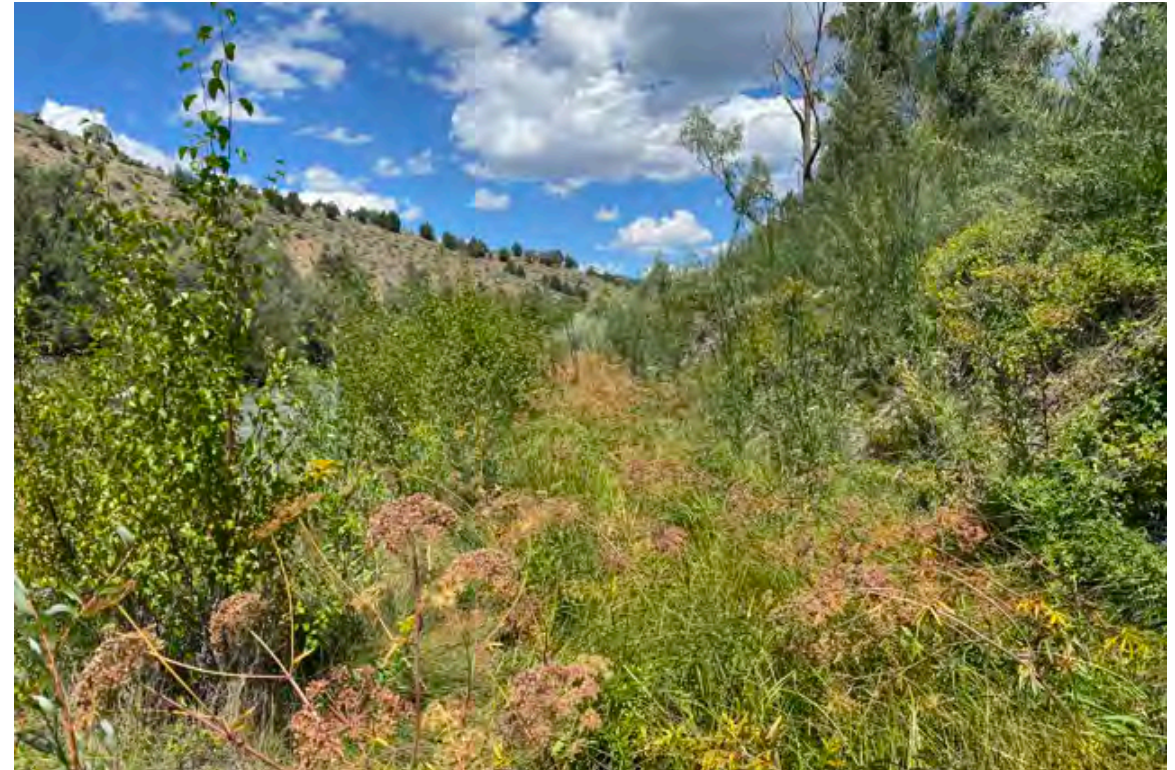
**Photo 6:** High density poison hemlock

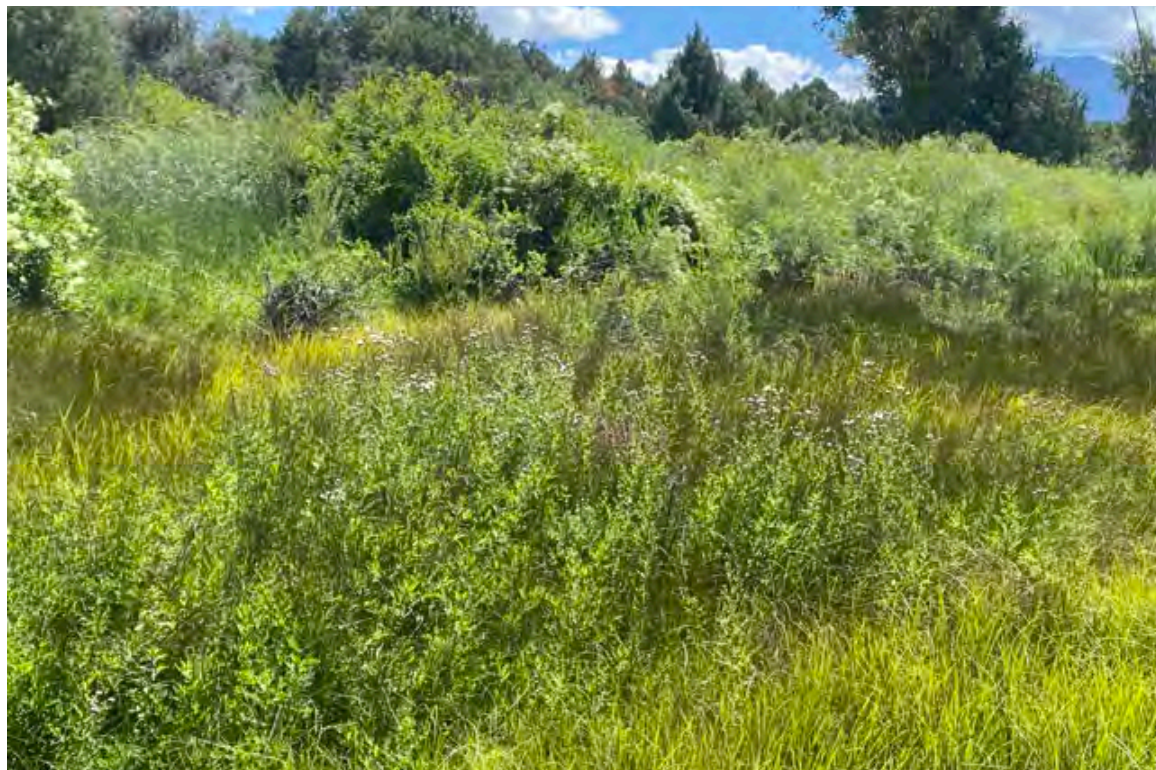
**Photo 7:** High density Canada thistle located within emergent wetland area.

The perennial, state listed noxious vegetation species found on site consist of Canada thistle and Russian knapweed. In general, these species are deep-rooted perennial forbs that tend to form large colonies connected by a common root system. These root systems are often extensive, reaching depths of up to 20 feet and spreading up to 15 feet laterally. They have the ability to reproduce by rhizomes and via seed, therefore it is essential to both suppress seed production and systematically kill the below ground root systems. Using a combination of chemical, mechanical and cultural treatments, the key to control of these species is to continually stress the plants to diminish their energy reserves deplete their rhizomatous root systems beneath the ground.

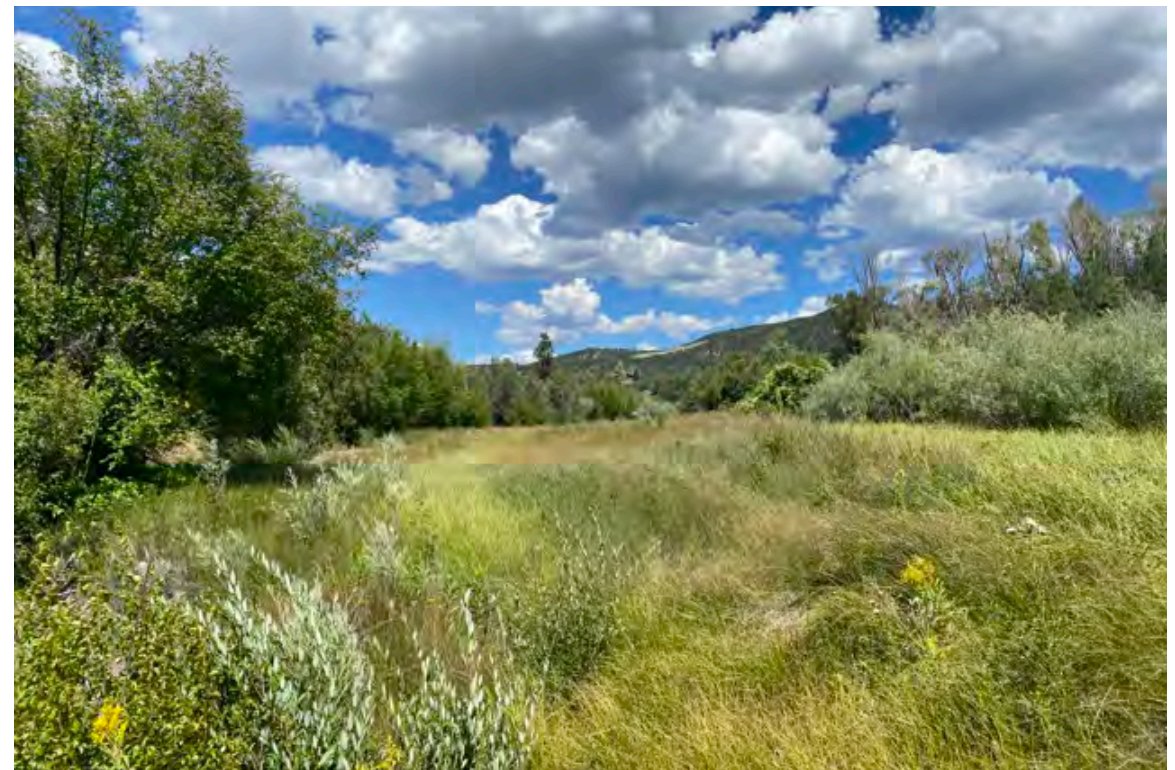
**Photo 8:** View looking north at existing emergent wetland. Potential location for wetland creation - emergent marsh and boardwalk.

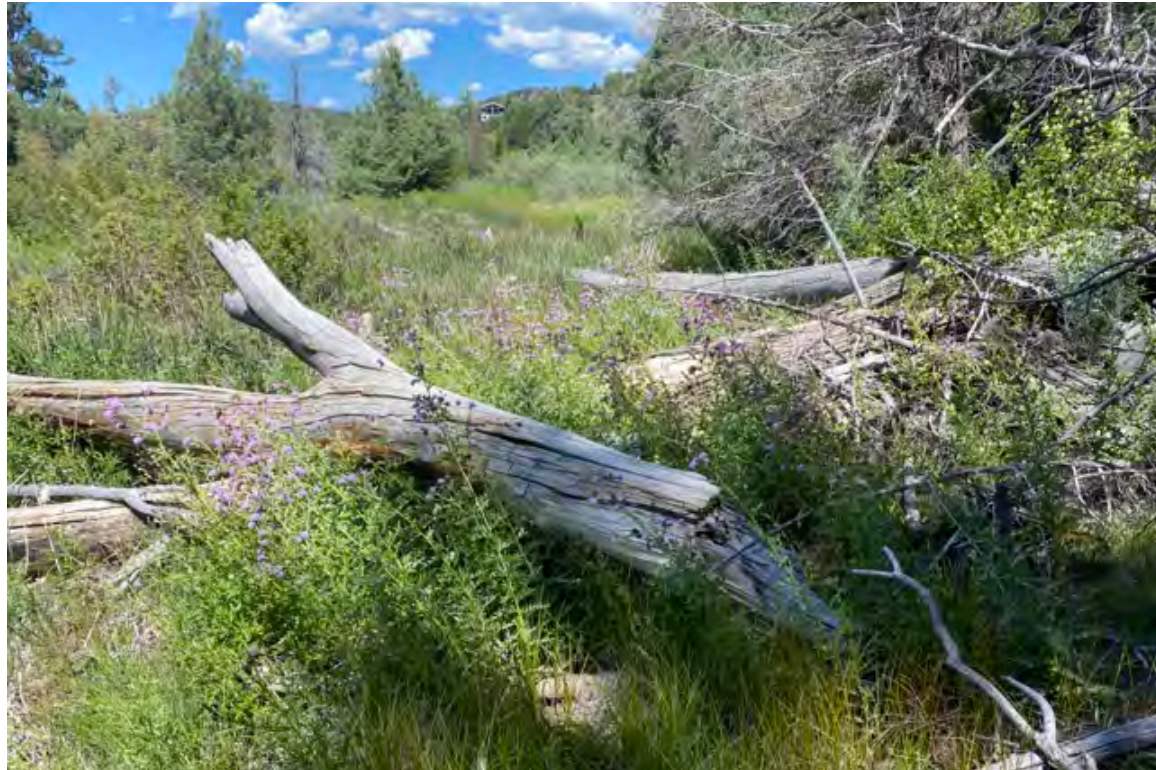
**Photo 9:** Significant infestation of musk thistle.

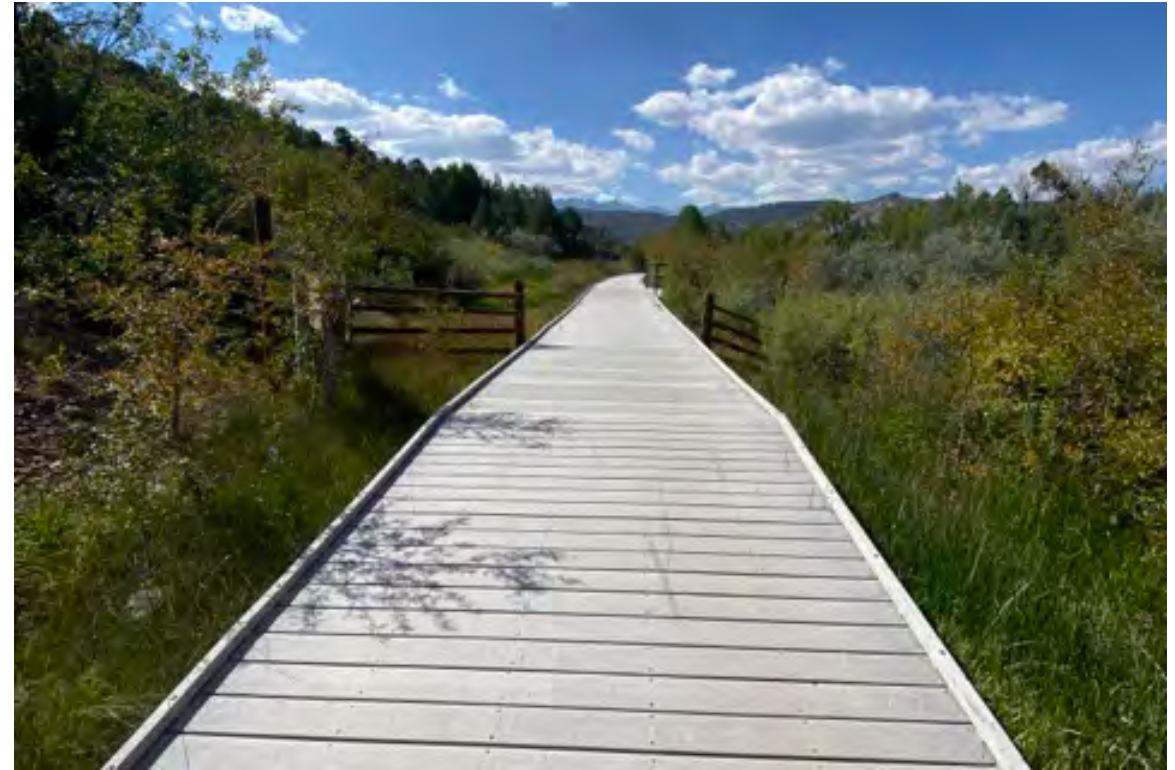
**Photo 10:** Existing constructed boardwalk over wetlands on BLM property.

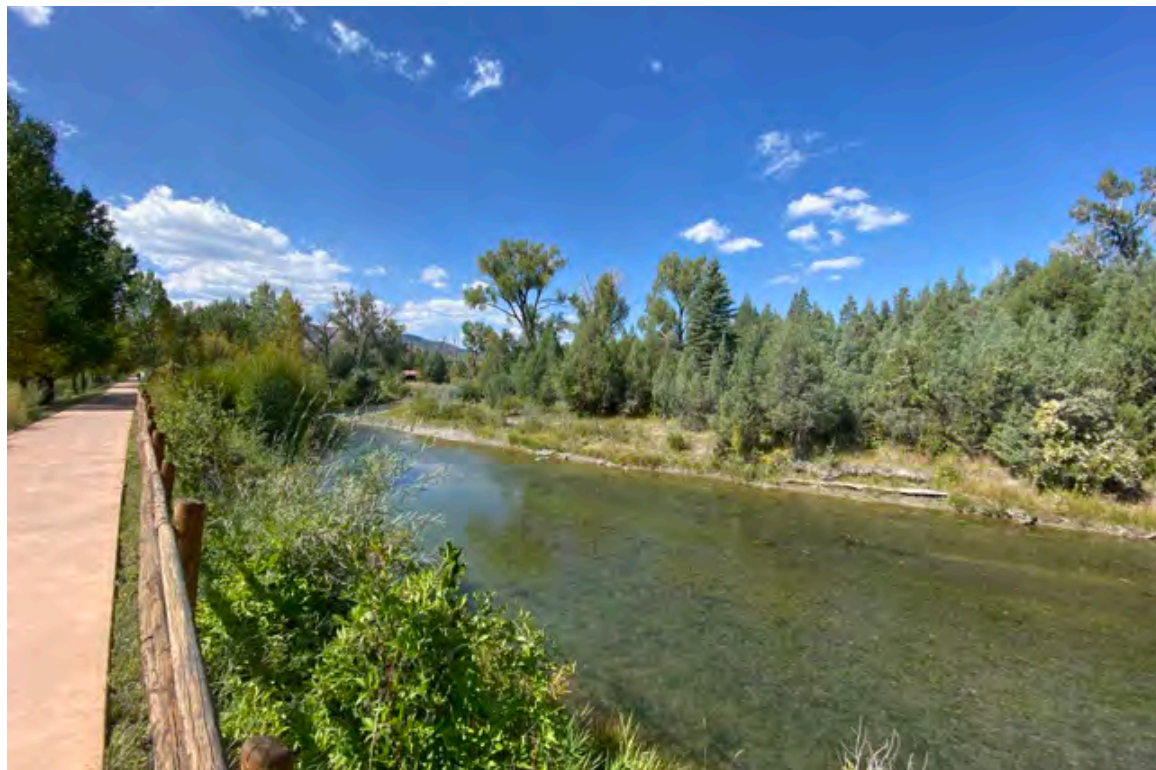
**Photo 11:** View looking south at Uncompahgre River. Pinyon juniper encroachment to river edge (foreground). Large cottwood community in background.

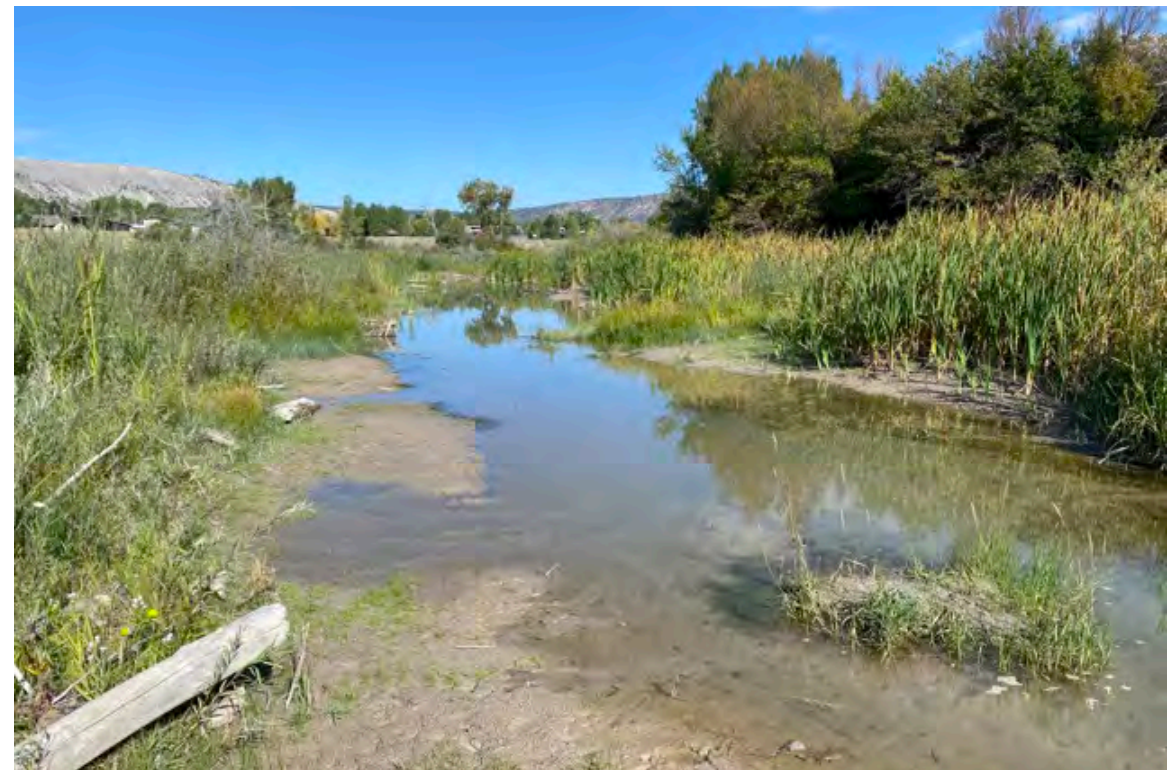
**Photo 12:** View looking south at transitional side channel marsh habitat. High wildlife utilization (tracks) observed in this location.

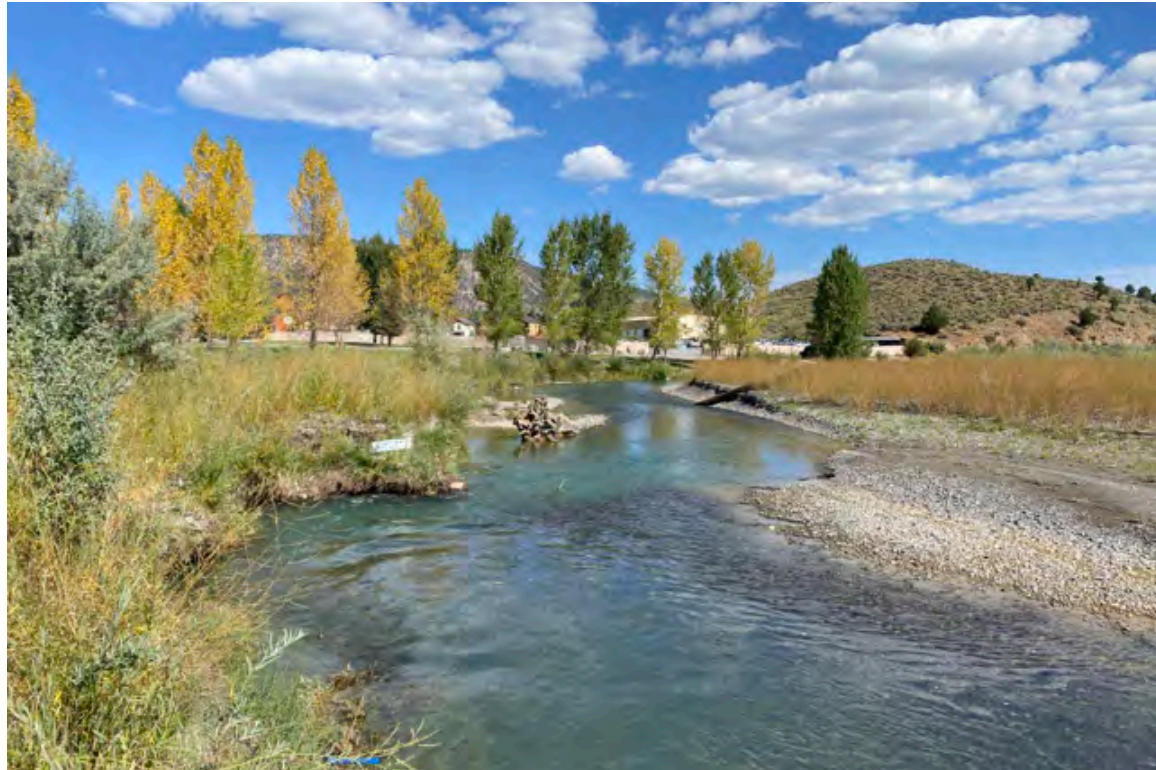
**Photo 13:** View looking south towards water treatment facility and planted cottonwoods. White sweetclover investment on river right. Coyote willow scrub shrub on left.

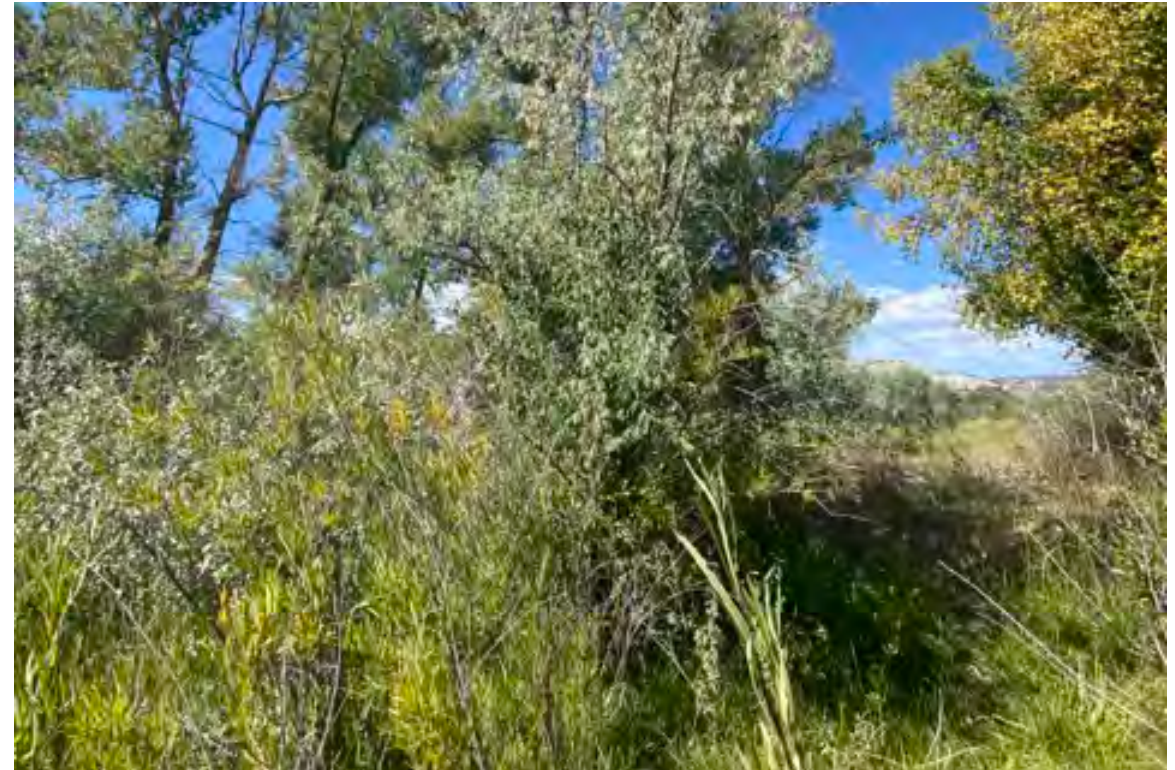
**Photo 14:** View looking at Russian olive located in Rollans Park. Recommend removal.

Russian olive is the primary woody species of concern identified within the Uncompahgre River riparian area, with localized established populations to be eradicated. Cut stump treatments timed in the fall, when trees are focusing transfer energy to the root systems, is the recommended treatment strategy for Russian olive. Follow up foliar treatments to newly-established sucker growth is likely in the years following removal.

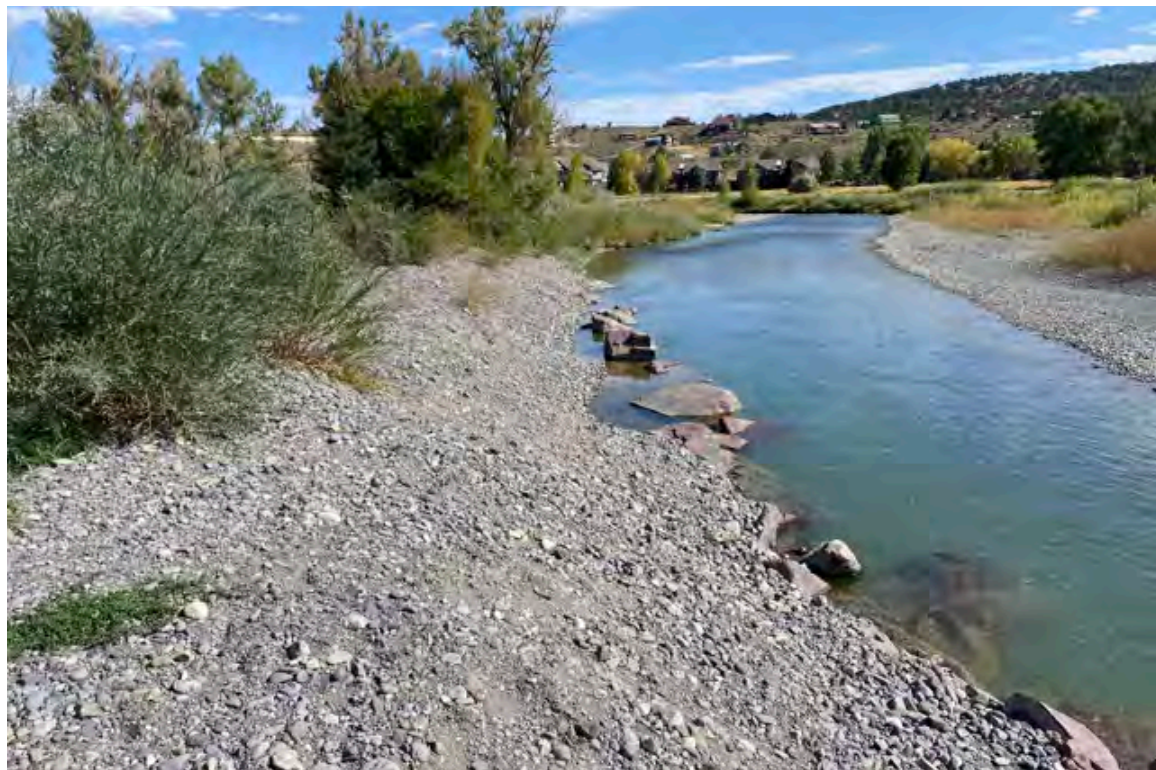
**Photo 15:** View looking north at area recommended for bank stabilization
