# Uncompahgre River Corridor

*Ecological Assessment and Recommendations Report*

TOWN OF RIDGWAY, COLORADO

DHM DESIGN

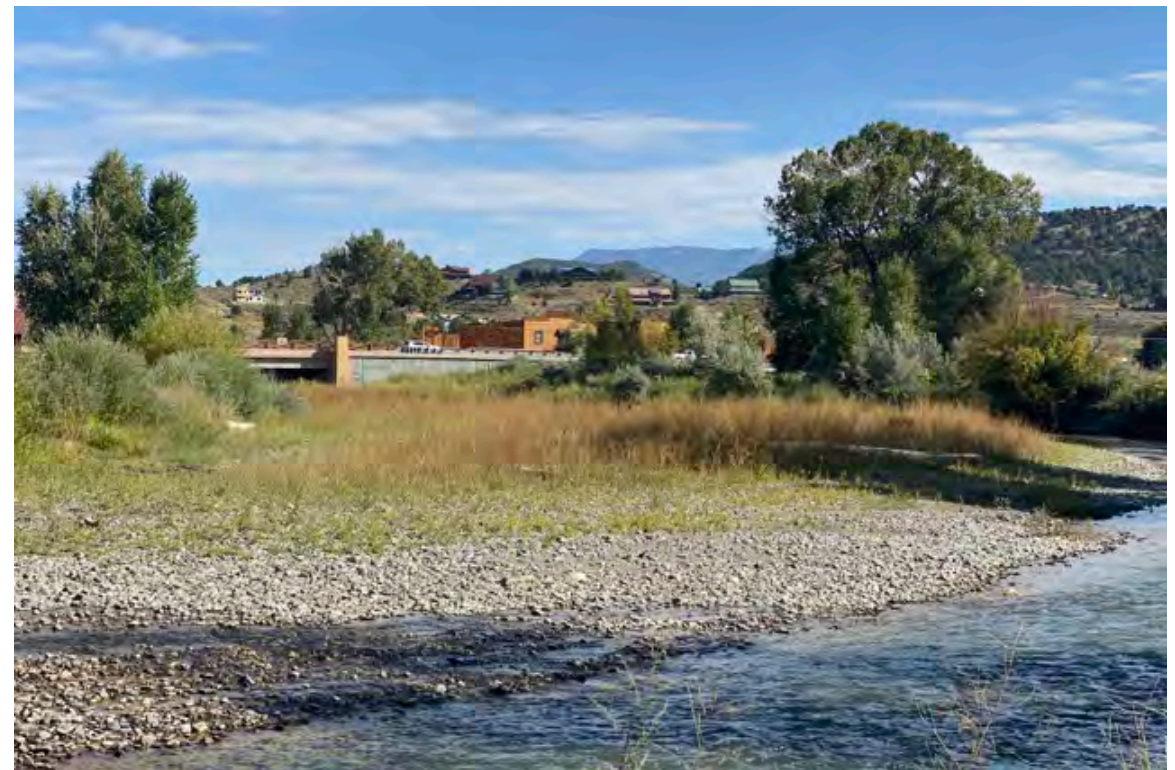
**Photo 16:** View looking northeast at large infestation of white sweet clover.

The biennial forb species found on site consist of common burdock, plumeless thistle, poison hemlock, and sweet clover. These species reproduce solely by seed and are considered aggressive due to their high seed production rates. The key to control for these species is to suppress seed production and to eliminate the seed bank. Targeting first year plant growth in the early rosette stage, and second year plant growth as it starts to bolt in the late spring/early summer with repeated applications of herbicide or mechanical control are strategies to manage these species. Specifically, management efforts for these species will utilize a hybrid option of mechanical and chemical treatments, targeting spring and fall rosettes with chemical spot spray treatments and mechanical removal of any flowering plants before they go to seed.

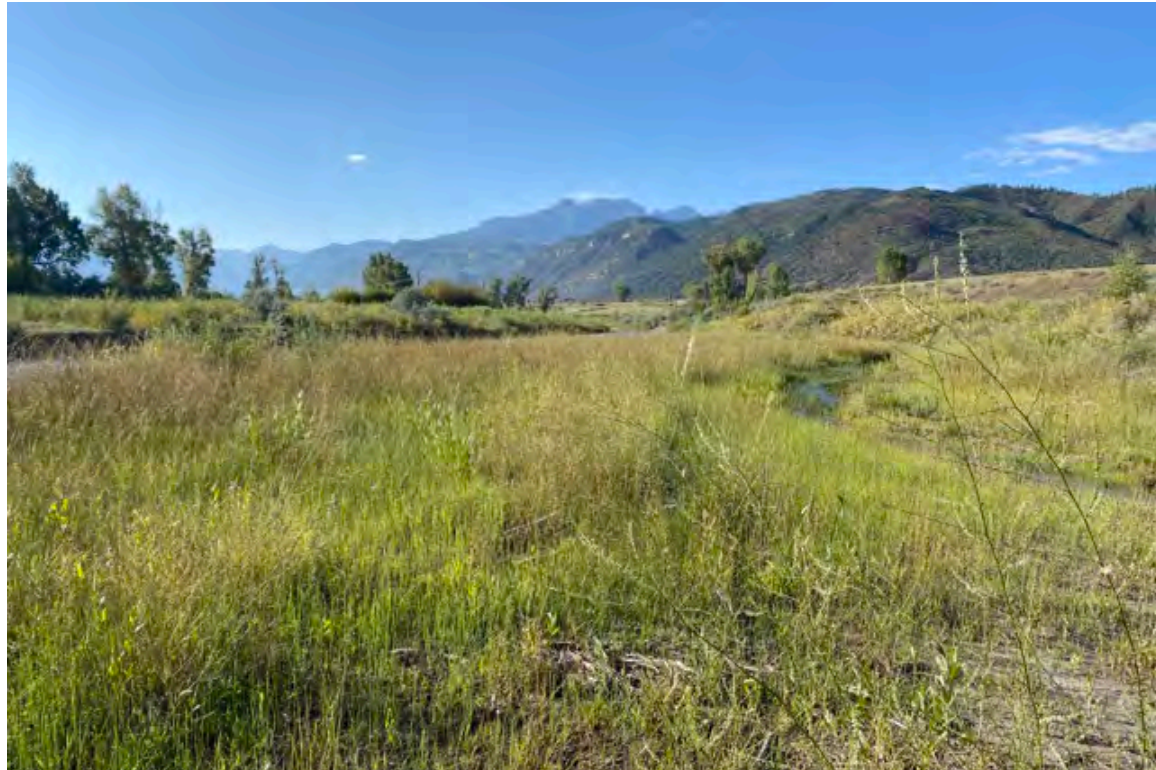
**Photo 17:** View looking north at emergent wetland with white sweet clover infestation occurring. Side channel on right good quality fish rearing habitat.

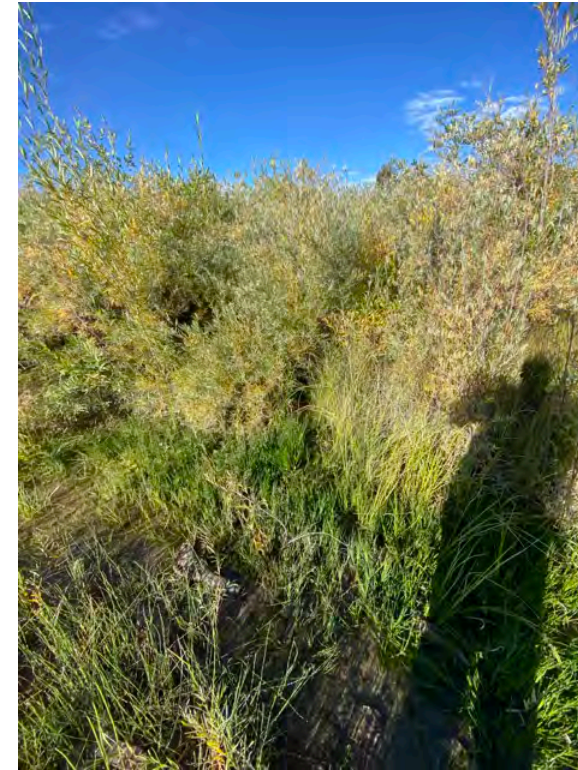
**Photo 18:** Spring input located along side channel.

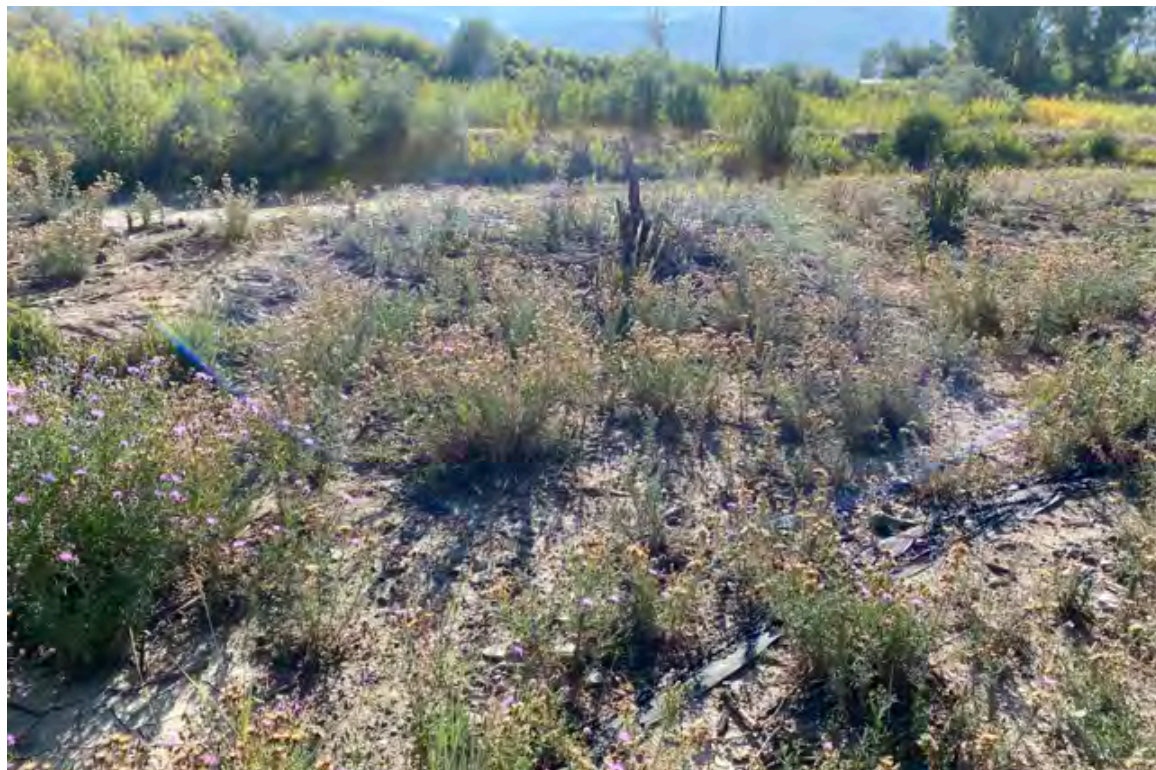
**Photo 19:** Spotted knapweed located on river right.

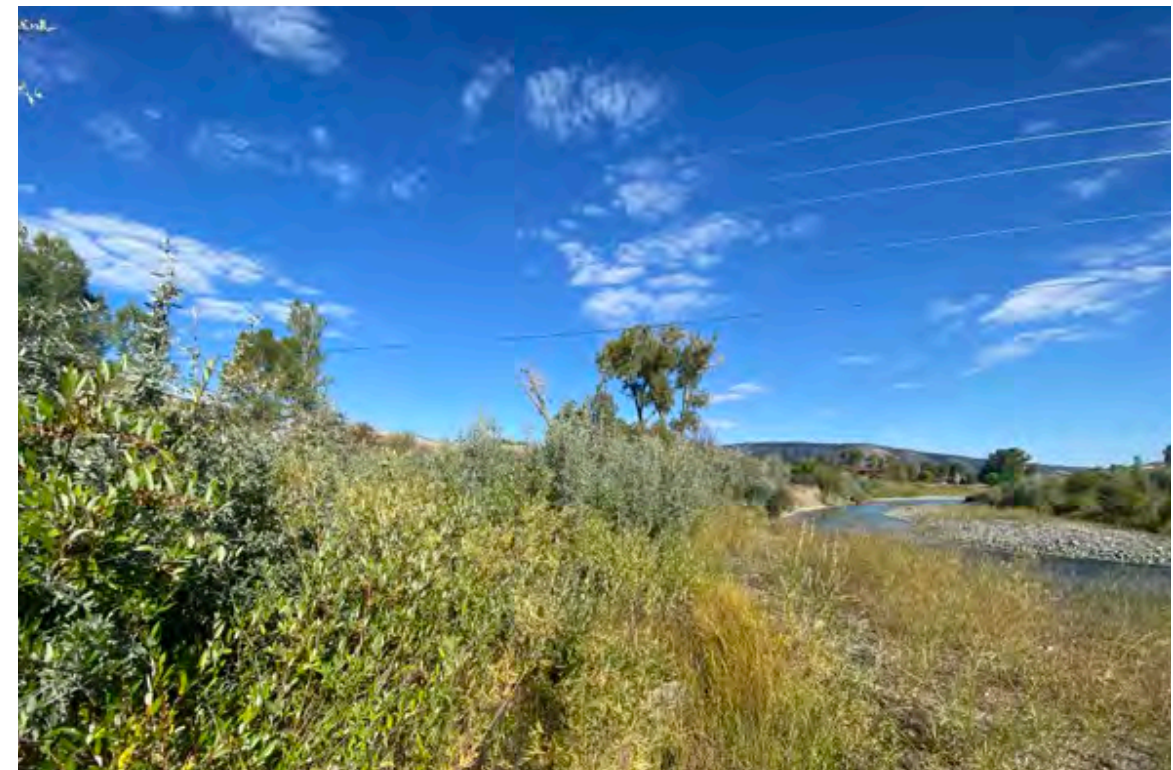
**Photo 20:** View looking south along riparian scrub shrub and emergent wetland boundary.

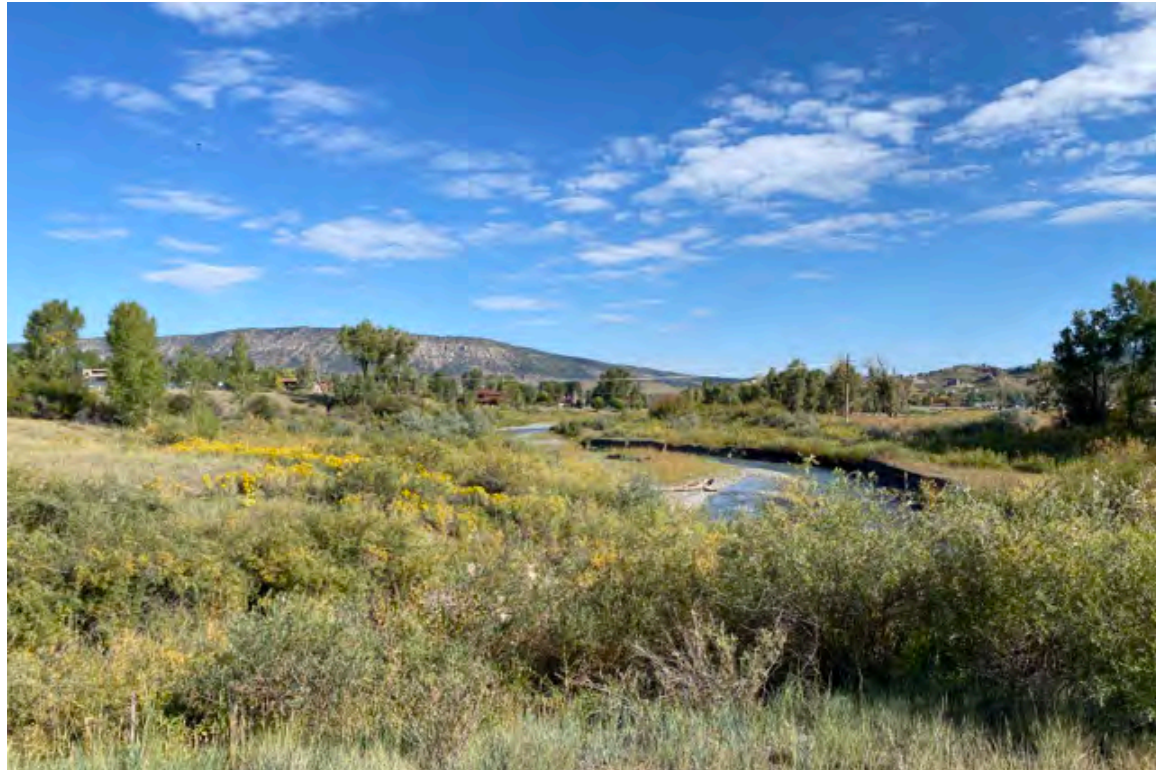
**Photo 21:** View looking south along Uncompahgre River Assessment Area.

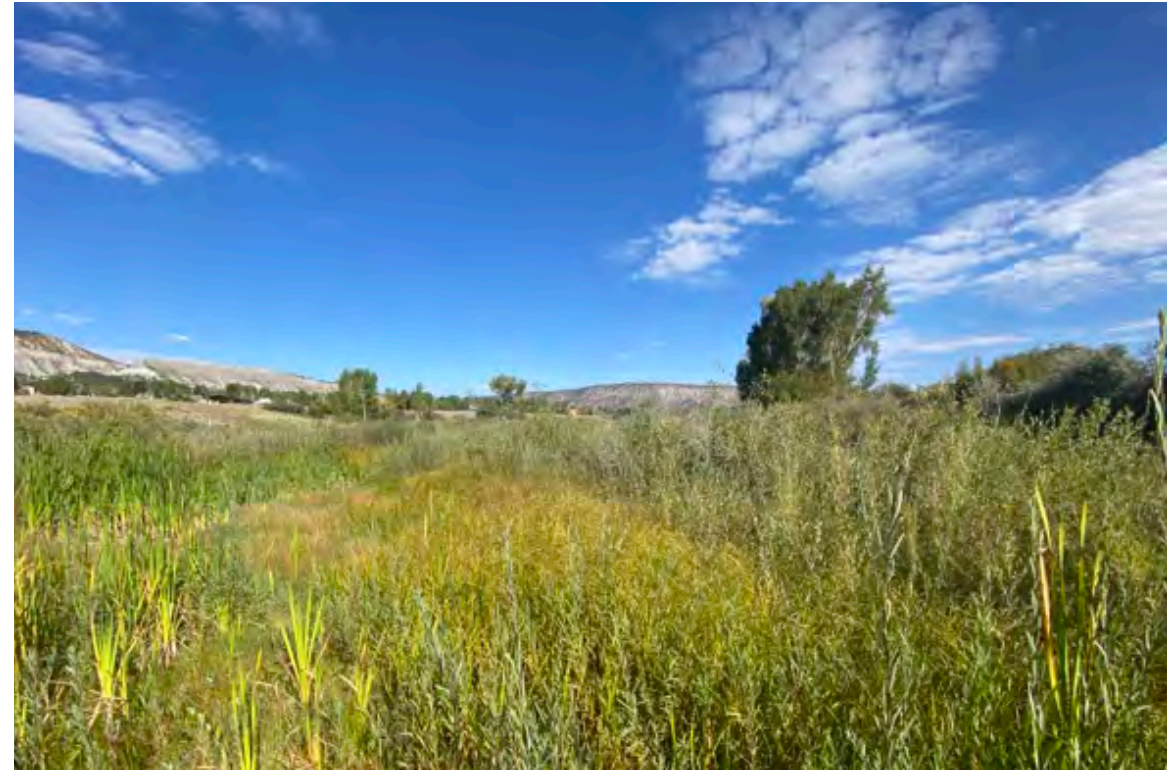
**Photo 22:** View looking north at high quality emergent wetland and scrub shrub wetland interface. High quality wildlife habitat.

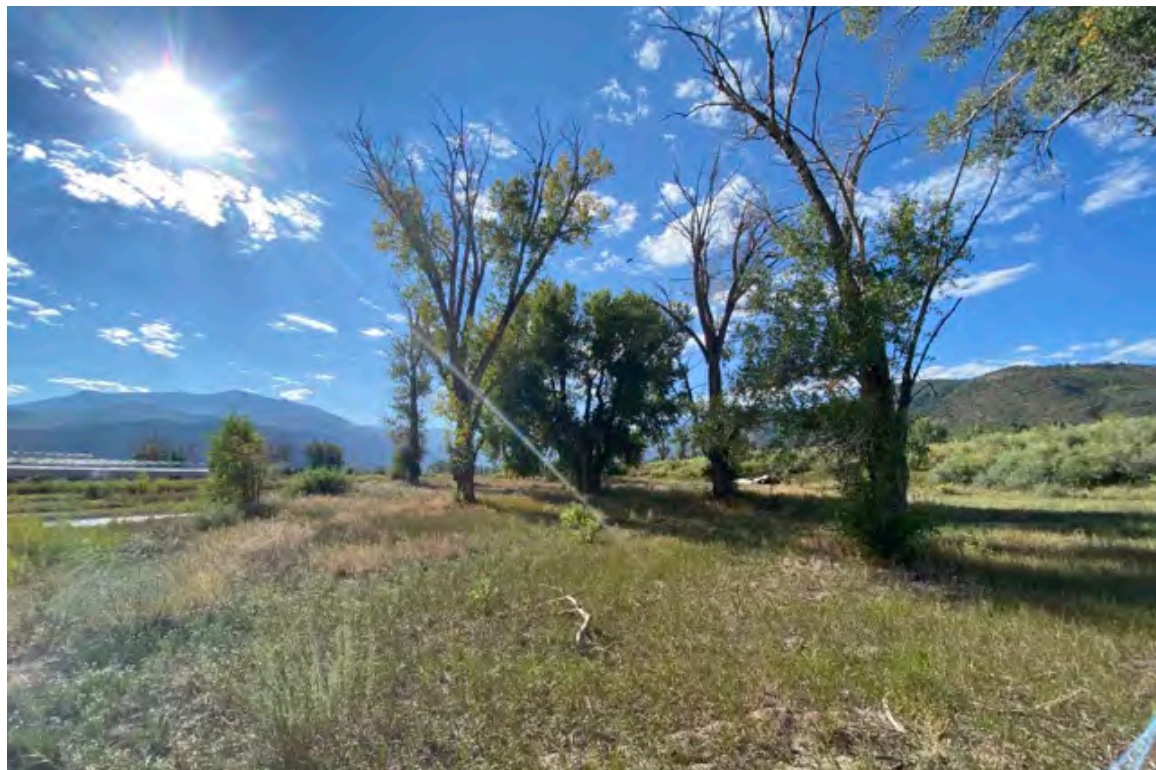
**Photo 23:** View looking south at decadent narrowleaf cottonwood tree grouping. High quality avian habitat.

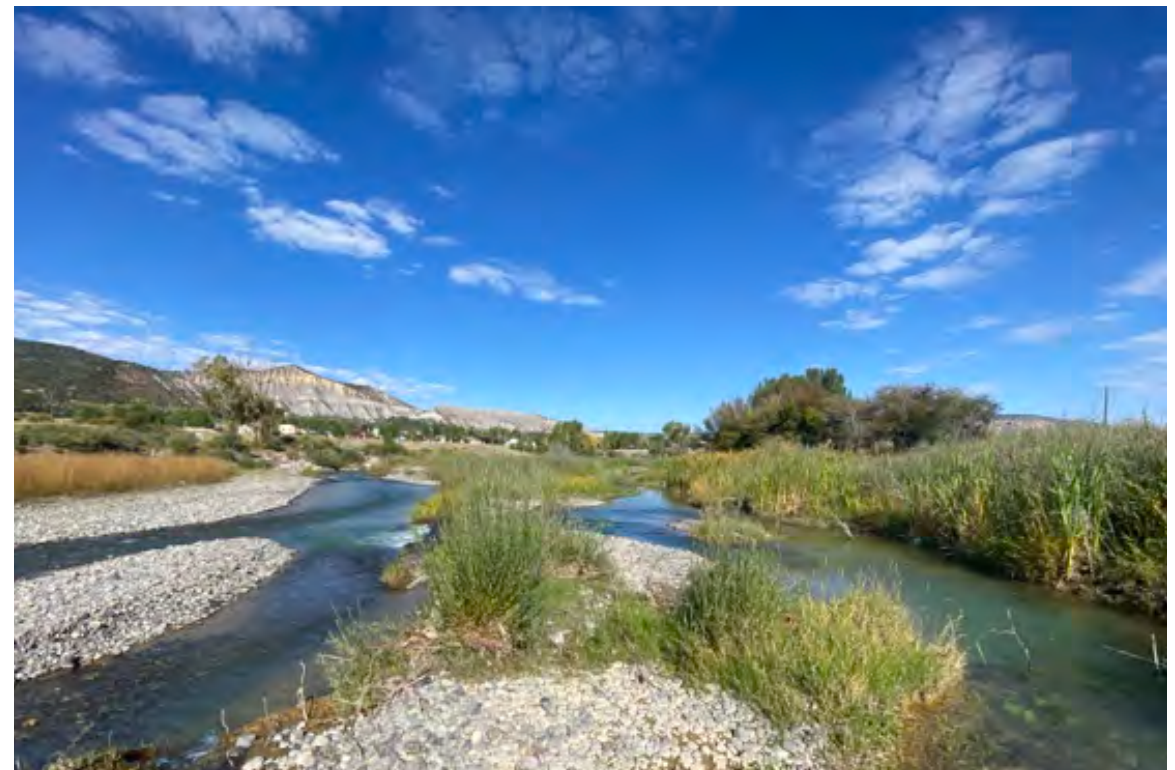
**Photo 24:** View looking south along braided section of Uncompahgre River.
