M² Associates Inc

Re: Phase I Geologic Report for Brian Plushanski Site Plan, Block 22 Lots 3 and 4 in Union Township, Hunterdon County, New Jersey.

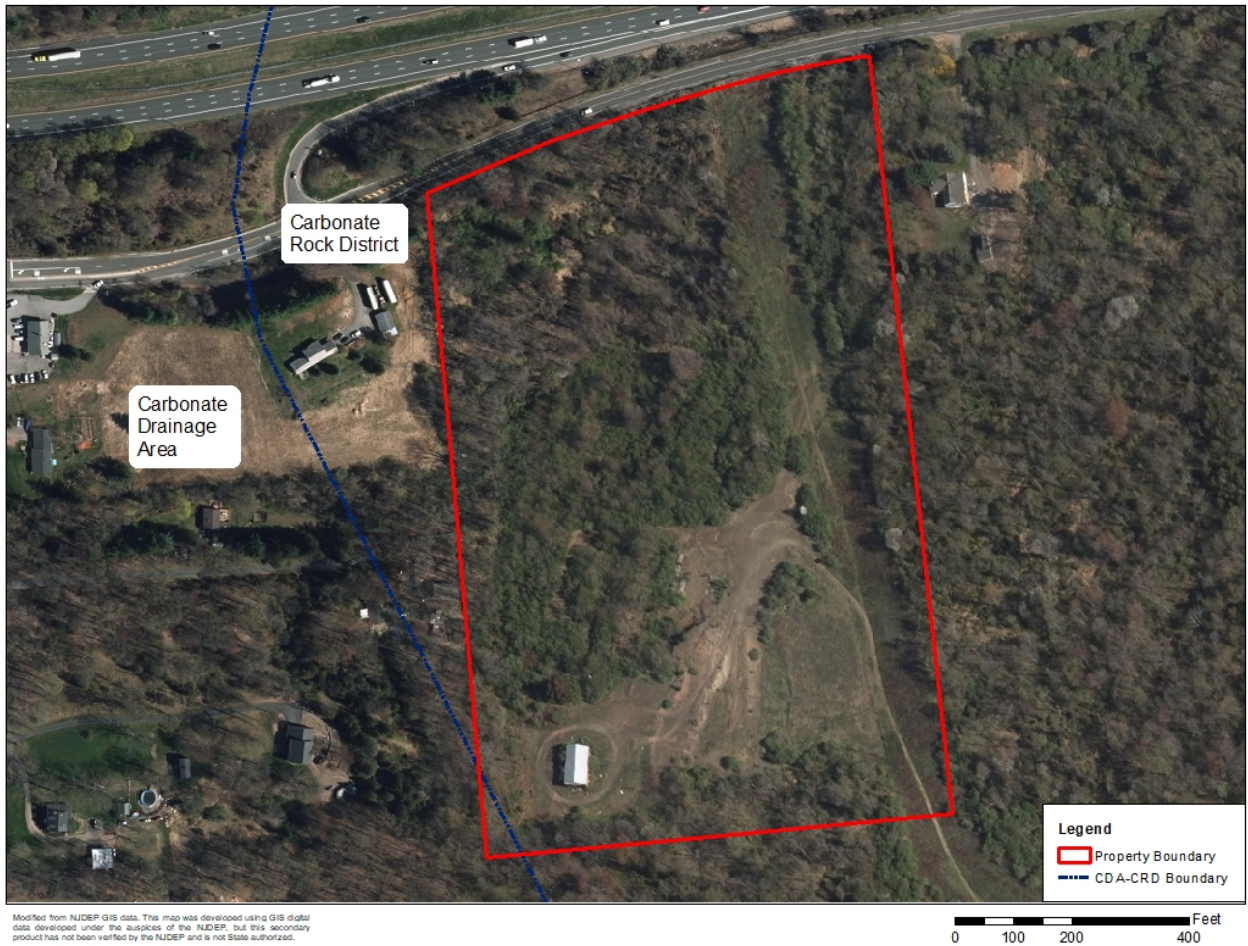
Figure 2: 2016 Aerial Photographs Depicting Brian Plushanski Site, Block 22 Lots 3 & 4, Union Township, Hunterdon County, New Jersey

The blue line trending from south to north and intersecting the southwestern corner of the property is the Union Township boundary between the Carbonate Drainage Area (CDA) to the west and the Carbonate Rock District (CRD) to the east. Approximately 0.1-acre of the site is in the CDA and the remainder is located within the CRD. The Union Township

boundary between the CDA and CRD was defined as the geologic contact between Triassic Lockatong Formation conglomerates west of the boundary and Ordovician-Middle Cambrian Jutland Klippe rocks. Based on absence of carbonate rocks beneath the property, the entire site should be in the CDA and not in the CRD.

The 2016 aerial photograph used to create Figure 2 indicates a single-story building encompassing approximately 2700 square feet located in the southern portion of the property. An easement, 90-feet in width, for three underground natural gas transmission pipelines transects the eastern portion of the site from south to north. Former quarrying operations are apparent in the southern section of the site.

The Plushanski site is located within Union Township's Carbonate Area District (see Figure 2). The Carbonate Area District is comprised of the Carbonate Rock District (CRD) (sections of the Township underlain by rocks primarily comprised of carbonate minerals) and Carbonate Drainage Area (CDA) (sections of the Township where water drains toward carbonate rock). Based on current mapping of local geology, the site should be located in the Carbonate Drainage Area but not in the Carbonate Rock District. The site is not underlain by limestone or dolomite, in which cavities and sinkholes could form.

A copy of the 2016 aerial photograph obtained from the NJDEP is provided as Figure 2. Figures 7, 8, 9, and 10 show the site in 1953, 1970, 1995, and 2007. The 1953 aerial photograph depicts a section of the property that extends further north than the current boundary. The roadway observed north of the site is the former U.S. Highway 22 and not Interstate 78. The northern property boundary was modified after construction of the interstate highway which is apparent on the 1970 aerial photograph (see Figure 8).

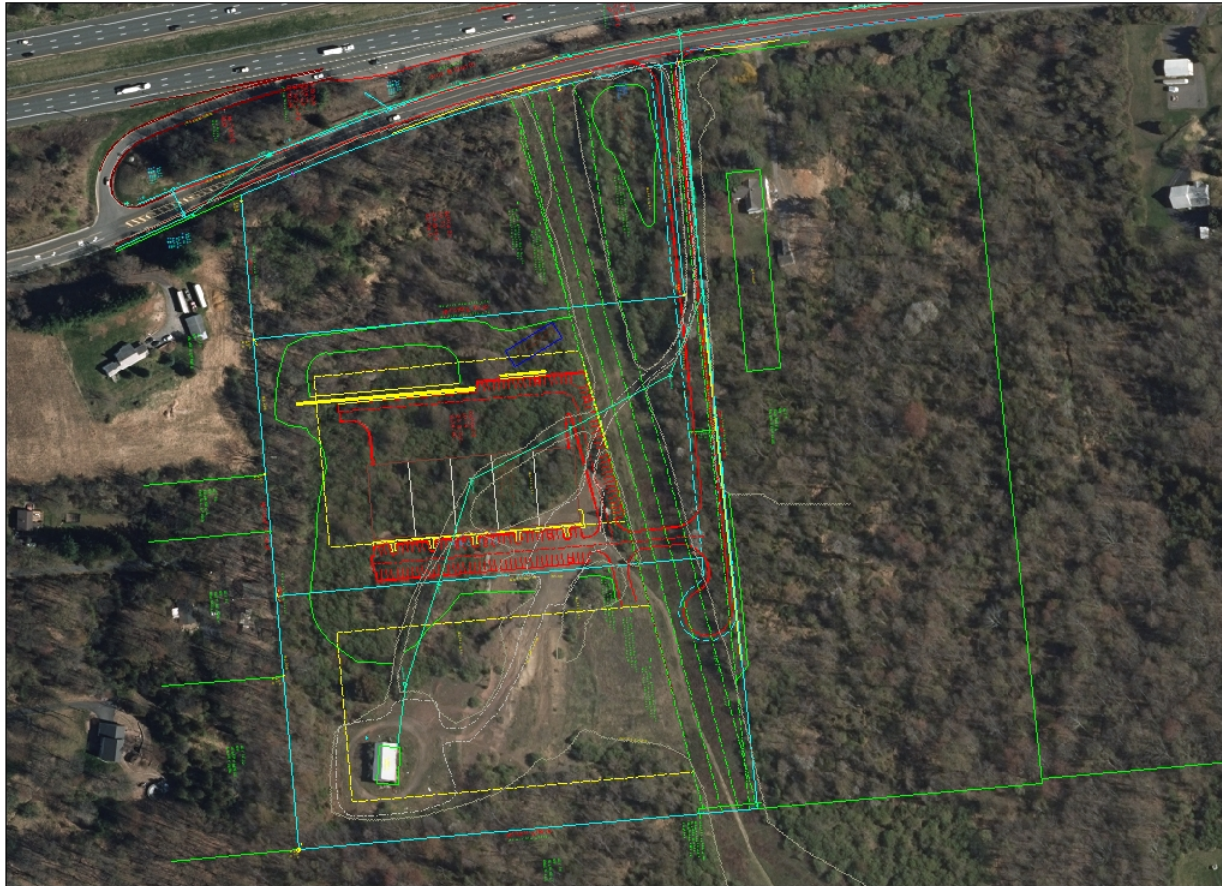
Figure 3: Sketch Map of the Proposed Project for Brian Plushanski Site, Block 22 Lots 3 & 4, Union Township, Hunterdon County, New Jersey

Plushanski is requesting approval to construct a 1-story building encompassing 46,800 square feet (ft²) approximately centered on the site. Approximately 6000 ft² will be used for office space and the remaining 40,800 ft² will be used for warehouse purposes. The small building depicted on Figure 2 will remain. In addition to the building, other infrastructure to be constructed will include parking areas, treated wastewater disposal bed, and two stormwater detention basins. Additional details are provided on site plans prepared by PS&S. A sketch plan derived from the PS&S site plans is provided on Figure 3.

Site plans have been prepared by PS&S and have been submitted to the Township and the Figure 3 sketch does not replace the PS&S site plans and should not be used for actual construction. No hazardous substances or toxic materials will be manufactured at the site. While it is possible that some petroleum products will be stored and used at the site, these materials will be used, recycled, and disposed in accordance with NJDEP regulations.

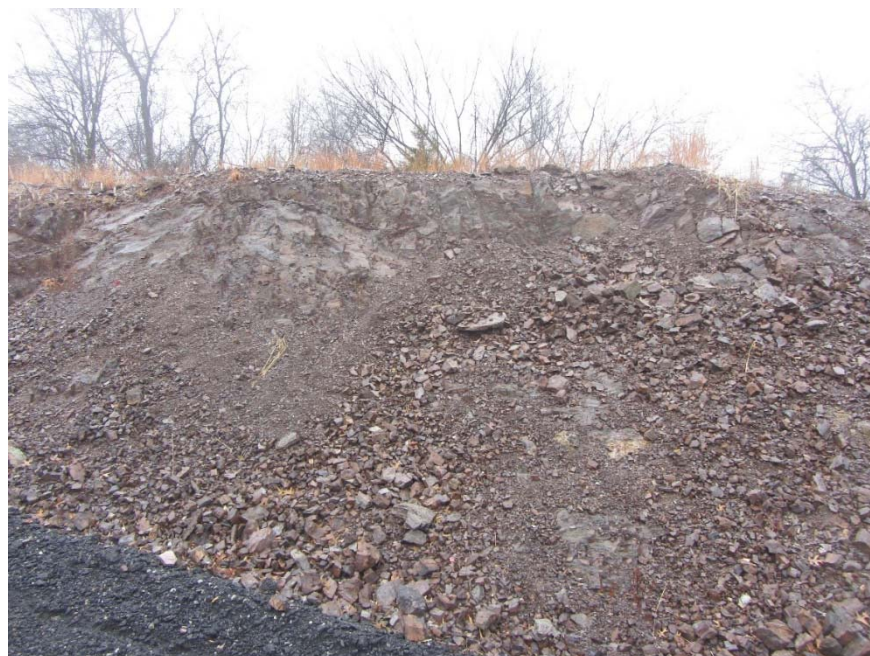
A small outcrop primarily of red shale created as part of quarrying operations is present along the driveway approximately 180 feet east-northeast of the northeast corner of the existing building (see photograph below). Small piles of shale are present at the site as a result of past quarry operations. A well for the existing 1-story Morton Building is present approximately 16-feet northwest of the northwestern corner of this building.

Outcrops of the Jutland Klippe are apparent along the railroad tracks near Jutland in Union Township and in the former quarry on the site (see photograph above). These four regional maps (1992, 1996, 1999, and 2014) differentiate the Jutland Klippe into three sequences: Sequence Unit A, Sequence Unit B, and Undifferentiated, which is not present in Union Township. Figure 4 depicts bedrock geology beneath the site based on the 1996, 1999, and 2014 GIS regional mapping provided by NJGS.

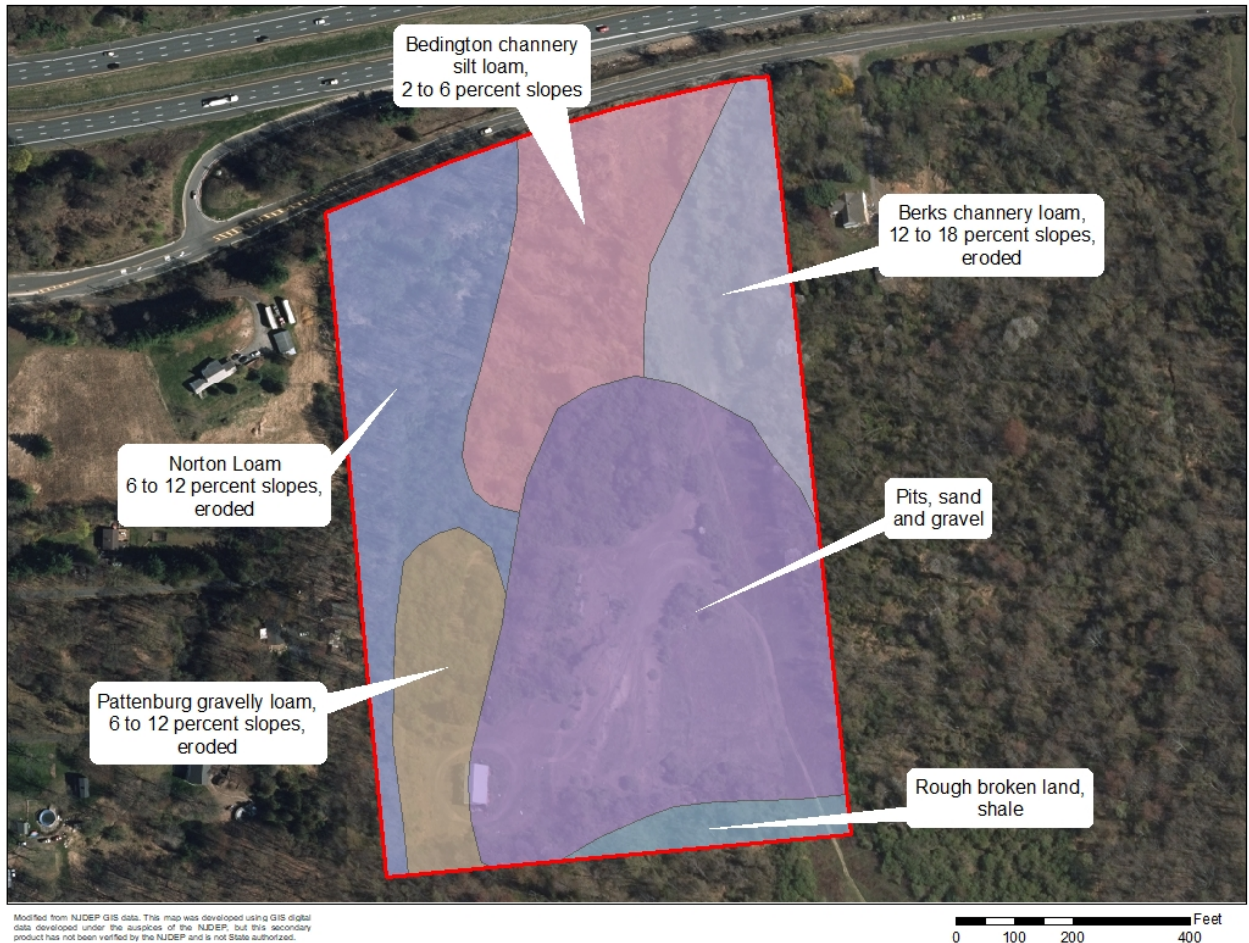
Figure 6: Soils Beneath the Brian Plushanski Site, Block 22 Lots 3 & 4, Union Township, Hunterdon County, New Jersey

The Soil Conservation Service’s “Soil Survey of Hunterdon County” and soil mapping compiled by the United States Department of Agriculture-Natural Resources Conservation Service (USDA-NRCS) were used to evaluate soil conditions beneath the site. The USDA-NRCS mapping obtained from their GIS system is depicted on Figure 6.

Based on the USDA-NRCS mapping, slightly more than 9-acres of the site are underlain by broken rock and sandy soils derived from past quarrying operations (Pits, sand and gravel). Approximately 4.4-acres of the site are underlain by Norton loam with 6 to 12 percent slopes. Norton loam is present along the western boundary of the property and described by USDA-NRCS as red fine-grained silty till and/or colluvium derived from weathering underlying bedrock encountered at depths ranging from 7 to 8 feet below ground surface.

Approximately 3.6-acres near the northern boundary and center of the site are underlain by Bedington channery silt loam on slopes ranging from 2 to 6 percent. These soils are derived from weathering of shale and siltstone bedrock encountered at depths ranging from 5 to 7 feet below ground surface. Approximately 2.7-acres located in the northeastern corner of the site are underlain by Berks channery loam with slopes ranging from 12 to 18 percent. These soils are also derived from weathering of shallow (3 to 7 feet below ground surface) shale and siltstone bedrock.

Approximately 1.9-acres in the southwestern section of the site are underlain by Pattenburg gravelly loam with slopes ranging from 6 to 12 percent. These red soils contain quartz and are derived from weathering of underlying conglomerate and are likely associated with the Lockatong Formation conglomerate mapped along the western property boundary. Along the south-central to southeastern property boundary and approximately 0.7-acre, the USDA-NRCS has mapped the presence of “Rough, broken land shale” or talus derived from weathering of very shallow conglomeratic bedrock.

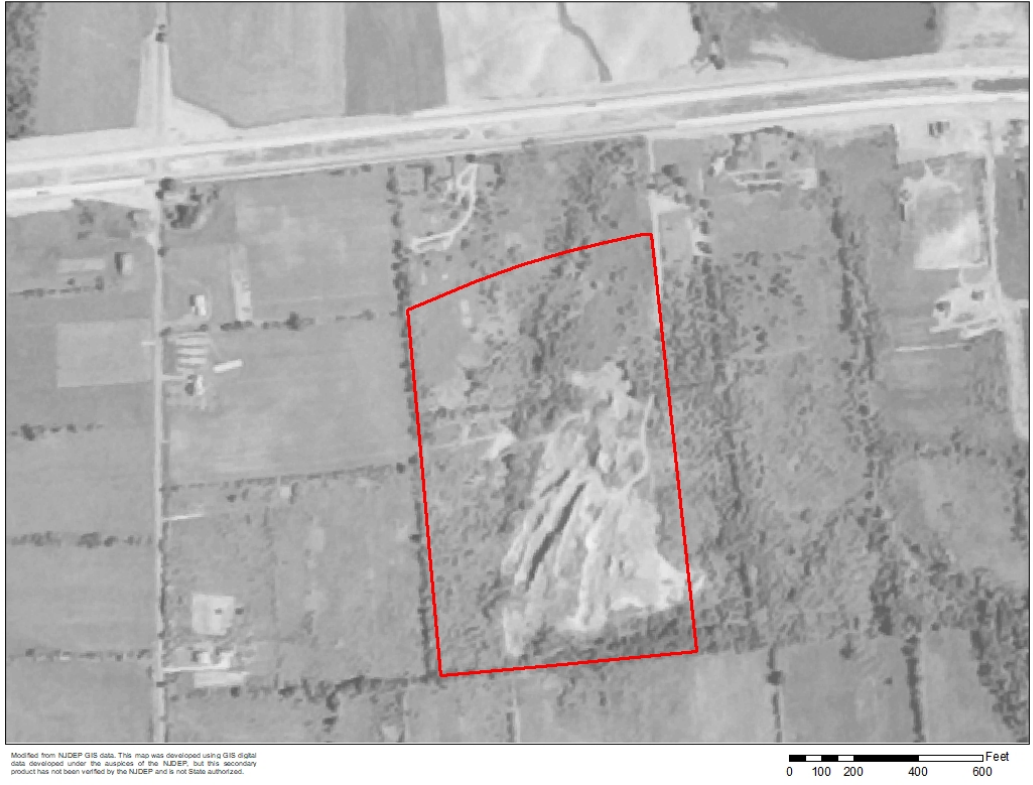
Figure 7: 1953 Aerial Photograph of Brian Plushanski Site, Block 22 Lots 3 & 4, Union Township, Hunterdon County, New Jersey

By 1953, quarrying operations are evident (see Figure 7) but the extent does not significantly change between 1953, 1957, and 1960. The gas transmission easement is apparent in the 1960 aerial photograph transecting the site. The 1970 aerial photograph indicates a small building in the southwestern corner and a house with an outbuildings in the northwestern corner, of the property.
