**Environmental Report (ER)**  
**Village of Vinton**  
**Proposed Water System Improvements**

**August 10, 2012**

**ENVIRONMENTAL REPORT (ER)**  
**FOR THE**  
**VILLAGE OF VINTON**  
**PROPOSED WATER SYSTEM IMPROVEMENTS PROJECT**

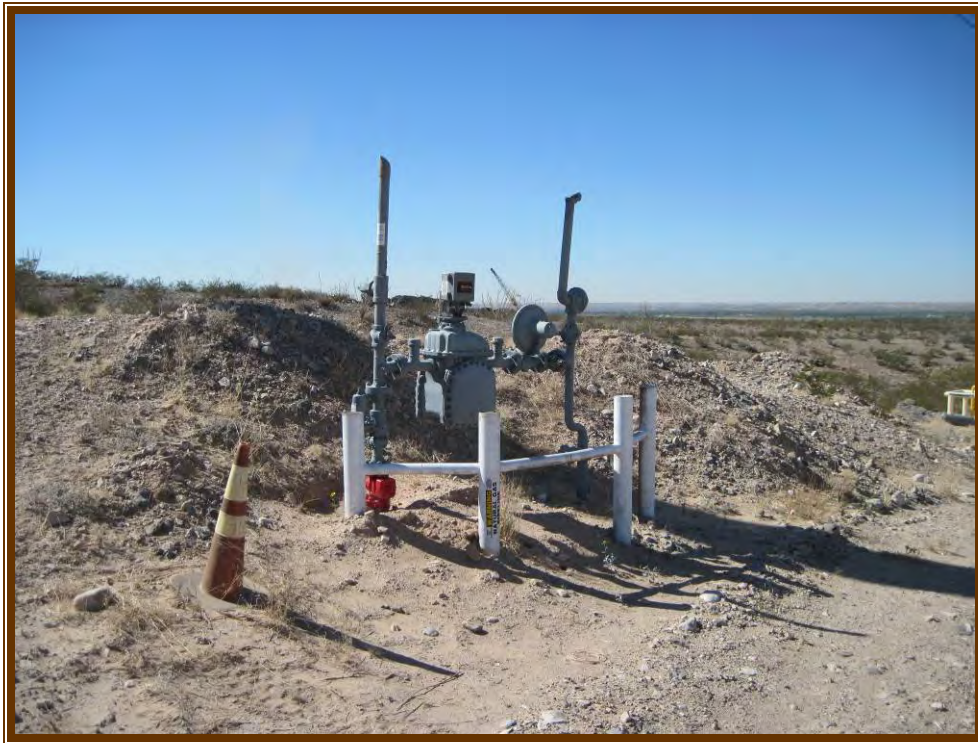
Photo 5. View gas pipeline on Border Steel Road.

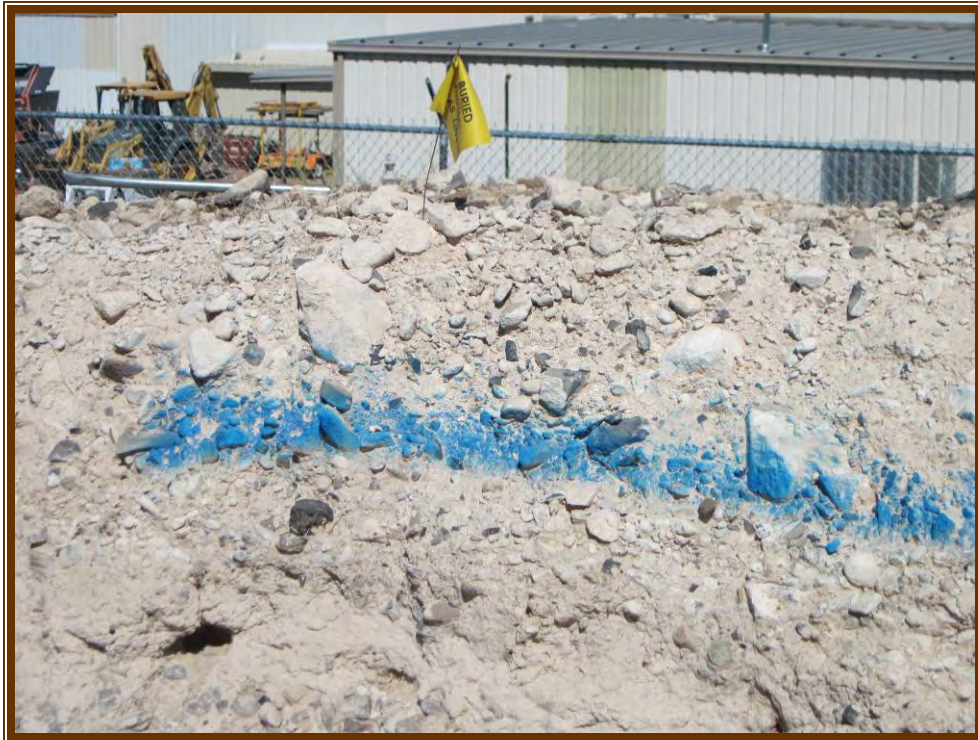
Photo 6. View of marked gas pipeline along Border Steel Road.
