Kenya Water Towers Status Report Mwangea Hills

Kenya Water Towers Status Report

for
Mwangea Hills

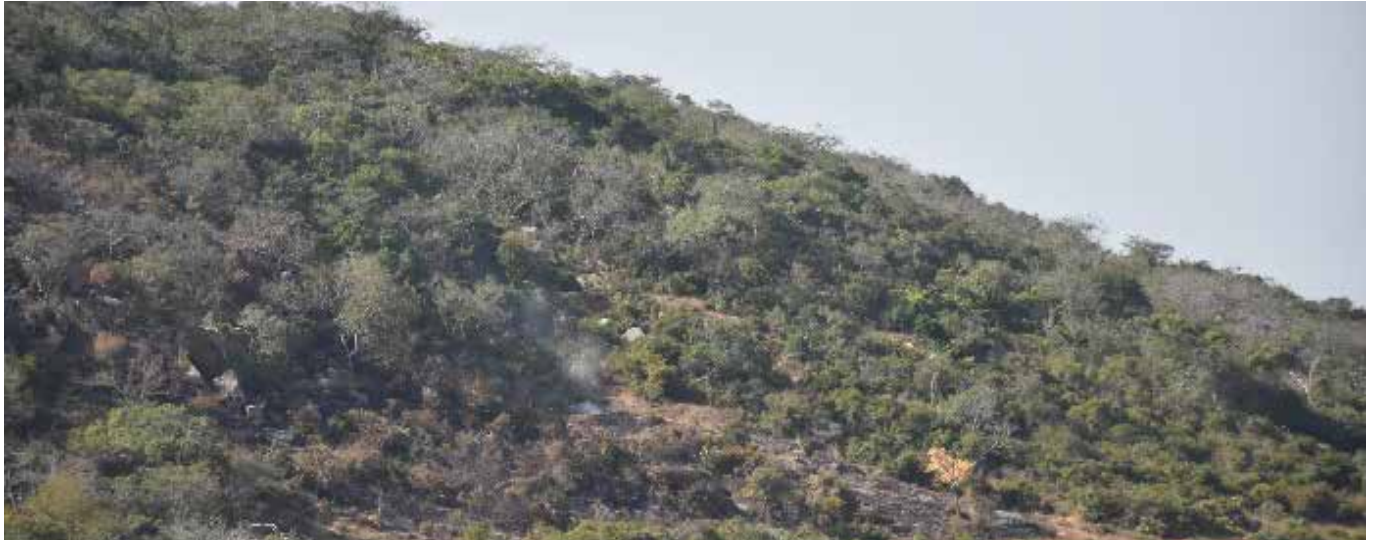
Forest cover cleared to create land for farming

To address encroachment and reverse degradation, there is need to secure, reclaim, restore and gazette the Water Tower.

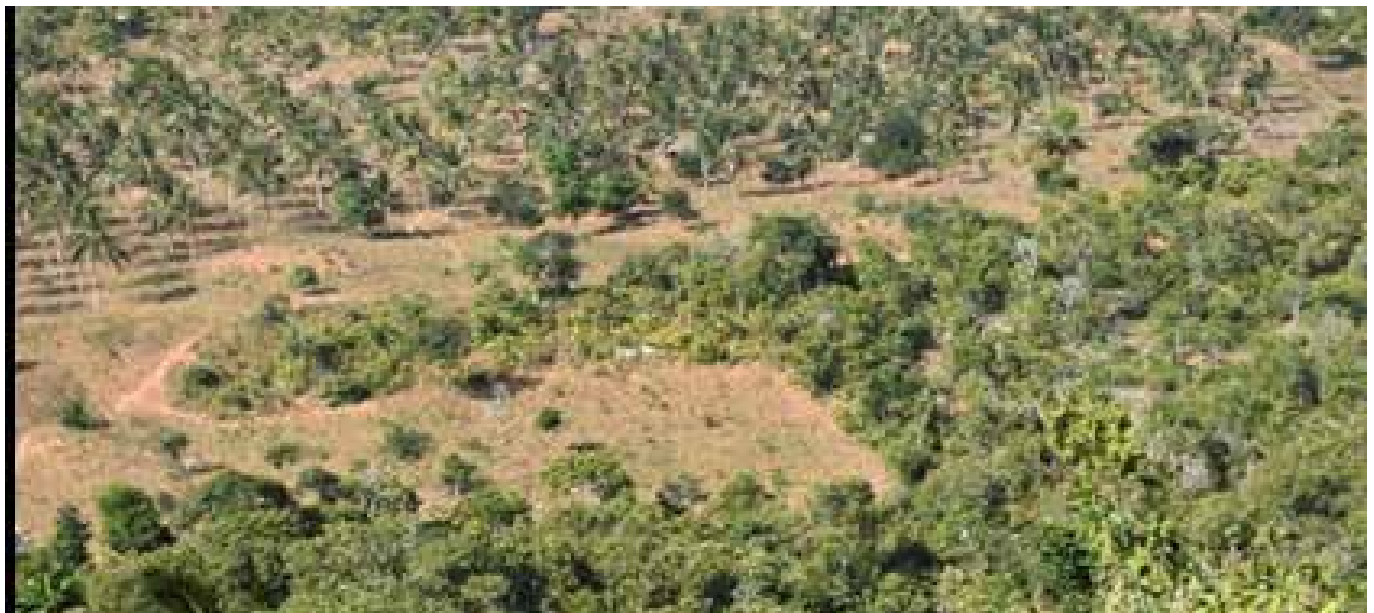
Remaining forest patches in Mwangea hills

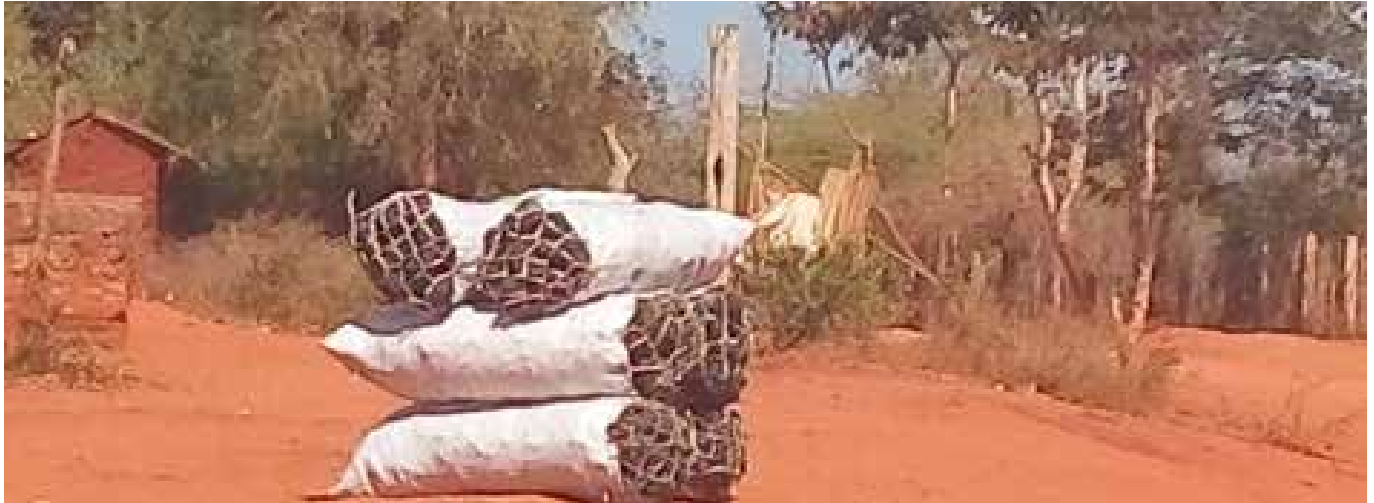
The unsustainable open kilning coupled with weak law enforcement and increasing demand for charcoal contributes to continued depletion of forest resources.

Charcoal production in the buffer zone

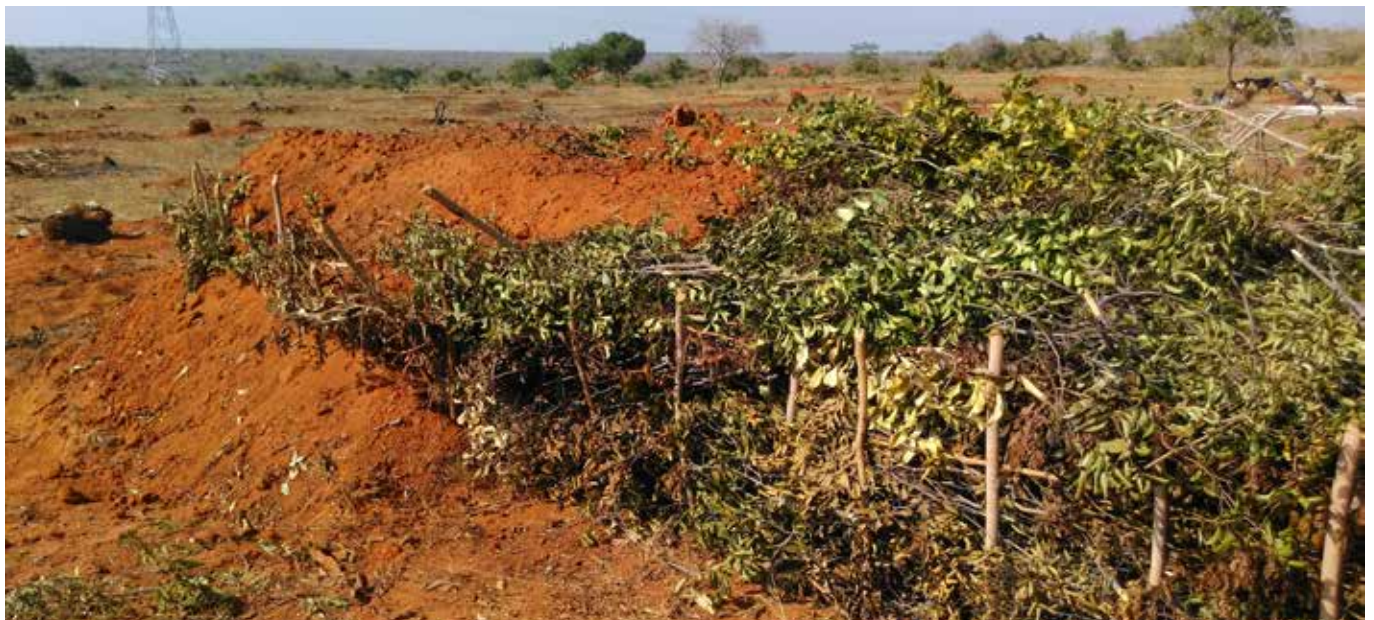
Charcoal kiln within the buffer zone

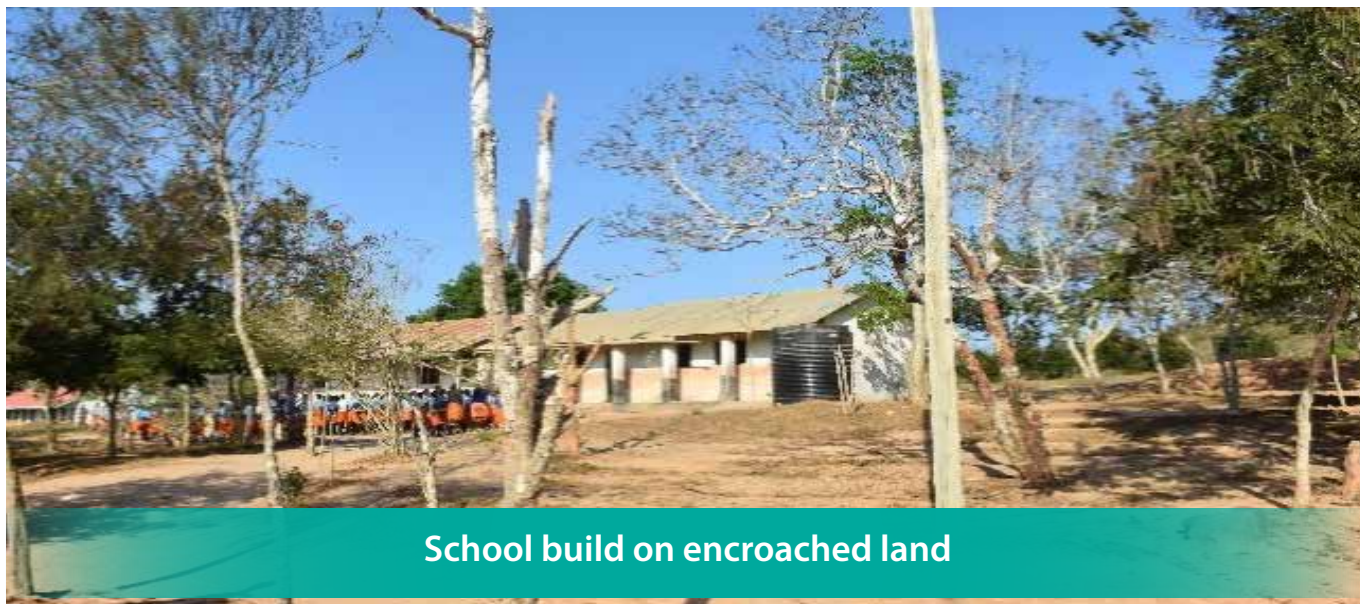
School build on encroached land
