Kenya Water Towers Status Report Mwangea Hills

Coordinated Water Towers Conservation
2019 - 2020 (3rd Quarter)

Kenya Water Towers Status Report

for
Mwangea Hills

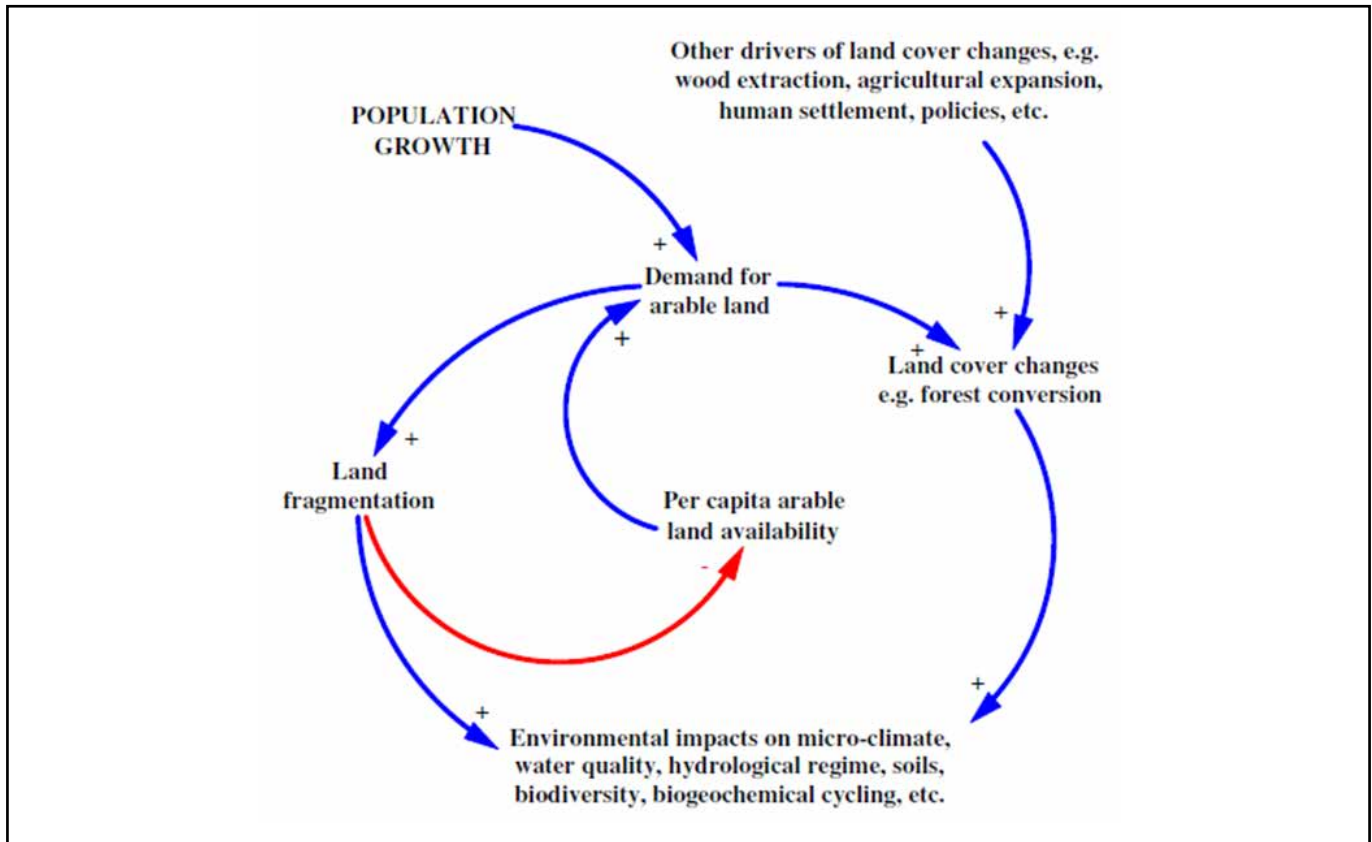
Figure 1.2: Causal loop diagram illustrating threats facing Water Towers (Were et al, (2013)

Water towers influence all aspects of the economy including agriculture (irrigation), energy (hydropower), tourism (wildlife), urban development (water supply) and industry (water supply). Protection and conservation of these important ecosystems continues to face a number of challenges such as rapid population growth whose spiral effects include increased land fragmentation, encroachment on ecologically sensitive areas and over exploitation of declining natural resources within the water towers ecosystems. This results to adverse environmental impacts such as drying up of rivers, dams and springs; loss of biodiversity and changes in micro-climatic conditions (Figure 1.2). 4

Note: The positive (+) sign denotes an increasing effect while the negative (-) sign denotes a decreasing effect)

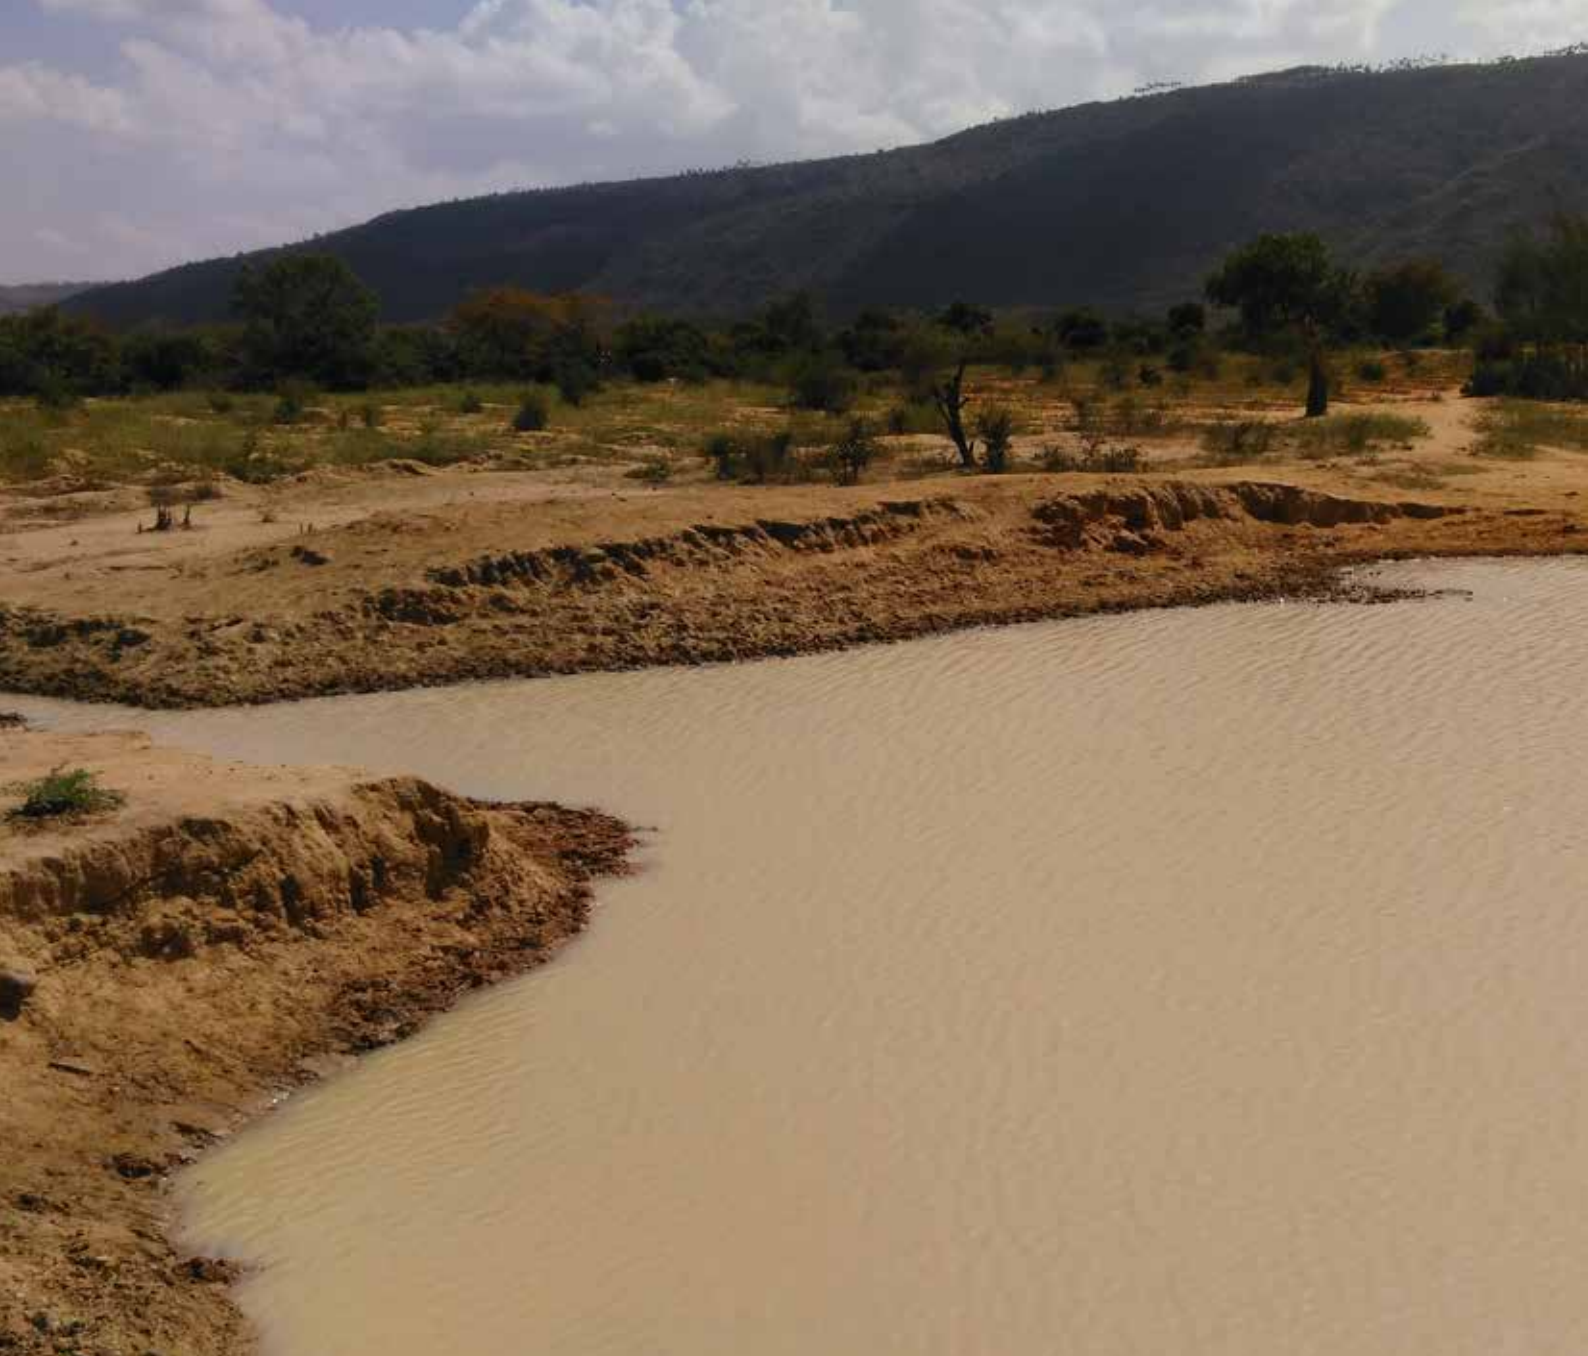
A water pan in Mwangea Hill Water Tower © KWTa 2020

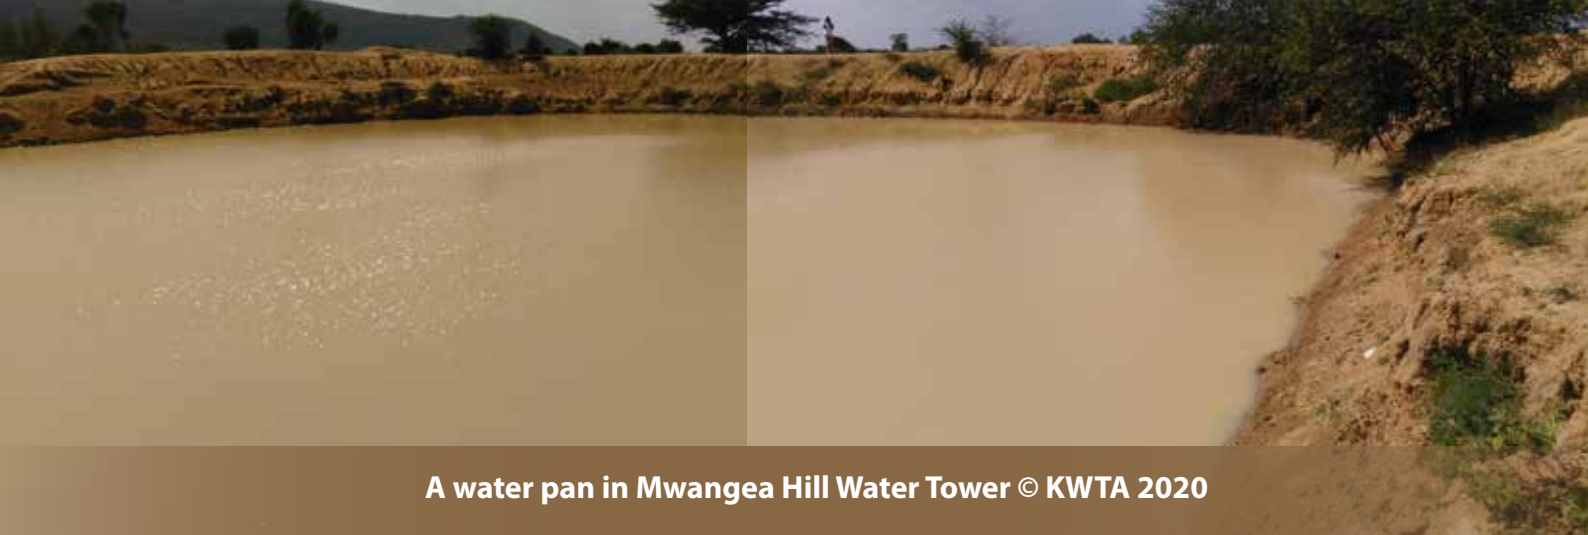
Other water sources are earthen dams which include: Kwa kijego, Kwa mwaiha, Kwa mkamba, Dangarani, Kwa katuku, Kisiwani, Kwa kamba, Kwa dadu, Kwa maitha, Kwa kacheku, Kwa mwalewa, Kwa mumba pala, Ziarakuruma, Bilakule, Kaziweni, Kwa mwambire, Kaziweni, Mwahera.

A water pan in Mwangea Hill Water Tower © KWTa 2020

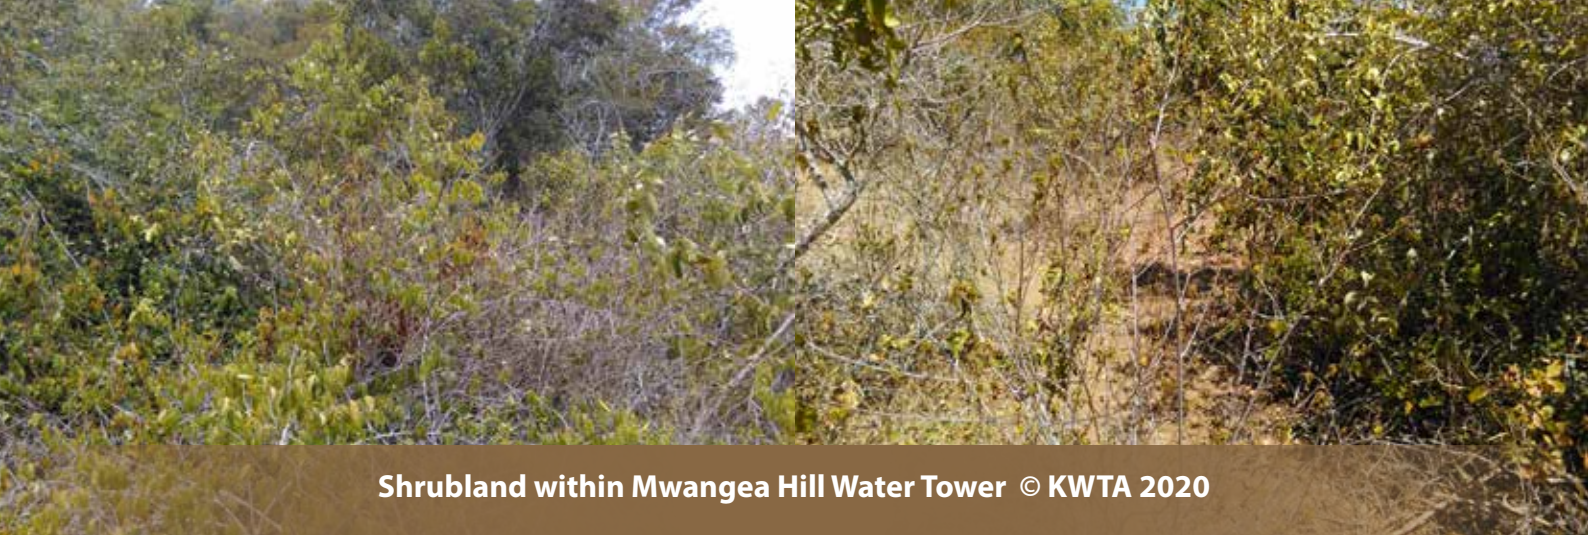
Shrubland within Mwangea Hill Water Tower © KWTa 2020

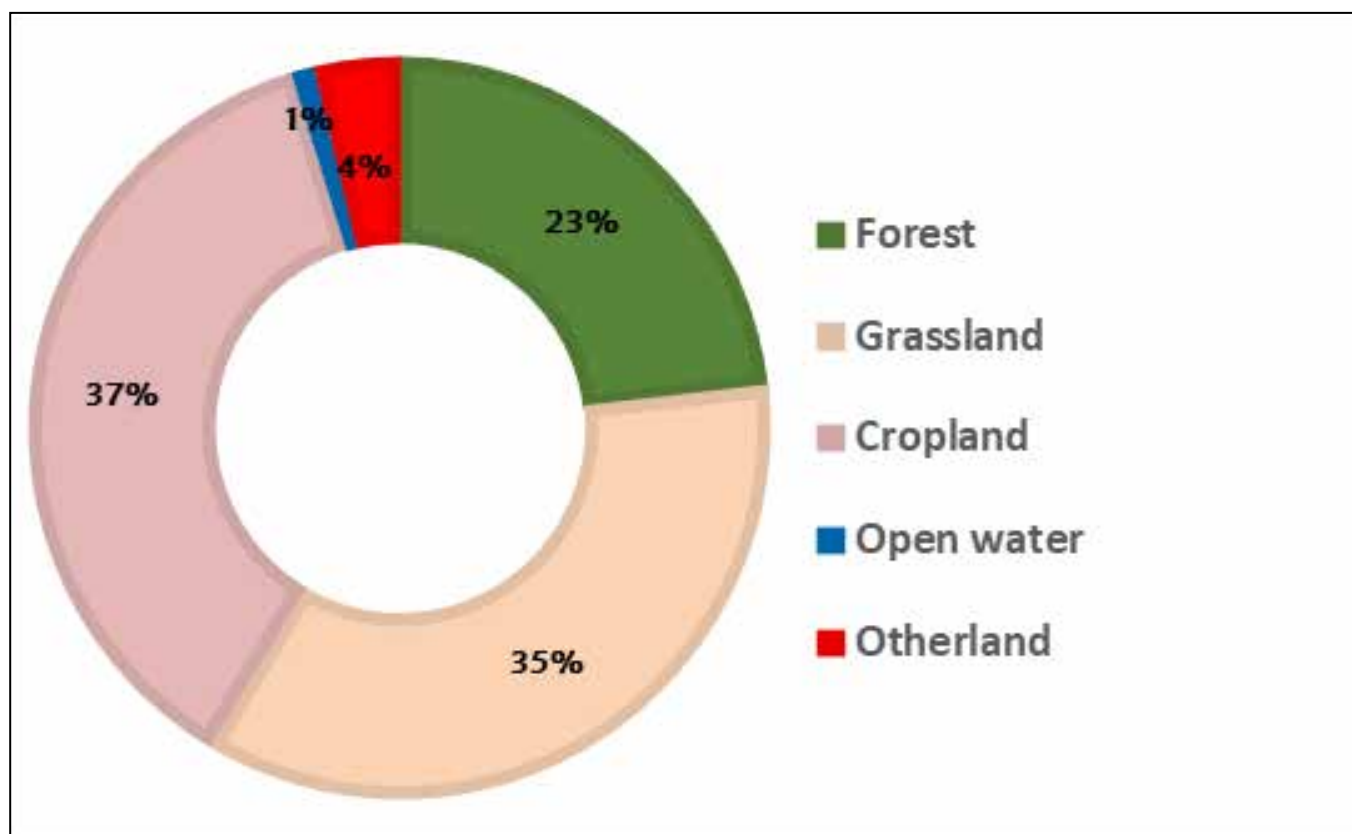
Figure 2.5: Land cover and Land use in Mwangea Hill Water Tower

The major land cover in Mwangea Hill Water Tower is cropland, 9047 ha (37%) followed by grassland, 8748 ha (35%) and forest, 5723 ha (23%) and the least is wetland 247 ha, which represents 1% (Fig. 2.5). Cropland covers both annual and perennial crops. Annual crops consist of maize, cowpeas, beans, sorghum, vegetables and cassavas among others. Perennial crops include coconut, citrus and cashewnut trees.

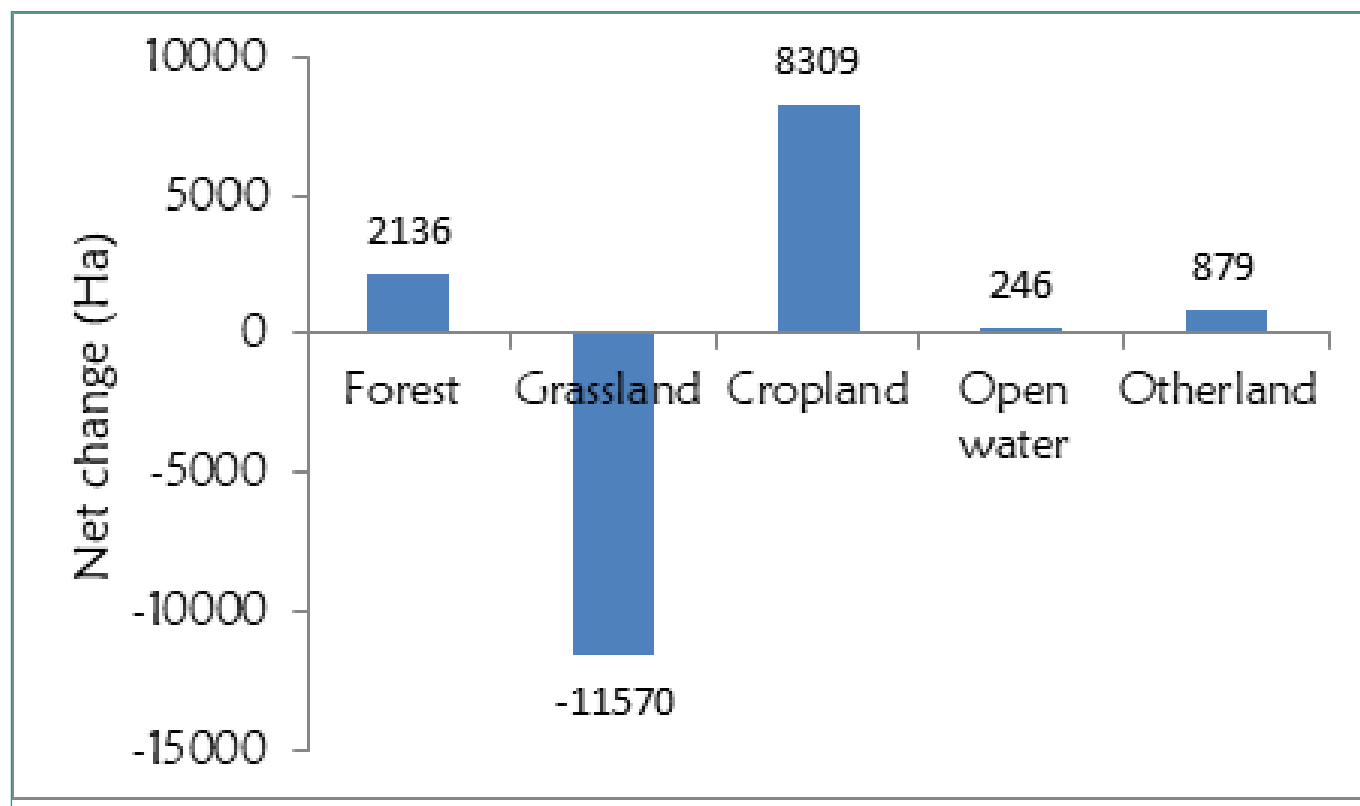
Figure 2.6 : Net changes in LCLU categories in Mwangea Hill from 1990 – 2019

Over the period 1990 – 2018, the net LCLU changes varied from one LCLU class to another. All the classes with an exception of grasslands showed a net increase, with cropland recording the most increase (8309 ha). Grassland recorded the most decrease (-11570 ha) (Fig. 2.6).

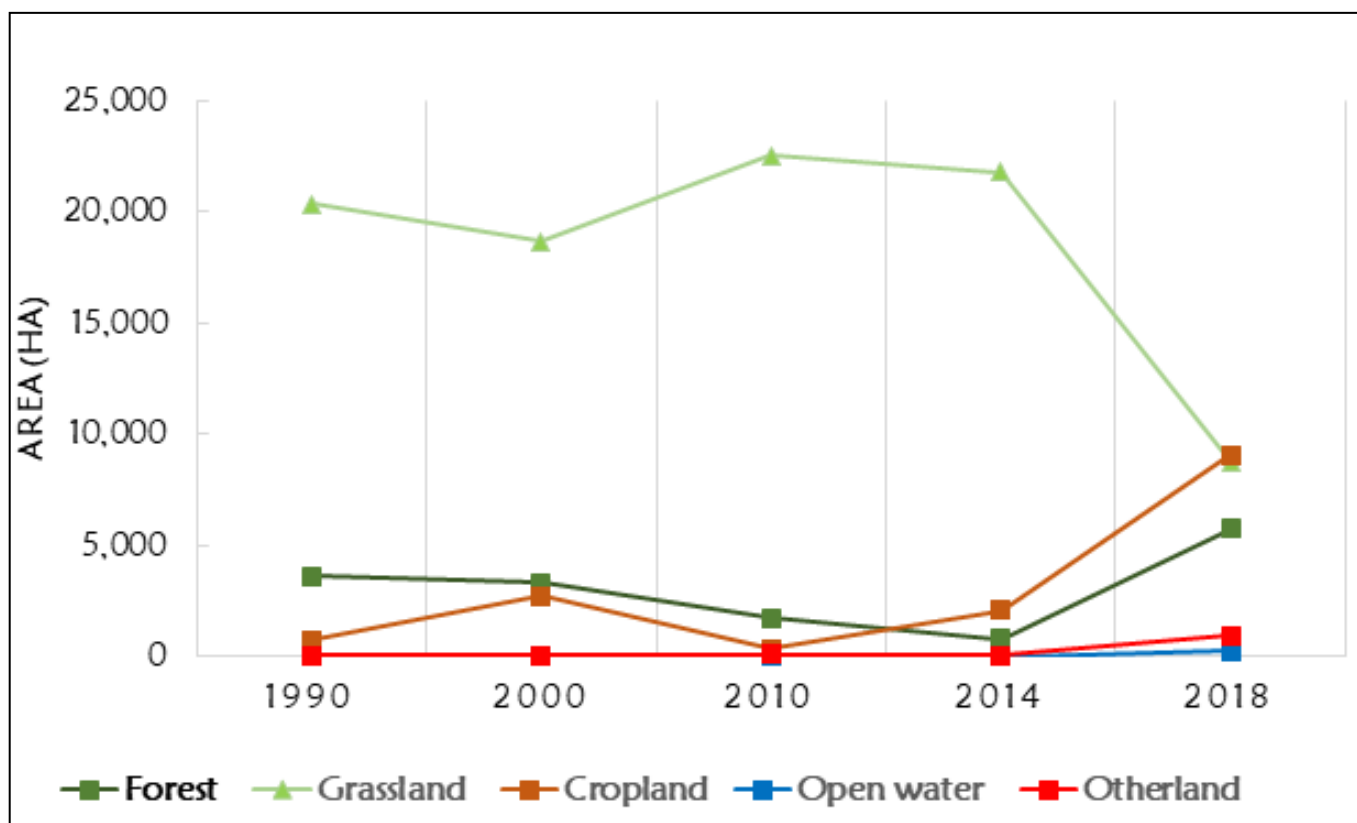
Figure 2.7: Land cover land use trend analysis in Mwangea Hill Water Tower

The Land cover and land use trends indicate that forest has been on a downward trend since 1990 to 2014, recording cumulative loss of 2799 ha. Since then, conservation efforts have seen an increment of 4935 ha between 2014 and 2018 (Fig. 2.7). Grassland has been decreasing within the same period while cropland has been increasing (Fig. 2.7). This is an indication that most of the grasslands have been converted into croplands.

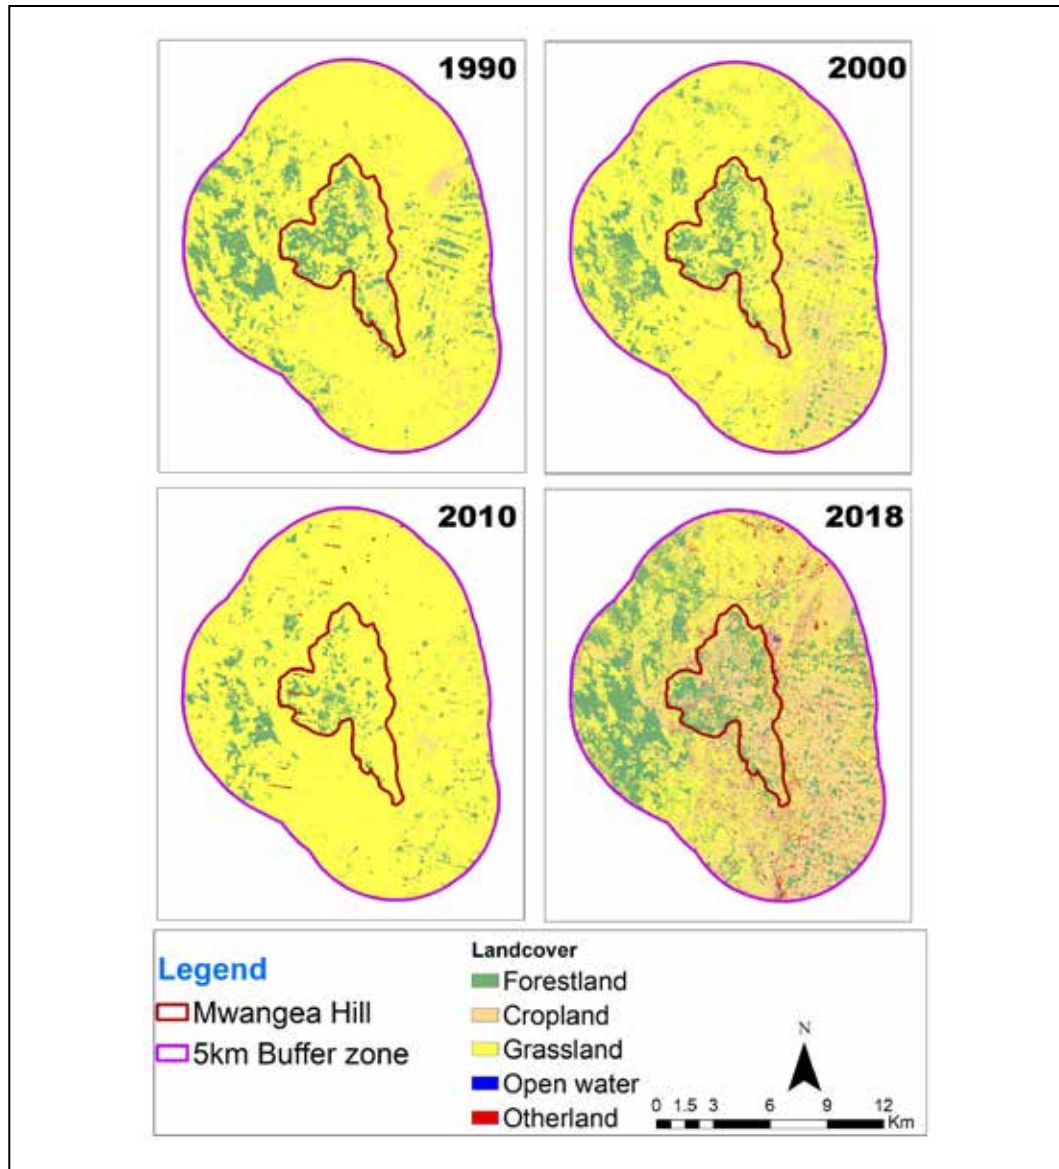
Figure 2.8: Land Cover Land Use classification map for Mwangea Hill Water Tower

The figure below shows the gross LCLU classification in 1990, 2000, 2010 and 2018.

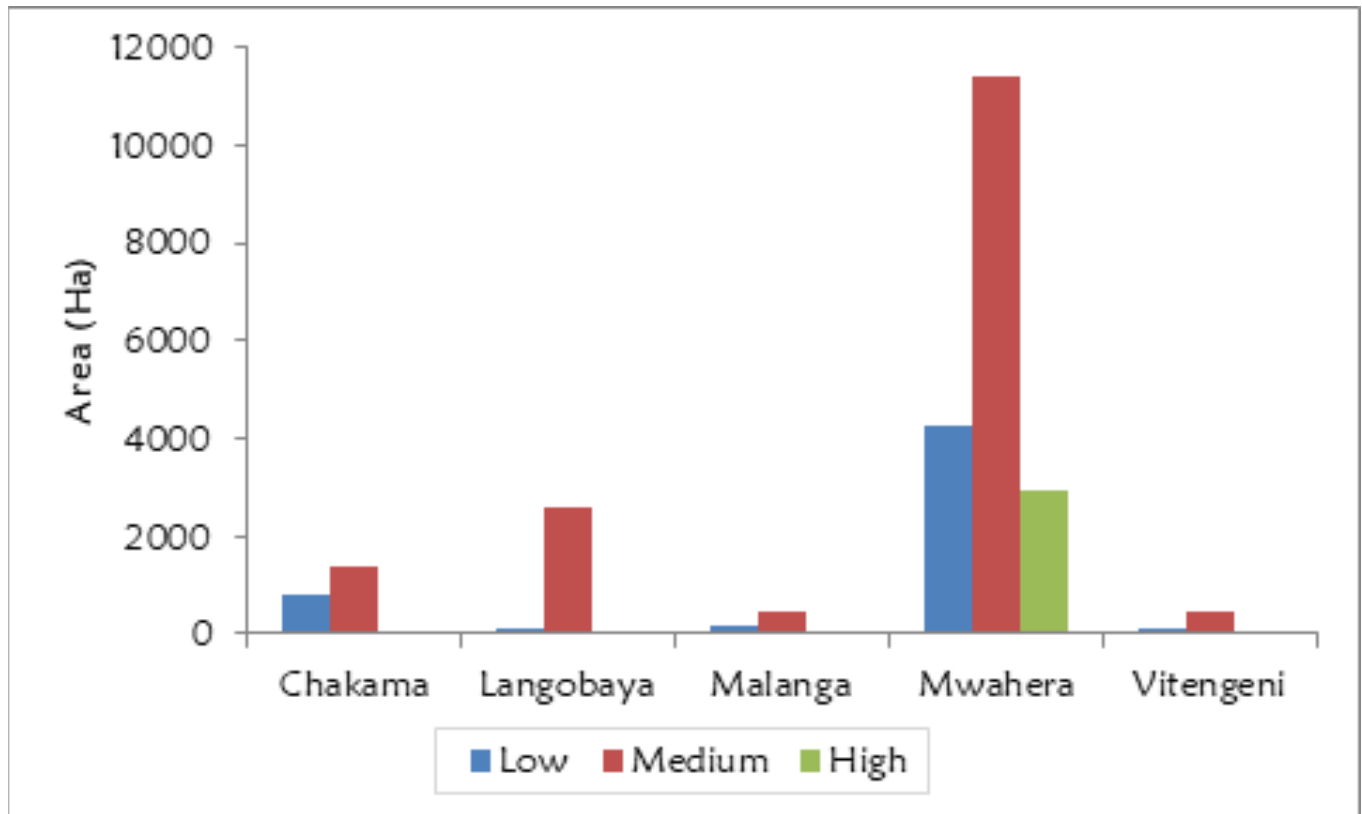
Figure 2.9: Levels of degradation in Mwangea Hill Water Tower

Mwahera location faces the highest levels of degradation compared to other locations (Fig. 2.9 & 2.10). This location covers a major section of the Water Tower and it was noted that encroachment and forest destruction was rampant. The high level of degradation covers 2,934 ha, while the low and medium levels of degradation covers 5,465 ha and 16,277 ha respectively.

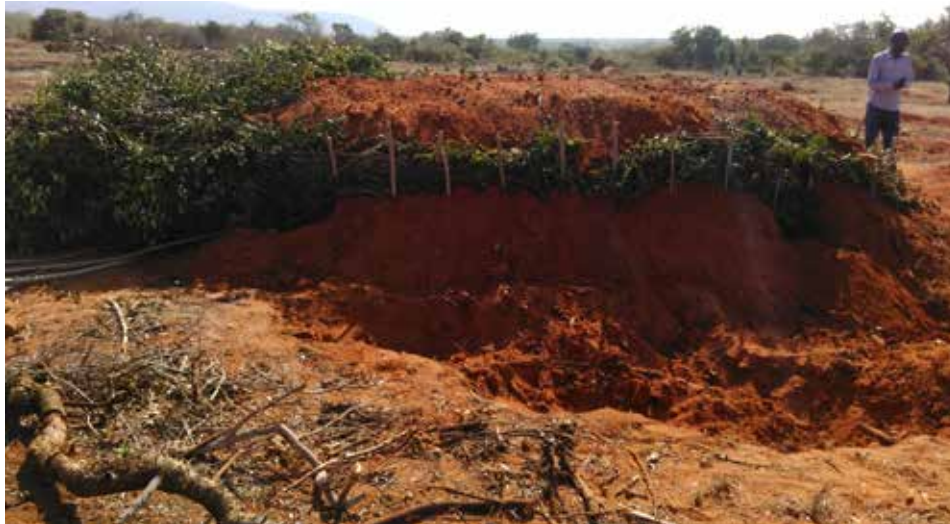
Mwangea hill has suffered major damage from illegal logging and clearing of the forest to provide fuel wood for Malindi, Kilifi and Mombasa.

The unsustainable open kilning coupled with weak law enforcement and increasing demand for charcoal contributes to continued depletion of forest resources.

The most affected areas include Mwangea location, Mikobachenda and Sita hill, Mwele, Kabuni, Midugani, Muchemudzo, Matsajeni and Kazandani.

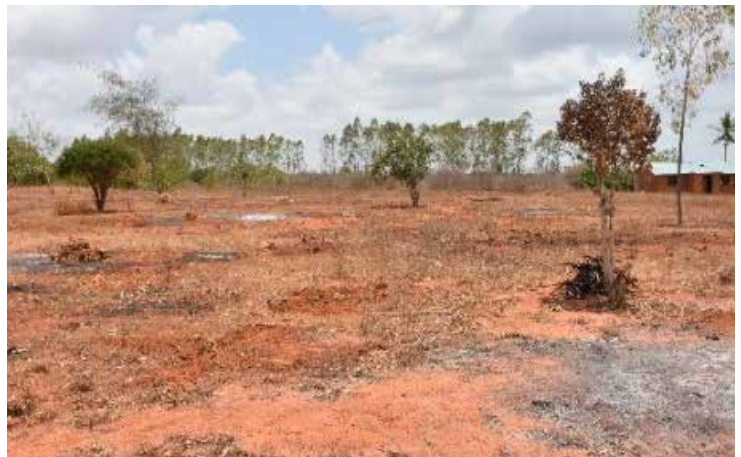
4. Poor farming practices

Cultivation on the slopes and unsustainable farming practices such as slash and burn method of land clearing has increased soil erosion leading to development of gullies.

The common practice of slash and burn in the area reduces soil organic matter, exposing the soil surface hence aggravating soil erosion

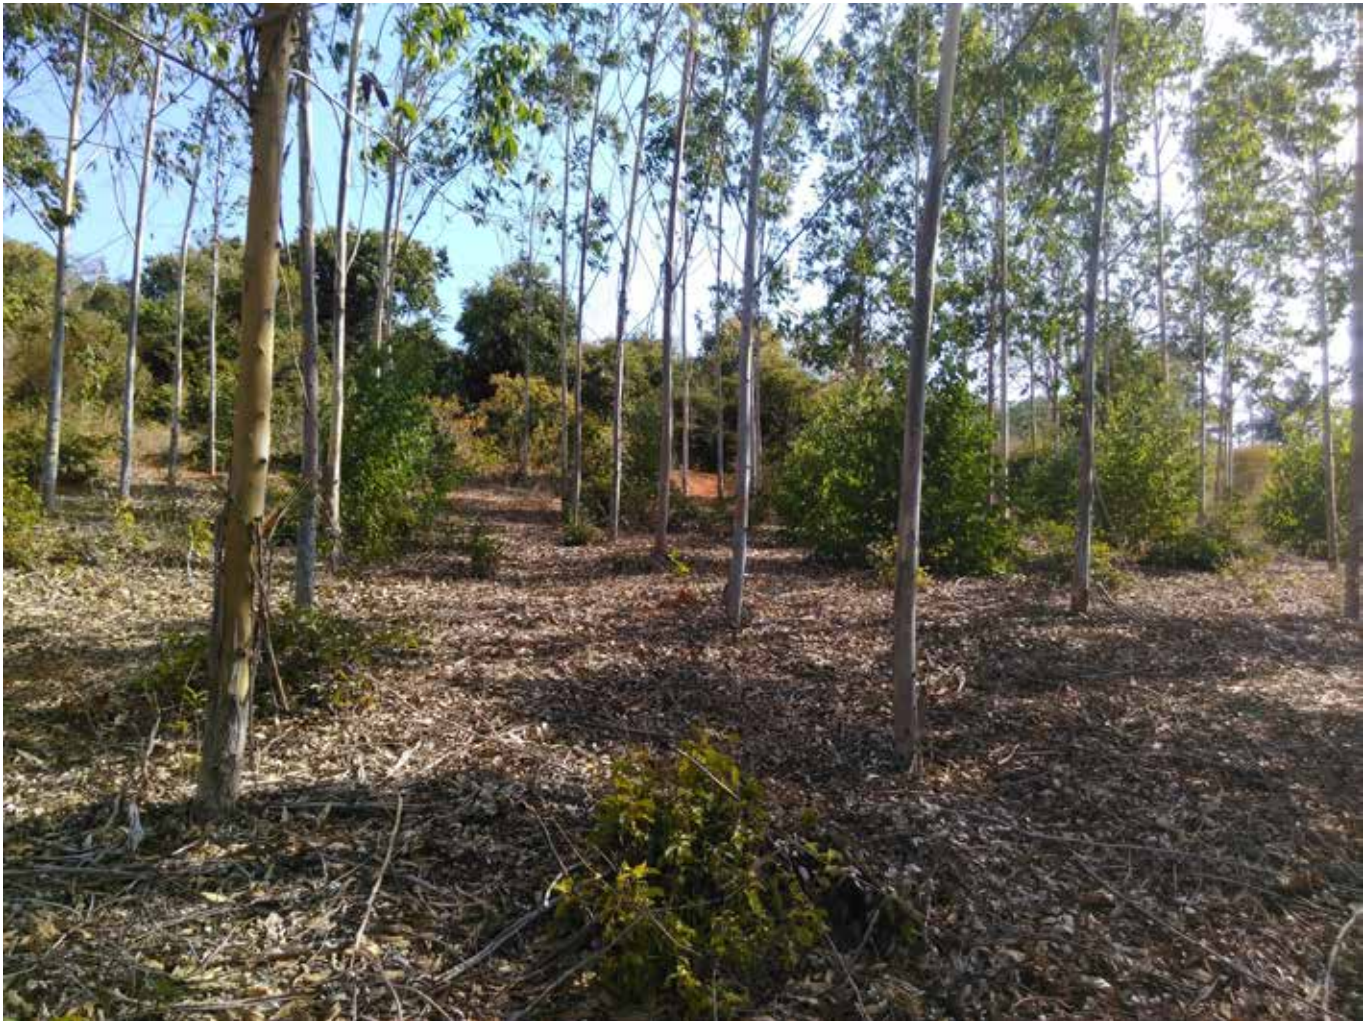
5. Growing of exotic trees

The living in this water tower have replaced indigenous trees with fast growing exotic tree species mainly Eucalyptus species. There is an NGO called Komaza which has been supporting the growth of the Eucalyptus in this area. This species has adverse effects as it takes up a lot of water and suppresses growth of indigenous tree species hence reducing biodiversity.

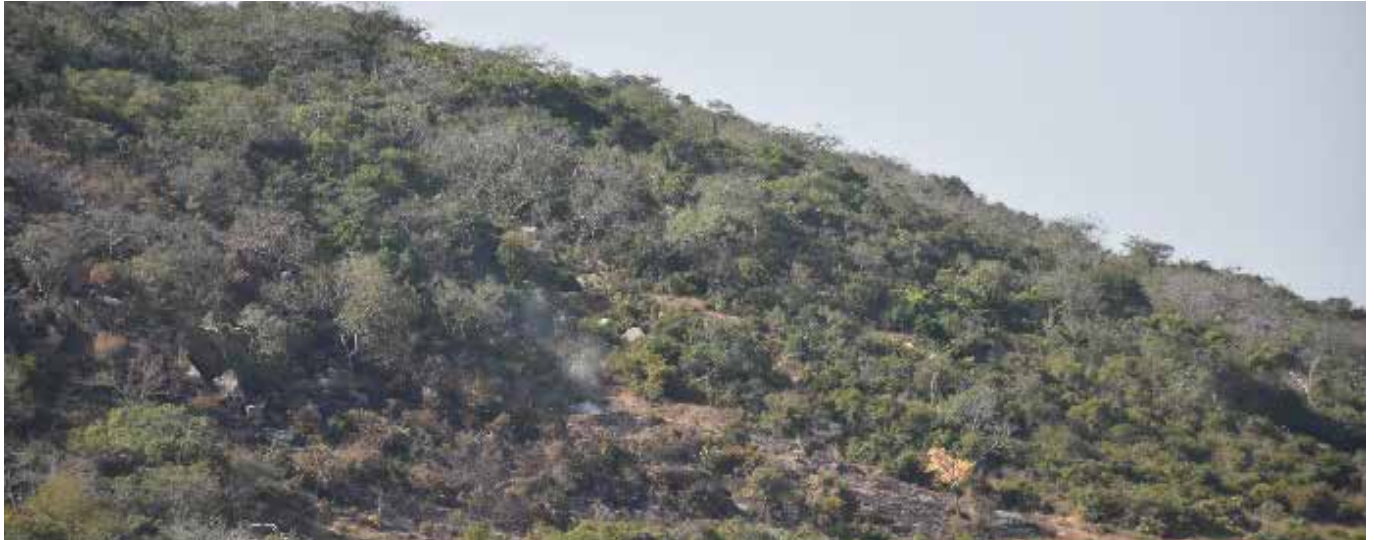
Forest cover cleared to create land for farming

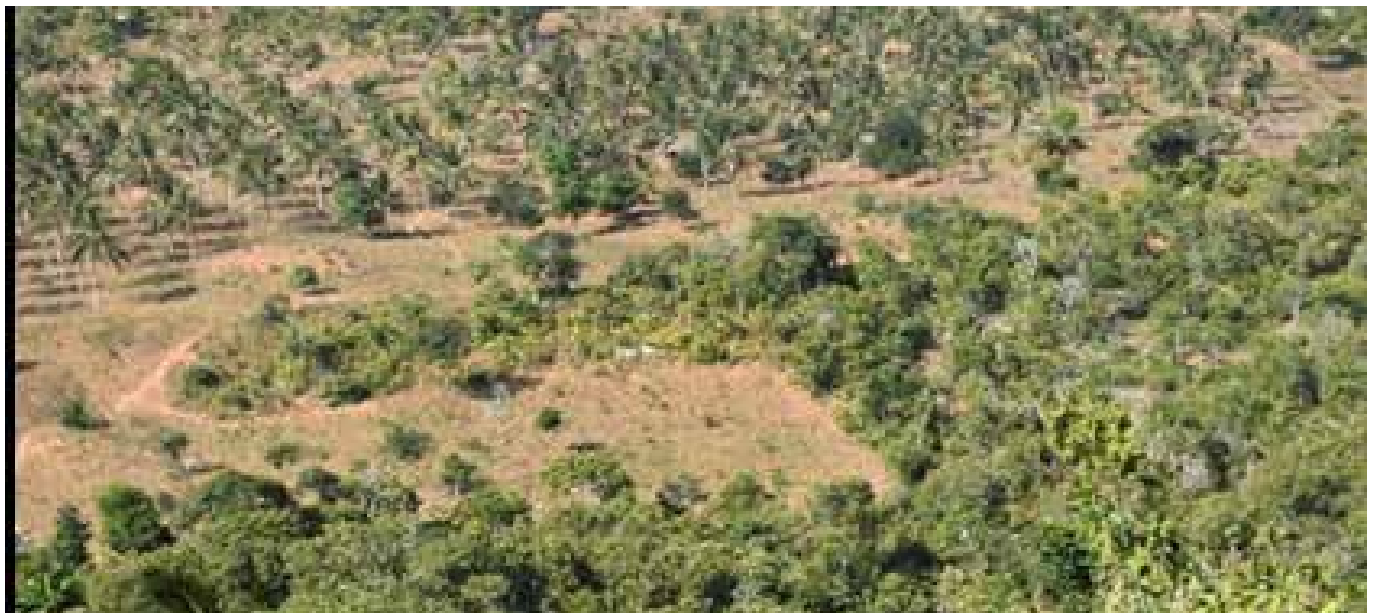
Remaining forest patches in Mwangea hills

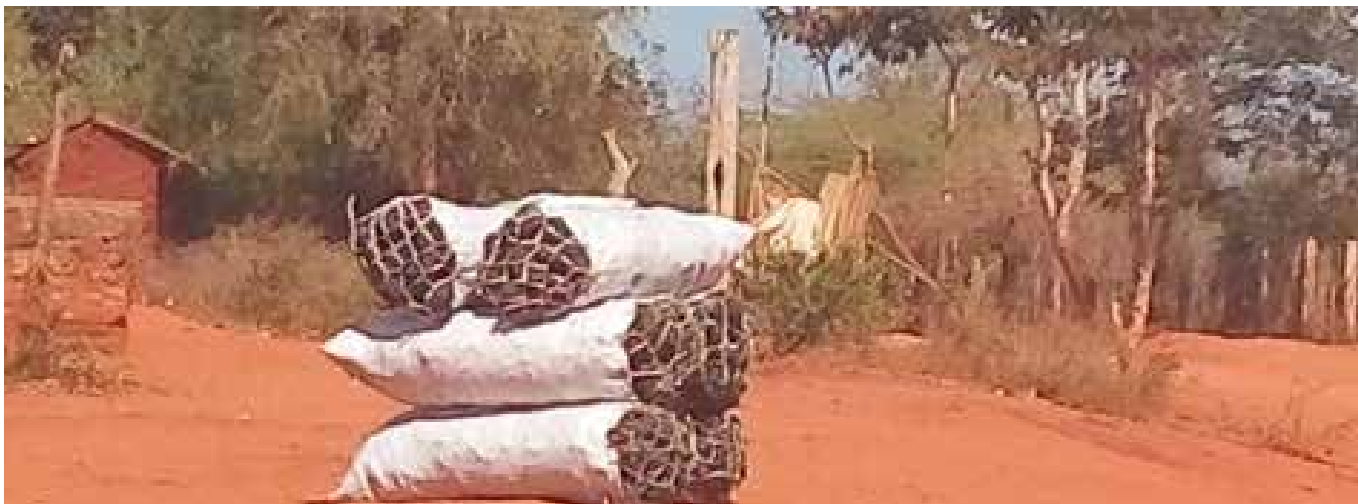
Charcoal production in the buffer zone

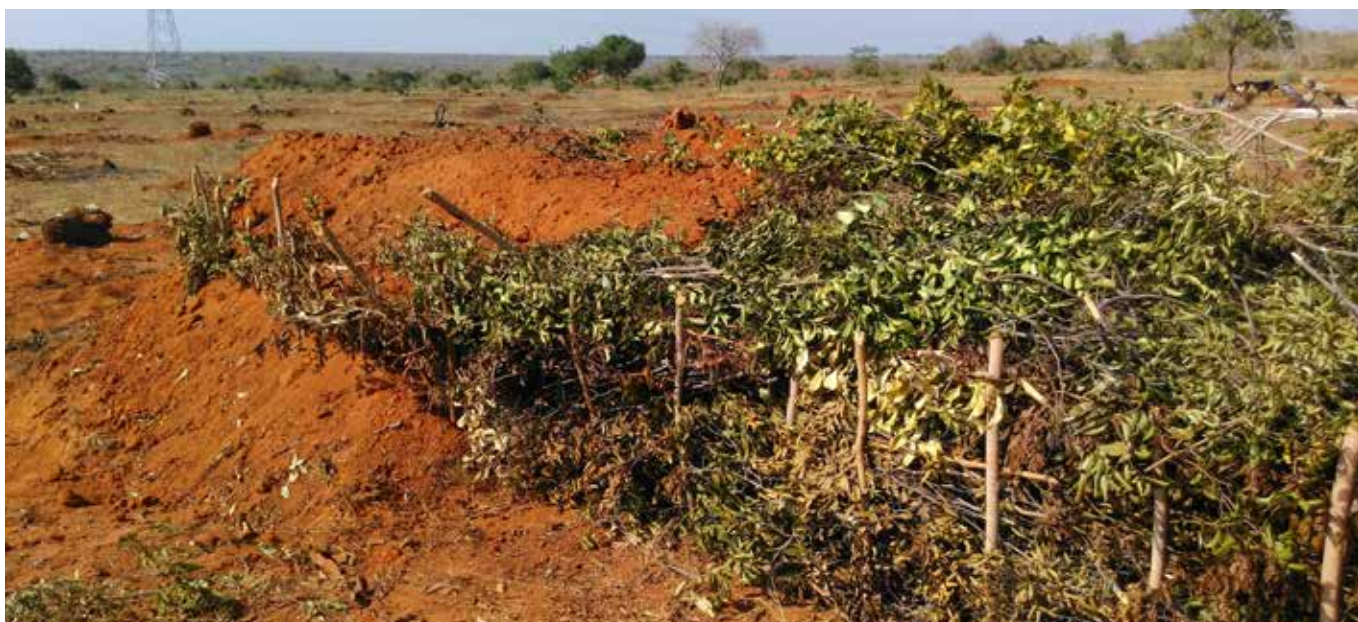
Charcoal kiln within the buffer zone

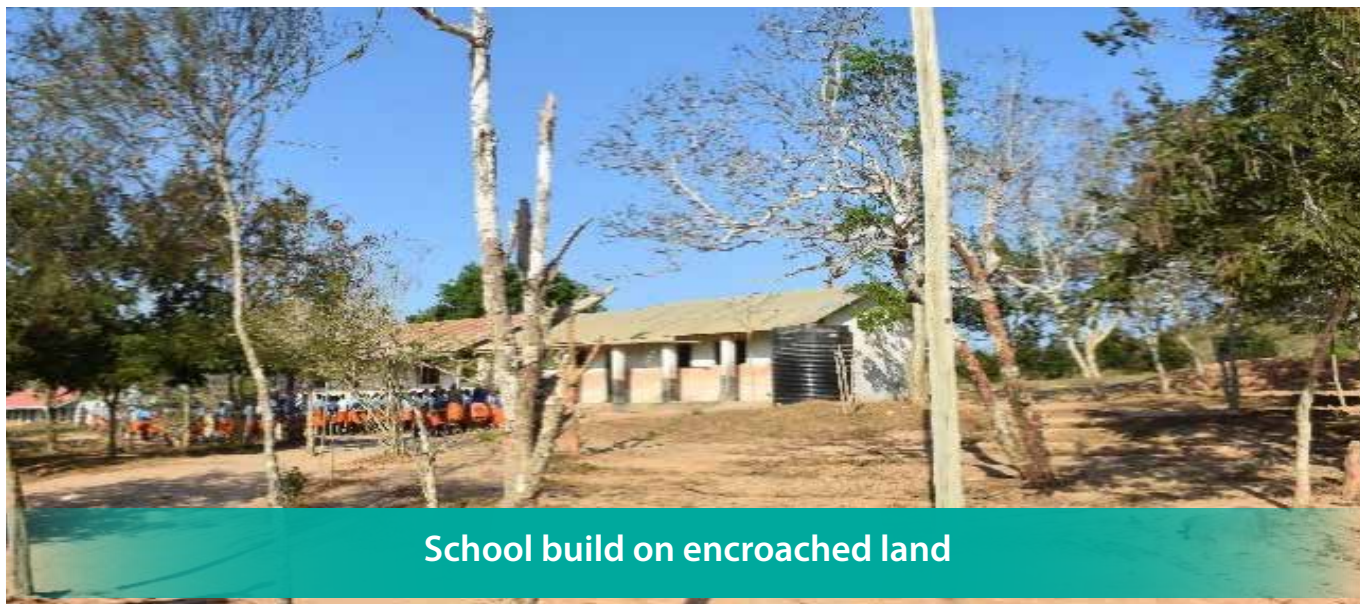
School build on encroached land

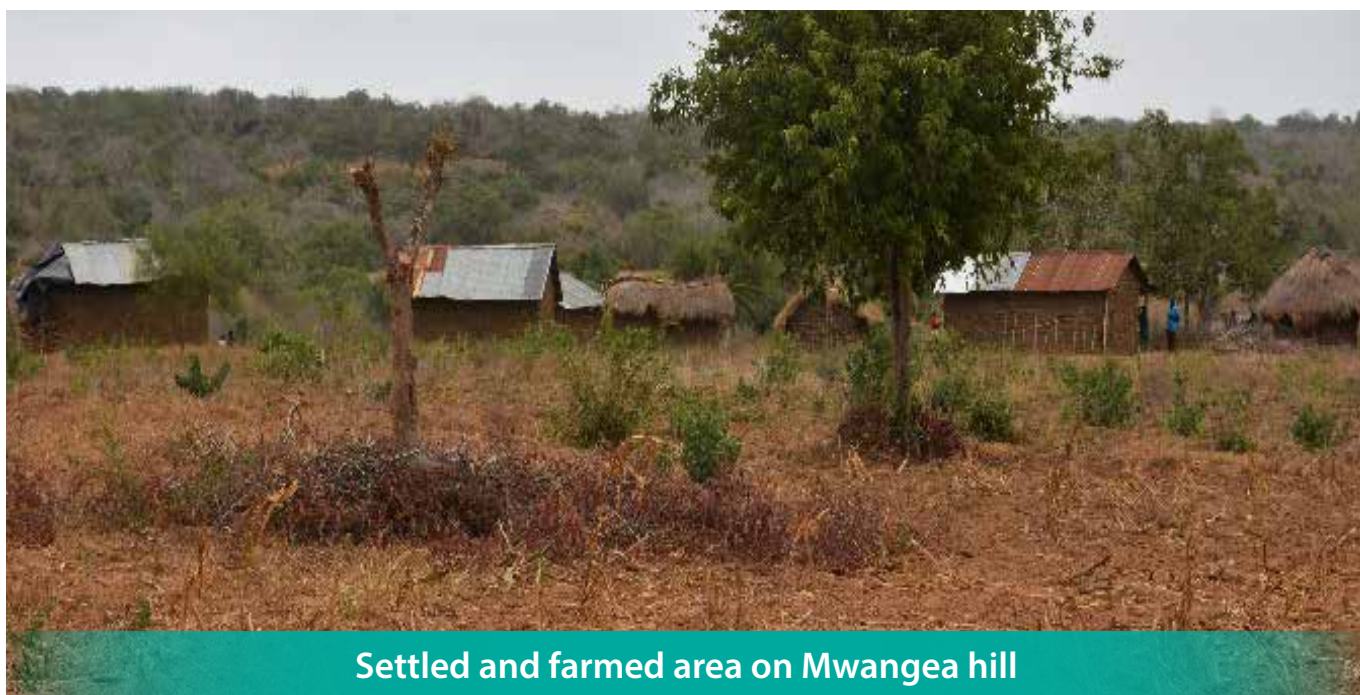
Settled and farmed area on Mwangea hill
