WINCHESTER SOUTH PROJECT

Aquatic Ecology and Stygofauna Assessment

Prepared for: Whitehaven WS Pty Ltd

May 2021

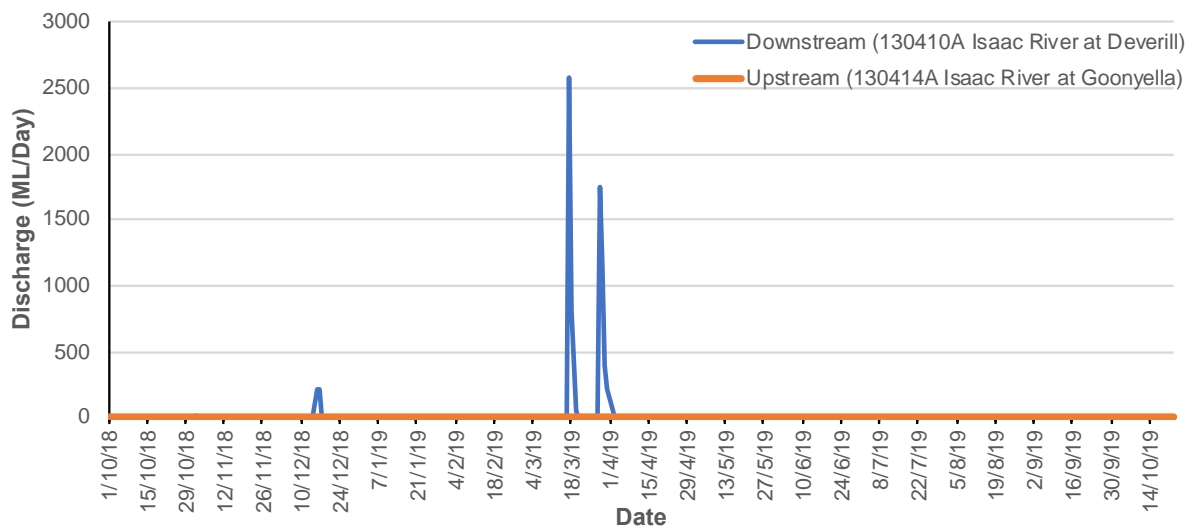
Figure 2.2 Stream flow recorded leading up to the May and October 2019 surveys

The early-wet season aquatic ecology survey was completed from 14 to 22 October 2019. The weather was dry and sunny, with temperatures ranging from 15 – 39°C and rainfall in the months prior to the survey was low. Rainfall between June and October was below the long-term average for the region, except in June when 25 mm was recorded. Some rain was recorded in the week leading up to the survey with 13 mm recorded between 11 and 12 October (BOM 2019a) (Figure 2.1), however this was not considered significant enough to alter the conditions on-site. Furthermore, no flow was recorded in the Isaac River upstream or downstream of the Project in the months leading up to the survey, which is reflective of the dry conditions (DNRME 2019; Figure 2.2).

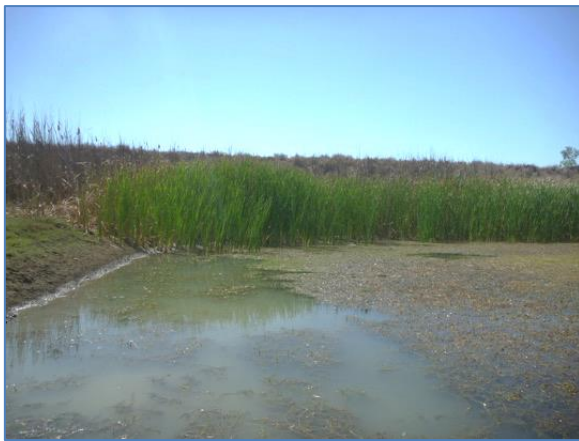
Figure 3.1 Diverse and abundant aquatic plant communities at farm dam site LW5 in October 2019

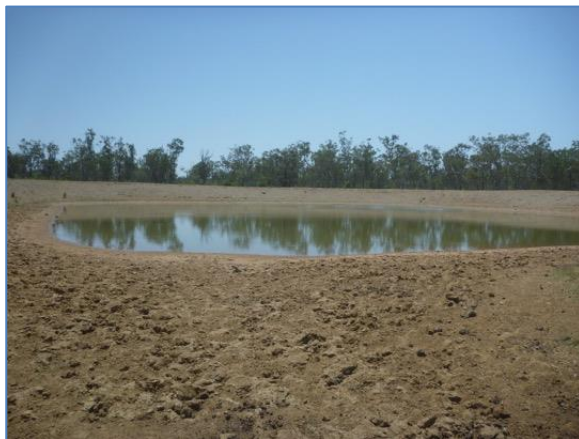
Aquatic habitat at mapped lacustrine wetlands (DES 2020d) and farm dams not mapped by DES was relatively similar and consisted of shallow and deep pools with some terrestrial woody debris and detritus. Instream sediments were typically dominated by blanketing fine silt / clay. The water level was low at most sites, particularly during October 2019, resulting in poor canopy cover and instream shading from riparian vegetation and limited trailing and overhanging vegetation. Some sites contained abundant and diverse aquatic plant communities, including floating and submerged species, indicating that they hold water for extended periods and provide relatively favourable conditions for aquatic flora (Figure 3.1). Most sites were highly impacted by cattle access, resulting in extensive vegetation clearing of the riparian zone, eroded banks and trampling (Figure 3.2).

Figure 3.2 High levels of vegetation clearing and disturbance from cattle access at farm dam site FD7 in October 2019

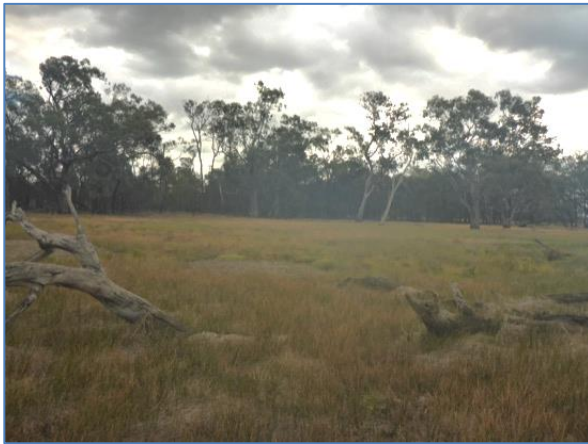
Figure 3.3 Abundant emergent aquatic plant communities in the dry bed at site PW2 in May 2019

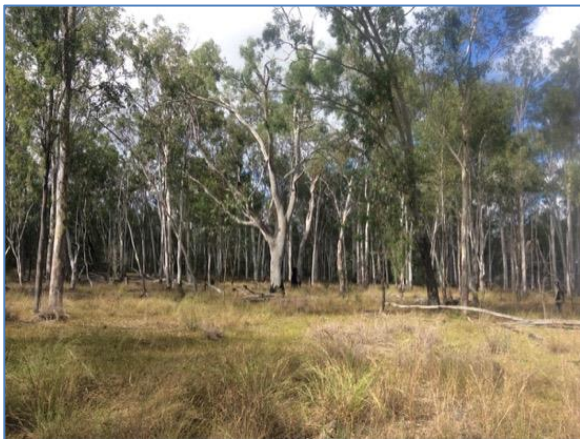
Figure 3.4 Good riparian coverage and emergent aquatic plants at site PW1 (HES wetland) in May 2019

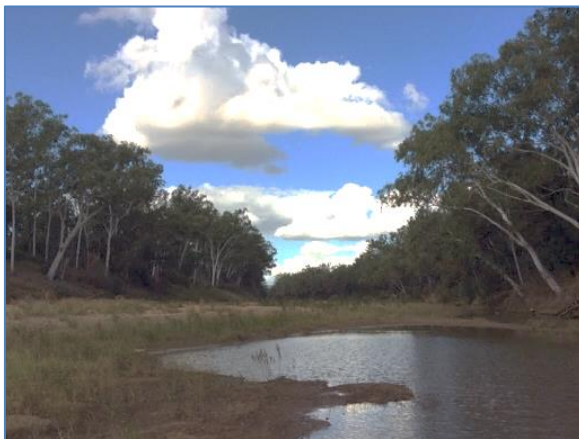
Figure 3.6 Isolated pool habitat at site I3 (Isaac River) in May 2019

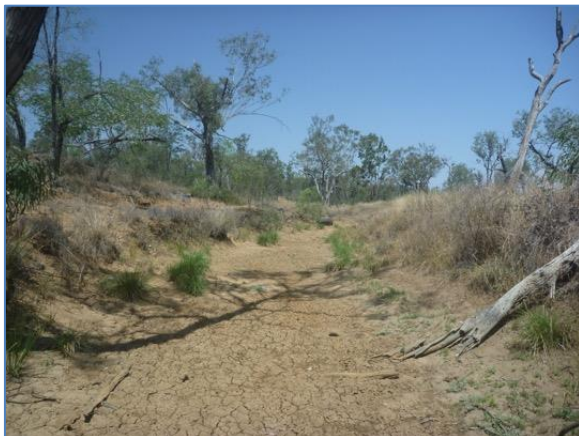
Figure 3.7 Dry, ephemeral channel at site U1 (unnamed tributary of the Isaac River in the north of the Project area) in October 2019

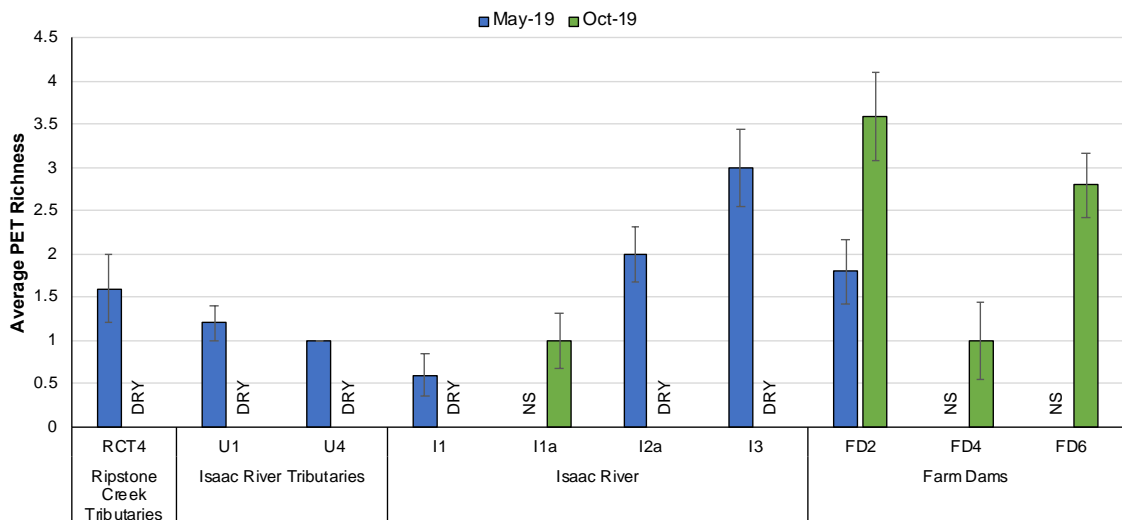
Average PET richness was highest at most of the farm dams (i.e. site FD2 and site FD6) in October 2019; and at site I3 (Isaac River downstream of the Project) in May 2019 (Figure 3.13). These sites consisted of large pools, providing more stable habitat for aquatic macroinvertebrate communities than most other sites (which consisted of small shallow pools with limited habitat availability and complexity). At site FD2 (farm dam), which was sampled during both surveys, average PET richness was higher in October than in May 2019 (Figure 3.13).

Figure 3.13 Average PET richness of macroinvertebrates in edge habitat at each site; NS indicates site not surveyed, DRY indicates the site was dry and could not be surveyed

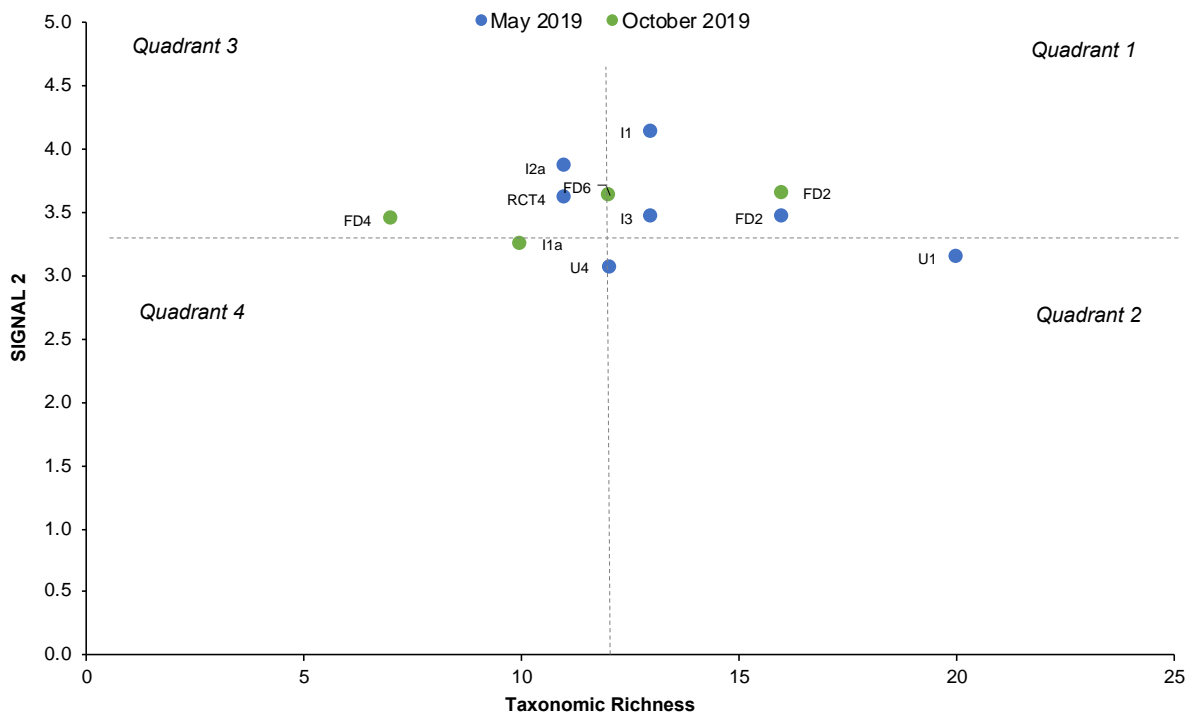
- Site I1a (Isaac River downstream of the Project area), which was on the border of quadrant three and quadrant four in October 2019, indicating toxic pollution or harsh physical conditions, and industrial or agricultural pollution. Given the aquatic habitat condition and water quality results at this site, it is likely that a combination of harsh physical conditions and agricultural pollution contributed to this result. This site consisted of an isolated, drying pool during the field survey, and was impacted by cattle access and trampling (with high concentrations of nutrients and total petroleum hydrocarbons present in the water; Table 3.1).

Figure 3.22 SIGNAL 2 / family bi-plot of macroinvertebrates in bed habitat at each site

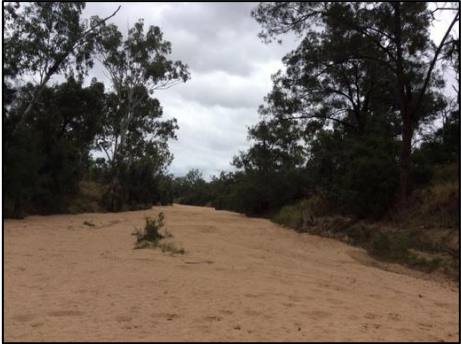
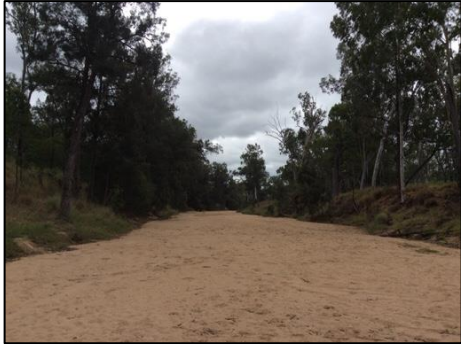
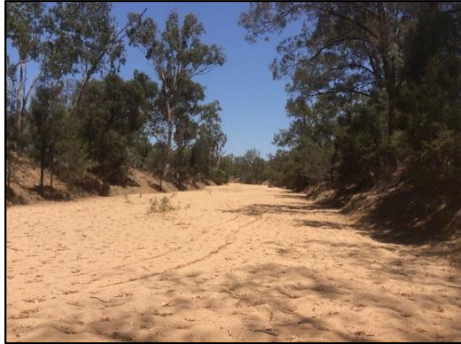
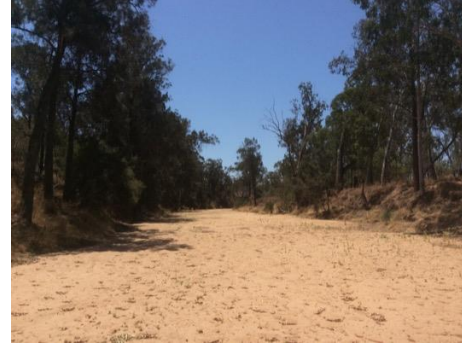
Site: CK1		Location: Upstream of MLAs; Upstream of Project area		Stream Order: 5		Waterway: Cherwell Creek																						
Upstream: May 2019		Downstream: May 2019		Upstream: October 2019		Downstream: October 2019

Aquatic Ecosystem Value: Moderate		MNES/MSES: None present or likely to occur		Dry season refuge: No		Connectivity: Good, during periods of flow																						
In-stream condition: Fair Key potential habitat features included: <ul style="list-style-type: none"> • small amounts of small and large woody debris and detritus • a limited range of sediment grain sizes (predominately sand with some silt/clay), and • trailing and overhanging bank vegetation. The site was dry during both the May and October surveys.		Riparian condition: Fair There was a band of riparian vegetation around the perimeter of the waterway (approximately 10m on both banks), however the extent of the surrounding vegetation had been reduced by land clearing for a fence line, access track and grazing. Vegetation consisted of mature grasses, shrubs and trees (predominantly <i>Eucalyptus</i> and <i>Casuarina</i>). Banks were between 3 m and 6 m high, and gently sloping with some erosion. There were some exotic riparian species present at the site.		External Impacts: Moderate External impacts at the site were mostly associated with the surrounding land-use and included: <ul style="list-style-type: none"> • reduced riparian vegetation as a result of land clearing for a fence line, access track and grazing, and • evidence of cattle access. 		Water Quality:

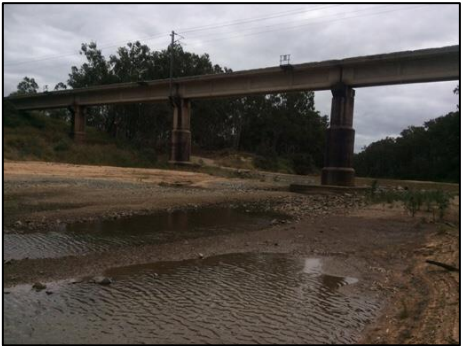
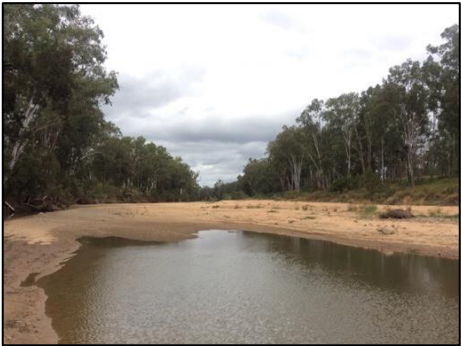
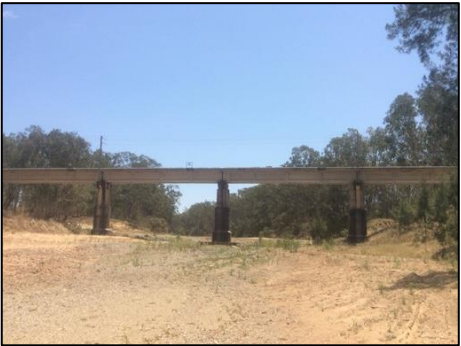
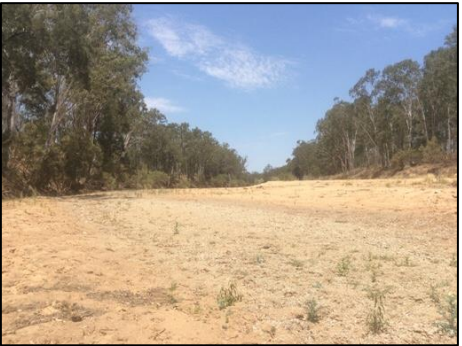
Site: I1		Location: Upstream of MLAs; Upstream of Project area		Stream Order: 6		Waterway: Isaac River																						
Upstream: May 2019		Downstream: May 2019		Upstream: October 2019		Downstream: October 2019

Aquatic Ecosystem Value: Moderate		MNES/MSES: None present or likely to occur		Dry season refuge: No		Connectivity: Good, during periods of flow.																						
In-stream condition: Fair Key habitat features in May included: <ul style="list-style-type: none"> • aquatic plants • a variety of woody debris • periphyton • filamentous algae • blanketing silt • a range of sediment grain sizes (predominately sand with silt/clay, gravel, pebbles, cobble and boulders) • shallow, sandy and rocky pools, and • trailing and overhanging bank vegetation. The site was near a road and rail crossing and consisted of isolated pools in May and was dry in October.		Riparian condition: Fair The riparian zone was mostly continuous around the perimeter of the waterway, although the extent of the vegetation had been reduced by clearing near the road and rail crossings (vegetation zone was approx. 5 to 10 m wide near crossing). Vegetation consisted of grass, shrubs and trees (predominantly <i>Eucalyptus</i> and <i>Casuarina</i>). Banks were low (6 m – 8 m high) and gently sloping with minimal erosion. There some exotic terrestrial riparian species at the site, with an increased abundance surrounding the crossing.		External Impacts: Moderate External impacts at the site were mostly associated with the surrounding land-use and included: <ul style="list-style-type: none"> • alteration of the habitat for the construction of the road and rail crossings, and • reduced riparian vegetation as a result of land clearing. 		Water Quality:

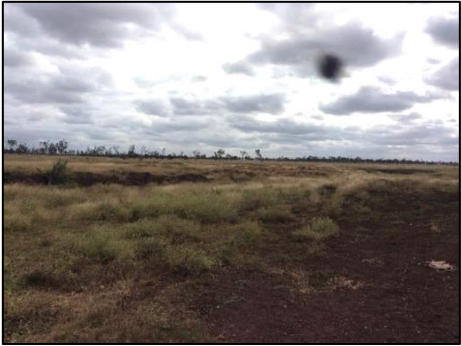
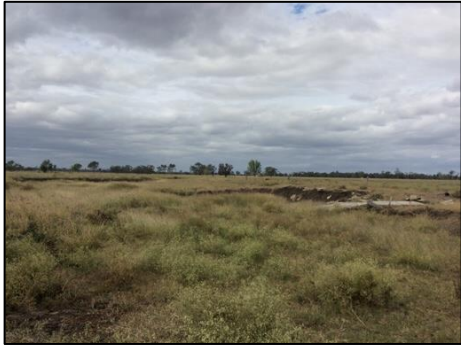
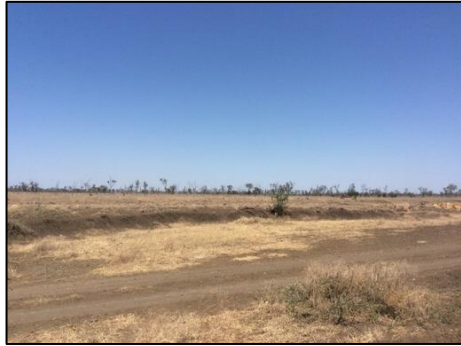
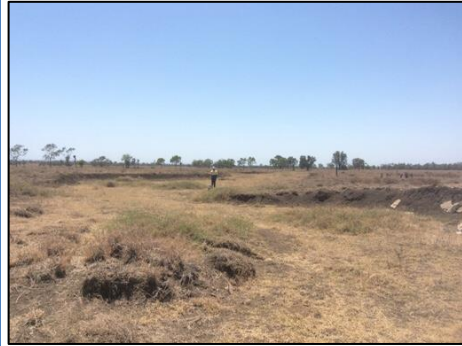
Site: U3		Location: Upstream of MLAs; Upstream of Project area; Eagle Downs		Stream Order: 1		Waterway: Unnamed tributary of the Isaac River																						
Upstream: May 2019		Downstream: May 2019		Upstream: October 2019		Downstream: October 2019

Aquatic Ecosystem Value: Low		MNES/MSES: None present or likely to occur		Dry season refuge: No		Connectivity: Moderate, during periods of flow																						
<p>In-stream condition: Poor</p> <p>Key potential habitat features included:</p> <ul style="list-style-type: none"> • a range of sediment grain sizes (predominately silt/clay with some cobble and boulders), and • some trailing vegetation. <p>The site was dry during both the May and October surveys.</p>		<p>Riparian condition: Poor</p> <p>The extent of the vegetation had been significantly reduced by land clearing (there was no remaining riparian vegetation). Vegetation consisted of grass. Banks were low (1 m high) and gently sloping with some erosion. There was a high abundance of exotic terrestrial riparian species.</p>		<p>External Impacts: High</p> <p>External impacts at the site were mostly associated with the surrounding land-use and included:</p> <ul style="list-style-type: none"> • reduced riparian vegetation as a result of extensive land clearing for grazing and an access track. 		<p>Water Quality:</p>

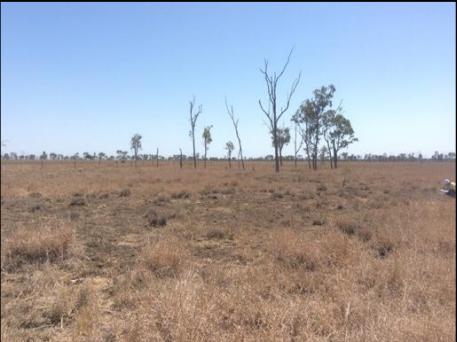
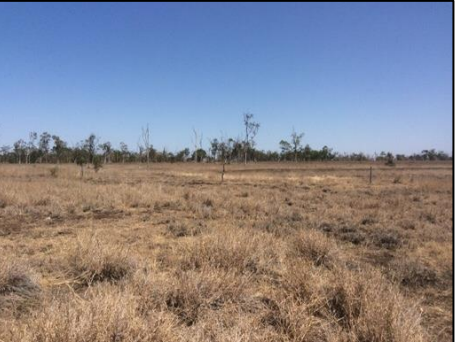
Site: U3a	Location: Upstream of MLAs; Upstream of Project area	Stream Order: 1	Waterway: Unnamed tributary of the Isaac River																					
<p>Left bank, downstream: October 2019</p>

<p>Downstream: October 2019</p>  																					
<p>Aquatic Ecosystem Value: Low</p>	<p>MNES/MSES: None present or likely to occur</p>	<p>Dry season refuge: No</p>	<p>Connectivity: Poor</p>																					
<p>In-stream condition: Poor</p> <p>Key potential habitat features included:</p> <ul style="list-style-type: none"> • a limited range of sediment grain sizes (including silt/clay and sand), and • blanketing silt. <p>The site was dry and only surveyed in October.</p> <p>The site would act only as a drainage channel conveying surface flows during high rainfall events.</p>	<p>Riparian condition: Poor</p> <p>The riparian vegetation had been cleared and there was no riparian zone evident. Vegetation consisted of predominantly grasses. Banks of the drainage channel were low and poorly defined (0.1 m high).</p>	<p>External Impacts: High</p> <p>External impacts at the site were mostly associated with the surrounding land-use and included reduced riparian vegetation as a result of land clearing for grazing.</p>	<p>Water Quality:</p>

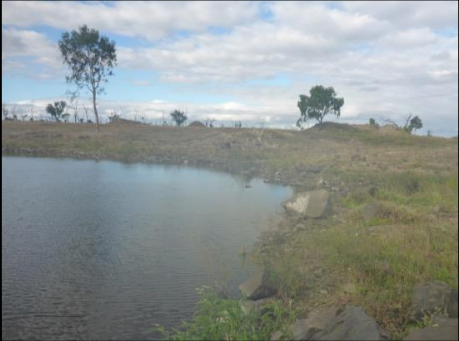
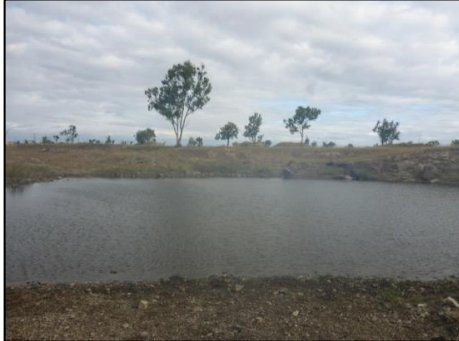
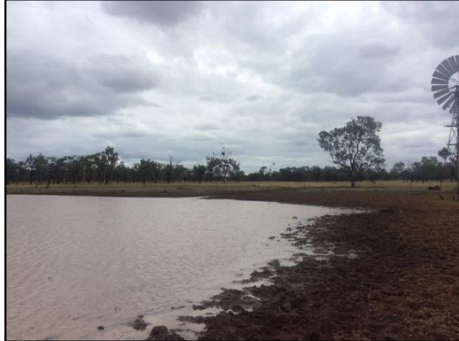
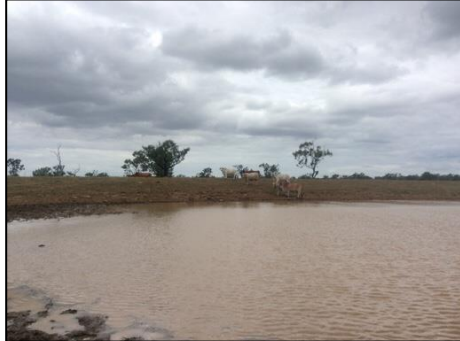
Site: FD1		Location: Within MLA700049; Upstream of Project area		Stream Order: 1		Waterway: Unmapped farm dam on an unnamed tributary of the Isaac River																						
Upstream: May 2019		Downstream: May 2019		Upstream: October 2019		Downstream: October 2019

Aquatic Ecosystem Value: Low		MNES/MSES: None present or likely to occur		Dry season refuge: Yes, but poor quality		Connectivity: Limited except during high flows due to high dam walls																						
<p>In-stream condition: Poor</p> <p>Key habitat features included:</p> <ul style="list-style-type: none"> • periphyton • filamentous algae • blanketing silt • substrate anoxia • a range of sediment grain sizes (predominately silt/clay with some sand and boulders), and • shallow and deep pools. <p>The site consisted of a large farm dam which was surveyed during both May and October. The water level was lower in October than in May.</p>		<p>Riparian condition: Poor</p> <p>The riparian zone had been reduced by land clearing and there was no remaining riparian vegetation except for some isolated mature trees in the broader area. Banks were low (0.5 m high) and gently sloping with some erosion. There was a moderate abundance of terrestrial weeds.</p>		<p>External Impacts: High</p> <p>External impacts at the site were mostly associated with the surrounding land-use and included:</p> <ul style="list-style-type: none"> • alteration of habitat for the dam construction • disturbance to bank stability and instream habitat from cattle access, and • reduced riparian vegetation as a result of land clearing. 		<p>Water Quality:</p>

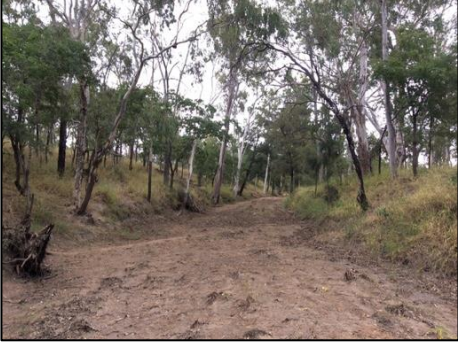
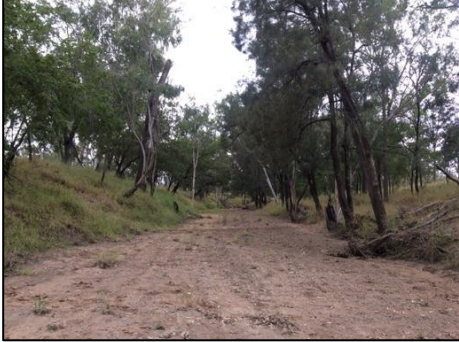
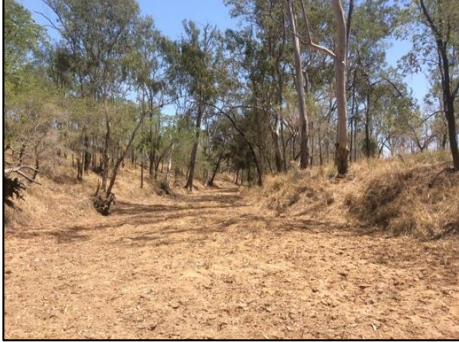
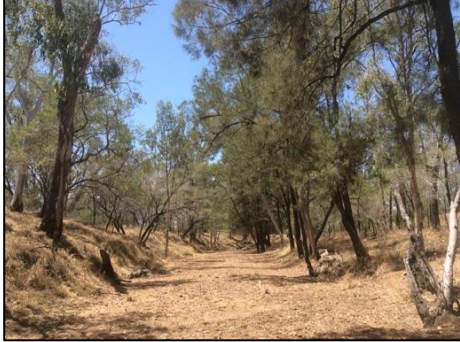
Site: RC1		Location: Adjacent to MLAs; Adjacent to Project area		Stream Order: 3		Waterway: Ripstone Creek																						
Upstream: May 2019		Downstream: May 2019		Upstream: October 2019		Downstream: October 2019

Aquatic Ecosystem Value: Moderate		MNES/MSES: None present or likely to occur		Dry season refuge: No		Connectivity: Moderate, but only during periods of high flow																						
In-stream condition: Fair Key potential habitat features included: <ul style="list-style-type: none"> • low abundance of aquatic plants • a variety of woody debris • good canopy cover • some blanketing silt • a limited range of sediment grain sizes (predominately sand with some silt/clay, gravel and pebbles), and • trailing and overhanging bank vegetation. The site was dry during both the May and October surveys.		Riparian condition: Good The riparian zone consisted of continuous band of vegetation along the waterway, although the extent of the vegetation in the greater region had been reduced by land clearing (remaining riparian zone was approx. 10 - 15 m wide). Vegetation consisted of grasses, shrubs and trees (predominantly <i>Casuarina</i> and iron bark). Banks were approximately 4 m high and steep with some erosion. There was a moderate abundance of exotic riparian species present at the site.		External Impacts: Moderate External impacts at the site were mostly associated with the surrounding land-use and included: <ul style="list-style-type: none"> • disturbance to habitat from cattle access, and • reduced riparian vegetation as a result of land clearing for grazing and access tracks. 		Water Quality:

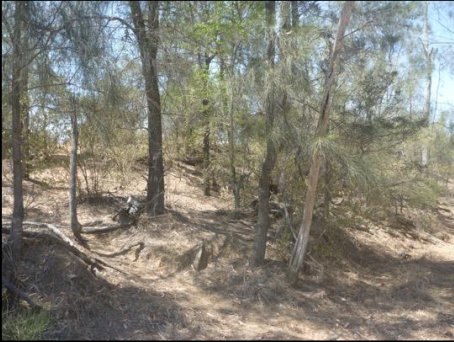
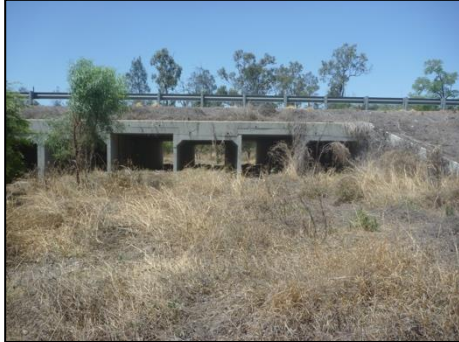
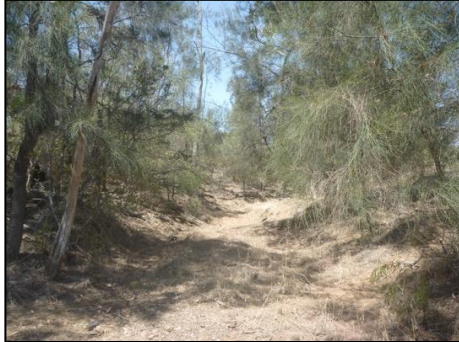
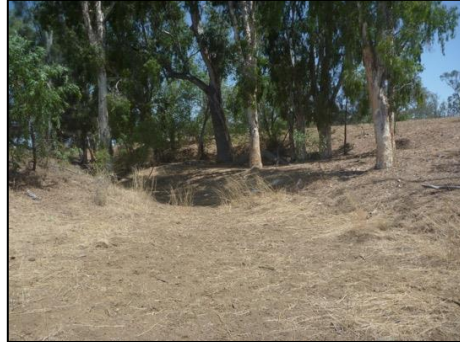
Site: RCT1a		Location: Adjacent to MLAs; Adjacent to Project area		Stream Order: 2		Waterway: Unnamed tributary of Ripstone Creek																						
Left bank: October 2019		Waterway crossing: October 2019		Upstream: October 2019		Downstream: October 2019

Aquatic Ecosystem Value: Low		MNES/MSES: None present or likely to occur		Dry season refuge: No		Connectivity: Limited, would rarely hold water except for times of high flow																						
<p>In-stream condition: Poor to fair</p> <p>Key potential habitat features included:</p> <ul style="list-style-type: none"> • a range of woody debris including large woody debris • canopy cover • blanketing silt • a range of sediment grain sizes (predominately silt/clay and sand with some gravel, pebbles, cobble and boulders), and • trailing and overhanging bank vegetation. <p>The site was only surveyed in October and was dry.</p>		<p>Riparian condition: Fair</p> <p>The riparian zone consisted of a thin strip of vegetation that had been reduced by land clearing (remaining vegetation zone was approx. 5 m wide on both banks). Vegetation consisted of predominately grasses with some shrubs and trees (<i>Eucalyptus</i>). Banks were low (1.5 m high) and gently sloping with some erosion. There was extensive exotic weed species present at the site.</p>		<p>External Impacts: Moderate</p> <p>External impacts at the site were mostly associated with the surrounding land-use and included:</p> <ul style="list-style-type: none"> • reduced riparian vegetation as a result of land clearing for access tracks, rail crossing and grazing, and • presence of culverts. 		<p>Water Quality:</p>

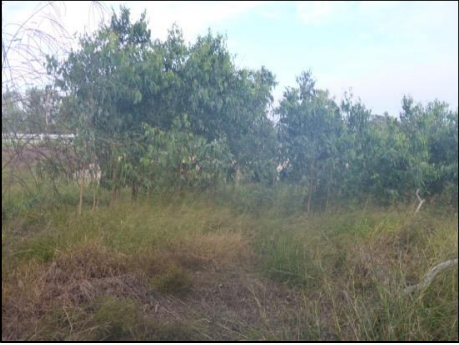
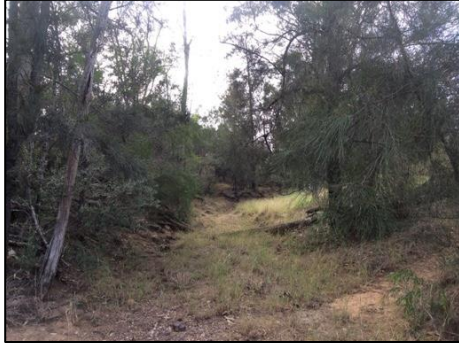
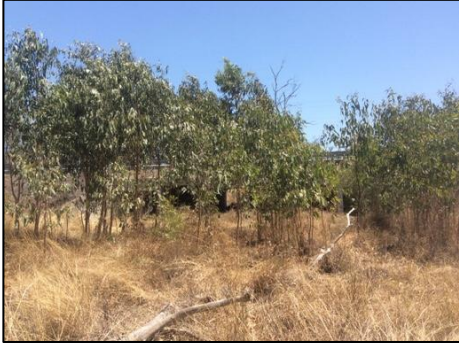
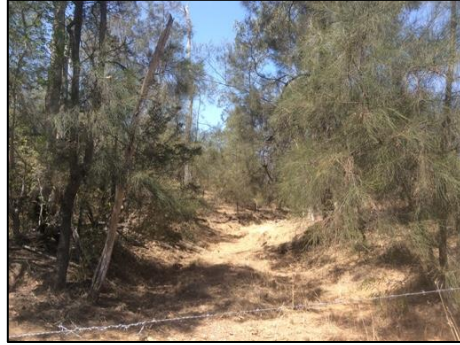
Site: RCT1		Location: Adjacent to MLAs; Adjacent to Project area		Stream Order: 2		Waterway: Unnamed tributary of Ripstone Creek																						
Upstream: May 2019		Downstream: May 2019		Upstream: October 2019		Downstream: October 2019

Aquatic Ecosystem Value: Low		MNES/MSES: None present or likely to occur		Dry season refuge: No		Connectivity: Limited, would rarely hold water except for times of high flow																						
<p>In-stream condition: Poor to fair</p> <p>Key potential habitat features included:</p> <ul style="list-style-type: none"> minimal aquatic plants a range of woody debris canopy cover blanketing silt a range of sediment grain sizes (predominately silt/clay and sand with some gravel, pebbles, cobble and boulders), and trailing and overhanging bank vegetation. <p>The site was dry in both the May and October surveys.</p>		<p>Riparian condition: Fair</p> <p>The riparian zone consisted of a thin strip of vegetation that had been reduced by land clearing (remaining vegetation zone was approx. 5 m wide on the left bank and 3 m wide on the right bank). Vegetation consisted of predominately grasses with some shrubs and trees (<i>Casuarina</i> and <i>Eucalyptus</i>). Banks were low (3 m high) and gently sloping with some erosion. There was extensive exotic weed species present at the site.</p>		<p>External Impacts: Moderate</p> <p>External impacts at the site were mostly associated with the surrounding land-use and included:</p> <ul style="list-style-type: none"> reduced riparian vegetation as a result of land clearing for the highway crossing and grazing presence of culverts at the highway crossing, and rubbish and litter. 		<p>Water Quality:</p>

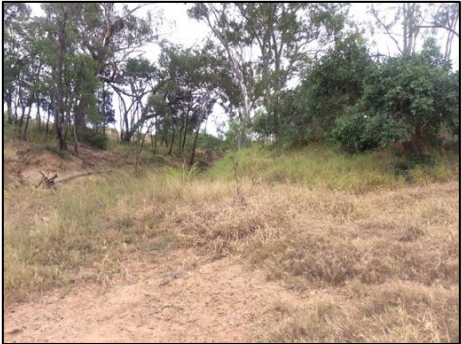
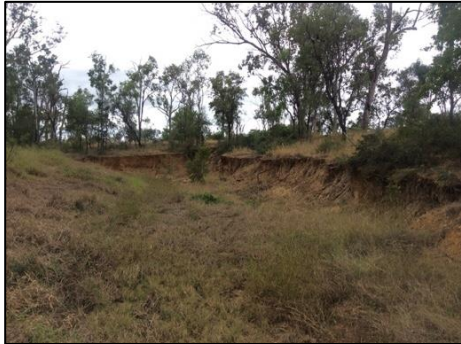
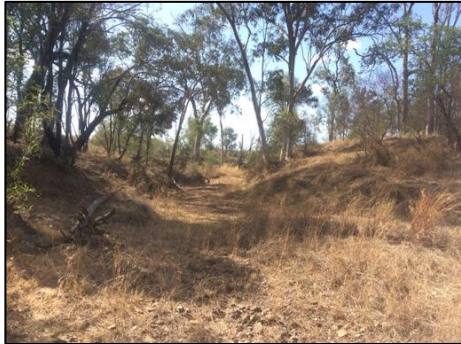
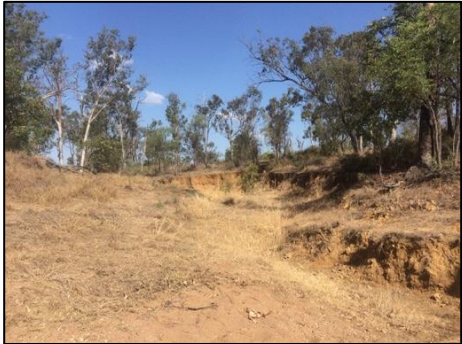
Site: RCT2		Location: Adjacent to MLAs; Adjacent to Project area		Stream Order: 2		Waterway : Unnamed tributary of Ripstone Creek																						
Upstream: May 2019		Downstream: May 2019		Upstream: October 2019		Downstream: October 2019

Aquatic Ecosystem Value: Low		MNES/MSES: None present or likely to occur		Dry season refuge: No		Connectivity: Limited, only during periods of high flow																						
<p>In-stream condition: Poor</p> <p>Key potential habitat features included:</p> <ul style="list-style-type: none"> limited aquatic plants a variety of woody debris types minimal canopy cover a range of sediment grain sizes (predominantly sand with some silt/clay, gravel, pebbles, cobble and boulders) blanketing silt, and trailing and overhanging bank vegetation. <p>The site was dry during both the May and October surveys.</p>		<p>Riparian condition: Fair</p> <p>Vegetation consisted of a continuous strip around the perimeter of the waterway, although the extent of the vegetation in the greater region had been reduced by land clearing (remaining riparian zone was approx. 5 m wide). Vegetation consisted of grasses, shrubs and trees (predominantly <i>Eucalyptus</i> and iron bark). Banks were low (3 m high) and steep with high levels of erosion in some sections. There was a moderate abundance of exotic riparian species present at the site.</p>		<p>External Impacts: Moderate</p> <p>External impacts at the site were mostly associated with the surrounding land-use and included:</p> <ul style="list-style-type: none"> reduced riparian vegetation and subsequent erosion as a result of land clearing. 		<p>Water Quality:</p>

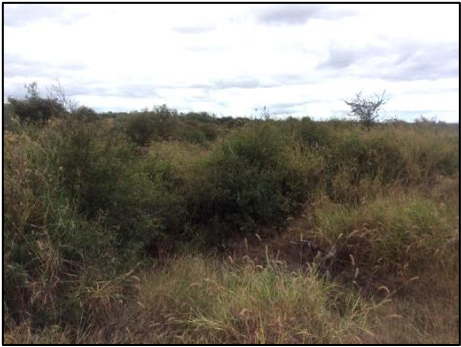
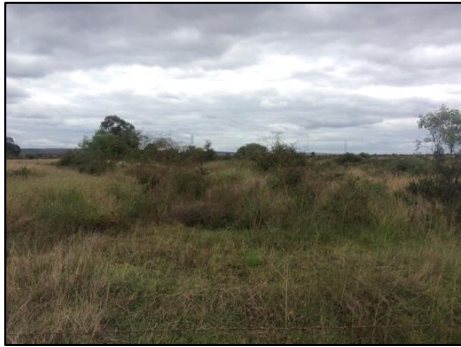
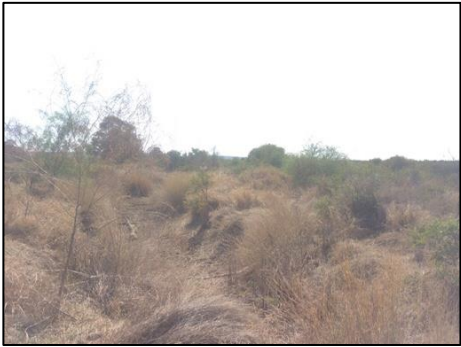
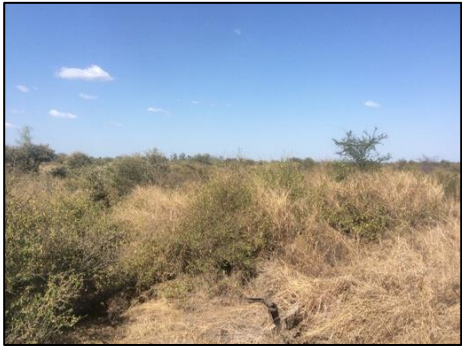
Site: RCT3		Location: Adjacent to MLAs; Adjacent to Project area		Stream Order: 1		Waterway: Unnamed tributary of Ripstone Creek																						
Upstream: May 2019		Downstream: May 2019		Upstream: October 2019		Downstream: October 2019

Aquatic Ecosystem Value: Low		MNES/MSES: None present or likely to occur		Dry season refuge: No		Connectivity: Limited, during periods of high flow																						
In-stream condition: Poor Key habitat features in May included: <ul style="list-style-type: none"> • limited aquatic plants • variety of woody debris • periphyton • blanketing silt • a limited range of sediment grain sizes (including silt/clay and sand), and • trailing bank vegetation. The site consisted of small shallow pool in May and was dry during October.		Riparian condition: Poor There was a narrow strip of vegetation around the perimeter of the waterway (2 m wide on the left bank and 3 m wide on the right bank), and the surrounding land had been impacted by extensive land clearing of the riparian zone. Vegetation consisted of grasses, shrubs and trees (predominantly <i>Acacia</i>). Banks were low (1 m high) and stable with little erosion. There were some exotic terrestrial weeds present at this site.		External Impacts: High External impacts at the site were mostly associated with the surrounding land-use and included: <ul style="list-style-type: none"> • disturbance to bank stability, vegetation and instream habitat from cattle access, and • reduced riparian vegetation as a result of land clearing. 		Water Quality:

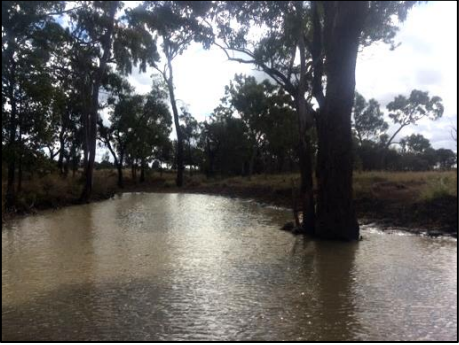
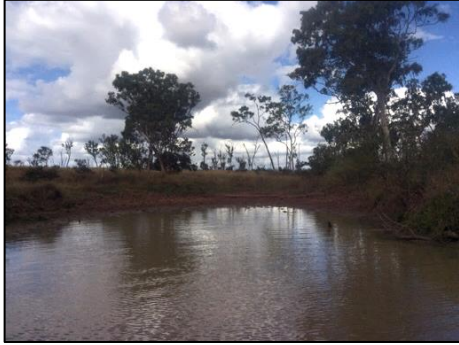
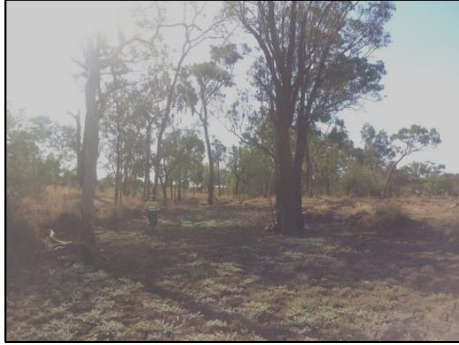
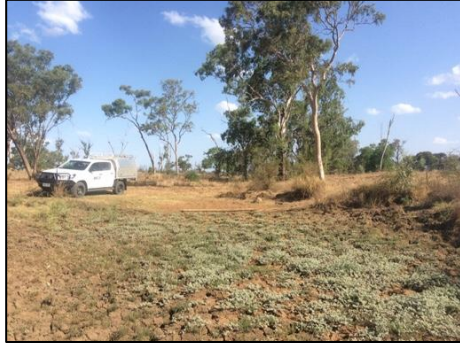
Site: RCT4		Location: Adjacent to MLAs; Adjacent to Project area		Stream Order: 1		Waterway: Unnamed tributary of Ripstone Creek																						
Upstream: May 2019		Downstream: May 2019		Upstream: October 2019		Downstream: October 2019

Aquatic Ecosystem Value: Low		MNES/MSES: None present or likely to occur		Dry season refuge: No		Connectivity: Limited, due to downstream track crossing and extended dry periods																						
<p>In-stream condition: Poor</p> <p>Key habitat features in May included:</p> <ul style="list-style-type: none"> • limited aquatic plants • woody debris • periphyton • a limited range of sediment grain sizes (including silt/clay and sand), and • some trailing and overhanging bank vegetation. <p>The site consisted of a large shallow pool in May and was dry in October.</p>		<p>Riparian condition: Poor</p> <p>The extent of riparian vegetation had been reduced by land clearing and cattle trampling (remaining vegetation zone was approx. 1 – 2 m wide). Vegetation consisted of predominantly grasses with some shrubs and trees (predominantly <i>Eucalyptus</i>). Banks were low (0.5 m – 1 m high) and gently sloping with erosion from cattle access. There were some exotic riparian species present at the site.</p>		<p>External Impacts: High</p> <p>External impacts at the site were mostly associated with the surrounding land-use and included:</p> <ul style="list-style-type: none"> • alteration of the habitat to construct the downstream track crossing • disturbance to bank stability and instream habitat from cattle access, and • reduced riparian vegetation as a result of land clearing. 		<p>Water Quality:</p>

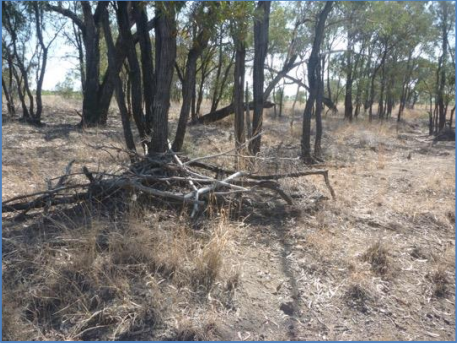
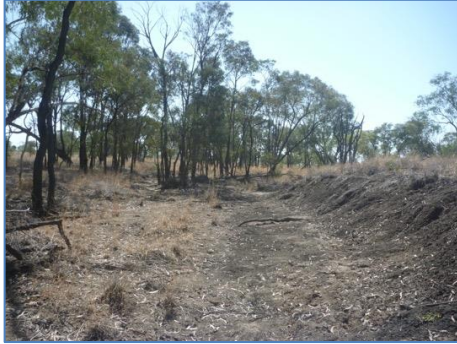
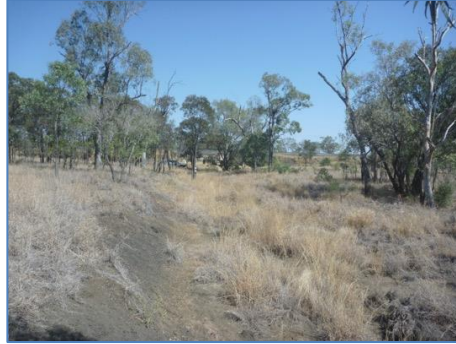
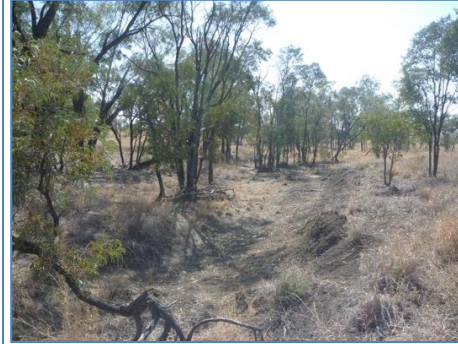
Site: RCT5		Location: Adjacent to MLAs; Adjacent to Project area		Stream Order: 1		Waterway: Unnamed tributary of Ripstone Creek																						
Left bank, downstream: October 2019		Right bank, downstream: October 2019		Upstream: October 2019		Downstream: October 2019

Aquatic Ecosystem Value: Low		MNES/MSES: None present or likely to occur		Dry season refuge: No		Connectivity: Limited, during periods of high flow																						
<p>In-stream condition: Poor</p> <p>Key potential habitat features in May included:</p> <ul style="list-style-type: none"> woody debris terrestrial detritus a limited range of sediment grain sizes (including silt/clay and sand), and trailing and overhanging bank vegetation. <p>The site was not surveyed in May and was dry in October.</p>		<p>Riparian condition: Fair</p> <p>The riparian zone consisted of a thin strip of vegetation that had been reduced by land clearing (remaining vegetation zone was approx. 5 m wide on both banks). Vegetation consisted of predominately grasses with some shrubs and trees (<i>Eucalyptus</i>). Banks were low (1 m high) and gently sloping with some erosion. There was extensive exotic weed species present at the site.</p>		<p>External Impacts: Moderate</p> <p>External impacts at the site were mostly associated with the surrounding land-use and included:</p> <ul style="list-style-type: none"> alteration of the habitat to construct a track crossing at the upstream extent of the site disturbance to bank stability and instream habitat from cattle access, and reduced riparian vegetation as a result of land clearing, particularly around the rail crossing. 		<p>Water Quality:</p>

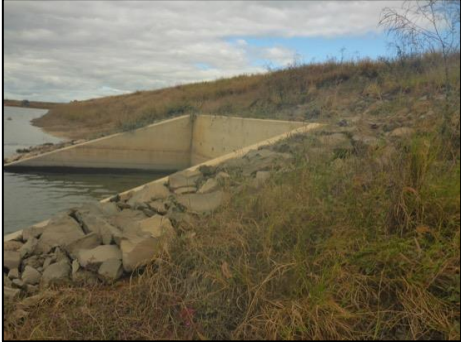
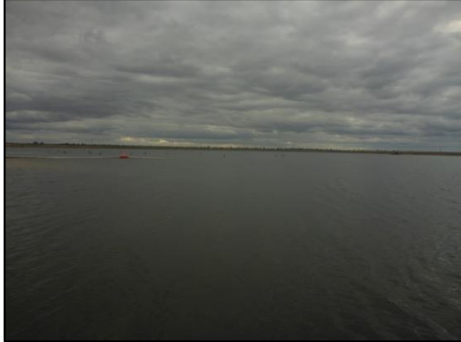
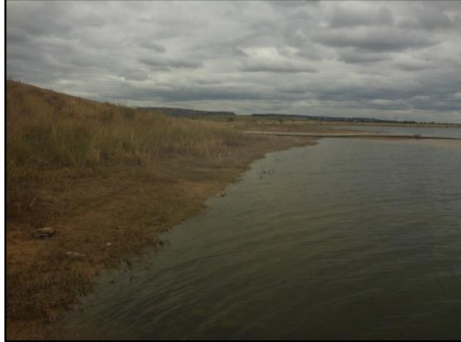
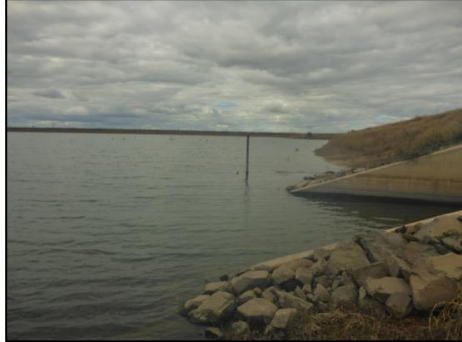
Site: LW4		Location: Upstream of MLAs; Adjacent to Project area		Stream Order: 1		Waterway: Mapped lacustrine wetland																						
Upstream: May 2019		Downstream: May 2019		Upstream: May 2019		Downstream: May 2019

Aquatic Ecosystem Value: Low		MNES/MSES: None present or likely to occur		Dry season refuge: Contains water year-round but very poor water quality		Connectivity: Limited upstream and downstream by high dam walls																						
In-stream condition: Poor Key habitat features in May included: <ul style="list-style-type: none"> shallow and deep pools, and sediment dominated by silt with some boulders. 		Riparian condition: Poor No riparian zone was present due to extensive clearing for construction of the dam and access tracks. Banks were high (approx. 5 m high) and gently sloping with minimal erosion. A moderate abundance of grass and terrestrial weeds was present along the banks.		External Impacts: High This site consisted of an artificial dam that was part of a mine water management system. There was no riparian vegetation and water quality was poor, with very high EC.		Water Quality:

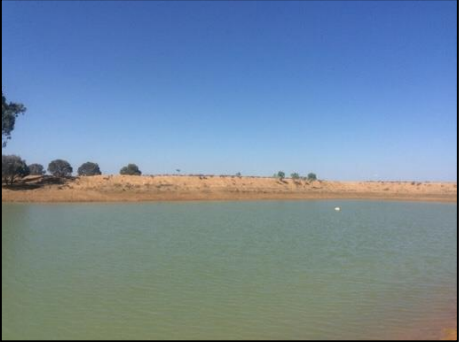
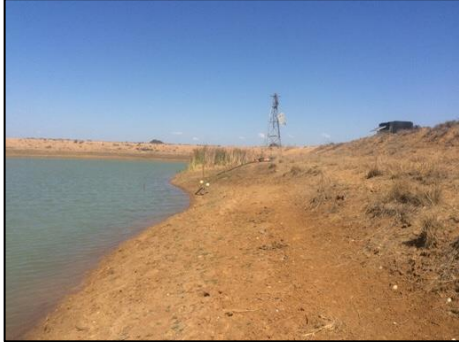
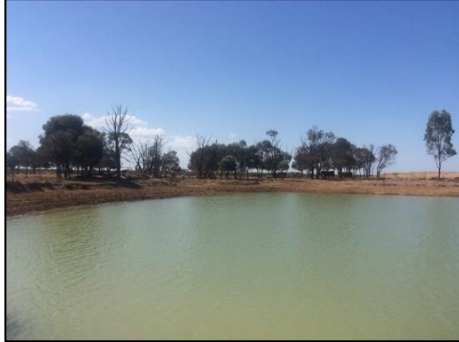
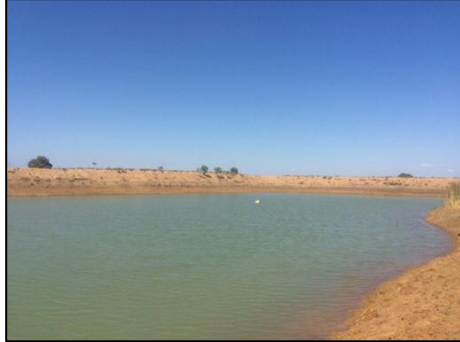
Site: FD5		Location: Within MLA700050; Adjacent to Project area		Stream Order: 1		Waterway: Unmapped farm dam																						
Left bank, downstream: October 2019		Right bank, downstream: October 2019		Upstream: October 2019		Downstream: October 2019

Aquatic Ecosystem Value: Low		MNES/MSES: None present or likely to occur		Dry season refuge: Yes		Connectivity: Poor																						
In-stream condition: Poor Key habitat features in October included: <ul style="list-style-type: none"> minimal coverage of aquatic plants a limited range of sediment grain sizes (predominantly silt/clay and sand) periphyton shallow and deep pools, and blanketing silt. The site was only surveyed in October.		Riparian condition: Poor The extent of the riparian zone had been reduced by land clearing, there was no riparian vegetation except for a small number of isolated mature trees (predominantly <i>Eucalyptus</i> and <i>Acacia</i>) upstream of the dam. Banks were high (5 m high) and gently sloping with minimal erosion. There was a moderate abundance of terrestrial weeds.		External Impacts: High External impacts at the site were mostly associated with the surrounding land-use and included: <ul style="list-style-type: none"> alteration of habitat to construct the dam disturbance to bank stability and instream habitat from cattle access, and reduced riparian vegetation as a result of land clearing. 		Water Quality:

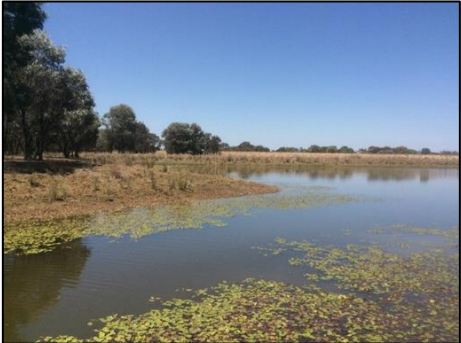
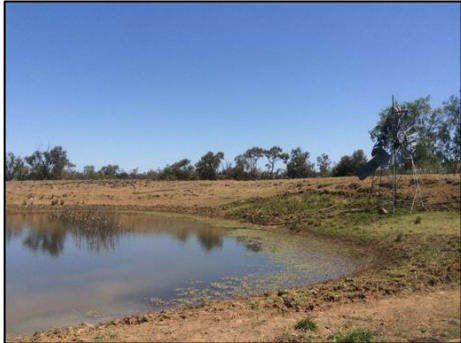
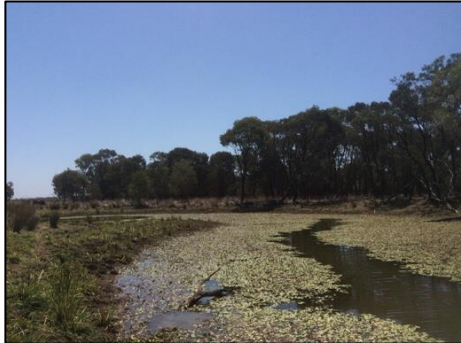
Site: FD6		Location: Within MLA700050; Adjacent to Project area		Stream Order: 1		Waterway: Unmapped farm dam on an unnamed tributary of Ripstone Creek																						
Left bank, downstream: October 2019		Right bank, downstream: October 2019		Upstream: October 2019		Downstream: October 2019

Aquatic Ecosystem Value: Moderate		MNES/MSES: None present or likely to occur		Dry season refuge: Yes		Connectivity: Poor, due to high dam walls																						
<p>In-stream condition: Fair</p> <p>Key habitat features in October included:</p> <ul style="list-style-type: none"> • diverse range of aquatic plants • a variety of woody debris • a limited range of sediment grain sizes (predominately clay/silt) • blanketing silt • filamentous algae • periphyton • shallow and deep pools, and • overhanging bank vegetation. <p>The site was only surveyed during October.</p>		<p>Riparian condition: Poor</p> <p>The riparian zone was mostly continuous around the upstream channel (approx. 8 m wide) but the vegetation surrounding the dam had been cleared. Vegetation consisted of mostly grasses with some shrubs and small trees (predominantly <i>Acacia</i> with some <i>Eucalyptus</i>). Banks were low (1 m – 3 m high) and gently sloping with some erosion. There were some exotic riparian species present at the site.</p>		<p>External Impacts: Moderate to high</p> <p>External impacts at the site were mostly associated with the surrounding land-use and included:</p> <ul style="list-style-type: none"> • alteration of habitat to construct the dam • disturbance to bank stability and instream habitat from cattle access, and • reduced riparian vegetation as a result of land clearing. 		<p>Water Quality:</p>

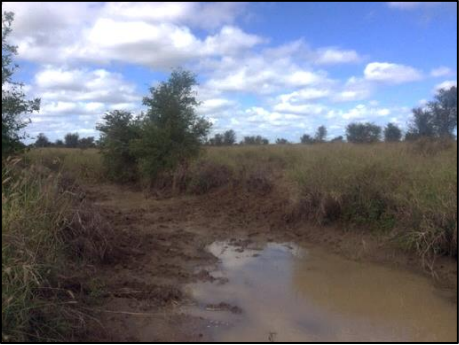
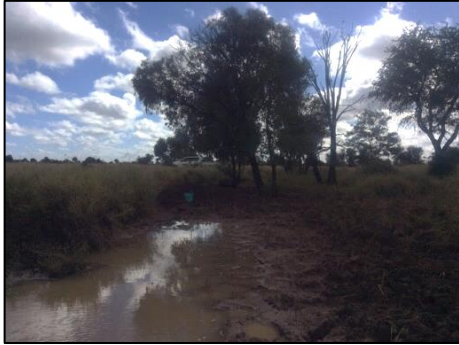
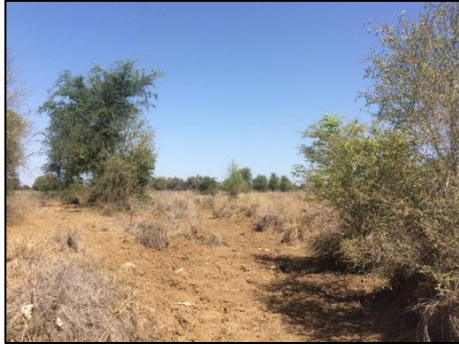
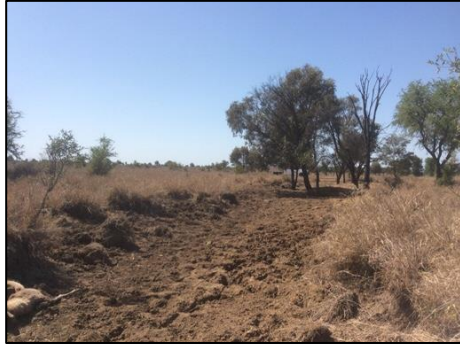
Site: U4		Location: Within MLA700049; Within Project area		Stream Order: 1		Waterway: Unmapped unnamed tributary of the Isaac River																						
Upstream: May 2019		Downstream: May 2019		Upstream: October 2019		Downstream: October 2019

Aquatic Ecosystem Value: Low		MNES/MSES: None present or likely to occur		Dry season refuge: No		Connectivity: Limited, to periods of high flow																						
<p>In-stream condition: Poor</p> <p>Key habitat features in May included:</p> <ul style="list-style-type: none"> limited in stream habitat extensive in stream siltation periphyton a limited range of sediment grain sizes (including silt/clay and sand) substrate anoxia shallow and sandy pools, and limited trailing and overhanging bank vegetation. <p>The site consisted of a chain of shallow pools during the May survey and was dry in October.</p>		<p>Riparian condition: Poor</p> <p>Riparian vegetation had been significantly reduced by land clearing and trampling (remaining vegetation zone was approx. 2 m wide). Vegetation consisted of predominately grasses with some shrubs and trees (including brigalow (<i>Acacia harpophylla</i>) and other <i>Acacia</i> spp.. Banks were low (1 m high) and gently sloping with some erosion. There were some exotic terrestrial weeds present at the site.</p>		<p>External Impacts: Moderate</p> <p>External impacts at the site were mostly associated with the surrounding land-use and included:</p> <ul style="list-style-type: none"> disturbance to bank stability and instream habitat from cattle access, and reduced riparian vegetation as a result of land clearing for grazing and cattle access. 		<p>Water Quality:</p>

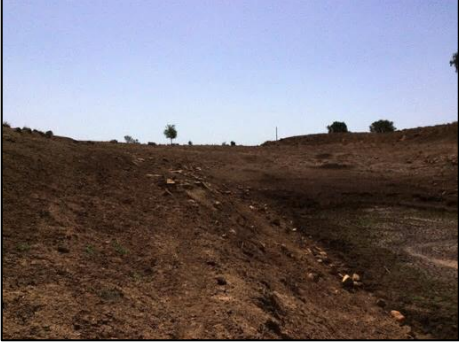
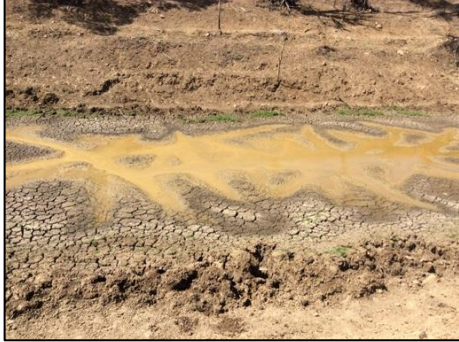
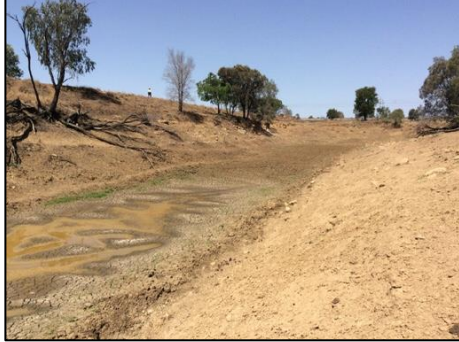
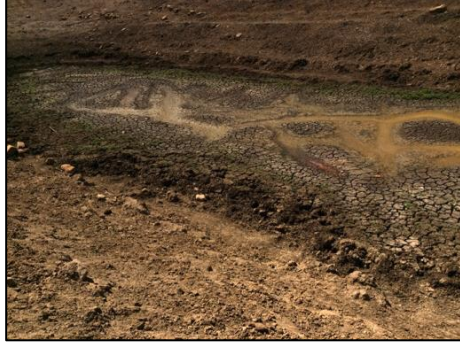
Site: LW1		Location: Within MLA700049; Within Project area		Stream Order: 1		Waterway: Mapped lacustrine wetland																						
Left bank, downstream: October 2019		Right bank: October 2019		Upstream: October 2019		Downstream: October 2019

Aquatic Ecosystem Value: Low		MNES/MSES: None present or likely to occur		Dry season refuge: No		Connectivity: Limited, would only hold water during periods of high flow																						
<p>In-stream condition: Poor</p> <p>Key potential habitat features included:</p> <ul style="list-style-type: none"> limited woody debris consisting of detritus and sticks periphyton filamentous algae blanketing silt, and a limited range of sediment grain sizes (predominately silt/clay with some sand and boulders). <p>The site was only surveyed in October. Only remnant pools remained that were too shallow to be sampled.</p>		<p>Riparian condition: Poor</p> <p>The riparian zone had been significantly reduced by vegetation clearing (remaining vegetation zone was approx. 10 m wide on the left bank and 0 m on the right bank). Vegetation consisted of a small amount of grasses, shrubs and trees. Banks were high (8 m high) and steep, with moderate levels of erosion. There were some exotic riparian species present at the site.</p>		<p>External Impacts: High</p> <p>External impacts at the site were mostly associated with the surrounding land-use and included:</p> <ul style="list-style-type: none"> disturbance to bank stability and instream habitat from cattle and feral animal access alteration of habitat to construct the dam, and reduced riparian vegetation as a result of land clearing. 		<p>Water Quality:</p>
