WINCHESTER SOUTH PROJECT

Aquatic Ecology and Stygofauna Assessment

Prepared for: Whitehaven WS Pty Ltd

May 2021

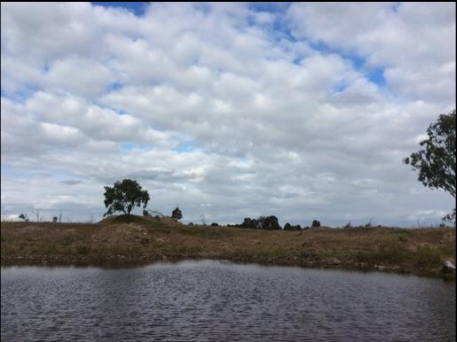
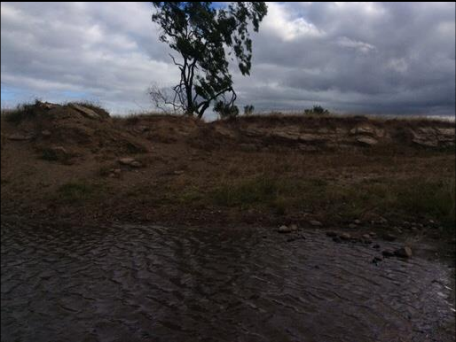
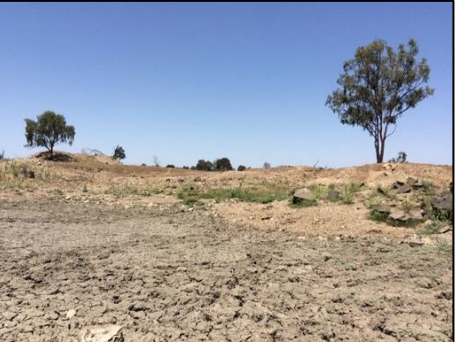
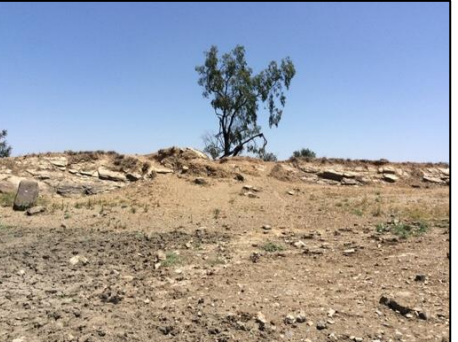
Site: LW2	Location: Within MLA700049; Within Project area	Stream Order: 1	Waterway : Mapped lacustrine wetland																						
<p>Upstream: May 2019</p>

<p>Aquatic Ecosystem Value: Low</p>	<p>MNES/MSES: None present or likely to occur</p>	<p>Dry season refuge: No</p>	<p>Connectivity: Poor</p>																						
<p>In-stream condition: Poor</p> <p>Key habitat features in May included:</p> <ul style="list-style-type: none"> • low coverage of emergent aquatic plants • a variety of woody debris • a wide range of sediment grain sizes (though predominately silt/clay) • blanketing silt • filamentous algae and periphyton • shallow and deep pools, and • little trailing bank vegetation. <p>The site consisted of two disconnected pools in May and was dry during October.</p>	<p>Riparian condition: Poor</p> <p>There was extensive clearing of the riparian zone, with limited vegetation remaining. Vegetation consisted of mature trees (predominantly <i>Eucalyptus</i>), with some grasses and shrubs. Banks were low (1 m – 2 m high) with limited erosion. There were some exotic riparian species present at the site.</p>	<p>External Impacts: High</p> <p>External impacts at the site were mostly associated with the surrounding land-use and included:</p> <ul style="list-style-type: none"> • alteration of habitat to construct the dam, with excavation piles around the broader area • disturbance to bank stability and instream habitat from cattle and feral animal access, and • reduced riparian vegetation as a result of land clearing. 	<p>Water Quality:</p>

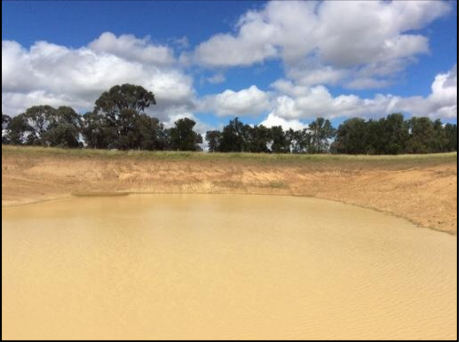
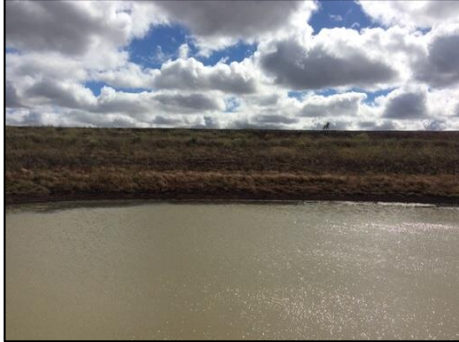
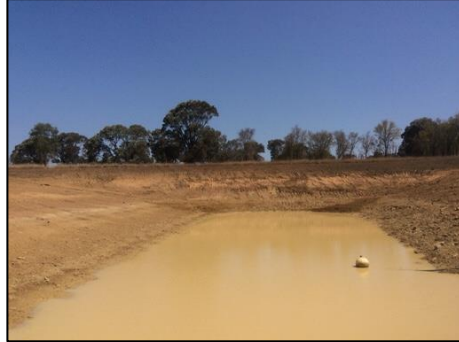
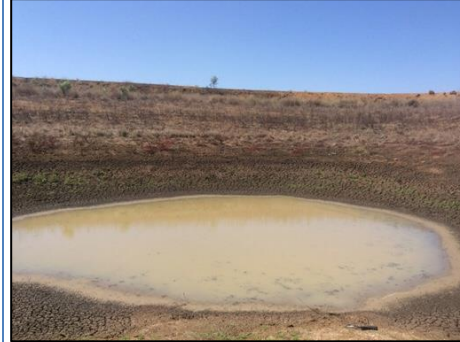
Site: LW3		Location: Within MLA700049; Within Project area		Stream Order: 1		Waterway: Mapped lacustrine wetland																						
Upstream: May 2019		Downstream: May 2019		Upstream: October 2019		Downstream: October 2019

Aquatic Ecosystem Value: Low		MNES/MSES: None present or likely to occur		Dry season refuge: Possible, but unlikely due to poor connectivity		Connectivity: Poor																						
<p>In-stream condition: Poor</p> <p>Key habitat features included:</p> <ul style="list-style-type: none"> limited aquatic plants periphyton filamentous algae a range of sediment grain sizes (predominantly silt/clay with some sand, gravel, pebble and cobble), and shallow and deep pools. <p>The site was surveyed in both May and October. The water level was lower in October than in May.</p>		<p>Riparian condition: Poor</p> <p>The riparian zone had been reduced by land clearing and there was no remaining riparian vegetation. The site was predominantly bare, with very few grasses and shrubs present. Banks were high (7 m high) and steep with extensive erosion on bare banks. There was a moderate abundance of terrestrial weeds along the upper banks.</p>		<p>External Impacts: High</p> <p>External impacts at the site were mostly associated with the surrounding land-use and included:</p> <ul style="list-style-type: none"> alteration of habitat for the dam construction disturbance to bank stability and instream habitat from cattle and feral animal access, and reduced riparian vegetation as a result of land clearing. 		<p>Water Quality:</p>

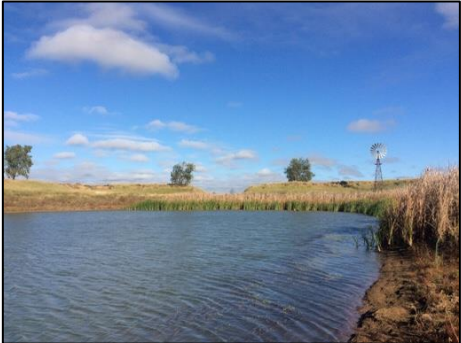
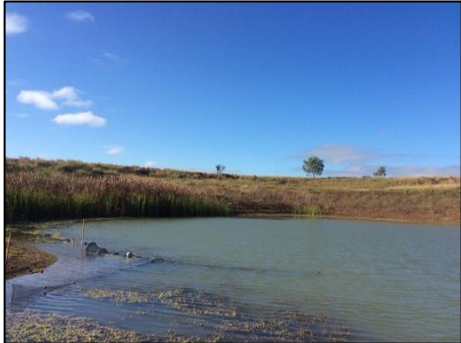
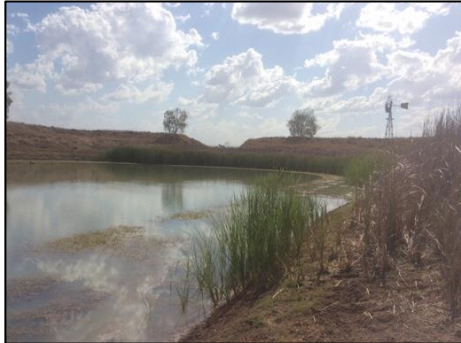
Site: FD2		Location: Within MLA700049; Within Project area		Stream Order: 2		Waterway: Unmapped farm dam on an unnamed tributary of the Isaac River																						
Upstream: May 2019		Downstream: May 2019		Upstream: October 2019		Downstream: October 2019

Aquatic Ecosystem Value: Moderate		MNES/MSES: None present or likely to occur		Dry season refuge: Yes		Connectivity: Limited, due to high dam walls																						
<p>In-stream condition: Fair</p> <p>Key habitat features included:</p> <ul style="list-style-type: none"> • aquatic plants • limited woody debris (detritus / sticks) • a range of sediment grain sizes (predominately silt/clay with some sand, gravel and pebbles) • blanketing silt • filamentous algae and periphyton • shallow and deep pools, and • substrate anoxia. <p>The site was surveyed in both May and October. The water level was lower in October than in May.</p>		<p>Riparian condition: Poor</p> <p>There was extensive clearing of the riparian zone, with little remaining riparian vegetation. Vegetation consisted of some grasses and shrubs, with isolated trees (predominantly <i>Acacia</i>). Banks were 4 m high, steep with little erosion. There was extensive coverage of exotic riparian species at the site.</p>		<p>External Impacts: Moderate</p> <p>External impacts at the site were mostly associated with the surrounding land-use and included:</p> <ul style="list-style-type: none"> • alteration of the habitat to construct the dam, and • reduced riparian vegetation as a result of land clearing. 		<p>Water Quality:</p>

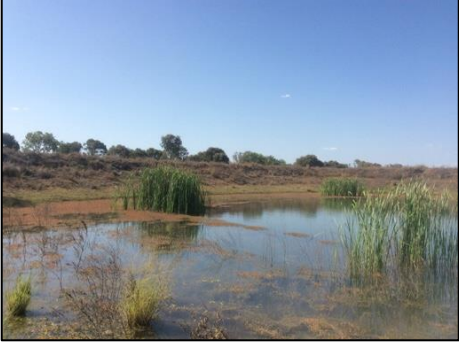
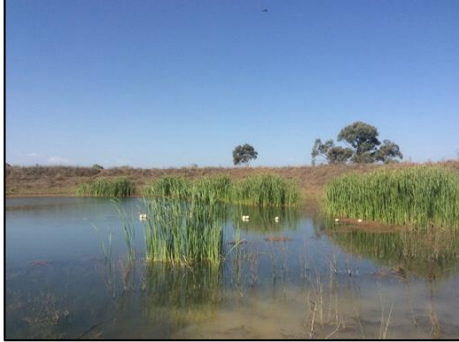
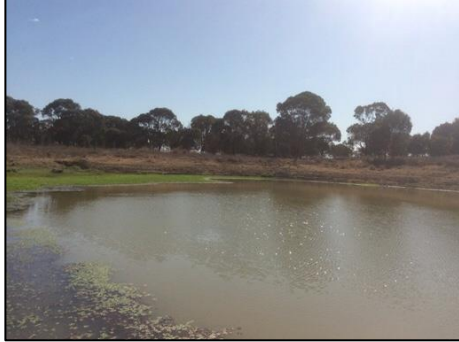
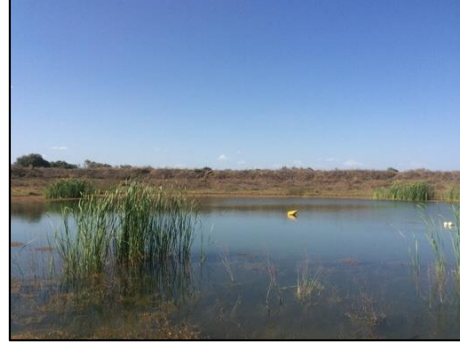
Site: FD4		Location: Within MLA700050; Within Project area		Stream Order: 1		Waterway: Unmapped farm dam																						
Left bank, downstream: October 2019		Right bank, downstream: October 2019		Upstream: October 2019		Downstream: October 2019

Aquatic Ecosystem Value: Moderate		MNES/MSES: None present or likely to occur		Dry season refuge: Yes		Connectivity: Poor due to high dam walls																						
<p>In-stream condition: Fair</p> <p>Key habitat features in October included:</p> <ul style="list-style-type: none"> • aquatic plants • small woody debris (detritus and sticks) • filamentous algae and periphyton • blanketing silt • a limited range of sediment grain sizes (predominantly silt/clay with some sand) • shallow and deep pools, and • trailing bank vegetation. <p>The site was only surveyed during October.</p>		<p>Riparian condition: Poor</p> <p>The extent of the riparian vegetation had been significantly reduced by land clearing. There was no riparian vegetation immediately surrounding the dam although brigalow was present in the wider area. Vegetation consisted of grasses and shrubs. Banks were high (5 m high) and steep with minimal erosion. There were some exotic riparian species present at the site.</p>		<p>External Impacts: High</p> <p>External impacts at the site were mostly associated with the surrounding land-use and included:</p> <ul style="list-style-type: none"> • alteration of habitat to construct the dam • disturbance to bank stability and instream habitat from cattle access, and • reduced riparian vegetation as a result of land clearing. 		<p>Water Quality:</p>

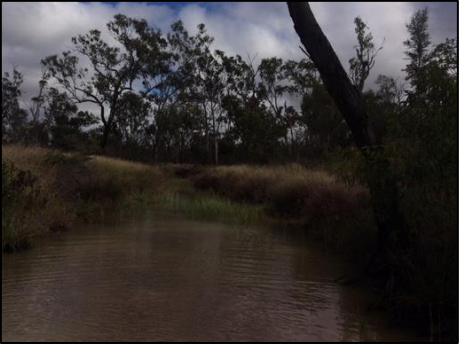
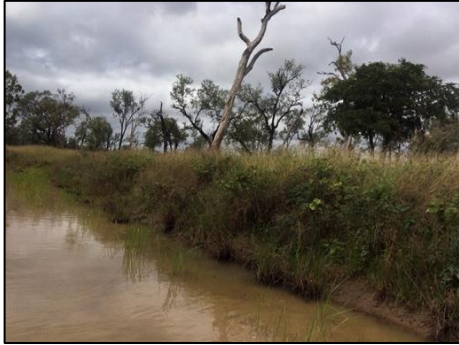
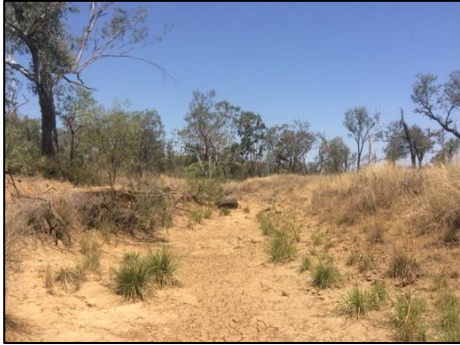
Site: U1		Location: Within MLA700049; Downstream of Project area		Stream Order: 2		Waterway: Unnamed tributary of the Isaac River																						
Upstream: May 2019		Downstream: May 2019		Upstream: October 2019		Downstream: October 2019

Aquatic Ecosystem Value: Moderate		MNES/MSES: None present or likely to occur		Dry season refuge: No		Connectivity: Good, but only during periods of high flow																						
<p>In-stream condition: Fair</p> <p>Key habitat features in May included:</p> <ul style="list-style-type: none"> • aquatic plants • a variety of woody debris • periphyton • blanketing silt • a range of sediment grain sizes (predominately silt/clay with some sand and boulders) • shallow pools, and • trailing and overhanging bank vegetation. <p>The site consisted of a series of isolated shallow pools in May and was dry during October.</p>		<p>Riparian condition: Moderate</p> <p>The vegetation surrounding the site had been significantly reduced by land clearing (remaining vegetation zone was approx. 2 - 5 m wide), however there was good coverage of riparian vegetation upstream and downstream of the site. Vegetation consisted of grass, shrubs and trees (predominantly <i>Eucalyptus</i>). Banks were low (1.5 m high) and gently sloping with minimal erosion. There was a moderate abundance of terrestrial weeds.</p>		<p>External Impacts: Moderate</p> <p>External impacts at the site were mostly associated with the surrounding land-use and included reduced riparian vegetation as a result of land clearing.</p>		<p>Water Quality:</p>

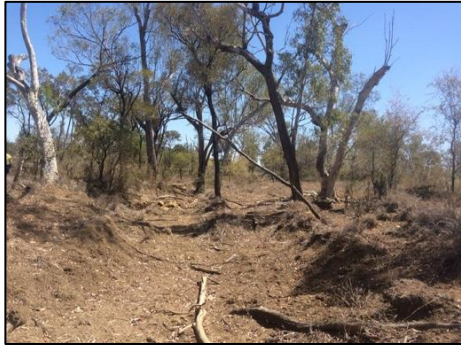
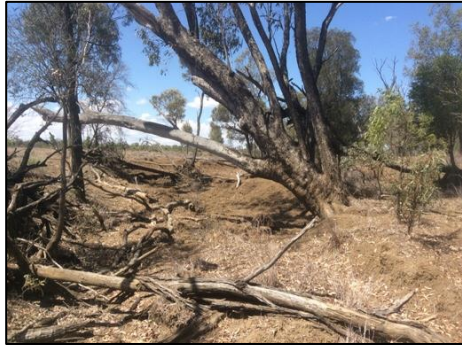
Site: U2		Location: Within MLA700050; Downstream of Project area		Stream Order: 2		Waterway: Unnamed tributary of the Isaac River																						
Upstream: May 2019		Downstream: May 2019		Upstream: October 2019		Downstream: October 2019

Aquatic Ecosystem Value: Low		MNES/MSES: None present or likely to occur		Dry season refuge: No		Connectivity: Good, but only during periods of high flow																						
<p>In-stream condition: Poor</p> <p>Key potential habitat features included:</p> <ul style="list-style-type: none"> • a variety of woody debris including detritus, sticks, branches and logs • a range of sediment grain sizes (predominately silt/clay with some sand, gravel, pebble, cobble and boulders) • blanketing silt, and • trailing and overhanging bank vegetation. <p>The site was dry during both the May and October surveys.</p>		<p>Riparian condition: Poor to fair</p> <p>There was a thin strip of riparian vegetation (approx. 5 m wide on the left bank and 10 m wide on the right bank) at the perimeter of the waterway. Surrounding vegetation had been reduced by land clearing. Vegetation consisted of mature trees (predominantly <i>Eucalyptus</i> and <i>Casuarina</i>). Banks were low (1.5 m high) and gently sloping with moderate erosion. There was a moderate amount of exotic riparian species present at the site.</p>		<p>External Impacts: Moderate</p> <p>External impacts at the site were mostly associated with the surrounding land-use and included:</p> <ul style="list-style-type: none"> • disturbance to bank stability and instream habitat from cattle access, and • reduced riparian vegetation as a result of land clearing. 		<p>Water Quality:</p>

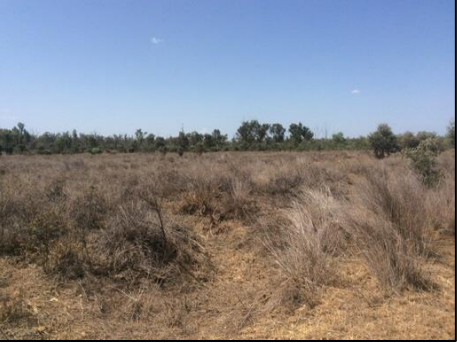
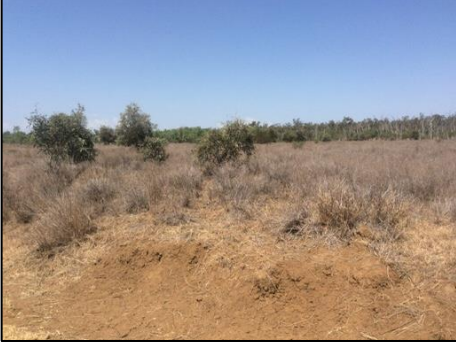
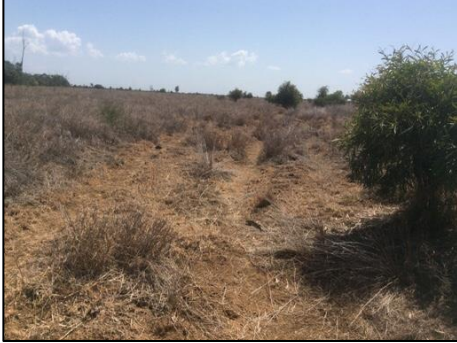
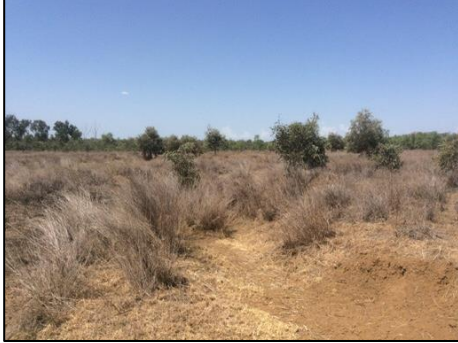
Site: U5		Location: Within MLA700050; Downstream of Project area		Stream Order: 1		Waterway: Unnamed tributary of the Isaac River																						
Left bank, downstream: October 2019		Right bank, downstream: October 2019		Upstream: October 2019		Downstream: October 2019

Aquatic Ecosystem Value: Low		MNES/MSES: None present or likely to occur		Dry season refuge: No		Connectivity: Poor																						
<p>In-stream condition: Poor</p> <p>Key potential habitat features included:</p> <ul style="list-style-type: none"> • low diversity of aquatic plants • minimal woody debris • a limited range of sediment grain sizes (including silt/clay and sand) • limited canopy cover, and • limited trailing and overhanging bank vegetation. <p>The site was only surveyed during October when it was dry.</p>		<p>Riparian condition: Poor</p> <p>The riparian zone had been reduced by land clearing (remaining vegetation zone was approx. 1 m wide). Vegetation consisted of grasses, shrubs and some small trees (predominantly <i>Acacia</i>). Banks were low (0.5 m high) and gently sloping with some erosion. There were some exotic riparian species present at the site.</p>		<p>External Impacts: High</p> <p>External impacts at the site were mostly associated with the surrounding land-use and included:</p> <ul style="list-style-type: none"> • disturbance to bank stability and instream habitat from cattle access, and • reduced riparian vegetation as a result of land clearing. 		<p>Water Quality:</p>

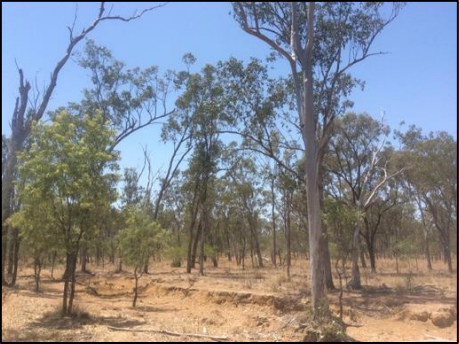
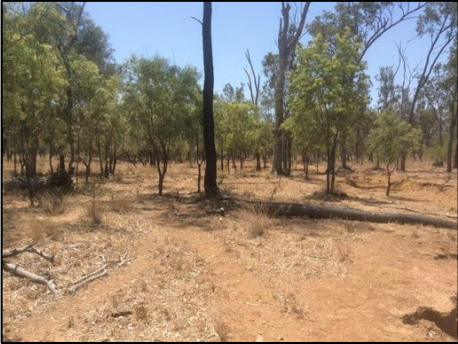
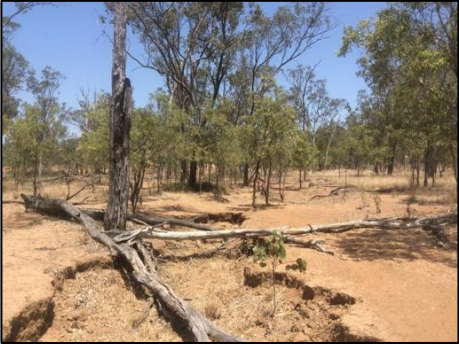
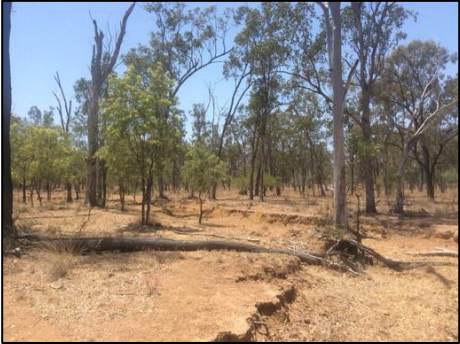
Site: U6	Location: Downstream of MLAs; Downstream of Project area	Stream Order: 1	Waterway: Unnamed tributary of the Isaac River																					
<p>Left bank, downstream: October 2019</p>

<p>Aquatic Ecosystem Value: Low</p>	<p>MNES/MSES: None present or likely to occur</p>	<p>Dry season refuge: No</p>	<p>Connectivity: Limited, downstream of farm dam and would only be connected during periods of high rainfall.</p>																					
<p>In-stream condition: Moderate</p> <p>Key potential habitat features included:</p> <ul style="list-style-type: none"> • a range of woody debris (including detritus, sticks, branches and logs) • a limited range of sediment grain sizes (including silt/clay and sand) • moderate canopy cover, and • trailing and overhanging bank vegetation. <p>The site was only surveyed during October when it was dry.</p>	<p>Riparian condition: Fair</p> <p>The riparian zone consisted of continuous vegetation around the perimeter of the waterway. Vegetation consisted of mature trees (predominantly <i>Eucalyptus</i> and <i>Acacia</i>). Banks were low (0.5 m) and steep with extensive erosion. There were some exotic riparian species present at the site.</p>	<p>External Impacts: Moderate</p> <p>External impacts at the site were mostly associated with the surrounding land-use and included:</p> <ul style="list-style-type: none"> • alteration of habitat to construct a dam upstream, and • disturbance to bank stability and instream habitat from cattle and feral animal access. 	<p>Water Quality:</p>

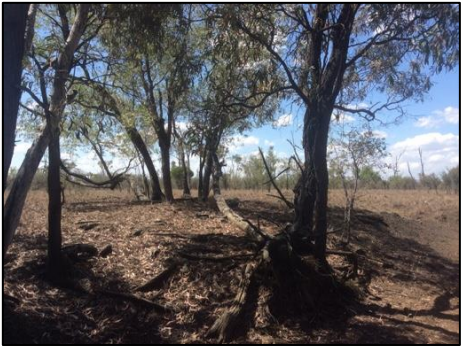
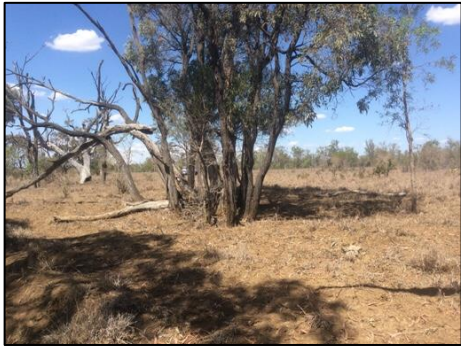
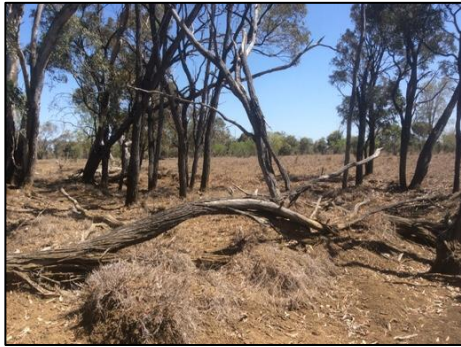
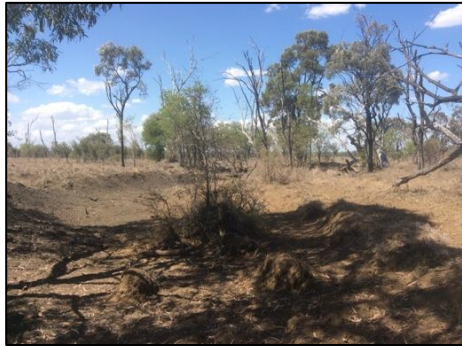
Site: U7		Location: Within MLA700050; Downstream of Project area		Stream Order: 1		Waterway: Unnamed tributary of the Isaac River																						
Upstream: October 2019		Downstream: October 2019		Upstream: October 2019		Downstream: October 2019

Aquatic Ecosystem Value: Low		MNES/MSES: None present or likely to occur		Dry season refuge: Possible - Unlikely		Connectivity: Moderate, during periods of high flow																						
In-stream condition: Poor Key potential habitat features included: <ul style="list-style-type: none"> • some woody debris (detritus, sticks, branches and logs) • a limited range of sediment grain sizes (including silt/clay, sand and gravel) • some canopy cover, and • some trailing and overhanging bank vegetation. The site was only surveyed during October when it was dry.		Riparian condition: Poor The riparian zone had been extensively cleared for grazing with only thin sections of riparian vegetation remaining (vegetation was approximately 5m wide). Vegetation consisted of <i>Eucalyptus</i> and <i>Acacia</i> (up to 10m high). Banks were low (0.5m) with a gentle slope and minimal erosion. There were some exotic riparian species at the site.		External Impacts: High External impacts at the site were mostly associated with the surrounding land-use and included: <ul style="list-style-type: none"> • reduced riparian vegetation as a result of land clearing, and • disturbance to bank stability and instream habitat from cattle. 		Water Quality:

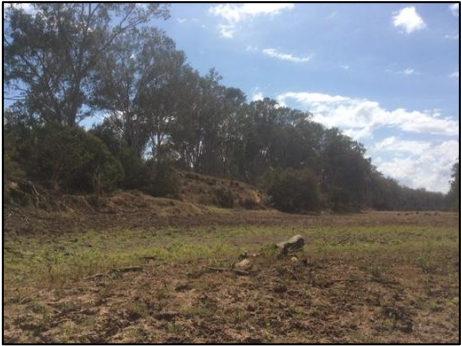
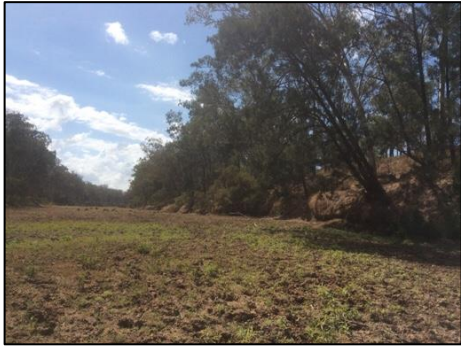
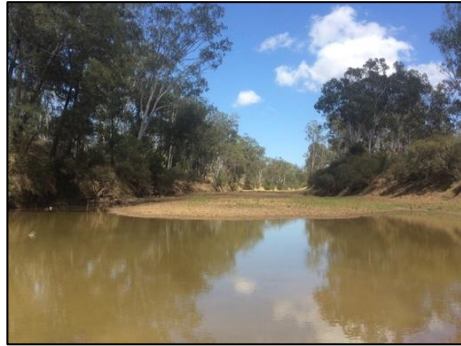
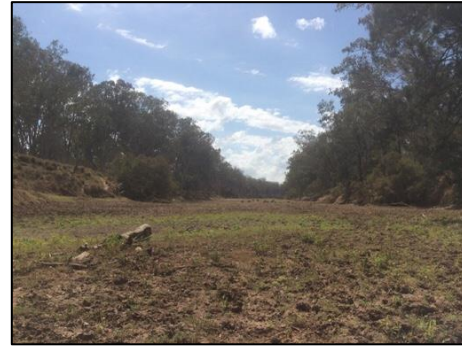
Site: I1a		Location: Downstream of MLAs; Downstream of Project area		Stream Order: 6		Waterway: Isaac River																						
Left bank, downstream: October 2019		Right bank, downstream: October 2019		Upstream: October 2019		Downstream: October 2019

Aquatic Ecosystem Value: Moderate		MNES/MSES: None present or likely to occur		Dry season refuge: Yes		Connectivity: Good, during periods of flow																						
In-stream condition: Good Key habitat features in October included: <ul style="list-style-type: none"> • instream sandy bars • aquatic plants • large woody debris • a limited range of sediment grain sizes (predominately sand with some silt/clay) • shallow and deep pools, and • trailing and overhanging bank vegetation. The site was only surveyed during October.		Riparian condition: Good The riparian zone was mostly continuous although the extent of the vegetation had been reduced by land clearing for grazing (remaining vegetation zone was approx. 10 m wide). Vegetation consisted of mature trees (predominantly <i>Eucalyptus</i> and <i>Melaleuca</i>). Banks were high (7 m high) and gently sloping with some erosion. There were some exotic riparian species present at the site.		External Impacts: Moderate External impacts at the site were mostly associated with the surrounding land-use and included: <ul style="list-style-type: none"> • disturbance to bank stability and instream habitat from cattle access, and • reduced vegetation in the broader area as a result of land clearing. 		Water Quality:

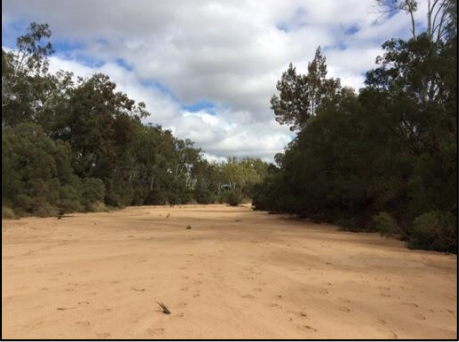
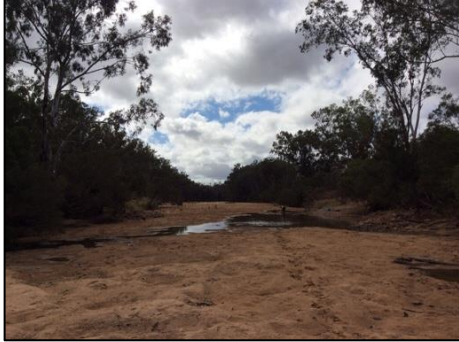
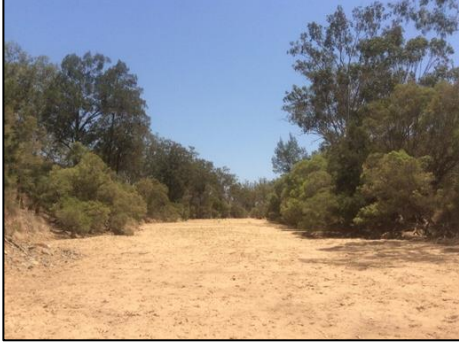
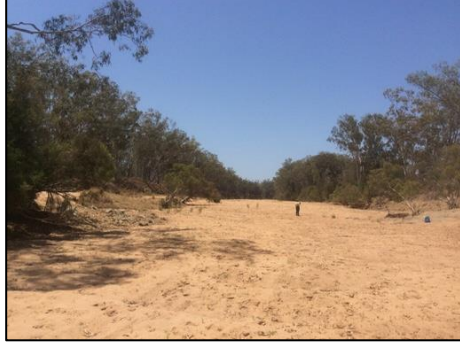
Site: I2a		Location: Downstream of MLAs; Downstream of Project area		Stream Order: 6		Waterway: Isaac River																						
Upstream: May 2019		Downstream: May 2019		Upstream: October 2019		Downstream: October 2019

Aquatic Ecosystem Value: Moderate		MNES/MSES: None present or likely to occur		Dry season refuge: No		Connectivity: Good, during periods of high flow																						
In-stream condition: Fair Key habitat features in May included: <ul style="list-style-type: none"> • aquatic plants and periphyton • a range of woody debris • filamentous algae • blanketing silt • a range of sediment grain sizes (sand with some silt/clay, gravel, pebble, cobble, boulder, and bed rock) • shallow, rocky and sandy pools, and • trailing and overhanging bank vegetation. The site consisted of shallow isolated pools in May and was dry in October.		Riparian condition: Fair The riparian zone was mostly continuous on the left bank of the waterway, although the extent of the vegetation had been reduced by land clearing (remaining vegetation zone was continuous on left bank and approx. 7 m wide on right bank). Vegetation consisted of grasses, shrubs and trees (predominantly <i>Eucalyptus</i> and <i>Melaleuca</i>). Banks were high (approx. 6 m high) and gently sloping with some erosion. There were exotic riparian species present at the site.		External Impacts: Moderate External impacts at the site were mostly associated with the surrounding land-use and included: <ul style="list-style-type: none"> • disturbance to bank stability and instream habitat from cattle access, and • reduced riparian vegetation as a result of land clearing for grazing and track crossing. 		Water Quality:

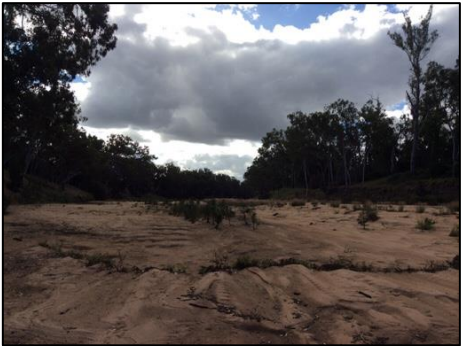
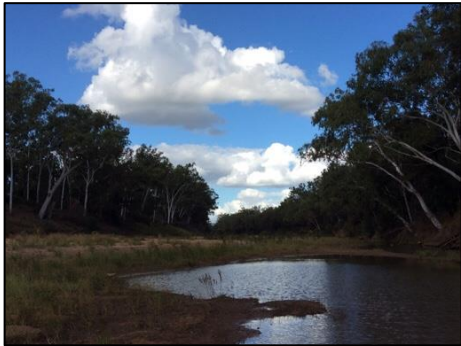
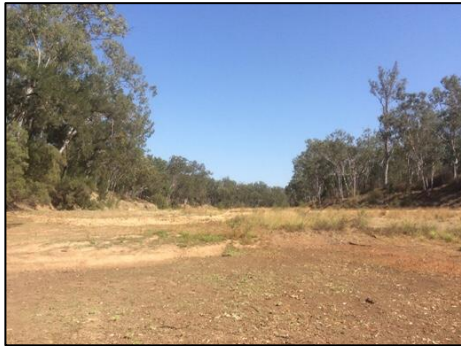
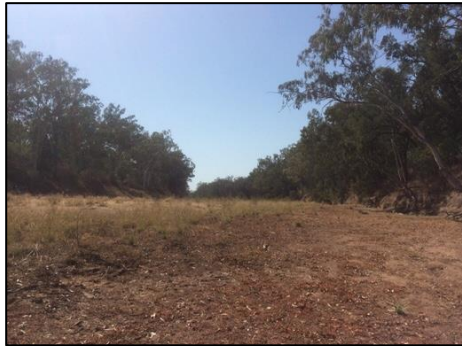
Aquatic Ecosystem Value: Moderate		MNES/MSES: None present or likely to occur		Dry season refuge: No		Connectivity: Good, during periods of high flow																						
In-stream condition: Good Key habitat features in May included: <ul style="list-style-type: none"> • aquatic plants and periphyton • a variety of woody debris including detritus, sticks, branches and logs • blanketing silt • undercut banks • a limited range of sediment grain sizes (predominately sand with some silt/clay) • shallow, deep and sandy pools, and • trailing and overhanging bank vegetation. The site consisted of several isolated pools during the May survey and was dry in October.		Riparian condition: Moderate The riparian zone was mostly continuous, although the extent of the vegetation had been reduced by land clearing for tracks (remaining vegetation zone was approx. 20 m wide on right bank and continuous on the left bank). Vegetation consisted of a moderate cover of grasses, shrubs and trees (predominantly <i>Eucalyptus</i> and <i>Casuarina</i>). Banks were high (7 m high) and steep with minimal erosion. There were some exotic riparian species present at this site.		External Impacts: Moderate External impacts at the site were mostly associated with the surrounding land-use and included: <ul style="list-style-type: none"> • some disturbance to bank stability and instream habitat from cattle access, and • reduced riparian vegetation as a result of land clearing for tracks and grazing. 		Water Quality:

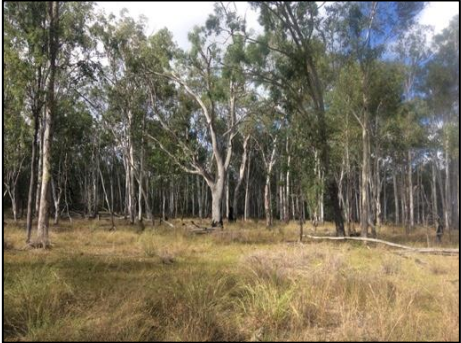
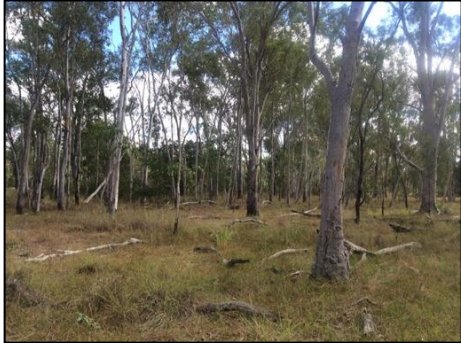
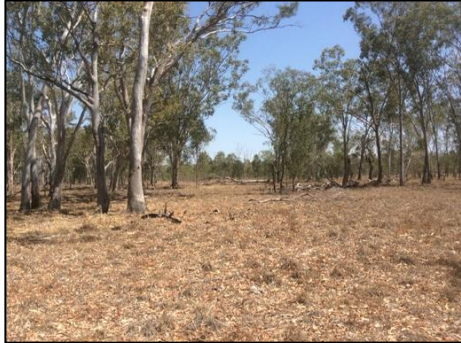
Site: PW1		Location: Downstream of MLAs; Downstream of Project area		Stream Order: 1		Waterway: Mapped HES/WPA palustrine wetland in Isaac River floodplain																						
Upstream: May 2019		Downstream: May 2019		Upstream: October 2019		Downstream: October 2019

Aquatic Ecosystem Value: Low		MNES/MSES: None present or likely to occur		Dry season refuge: No		Connectivity: Limited, would only hold water during periods of high rainfall																						
<p>In-stream condition: Good</p> <p>Key potential habitat features included:</p> <ul style="list-style-type: none"> • aquatic plants • a variety of woody debris including detritus, sticks, branches and logs • canopy cover and shading • a limited range of sediment grain sizes (predominately silt/clay with some sand), and • trailing and overhanging bank vegetation. <p>The site was dry during both the May and October surveys.</p>		<p>Riparian condition: Good</p> <p>The riparian zone was mostly continuous around the perimeter of the wetland. Vegetation consisted of grasses, shrubs, and trees (predominantly <i>Eucalyptus</i>). Banks were low (0.2 m high) and gently sloping with some erosion. There were some exotic riparian species present at the site.</p>		<p>External Impacts: Minimal</p> <p>External impacts at the site were mostly associated with the surrounding land-use and included:</p> <ul style="list-style-type: none"> • some land clearing throughout the broader area, and • grazing by cattle. 		<p>Water Quality:</p>

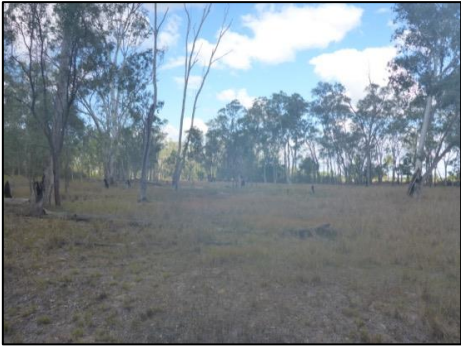
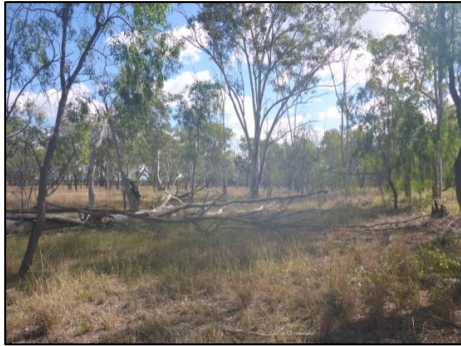
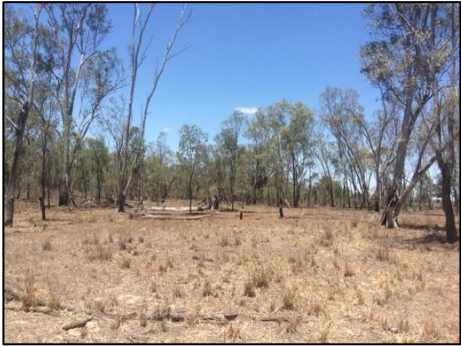
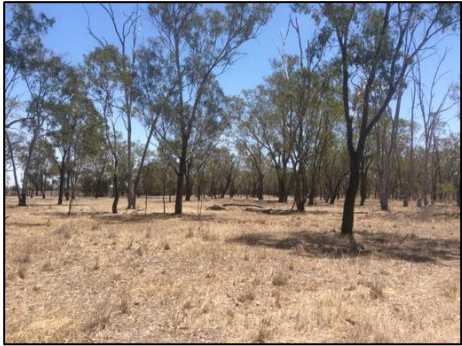
Aquatic Ecosystem Value: Low		MNES/MSES: None present or likely to occur		Dry season refuge: No		Connectivity: Limited, would only hold water during periods of high flow																						
<p>In-stream condition: Moderate</p> <p>Key potential habitat features included:</p> <ul style="list-style-type: none"> • aquatic plants • a range of woody debris including detritus, sticks, branches and logs • canopy cover and shading of the reach • a limited range of sediment grain sizes (including silt/clay and sand), and • trailing and overhanging bank vegetation. <p>The site was dry during both the May and October surveys, and most of the aquatic plants in the dry bed had died back in the October survey.</p>		<p>Riparian condition: Moderate</p> <p>The riparian zone was mostly continuous around the perimeter of the wetland, although the extent of the vegetation had been reduced by land clearing in some sections (remaining vegetation zone was approx. 10 m wide). Vegetation consisted of grass, shrubs and trees (predominantly <i>Eucalyptus</i>). Banks were low (0.3 m), with little slope and some erosion. There were some exotic riparian species present at the site.</p>		<p>External Impacts: Moderate</p> <p>External impacts at the site were mostly associated with the surrounding land-use and included:</p> <ul style="list-style-type: none"> • disturbance to bank stability and potential instream habitat from cattle access, and • reduced riparian vegetation as a result of land clearing for grazing and road tracks. 		<p>Water Quality:</p>

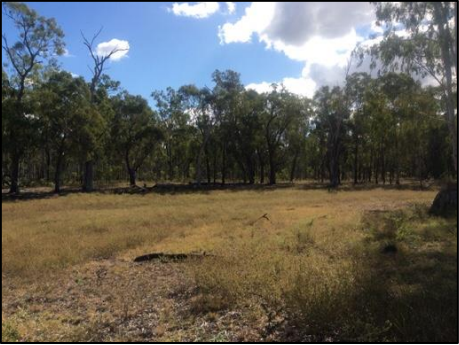
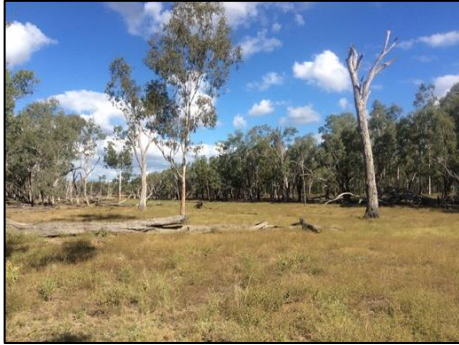
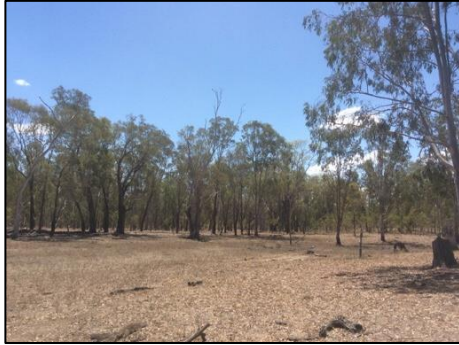
Site: PW4		Location: Downstream of MLAs; Downstream of Project area		Stream Order: 1		Waterway : Mapped palustrine wetland in Isaac River floodplain																						
Upstream: May 2019		Downstream: May 2019		Upstream: October 2019		Downstream: October 2019

Aquatic Ecosystem Value: Low		MNES/MSES: None present or likely to occur		Dry season refuge: No		Connectivity: Limited, would only hold water during periods of high flow																						
In-stream condition: Fair Key potential habitat features included: <ul style="list-style-type: none"> • aquatic plants • variety of woody debris including detritus, sticks, branches and logs • a limited range of sediment grain sizes (including silt/clay and sand), and • trailing and overhanging bank vegetation. The site was dry during both the May and October surveys.		Riparian condition: Good The riparian zone was mostly continuous around the perimeter of the wetland, with limited clearing. Vegetation consisted of grasses, shrubs and trees (predominantly <i>Eucalyptus</i>). Banks were low (1 m high), with minimal slope and erosion. There was a moderate abundance of exotic riparian species present at the site.		External Impacts: Moderate External impacts at the site were mostly associated with the surrounding land-use and included: <ul style="list-style-type: none"> • disturbance to bank stability, vegetation and instream habitat from cattle access. 		Water Quality:

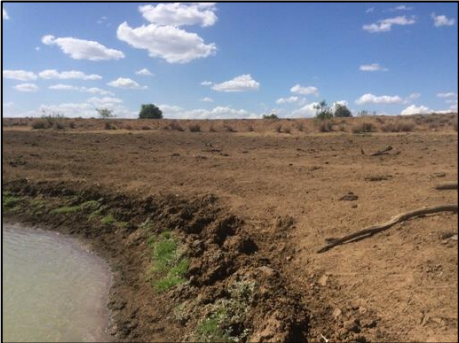
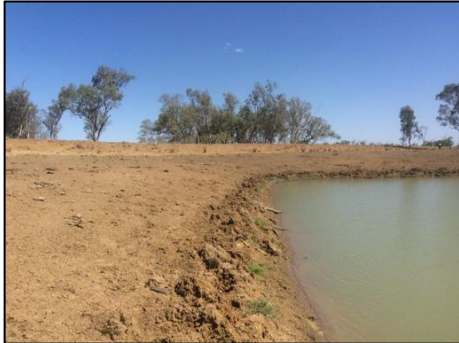
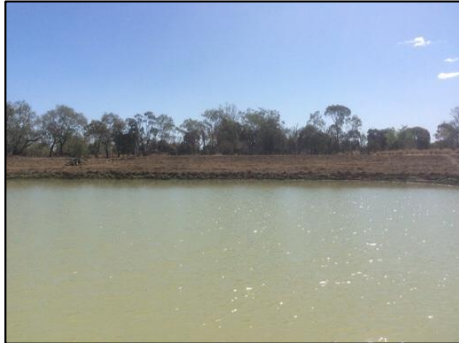
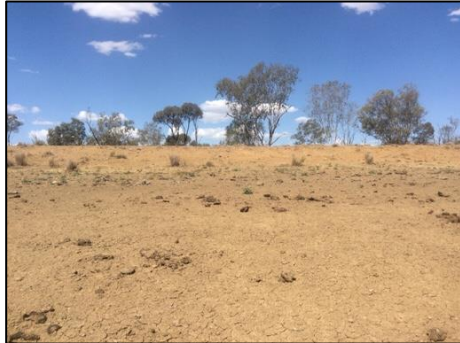
Site: FD3		Location: Within MLA700049; Downstream of Project area		Stream Order: 2		Waterway: Unmapped farm dam on an unnamed tributary of the Isaac River																						
Left bank, downstream: October 2019		Right bank, downstream: October 2019		Upstream: October 2019		Downstream: October 2019

Aquatic Ecosystem Value: Low		MNES/MSES: None present or likely to occur		Dry season refuge: Yes, but poor quality habitat		Connectivity: Poor, due to high dam walls																						
In-stream condition: Poor Key habitat features in October included: <ul style="list-style-type: none"> • lack of in-stream habitat structure, and • a limited range of sediment grain sizes (silt/clay and sand). The site was only surveyed during October.		Riparian condition: Poor The riparian zone had been extensively cleared. Vegetation consisted of a limited coverage of grasses and shrubs. Both banks were high with a 3m lower and 5m upper height. There was a small abundance of terrestrial weeds.		External Impacts: High External impacts at the site were greatly associated with the surrounding land-use and included: <ul style="list-style-type: none"> • alteration of the waterway for dam construction • cleared riparian vegetation for grazing, and • disturbance to bank stability and instream habitat from cattle access. 		Water Quality:

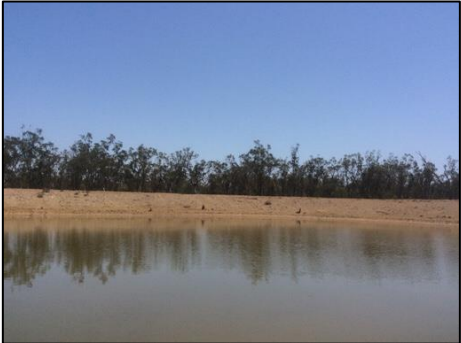
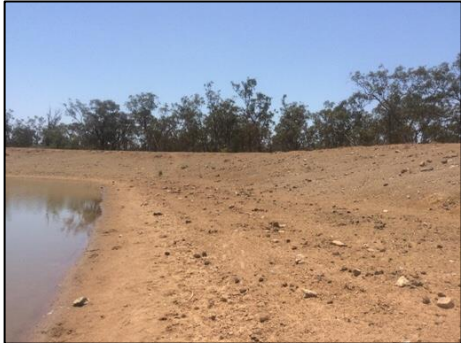
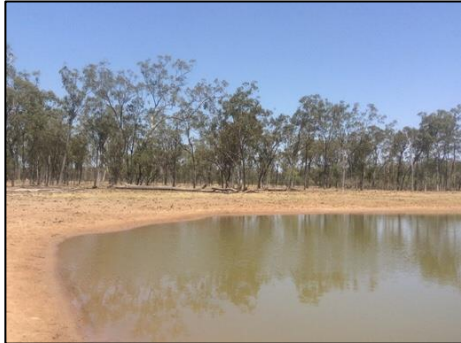
Site: FD7		Location: Within MLA700051; Downstream of Project area		Stream Order: 1		Waterway: Unmapped farm dam on an unnamed tributary of the Isaac River																						
Upstream: October 2019		Downstream: October 2019		Upstream: October 2019		Downstream: October 2019

Aquatic Ecosystem Value: Low		MNES/MSES: None present or likely to occur		Dry season refuge: Yes		Connectivity: Limited upstream and downstream by high dam walls																						
In-stream condition: Poor Key habitat features in October included: <ul style="list-style-type: none"> • a range of sediment grain sizes (predominantly silt/clay & sand, but also some boulders, cobble, pebbles and gravel) • periphyton • shallow and deep pools, and • blanketing silt. The site was only surveyed during October.		Riparian condition: Poor There was no riparian vegetation directly surrounding the dam due to land clearing, however there was good vegetation coverage in the wider area. The dam wall banks were 3 m high downstream of the dam and 0.5 m high upstream of the dam. The walls were gently sloping with minimal erosion. There were some exotic riparian species present at the site.		External Impacts: High External impacts at the site were mostly associated with the surrounding land-use and included: <ul style="list-style-type: none"> • alteration to the habitat to construct the dam • reduced riparian vegetation as a result of land clearing and • disturbance to bank stability and instream habitat from cattle access. 		Water Quality:
