# COWARAMUP BAY COASTAL MANAGEMENT PLAN

Prepared June 2019  
by Litoria Ecoservices  
for the Shire of Augusta Margaret River

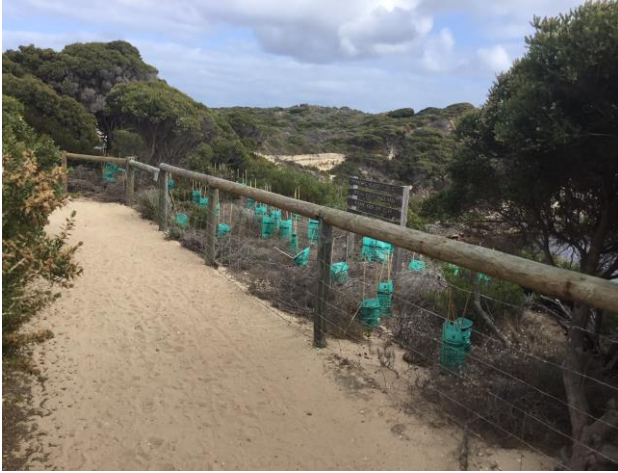
Effective brushing and reveg. Of high cliff risk zone

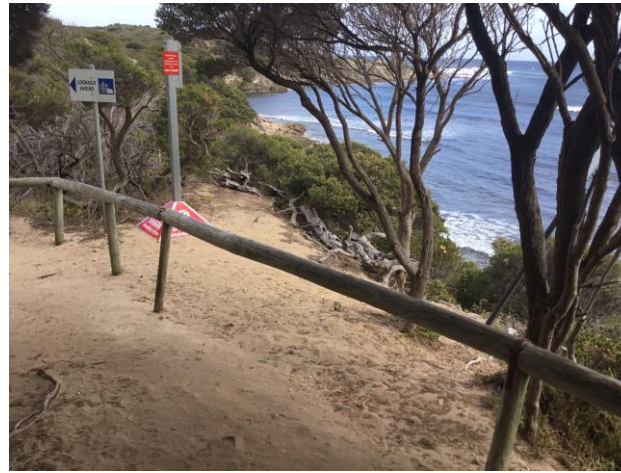
High risk areas in need of brushing, revegetation and signage to address continuing access

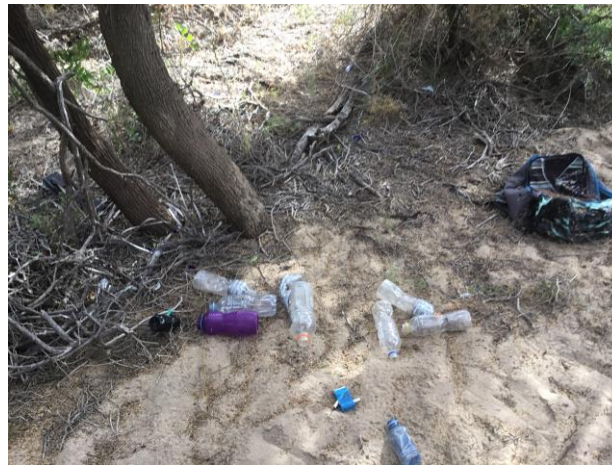
Litter and rubbish left in the dunes

1.3	Brush entrance tracks to dunes behind and surrounding the carpark to address the network of tracks, degraded areas and litter hotspots.	M
1.4	Ensure rangers regularly patrol for illegal camping and fires	H

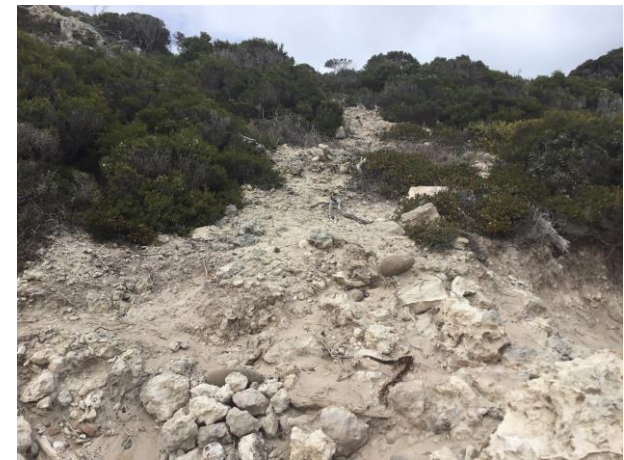
Cliff base areas in need of brushing

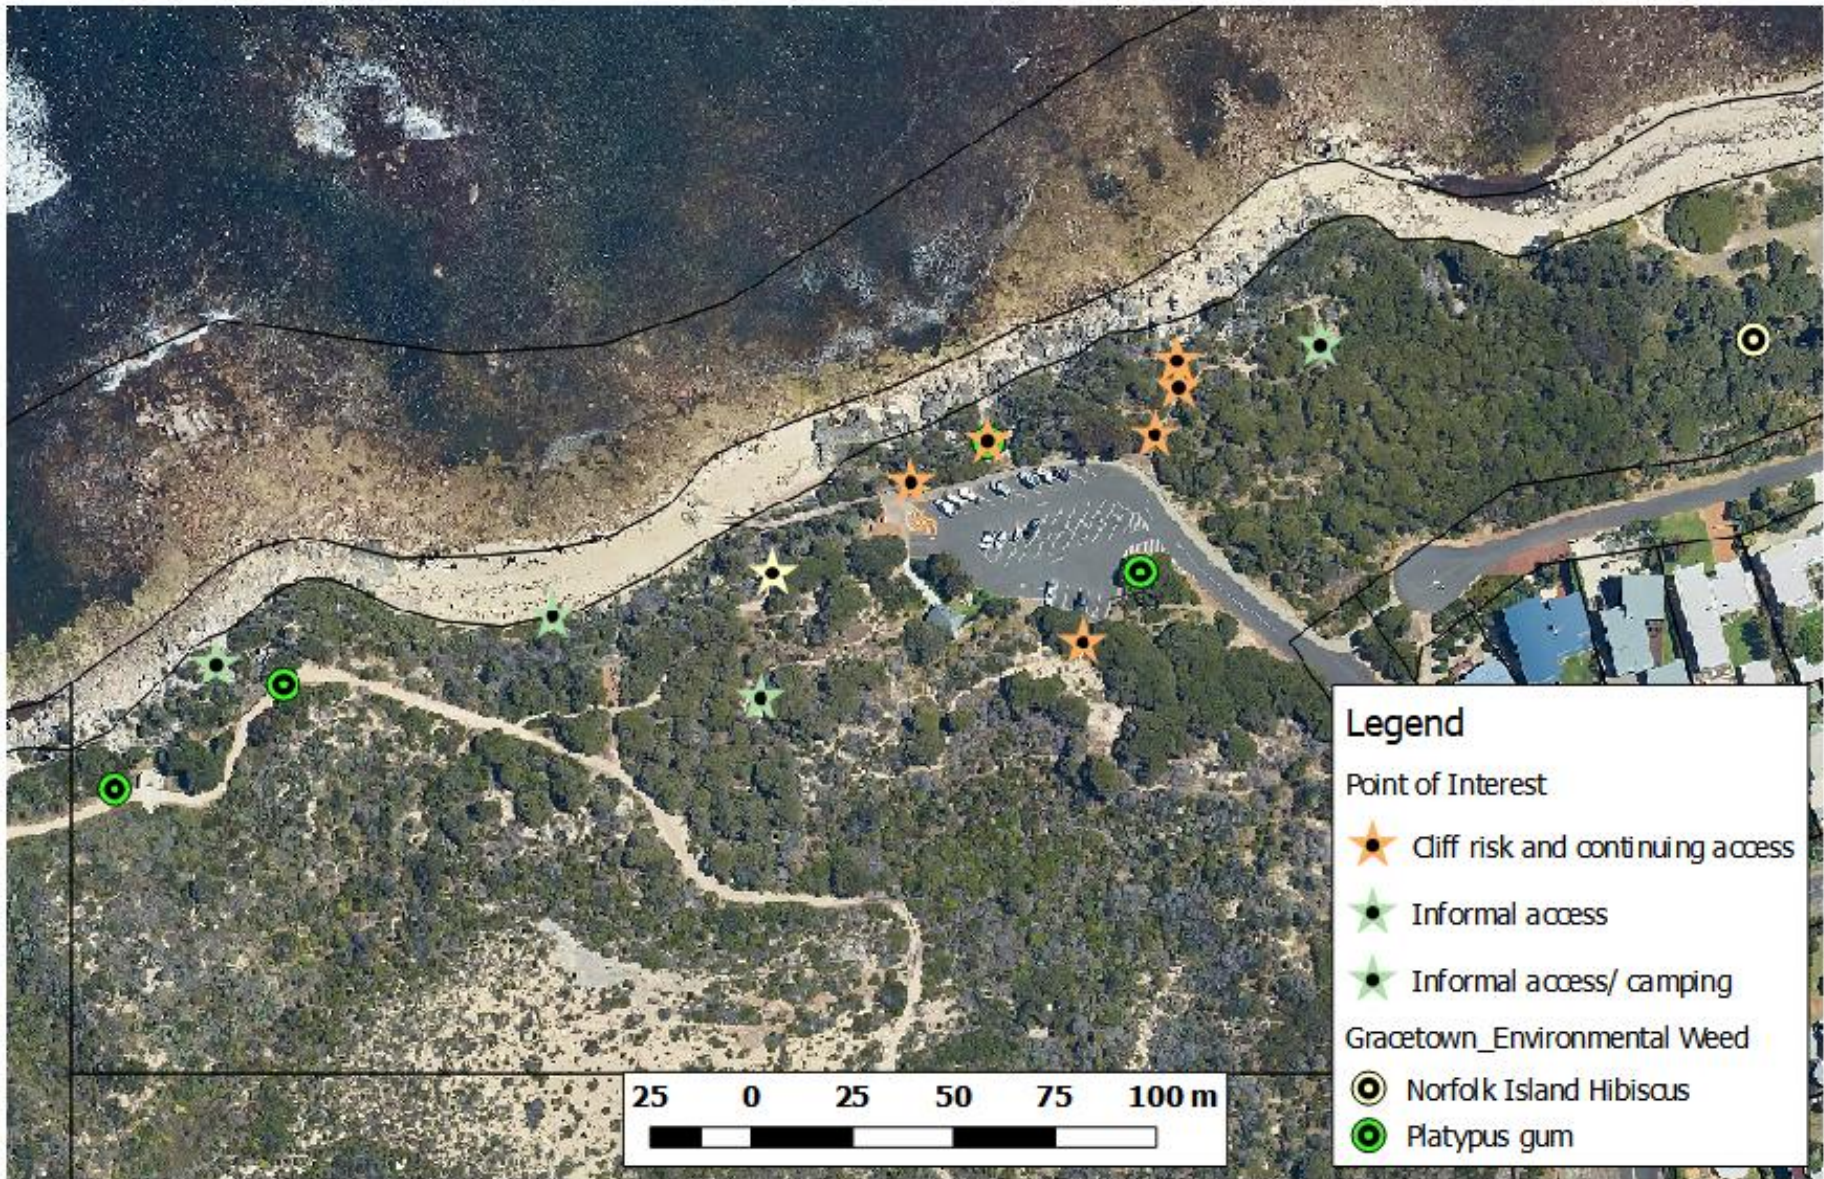
**Figure 2. Zone 1 Management Issues**

- Continued pedestrian access through and onto the vulnerable and high risk cliff areas;
- Need to protect and enhance native vegetation cover and condition for cliff stability, amenity and habitat;
- Small but highly visual areas of grassy weeds in open degraded areas around the memorials and carpark;
- Uncontrolled access to and degradation of the dunes behind the coastal track including large areas of litter and debris
- Water flow from the path at Volunteers Rest and from the Huzzas carpark down the adjacent cliff faces which is adding to instability
- Improved cliff risk signage along the top and bottom of the cliff
- Protection of existing Rottnest Island Tea Tree around picnic area and pathway and implement succession planting
- Need for interpretive signage at the Huzzas lookout focused on surfing etiquette
- Illegal camping and beach fires around Huzzas

- Desire from the Cowaramup Bay Boardriders to install a judging/ viewing platform along the Southpoint track (it is understood that this is currently being considered by the Shire in detail)

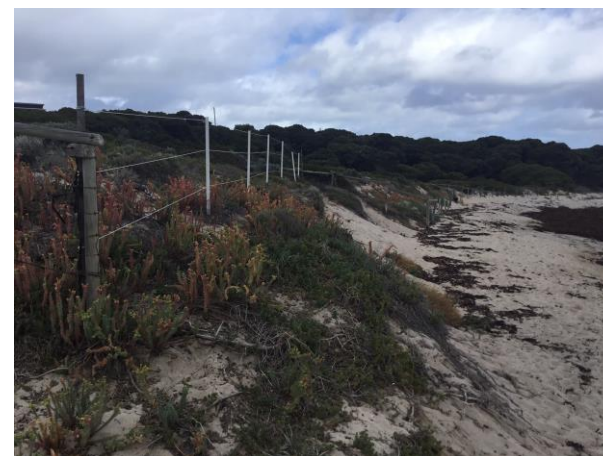
Fencing to protect the foredunes

<b>ZONE 2 MELALEUCA BEACH</b>		
<b>#</b>	<b>RECOMMENDATIONS</b>	<b>PRIORITY</b>
2.1	Repair and maintain foredune fencing	H
2.2	Continue dune stabilisation and revegetation activities along the foredune including brushing, transplanting pigface and spinifex runners and strategic planting of a small range of hardy native dune species	H

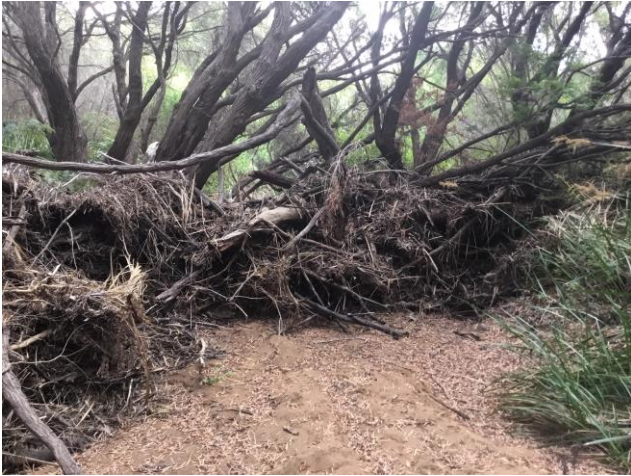
Build up of debris effectively damming the channel

3.3	Undertake staged replacement of exotic plantings in the parkland area north of the trail with WA Peppermint and Rottneest Island Teatree	M
3.4	Realign the woody debris built up at key locations within the brook to protect vulnerable banks	H

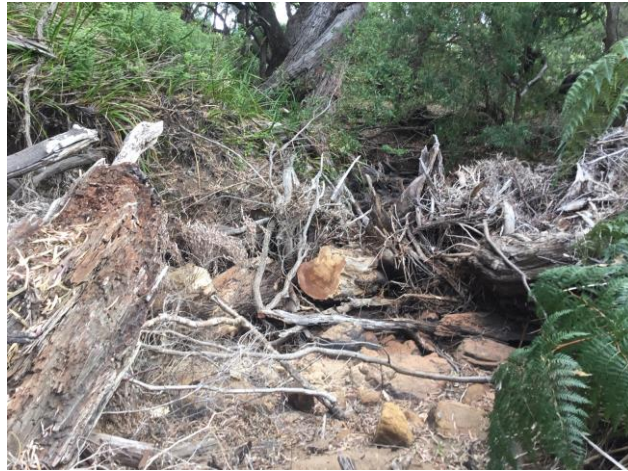
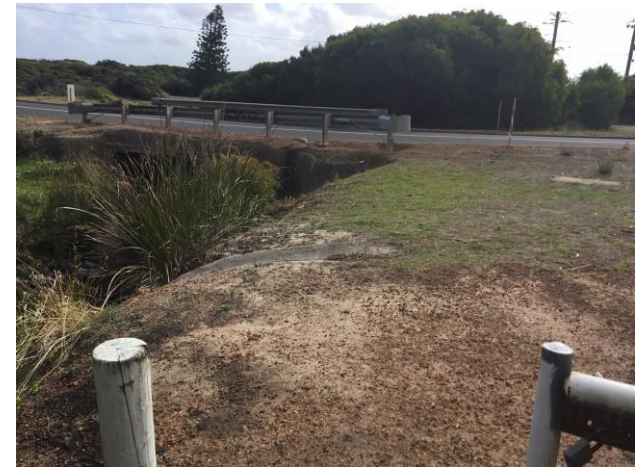
Bare and eroding banks needing revegetation

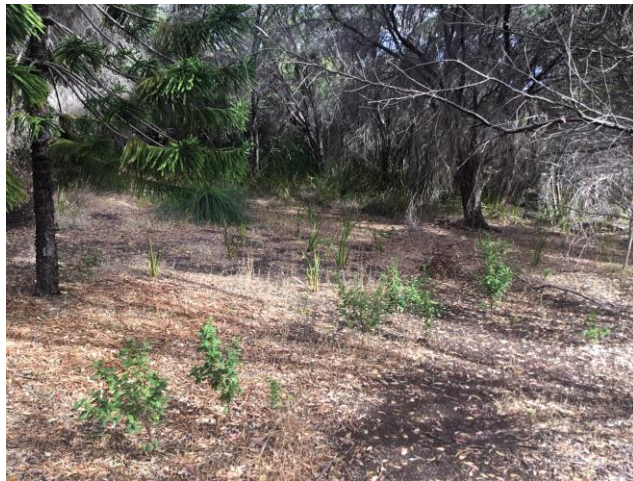
Successful revegetation from 2018

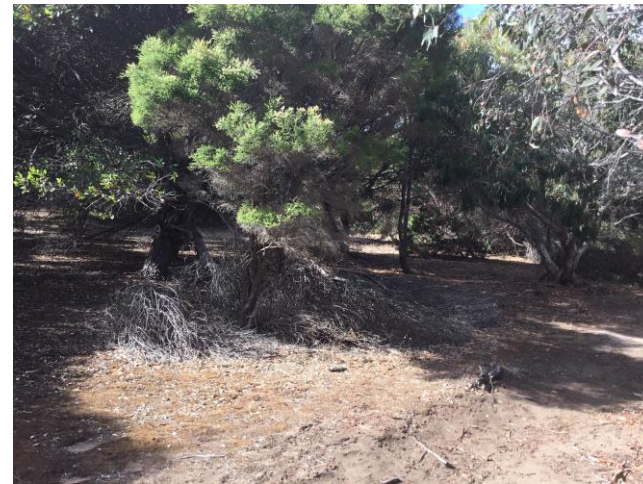
Open space area planted to non natives and weed species

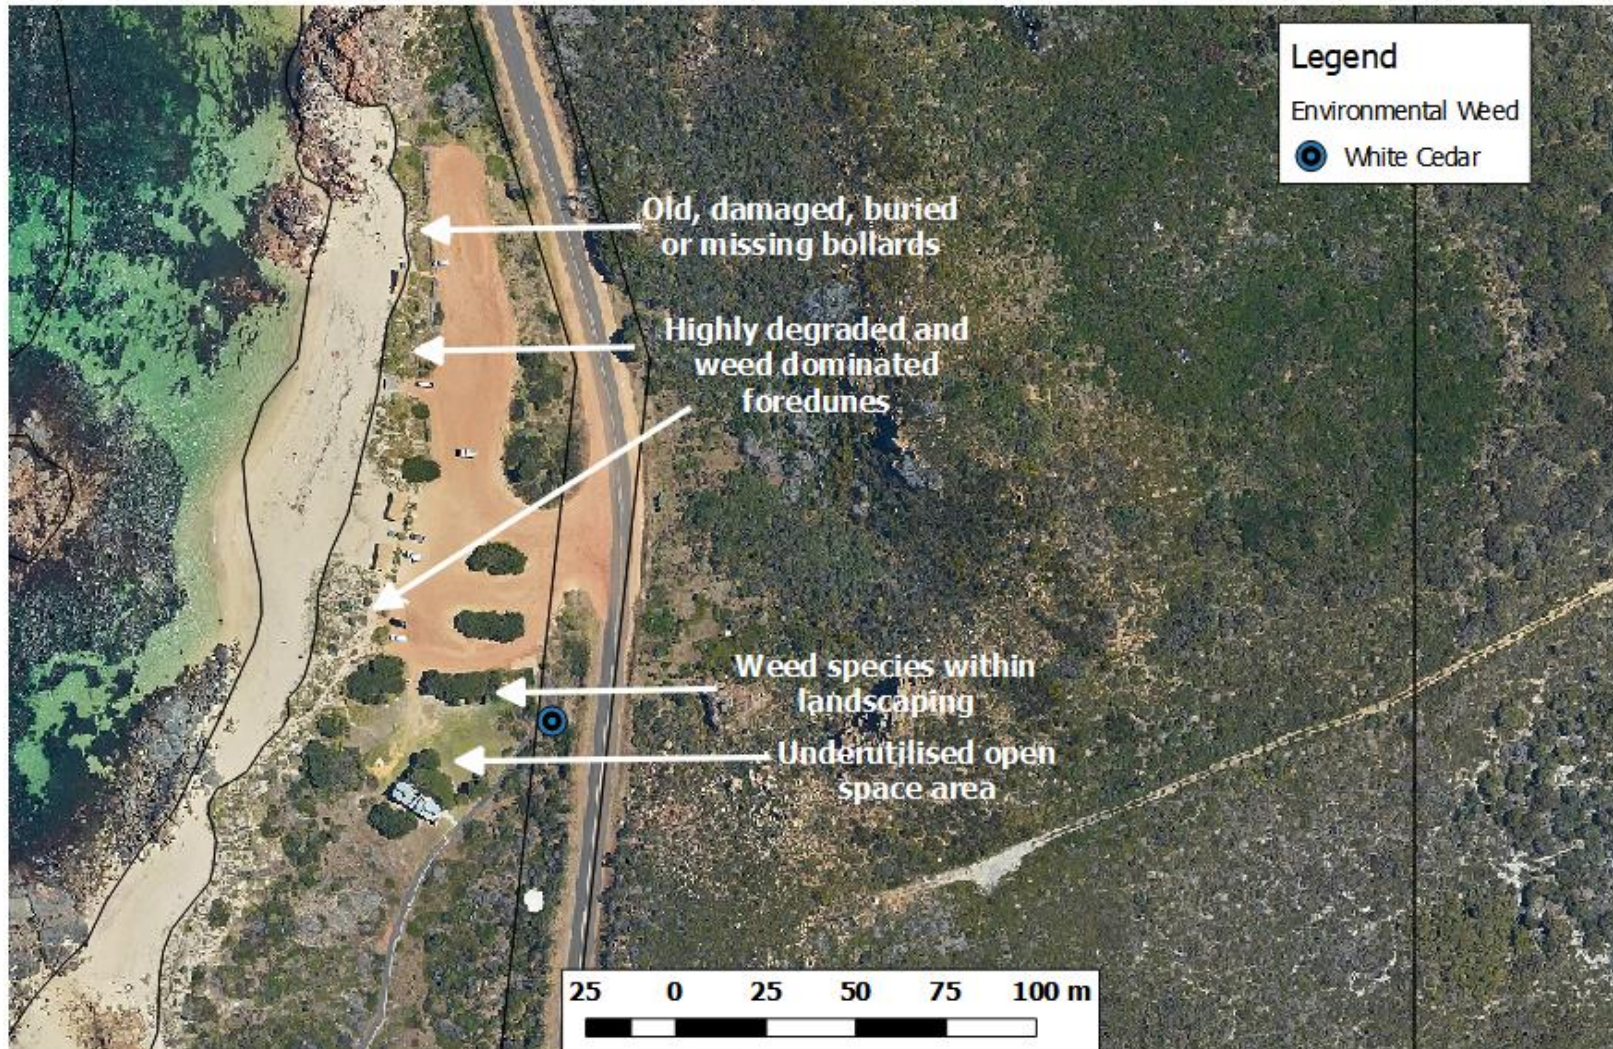
**Figure 5. Swimmers Beach Management Issues**

- Degraded, weed dominated dunes
- Old, half buried bollards
- Underutilised open space area around the toilets
- Presence of priority environmental weeds
- Need for safe pedestrian access between cars and dunes
- Access required around the granite rock to the north of the carpark – including for Cape to Cape track walkers
- Need for disabled access into the water
- Demand for increasing parking and overflow parking from northpoint

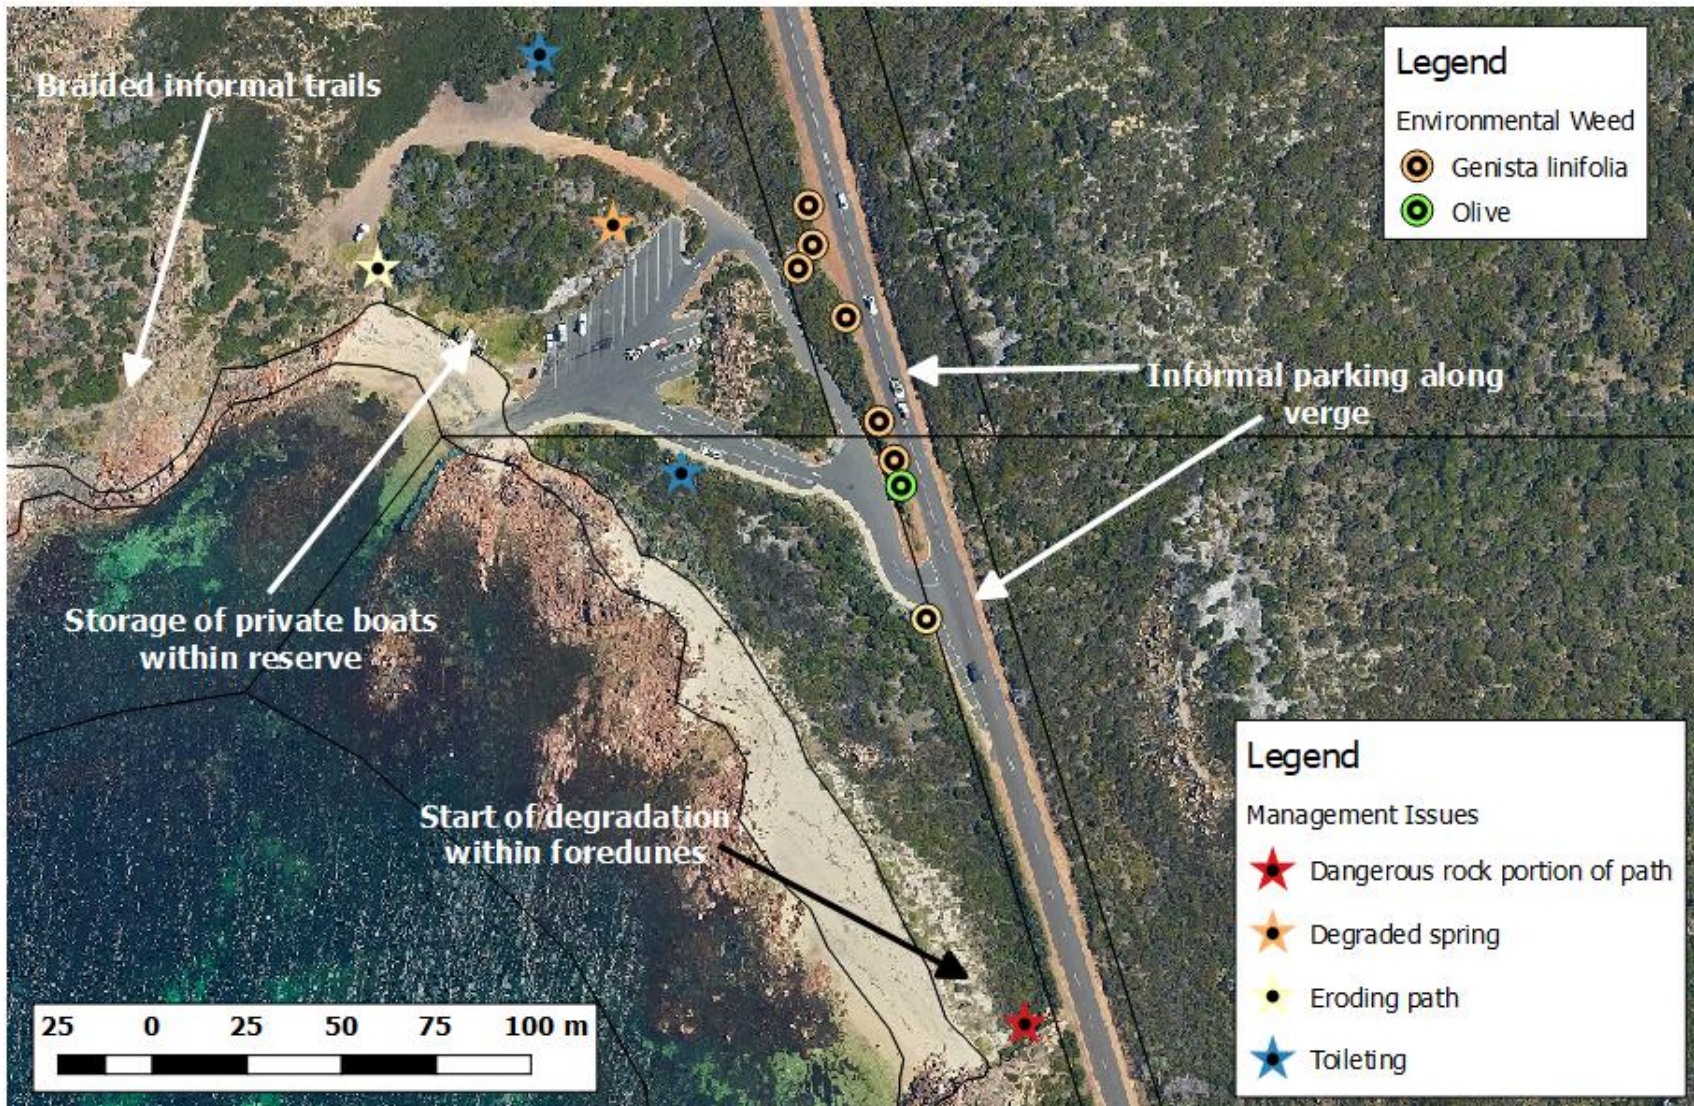
Figure 6. Northpoint Management Issues

- Crowded and overloaded carpark on good surf and fishing days
- Braided tracks from carpark out to Northpoint jump off
- Lack of toilets and evidence of toileting in the surrounding vegetation
- Parking pushing on to boatramp beach and off the top track
- Eroding path from the top track to boatramp beach
- Degraded spring area near the trailer parking bays
- Priority environmental weed present near Bayview Drive
- Need for safe pedestrian access along the edge of Bayview Drive to northpoint carpark and uphill to the 'top' carpark
- Concerns were raised about charter group operators and clientele crowding up the limited carspaces available to independent recreational users.

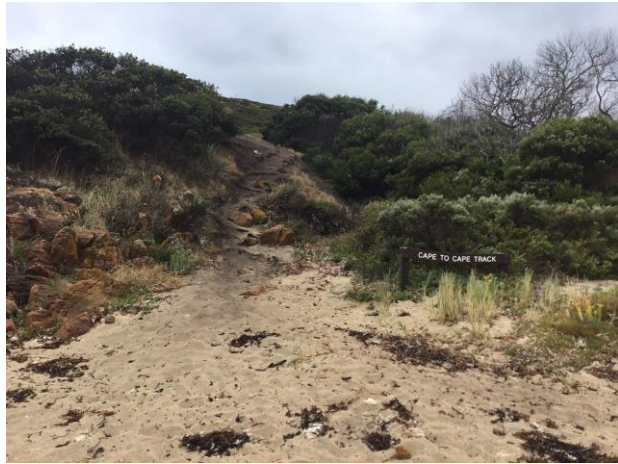
Eroding track from top car park

<b>ZONE 5 - NORTHPOINT</b>		
<b>#</b>	<b>RECOMMENDATIONS</b>	<b>PRIORITY</b>
5.1	Address the eroding informal access from the top (western most) carpark down onto 'boatramp beach'	H

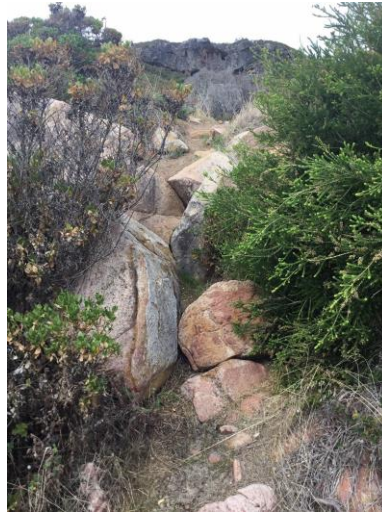
Rocks needing steps

5.10	Install a short ~5m section of steps to assist traffic around the granite outcrop towards swimmers beach.	H
5.11	Address the safety and encroachment issue of parking along the edge of Bayview drive during good surf days – in conjunction with traffic/ road advice.	H

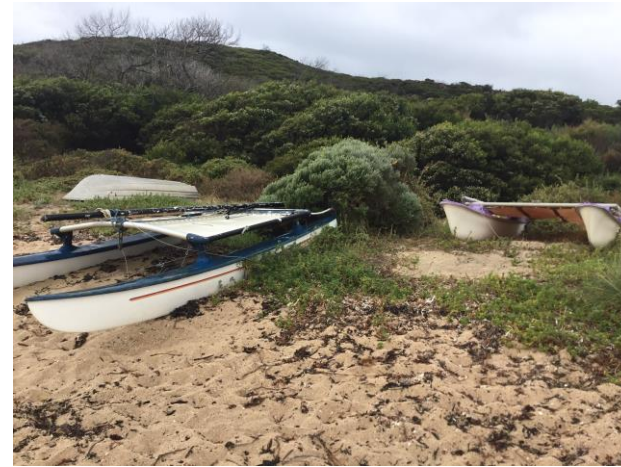
Storage of private boats in reserve

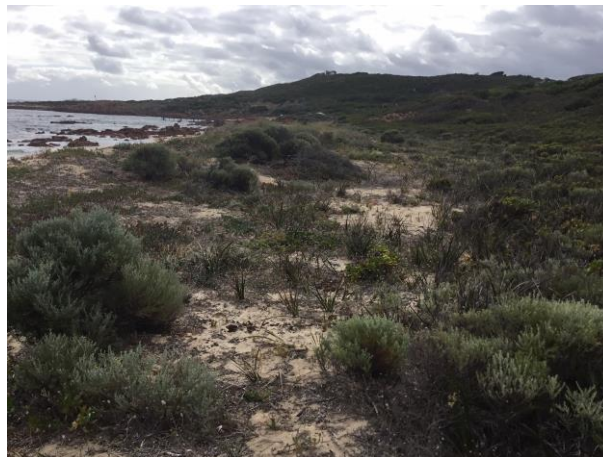
Degraded dunes towards at the southern end

5.7	Undertake dune rehabilitation and revegetation/ brushing in the degraded dune section at the very southern end of this zone.	H
5.8	Consider increased signage of the Cape to Cape Track through this zone especially around the granite outcrop towards swimmers beach to ensure pedestrian traffic is focused on appropriate paths and where possible directed away from the road verge.	M

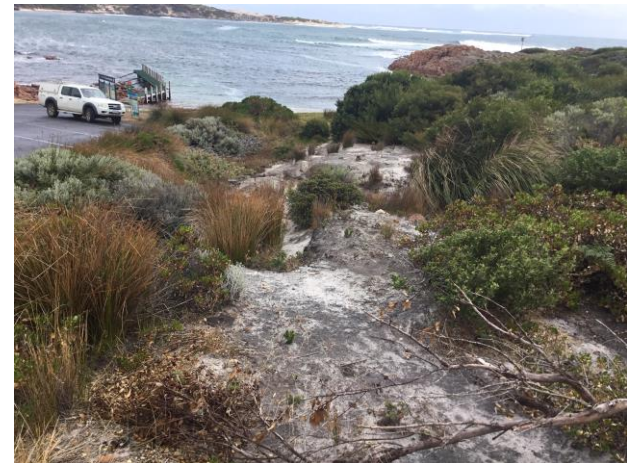
Degraded.bare spring area

5.4	Undertake planting and bush regeneration of the small spring and wetland vegetation above the boatramp beach that was disturbed and degraded during the carpark construction	H
