Remote Sensing Investigations at a Hazardous-Waste Landfill

Christopher Stohr, W. J. Su, P. B. DuMontelle, and R.A. Griffin

Illinois State Geological Survey, Natural Resources Building, 615 East Peabody Drive, Champaign, IL 61820

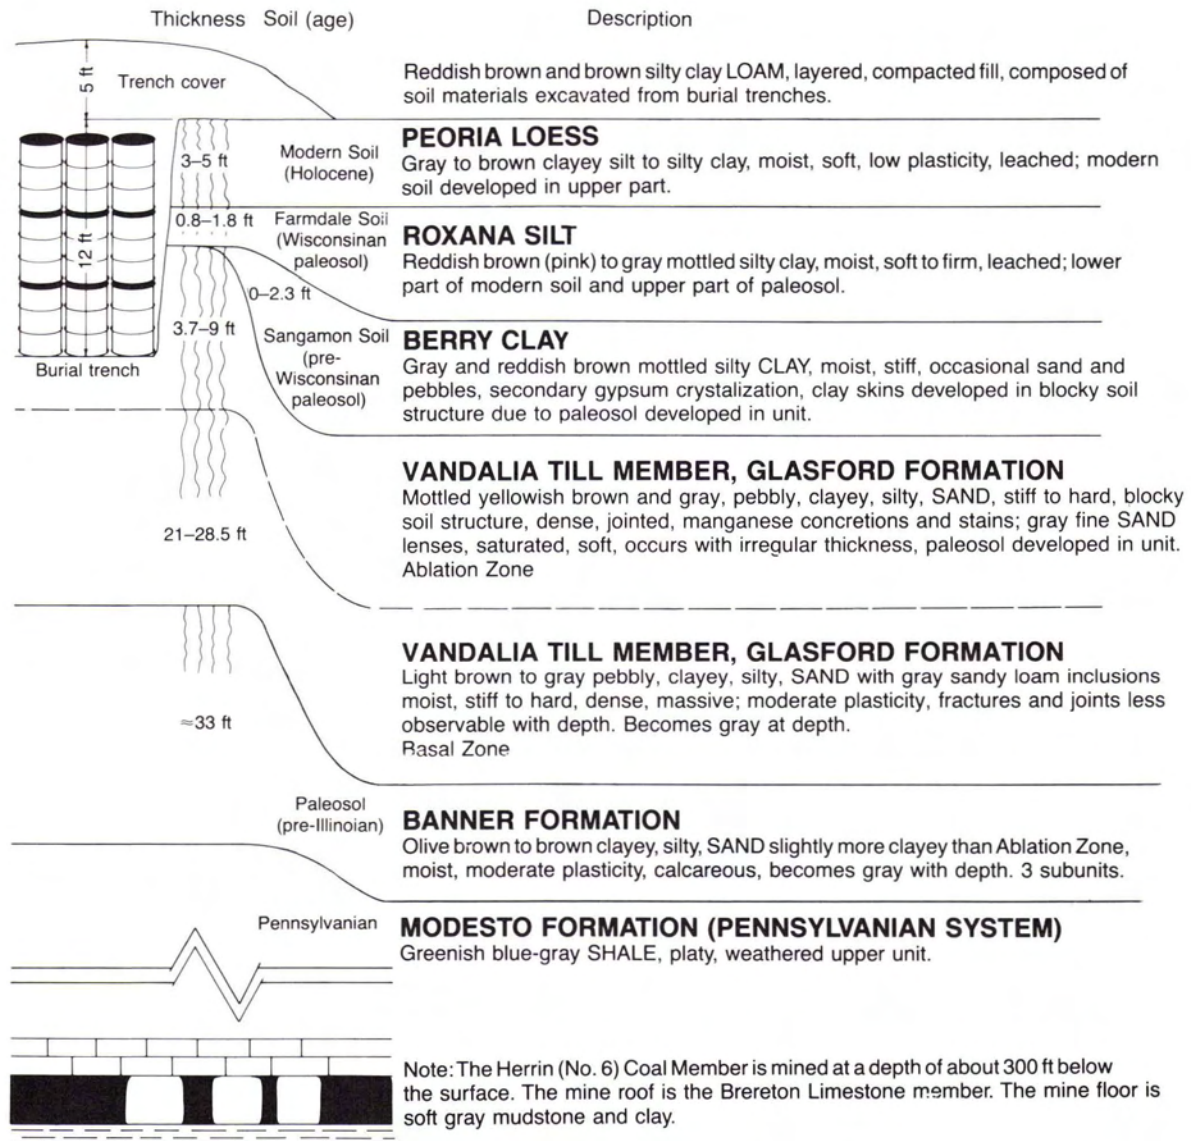
FIG. 2. Summary geologic profile of Earthline Corporation landfill.

Figure 2 shows a geologic profile of the landfill site. The upper part of the profile consists chiefly of two loessial units—Peoria Loess (upper) and Roxana Silt (lower)—which in turn overlie the Vandalia Till Member of the Glasford Formation. The discontinuous Berry Clay Member consists of colluvial deposits of loess and till eroded from high areas and deposited in depressions and low-lying areas where the soil materials became “gleyed.” Beneath the Illinoian-age Vandalia Till lies the pre-Illinoian till of the Banner Formation, which overlies Pennsylvanian-age bedrock of the Modesto Formation. About 300-feet below the surface is an underground coal mine developed in the Herrin (No. 6) Coal Member of the Carbondale Formation. The mine roof is the Brereton Limestone Member; the mine floor is an unnamed gray mudstone and clay.

Modern soil is developed in the Peoria Loess. Paleosols (ancient soil profiles) are developed in the Roxana (Farmdale Paleosol), Vandalia Till and Berry Clay (Sangamon Paleosol), and the Banner Formation (unnamed paleosol). The paleosols permit time-stratigraphic relationships to be determined and facilitate field identification of the units.

One unit, the Vandalia Till Member, is subdivided into its ablation zone and basal zone. The ablation zone is composed of materials left during glacial retreat; the basal zone is composed of glacial advance deposits. The basal zone can be further subdivided into weathered and unweathered basal till.

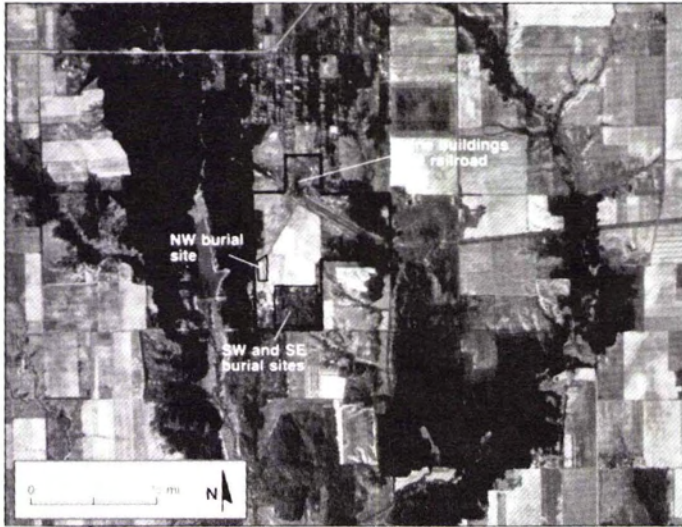
FIG. 5. 1937 USDA aerial photograph with 1982 location of the Earthline Corporation hazardous-waste landfill site superimposed.

Impact of prior land use, excavations, or construction at a new waste disposal site can be quickly assessed by interpretation of historical aerial photography (Lyon, 1982; Erb *et al.*, 1981). Comparison of five decades of aerial photography of the land on which the landfill is located show several changes in land use and land cover. In the fall of 1937, the site (Figure 5) was dominated by an active underground coal-mining operation, including a shaft, processing plant, and railroad spur. Cropland lies to the south and east of the mining operation; the city of Wilsonville lies to the north. A reservoir in a forested valley adjoins the mine property to the west. A dwelling and outbuildings are observed on the southwest part of the property. The future northwest burial site was cropland, and southern burial sites were wood lots (see Figure 5).

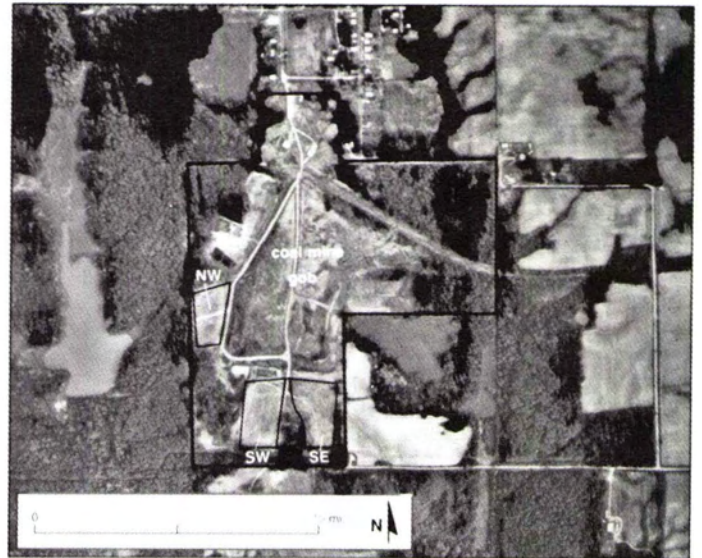
FIG. 8. 1982 aerial photograph of the Earthline landfill site.

The 1982 photography (Figure 8) was taken after operators ceased landfilling, but prior to exhumation of the buried wastes. New buildings supporting the disposal operation are seen in the northern part of the site. All of the burial sites are grass-covered clearings with gravel access roads. Water-holding rectangular pits are constructed near the burial sites. The study of historical aerial photography shows that

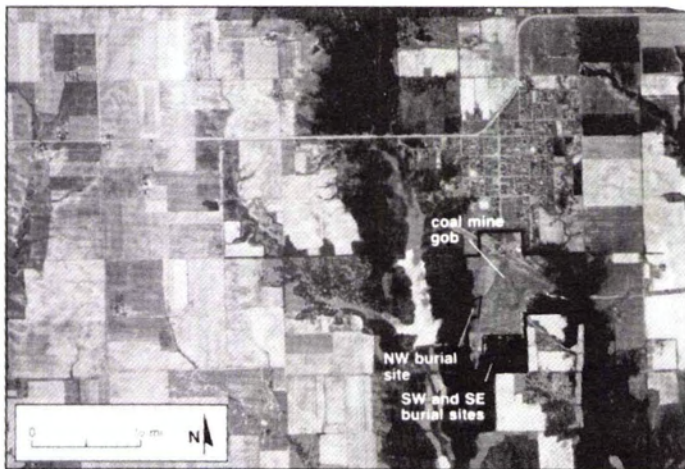
FIG. 6. 1950 USDA aerial photograph with superimposed location of the Earthline landfill site.

Photography taken in the summer of 1950 (Figure 6) showed the mine to be active. A sizable coal-cleaning refuse (gob) pile occupied the area directly south of the mine buildings. The

future northwest landfill area was apparently abandoned to scrub growth. The southern area remained as a wood lot.

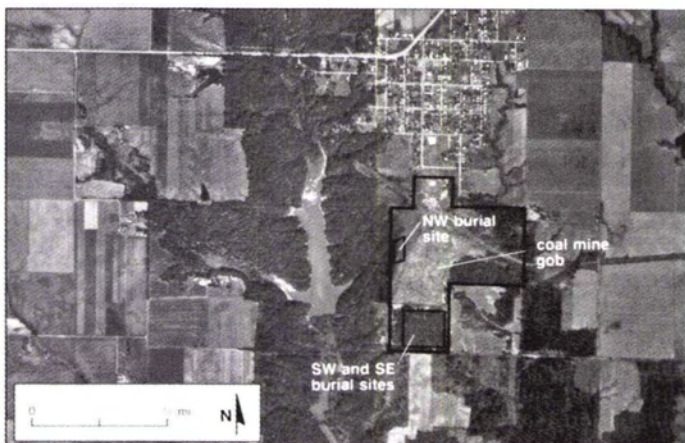
FIG. 7. 1968 USDA aerial photo of the location of the Earthline landfill site.

By 1968, the mine buildings were removed and railroad grade abandoned. The gob pile dominates the site, as it does to this day. The northwest area supports young deciduous trees. The southern area remains wooded (see Figure 7).

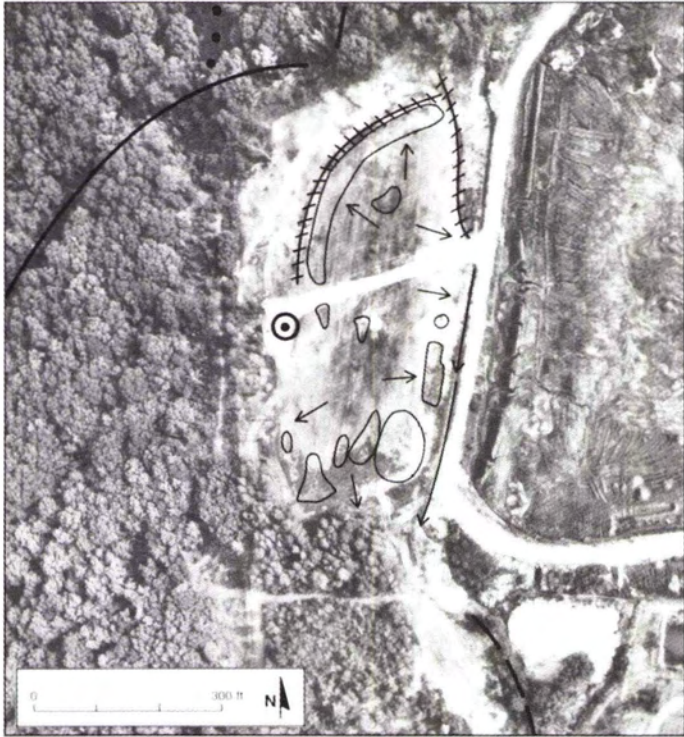
FIG. 11. Northwest burial site in center of photo; coal-cleaning tailings (gob) to right. Depressions on Earthline landfill cover are marked with circles. Hatchures are on crest of erosion control dike. Arrows show direction of drainage of the cover. Polluted wells lie at west end of burial site (encircled dot). Bold lines, dashes, and dots show lineaments from Figure 9.

to the depressions developed in a trench cover (see Figure 10, 11, and 12).
