Appendix 5.2-1
Vegetation Technical Appendix

Vegetation Technical Appendix

Visual Simulation - Snaring Road
For the Proposed NCR
Jasper Interconnection Project

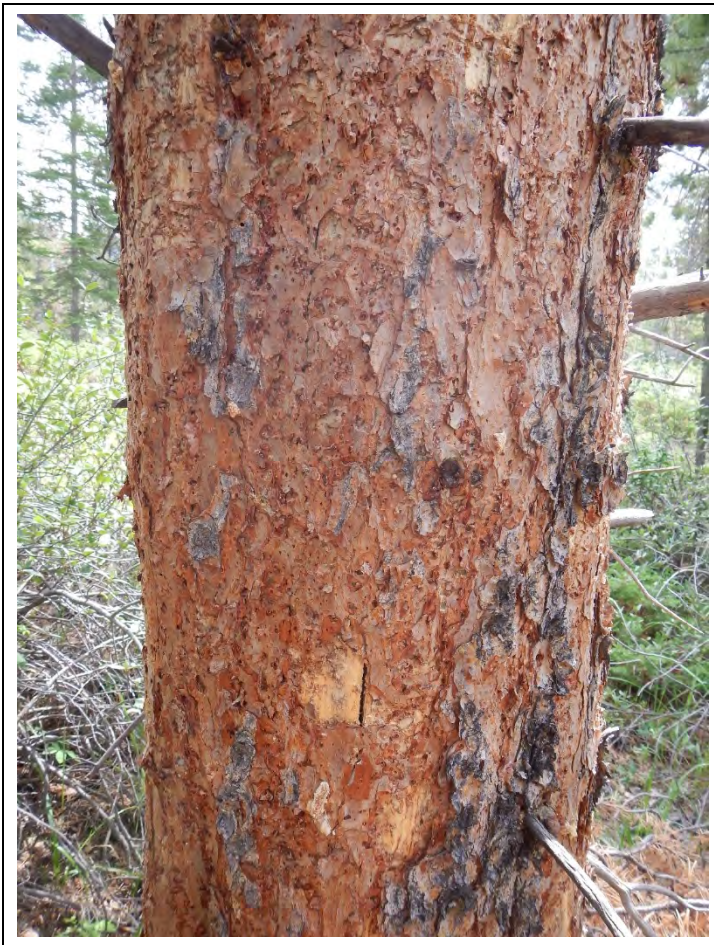
Photo A5.2-4-28. Potential mountain pine beetle damage observed at NE 5-47-1 W6M on June 7, 2015.

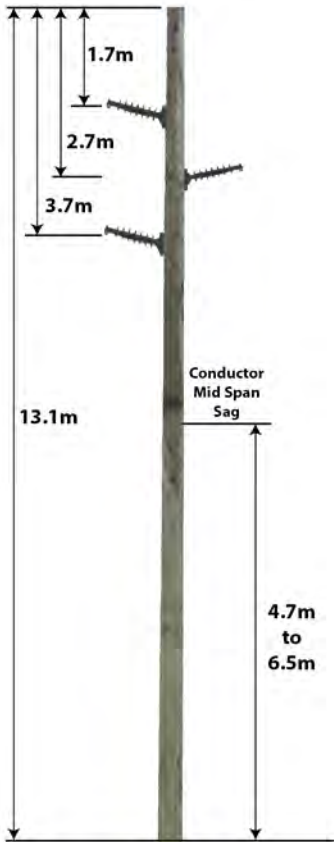
3D MODEL

Typical 69 kV Single Circuit
Horizontal Post Structure

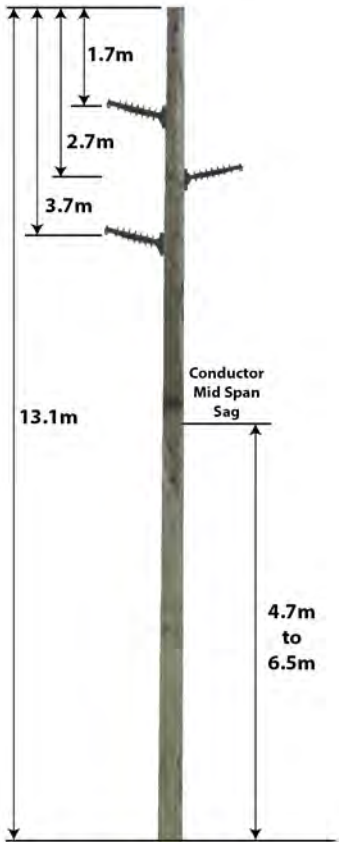
3D MODEL

Typical 69 kV Single Circuit
Horizontal Post Structure

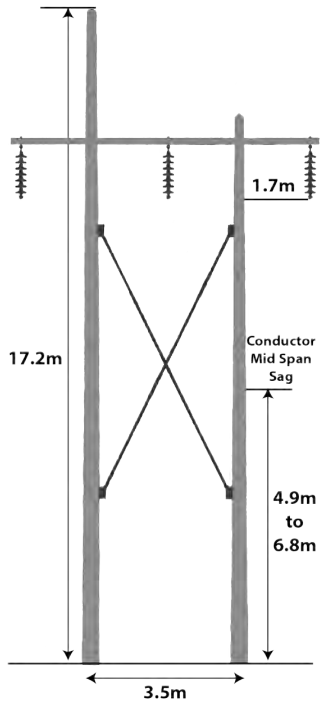
3D MODEL

Typical 69 kV Single Circuit
H - Frame Structure

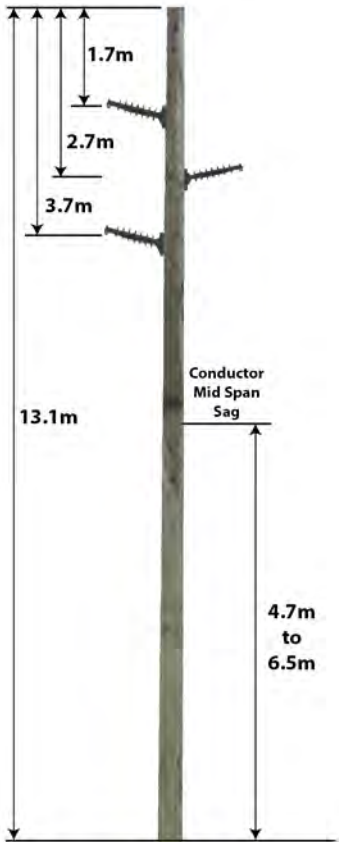
3D MODEL

Typical 69 kV Single Circuit
Horizontal Post Structure

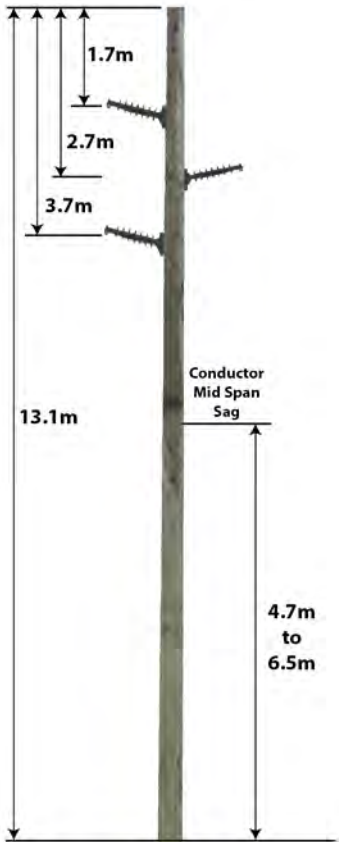
3D MODEL

Typical 69 kV Single Circuit
Horizontal Post Structure
