## B & J Catalano Shenton Ridge Hard Rock Quarry

### CPS 7943/1 – Clearing Report 2018 - 2023

AUGUST 2023

This Clearing Report summarises the actions and clearing conducted under CPS 7943/1 and EPBC 2017-8085.

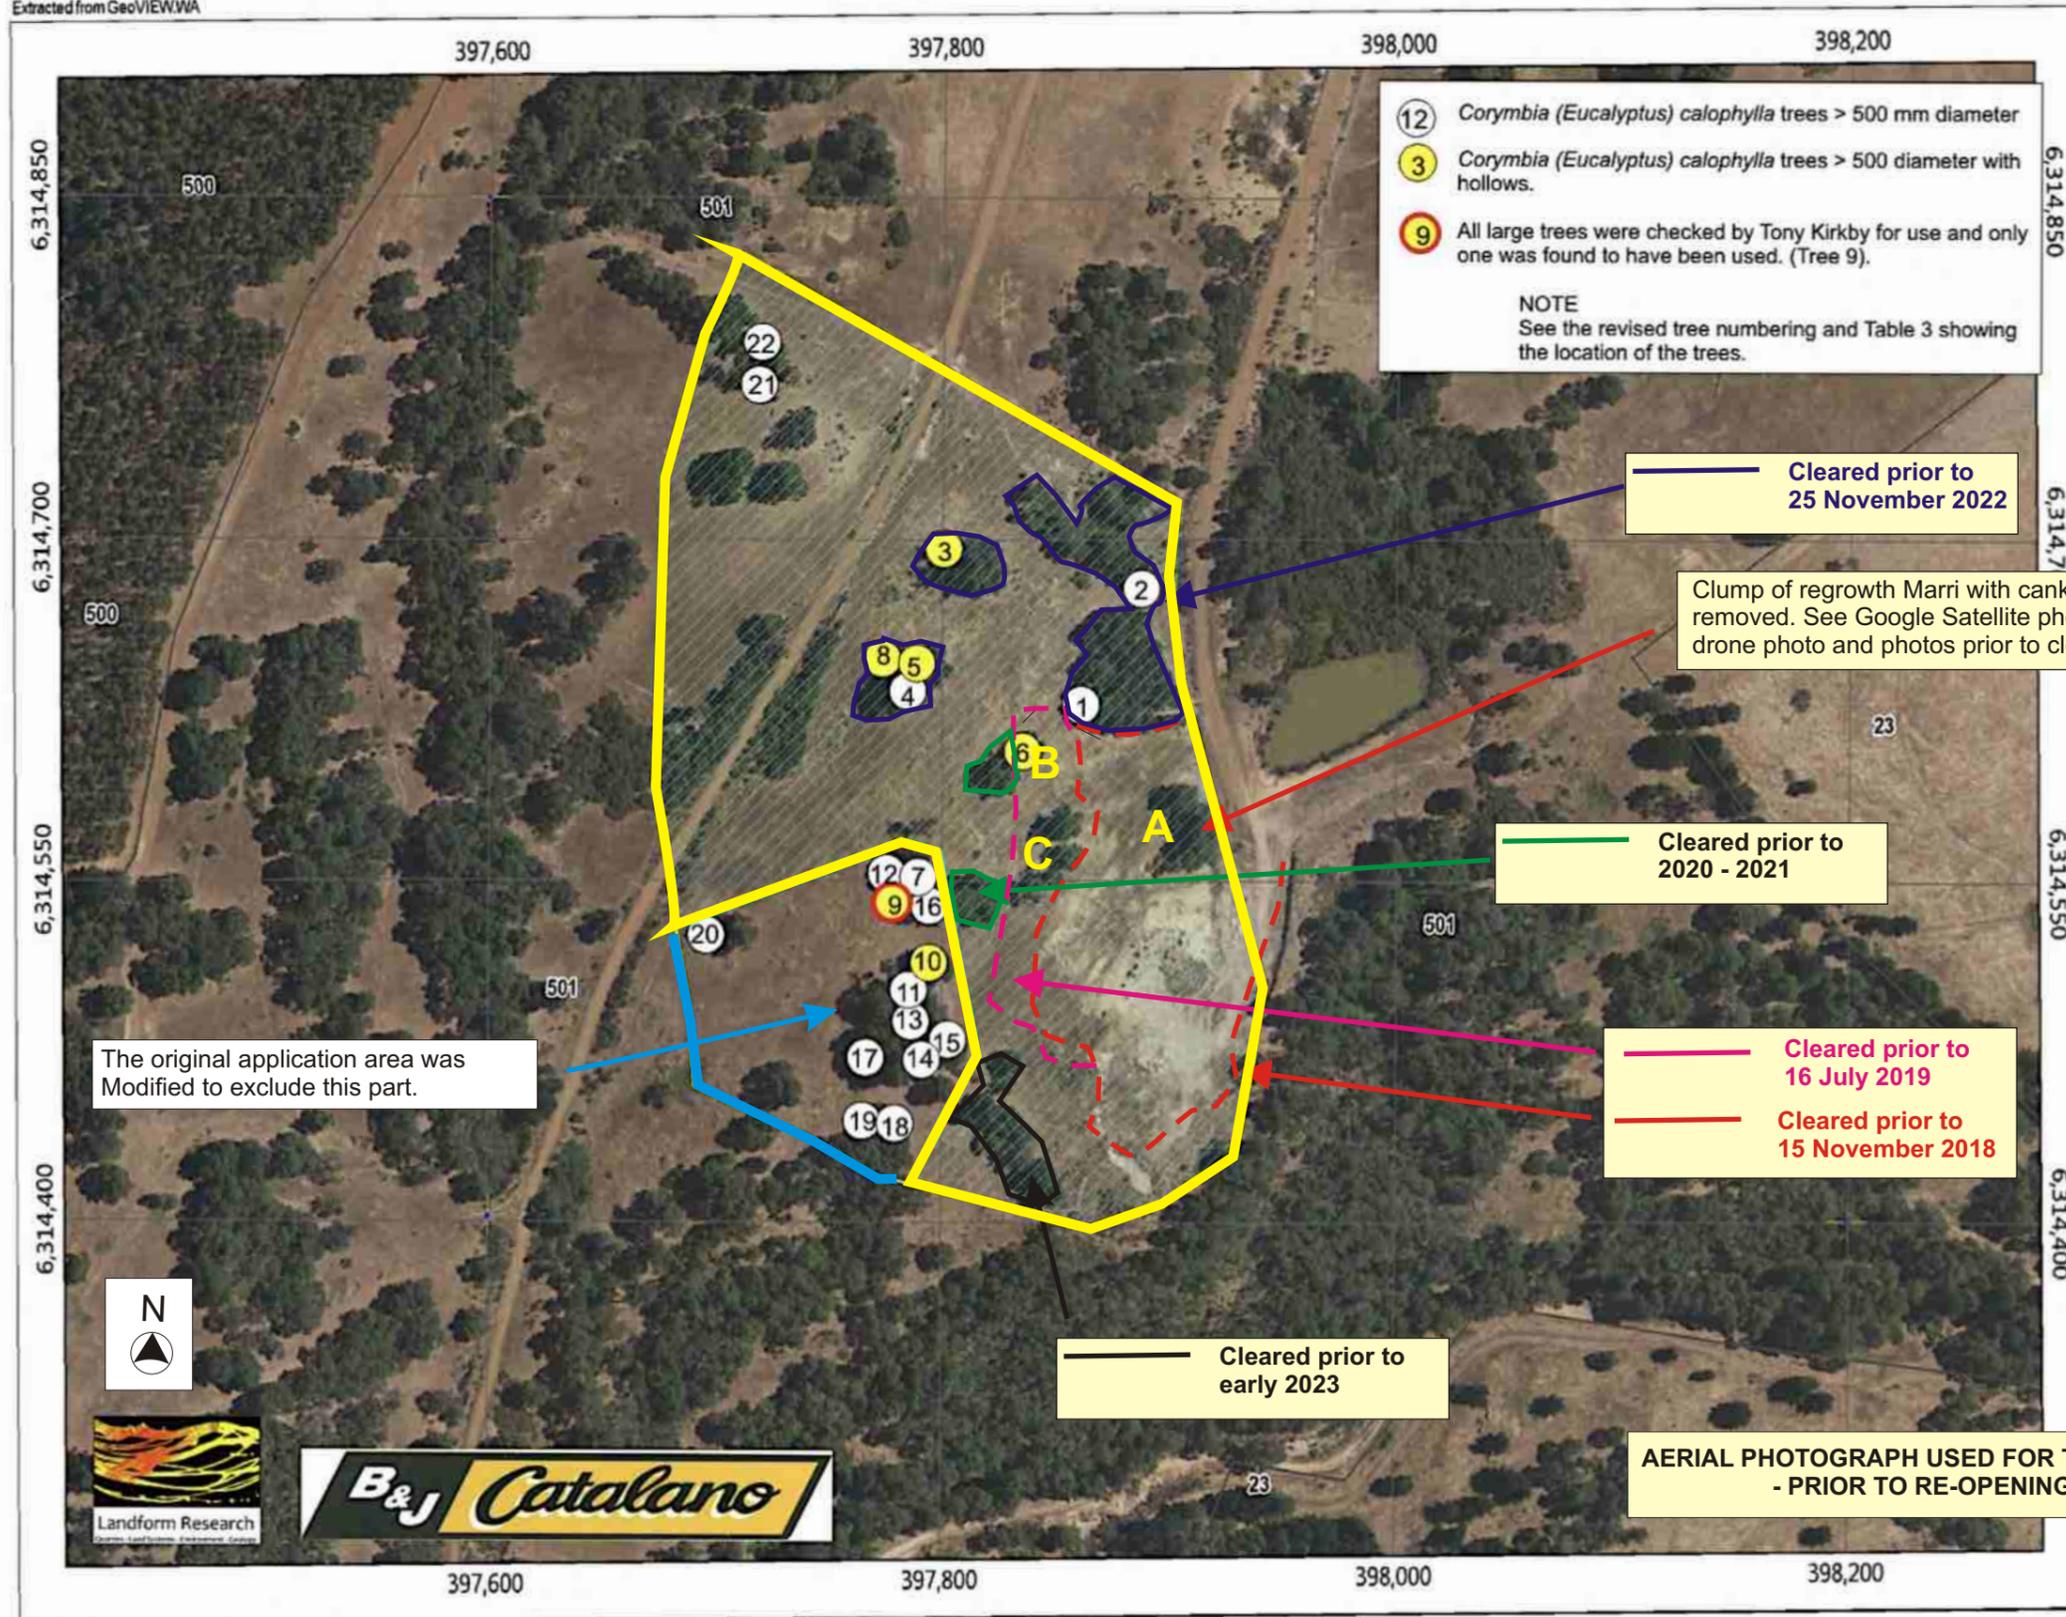
JULY 2023 FIGURE 1

# CATALANO SHENTON HARD ROCK QUARRY - LARGE TREES

7b		<p><b>If the tree is occupied</b></p> <p>The tree (Tree 9 on Figure 1) does not appear to be in use. Tony Kirkby noted that the tree had been in use up in 2021. Staff have not noted black cockatoos at the tree since 2021. It may be that the tree is no longer used because of the quarry activity. Certainly there is a tree in use in a Patch B. <b>See Figures 6 and 10.</b></p>
8a	Install three suitable nesting tubes	<p><b>Installation of the artificial nesting hollows</b></p> <p>13 artificial hollows were purchased 7 October 2019 and 3 June 2020 from the Shire of Serpentine Jarrahdale.</p> <p>The tubes were present on site on 15 January 2020 as evidenced by photographs taken on site by Lindsay Stephens on that day, of the hollows on site.</p> <p>As there was no proposed immediate action of clearing, the artificial hollows were not immediately installed but were retained on site. However the delay ran into COVID 19 restrictions and unknowns.</p> <p>The restrictions and unknowns relating to COVID 19 meant that a large enough mobile lift was not immediately available. As there was no intention of immediate clearing it was felt that a delay was acceptable.</p>

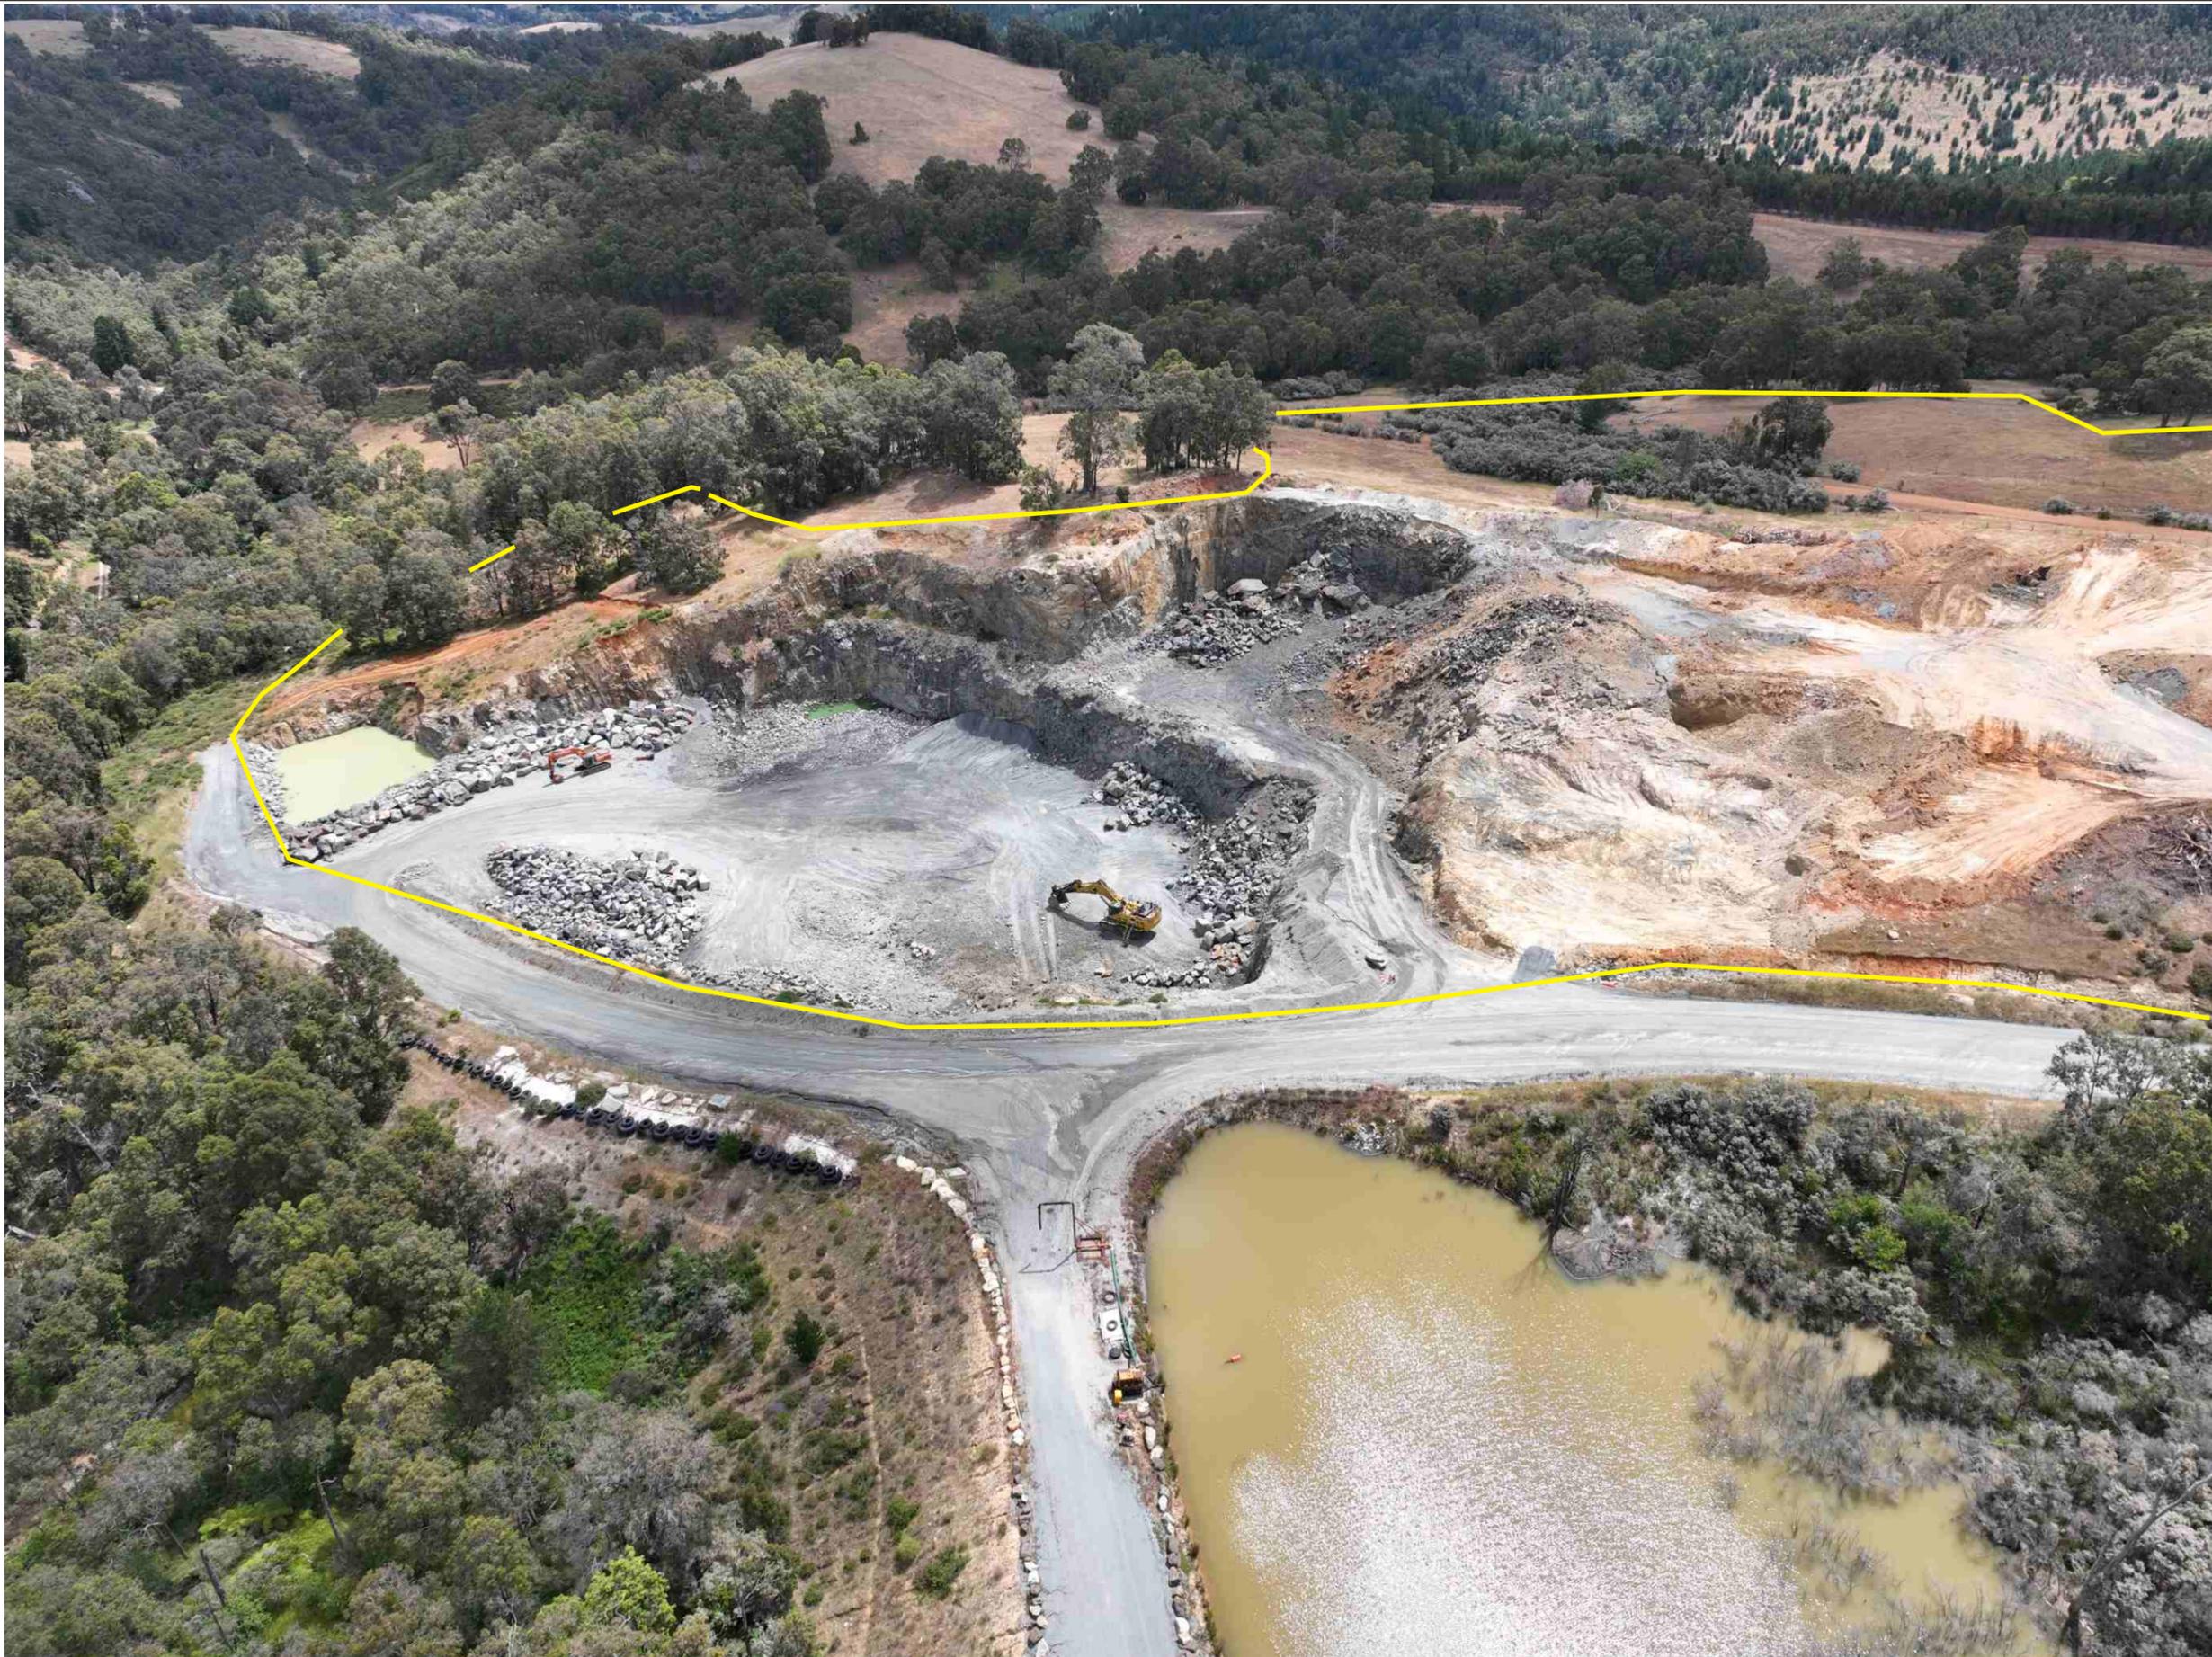
Condition	Clearing Permit Action CPS 7943/1	Discussion
6	Avoid minimise and reduce impacts and extent of clearing	The minimum number of trees has been cleared for the proposed works. The clearing has been progressive to minimise the impacts. <b>Figure 1.</b>
7a	Fauna management	<p><b>Tree 9</b></p> <p>Tree 9 has a hollow suitable for black cockatoo nesting and formed part of the approved area of clearing in the draft CPS 7943/1.</p> <p>The Commonwealth requested that Tree 9 be excluded and the boundary was altered so that Hole 9 lay outside the approved Area. <b>Figure 1.</b></p> <p>The location of Tree 9 is shown in <b>Figures 1, and 12.</b> In <b>Figures 12</b> it can be seen that the pit has become unsafe because of the very irregular and variable variations in the rock types and jointing which has left unsafe rock hanging above the pit face and floor.</p> <p>The nature of the rock type in the pit has meant that retaining the “knob” which includes Tree 9 means that the unsafe rock cannot be barred down and there is no space to backfill the face to make it safe.</p> <p>In an effort to make the pit more manageable and safe in that location the face heights have been reduced from 20 metres to 10 metres but that still has not made the face safe and the “knob” on which Tree 9 occurs.</p>

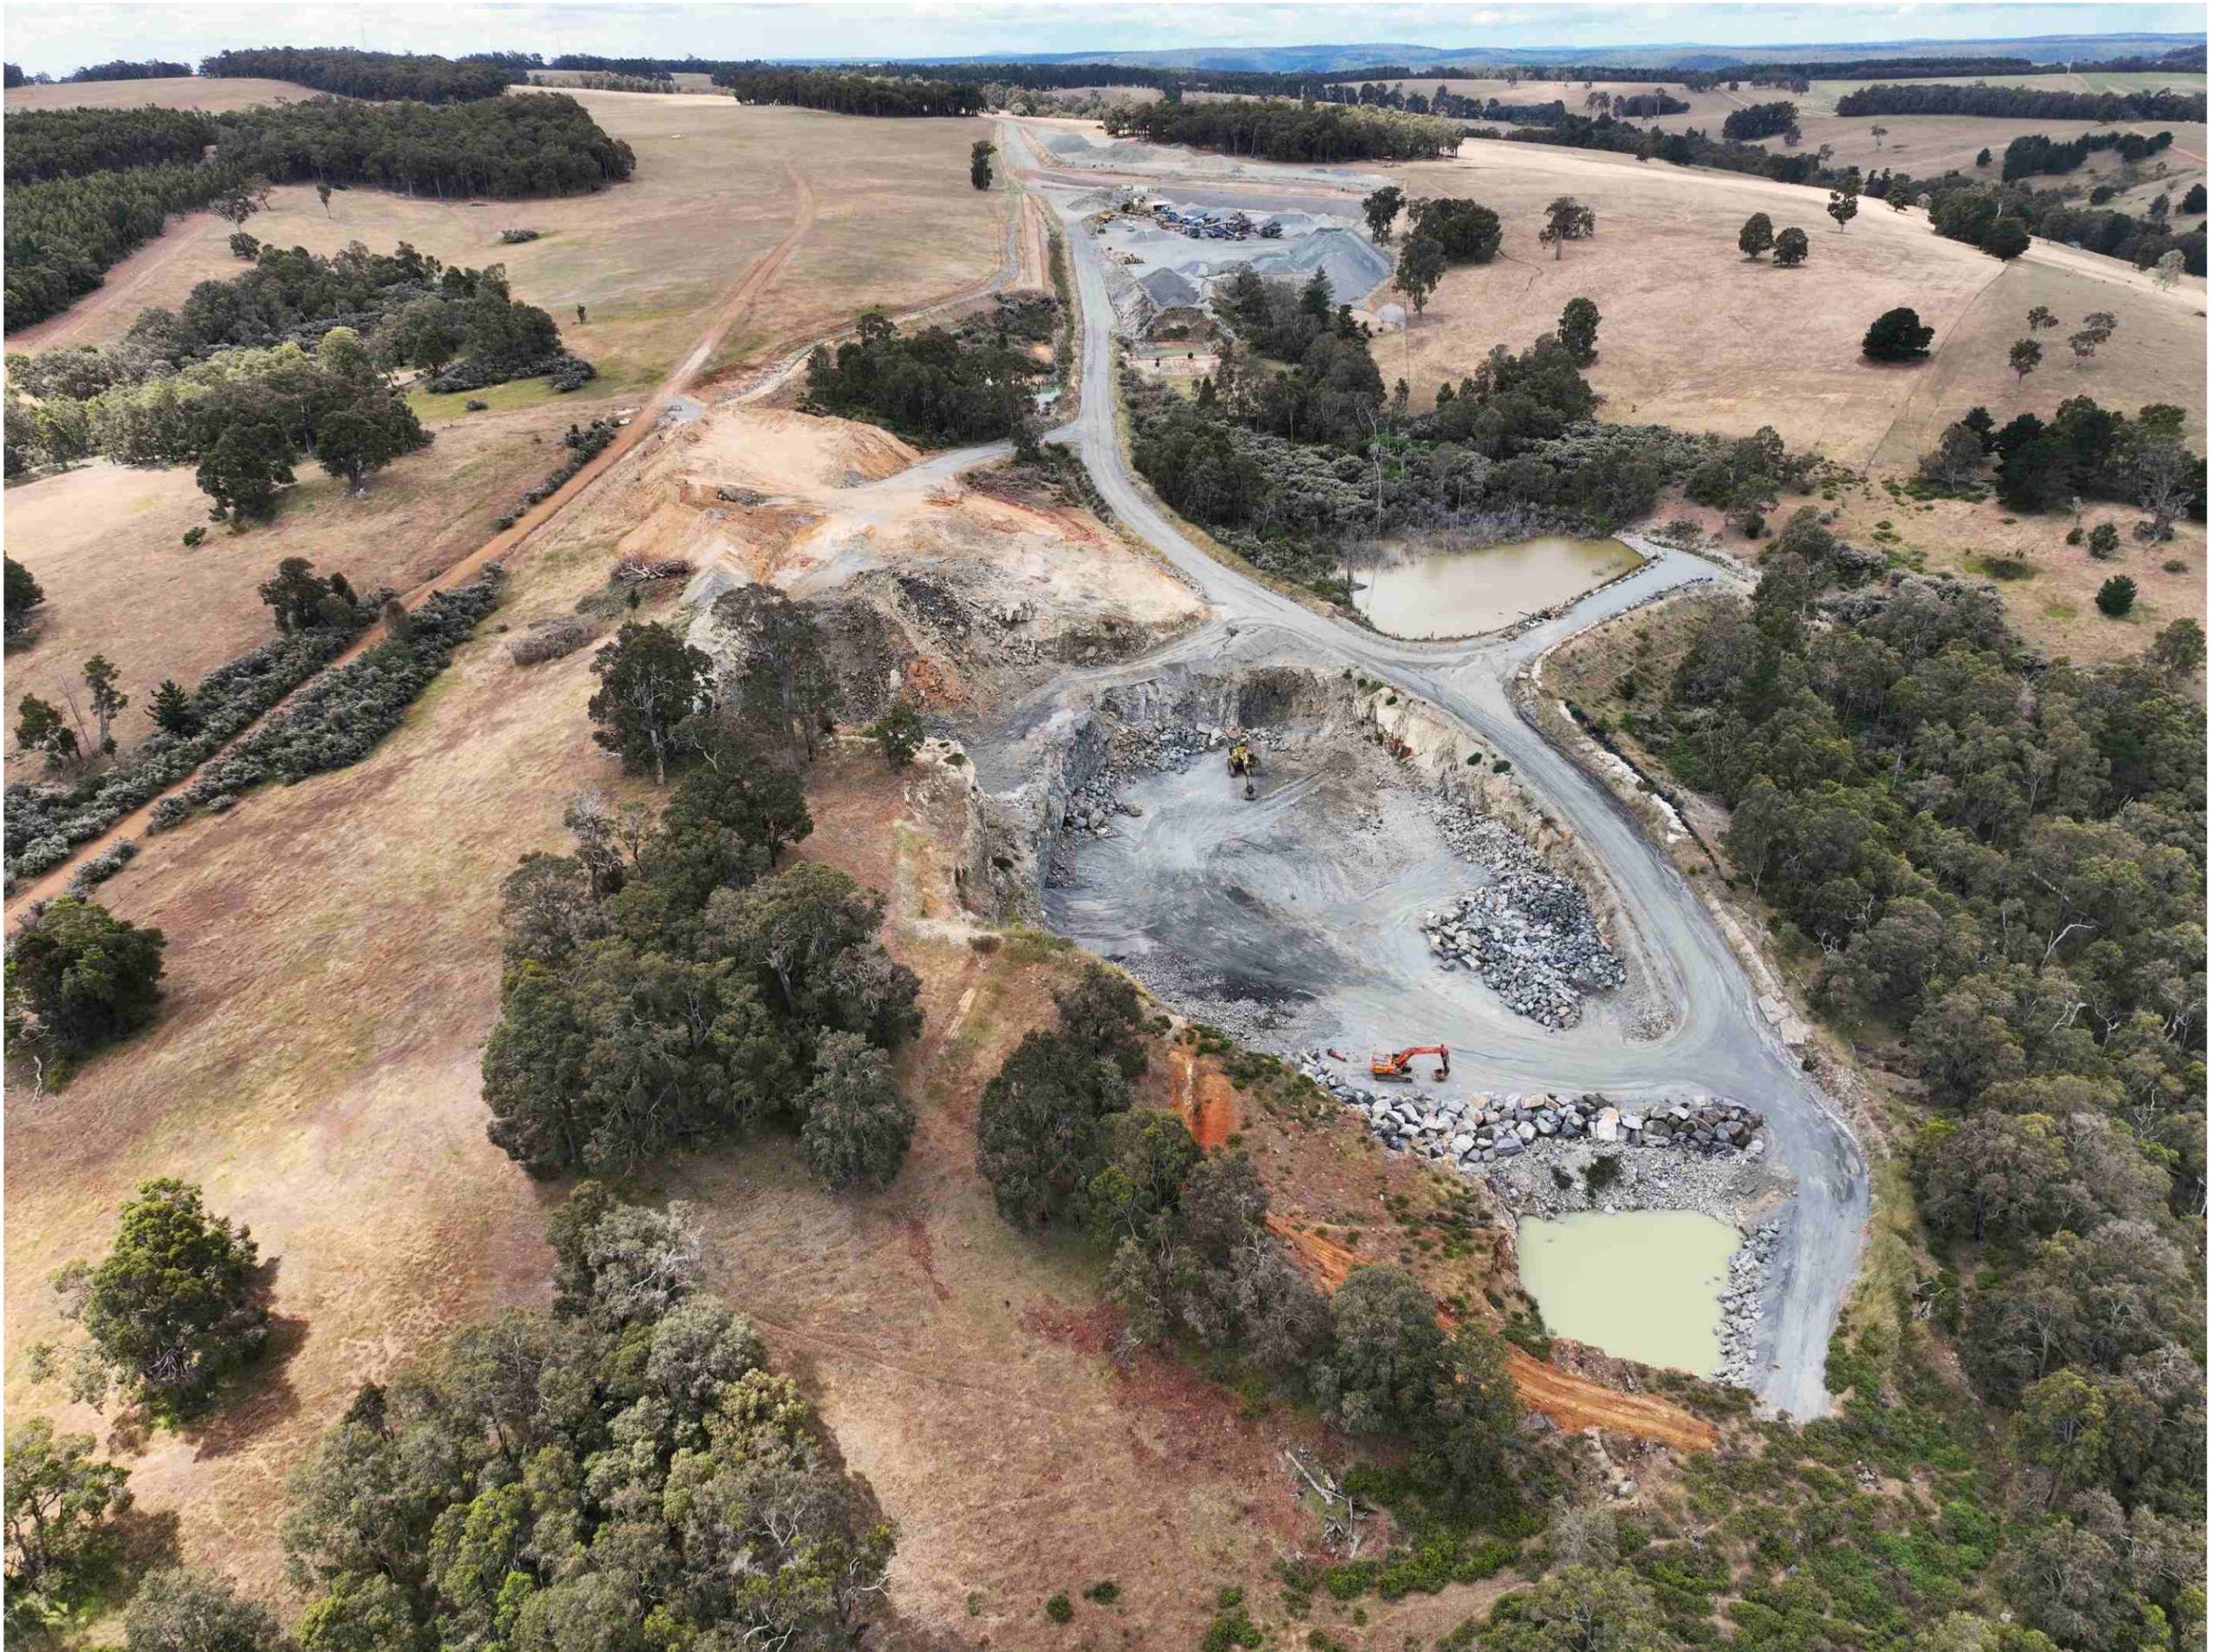
Catalano Shenton Ridge Hard Rock Quarry - EXTRACTION AREA DRONE PHOTOGRAPH FROM THE SOUTH - 25 November 2022  
PROPOSAL TO AMEND CLEARING PERMIT

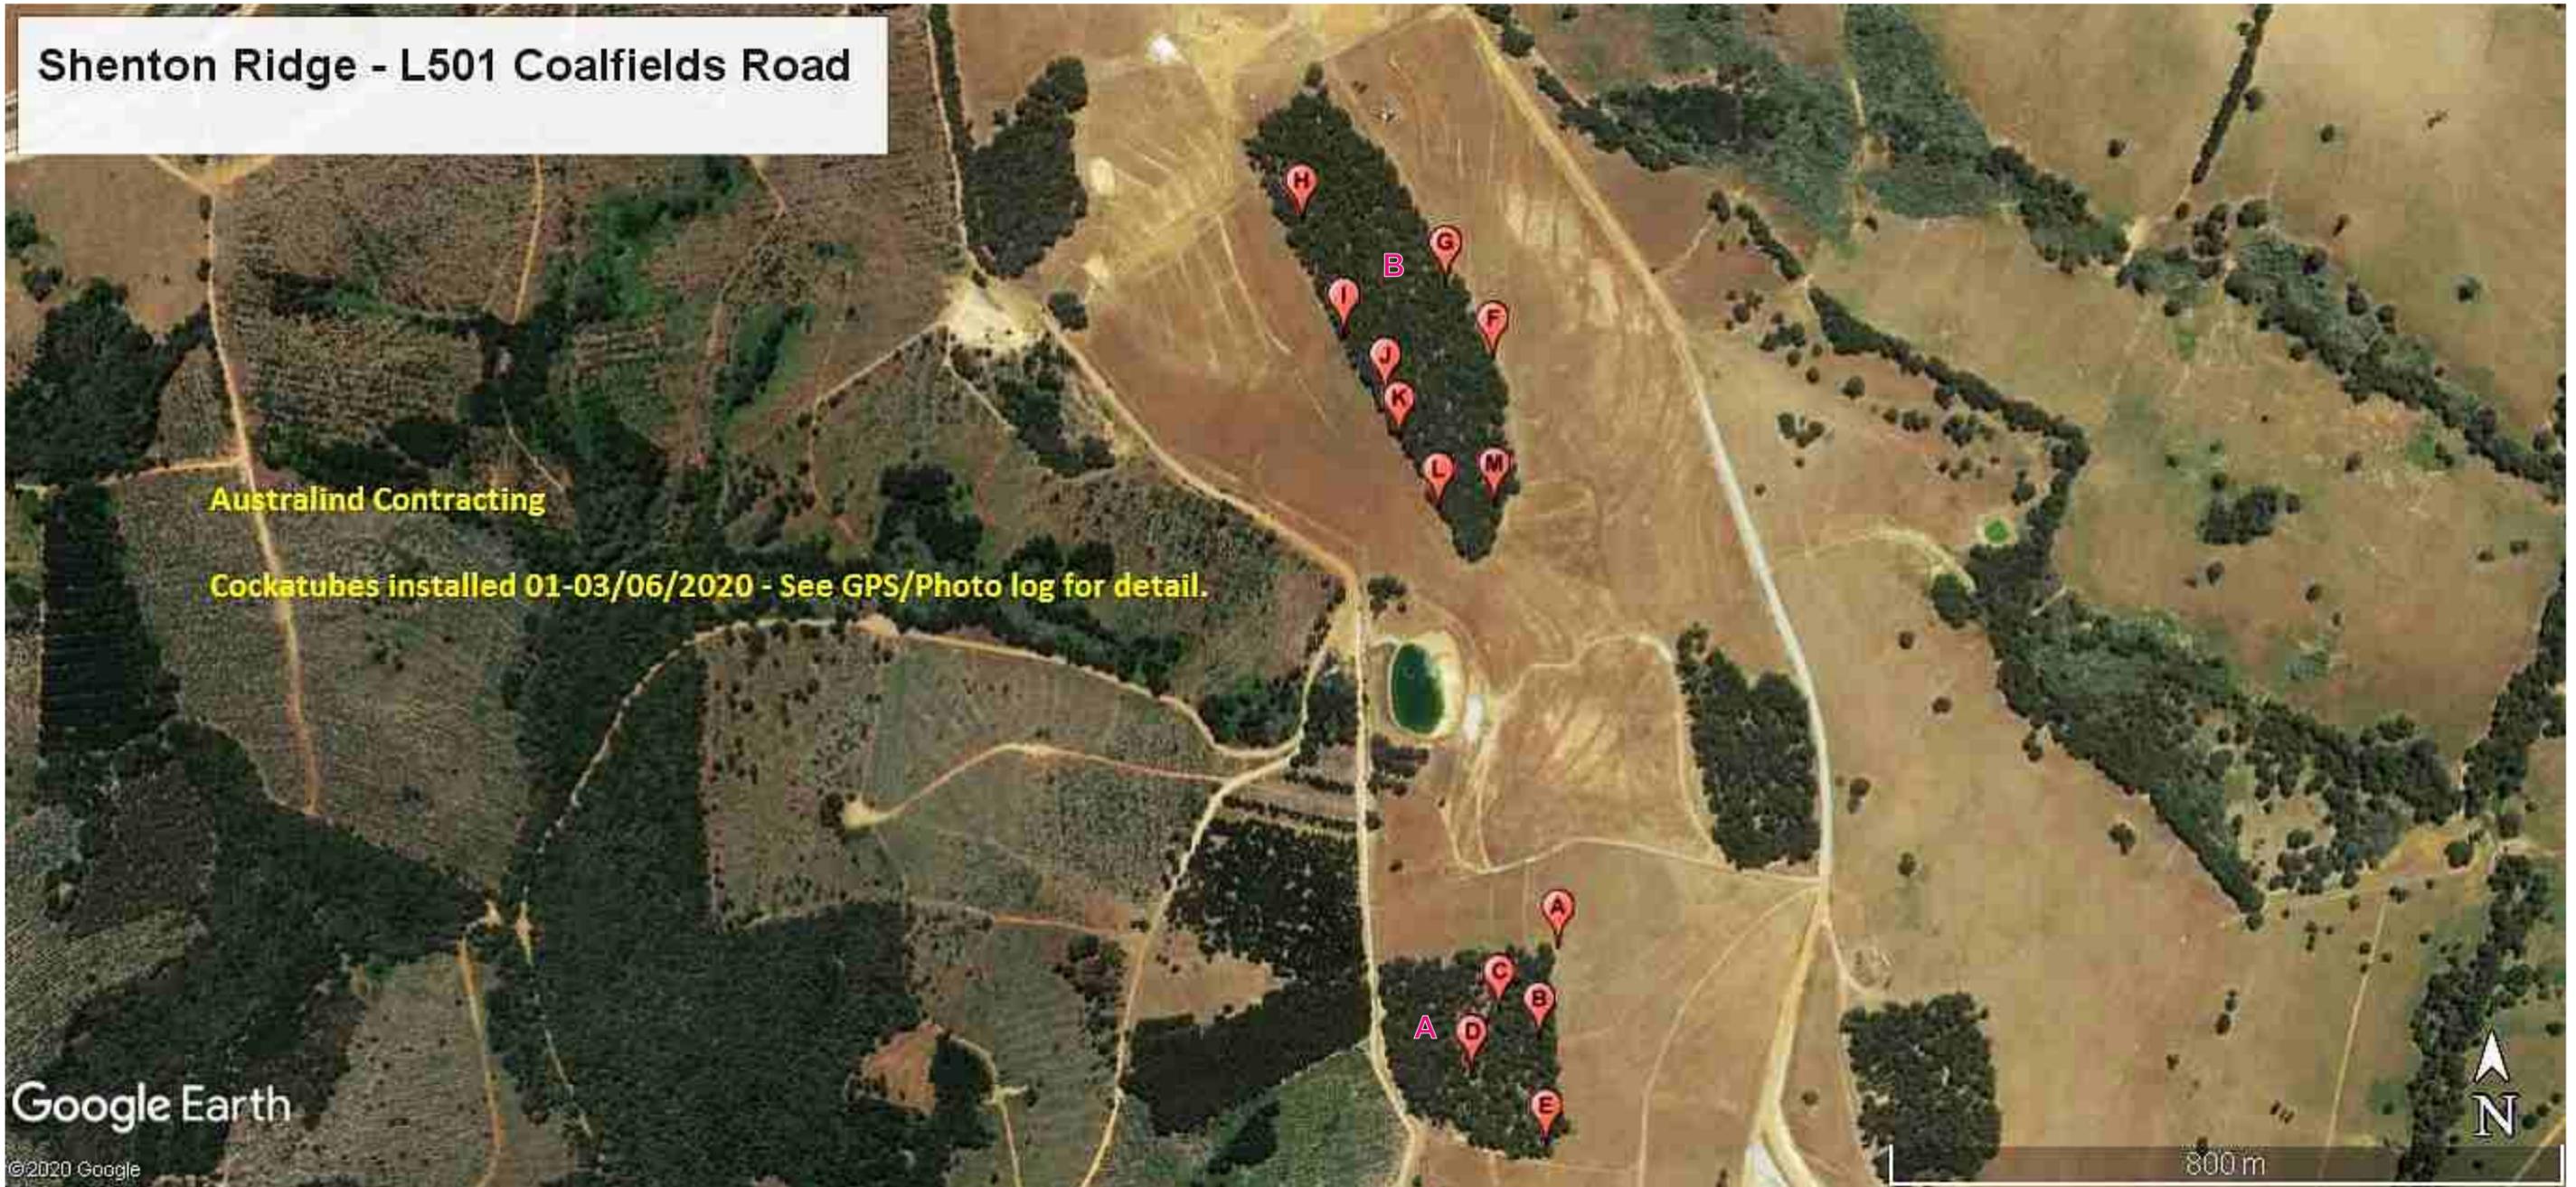
# Shenton Ridge - L501 Coalfields Road

Cockatubes installed 01-03/06/2020 - See GPS/Photo log for detail.

<p>The nesting tubes were installed on 3 June 2020 by Australind Contracting as per the attached email.</p> <p>The details of the installation are attached with the locations shown on the satellite photograph and the locations and photographs of each tube provided.</p> <p>The installation photos of the nesting tubes was supplied to Landform Research on 3 June 2020. See Figure 8 for the location of the nesting tubes.</p>
8b		<p><b>Design of the artificial nesting hollows</b></p> <p>13 artificial hollows were purchased 7 October 2019 and 3 June 2020 from the Shire of Serpentine Jarrahdale. The Shire is well recognised for their design and construction of the artificial nesting hollows as appended to Clearing Permit CPS 7943/1. 13 were installed on site on 1 – 3 June 2020.</p> <p>The reason the Shire of SJ Landcare was chosen to supply the nesting tubes is that they supply the majority of such tubes in Western Australia and assisted (DBCA) Parks and Wildlife with the writing and development of the DBCA documents on making and installing the nesting tubes.</p>

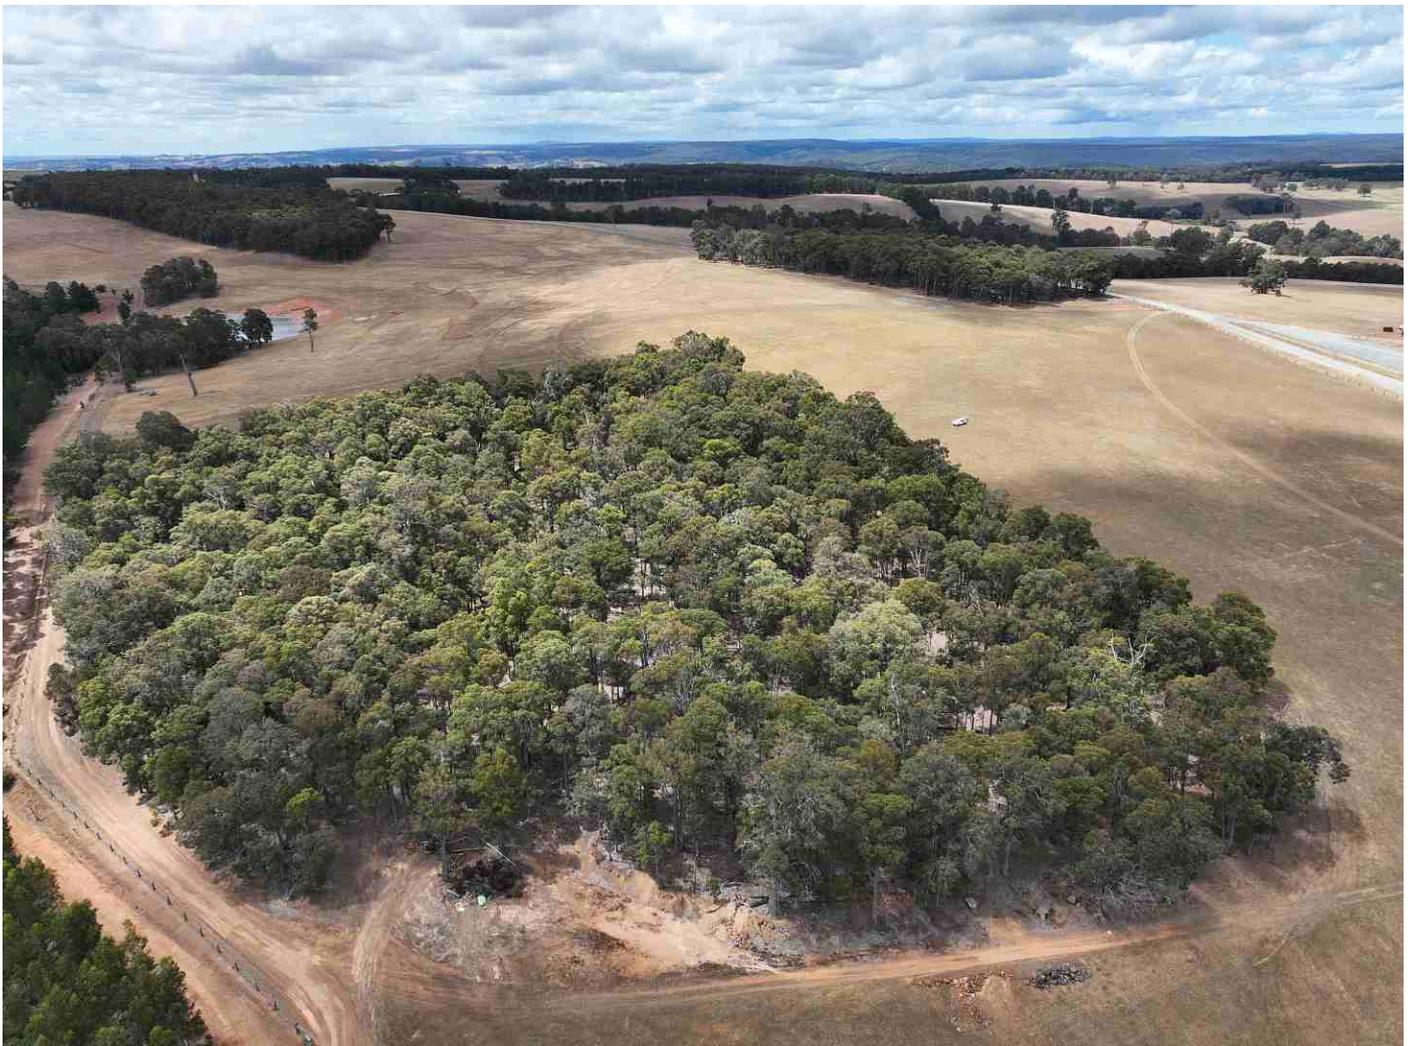
Patch A - contains regrowth trees, around 70 trees > 500 mm diameter and 9 trees with hollows potentially suitable for Cockatoo breeding

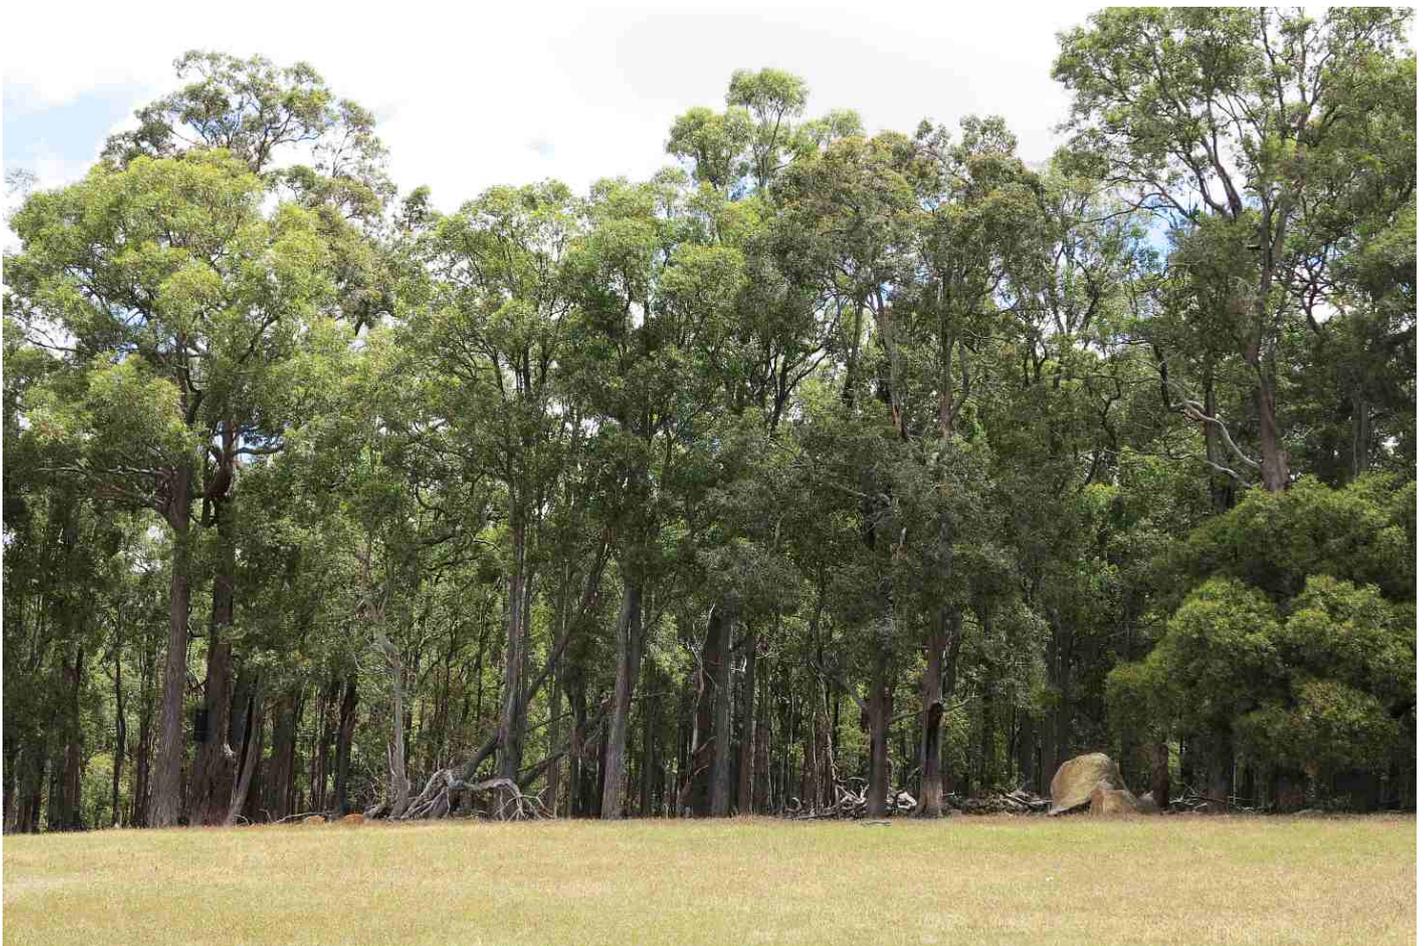
Patch A - view from the east

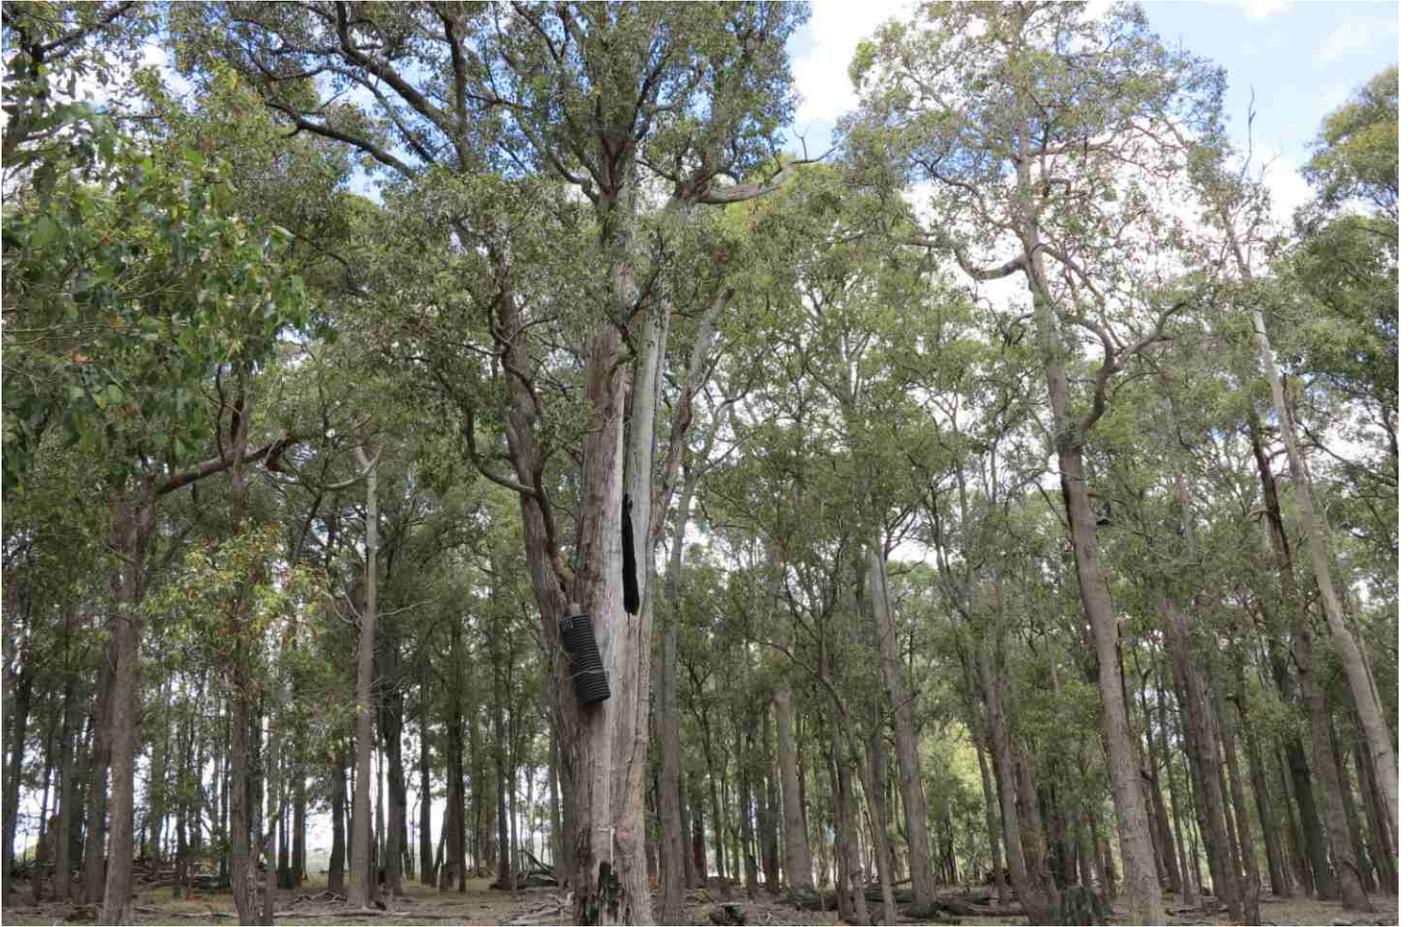
Patch A showing mature trees amongst regrowth Marri and Jarrah

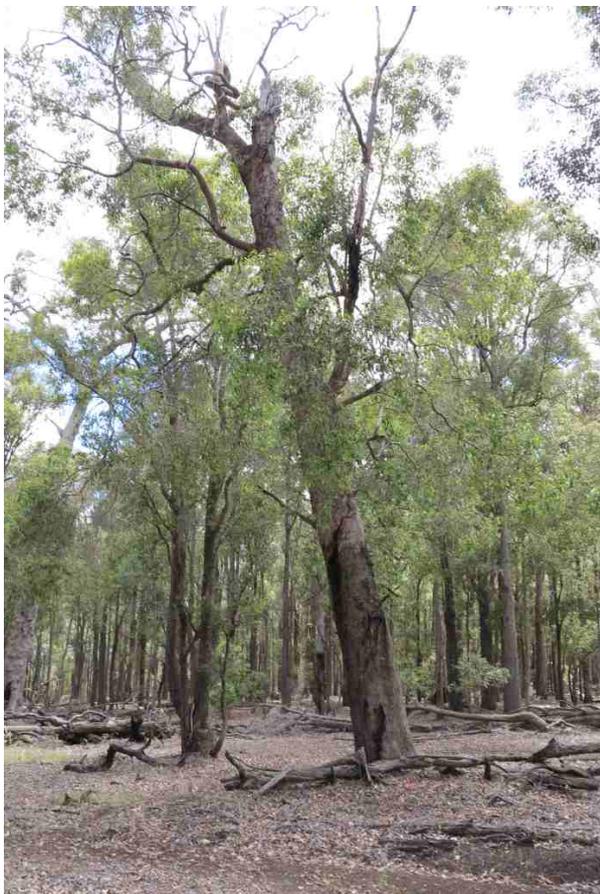
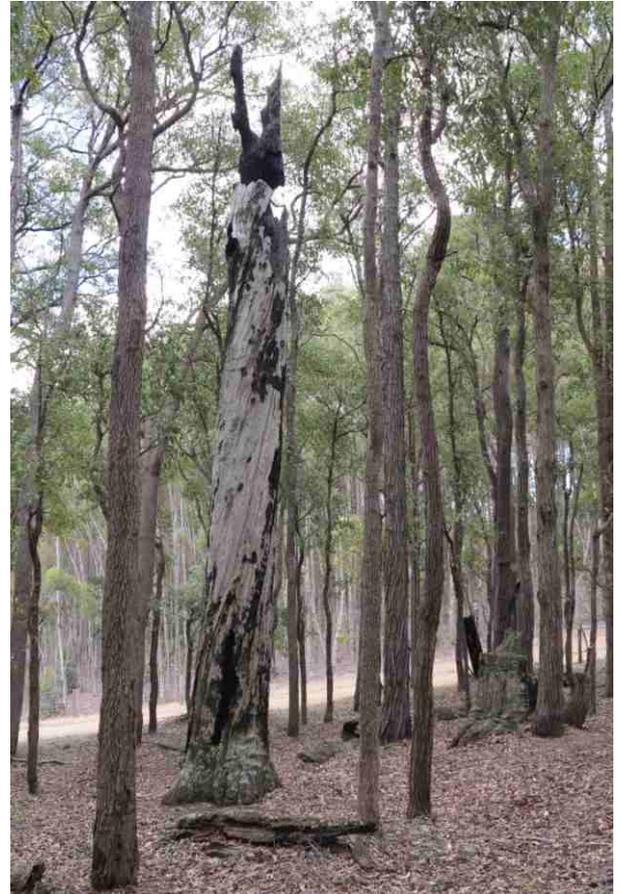
Patch A showing mature trees with suitable hollows and absence of ground cover

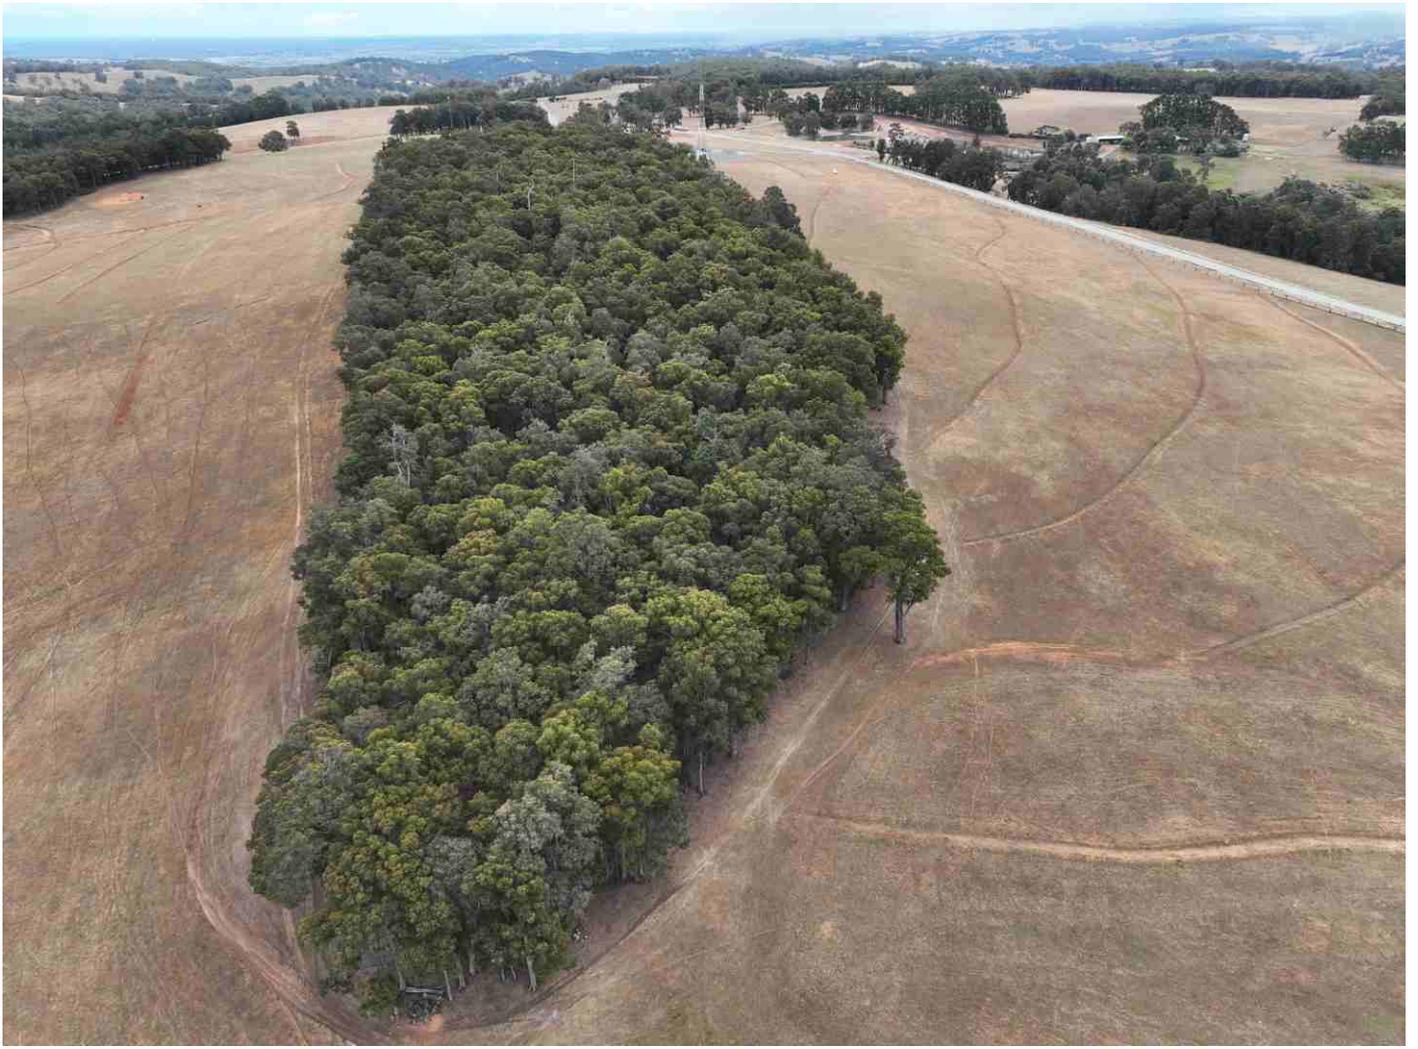
Patch B - contains regrowth trees, around 85 trees > 500 mm diameter and 12 trees with hollows potentially suitable for Cockatoo breeding and one hollow confirmed to be currently active.

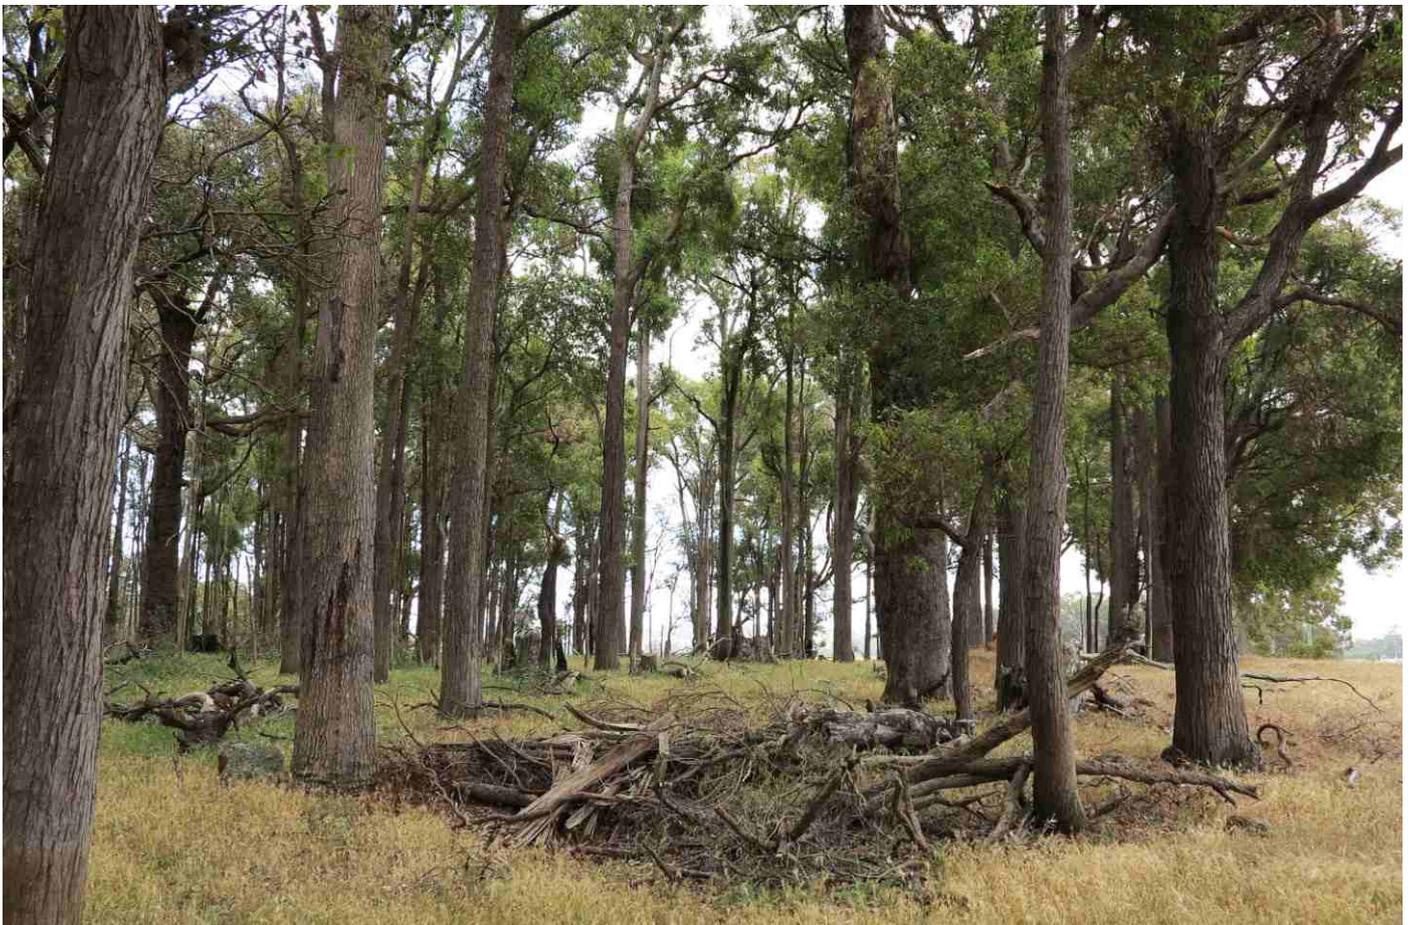
Patch B showing pasture understorey
