## B & J Catalano Shenton Ridge Hard Rock Quarry

### CPS 7943/1 – Clearing Report 2018 - 2023

AUGUST 2023

This Clearing Report summarises the actions and clearing conducted under CPS 7943/1 and EPBC 2017-8085.

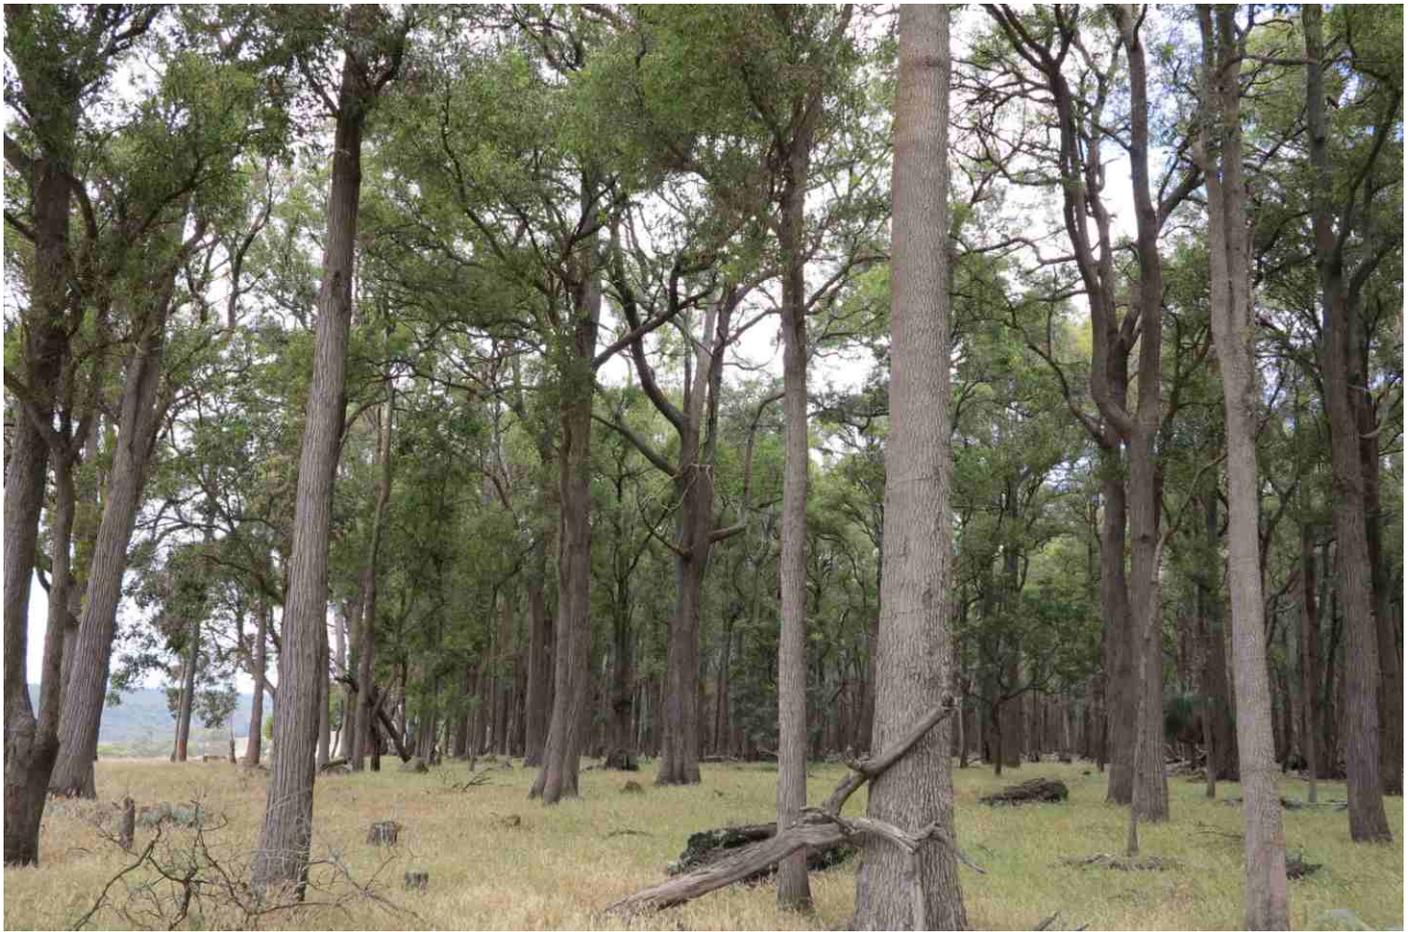
Patch B showing an area of regrowth Marri and Jarrah

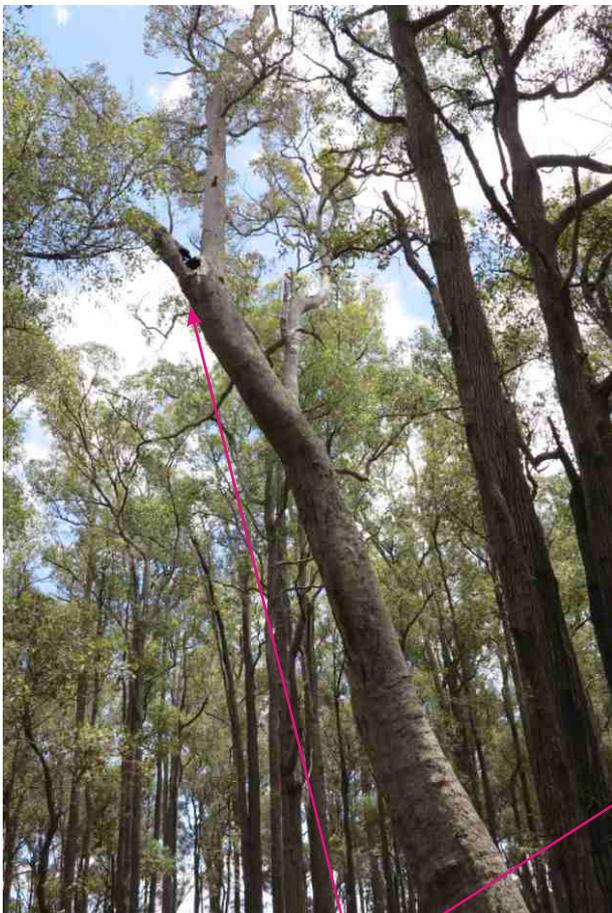
Tree hollow that is being actively used

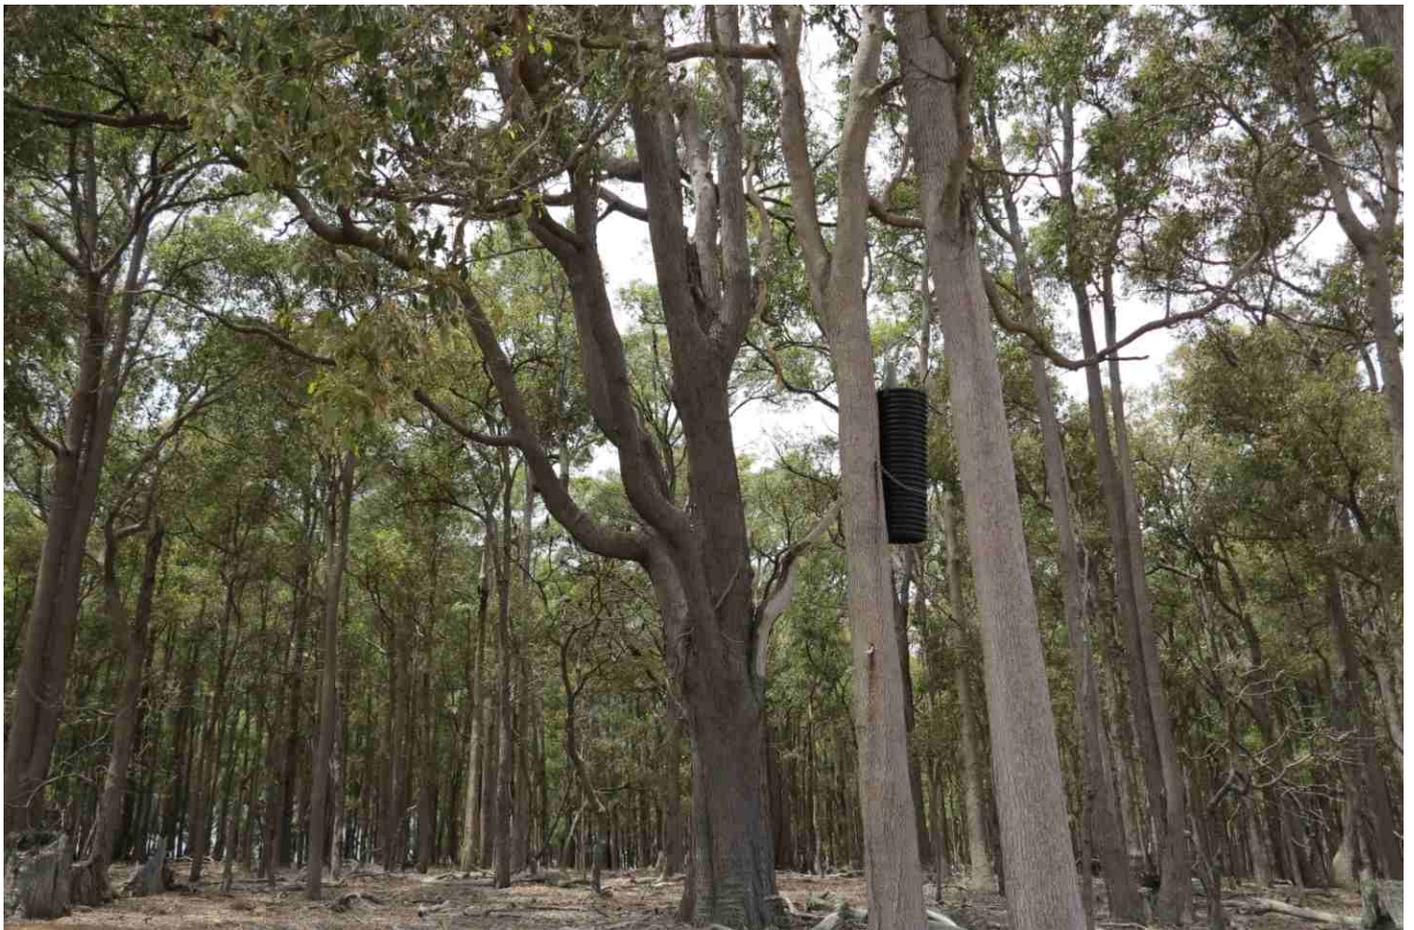
Patch B with an artificial hollow installed

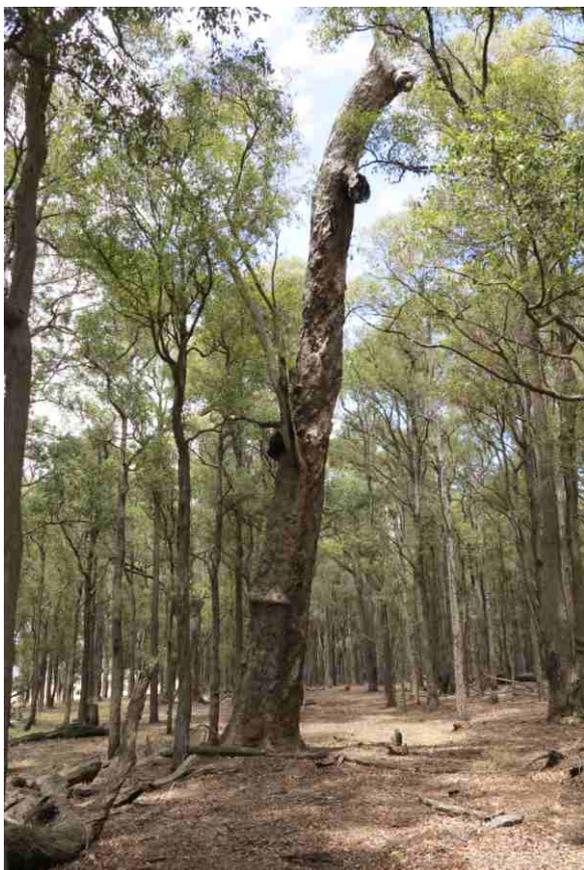
Patch B - Mature tree with suitable hollow

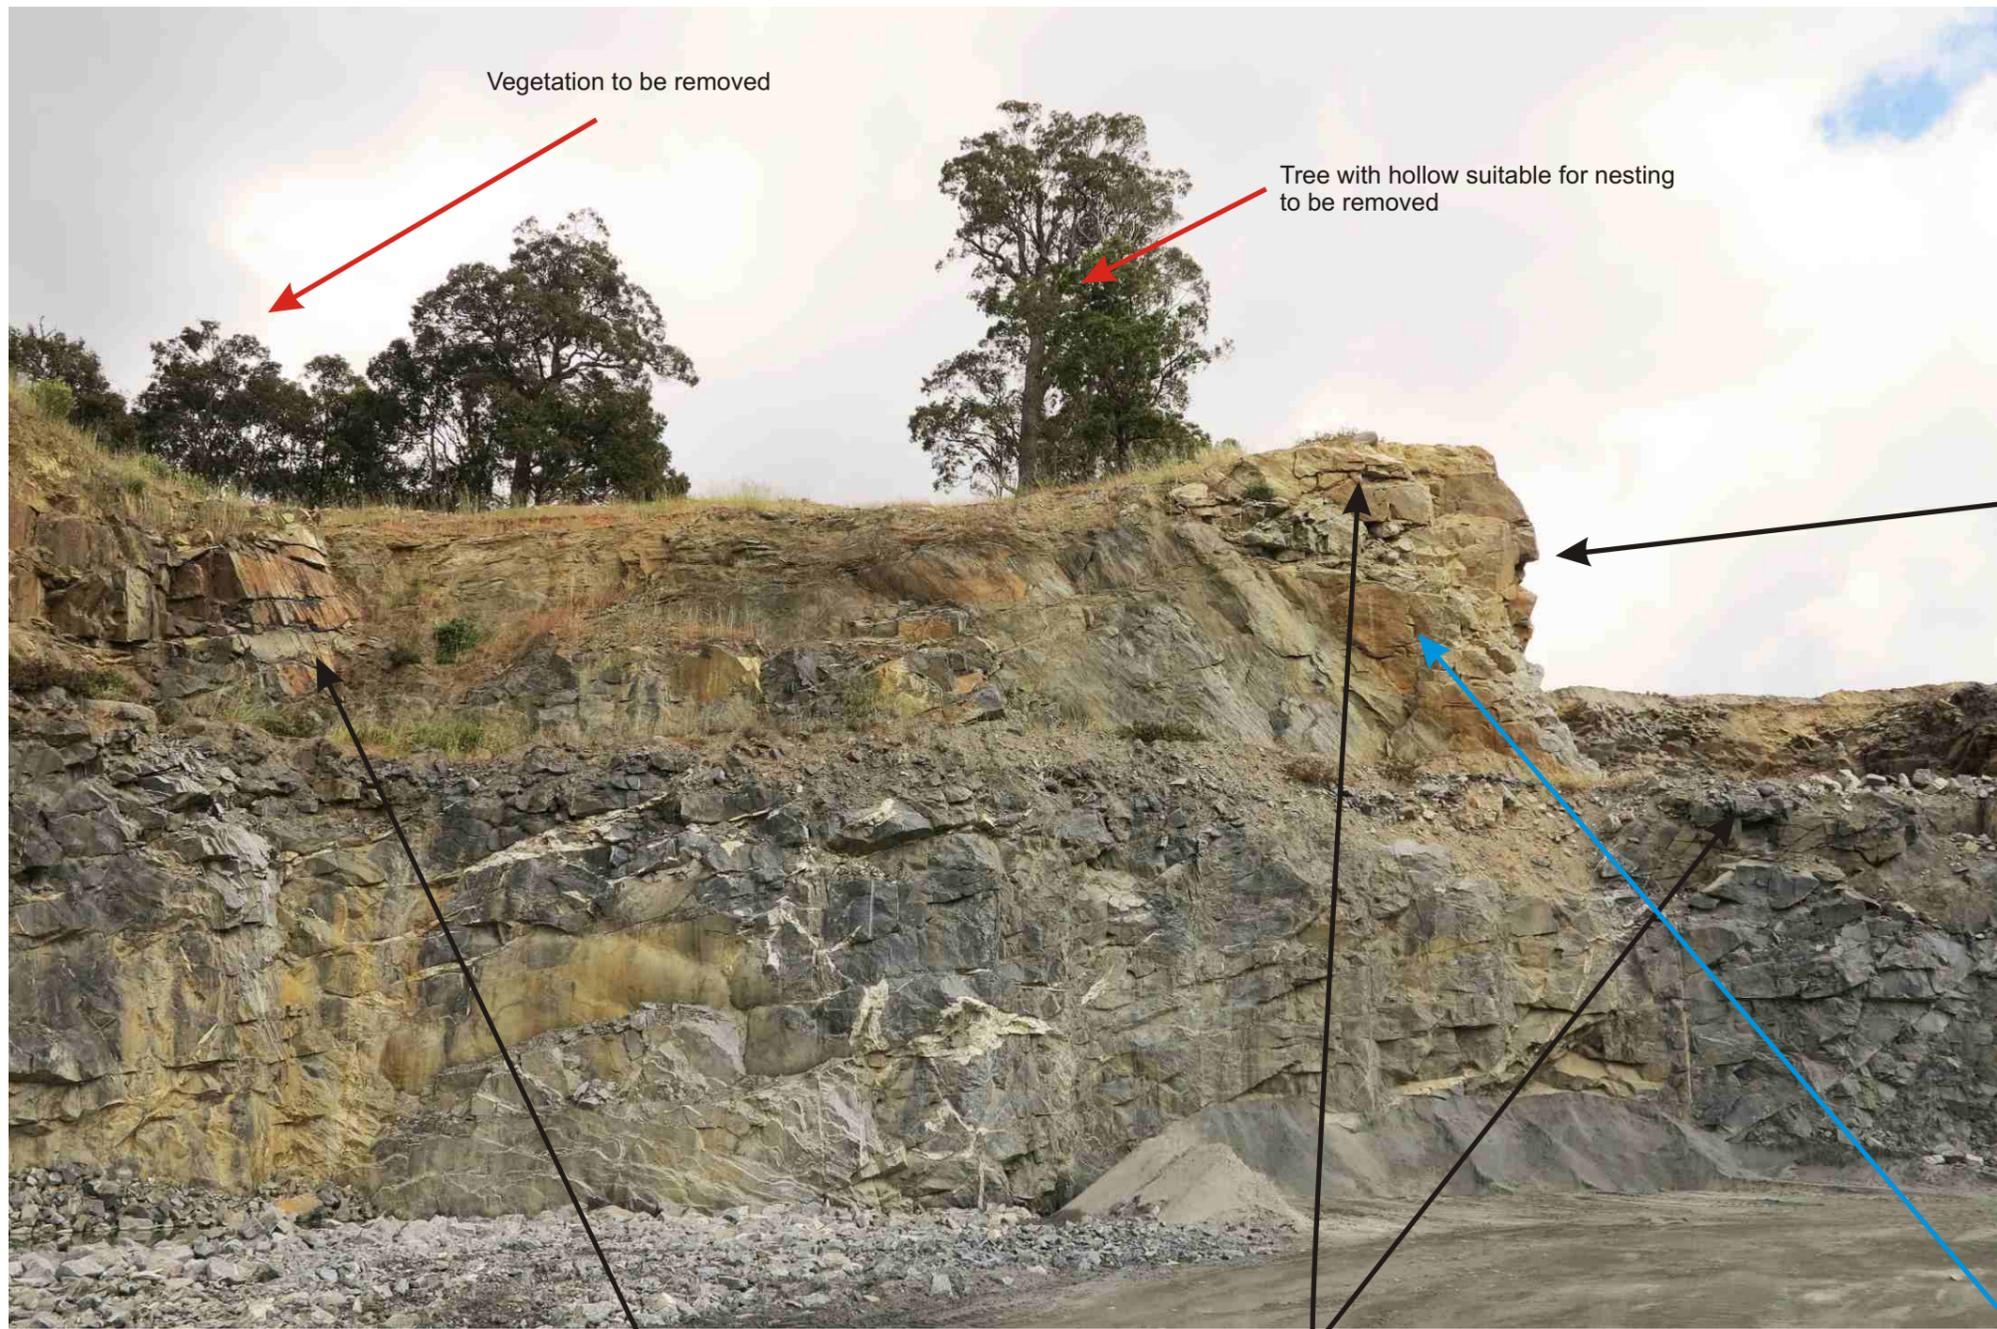
Difficult rock excavation conditions with multiple changes to rock types and jointing making even difficult.

Face changing from 20 metre high to 10 metre high to increase face safety and improve blast quality.

Unsafe face and rock that it is not possible to make safe whilst the tree remains.

Tree with hollow suitable for nesting to be removed

Condition	Clearing Permit Action CPS 7943/1	Discussion
6	Avoid minimise and reduce impacts and extent of clearing	The minimum number of trees has been cleared for the proposed works. The clearing has been progressive to minimise the impacts. <b>Figure 1.</b>
7a	Fauna management	<p><b>Tree 9</b></p> <p>Tree 9 has a hollow suitable for black cockatoo nesting and formed part of the approved area of clearing in the draft CPS 7943/1.</p> <p>The Commonwealth requested that Tree 9 be excluded and the boundary was altered so that Hole 9 lay outside the approved Area. <b>Figure 1.</b></p> <p>The location of Tree 9 is shown in <b>Figures 1, and 12.</b> In <b>Figures 12</b> it can be seen that the pit has become unsafe because of the very irregular and variable variations in the rock types and jointing which has left unsafe rock hanging above the pit face and floor.</p> <p>The nature of the rock type in the pit has meant that retaining the “knob” which includes Tree 9 means that the unsafe rock cannot be barred down and there is no space to backfill the face to make it safe.</p> <p>In an effort to make the pit more manageable and safe in that location the face heights have been reduced from 20 metres to 10 metres but that still has not made the face safe and the “knob” on which Tree 9 occurs.</p>

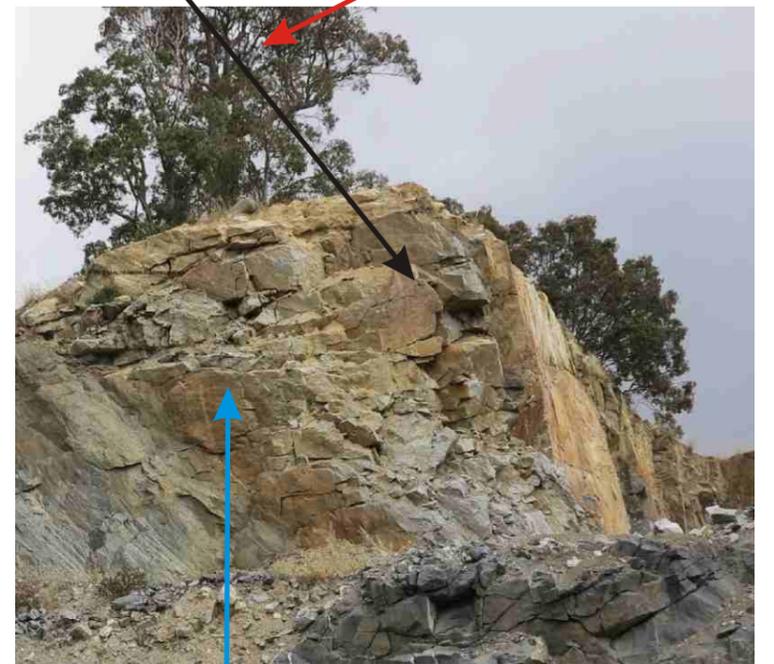
FIGURE 12

Catalano Shenton Ridge Hard Rock Quarry - CURRENT PIT - JULY 2023

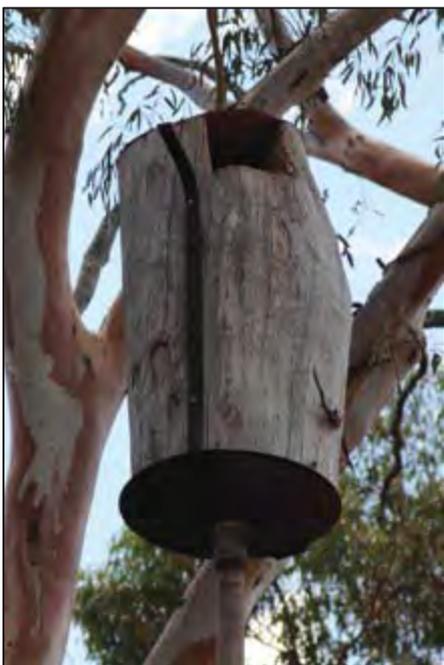
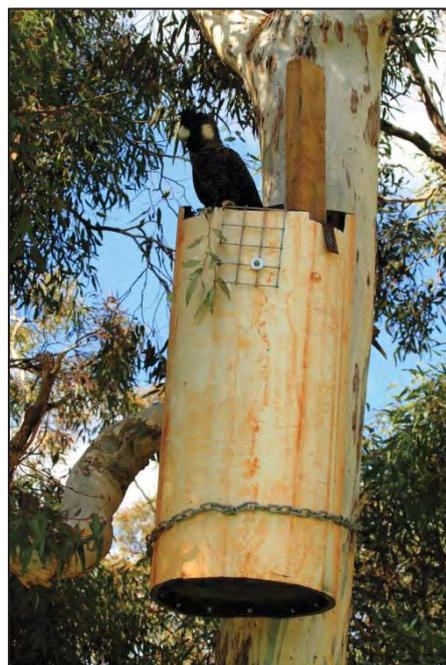
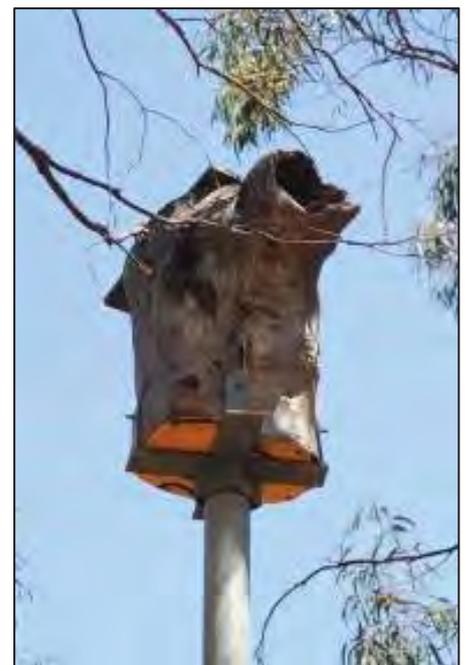
Below are three examples of successful artificial hollows used by Carnaby's cockatoo for nesting. Artificial hollows made from a natural log with cut side entrance (left), white industrial pipe with top entrance (centre) and natural log with natural side entrance (right).

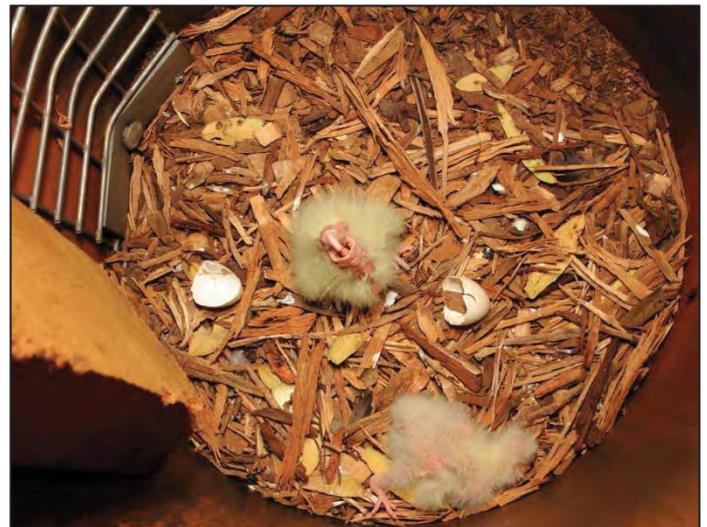
Bottom of an artificial hollow showing ladder that is fixed to the wall and a chewed sacrificial post which is 200 mm from the floor.

It is recommended that at least two posts are provided. Posts 70 x 50 mm have been used, but require replacing at least every second breeding season when the nest is active. Birds do vary in their chewing habits and therefore the frequency at which the chewing posts require replacement will also vary.

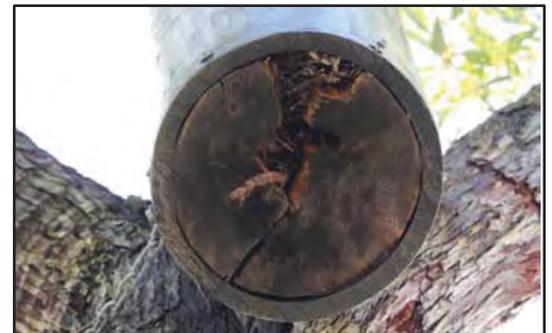
Artificial hollow base needing repair.  
Photo by Christine Groom

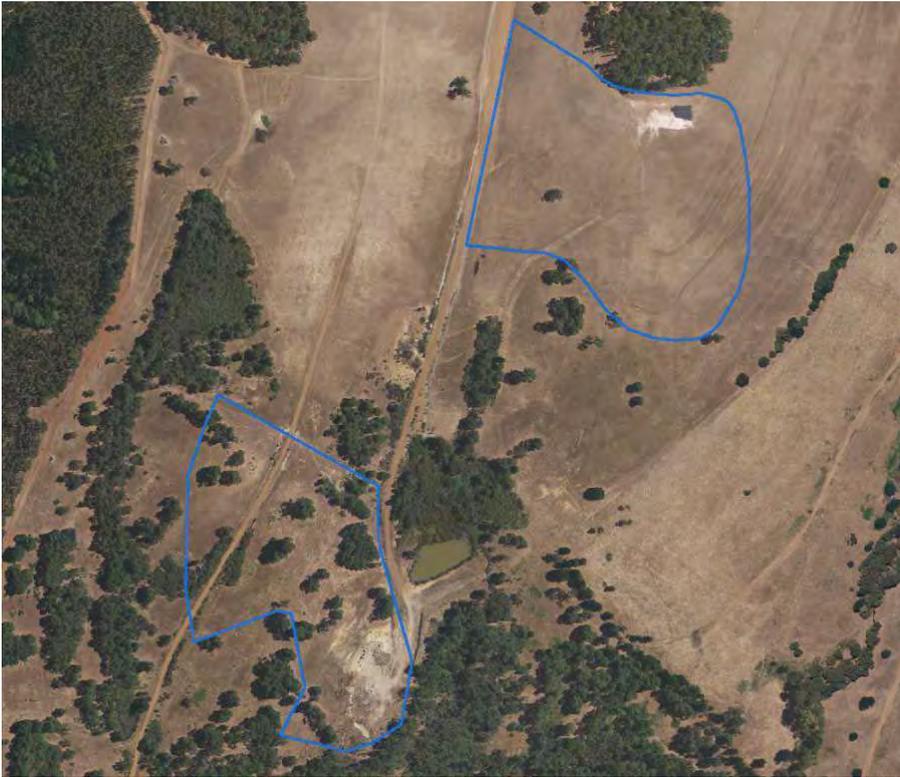
Figure 2. Map of revised application area (blue outline). Southwest corner of extraction area removed.

On 23 August 2018, the applicant responded to DWER providing a revised application area that avoids 13 of the 22 trees identified as having a diameter at breast height of 500 millimetres or greater (Landform Research, 2018a). The tree with a well chewed hollow is one of the 13 trees avoided. The revised application area is shown as Figure 2.

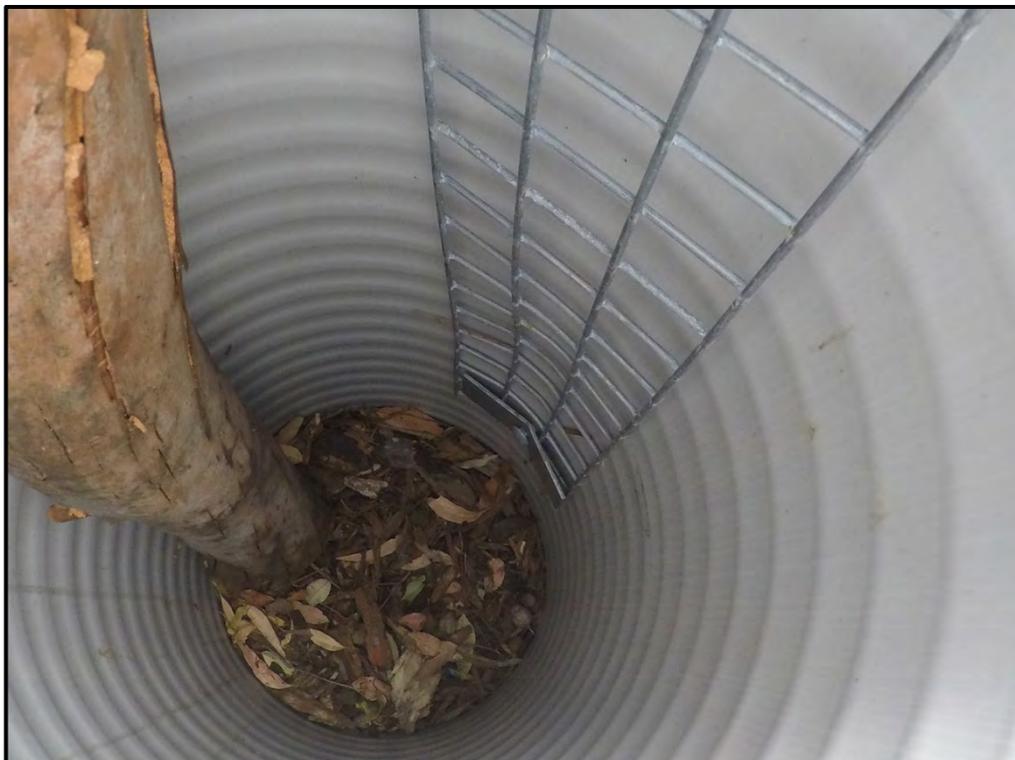
None of the 23 tubes inspected showed any signs of having been used by black cockatoos. See fig 2.

Fig 2. Nesting tube at the survey area showing no signs of use.

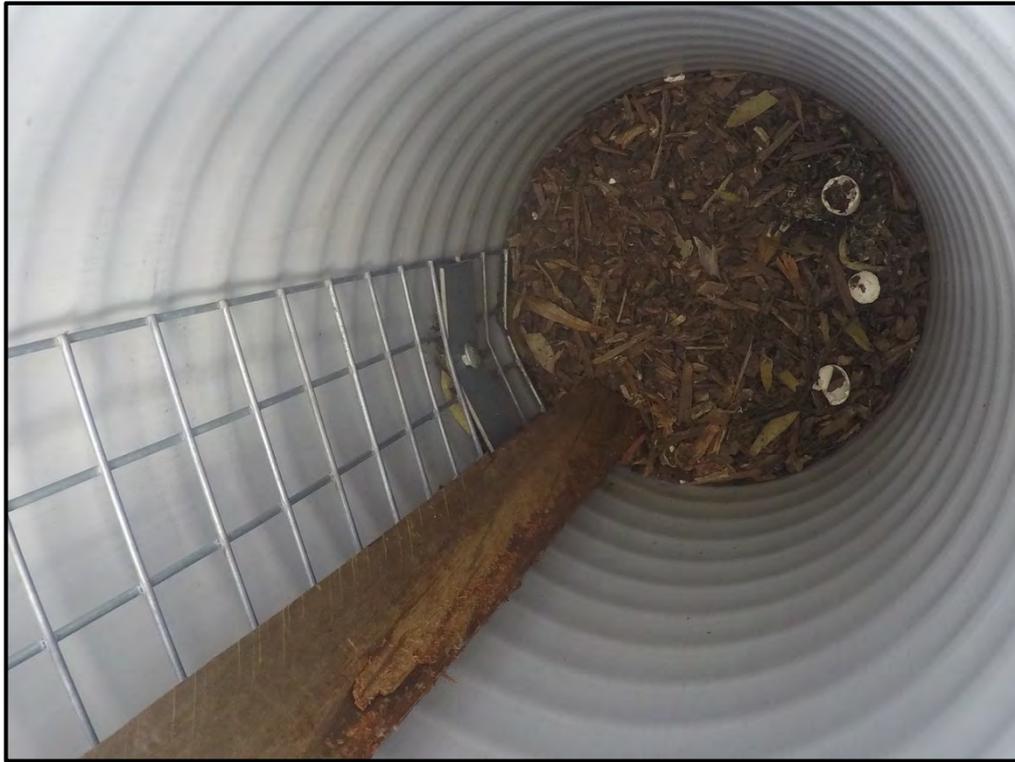
The design of these nesting tubes is such that the wooden sacrificial post provides an indicator of use by black cockatoos as they chew in and around a breeding hollow when renovating or breeding. Breeding is also evident by the presence of eggshells or occasionally feathers at the base of the nest chamber. See fig. 1.

Fig. 1. Example of a nesting tube at Bindoon which has been used and which shows chewing on sacrificial post and eggshells on nest floor.

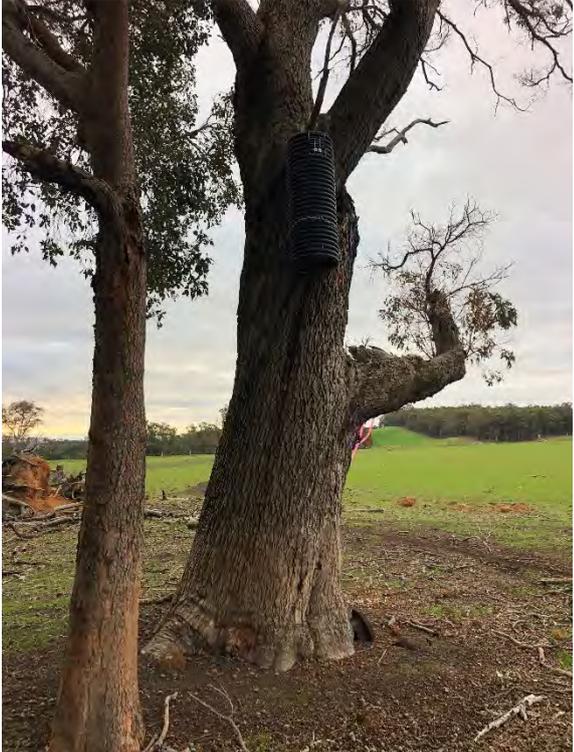
A	Lat: -33.295086° Long: 115.902419°

A photograph of a large, mature tree with a thick trunk. A black, cylindrical nesting tube is attached to the trunk. The tree is situated in an open field with a green lawn and some trees in the background under a cloudy sky.
B	Lat: -33.296030° Long: 115.902190°

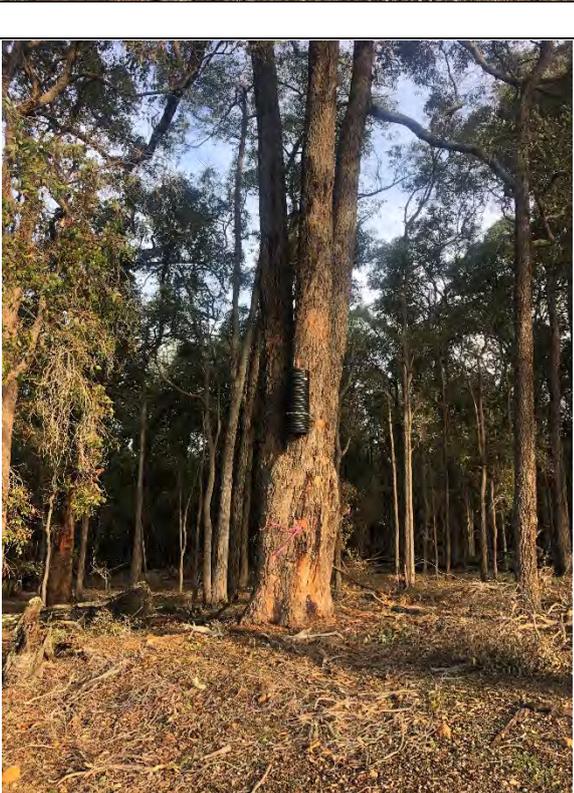
A photograph of a tree with a black nesting tube attached to its trunk. The tree is located in a wooded area with many other trees and a ground covered in dry leaves and twigs.

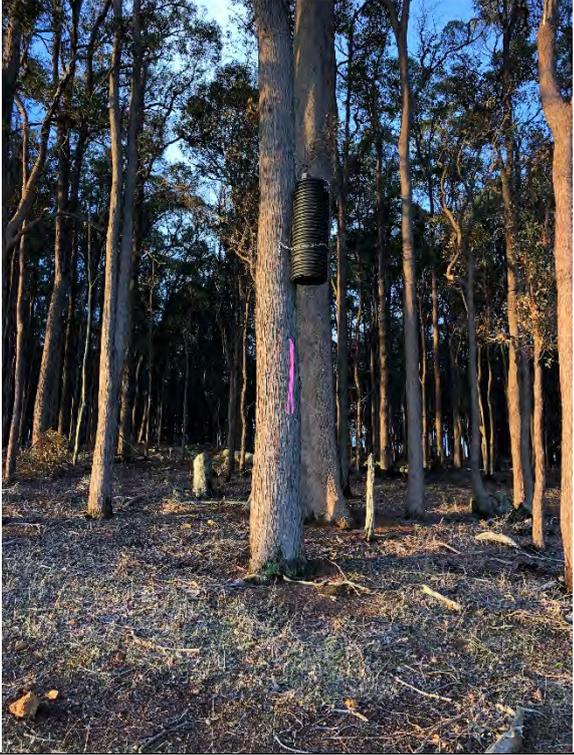
I	Lat: -33.288880° Long: 115.899850°

A photograph of a tree in a forest. A black, cylindrical nesting tube is attached to the trunk. A vertical pink marker is visible on the trunk below the tube. The ground is covered with dry leaves and twigs.
J	Lat: -33.289480° Long: 115.900350°

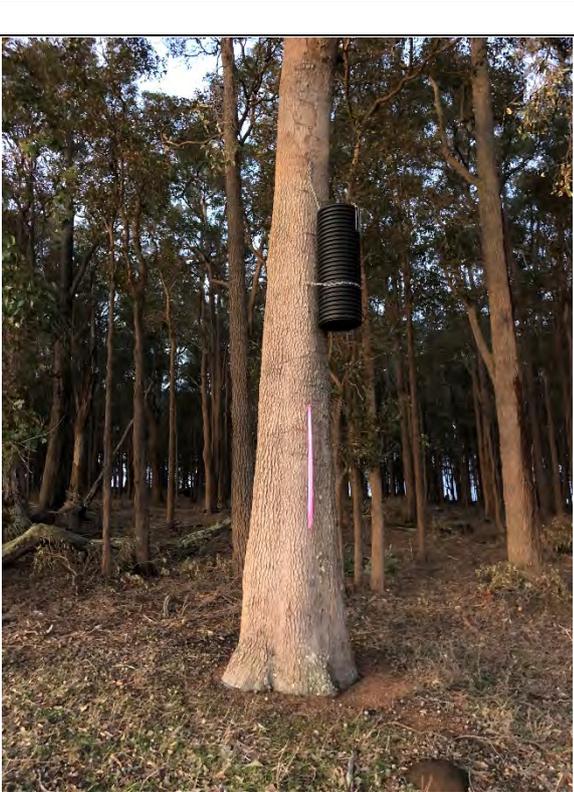
A photograph of a tree in a forest. A black, cylindrical nesting tube is attached to the trunk. A vertical pink marker is visible on the trunk below the tube. The ground is covered with dry leaves and twigs.
