# Ballyteigue-Bannow Catchment Assessment 2010-2015 (HA 13)

Catchment Science & Management Unit

Environmental Protection Agency

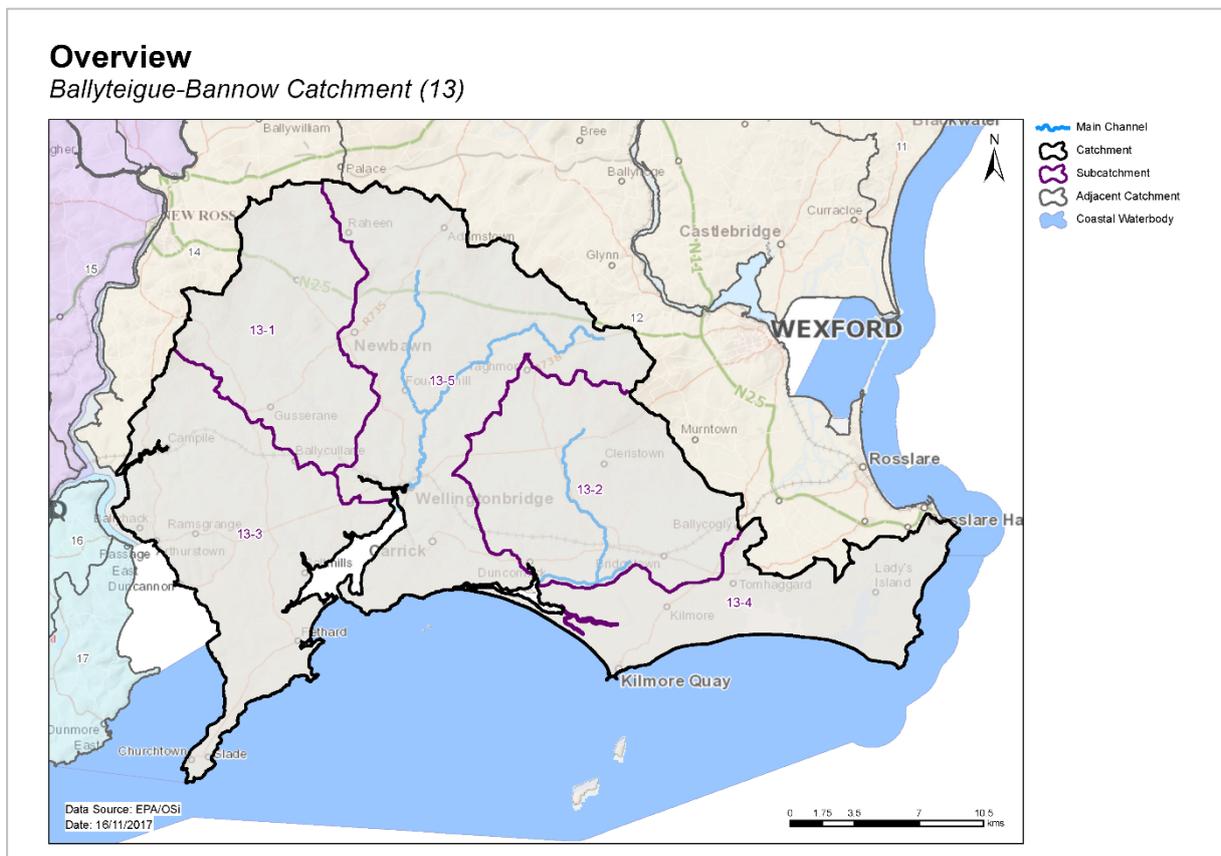
Figure 1. Subcatchments in the Ballyteige-Bannow catchment

The Ballyteige-Bannow catchment comprises five subcatchments (Table 1, Figure 1) with 30 river water bodies, six transitional water bodies, three coastal water bodies and four groundwater bodies.

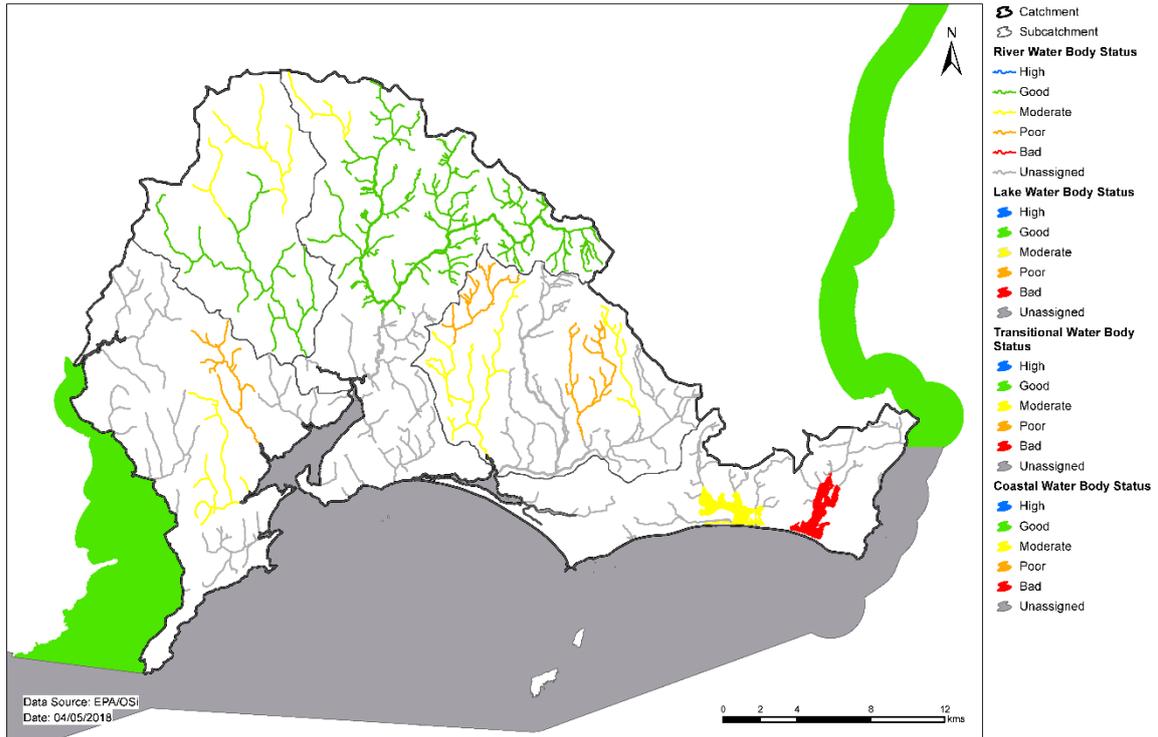
Figure 2. Surface water ecological status

- ◆ There were eight (27%) river water bodies at Good status, and nine (30%) at less than Good status in 2015 (Table 2, Figure 2). Thirteen (43%) river water bodies are unassigned. There are no lake water bodies in the Ballyteigue-Bannow catchment.
- ◆ No river water bodies have a high ecological status objective.
- ◆ The numbers of river water bodies at each status class in 2007-09 and 2010-15 are shown in Figure 3.
- ◆ Since 2007-09 when WFD monitoring began, four water bodies have an improved status whereas six have deteriorated (Figure 5).
- ◆ The variation in nutrient concentrations and loads in the Owenduff (Wexford) and Bridgetown (Wexford) main channels are illustrated in Appendix 1.

- ◆ There are ten transitional and coastal (TraCs) water bodies in the Ballyteigue-Bannow catchment (Figure 2, Table 2).
- ◆ There are no water bodies with a high ecological status objective.
- ◆ The numbers of TraC water bodies at each status class in 2007-09 and 2010-15 are shown in Figure 4.
- ◆ Since 2007-09 when WFD monitoring began, one water body has an improved status and one has deteriorated (Figure 5).
- ◆ Note that the coastal water body Southwestern Irish Sea (HAs 11;12) is shared with three other catchments (HAs 10,11,12).

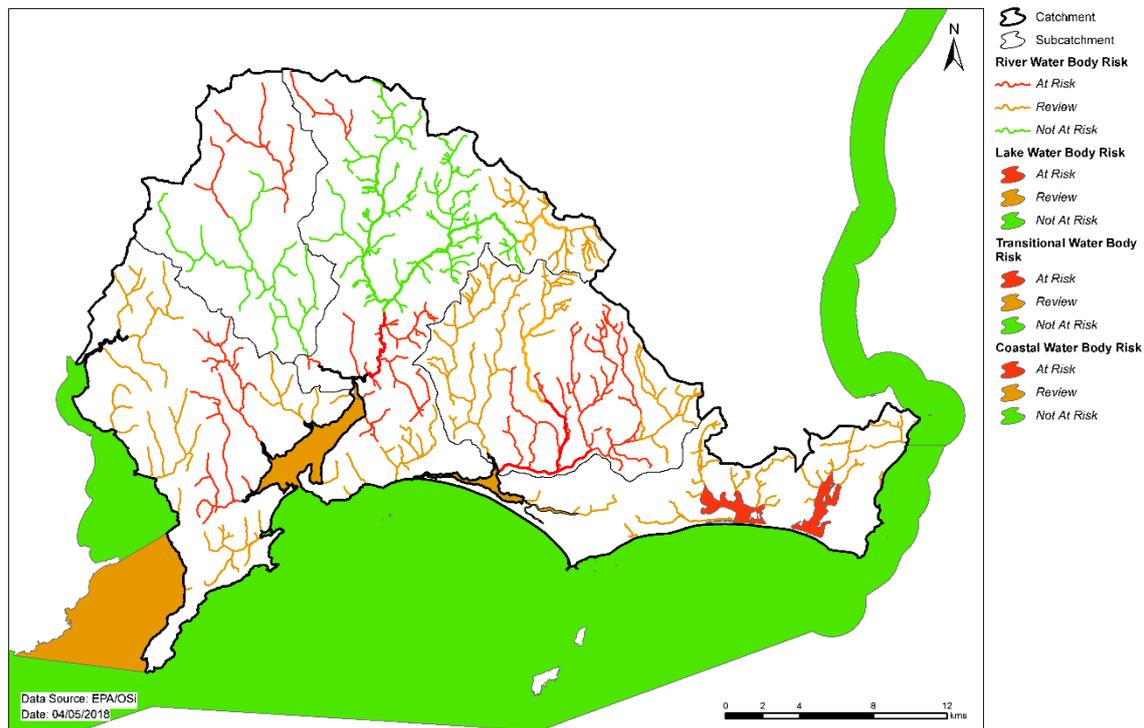
Figure 5. Surface water body risk

- ◆ There are seven *Not at Risk* river water bodies (Figure 5, Table 2) and these require no additional investigative assessment or measures to be applied, other than those measures that are already in place.
- ◆ There are 13 river water bodies in *Review*. This includes water bodies where more information is required.
- ◆ Ten river water bodies in the catchment are *At Risk* of not meeting their water quality objectives. Measures will be needed in these water bodies to improve the water quality outcomes.
- ◆ Summary information for the *At Risk* water bodies is given in Appendix 2.

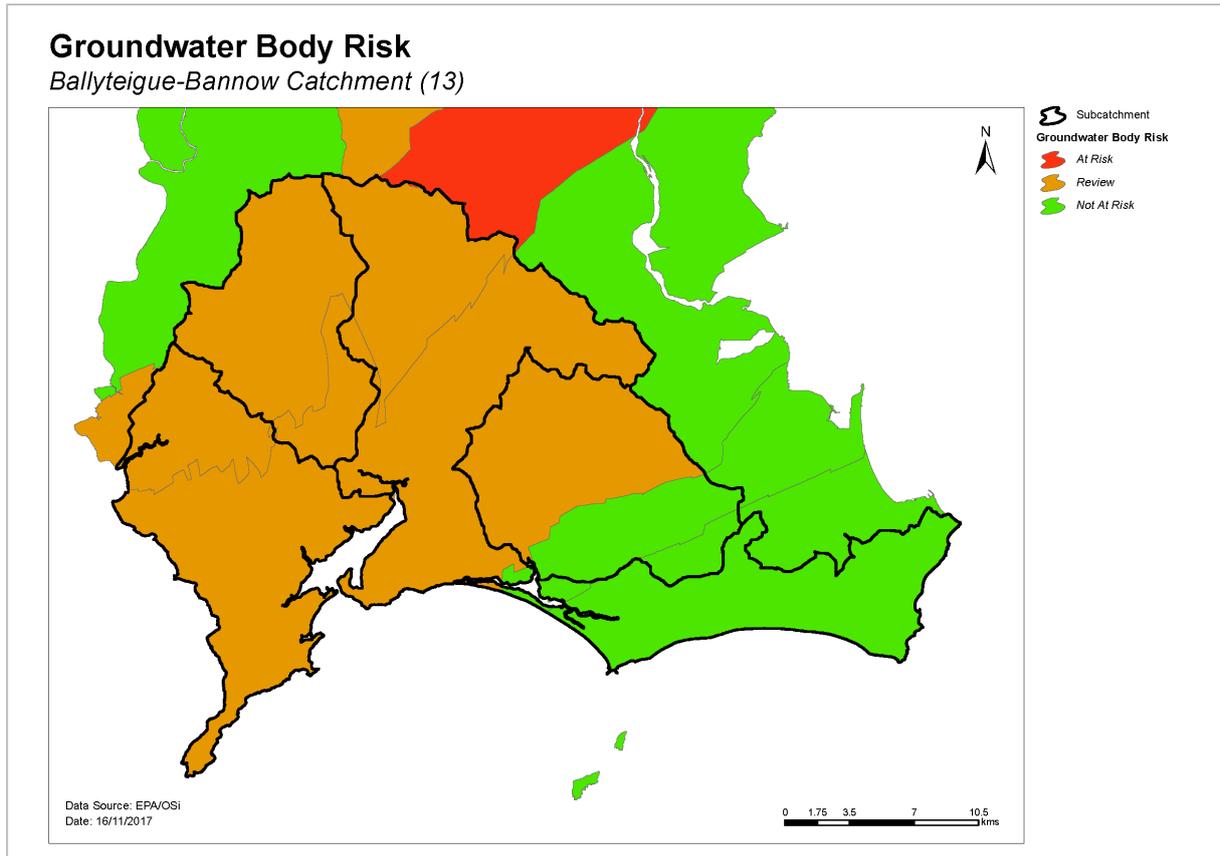
Figure 6. Groundwater body risk

- ◆ Two groundwater bodies, Bridgetown and Fardystown, are *Not at Risk* (Figure 6, Table 4) and require no additional investigative assessment or measures to be applied, other than those measures that are already in place.
- ◆ Two groundwater bodies are in *Review*. Both Adamstown and Fethard are in *Review* due to being hydrologically linked to surface waters where there is potential for the groundwaters to be a contributing source of phosphorus. Adamstown is also in *Review* due to elevated nitrate concentrations (Figure 6).
- ◆ There are no *At Risk* groundwater bodies.

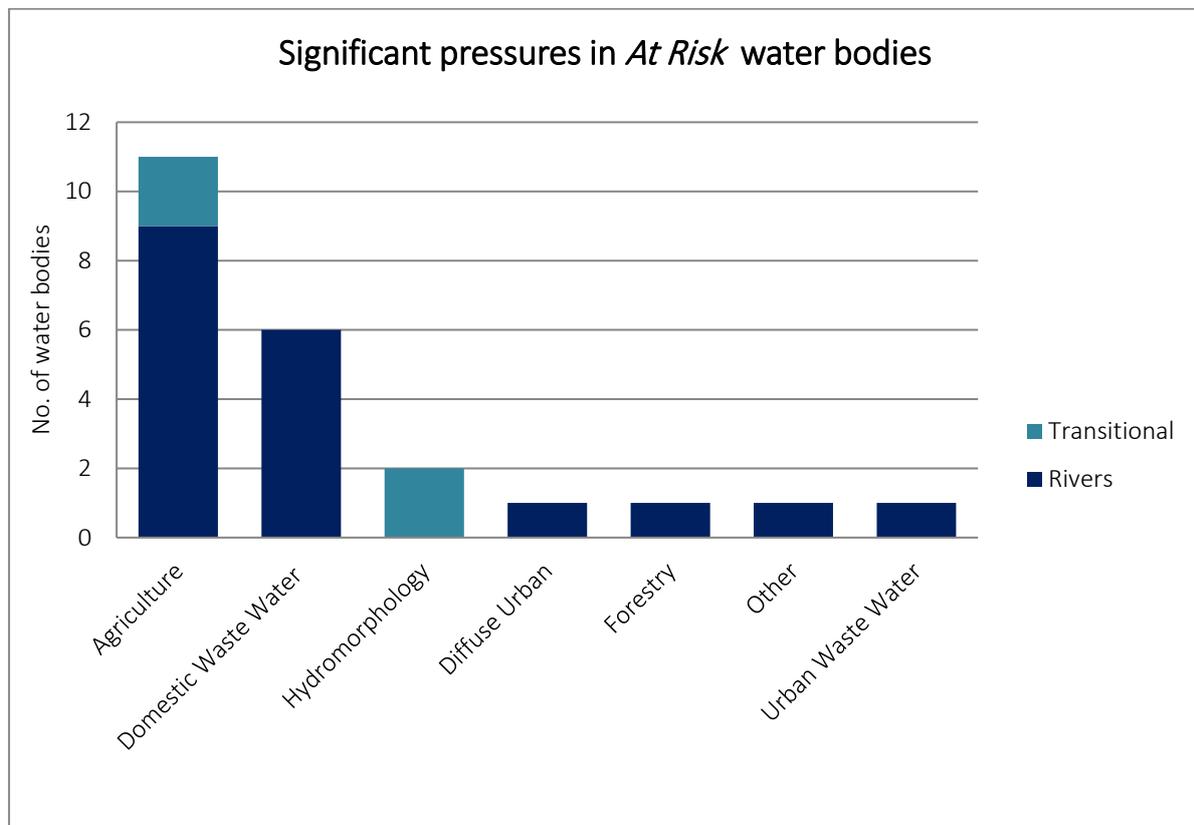
Figure 7. Significant pressures impacting on *At Risk* river water bodies

- ◆ Where water bodies have been classed as *At Risk*, by water quality or survey data, significant pressures have been identified.
- ◆ Figure 7 shows a breakdown of the number of *At Risk* river and transitional water bodies in each significant pressure category.

- ◆ There are no *At Risk* lake, coastal or groundwater bodies in the Ballyteigue-Bannow catchment. Significant pressures have been identified by the initial characterisation process in 12 water bodies, nine of which have multiple pressures. The significant pressures will be refined as further characterisation is carried out.
- ◆ The significant pressure affecting the greatest number of river water bodies is agriculture followed by domestic waste water, hydromorphology, diffuse urban, forestry, other and urban waste water (Figure 7).
- ◆ The significant pressures affecting the transitional water bodies are agriculture and hydromorphology (Figure 7).

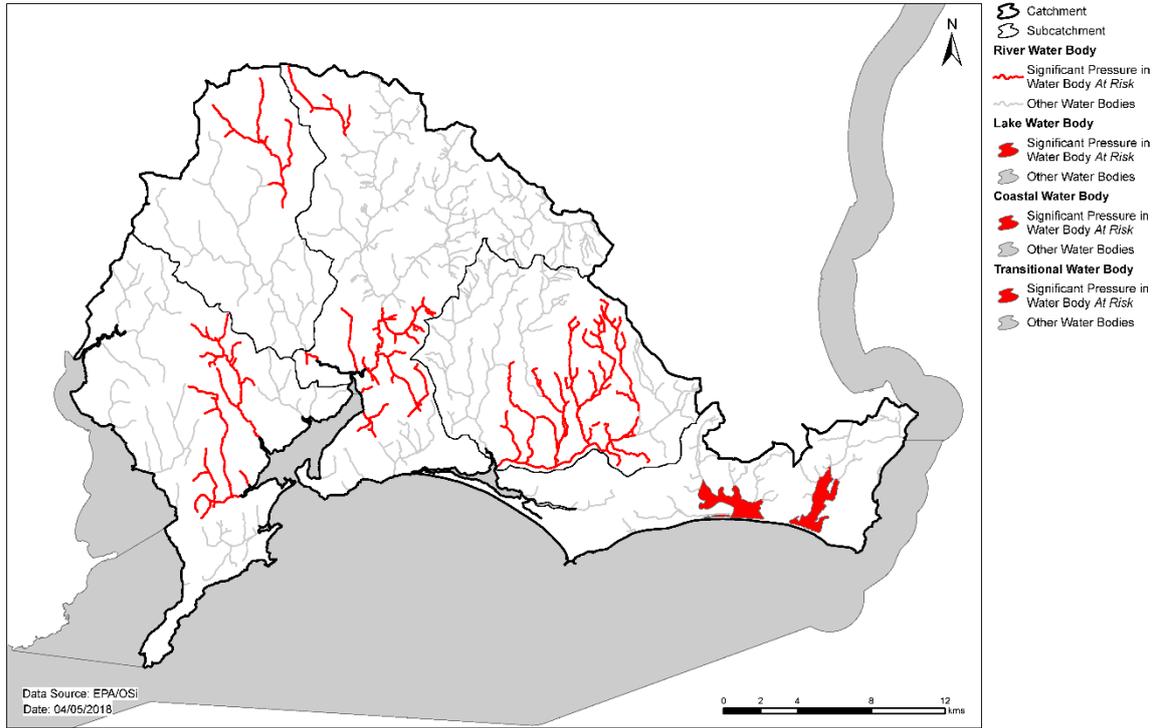
Figure 8. Water bodies that are At Risk and are impacted by agricultural activities

- ◆ Agriculture is a significant pressure in nine river water bodies across several subcatchments and two transitional water bodies (Lady's Island Lake and Tacumshin Lake); the water bodies affected by farming are shown in Figure 8. The issues related to farming in this catchment are diffuse phosphorus loss to surface waters from, for example, direct discharges; or runoff from yards, roadways or other compacted surfaces, or runoff from poorly draining soils. Sediment can also be a problem from land drainage works, bank erosion from animal access or stream crossings. The pollution impact potential map showing areas of relative risk for phosphorus loss from agriculture to surface water is given in Appendix 5.

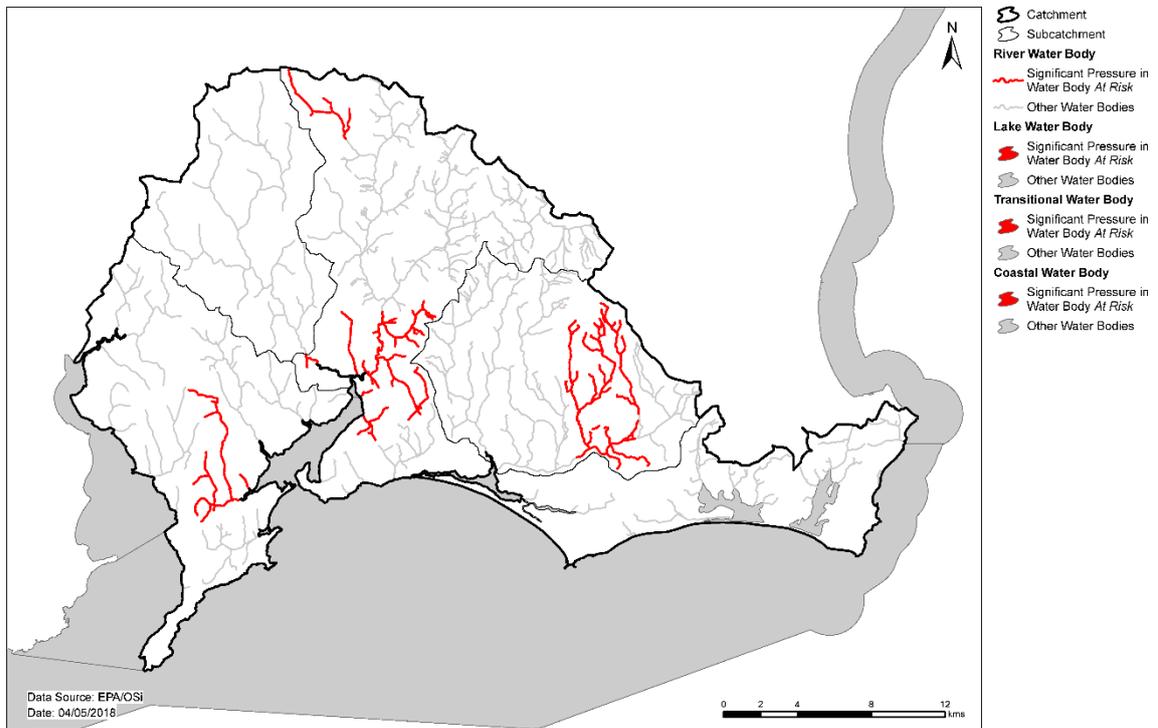
Figure 9. Water bodies that are At Risk and are impacted by domestic waste water

- ◆ Domestic waste water has been identified as a significant pressure in six river water bodies (Figure 9). This is due to high densities of unsuitable domestic waste water systems in close proximity to the water bodies, especially when sited on poorly draining soils. The significant issues are a combination of excess nutrients entering surface waters. Exceedances of EQS for baseline concentrations of phosphate and ammonia have been noted.

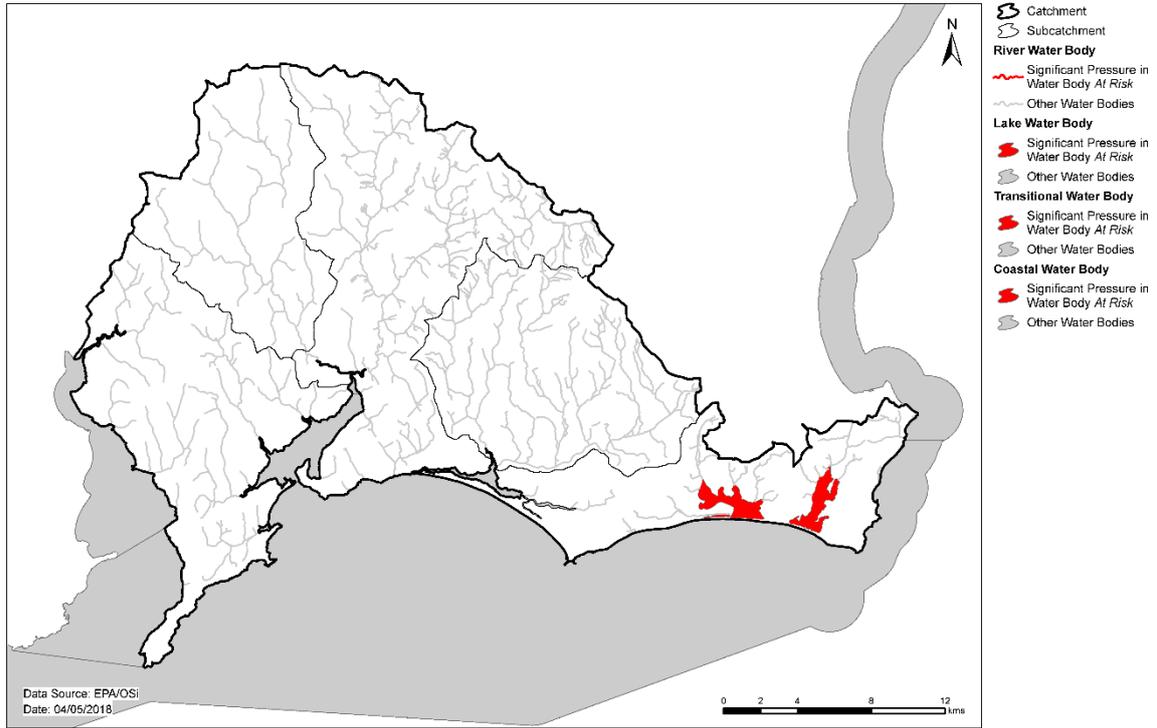
Figure 10. Water bodies that are *At Risk* and are impacted by hydromorphological pressure

- ◆ Both Lady's Island Lake and Tacumshin Lake are lagoons that are both *At Risk* are impacted by hydromorphology pressures. Figure 10.

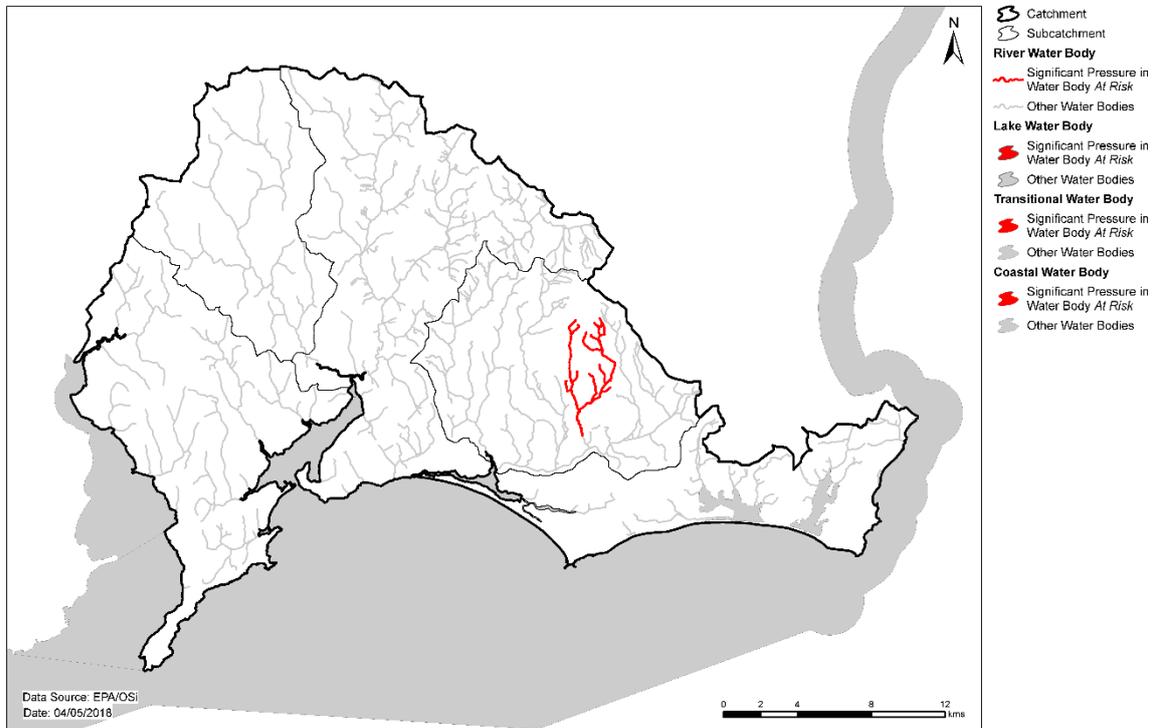
Figure 11. Water bodies that are *At Risk* and are impacted by diffuse urban pressures

- ◆ Diffuse urban has been identified as a significant pressure in one river water body, Cleristown Stream\_010 (Figure 11). This water body is impacted by excess nutrients from unfinished housing estates.

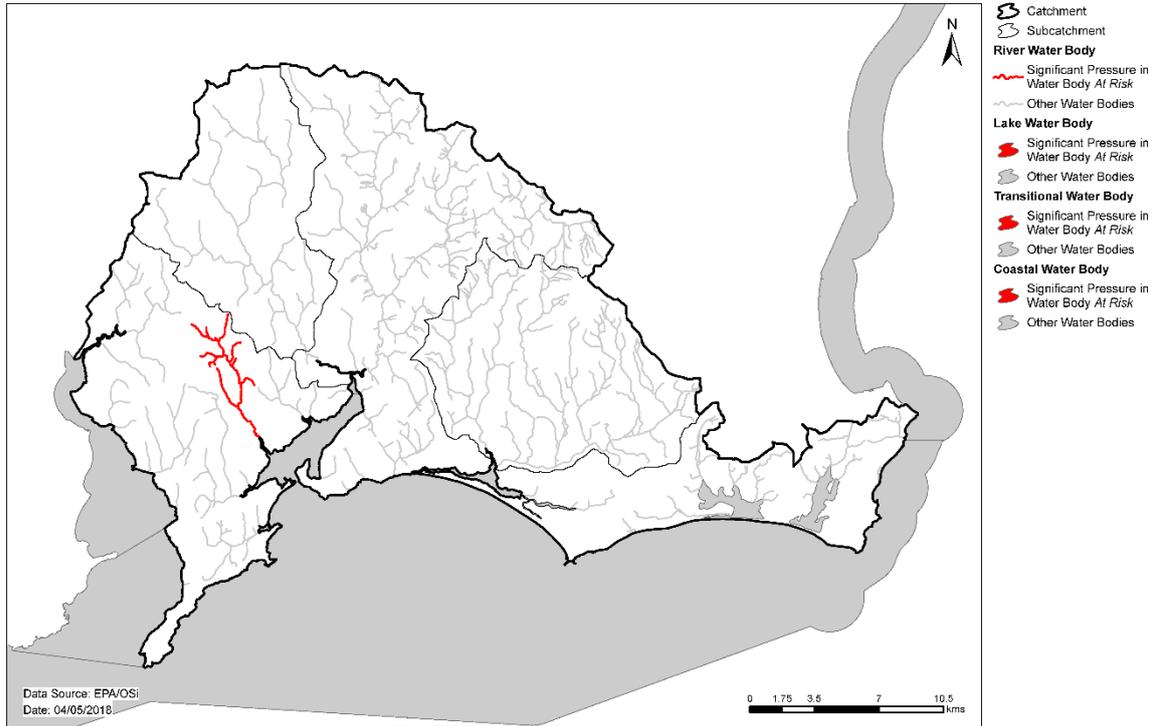
Figure 12. Water bodies that are *At Risk* and are impacted by forestry activities

- ◆ Forestry has been identified as a significant pressure in one river water body –Tintern Abbey Stream\_010 (Figure 12). The significant issues are a combination of general forestry activities and clearfelling, which have resulted in siltation and excess nutrients in surface water bodies.

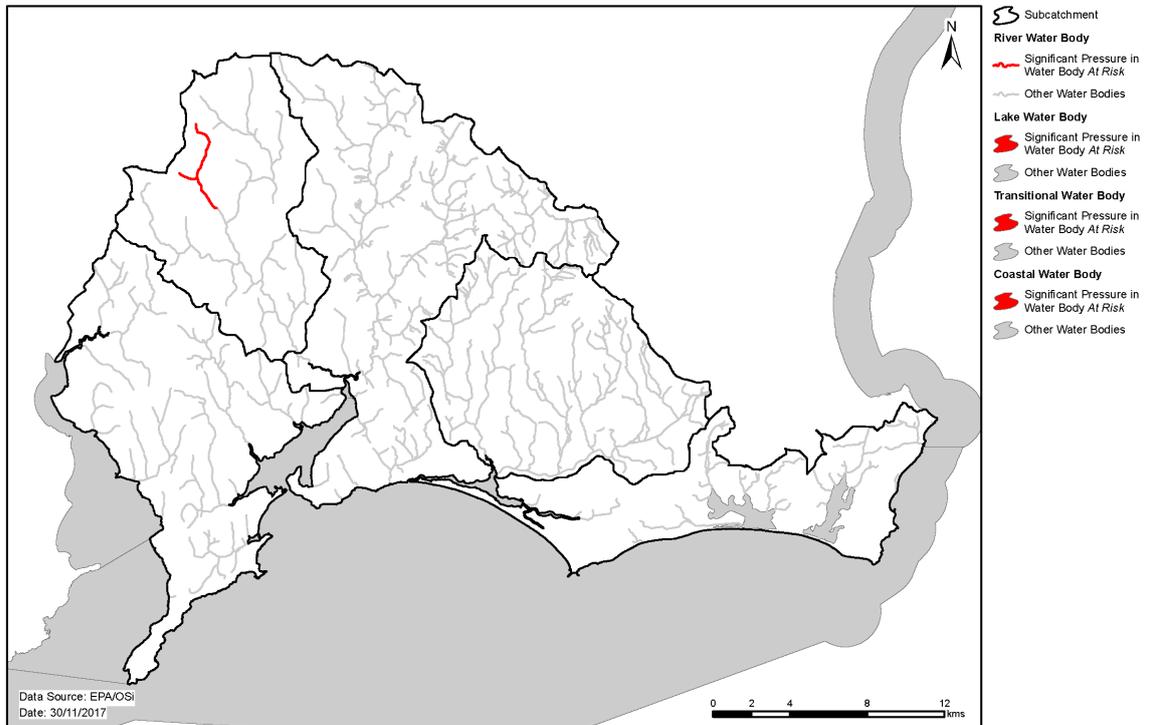
Figure 13. Water bodies that are *At Risk* and are impacted by other anthropogenic pressures

- ◆ *Unknown Anthropogenic*  
One *At Risk* water body, Begerin Stream\_010 has unknown anthropogenic pressures (Figure 13).

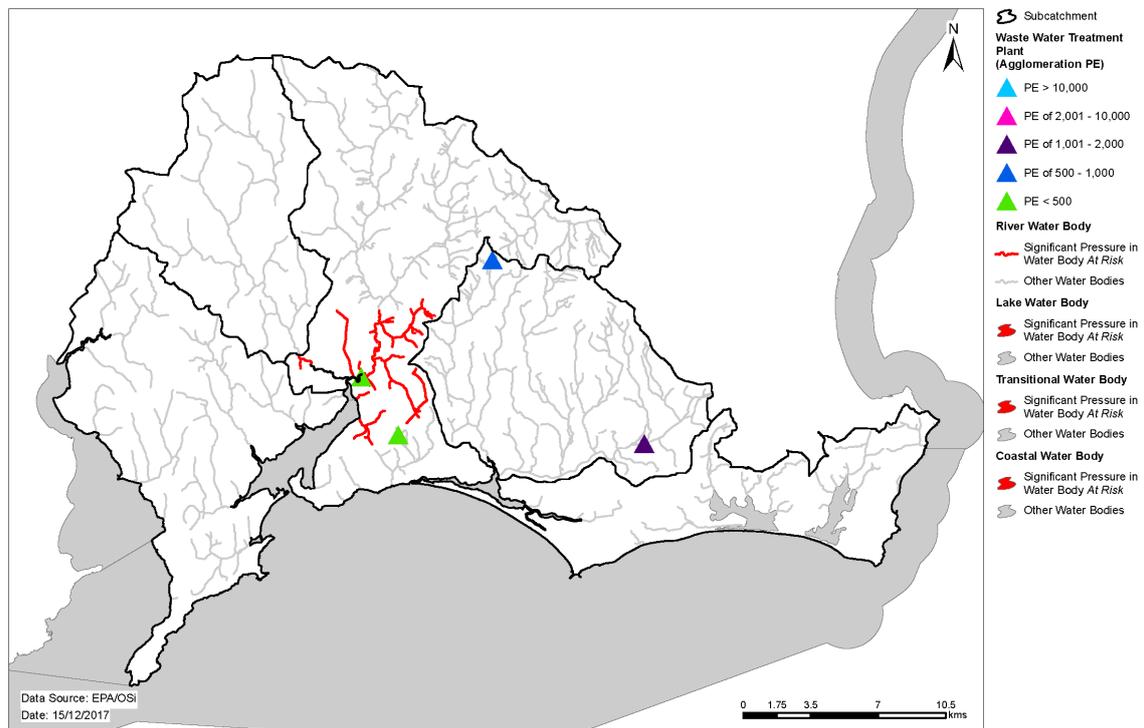
Figure 14. Water bodies that are *At Risk* and are impacted by urban waste water

- ◆ Urban Waste Water Treatment Plants (WWTPs) have been highlighted as a significant pressure in one *At Risk* water body, Corock\_040. This water body is impacted by Wellingtonbridge WWTP (A0245), which is currently not specified in improvement plans.

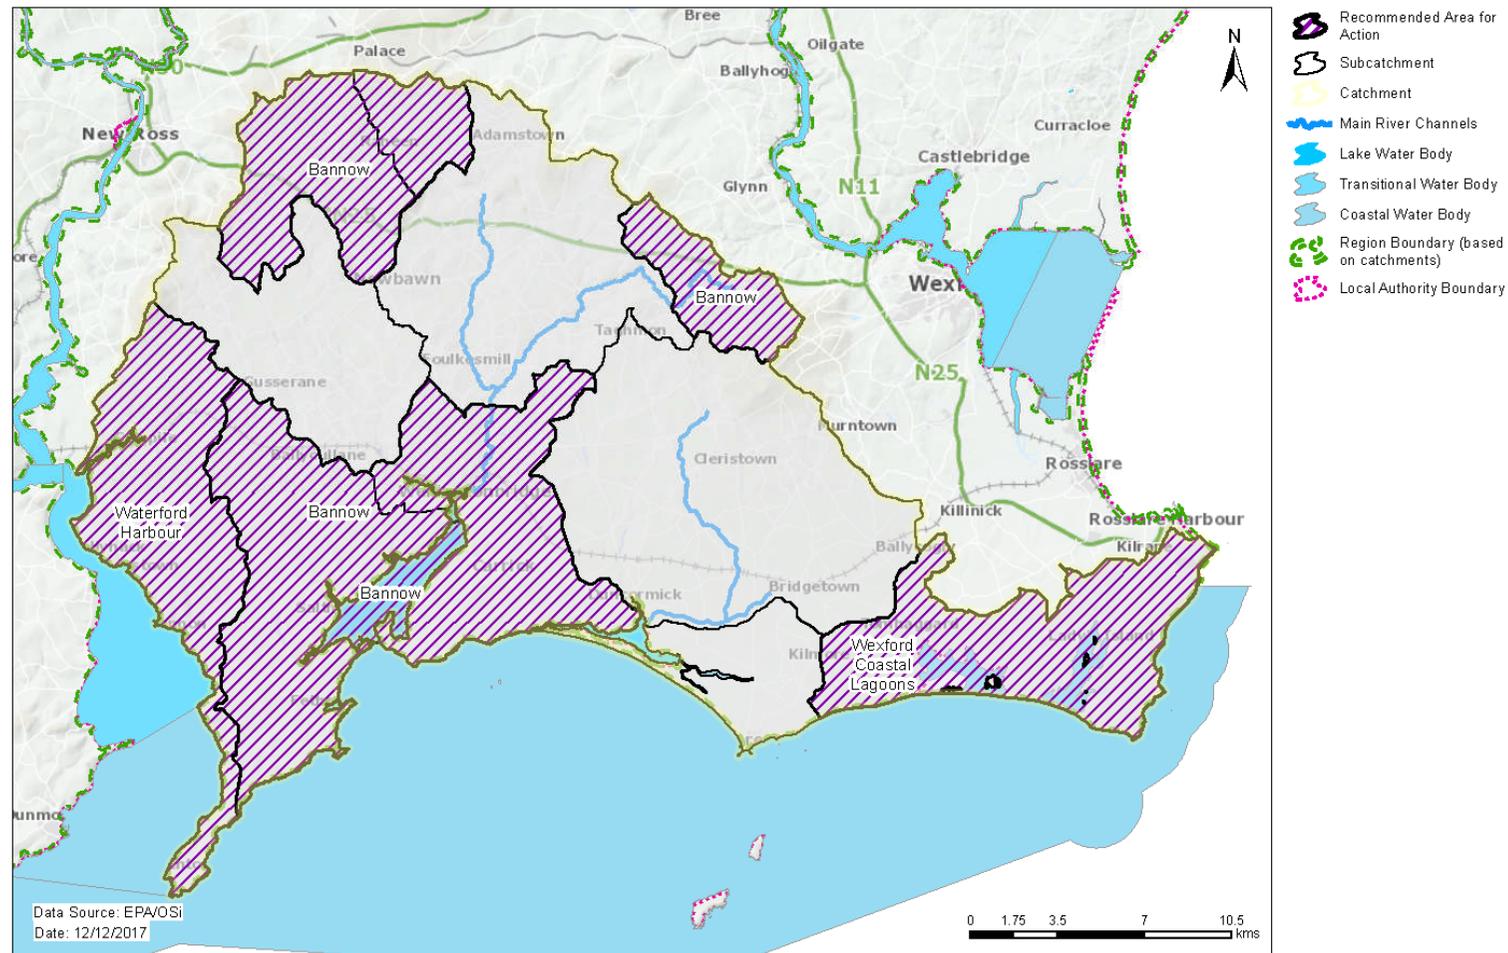
Figure 15. Location of Recommended Areas for Action in the Ballyteigue-Bannow Catchment

- ◆ Three recommended areas for actions (Table 9, Figure 15) were selected.
- ◆ These are the Wexford Coastal Lagoons, Bannow and Waterford Harbour.
- ◆ These include:
  - 14 river water bodies – six *At Risk* and eight *Review*, and
  - Four transitional and coastal (TraC) water bodies – two *At Risk* and two *Review*.
- ◆ Two groundwater bodies, that are in *Review* due to groundwater contribution of nutrients to surface water bodies, intersect with three of the recommended areas for action, see Table 10. Actions taken to improve surface water will need to take account of the groundwater contribution to surface water.

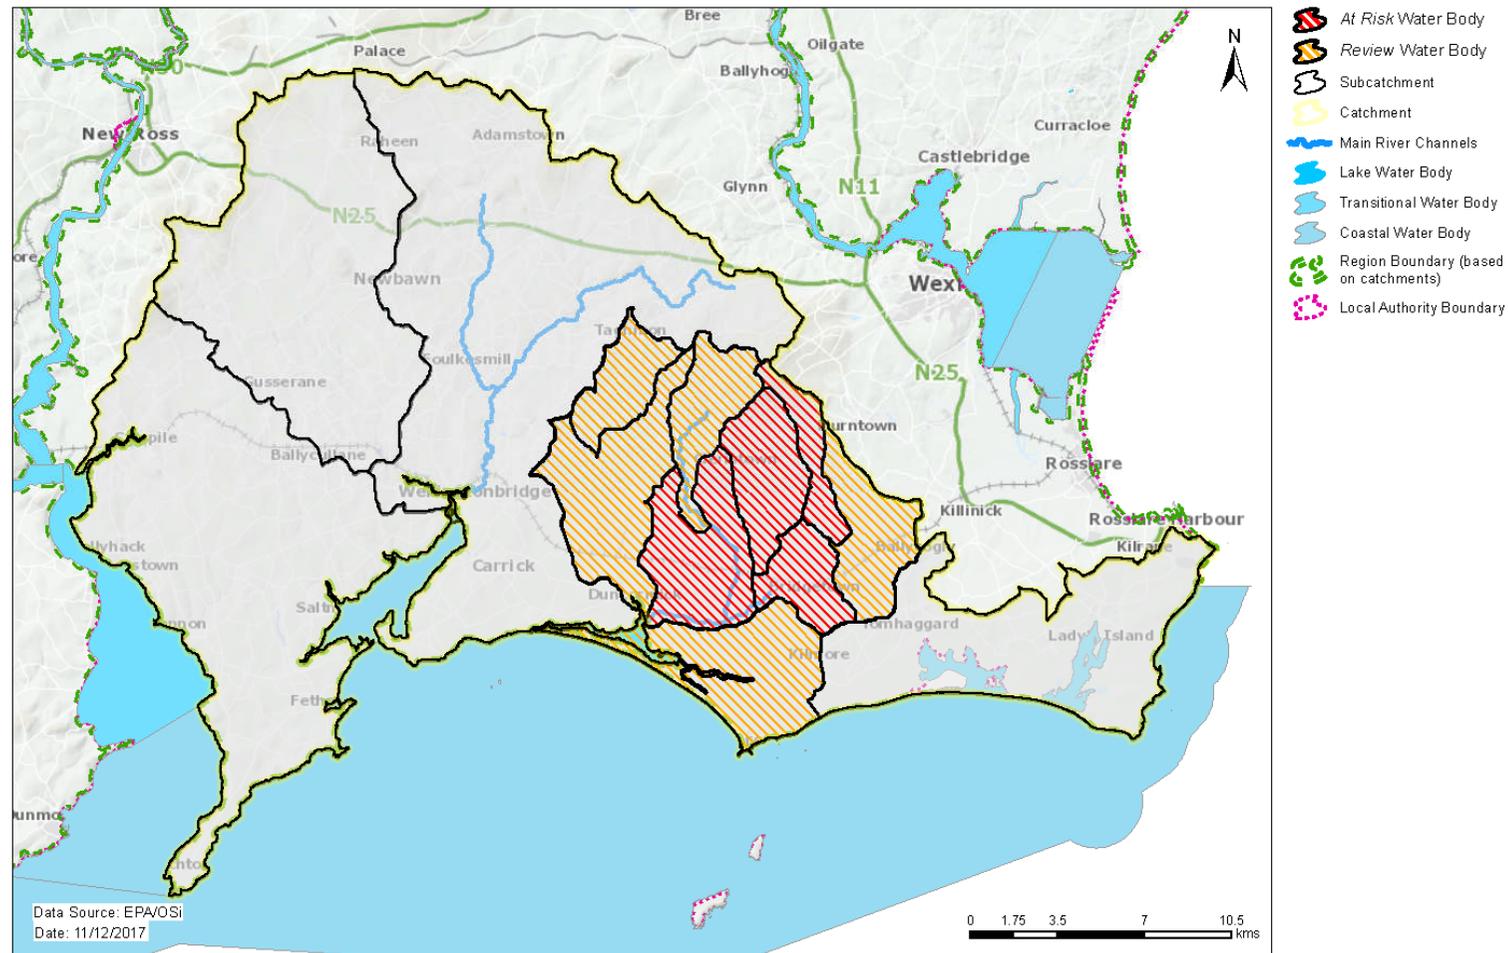
Figure 16. Location of *At Risk* and *Review* water bodies located outside Recommended Areas for Action in the Ballyteigue-Bannow Catchment

A remaining 12 *At Risk* and *Review* surface water bodies were not included in the recommended areas for action for the second cycle. The distribution of these is presented in Figure 16. These include:

- ◆ nine river water bodies – four *At Risk* and five *Review*, and
- ◆ three *Review* transitional water bodies.

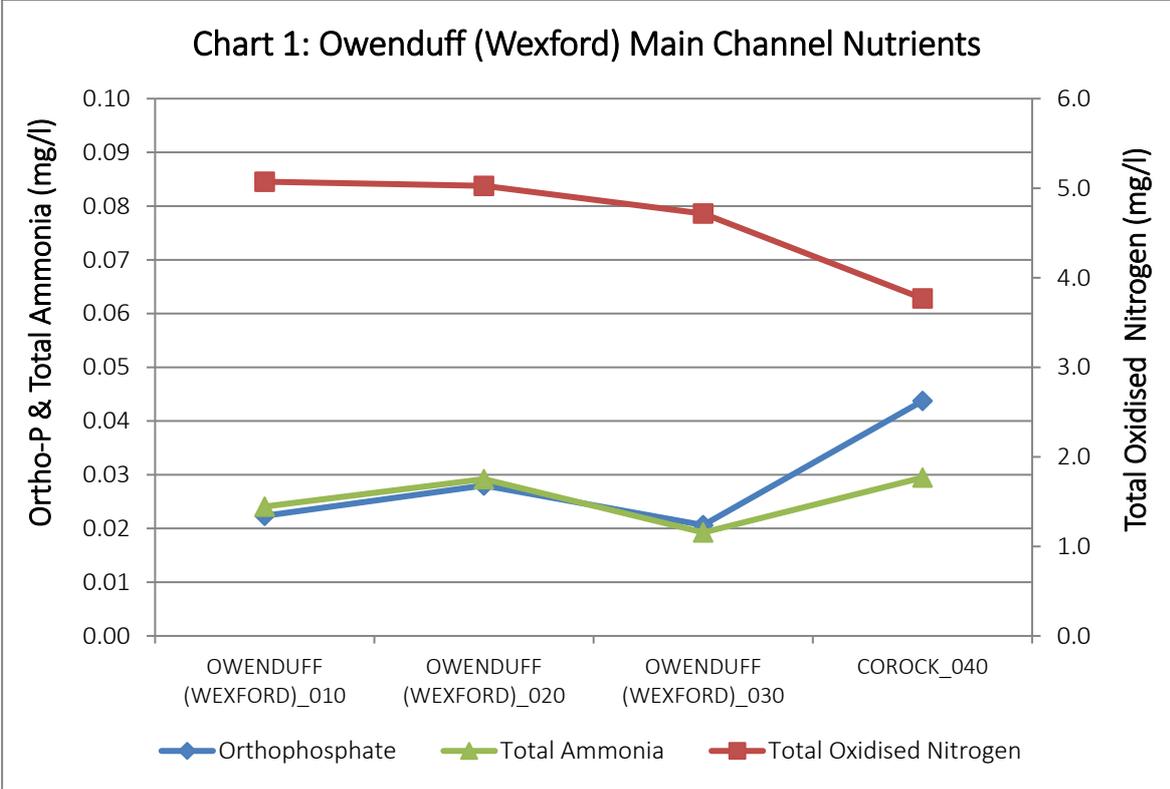
Like orthophosphate, ammonia is similar in concentrations and trend, but remain below the Environmental Quality Standard (EQS) for good status (0.065mg/l).

The TON concentrations are elevated above the 2.6mg/l drinking water threshold along the main channel, and are highest in the headwaters decreasing gradually downstream from 5.82mg/l to 3.77mg/l.

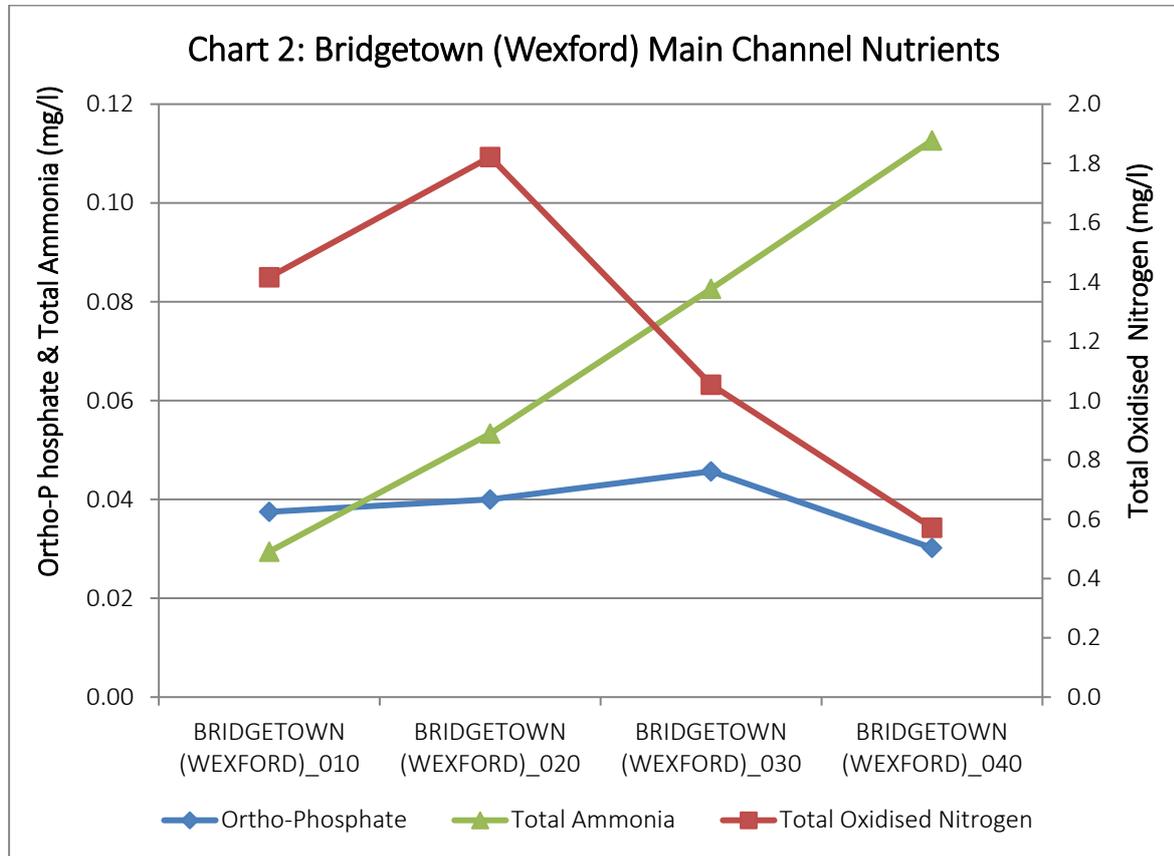
The results of the water quality assessment for the Bridgetown (Wexford) main channel are illustrated in Chart 2.

The results show that orthophosphate concentrations throughout the main channel are marginally elevated ranging from 0.030 to 0.046mg/l.

(0.065mg/l). Listed significant pressures for the main channel are a combination of diffuse agriculture and septic tank systems on poorly draining soils.

The TON concentrations are highest in the headwaters of the main channel decreasing downstream from 1.82mg/l to 0.57mg/l. The Bridgetown (Wexford)\_020 is the receiving water for the Bridgetown & Environs Waste Water Treatment Plant (WWTP).

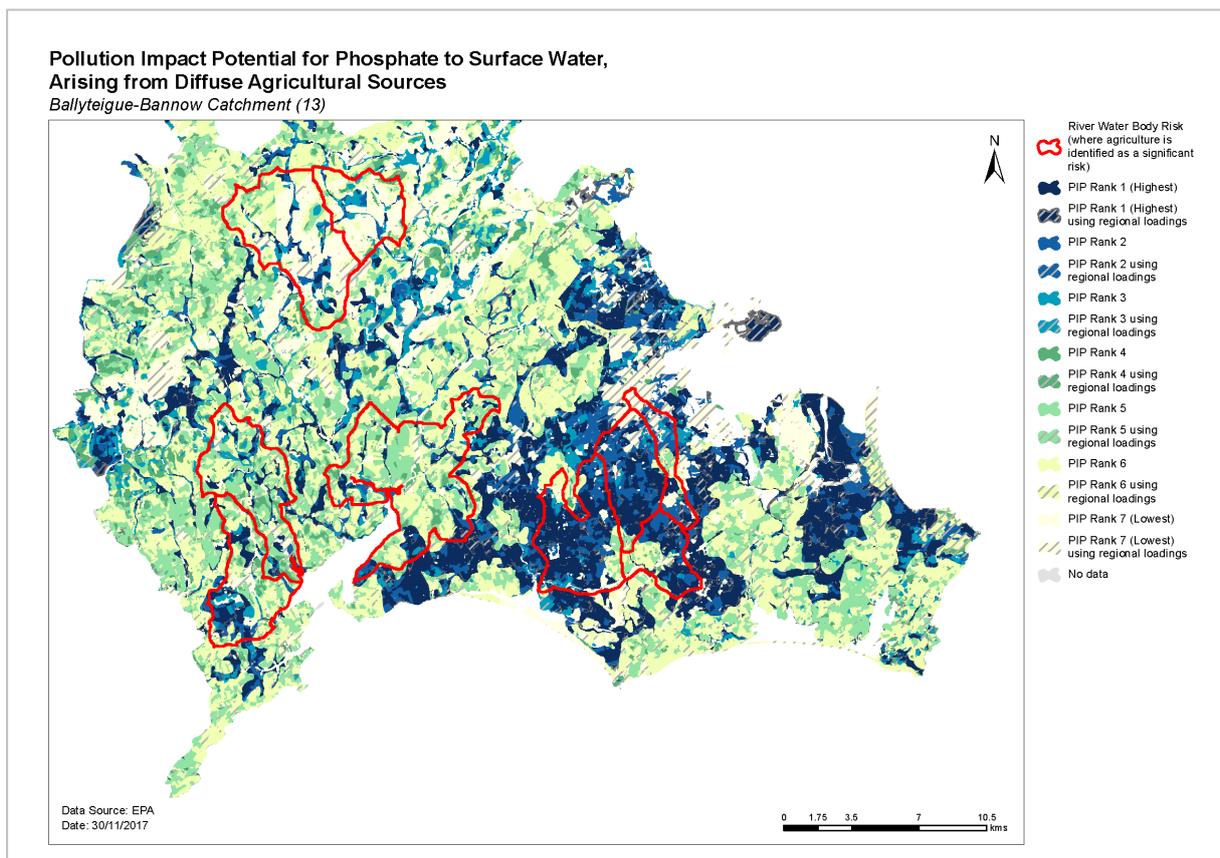
For areas where agriculture is deemed as the significant pressure, areas of high risk to surface water can be targeted. The map below shows relative risk of loss of phosphorus to surface water. The risk of phosphorus losses is strongly correlated on whether the land is poorly draining or free draining and the loadings applied i.e. significant loadings applied on poorly draining areas result in a high potential risk to surface water. However, this figure does not imply that actual losses from these areas are occurring but is a useful tool for informing where resources should be focused (i.e. by allowing high risk areas to be identified and prioritised for further investigation). PIP maps are available online at a scale of 1:20,000 and can be accessed by public bodies via the EDEN process.
