COMBINED CYCLE Journal

User Group Reports

501F and 501G Users Groups

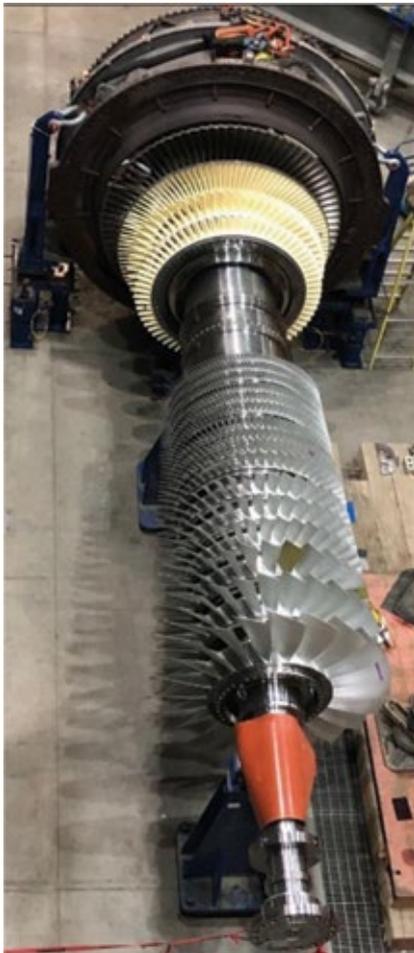
Hybrid rotor increases the shaft limit for the 501F to 227 MW

- 2019. Combustion inspection (at 85k EBOH and 1937 ES), plus replacement of turbine Row 1 blades and ring segments.
- 2022. Second major inspection (at 108k EBOH and 1943 ES), plus hybrid rotor upgrade, rotor air-cooling-system upgrade, installation of a direct air injection system (DAIS) to allow faster restarts and to mitigate blade tip rubs during warm starts, and several other improvements to boost output, increase

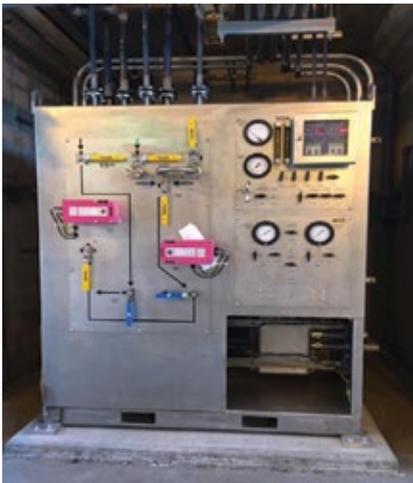
Environment One. Automated gas manifold H₂ monitoring system with automated purge-system options

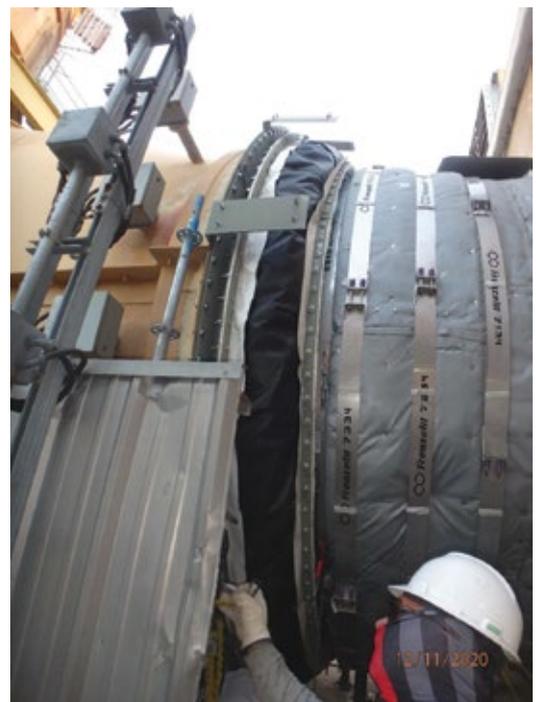
Frenzelit. Installing an upgraded expansion joint

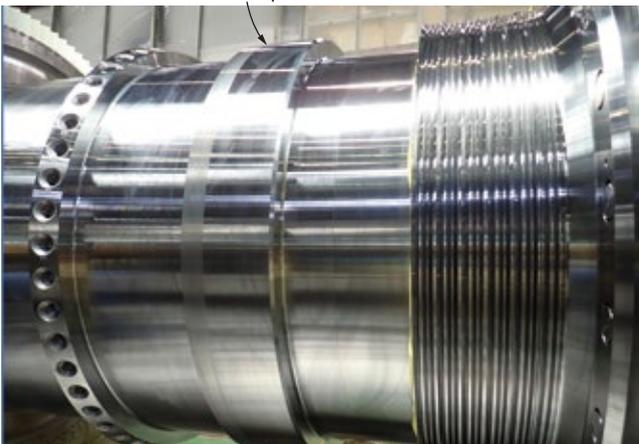
Thick torque tube

Mitsubishi Power's upgraded 501F rotor features a thick torque tube as a reliability improvement

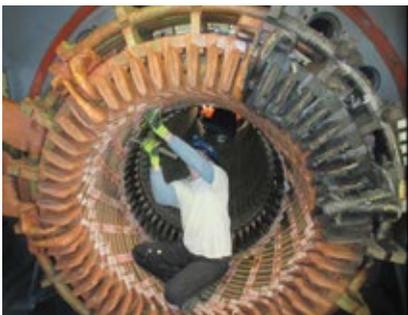
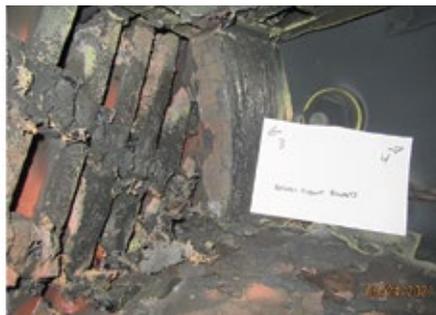
National Electric Coil. Stator failure: T6 neutral connection ring, ring tab to inboard flex connector assembly plate. Close-up of damage is at right

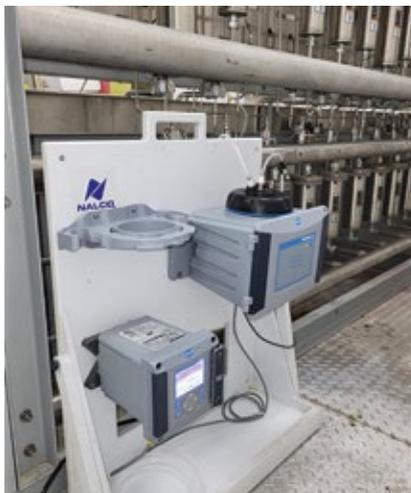
5. Iron concentration is measured with an online laser nephelometer

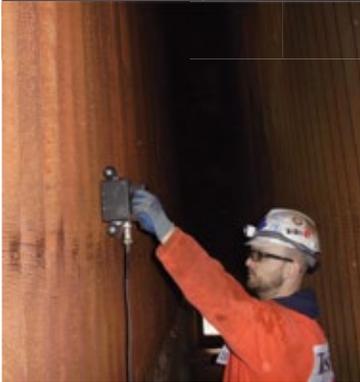
Through Fin Tube Scanning for Wall Thinning

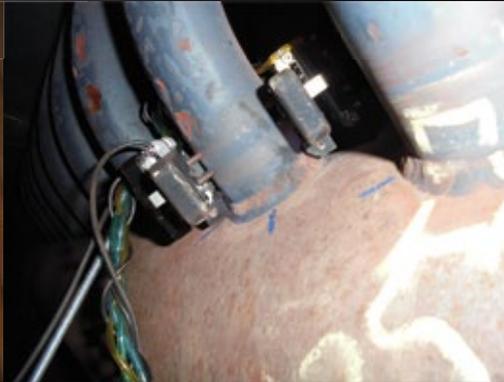
Tube to Header Weld Examination for Cracking

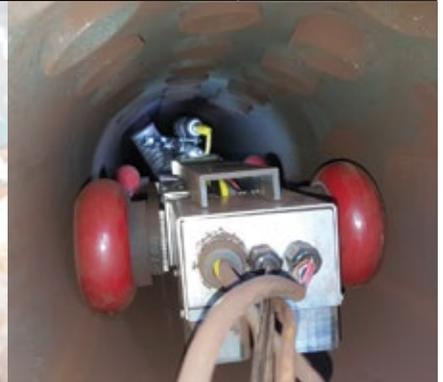
Internal Inspection, Collecting Tube Video & Measuring Wall Loss

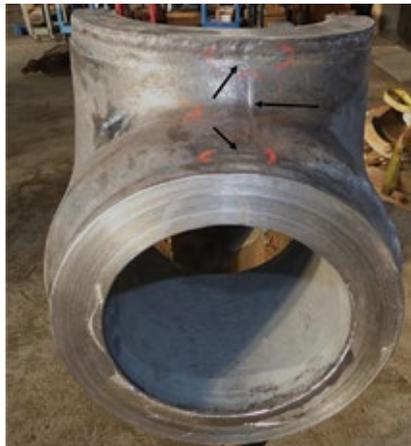
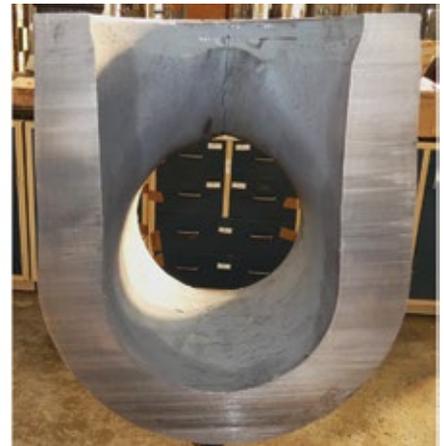
6. Tee suffered a through-wall crack at the crotch position on one side and another partially through-wall crack on the other

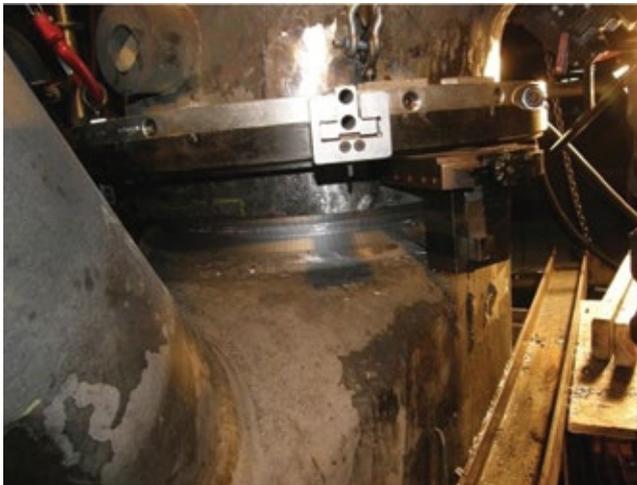
8. Creep-related failures may require full excavation of the damage (above)

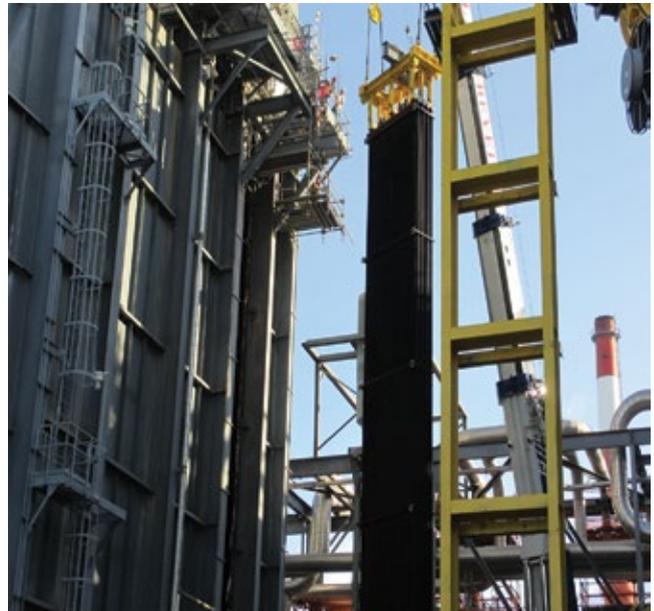
9. Access limitations may require trolley systems and lifting/turning frames (right)

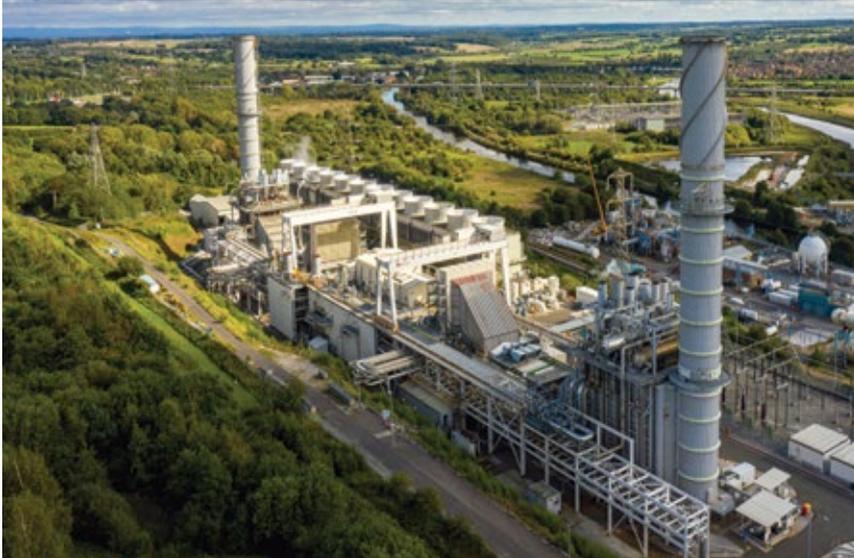
2. The UK's Rocksavage Power Station, near Liverpool, required a complete EV combustor rebuild on its GT26

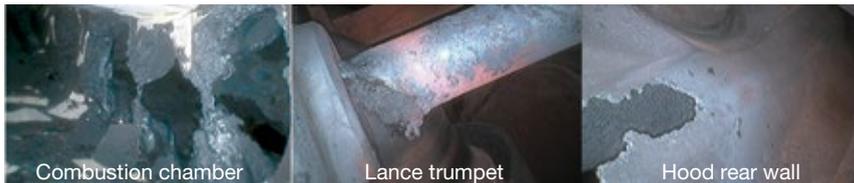
3. Damage to the Rocksavage combustor forced the unit out of service for six and a half months

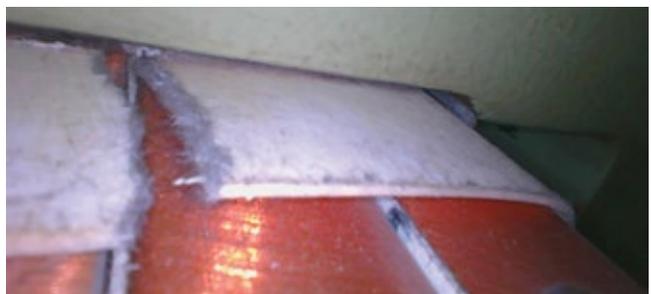
5. Failed/cracked slot liner was identified during bore-scope inspection (below)

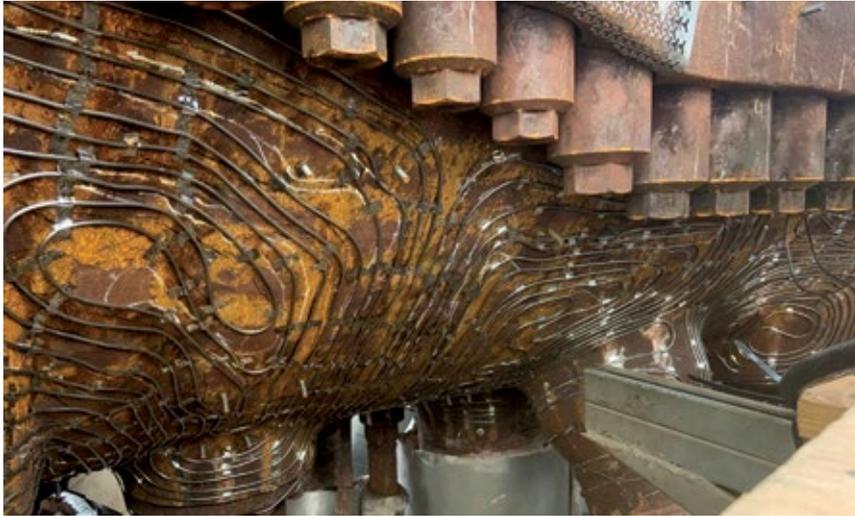
8. Permanent placement of redundant sets of heating wires on the turbine casing below the split line, plus the use of a heat-reflecting shield over the wires,

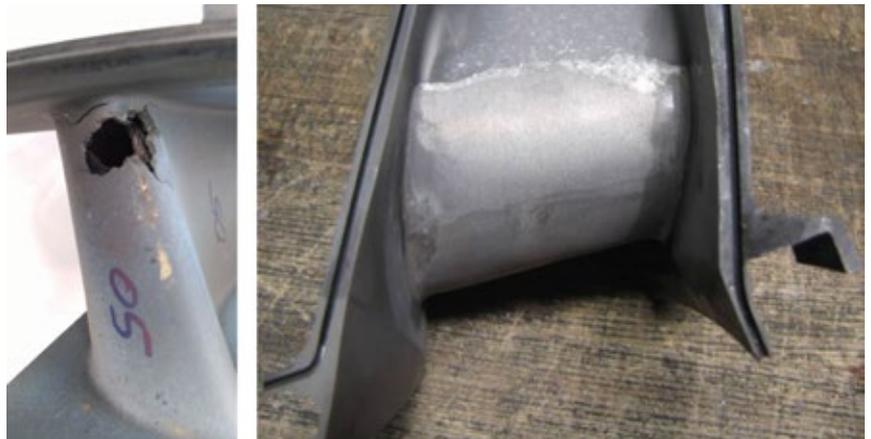
10. Impact damage to nozzle guide vane is heavy on leading edge; some trailing-edge damage as well. Otherwise, however, part is in good shape with low hours (left). At right, repair success using Liburdi Powdered Metallurgy: Part was returned to service for a 24,000-hr interval. Post service inspection found no indications or material loss

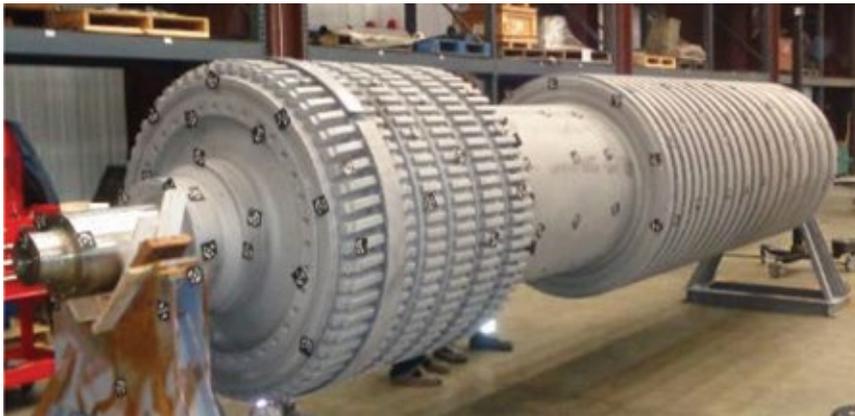
15. Doosan Turbomachinery Services’ reverse engineering involves internal and external characterization and metallurgical evaluation

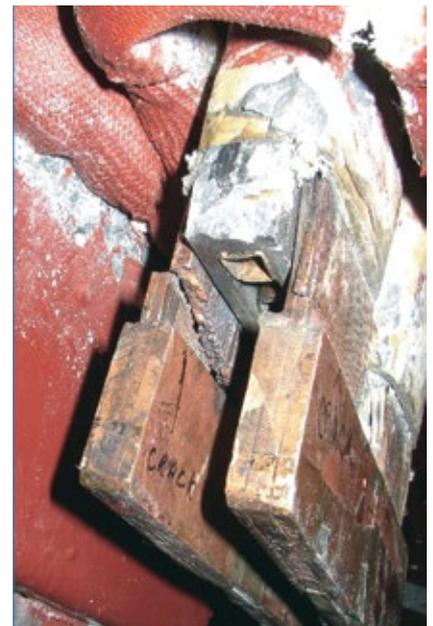
16. Stator and field are impacted by mechanical and thermal forces. Broken strands are one possible result

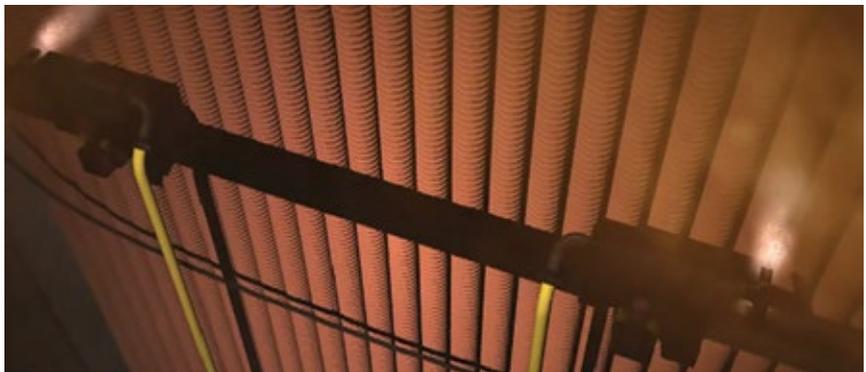
17, 18. Key steps in KinetiClean’s HRSG tube-cleaning process include the hanging of det cord the full length of the heat-transfer surface (arranged similar to a festoon system typically used for electrical cables, as shown above) and using track-mounted compressed-air nozzles to traverse the tube bundles (below) and remove loosened debris

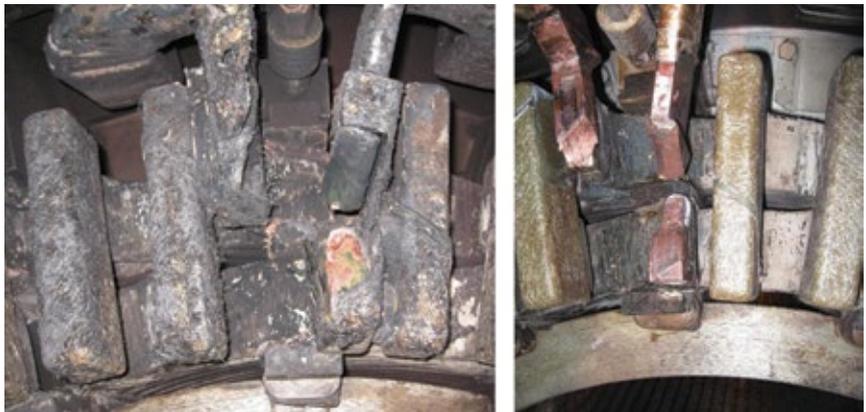
19. Generator endwinding resonance and main lead failure are among the leading stator issues

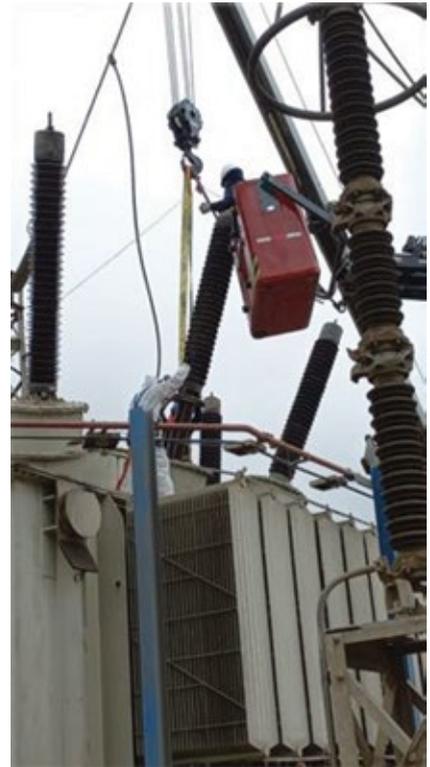
1. A bushing failure several years ago forced Ventanilla out of service

Challenge. Prevent the recurrence of a transformer forced outage suffered by Ventanilla a few years ago when an HV bushing failed (Fig 1).

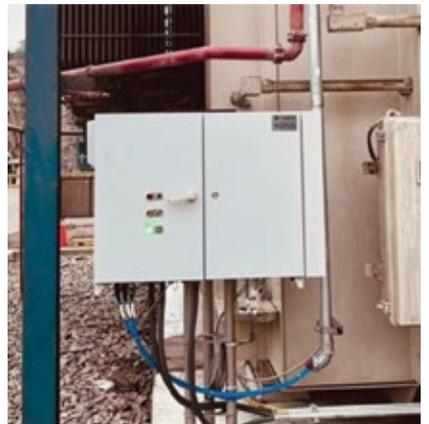
2. Online monitoring of critical transformer data helps identify issues before they cause an outage

PD monitoring of transformer windings identifies amplitude, repetition rate, and PD persistence—the last to avoid a false alarm and provide reliable information. A PD-status level (scale of 1 to 10) is determined using amplitude and repetition rate.

Bushing health is tracked using tan delta and capacitance data. Leakage current from each bushing is monitored and variations in current amplitude and angle between adjacent phases calculated.

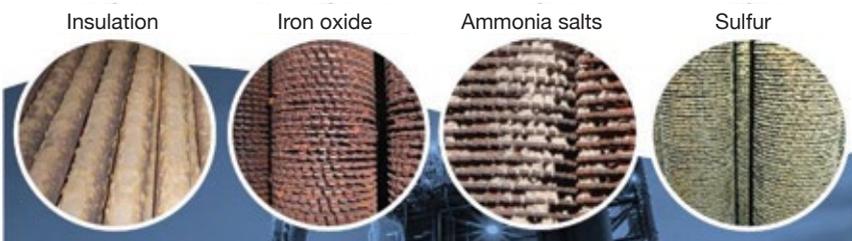
4. Types of fouling/deposits found on heat-transfer surfaces in Ventanilla’s HRSGs (l to r): insulation, iron oxide (rust), ammonia salts, and sulfur

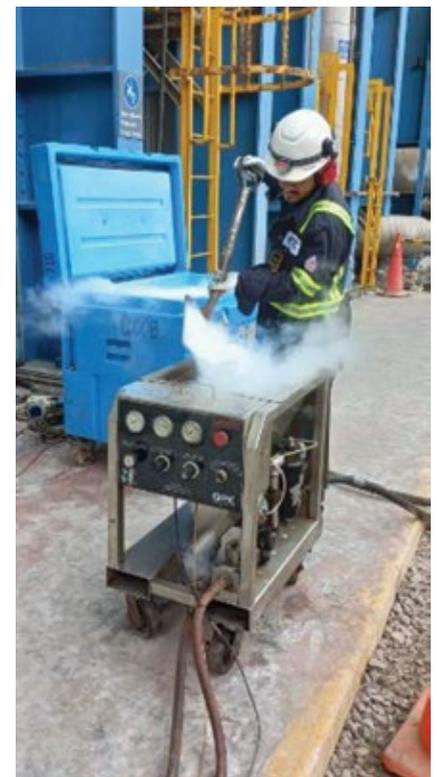
5. Dry ice was injected at ultra-high pressure to remove the fouling/deposits found in HRSG tube bundles

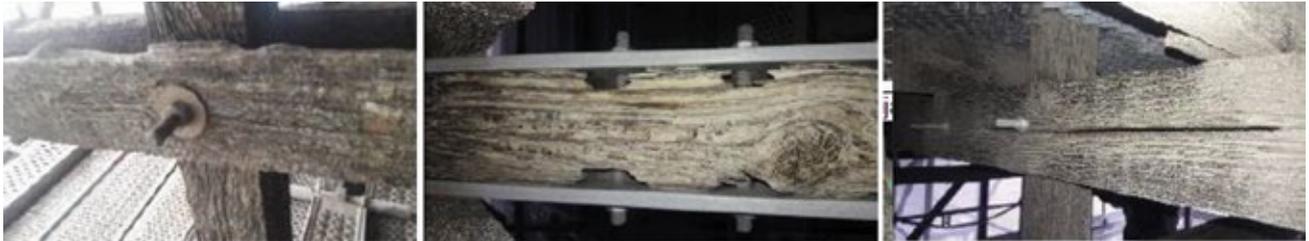
6. Cooling tower 2 was in poor condition. Examples: Loose tie bolts (left) and deterioration of (center) and fractured (right) structural members

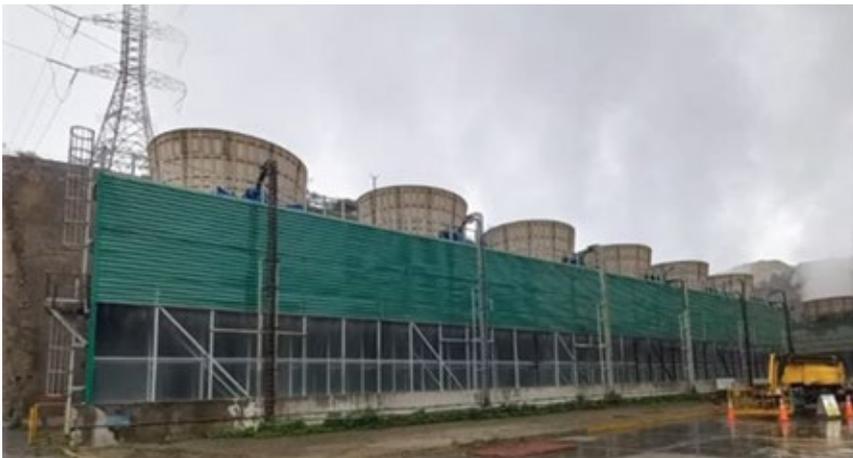
7. Ventanilla’s wet cooling towers each have six fans. Four fans remained in service throughout the overhaul activity

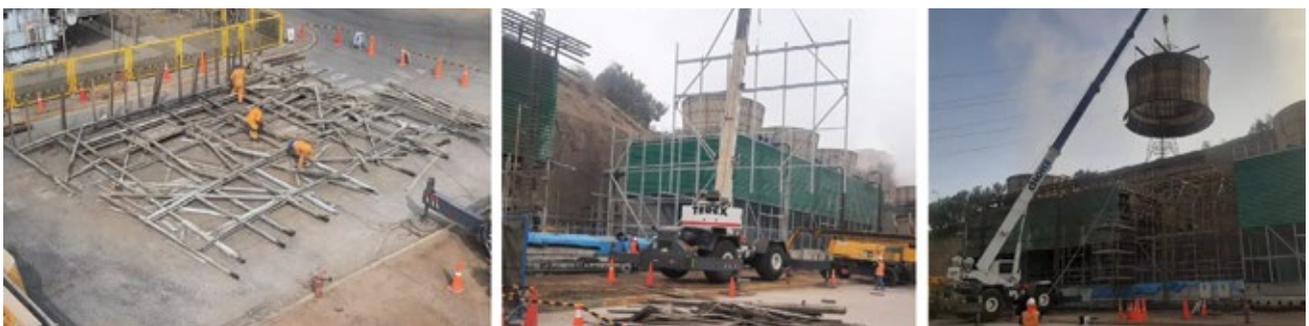
8. Tower 2 was disassembled (left) and reassembled (center) using glass-fiber reinforced plastic in place of wood for structural members. Fans were upgraded to increase air flow (right)

Result. Increasing cooling-air flow and changing fill improved tower performance to deliver 0.7 MW of increased generation. The financial impact was an additional \$134,000 in energy production annually plus a \$41,000 boost in capacity payments.

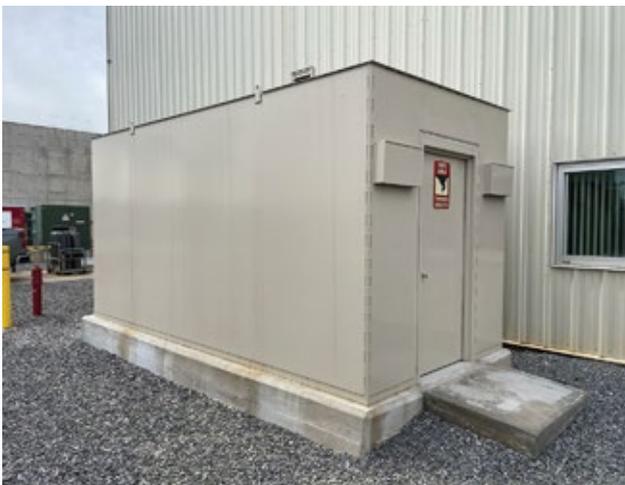
- 1. Storm shelter** was constructed in the contractor’s shop and trucked to the plant, where it was lifted by crane, placed on the concrete pad, and secured

ment of Change action to build a tornado shelter. Plant personnel worked with an engineering group to create a blueprint for an independent structure adjacent to the plant (Fig 1) and sent it out for bids. The contractor selected built the specified shelter in its shop and poured the concrete pad.

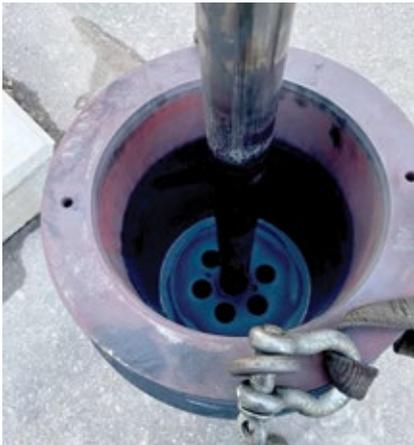
3. Plug and cage are stuck in position

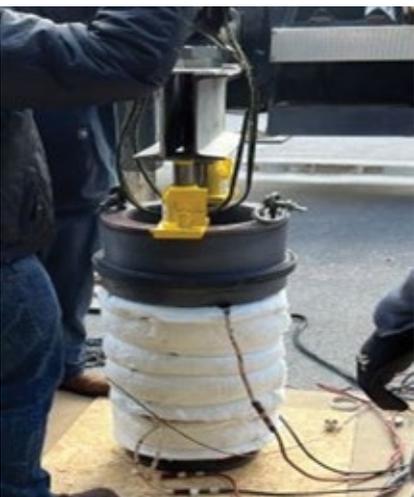
4. Separator rig relies on heat and jacks to separate the parts

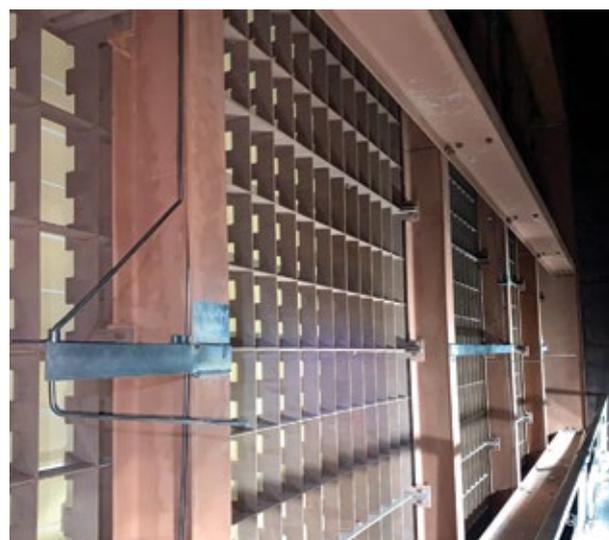
6. AIG tuning sample grid helps insure proper distribution of reagent across the catalyst

tion nozzles. A tuning grid was installed to help adjust ammonia injection in sections of catalyst so affected (Fig 6).

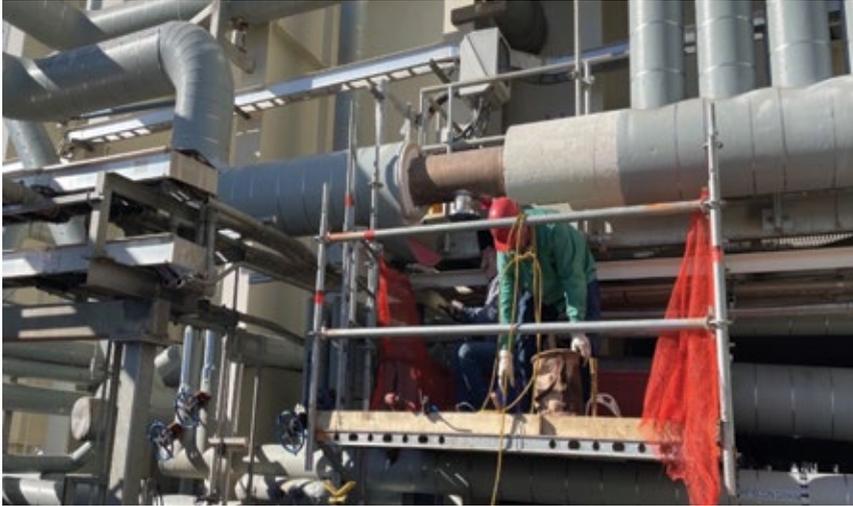
7. SCR piping is modified to allow connection of a vacuum truck for cleaning ammonia injection nozzles

in the SCR injection-blower discharge piping to allow a vacuum truck to connect to the injection piping and remove deposits in the injection nozzles (Fig 7).

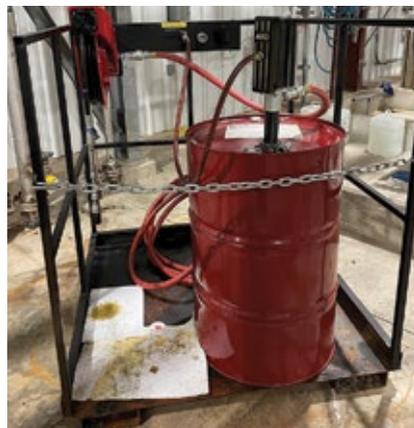
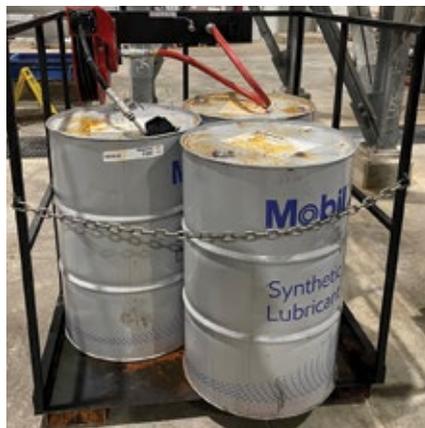
1. Identical totes are used for handling DTE (left) and SHC (right) oils separately

- Two identical totes are used for transferring DTE™ (Fig 1 left) and SHC™ (Fig 1 right) oils. Each is dedicated to the individual oil thereby eliminating the possibility of cross contamination. Reels provided on the totes make it easy to neatly and safely store the hose. The skids also are equipped with pneumatic oil pumps which are powered by compressed air, available throughout most of the plant.
- The third tote is dedicated to cooling-tower gearbox oil maintenance. Its design is such that the tote remains at ground level with a reel of hose that can reach the top deck of the tower. This is used to evacuate the oil from the gearbox down

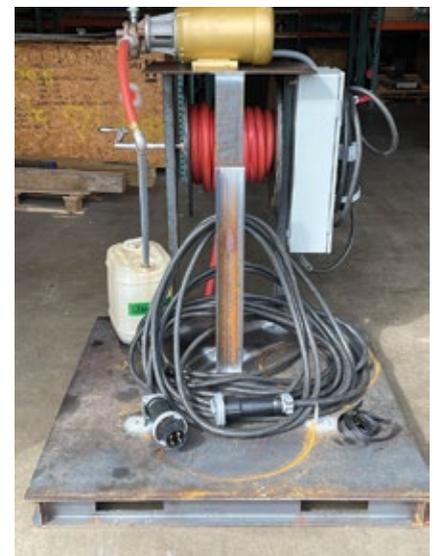
2. Cooling-tower tote, at ground level, eliminates the need to carry 40-lb pails of oil up and down the tower's stairs

to the tote at ground level. There is a second compartment with new oil and a second reel for replenishing the gearbox oil level. This tote has an electric pump because there is no plant air in the cooling-tower area.

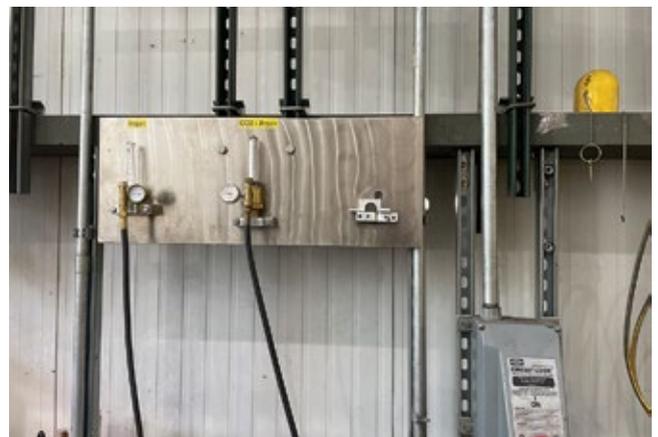
3. Bottles of inert gas are secured outside the shop (left); tubing brings the gas inside to the fixed manifold serving the welding machines (right)

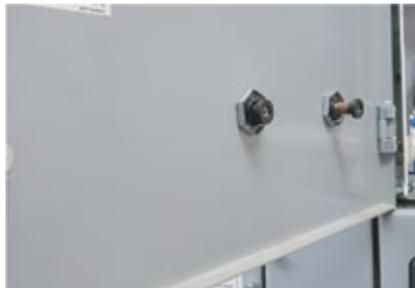
1. Pushbutton located outside motor starter, at left, is for resetting of the thermal overload; back side of the panel is at right

Challenge. Rolling Hills Generating has several pieces of equipment that rely on a motor starter to operate. Each motor starter has a resettable group of thermal overloads. The reset buttons for the overloads are installed inside the power-supply buckets. The only way to operate the reset is via an external pushbutton located on the outside of the cabinet (Fig 1)—this to avoid crossing the electrical boundary of the equipment.

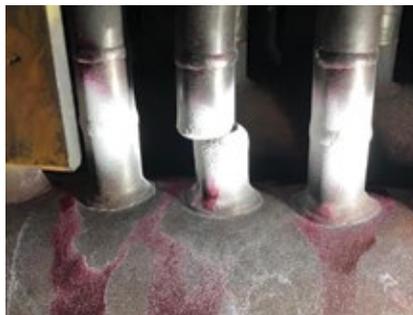
3. Failure in stainless-to-CSEF steel transition. EPRI is aware of steam leaks or failures in both link piping and tubing

Advanced alloys offer options, but also some learning curves. For example, there could be options when transitioning from stainless steel to CSEF steel within the HRSG (Fig 2). The transition shown could be in

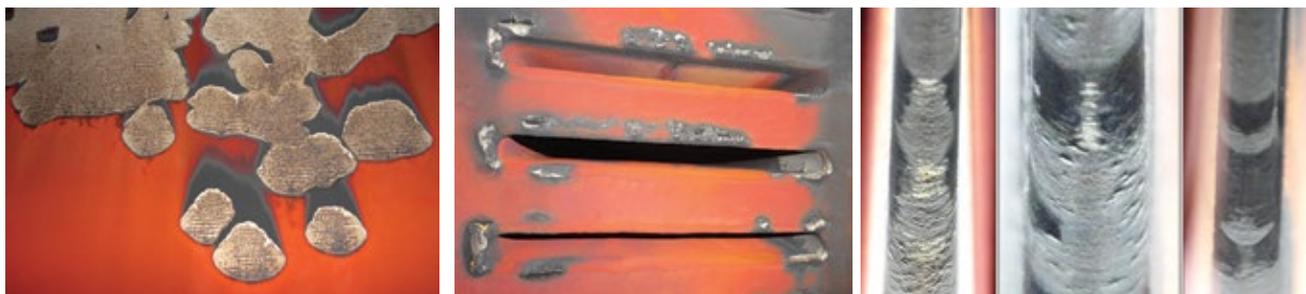
1-3. Metal loss from ACC duct walls attributed to LP-turbine steam exhaust (left); erosion/corrosion at ACC tube inlets (center) and 3 to 6 ft downstream of the tube inlets (right)

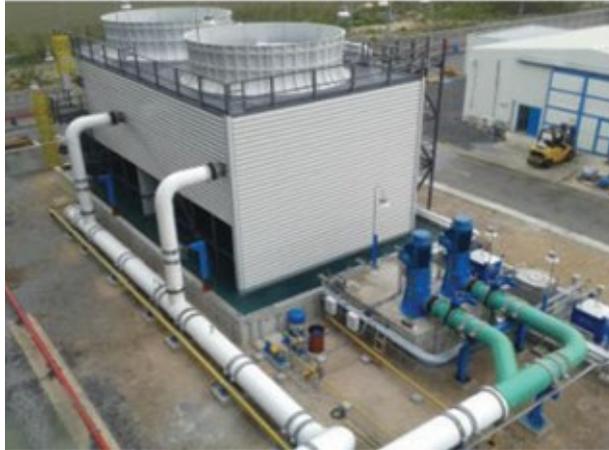
7. The two-cell wet cooling module retrofitted at Rio Bravo IV contributed a 20-MW increase in plant output

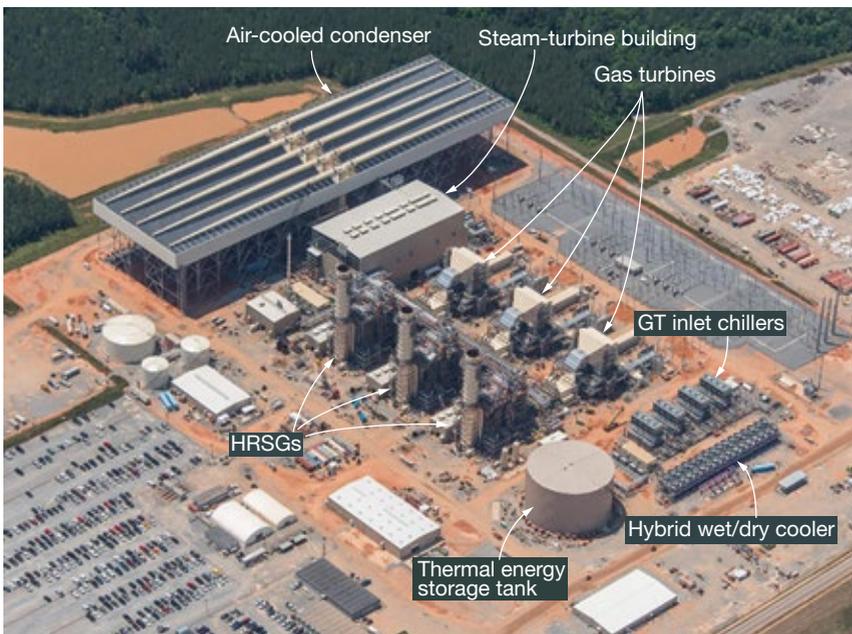
8. Dominion's Greenville is a 1680-MW 3 × 1 combined cycle which began commercial operation in December 2018. It has three Mitsubishi 501J gas turbines with steam-cooled combustors, a four-flow steamer of Alstom design, an 80-cell ACC, GT inlet chillers capable of boosting the plant's output by up to 150 MW, and six levels of duct burners capable of adding 200 MW

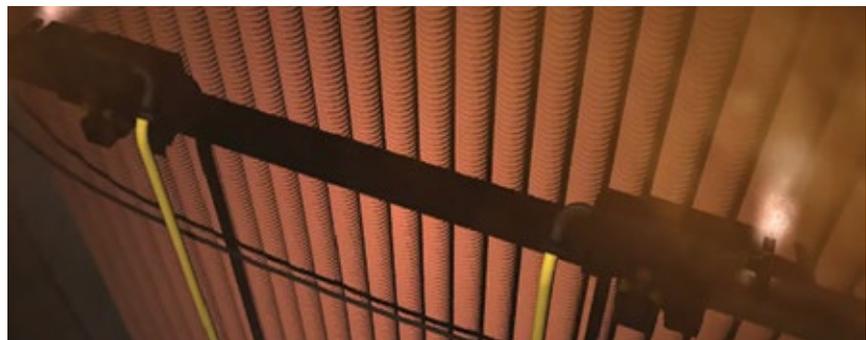
2. High-pressure air is delivered to track-mounted nozzles via the automated distribution system which traverses the tube bundles side to side and top to bottom. Loose debris falls to the floor and is vacuumed up

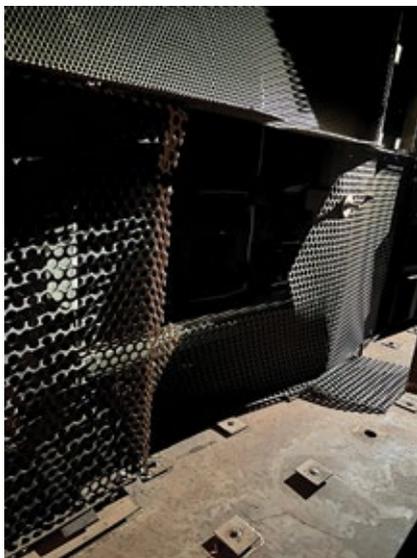
1. Careful design, robust framework, and heavy-gauge plate are required to prevent mechanical damage caused by the demanding environment downstream of the gas turbine
