ECOLOGICAL ASSESSMENT OF THE GROEN ESTUARY

J.B. Adams*, M. Cowie* and T.H. Wooldridge**

June 2015

Department of Botany* and Zoology**
Nelson Mandela Metropolitan University
PO Box 77000
Port Elizabeth
6031

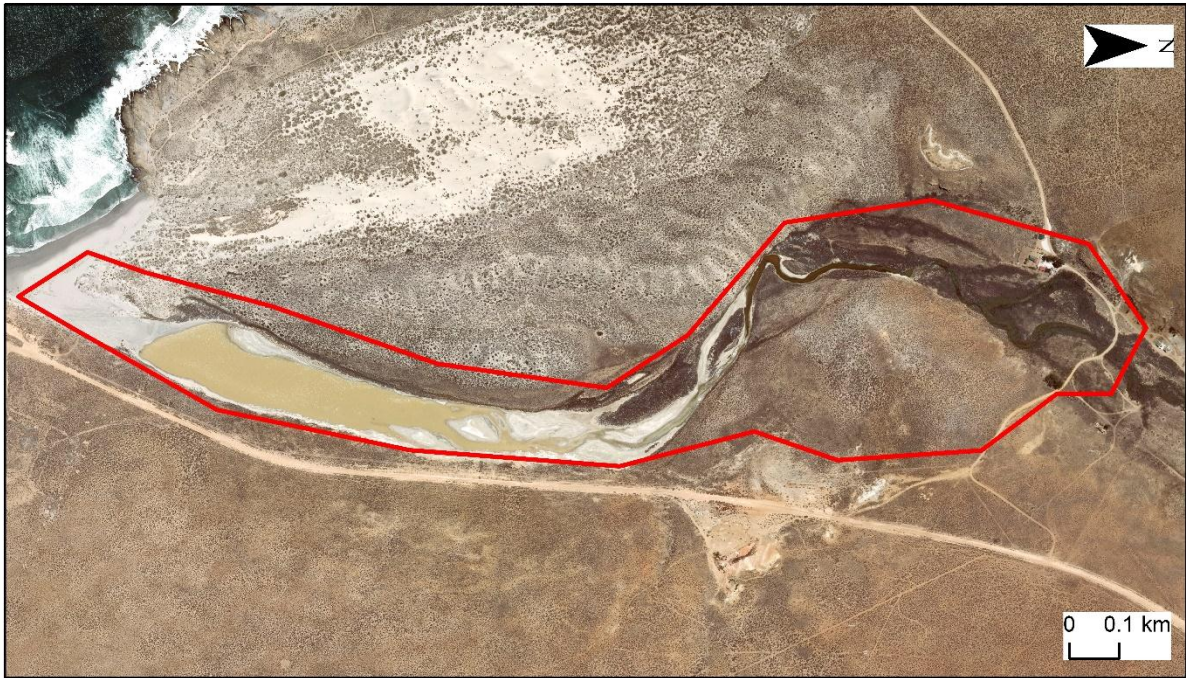
Figure 1 The Groen Estuary on the west coast of South Africa. The red line indicates the Estuarine Functional Zone according to the 2012 NBA (Image date: 2011)

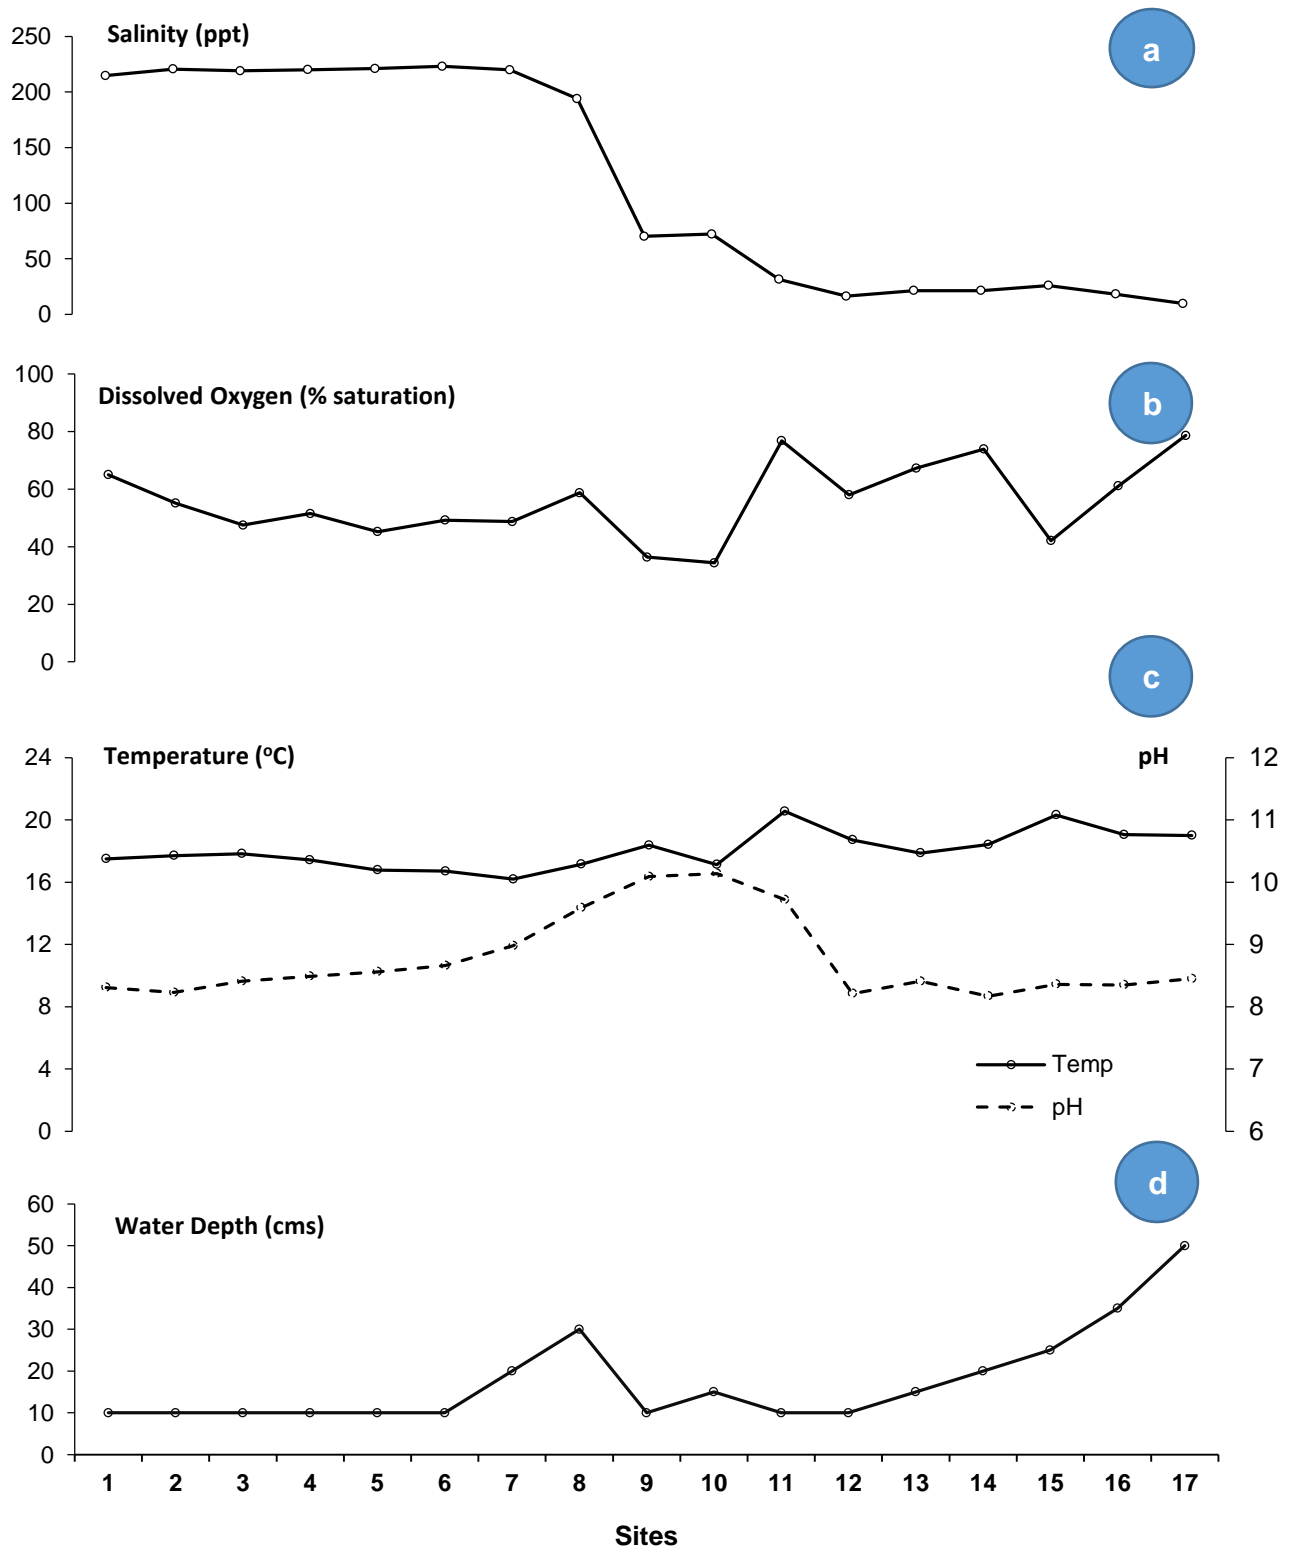
Figure 5 Physico-chemical characteristics at 17 sites along the length of the Groen Estuary (a) salinity; (b) dissolved oxygen; (c) temperature and pH; and (d) water depth.

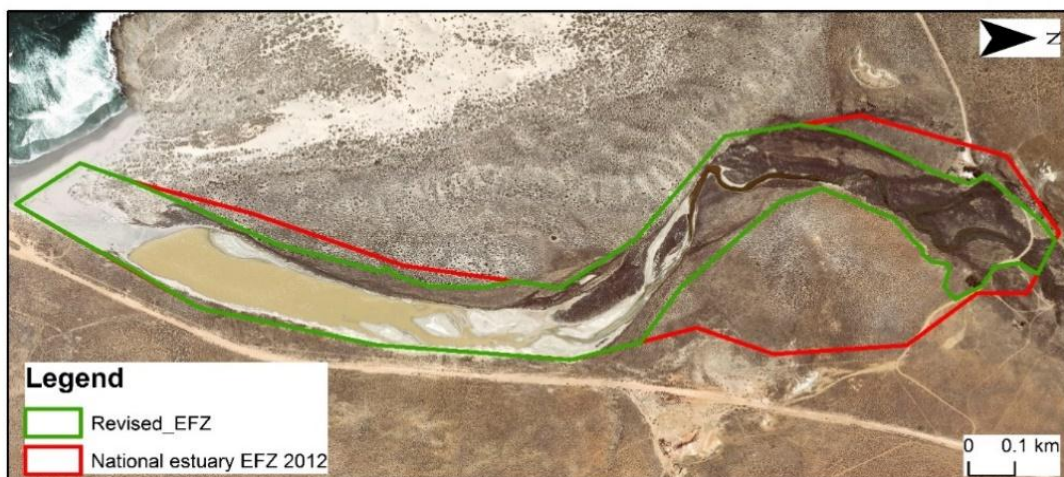
Figure 7 Revision of the estuarine functional zone (EFZ) for the Groen Estuary to exclude higher elevations.

The estuarine functional zone was remapped after the site visit. Figure 7 indicates the original 5 m contour line and the new proposed boundary. The new estuarine functional zone excludes dune vegetation that occurs on the north bank at the mouth of the estuary as well as the terrestrial vegetation on the south bank in the middle-upper reaches. The elevation of this habitat is not suitable for estuarine vegetation. The revised area of the estuarine functional zone of the Groen Estuary is 39 ha.

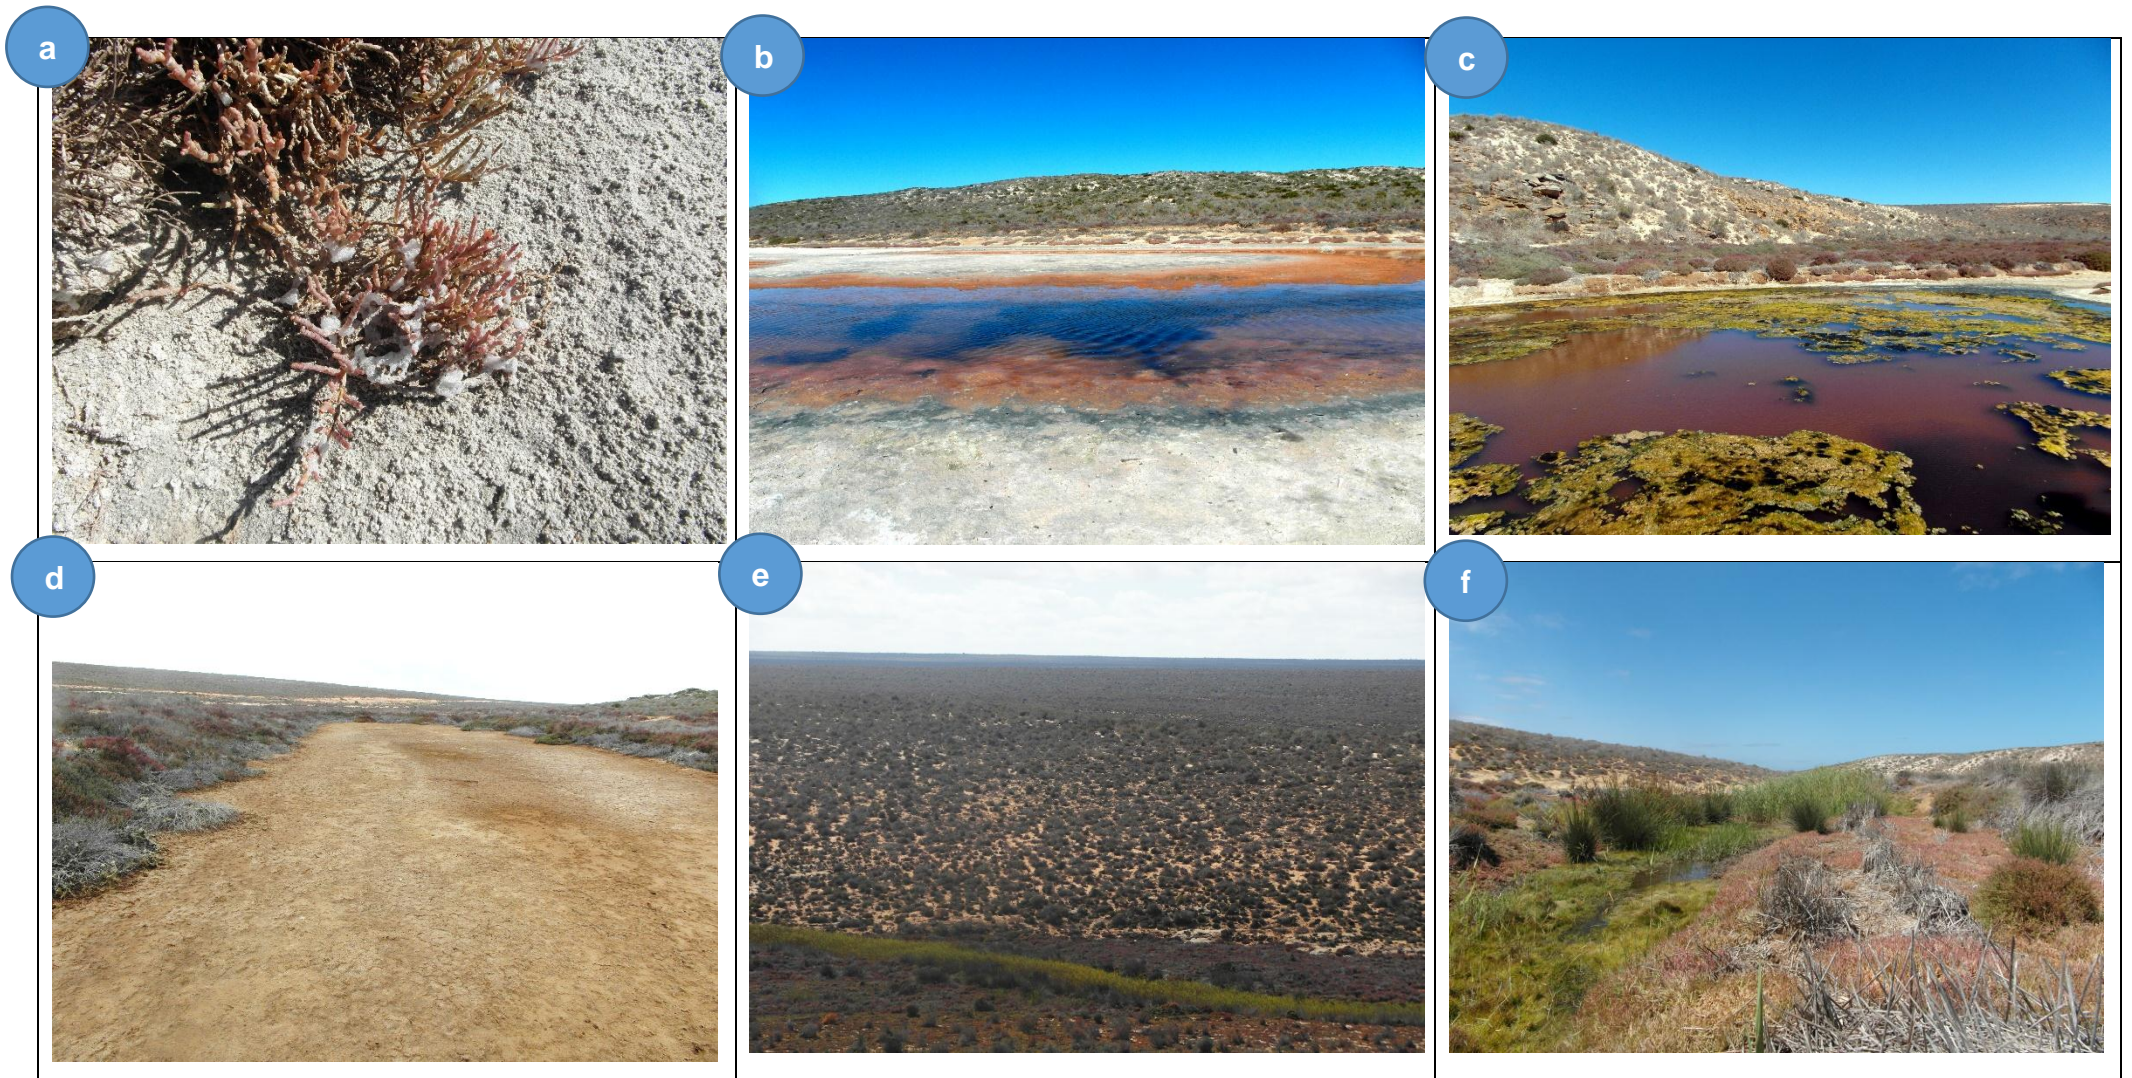
Plate 2 a) Windblown cyanobacteria and salt foam accumulated on salt marsh vegetation, b) cyanobacteria has discoloured the thick salt crust present on the sand surrounding the open water, c) thick floating mats of *Lyngbya* sp. present in the water column throughout the Groen Estuary, d) a dry arm of the estuary situated on the north bank in the middle reaches, e) reeds habitat can be clearly distinguished from the homogenous floodplain in the upper reaches, f) *Phragmites australis* and *Juncus acutus* present in the less saline upper reaches (Photographs taken by J. Adams, February 2015).

Salt pans were present in the middle and upper reaches of the estuary. These waterlogged areas were devoid of vegetation (Plate 2d). Much of the vegetation surrounding the estuary was dead at the time of sampling in February 2015 (Plate 1f). Although not included as estuarine habitat the following species were identified in the dune vegetation at the mouth of the estuary: *Aloe arenicola*, *Asparagus* spp., *Ballota africana*, *Calobota spinescens*, *Chrysanthemoides incana*, *Cotyledon orbiculata*, *Mesembryanthemum guerichianum*, *Salvia africana-lutea* and *Tapinanthus oleifolius*. The elevation of the north bank in the lower reaches is unsuitable for establishment of estuarine vegetation.

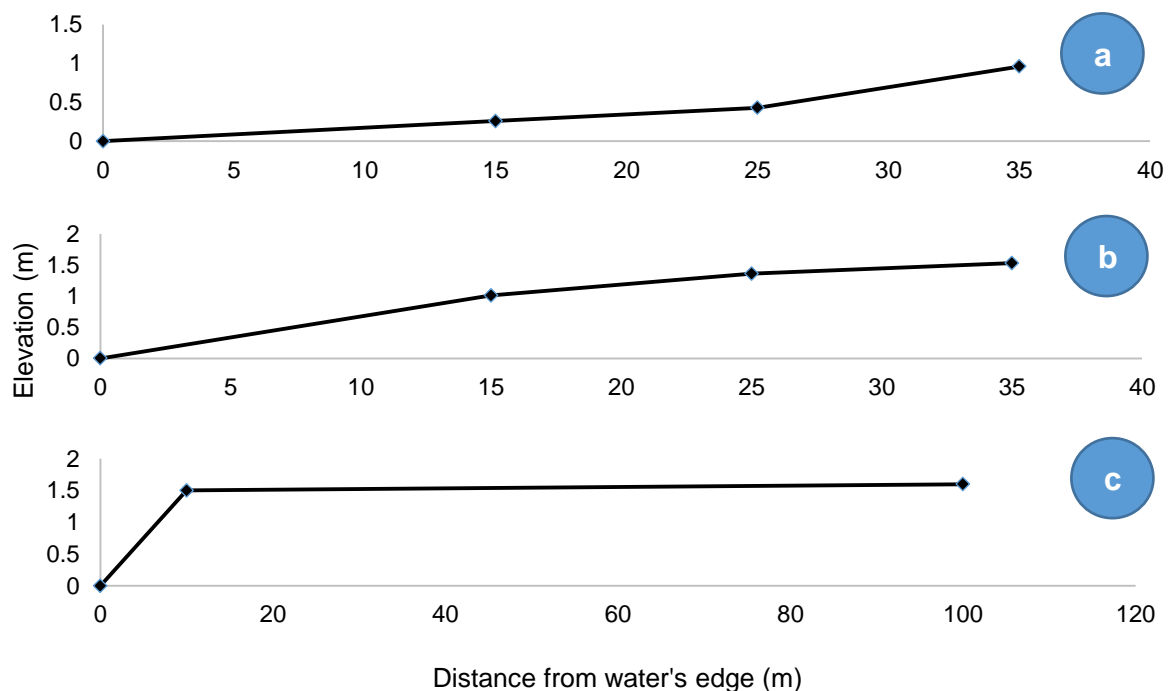
Figure 10 Elevation profiles of the three transects placed in the (a) lower, Transect 1 and (b & c) middle reaches of the Groen Estuary (Transects 2 and 3).

Salt marsh is typically distributed along an elevation gradient from lower intertidal to upper intertidal to supratidal salt marsh and then terrestrial vegetation. There was a gradual elevation change along Transect 1 and 2 with a more abrupt increase from lower intertidal to supratidal / floodplain area in Transect 3 (Figure 10). Transect 1 showed clear zonation with a large area of bare ground along the first 18 m, this was followed by a zone of the annual succulent *Salicornia meyeriana*. Thereafter the upper intertidal species *Sarcocornia natalensis* occurred but it was mostly dead. There was also a small zone of brakgras, *Sporobolus virginicus*. The supratidal zone was represented by *Sarcocornia pillansii* which was also mostly dead (16.3 % alive, 57.1 % dead). From 31 m bare ground increased with distance away from the main water channel. This represented a side channel that has dried up over time. *Sarcocornia pillansii* was the dominant plant along Transect 2 as this represented a supratidal salt marsh area. Most (22.7 % alive, 51.2 % dead) of the plants were also dead. There was greater species richness along Transect 3 as it consisted of a small intertidal marsh followed by a much larger supratidal area.

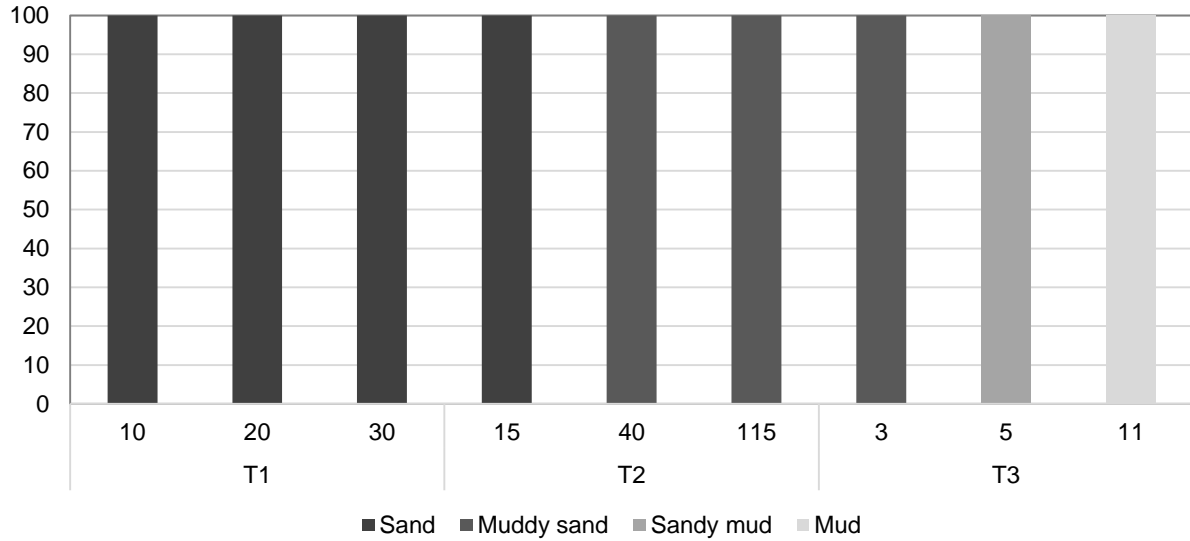
Figure 14 Sediment classes based on mud content of sediment collected in the three zones (lower intertidal, intertidal and supratidal) along transects at the Groen Estuary.

On average the soil texture of Transect 1 and 3 were a silt loam, Transect 2 was loam and the reed sites were a clay loam. Soil texture was similar along transects with the sand fraction decreasing away from the water channel. In general surface sediments had a higher sand fraction than bottom sediments. Soil texture of the reed sites varied greatly with Site 1 classified as clay, Site 2 as silt loam and Site 3 as loam (Figures 13 and 14).

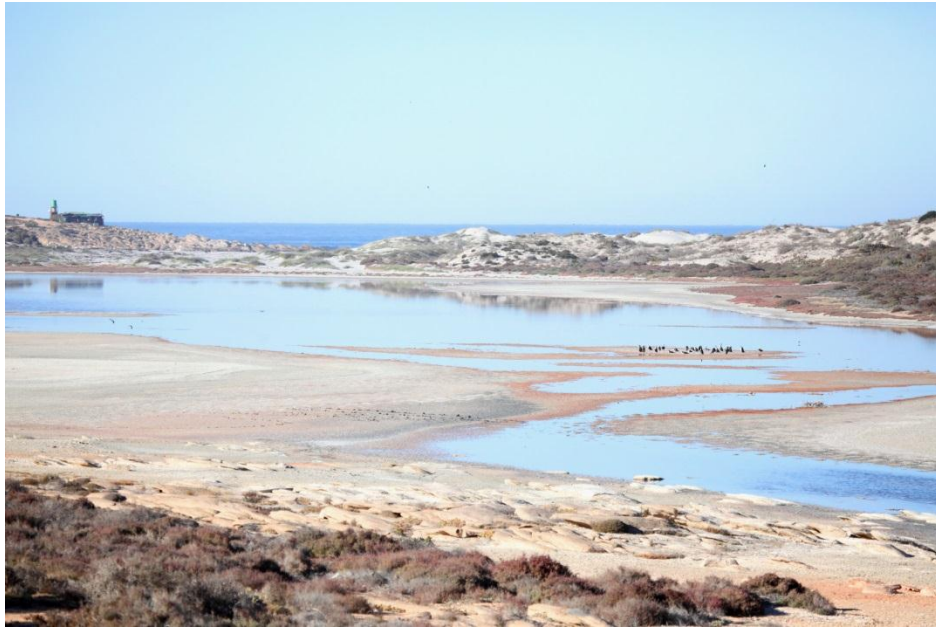
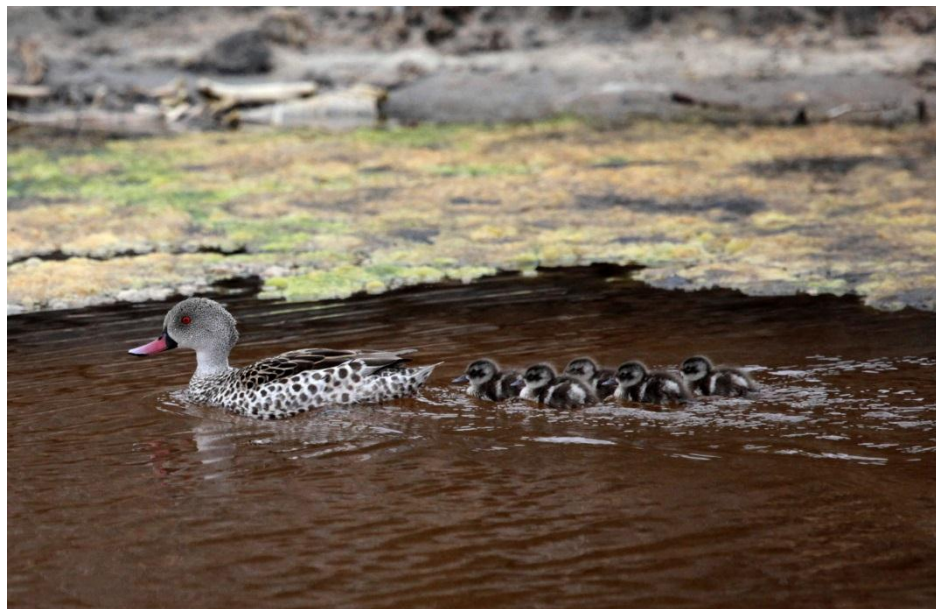
Plate 3 a) The lower reaches of the Groen Estuary, also showing a roosting flock of White-breasted Cormorants; and b) A Cape teal with its ducklings present at the Groen Estuary at the time of sampling.

The upper photograph in Plate 3a illustrates the lagoon near the mouth of the Groen Estuary. Also shown in the photo is the expansive sandflat adjacent to the water body and a roosting colony of White-breasted Cormorants. These birds were present for a few hours only. Most of the plover species were feeding on the open sandflat where insects were present. In the lower photograph (Plate 3b) a Cape Teal with accompanying ducklings swims past the clearly visible floating algal carpet at Site 15. The water was very clear at this site.

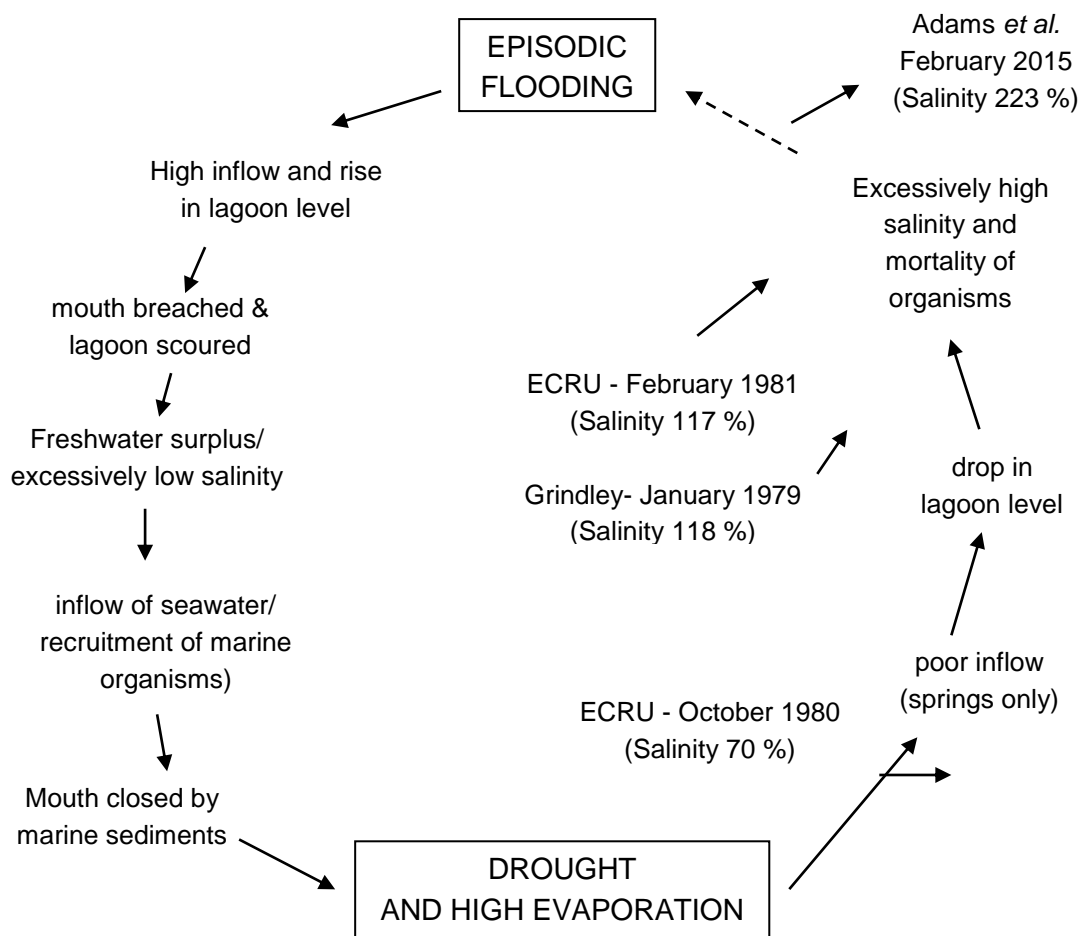
Figure 126 Generalized hydrological cycle for the Groen Estuary. The time periods for the completion of one cycle would depend on the frequency and degree of episodic flooding. Dashed line reflects highest salinity values – this state may persist from months to years (Adapted from Bickerton, 1981).

Figure 16 depicts a generalized hydrological cycle for the Groen Estuary adapted from Bickerton (1981). The time periods for the completion of one cycle would depend on the frequency and degree of episodic flooding. The changes in the estuary after episodic flooding have not been measured and monitored. For this reason the next flooding event should be followed by a detailed monitoring programme so that the functional importance of the estuary can be measured and understood.
