# PROJECT SUMMARY

## Drummond Townhouses

803 Drummond Way

## Environmental Assessment (EA) for the Drummond Way Land Use Approvals Project, Colwood, BC

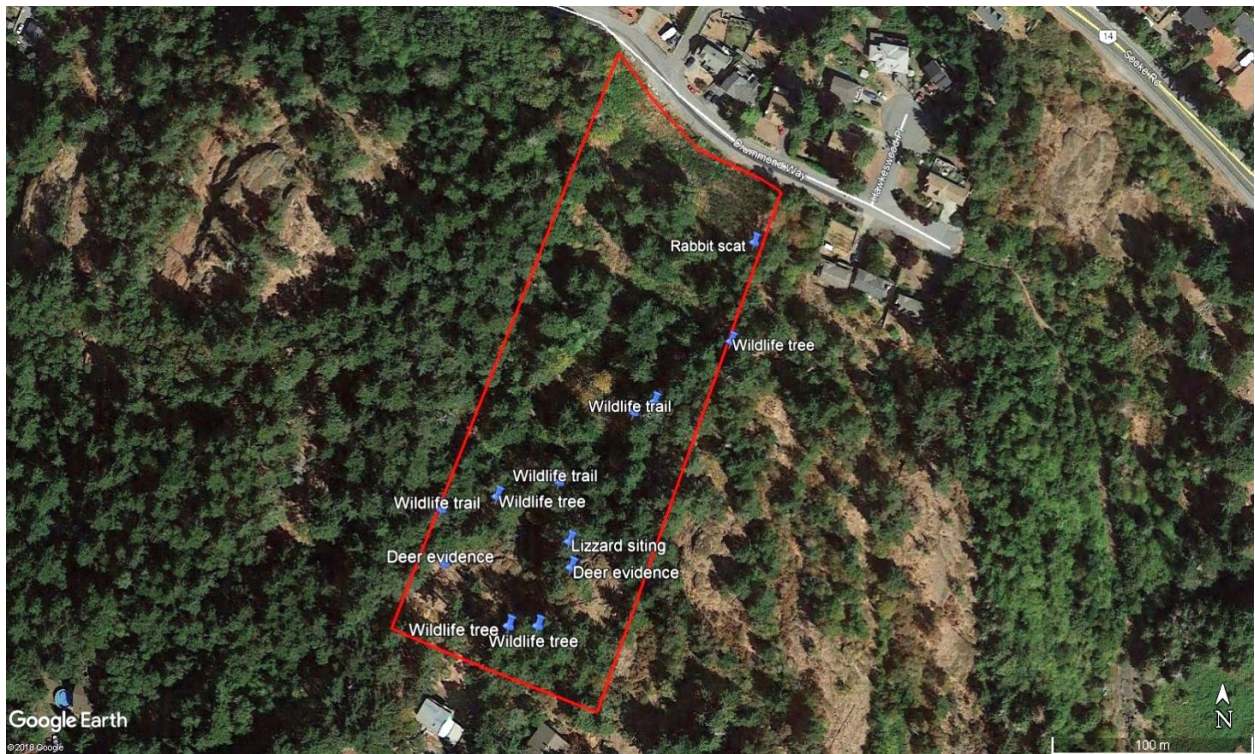
*Figure 6. Wildlife observations noted during the May 2018 site visit (image courtesy of the Google Earth).*

There are several large undeveloped forested areas in and around the City of Colwood, many of which are connected by narrow green spaces that act as wildlife corridors. This allows for large mammals to occasionally access the City. Although rare, large carnivores such as black bears (*Ursus americanus*), and cougars (*Puma concolor*) have been known to wander through the area. Incidental wildlife observations noted during the site visit are marked on *Figure 6*.

Black-tailed deer (*Odocoileus hemionus*) frequents the Site, several individuals were observed during the Site visit as well as evidence of their scat, trails and areas where they bed down (typically in the rocky outcrop Garry Oak meadows). Evidence of the black-tailed deer locations for bedding down and wildlife trails are shown *Photograph 7 & 8* and *Figure 6*. The deer encounters were on the northern and central portion of the Site and are not mapped.

Several wildlife trees were observed during the site visit, but many areas of the Site were not accessible for assessment. Locations of wildlife trees observed are marked on *Figure 6*. Mature trees that were greater than 80 cm in breast height diameter were also located and mapped. There was a wildlife tree located on the northern/central portion of the Site that would provide suitable perch habitat for birds of prey (*Photograph 9*). Numerous mature conifers were used by woodpeckers for foraging. Cavities created (*Photograph 10*) may be suitable for nesting passerines.

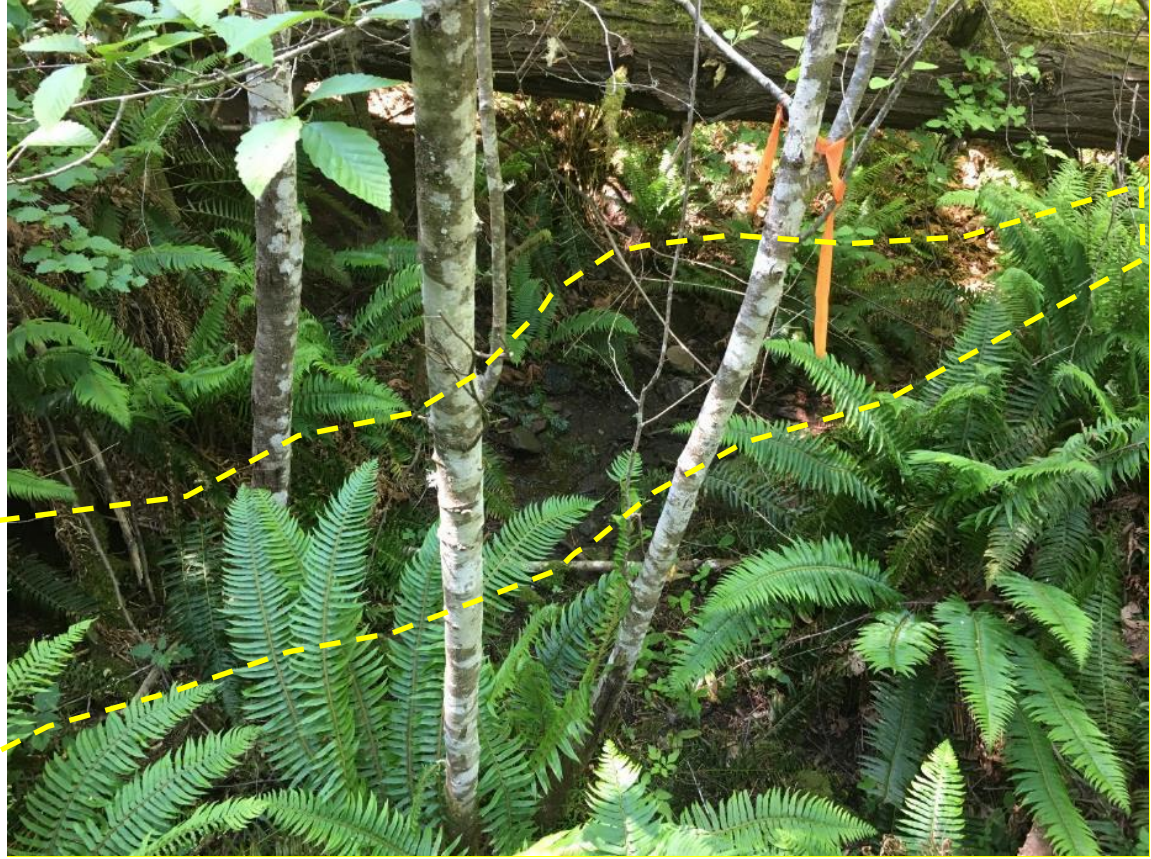
*Photograph 11. Manmade ephemeral drainage identified during the May 2018 Site visit*

An ephemeral drainage channel was identified running through in the center of the Site in 2018. The channel was approximately 1 m in width, incised, and dry during the summer (*Photograph 11*). Sections of the channel

appeared to be natural while others were distinctly manmade. The report issued at that time recommended follow up reviews of the watercourse during the rainy season with appropriately qualified professionals to determine if the watercourse was natural or manmade. The following section discusses initial data collected in 2018 and follow up data in 2020 used to determine that the watercourse is manmade.

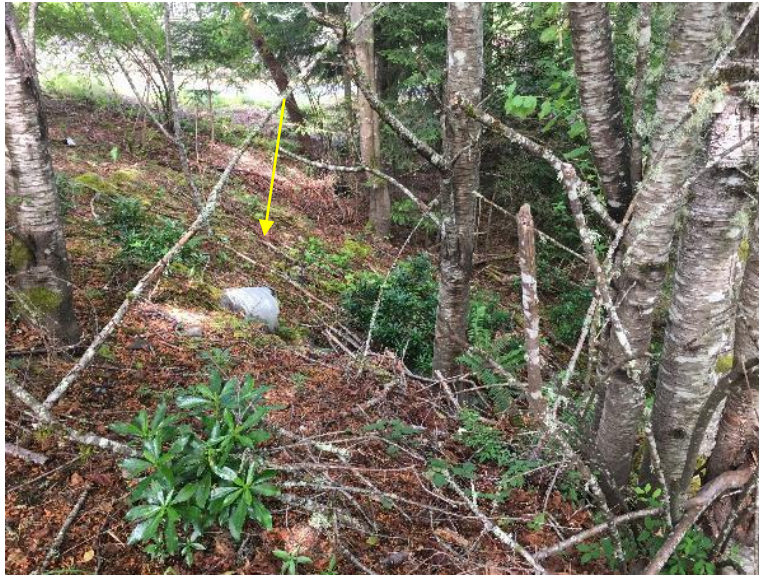
*Photograph 12. Steel corrugated culvert adjacent to Zapata Place to the north of the Site.*

At the summit of the hill on Zapata Place, there was a culvert directing stormwater flows (marked as a yellow star on *Figure 7* and shown in *Photograph 12*) on to the Site. A manmade drainage ditch was observed down gradient of the hanging corrugated steel culvert (*Photograph 13*). This drainage feature followed a natural depression and became less distinct within about 80 m of the culvert. No distinct drainage channel was observed at the northern boundary of the Site, but it was inferred that overland flow during precipitation follows the ravine like contours between the rock outcrops and would eventually flow into the drainage channel encountered in the center of the Site. The source and outlet of the drainage were not determined during the 2018 site visit but were inferred to result from the collection of water off the outcrops from overland flow.

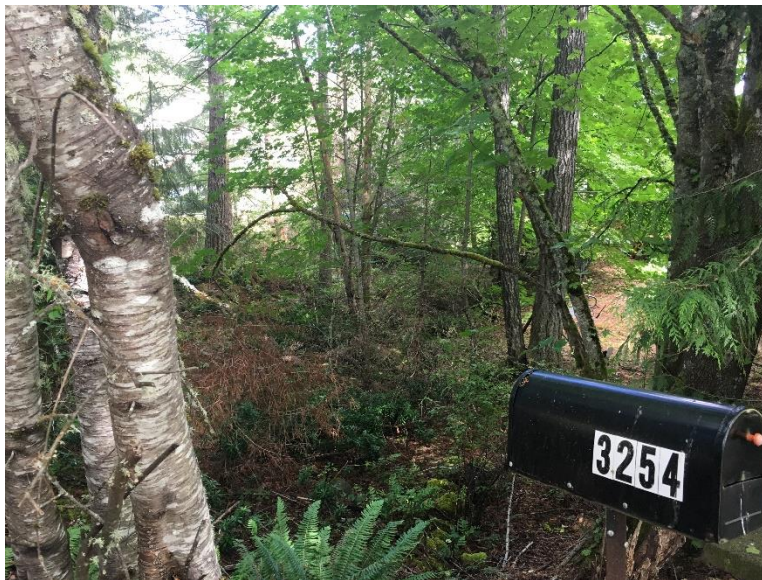
*Photograph 13. Drainage ditch located to the north of the Site.*

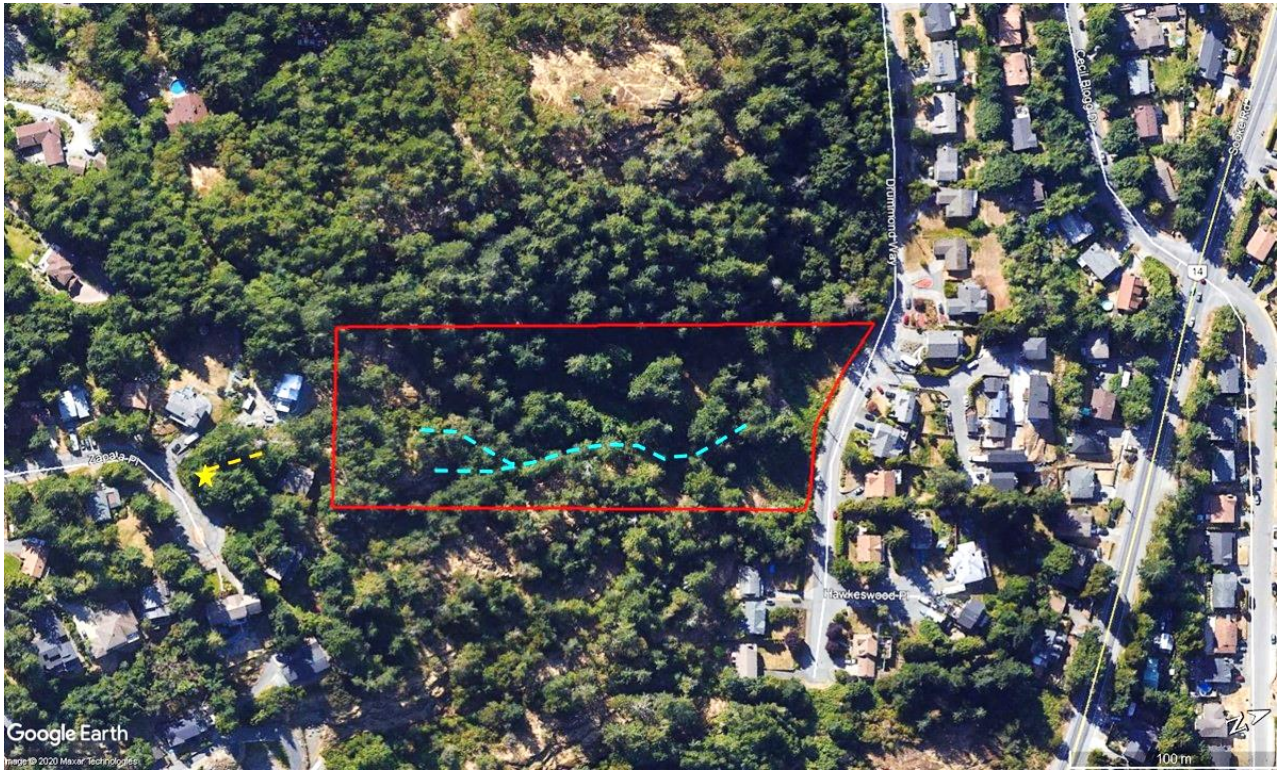
*Figure 7. Location of a manmade drainage channel including a culvert (yellow star) and a disconnected stormwater ditch south of the Site (orange dashed line).*

The ENKON report from 2011 indicated that there was a drainage channel that appeared to have been created by an excavator to drain hillslope runoff located adjacent to the T-shaped disturbed area in the center of the Site. The drainage channel was dry during their investigation. The location was not identified on a figure in their report and the description was inconsistent with where McElhanney encountered a drainage channel, thus, there was uncertainty if this was the same drainage feature seen by McElhanney. Furthermore, previously impacted areas had started to naturalize since the 2011 assessment.

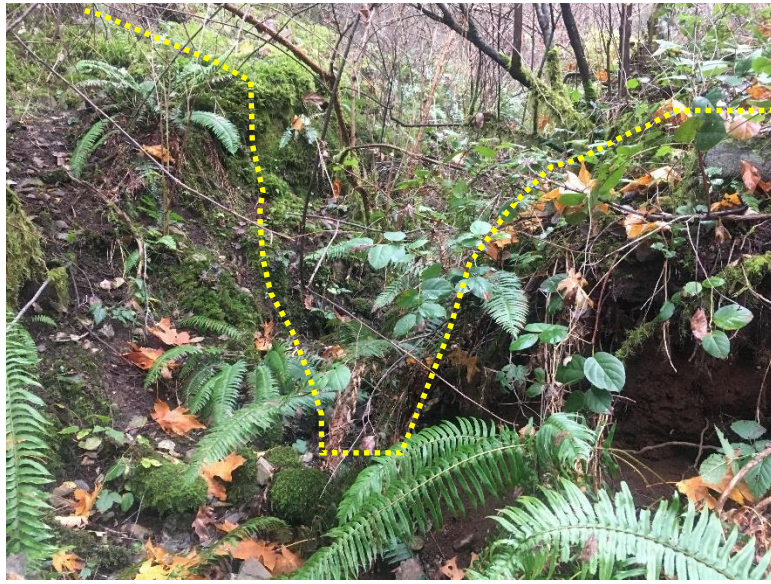
*Photograph 14. Drainage ditch with distinct evidence of former excavation that has begun to naturalize.*

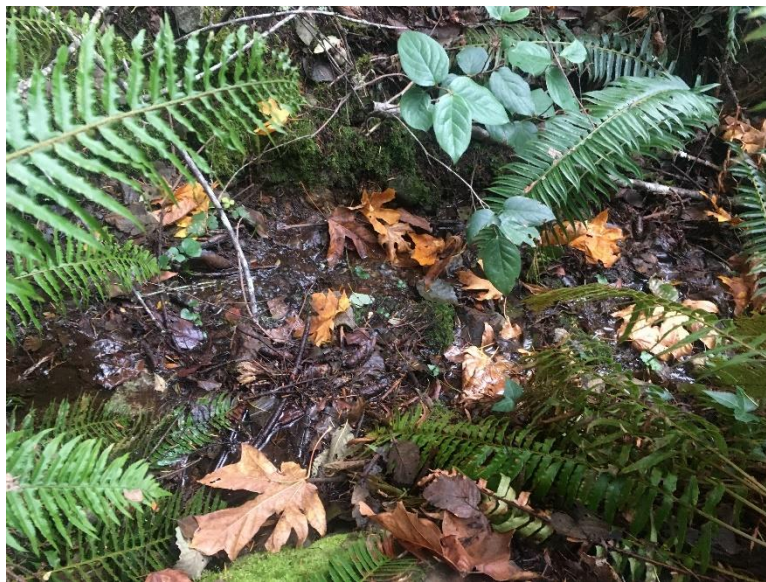
*Photograph 15. Flowing water in the drainage ditch observed in November 2020.*

Stormwater features or treatments, while sometimes conveying water, are not considered natural streams under the *Water Sustainability Act* (WSA). However, there is some provision of the WSA if the stormwater feature provides water directly connected to fish-bearing habitat. Features of the drainage channel as identified in 2018 are summarized in [Table 5](#). McElhanney completed an analysis of site topography, in combination with aerial photograph interpretation and the Site observations to determine the inferred location of the drainage channel ([Figure 7](#)). A slope analysis was completed for the Site and the area in which the drainage was identified had portions where the slopes were greater than 30%. Slopes greater than 20% tend to be a natural barrier to fish passage (BC 1998). The lack of connectivity to other watercourses suggests

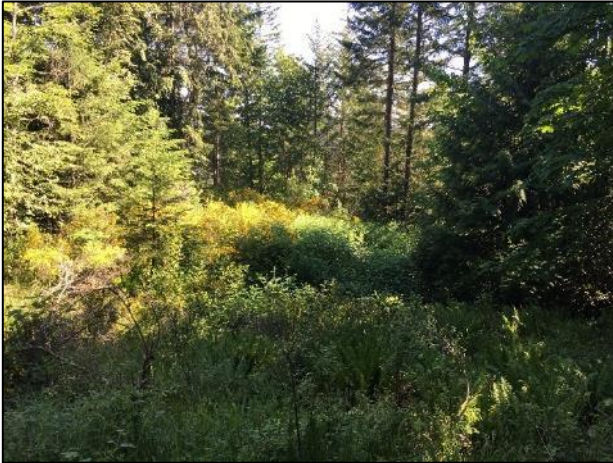
Photograph 16. T-shaped disturbed area in the center of the Site, dominated by Scotch broom.

The study area has a history of disturbance. There is a large “T” shaped disturbance in the middle of the Site that looks as though the area was at one time stripped of vegetation (*Photograph 16*). Soil disturbance, consistent to an excavator, was observed. This area has begun to revegetate with an early seral forest and a higher predominance of invasive species than found at many of the other areas on the Site. It is uncertain how recently this disturbance occurred, but it was documented in the 2011 ENKON report and was visible on the 2010 aerial photographs available through Google Earth.

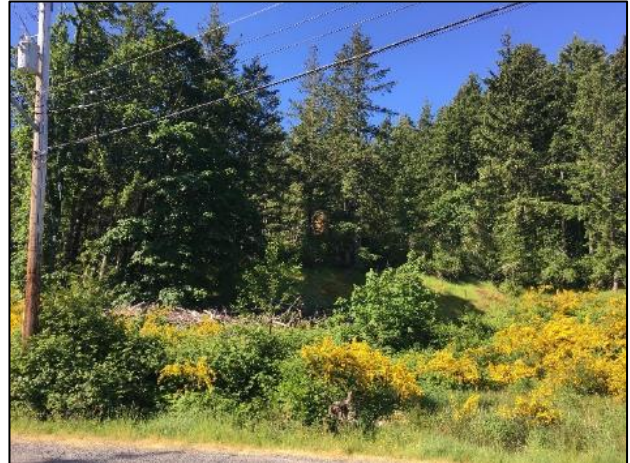
Photograph 17. Disturbed area on the north of the Site along Drummond Way, dominated by Scotch broom,

A second large disturbance area was located along the northern boundary of the Site near Drummond Way (*Photograph 17*). Google Earth aerial photographs show that the vegetation was cleared in 2012, which occurred after the previous environmental assessment. This area was the major area of change between the previous and current environmental assessments. The area has revegetated as a dense patch of Scotch broom with various other invasive species.

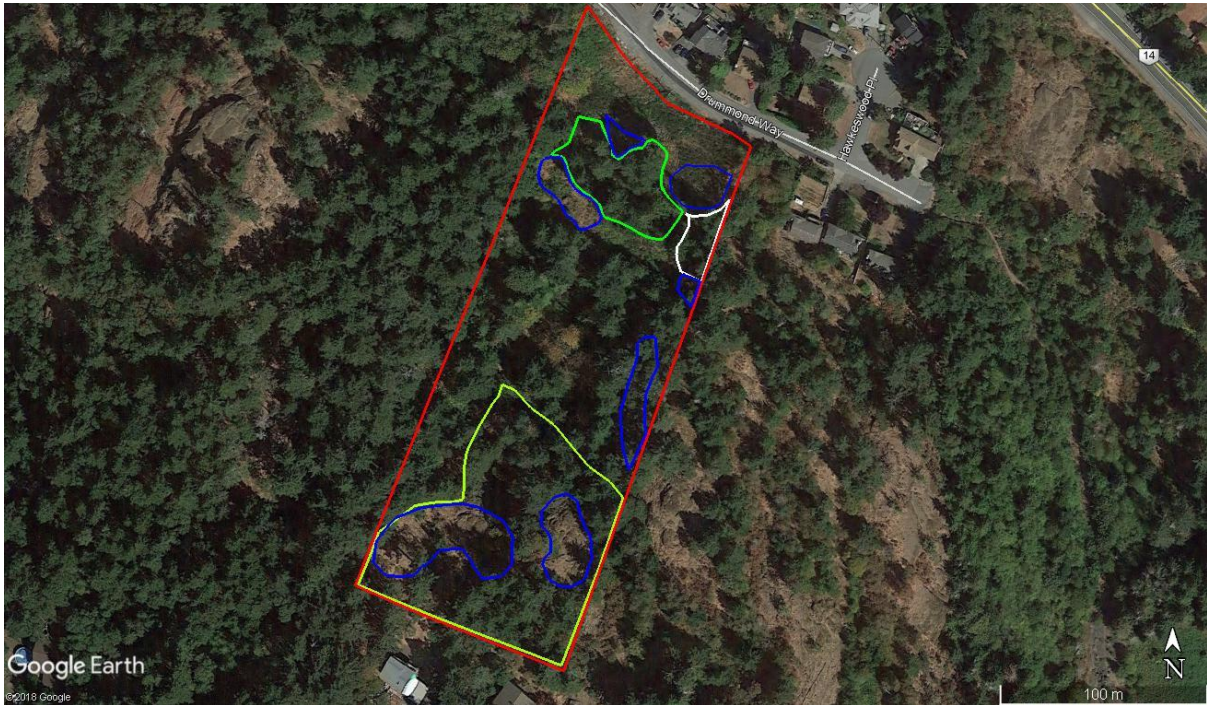
*Figure 8. Sensitive ecosystem on-site including Garry oak rocky outcrops (blue outline), Douglas-fir/Arbutus (green outline), and Douglas-fir/dull Oregon grape (white outline).*

*Figure 8* shows the environmentally sensitive ecosystems on the Site that will potentially be impacted by the project.

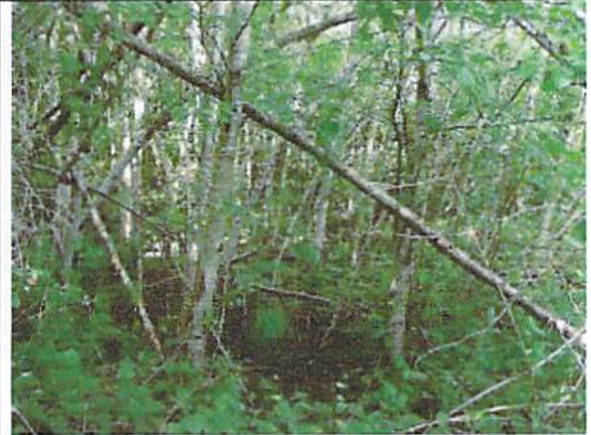
Photograph 13 - View Riparian plant community.

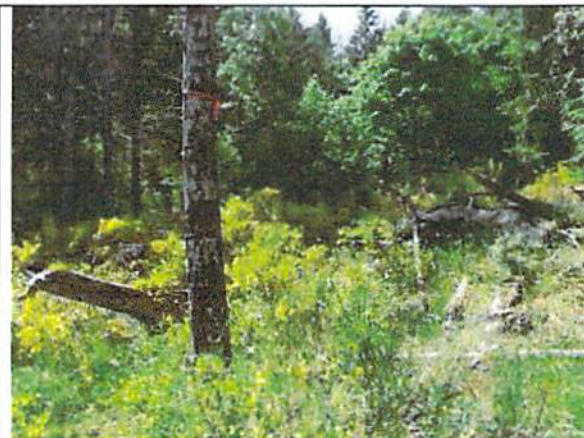
The disturbed portion of this property occurs in a “T” shape in the center of the property. It appears at one time this was an excavator track however it is currently heavily overgrown with invasive species such as Scotch broom and Himalayan blackberry with lesser amounts of salal, tall Oregon-grape, baldhip rose, Pacific sanicle, oceanspray and Garry oak seedlings. This disturbed area covers approximately 1274 m<sup>2</sup> or 6.34% of the site.

Photograph 14 – View of disturbed area.

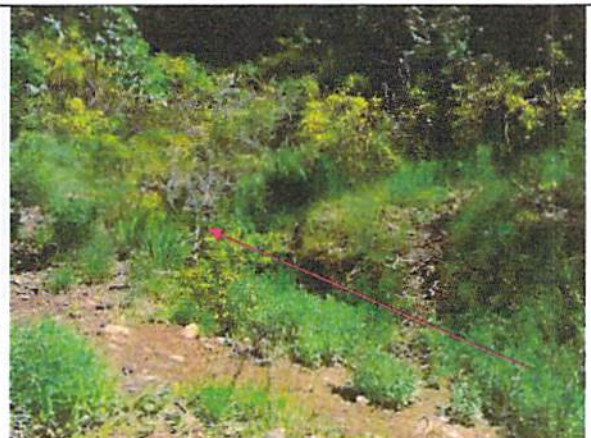
Photograph 15 - View of disturbed area (note ditch).

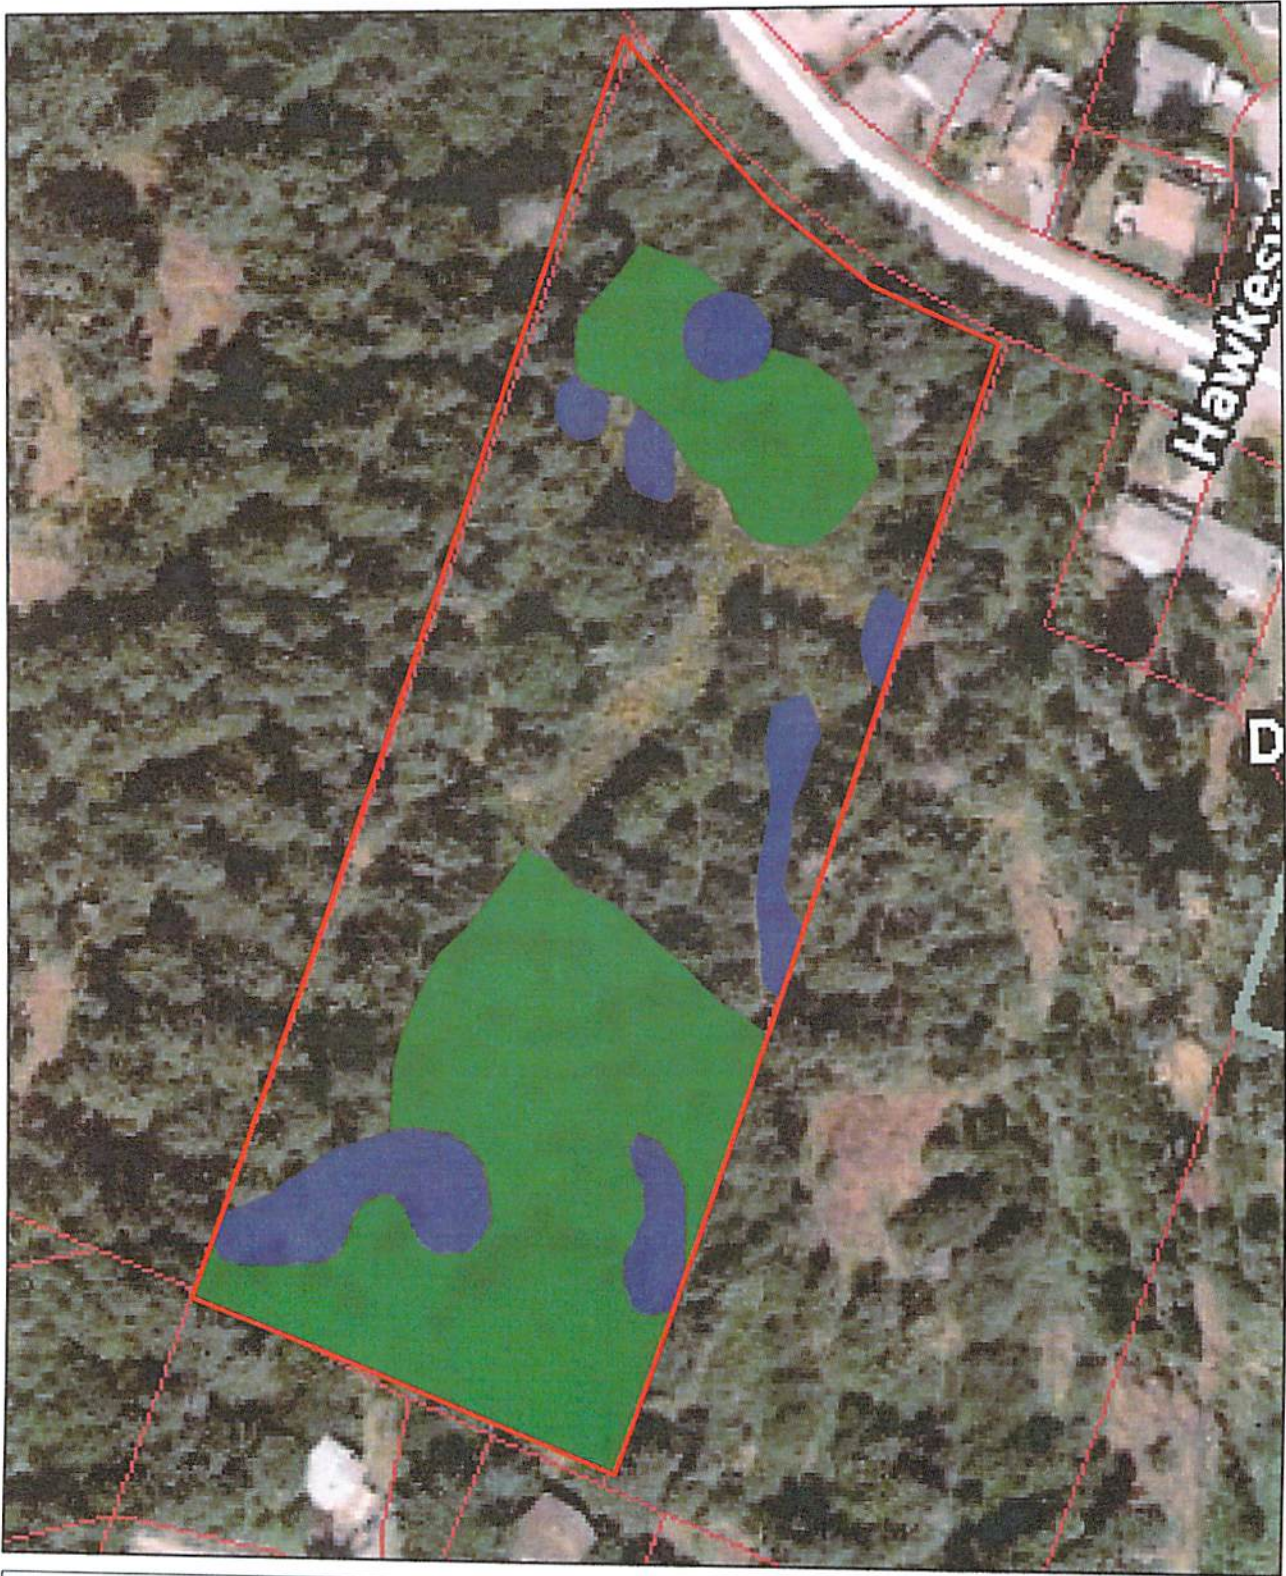
# Drummond Way - SEI

Terrestrial herbaceous ecosystems are defined as natural grasslands or byrophyte-dominated vegetation, including rock outcrop/grassland and rock outcrop/moss types, having greater than 20% cover. Woodlands can consist of Garry oak woodlands, Douglas-fir/Arbutus woodlands or trembling aspen stands. All sensitive ecosystems found on the site are shown on Figure 4.

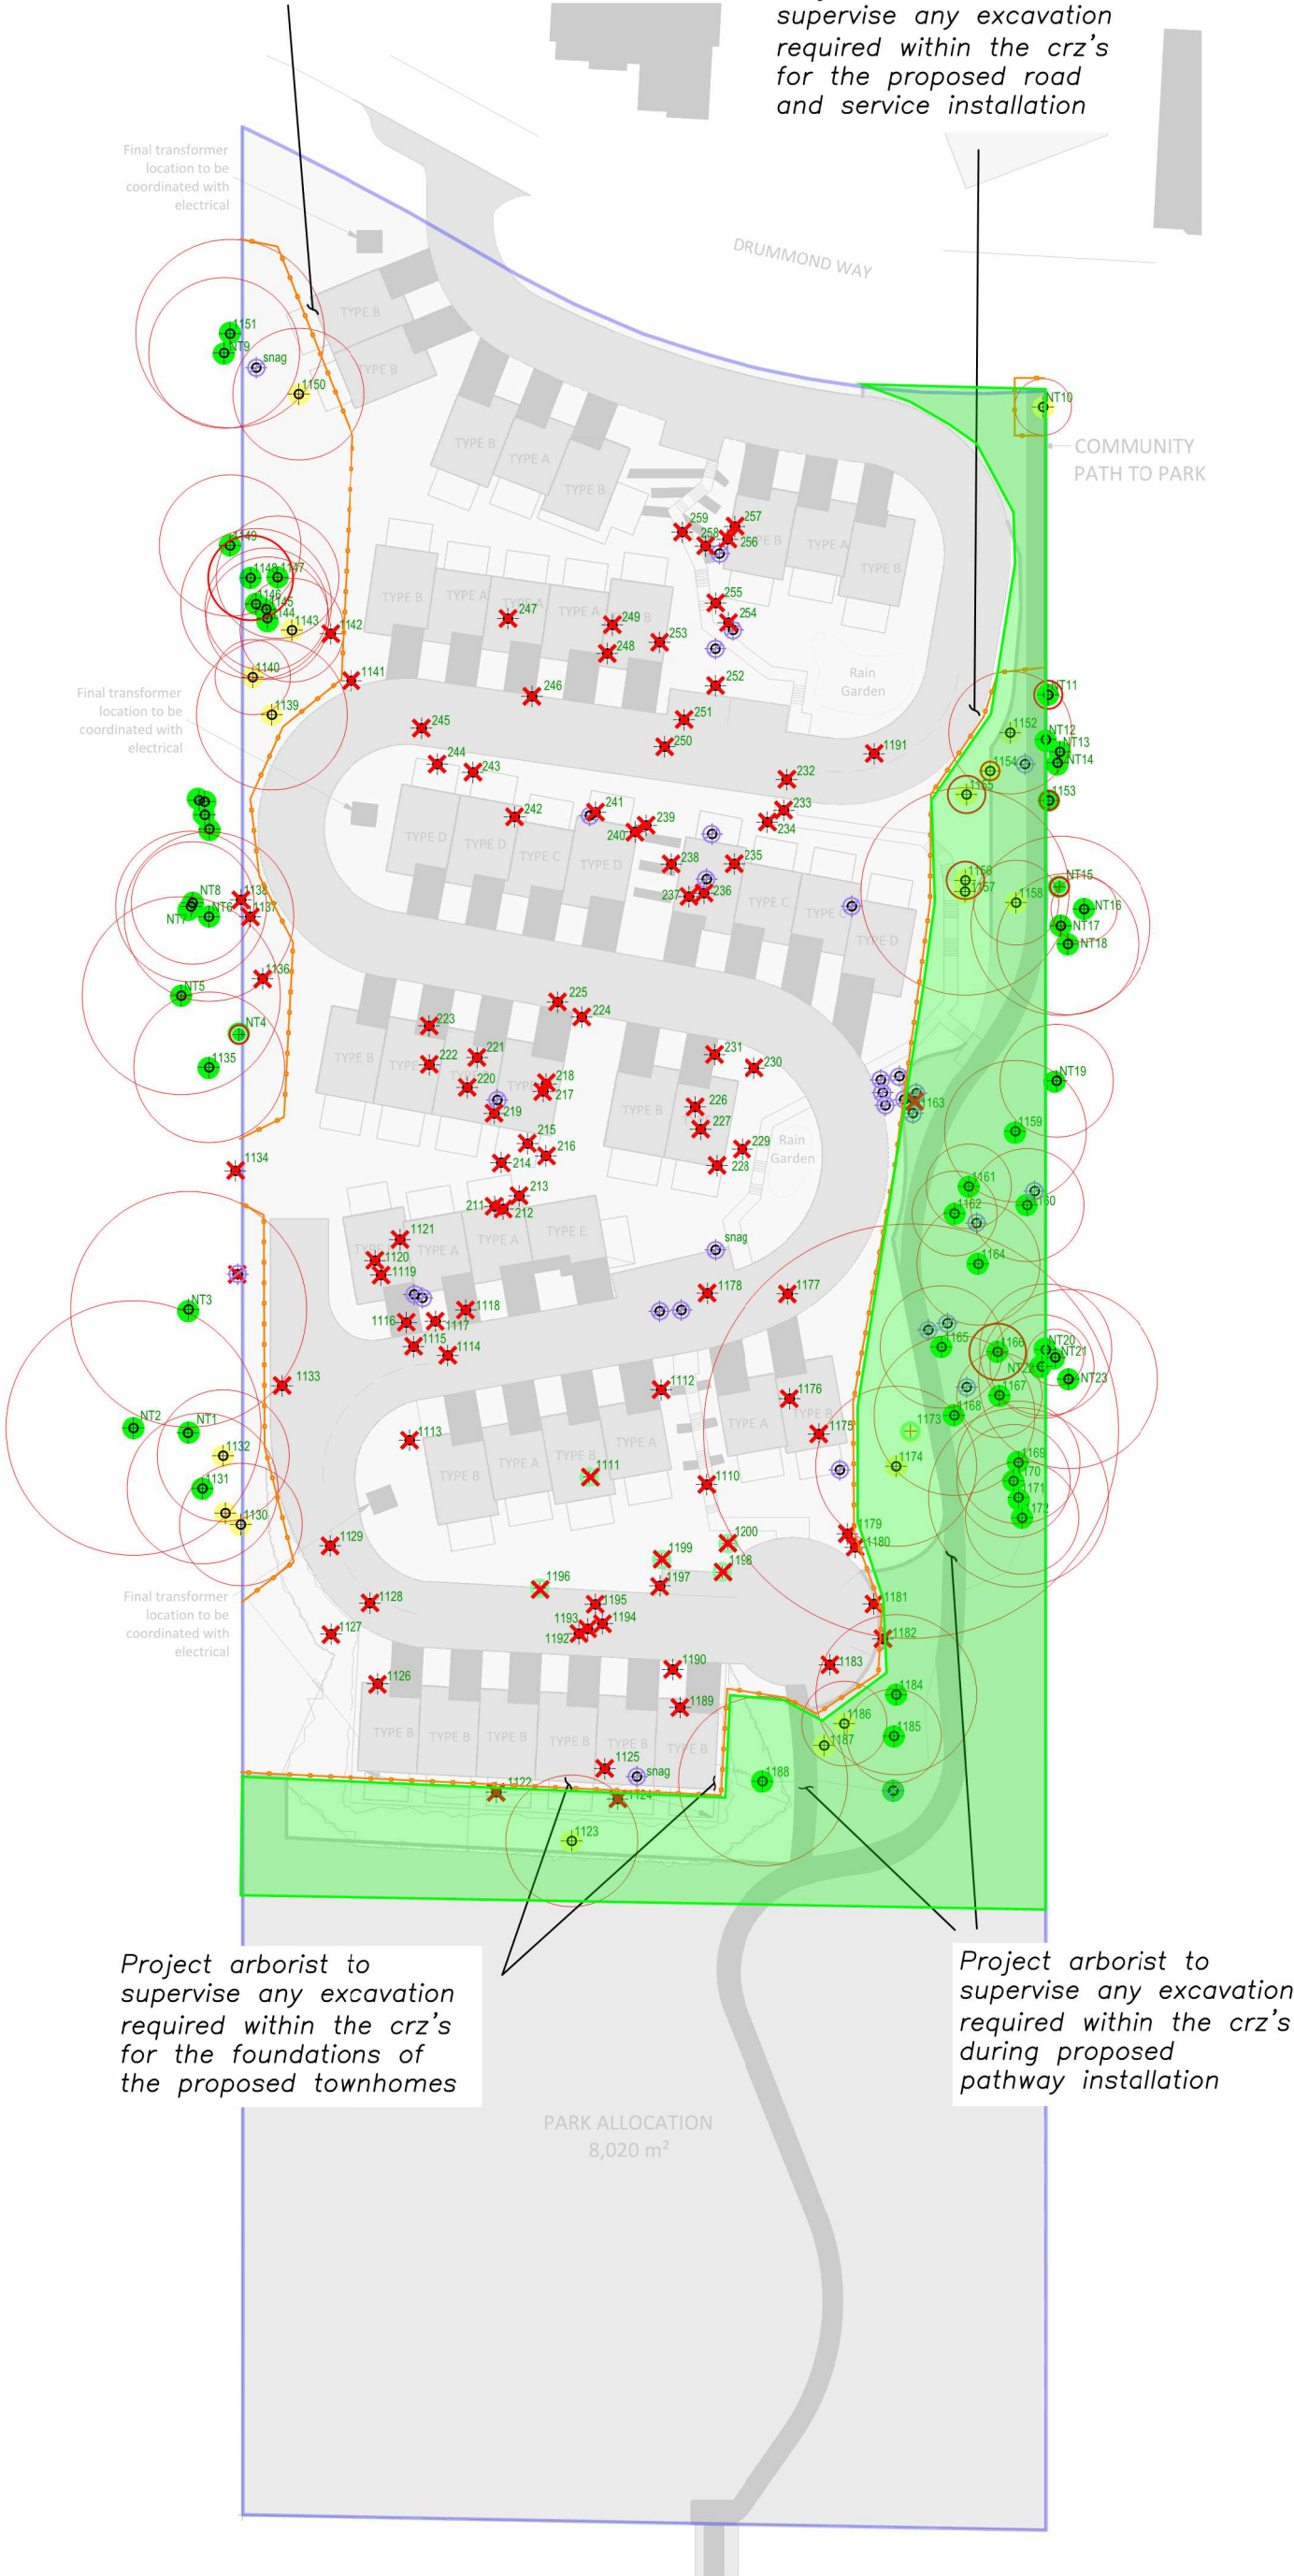
Proposed conservation areas where native soils, under story plantings and small trees should be retained where possible and inter planted with new native trees and plants.

Project arborist to supervise any excavation required within the crz's for the foundations of the proposed townhomes
