- What's going on in Elk/Beaver Lake?
 - How do we “fix” Elk/Beaver Lake?
 - What are the next steps?

ELK / BEAVER LAKE

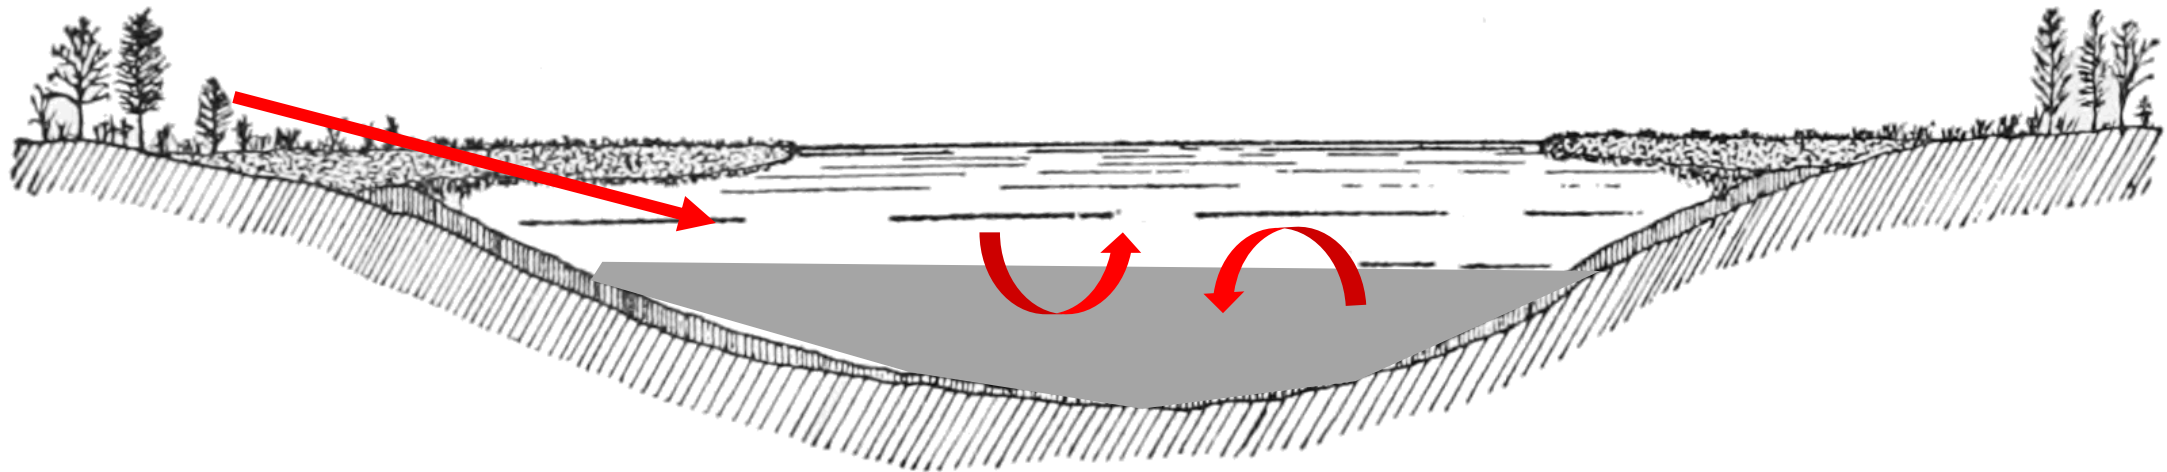
Elk Lake: November - February

4 degrees

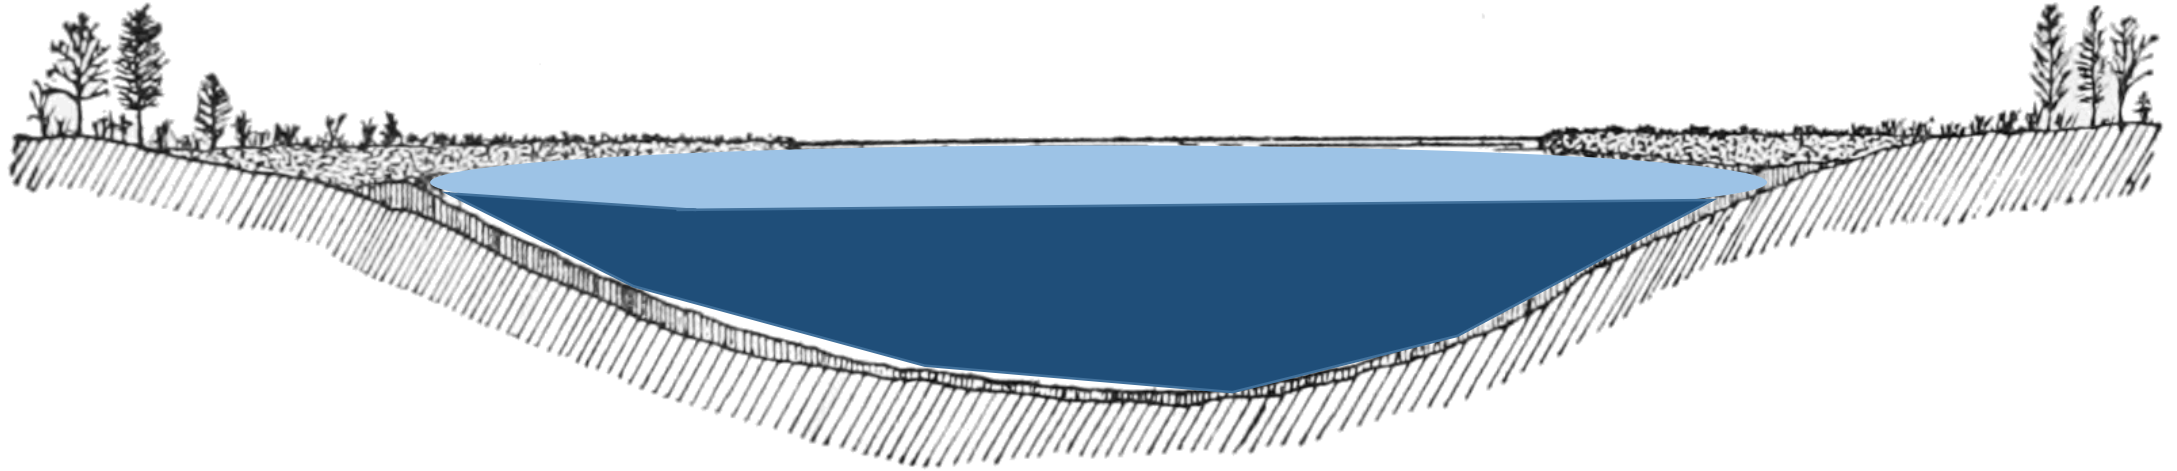
Elk Lake: April-August

12-20
degrees

Thermocline @ 8m

6-7
degrees

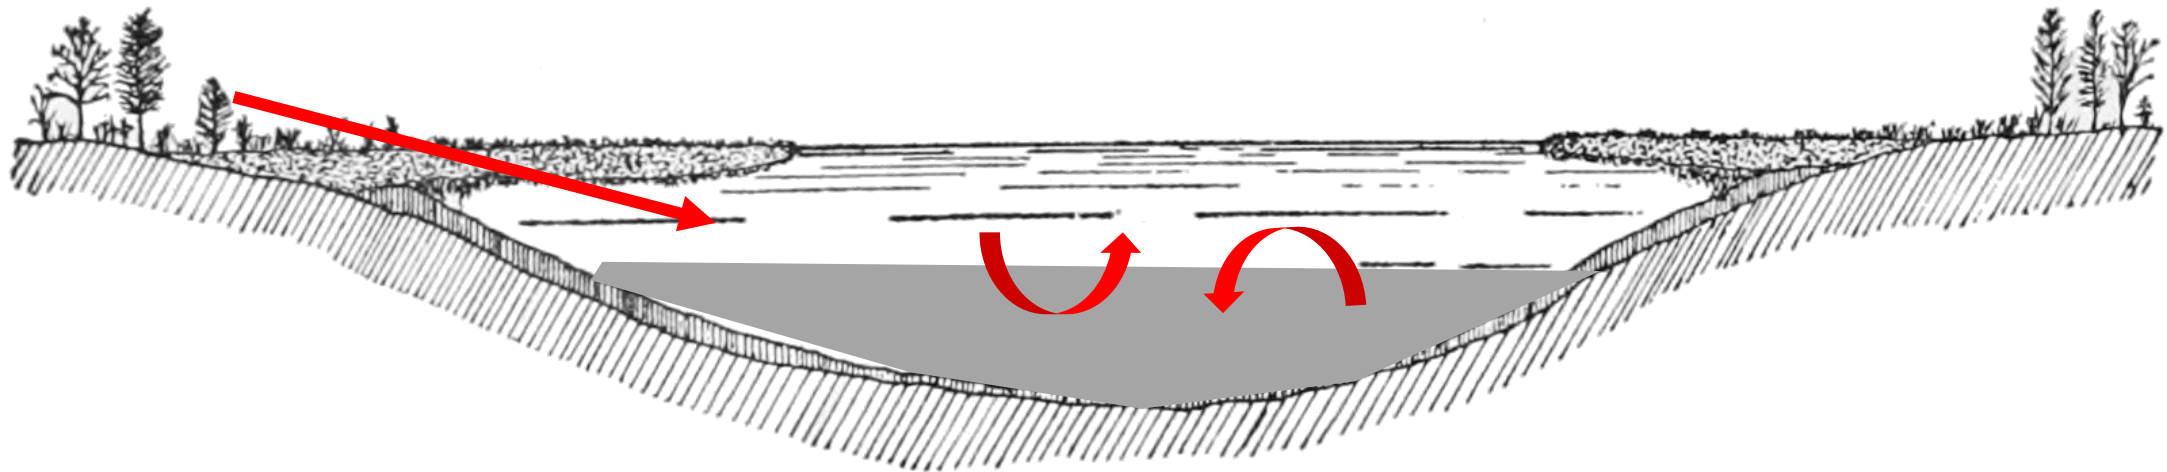
External Nutrient Loading

Atmospheric
Septic Tanks
Run-off
Birds

Internal Nutrient Loading

Resuspension/release from sediments

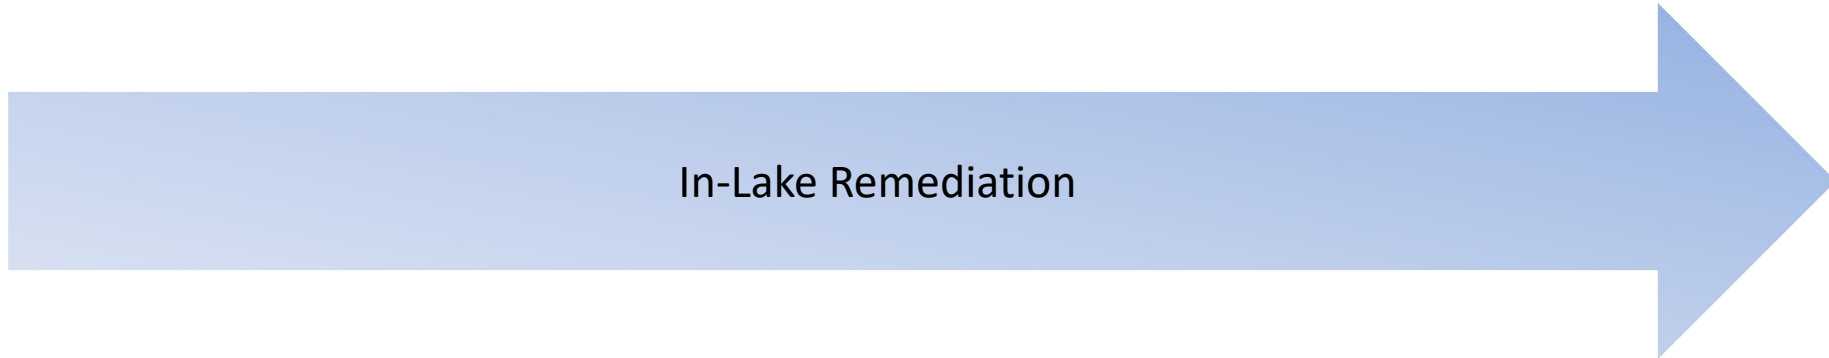
- Address internal loading issues (85%): in-lake remediation plan
