Mundy Creek Catchment and Riparian Management Strategy

December 2013

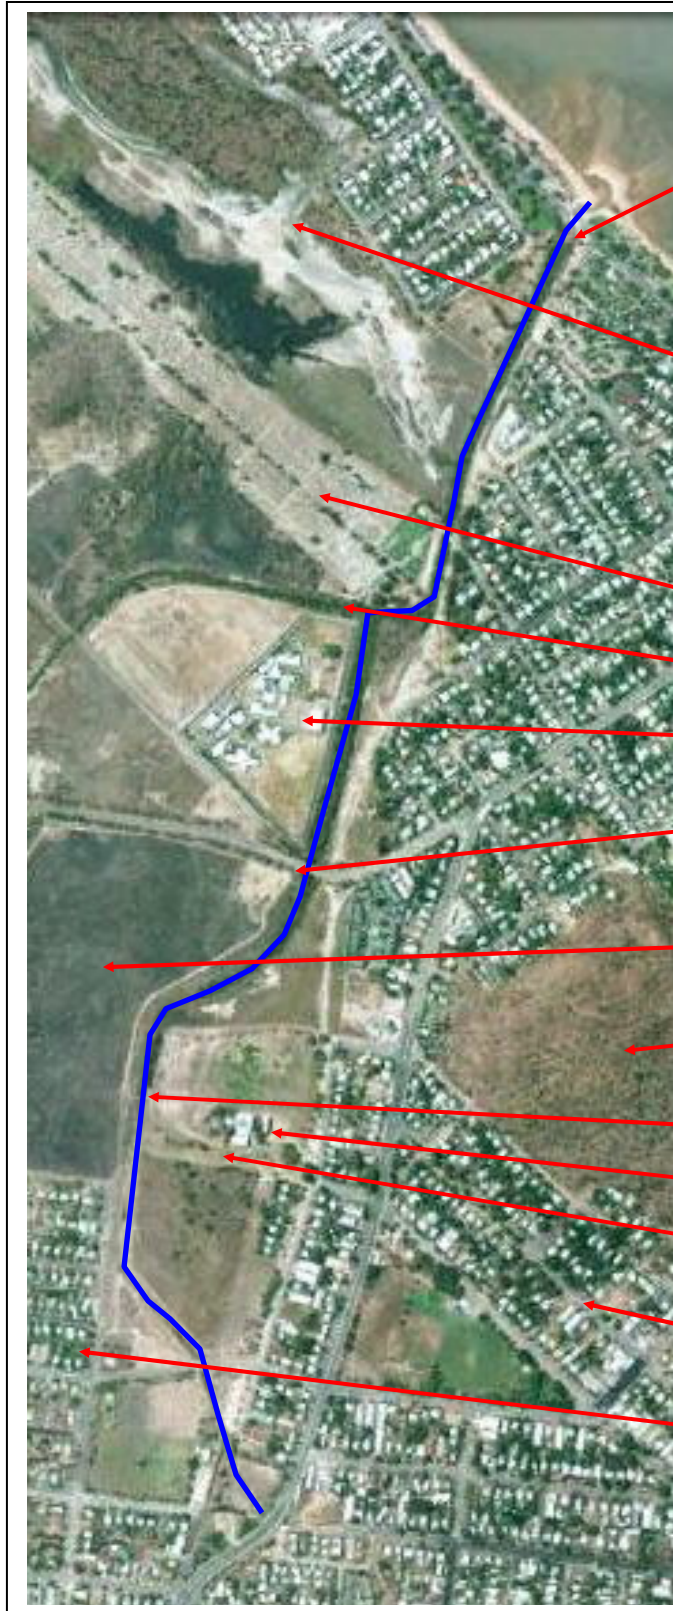
Figure 1-1 Mundy Creek Project Context

Creek to Coral, through the 'Increasing community engagement in Townsville coastal catchments for Biodiversity' Caring for our Country project committed to assisting Bernadette coordinate natural resource management (NRM) activities along the Mundy Creek natureway including through community events e.g. tree planting, and by the preparation of a riparian management strategy to guide future NRM activities. Mundy Creek is shown in Figure 1-1 with a more detailed view of the project area shown in Figure 3-1.

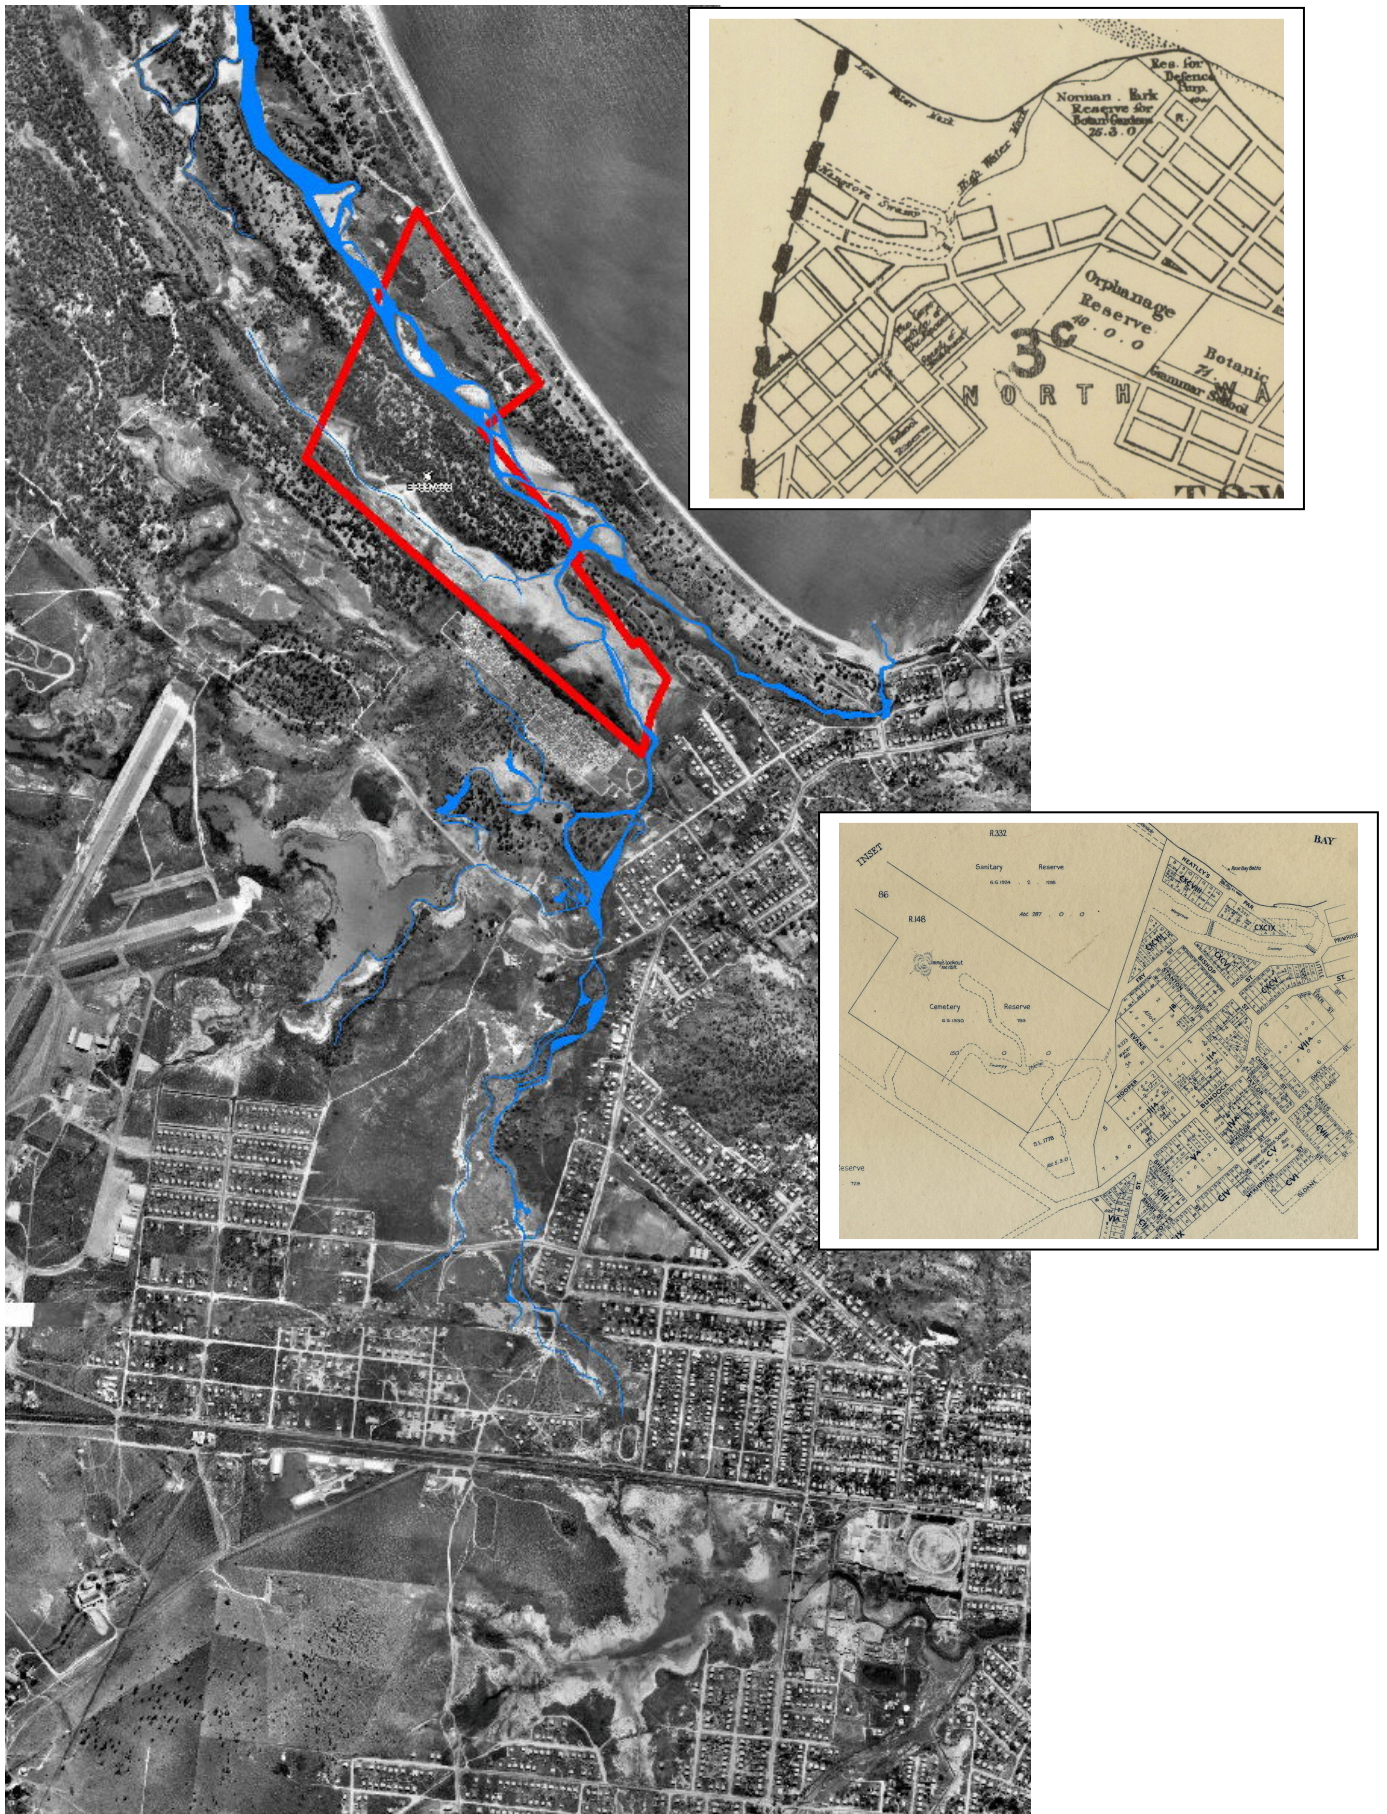
Figure 1-2 Mundy Creek Historically

Note: The base aerial is from 1941. The top inset is 1891 (Census District map) showing Mundy Creek mouth and the tidal extent. The bottom inset is 1938 showing the extensive nature of the 'swamps' associated with Mundy Creek. Rows Bay reserve is red.

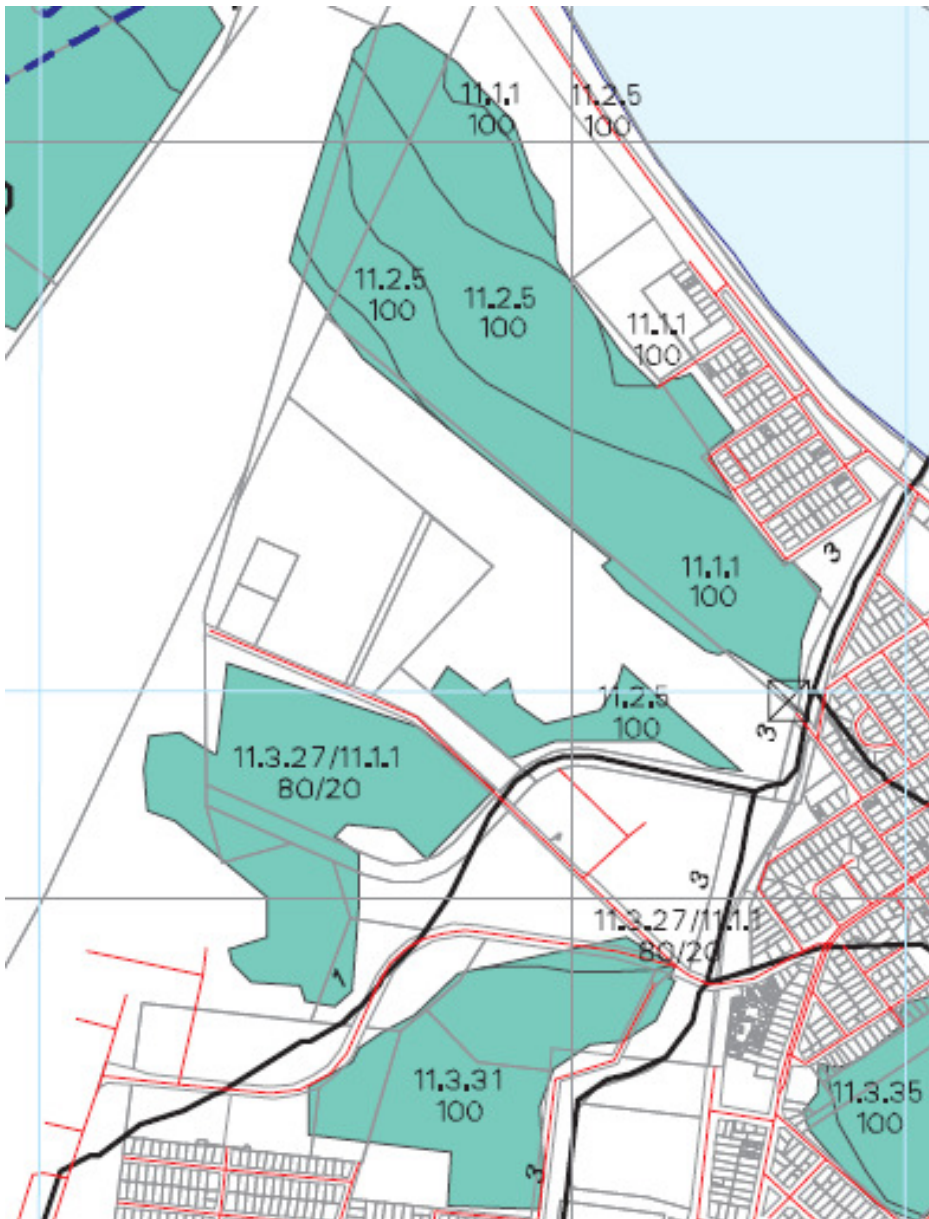
Figure 2-1 Regional Ecosystem Map

Regional ecosystems in the vicinity of Mundy Creek are illustrated in Figure 2-1 and described briefly in Table 2-1.

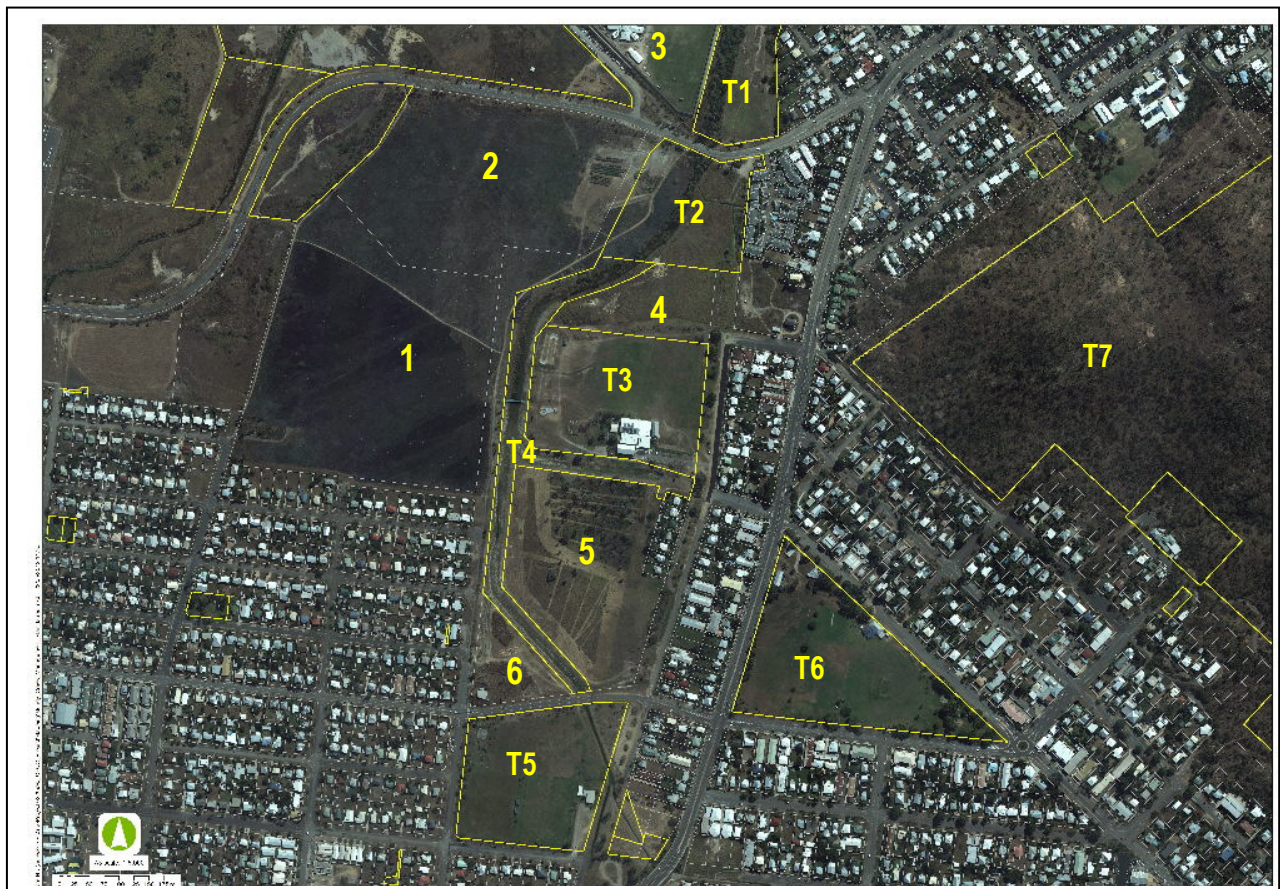
Figure 3-1 Mundy Creek Project Site

Note: Townsville City Council land assets are shown in yellow. Numbers correspond to tenure shown in Table 3-1. Road Reserves are not highlighted.

There are 11 different land parcels associated with 'upper' Mundy Creek and these do not all have the same land use purpose. Some of the parcels are obviously related to the drainage network or park recreation while the purpose of others is less obvious. The areas of State land that are significant habitat and/or serve some other purpose associated with environmental infrastructure could be usefully amalgamated into the environmental infrastructure layer and then the management plan could be prepared and updated based on a 'single' block rather than working across multiple blocks each with a 'discrete' purpose and different managers. The blocks of interest are shown in Figure 3-1 with tenure briefly described in Table 3-1

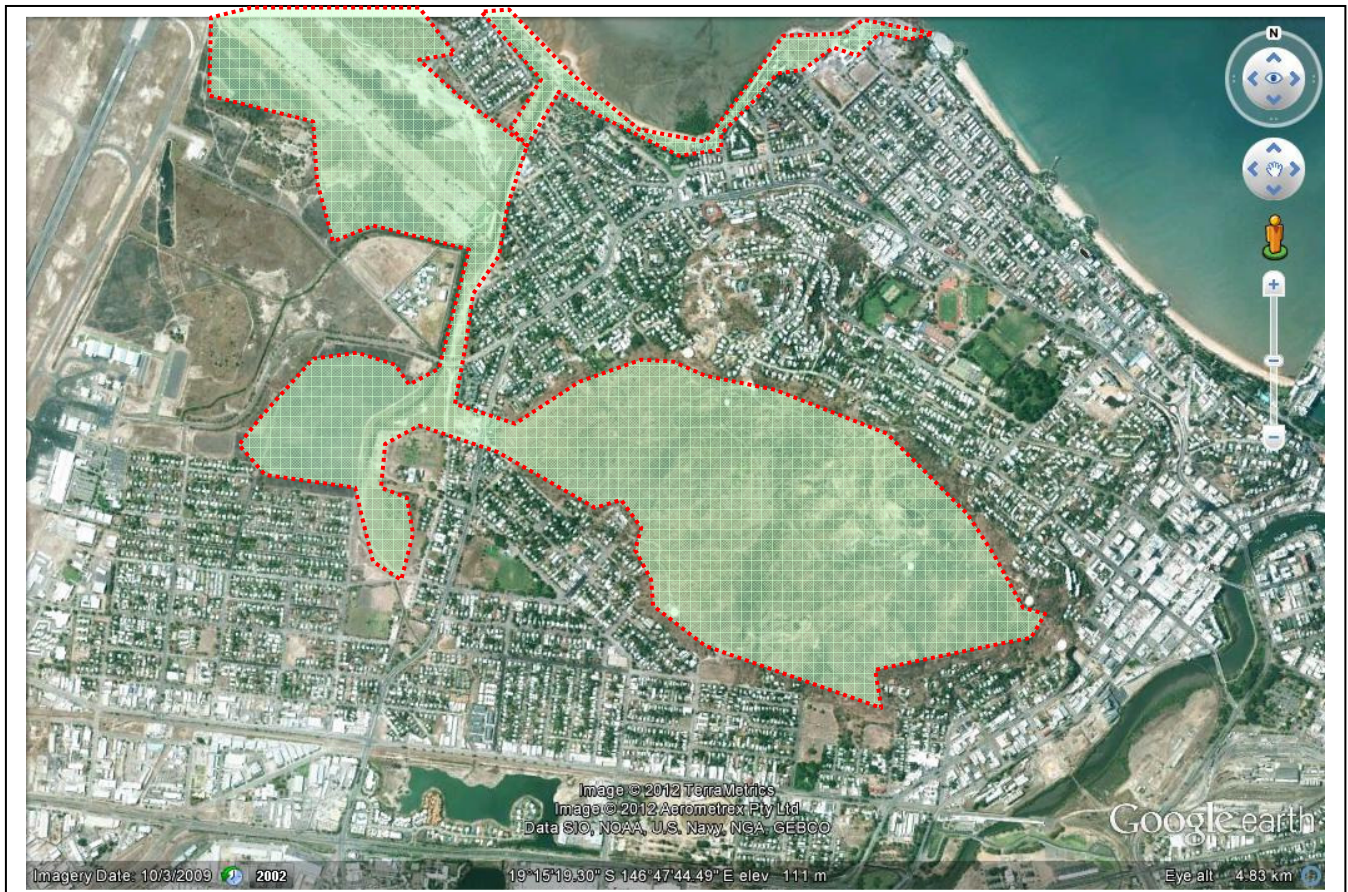
Figure 3-2 Castle Hill Connection

The long-term strategy is to have a functional urban drainage system that alleviates flood risk while retaining natural values and contributing to the functional network of managed urban 'natural' areas. The Mundy Creek natureway is also the closest (last remaining) link between Castle Hill and other natural areas (Rowes Bay wetlands, Rowes Bay esplanade and the Town Common) (see Figure 3-2). It would make sense to include the marked areas in the environmental infrastructure layer of the Townsville planning scheme and work with landowners to consolidate tenures to reflect the system as a catchment management unit based on hydrological function, habitat, connectivity and amenity restoration, enhancement and management with community.

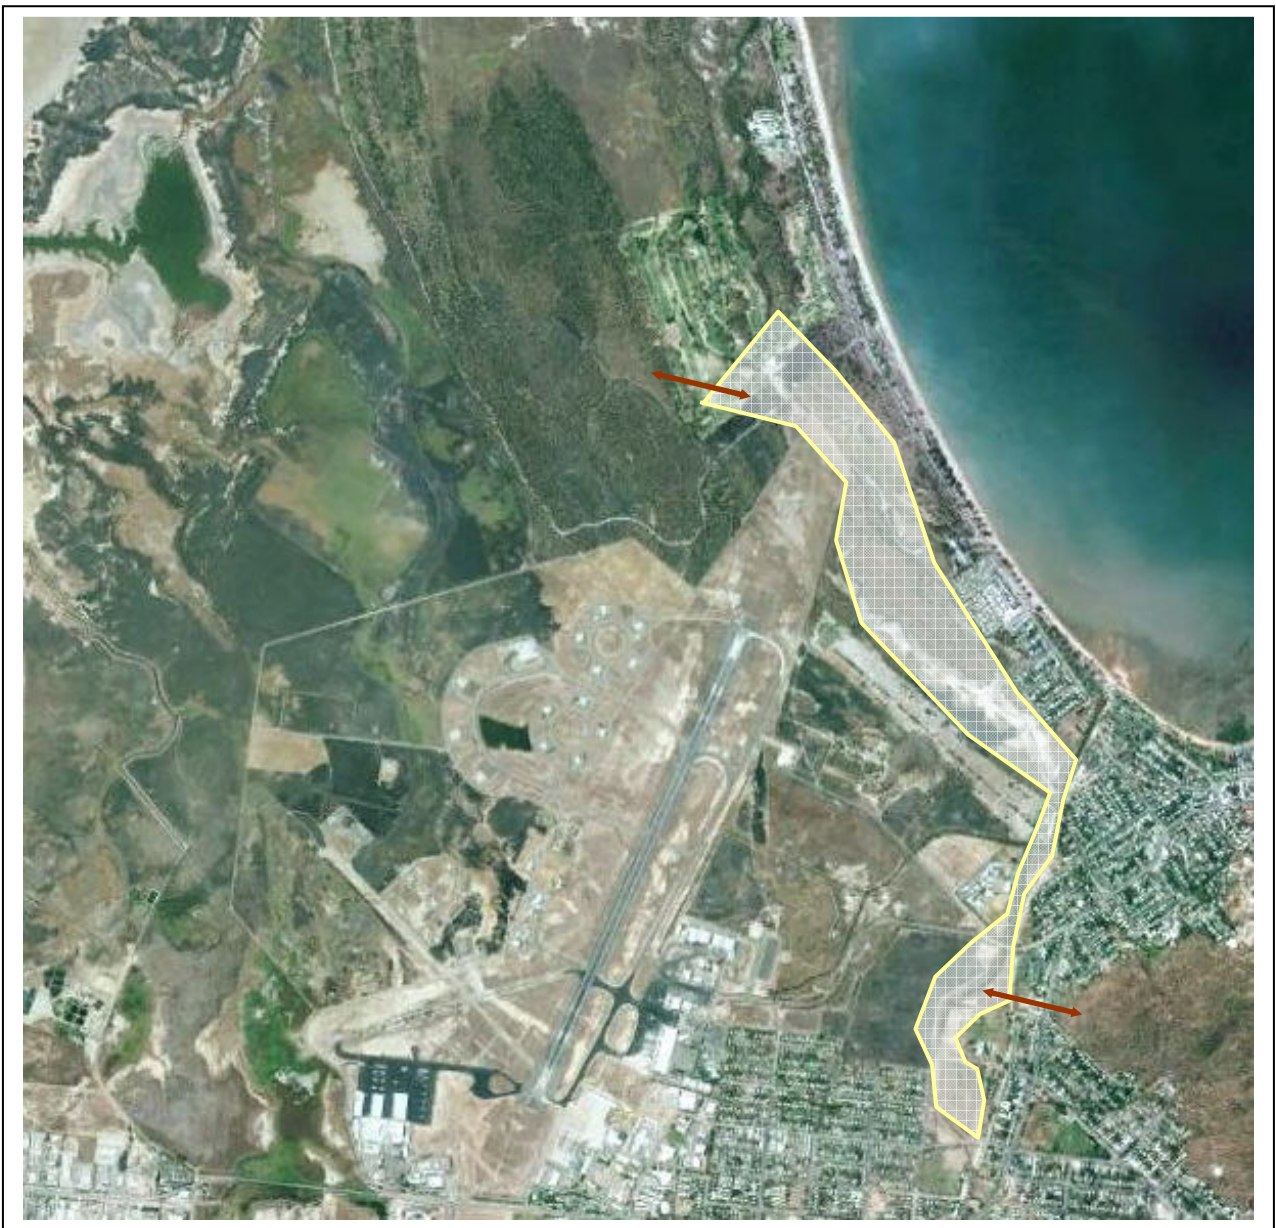
Figure 3-3 Anti-birdstrike Corridor

Note: The wildlife (anti-birdlife) corridor is marked in yellow and shaded with connecting links shown by arrows.

Strategy: Centred on Mundy Creek create a well-defined wildlife corridor (waterways, wetlands and native vegetation) that simultaneously attracts and 'houses' native wildlife due to its habitat values and provides a 'safe' conduit for bird movement away from the airport. The idea is to provide an attractive natural corridor in the urban setting that 'directs' bird traffic around the northern end of the runway where potential issues with air traffic are minimised. The location of the proposed bird movement corridor is shown in Figure 3-3.

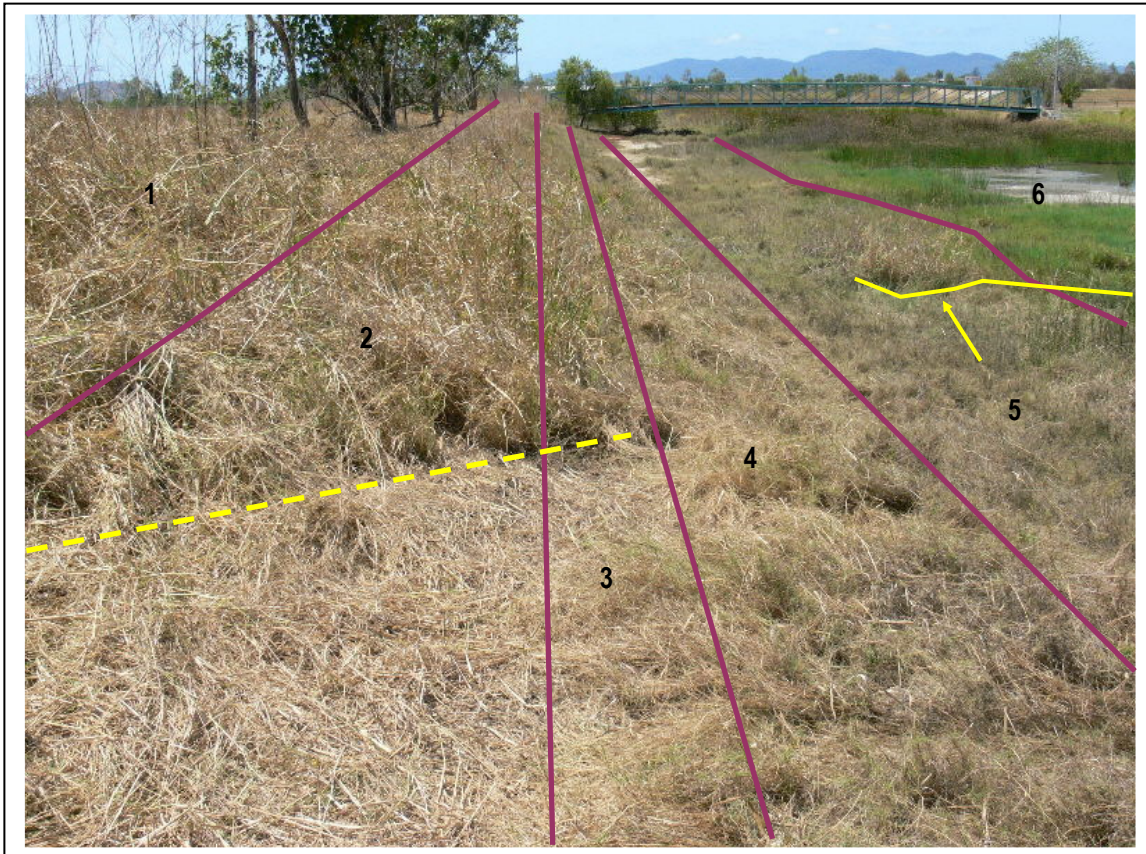
Figure 4-3 Mundy Creek West Bank General Management Lines and Zones

Note: Yellow indicates a lowland management line with the arrow showing the direction of progression of the management line. The upstream area has been cleared of Para Grass and the line indicates the interface between the salt couch (cleared of Para Grass) and the Para Grass patch. The broken yellow line indicates the edge of the access to the interface management line.

A fire swept through the site on 13 November 2012 (see Figure 4-4) removing most of the vegetation in Units 1-3 and in parts of Unit 4 (see Figure 4-3). The grasslands were totally burnt out and there was damage to fences, sheds, vegetation and livestock (chickens) on adjacent properties in Lockheed Street (see Figure 4-5).

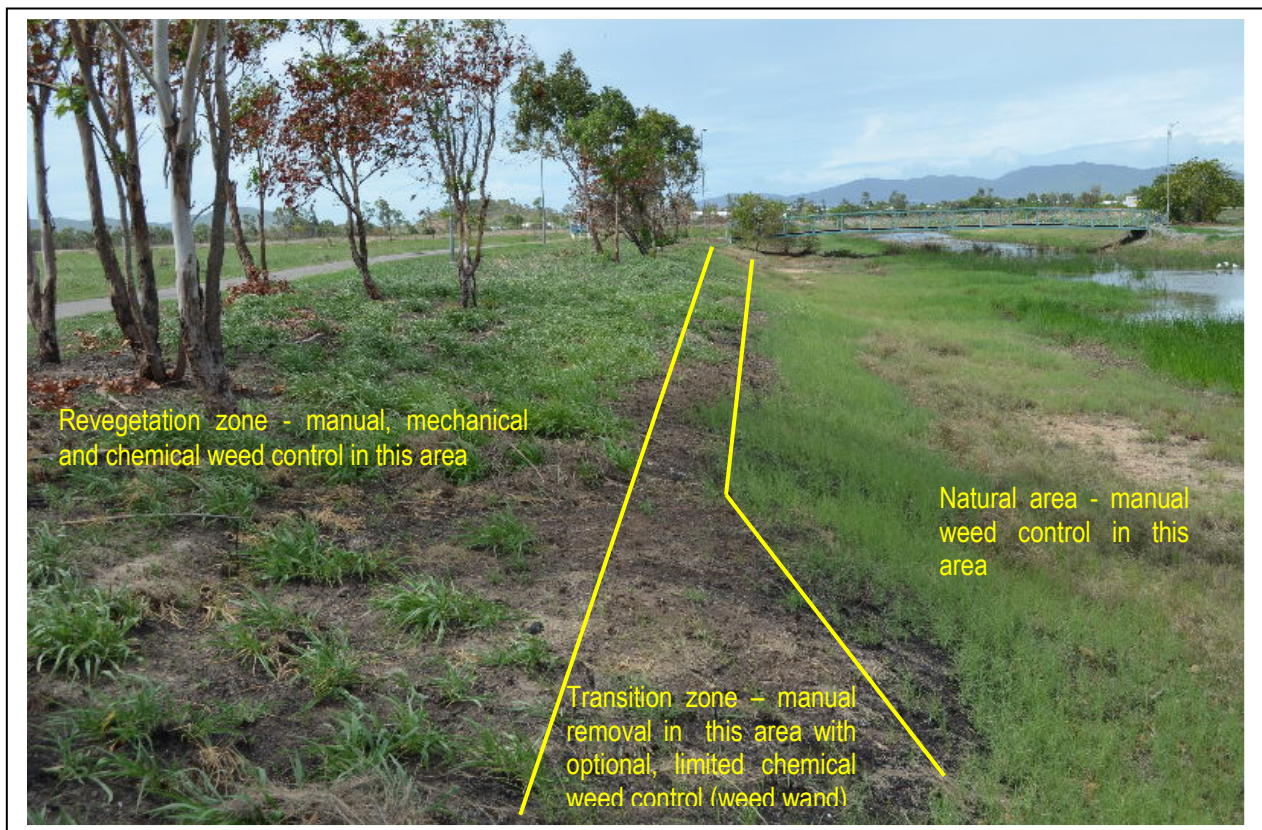
Figure 4-6 Management Zones Post Fire and Rain

The management concepts remain basically the same post fire with the main advantage being that the amount of dry vegetation is reduced which highlights the difference between natural areas and invasive species. This makes the establishment of management lines easier and enables a clear transition zone to be established. Soil moisture makes weed removal easier in what is otherwise a hard setting soil.

Note: Photo taken January 2013

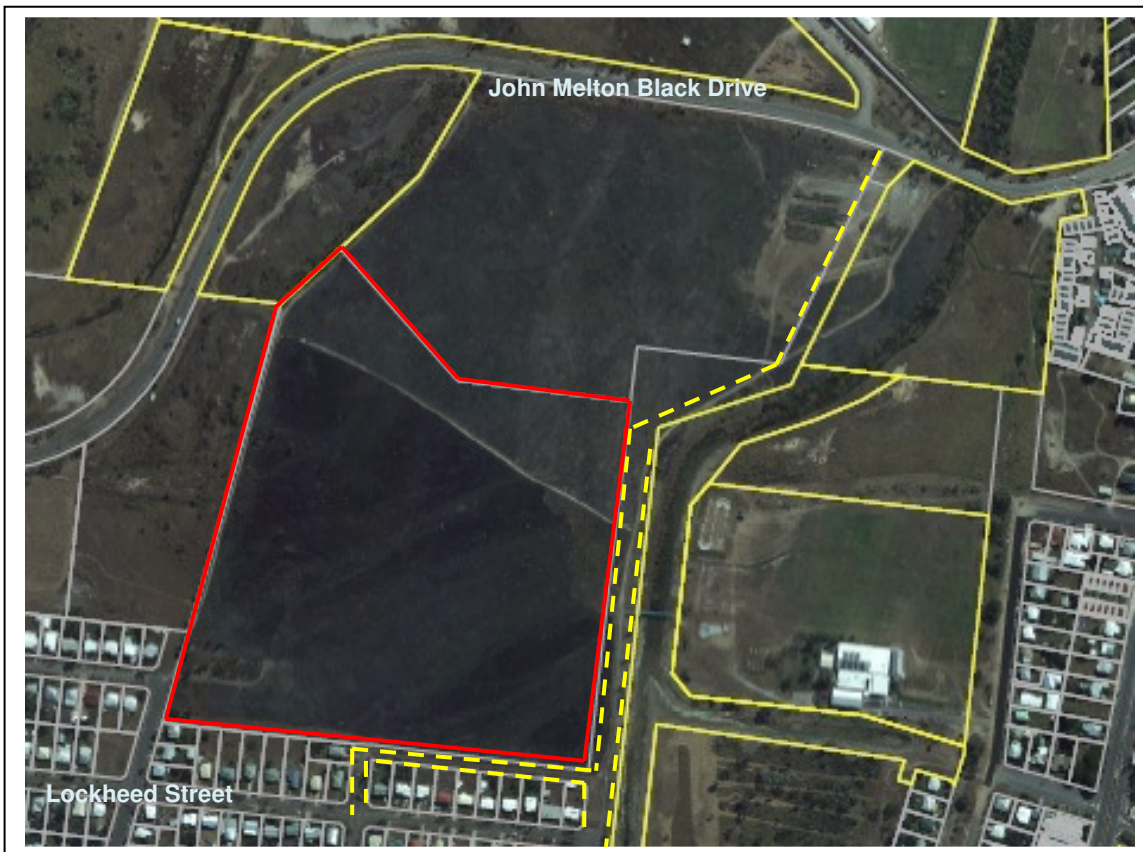
Figure A Grassland Overview

Note: Red is the state land grassland being managed as part of the Mundy Creek catchment strategy. Council land is shown in yellow with road reserves shown by broken lines.

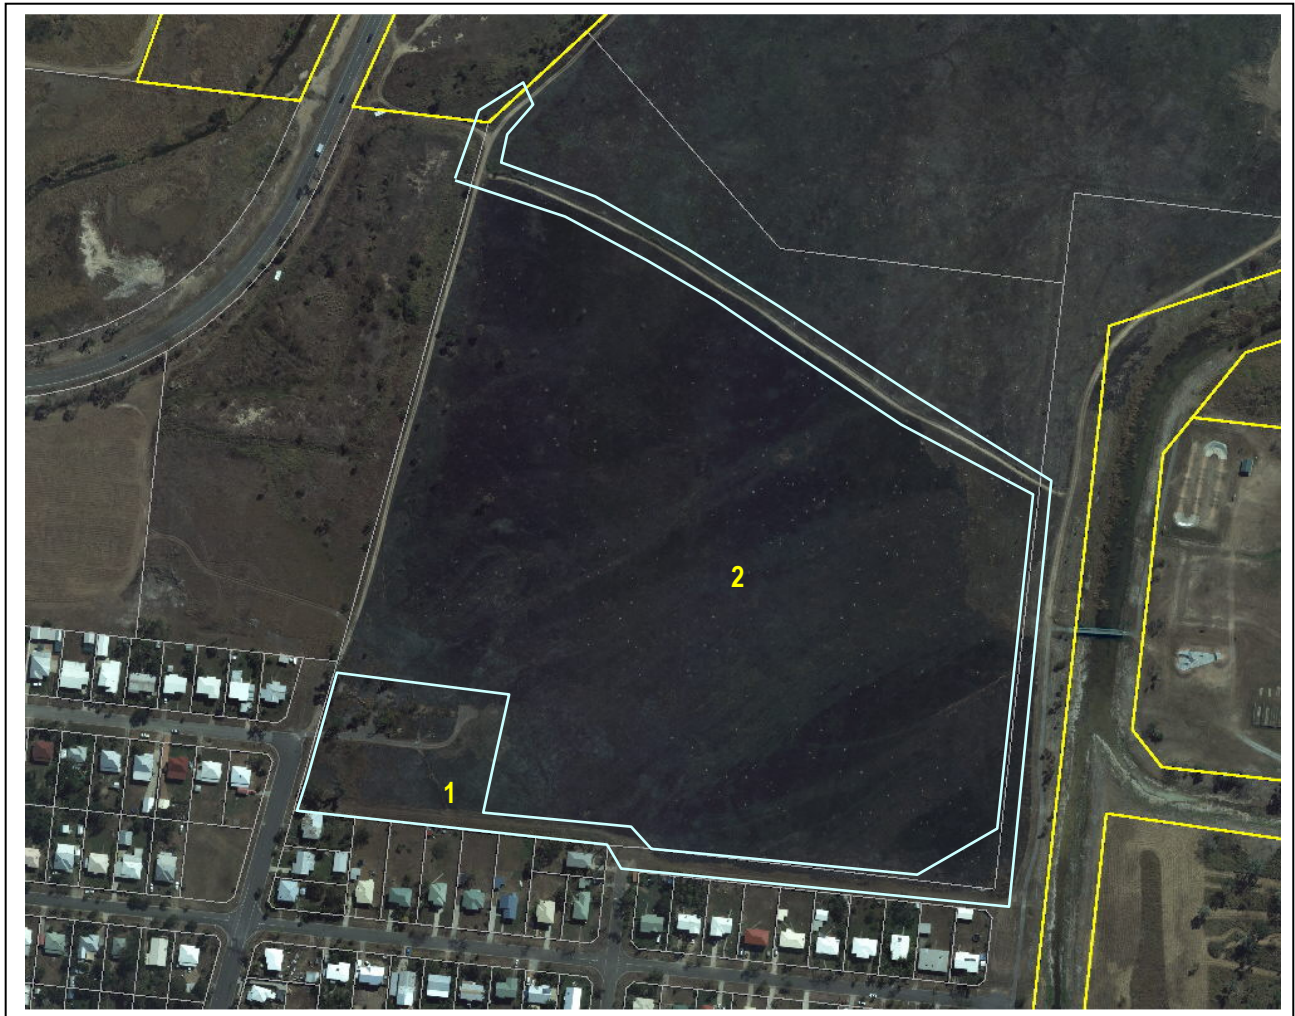
Figure B Integrated fire management zones

Note: Light blue (1) denotes the joint weed control management lines and fire hazard reduction management zone. The remainder (2) is the native habitat management zone (ecological burning practiced)

- Fire hazard reduction along the southern and western edges of the grassland,
- Maintaining dual fire and weed management lines around the edges and where existing tracks/firebreaks are located,
- Maintaining the overall ecological integrity of the grasslands.

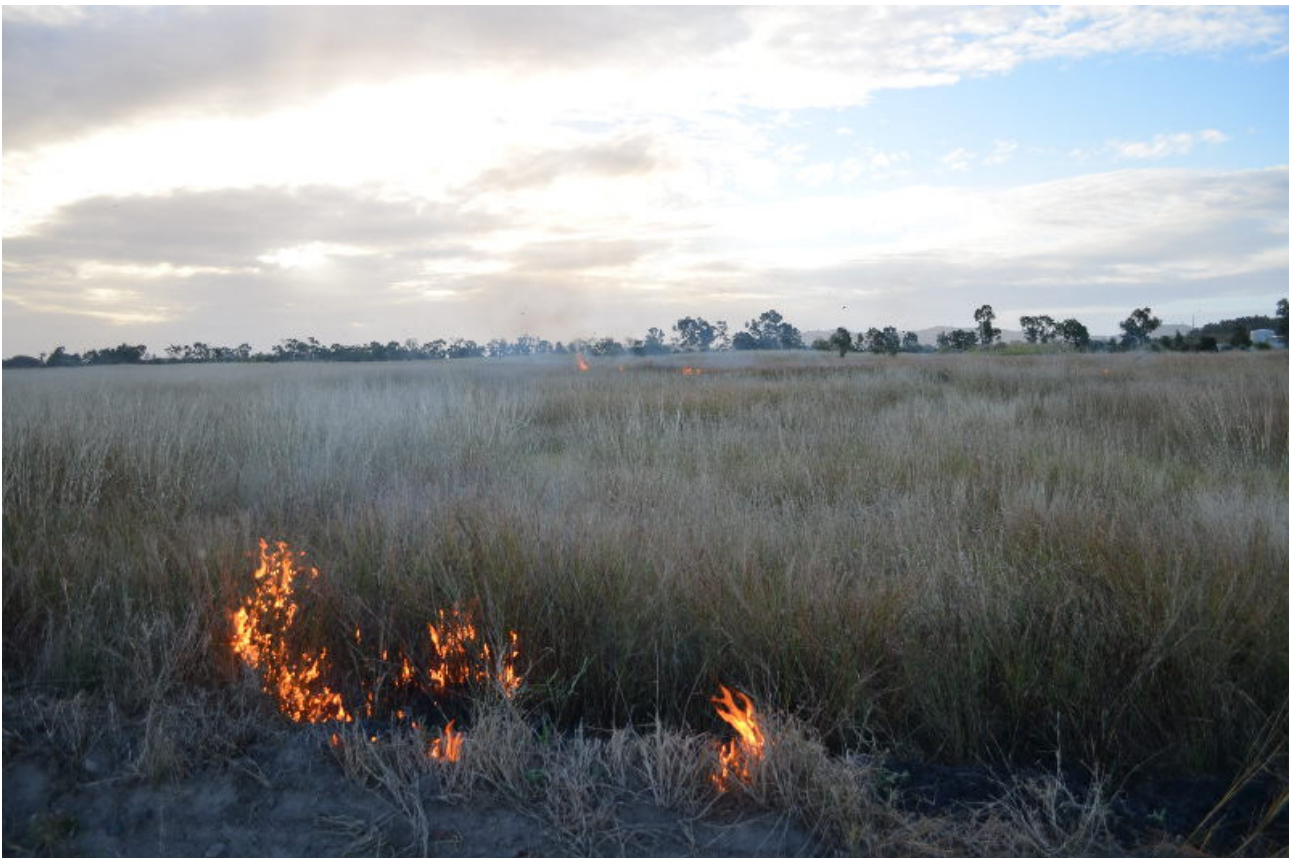
Slow burn 30 May 2013 (5.30pm)

Unauthorised fires were also lit along the track earlier in the year and these were also low intensity burns with the fire brigade called to the site on 30 May 2013 during the late afternoon to extinguish a slow moving fire, which would most likely have self-extinguished. All of the unauthorised fires served to 'clean' out the dry material and create patches of burnt and unburnt areas. When the July spread through the grassland conditions were such that the fire did not present as a risk to neighbours and did not adversely impact the grassland. Photographs of the grassland following the 2013 cool fires are provided below (compare to Figure 4-5).

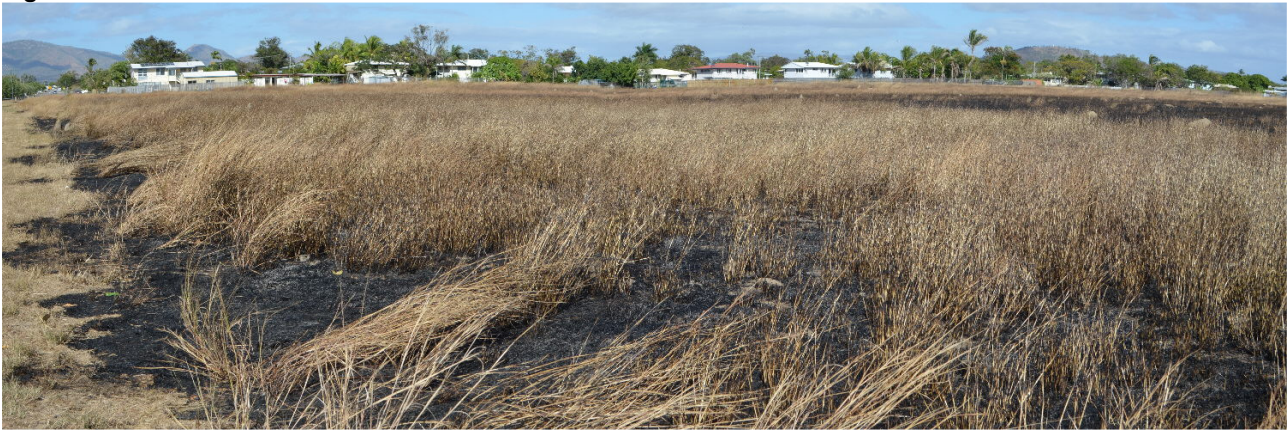
Figure C View to Lockheed Street Residences

20130713 post fire

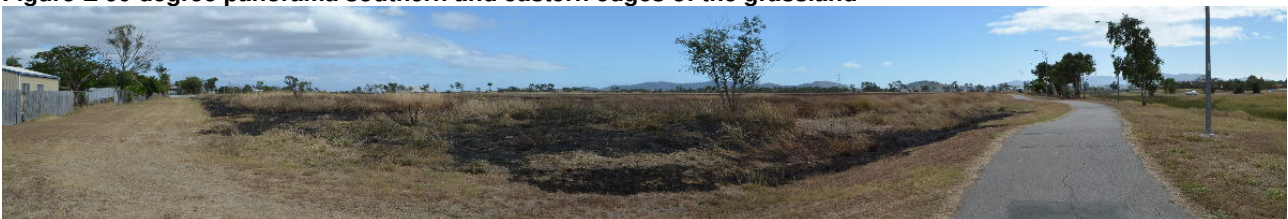
Figure E 90 degree panorama southern and eastern edges of the grassland

20130713 post fire
