OVER-VOLTAGE PROTECTION:

THE CRITICAL DIFFERENCES BETWEEN
SPARK GAPS AND DC DECOUPLERS

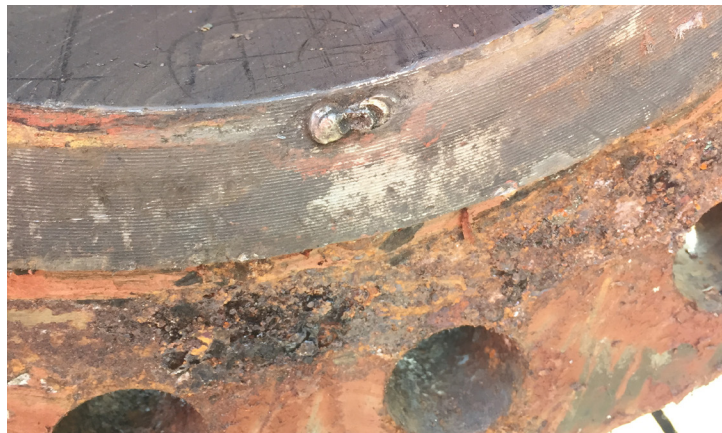
Figure 2. Bolted flange failure due to an AC fault on an unprotected joint

Voltages of this magnitude resulting from alternating current (AC) faults and lightning are not uncommon on pipelines. If the joint is exposed to electrical disturbances that cause differential voltages beyond the isolator's withstand voltage, an arc can form across or through the isolation material which can short out the joint and cause permanent damage to the isolation material and/or the joint itself. In some cases, the arc may cause the joint to rupture and result in a loss of product, fire, or environmental damage. Figure 2 shows an example of a bolted joint isolator failure resulting from an AC fault on the pipeline.

The high energy from the fault not only burned through the isolating gasket, but also literally welded the two flange faces together. Since the isolation joint was shorted, the CP system was compromised, and the affected pipeline was left without adequate protection until the short was identified and remedied. In this case, the entire bolted flange connection had to be replaced at considerable expense. Similar failures can result in more hazardous outcomes. Figure 3 shows the result of an AC fault on an unprotected dielectric union installed on a gas line. In this case, the surge caused the tubing to rupture and ignited the escaping gas, starting a fire.

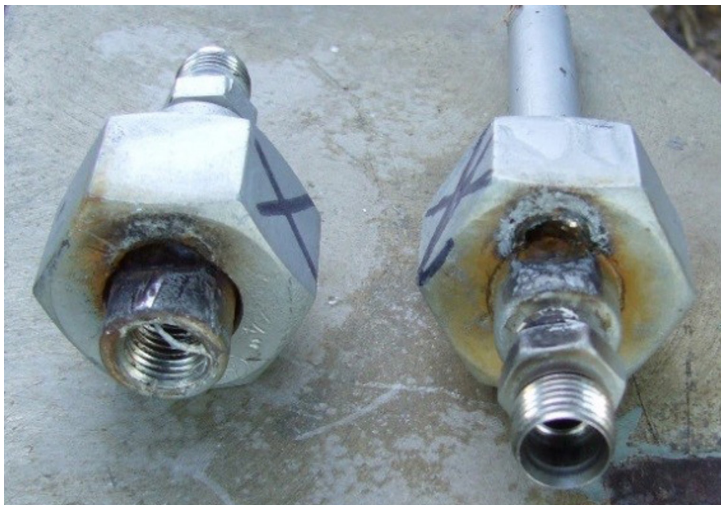
Figure 3. Rupture of a dielectric union resulting from an AC fault

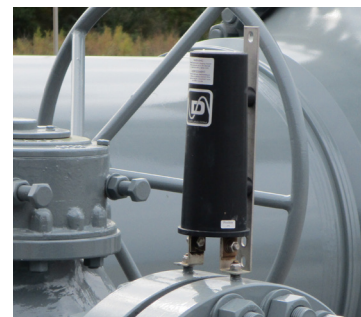
Figure 5. Solid-state Decoupler

Solid-state decouplers, in addition to protecting the joint from AC faults and lightning, provide a continuous conduction path for steady state AC, which may be induced onto the pipeline from nearby power transmission lines, to continuously pass through the device and across the joint. Examples of an over-voltage protector and a decoupler installed on isolation joints are shown in Figures 4 and 5.

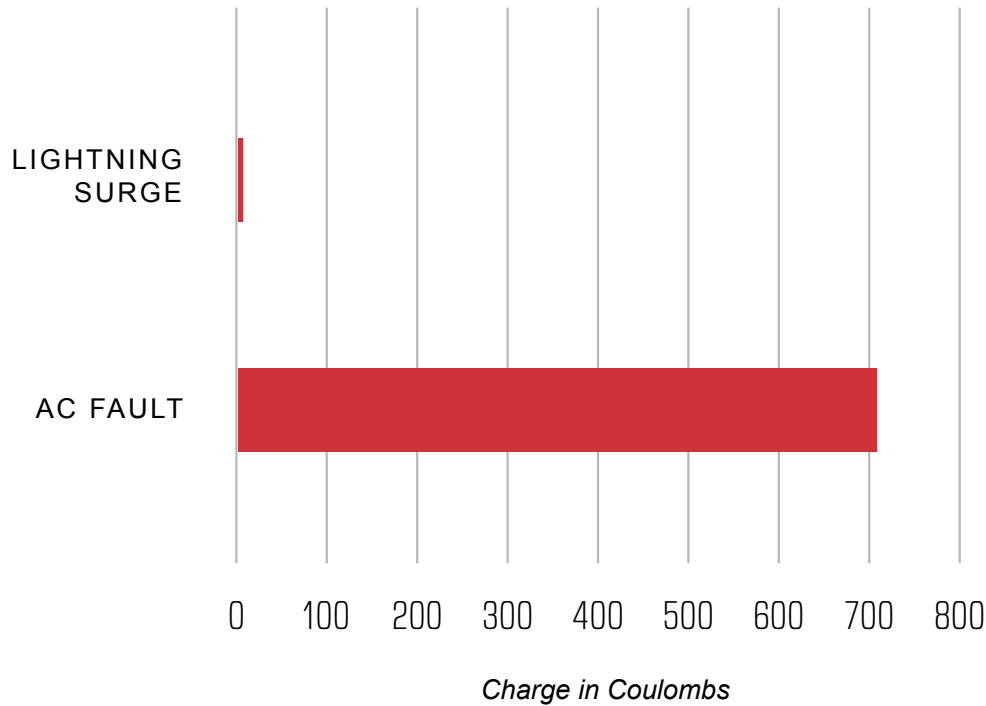
Figure 7. Energy levels of a typical lightning surge and AC fault

Spark gap devices are effective for protection against lightning and low-level fault currents. However, the total energy from an AC fault is orders of magnitudes greater than that from a typical lightning event, for which spark gaps are primarily designed. This is because an AC fault can last much longer and therefore present much higher total energy than lightning. For example, Figure 7 compares the total electrical charge energy of a 100kA 8x20 μ s lightning surge (2.3 Coulombs) to that of a 4000 Amp / 0.2 s AC fault (720 Coulombs). In this example, the total charge energy in the AC fault is over 300 times greater than the that of the lightning surge.

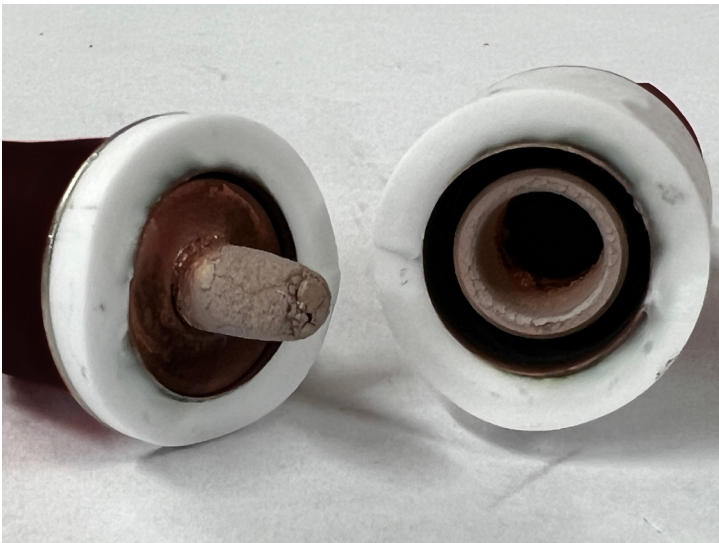
Figure 8c. Internals of spark gap following tests at 2500Arms. The sample failed open.

Figure 8c shows the internals of this failed spark gap test sample. The internals of the sample prior to testing are shown in Figure 8d. Note in Figure 8c how the electrode appears to have lost material which increased the gap size. In addition, though not shown in Figure 8c, the ceramic housing had cracked during the test, further increasing the gap between the electrodes and thus the spark-over voltage.

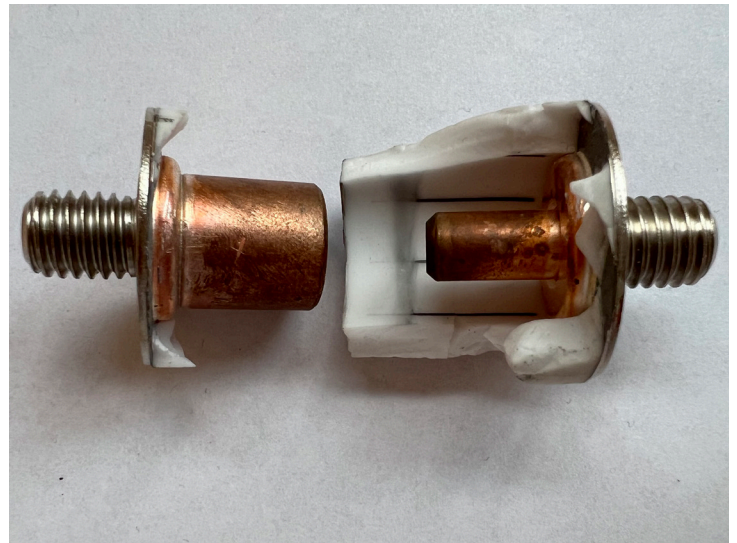
Figure 8d. Internals of the spark gap prior to testing

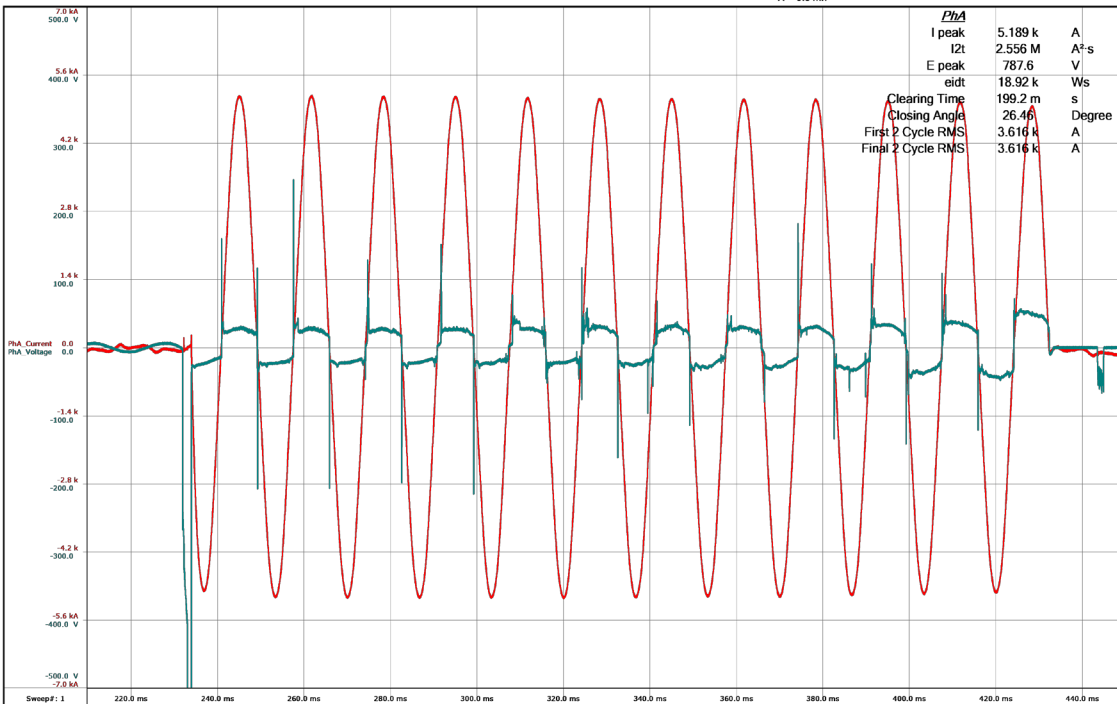
Open-Circuit Voltage: 745 V rms
Available Sym Current: 3700 A rms
Power Factor: 98 %
Tap = 4 XFMR = 600 7 in 9 out TC3
R = .07 Ohms
X = 0.0 mh

Figure 9a. Oscillograph of a new spark gap under initial fault test at 3700 Arms / 745 Vrms / 200 ms

Figure 9a shows an oscillograph of a new spark gap under an initial fault current test at $3700 A_{rms} / 745 V_{rms}$ at 60 Hz for 200 ms. Following this initial test, the unit was observed to have failed shorted. Though the shorted condition is not indicated in the oscillograph of the initial test, a second test under the same conditions verified that the unit was indeed

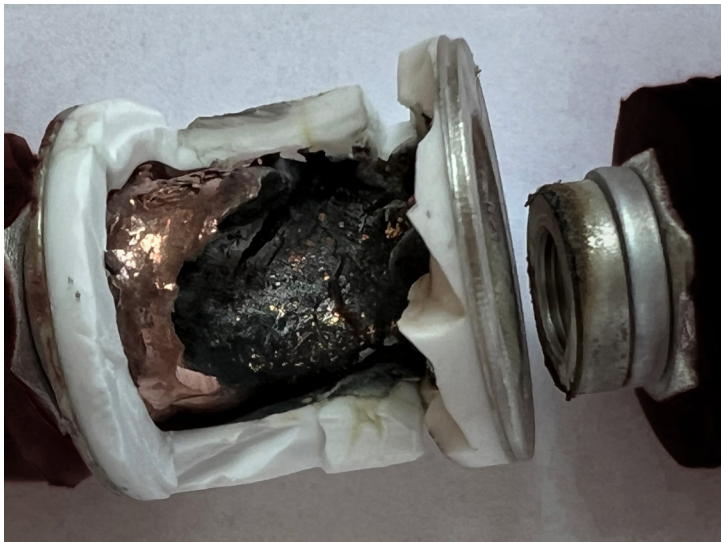
Figure 9c. Internals of failed spark gap tested at 3700Arms. The sample failed shorted.

shorted as shown in the oscillograph of Figure 9b and the photo of the failed unit shown in Figure 9c. Both internal electrodes of this sample had completely melted off and the copper material pooled from end-to-end of the unit, creating the shorted condition.

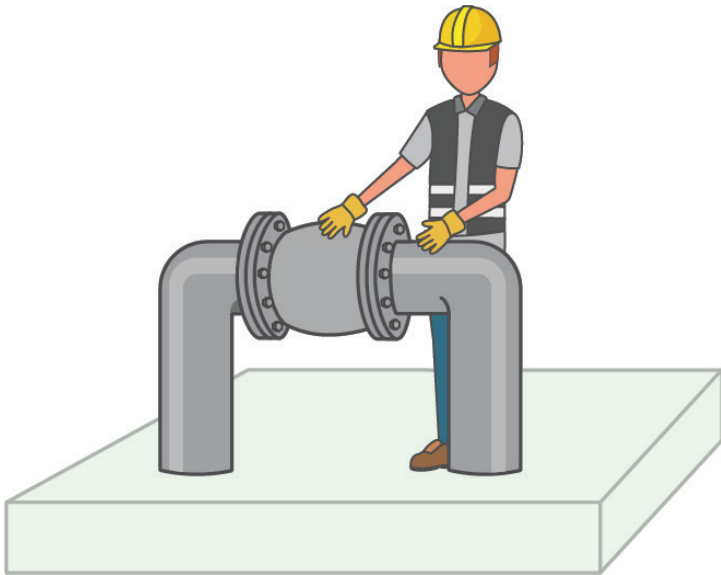
Figure 11. Touch potential across an Isolation Joint

One of the primary functions of over-voltage protection devices is to protect personnel coming into contact with isolation joints as illustrated in Figure 11. Assuming that the AC voltage on the pipeline under normal operating conditions is maintained at a safe level ($<15V_{rms}$ per NACE SP0177 [2] or $<60V_{rms}$ per EN 50443 [4]), it is reasonable to expect the voltage across isolation joints on the pipeline to be at a similar voltage. However, during fault and lightning events, the touch voltage on the pipeline and across isolation joints can be several thousand volts, as explained previously, and so may expose personnel to hazardous conditions if not properly addressed.
