Roadside Vegetation and Conservation Values in the Shire of Denmark

November 2011

Roadside Conservation Committee

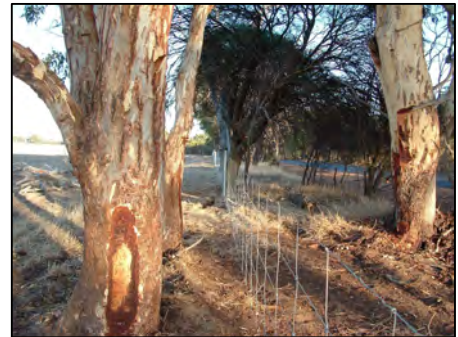
Care must be taken when clearing to ensure large trees are not damaged and that the clearing is actually necessary and that the necessary permits are obtained.

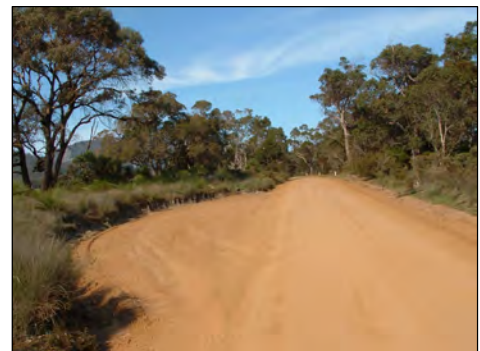
Creative solutions including creating passing areas rather than widening a whole road.

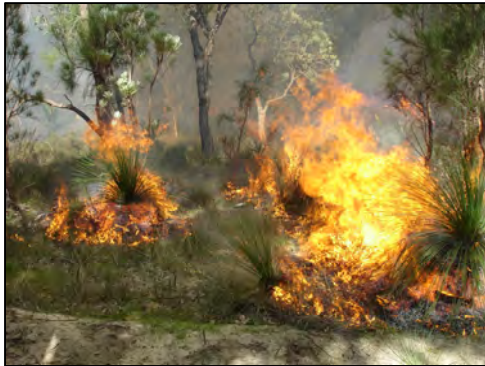
Controlled burning of roadside vegetation should result in a mosaic of burnt & unburnt patches

- Local Government Authorities should adopt by-laws to control roadside burning;
- roadside burning should be planned as part of a total Shire/area Fire Management Plan;
- only one side of a road should be burnt in any one year; *this will ensure habitat retention for associated fauna and also retention of some of the scenic values associated with the road.*
- when designing a Fire Management Plan, the two principles which must be kept in mind are the ecological management of vegetation and the abatement of fire hazard;
- no firebreaks within the Road Reserve should be permitted unless the width of the roadside vegetation strip is greater than 20m;

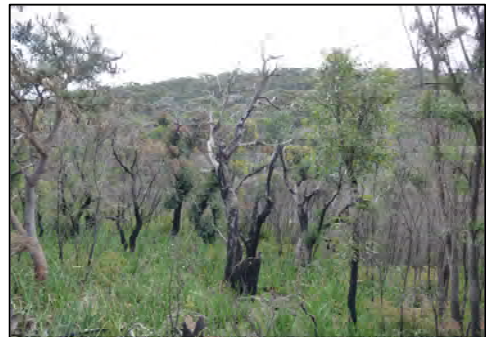
Burnt roadsides showing signs of regeneration of natives and weeds including African lovegrass (below). Follow up weed control needs to occur after burning to ensure flammable weeds don't establish after burning.

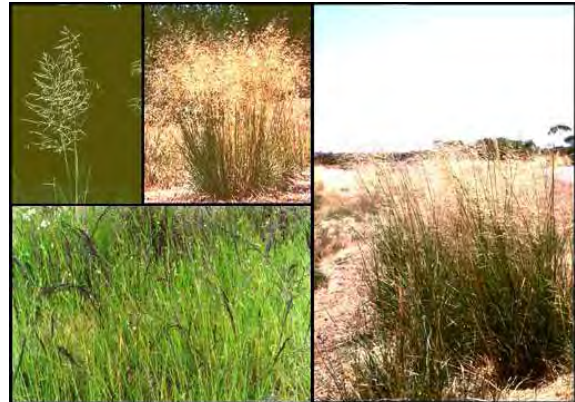
Eragrostis curvula

African Lovegrass is a widespread and serious roadside weed. It forms dense monocultures, creating large fuel loads and a fire hazard. Burning results in increased regeneration of this weed.

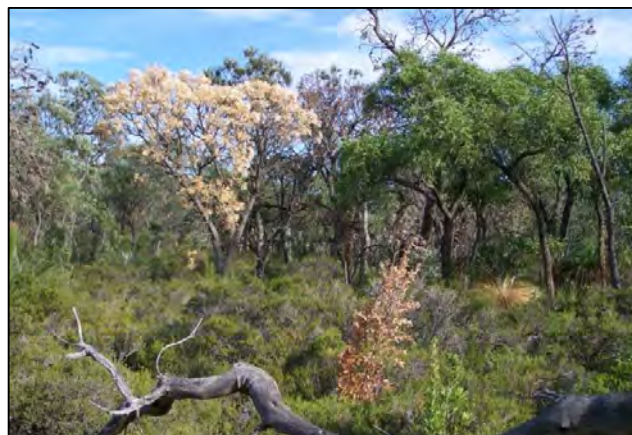
Recent infestation: Banksia and Xanthorrhoea (grass trees) species are very susceptible which suggests that the infestation has just reached this area. Close by is a firebreak and it is very likely that the spread of the infestation was accelerated by moving dirt along the firebreak
Photo: J. Brooker, Project Dieback

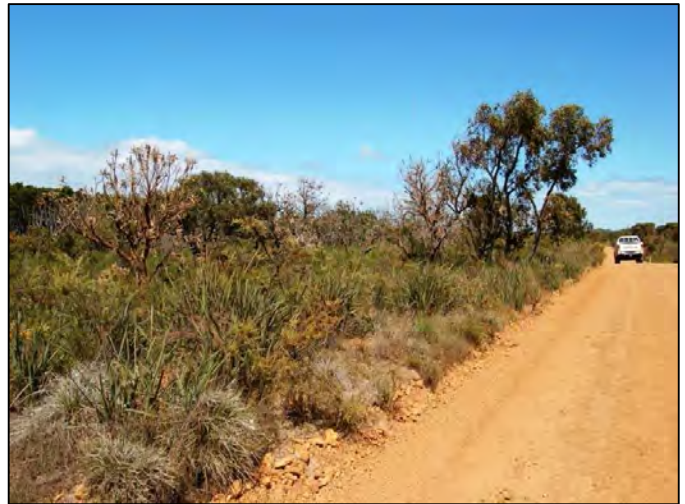
Roadside dieback front - Conspicuous Beach Rd.

- schedule activities for low rainfall months/plan activity for dry soil conditions;
- grade toward the infestation area (rather than away from it);
- lift the blade frequently to minimise the distance that dirt is carried;
- clean (dry clean or wash down) the blade (and the whole machine) before leaving the infested area; and
- *a little time and care taken can ensure the disease is not spread to another area.*

- Plan the activity for dry soil conditions only.
- Start clean, stay clean – clean machinery before arriving/working in these areas. *This also includes footwear or any equipment which comes in contact with any soil or plant material.*

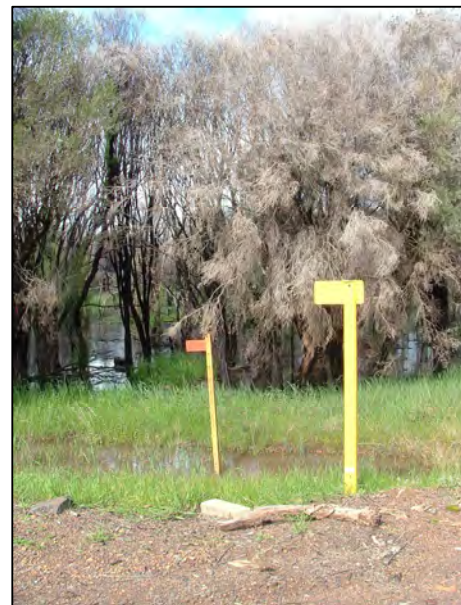
Roadside ESA markers are highly visible.
Photo by K. Jackson

Local Government's are encouraged to permanently mark ESA's to prevent inadvertent damage to rare flora or other values being protected. Markers of a uniform shape and colour will make recognition easier for other authorities using road reserves.

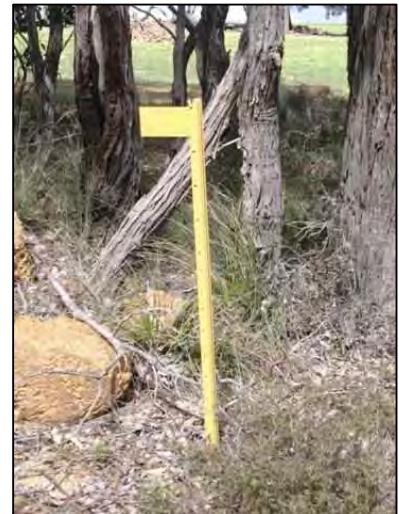
Threatened Flora sites should be clearly marked with these yellow posts.

Threatened Flora species, or populations, are of great conservation significance and should therefore be treated with special care when road and utility service, construction or maintenance is undertaken. Populations of Threatened Flora along roadsides are designated ESA's and should be delineated by yellow markers. It is the responsibility of the road manager to ensure these markers are installed. The RCC suggests using the publication *Guidelines for Managing Special Environmental Areas in Transport Corridors* as a guideline for managing these sites.

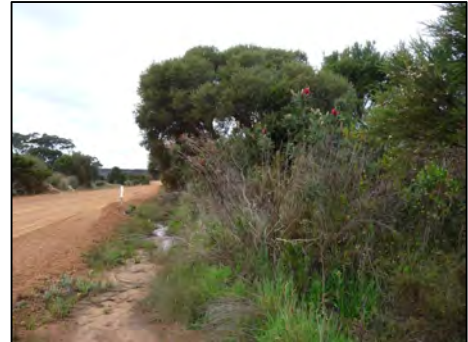
Medium-high conservation value roadsides contain a moderate number of native species, some disturbance and weed invasion, but have relatively intact natural structure.
Photo: K. Payne, RCC.

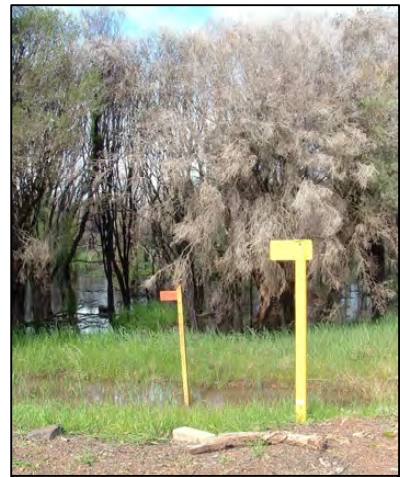
Medium-low conservation value roadsides may contain Threatened Flora.
Photo: RCC

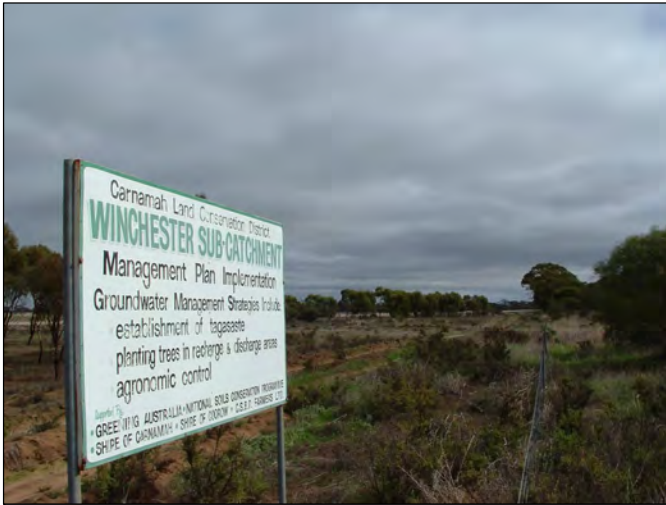
Catchment recovery projects, such as revegetation programs can utilise the information conveyed on roadside conservation value maps.

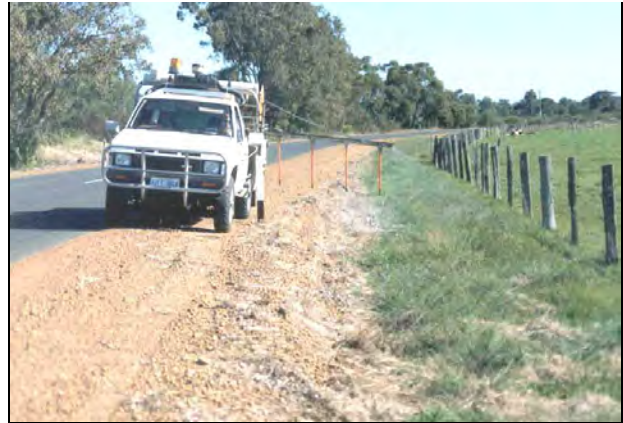
Weed control along a roadside.

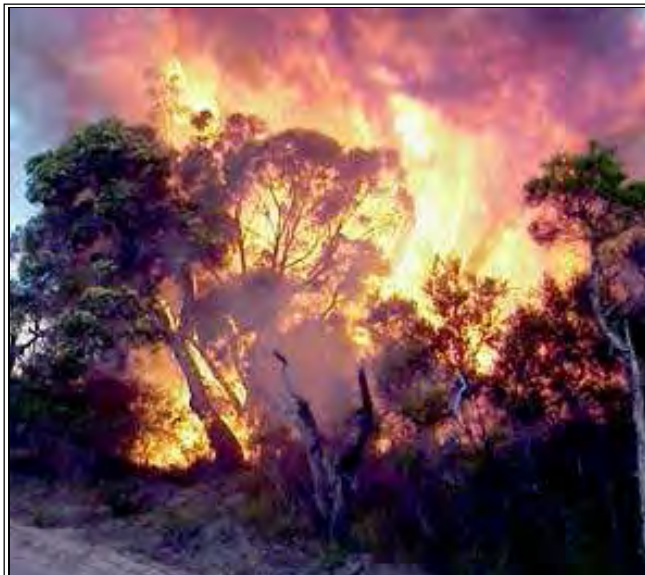
The survey data and map can be used in developing regional or district fire management plans.

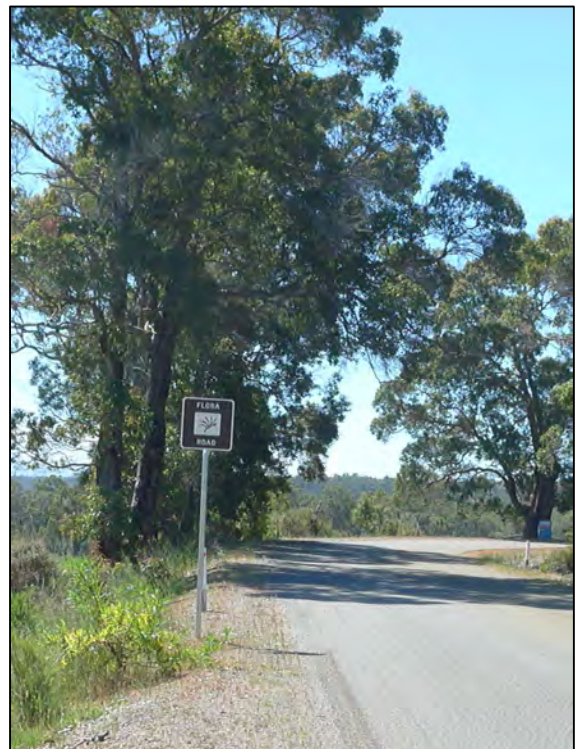
The road manager can declare high conservation value roads as Flora Roads.

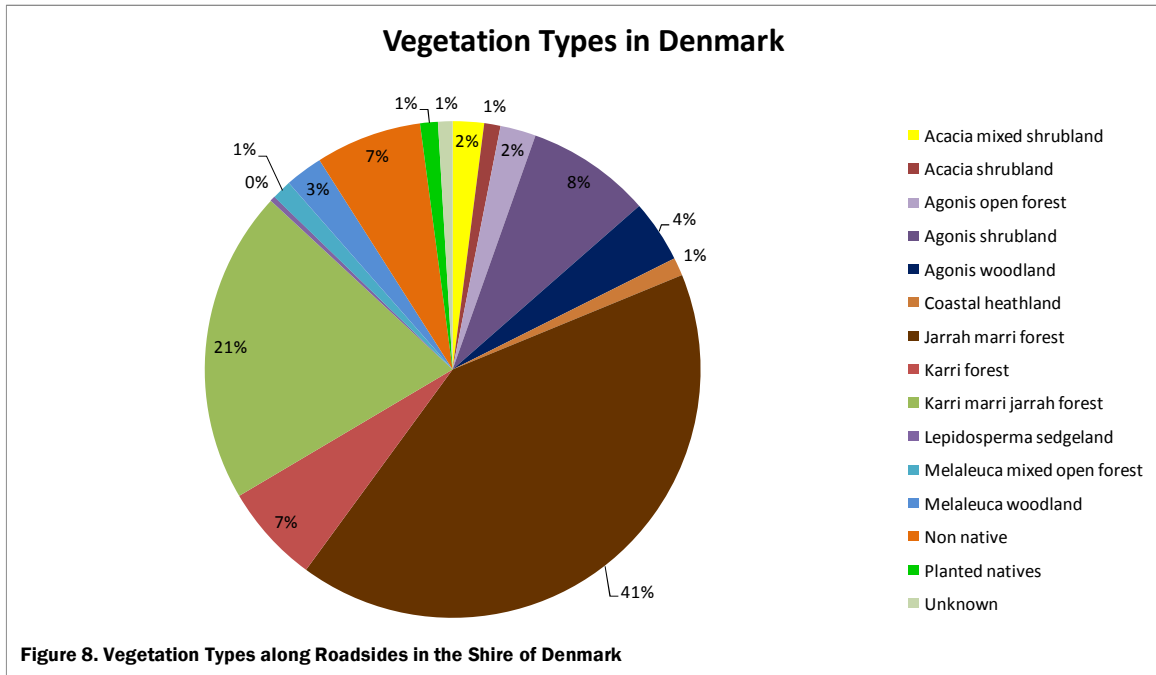
Roadside Vegetation Types

Surveyors were asked to record the main vegetation type along each section of roadside. The most dominant vegetation type was Jarrah Marri forest which was recorded along 362.2 km or 41% of roadsides in the Shire of Denmark. The next most common vegetation type was Karri Marri Jarrah forest 21% (178.72 km) followed by Agonis shrubland 8% (71.35 km). The Karri forest and Non Native vegetation types were found along 7% of roadsides (56.3 and 60.85 km respectively). Agonis woodland covered 4% of roadsides (35.7km) and Melaleuca woodland covered 3% (21.5 km). Acacia mixed shrubland and Agonis open forest vegetation types were identified along 2% of roadsides (17.9 and 20.4 km respectively). The vegetation types Acacia shrubland (9.4 km), Coastal heathland (10.3 km), Melaleuca mixed open forest (11.3 km), Planted Natives (10.1 km) and unknown vegetation type (8.4 km) all covered 1% each of roadsides. Lepidosperma sedgeland covered the least amount of roadsides with 3km. (Figure 8).

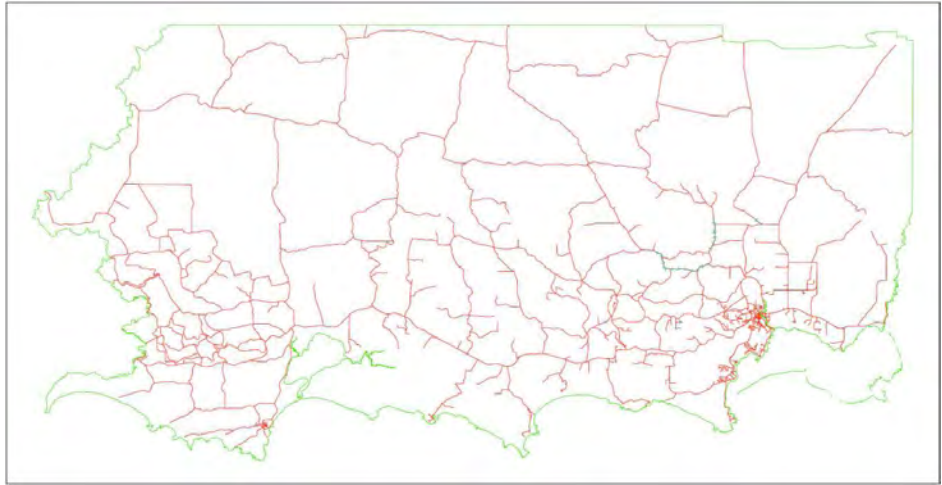
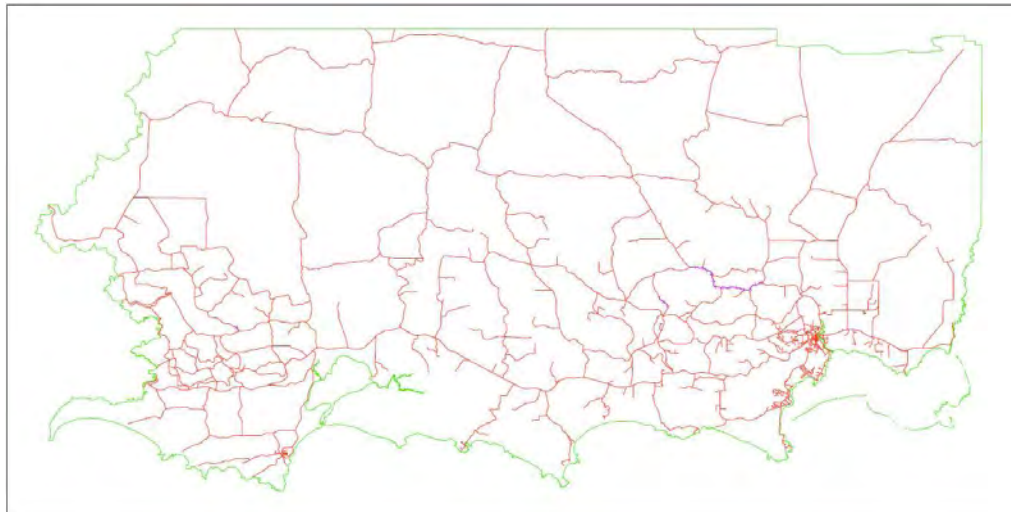
Figure 11. Spatial extent of nominated weeds on roadsides in the Shire of Denmark.

Of the nominated weeds species, Watsonia was the most prevalent and was recorded along 193.8km of the roads surveyed. The next most commonly recorded weeds were African Lovegrass (29.9km) and Sydney Golden Wattle (9.7km). Pittosporum was the next most commonly recorded weed, occurring along 8.2km of roads. Taylorina and Victorian Tea Tree were the least recorded chosen weeds and recorded along 5.7km and 5.6km of roads respectively (Figure 10). Figure 11 shows the spatial extent of these weeds on the Denmark map. These are shown in more detail on the weed overlays provided with the Roadside Conservation Value map.

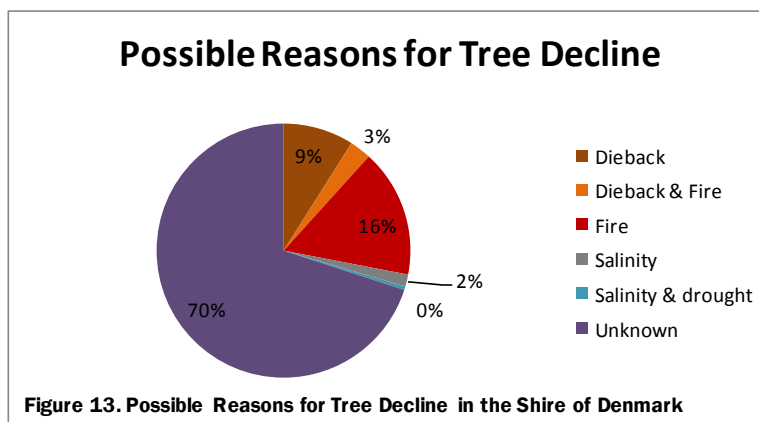
Tree Decline

Roadside surveyors were asked to record areas of tree decline and to record a possible reason for that decline. Of the roadsides surveyed 69% (603.52 km) did not have noticeable signs of tree decline. The majority of tree decline was from an unknown cause 70% (191.75 km). The second most common possible reason for tree decline was fire 16% (44.65 km). 9% of roadsides were

possibly affected by Dieback disease (24.6 km) and 3% were possibly affected by a combination of Fire and Dieback (7.5 km). Salinity was a probable cause along 2% of roadsides (4.2 km) and a combination of salinity and drought may have affected 1.2 km of roadsides. (Figure 13).

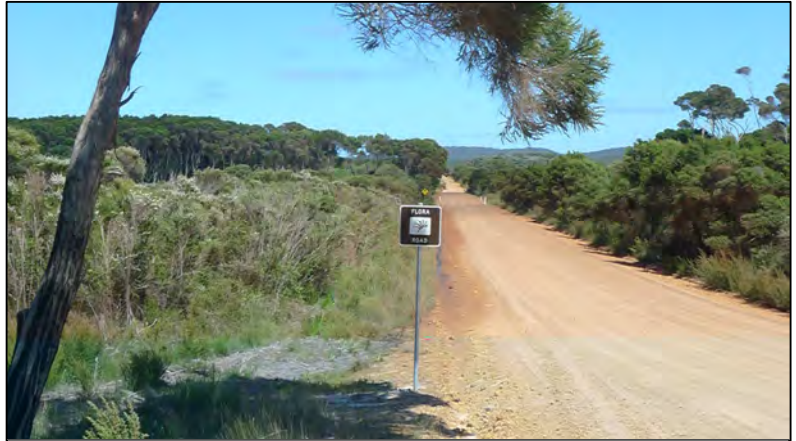
Ficifolia Road, a recently declared Flora Road
Photos: K. Gillies (above), K. Payne, RCC (below)

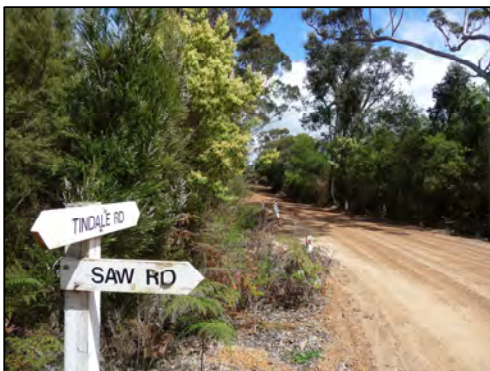
Tindale Road (left) and Mt Lindsay Rd (right) both recently declared Flora Roads

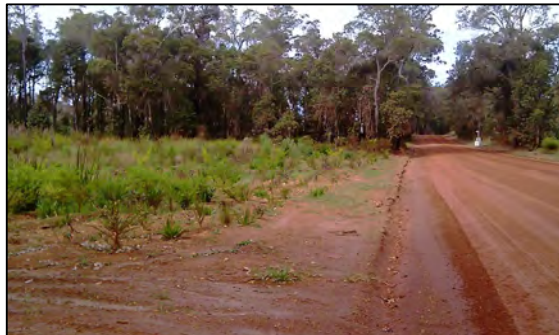
Revegetation area along Mt Lindsay Rd
Photo: K. Payne, RCC.

1.3 Improve roadside sections of medium to low conservation value by:

- minimising disturbance caused by machinery, adjoining land practices and incidences of fire;
- carrying out a targeted weed control program;
- retaining remnant trees and shrubs;
- allowing natural regeneration;
- spreading local native seed to encourage regeneration; and
- encouraging revegetation projects by adjacent landholders.

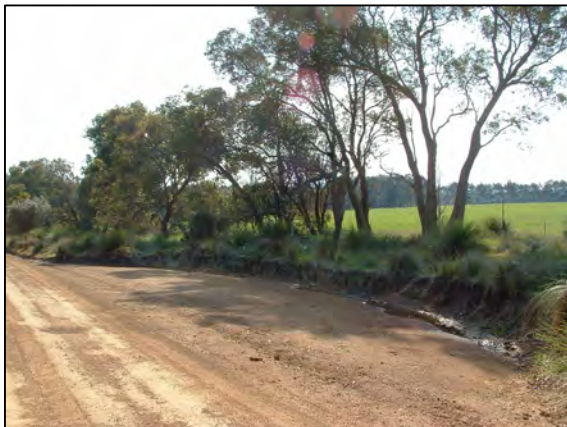
Creative solutions: A high value Flora Road in the Shire of Plantagenet. Passing lanes were established at various locations along the road to eliminate the need for widening the whole road.
