RE: PRZ Recycled Water Study and Economic Analysis  
10 Sites

# Reclaimed Water and Economic Implications for 10 Sites

## Denver Water

April 5, 2011

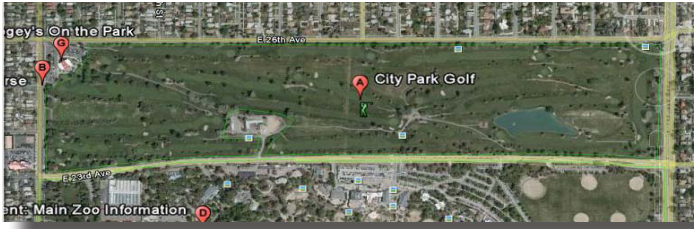
## 1. City Park Golf Course

- a. Location:  
Site is located between 26th Ave. and 23rd Ave., between York St. and Colorado Blvd.
- b. General Character/Site Conditions:  
Manicured public golf course. Many mature trees. A large pond helps to serve as a site detention area as well provide irrigation for the course.
- c. Turf/Plant Material Appearance:  
Several stressed and dying/dead trees were evident. Primarily Spruce and Pine species. Several large turf areas had little or no grass coverage.

Actions Recommended: Reduce direct spray onto the conifers. A sulfur burner could be used to re-

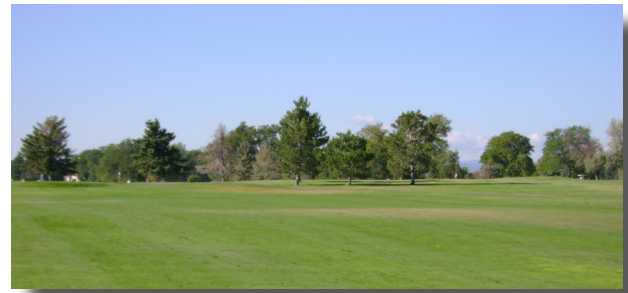
Stressed evergreen trees along City Park Golf Course perimeter

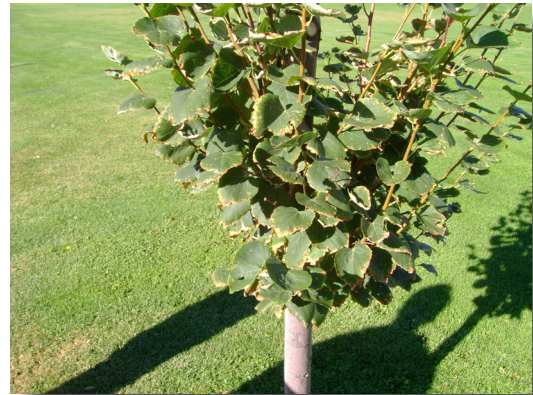
Stressed Little Leaf Linden (leaf burn) at City Park Golf Course

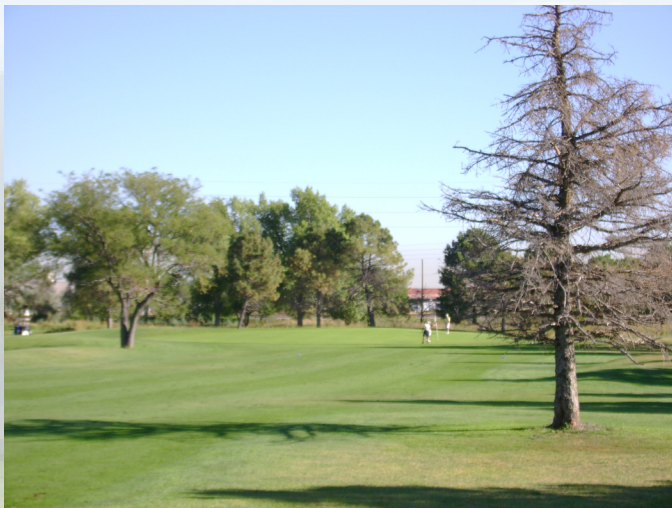
Dead Pine Tree at City Park Golf Course

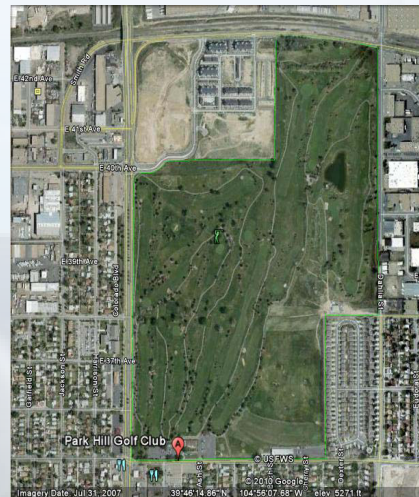
## 2. Park Hill Golf Course

- a. Location:  
Located south of Smith Rd. between Colorado Blvd. and Dahlia St.
- b. General Character/Site Conditions:  
Manicured public golf course. Many mature trees with several irrigation/detention ponds. Additional research indicates that this park was

- irrigated with saline wells prior to the introduction of recycled water.
- c. Turf/Plant Material Appearance: Many stressed and dying dead trees were evident, primarily Spruce, Pine and some oak species. Turf Areas were stressed in several areas.
  - d. Additional Information: The park superintendent indicated that valve seats, clogged heads etc. were requiring replacement at an unusually high rate and that Park Hill Golf Course lost approximately 40 trees (mostly evergreens) during 2010. Most of the Park Hill Golf Course problems were attributed to an antiquated irrigation system (low head pressure and no head-to-head coverage). In addition, information from the CSU study indicated that Park Hill Golf Course had a history of using saline well water for irrigation before recycled water was introduced, which was likely responsible for much of the tree and turf damage observed.

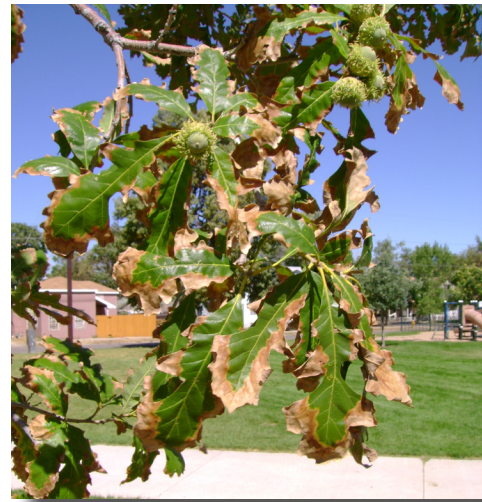
Leaf edge burn on Oak Tree at Park Hill Golf Course

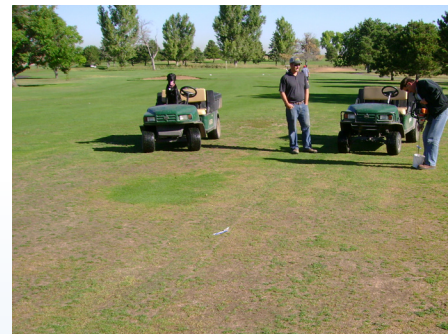
Poor Turf Condition at Park Hill Golf Course

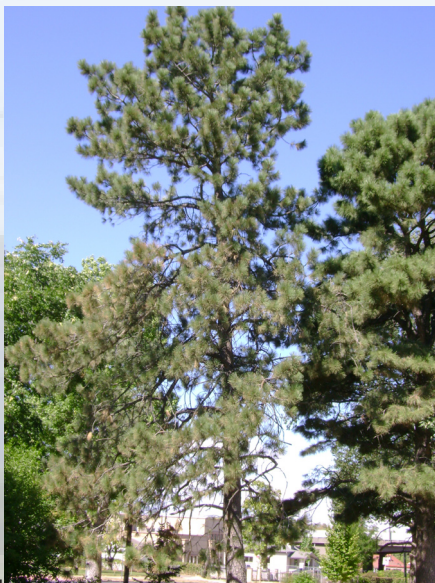
Stressed Ponderosa Pine at Park Hill Golf Course

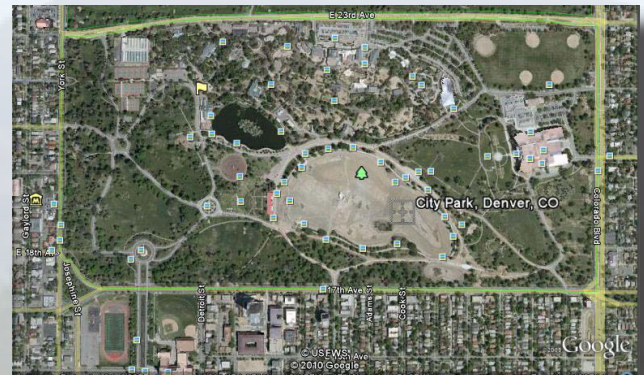
### 3. City Park

- a. Location: Located south of City Park Golf Course, bounded by 23rd Ave and 17th Ave (north and south) with Colorado Boulevard to the east and York Street to the west

- b. General Character/Site Conditions: Large park area with irrigated/manicured areas and natural, more xeric areas located throughout the park. Several large ponds and open channels also exist and serve to irrigate the park.
- c. Turf/Plant Material Appearance: Stressed and dying evergreen trees.
- d. Additional Information: The Park Superintendent indicated that there were issues with irrigation part replacement and problems with the pump room that pumped recycled water into the fountains. Valve seats, pump seals were reported to be degrading at a rapid rate and occurred after recycled water was introduced to that system.

This damage was primarily observed right after the system is turned on in the spring, possibly due to organic residue that has dried in the system after shut down in the fall that is causing a chemical reaction. Testing in the spring is recommended to determine the cause of this unique problem.

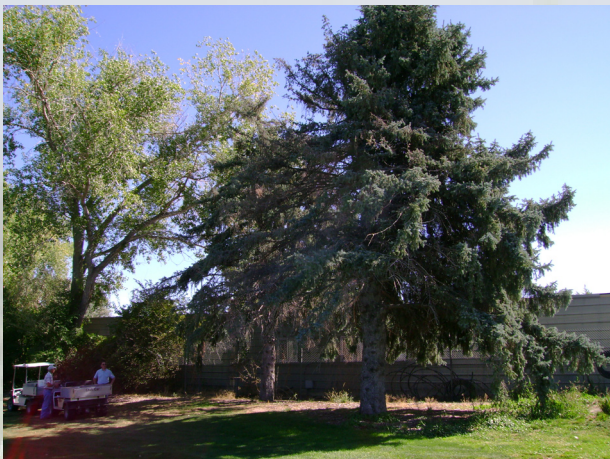
Dead/dying evergreen trees at City Park

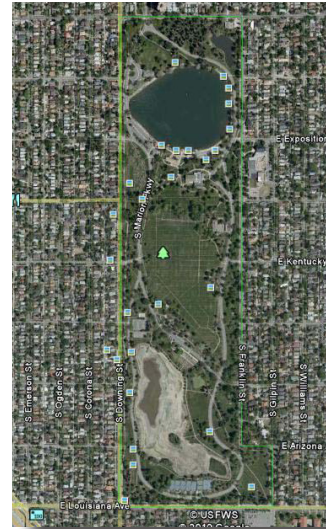
## 4. Washington Park

- a. Location: Large park located between Downing and Franklin Streets, south of Virginia Ave. and north of Louisiana Ave.
- b. General Character/Site Conditions: Large manicured park with large ponds and open channels for the conveyance of water. Additional research indicates that Washington Park has used "raw water" water for many years prior to the introduction of recycled water.
- c. Turf/Plant Material Appearance: Vast expanses of turf have little or no stressed growth patterns.
- d. Additional Information: Tree problems were specifically noted along one of the recycled water storage ponds along Franklin Street. A large Horn Bean and several evergreens were in a stressed condition, possibly due to having the root system that extends into the pond or being impacted by direct irrigation spray.

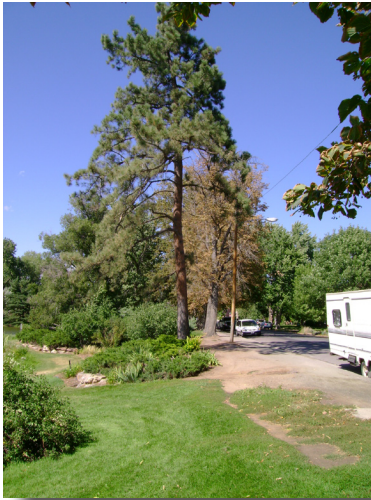
Stressed Ponderosa Pine and Horn Beam along Franklin Street (Existing irrigation pond is located to the left, off picture)

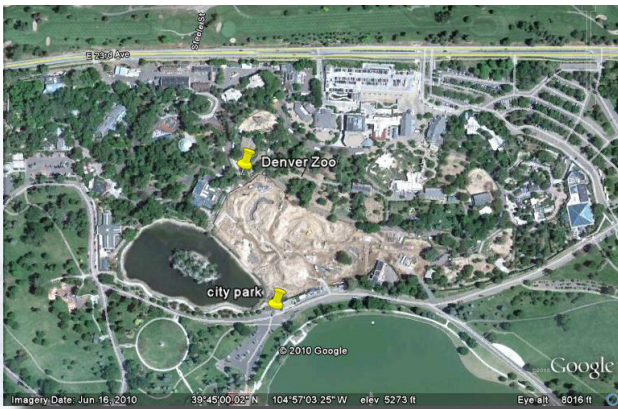
## 5. Denver Zoo

- a. Location:  
The Denver Zoo is located at the northern edge of Denver City Park along 23rd Avenue.
- b. General Character/Site Conditions:  
The Zoo has several grass open areas with mature trees.
- c. Turf/Plant Material Appearance:  
No specific problems were noticed.
- d. Additional Information:  
Soil samples were taken at one location where previous samples were taken. No problems were noticed from any of the staff regarding the recycled water usage.

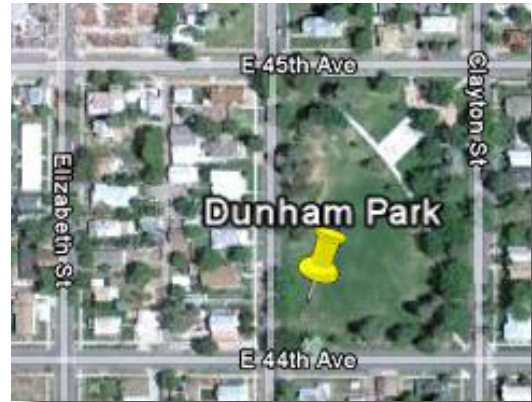
## 6. Dunham Park

- a. Location:  
This northeast Denver park is located between 44th Ave. and 45th Ave. along Clayton St.
- b. General Character/Site Conditions:  
Manicured park site with sport fields and mature trees.
- c. Turf/Plant Material Appearance:  
Minor visible problems with turf and vegetation. Burned leaf edges were prevalent.
- d. Additional Information:  
The park superintendent indicated that this park has not had any major problems since recycled water was introduced.

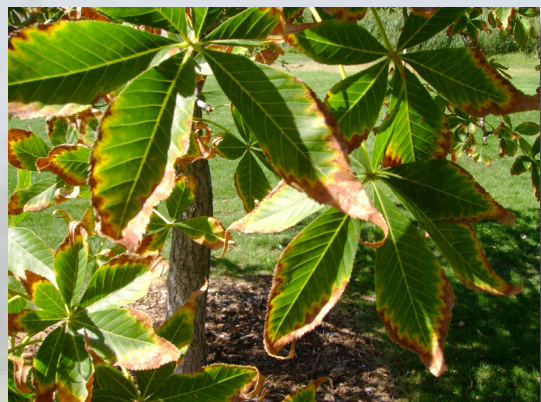
Leaf Burn on several deciduous trees at Dunham Park

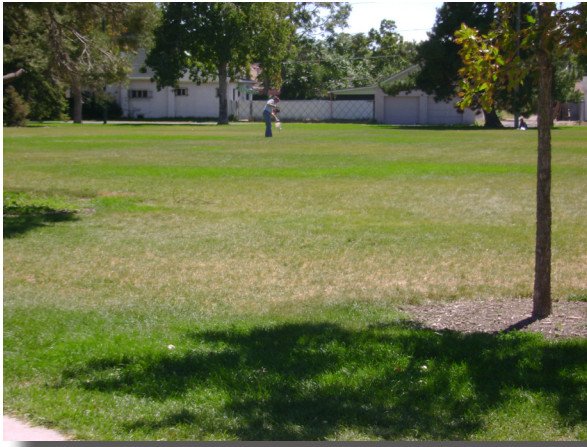
Stressed turf areas at Dunham Park

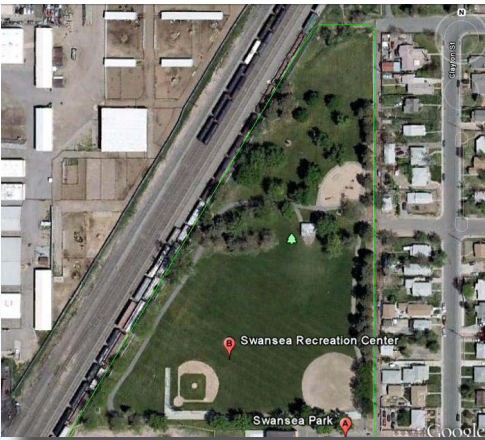
## 7. Swansea Park

- a. Location:  
Located at 37th Ave. and Clayton St.
- b. General Character/Site Conditions:  
Manicured park with ball fields, open play and mature stands of trees.
- c. Turf/Plant Material Appearance:  
No visible problems with turf or vegetation.
- d. Additional Information:  
Soil borings were taken and a site inventory was conducted. No park staff was available.

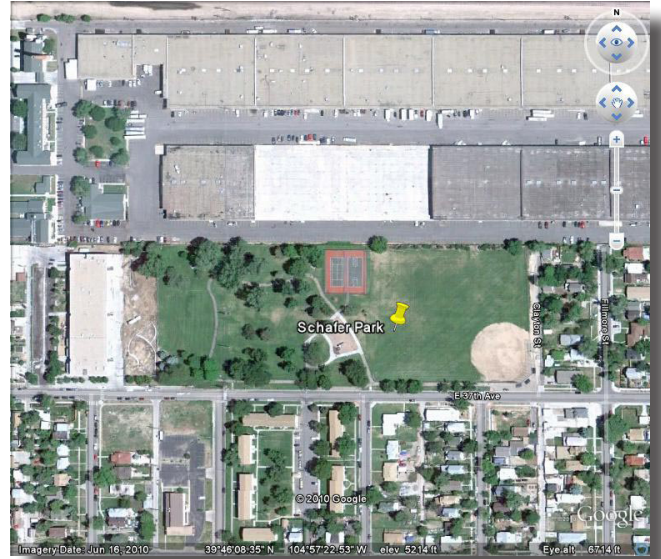
## 8. Schafer Park

- a. Location:  
37th Ave and Clayton St.
- b. General Character/Site Conditions:  
Manicured park site with tennis courts, ball fields and open play.
- c. Turf/Plant Material Appearance:  
No specific problems seen as related to recycled water.
- d. Additional Information:  
Phone conversation with park superintendent said that there were no known problems with using recycled water.

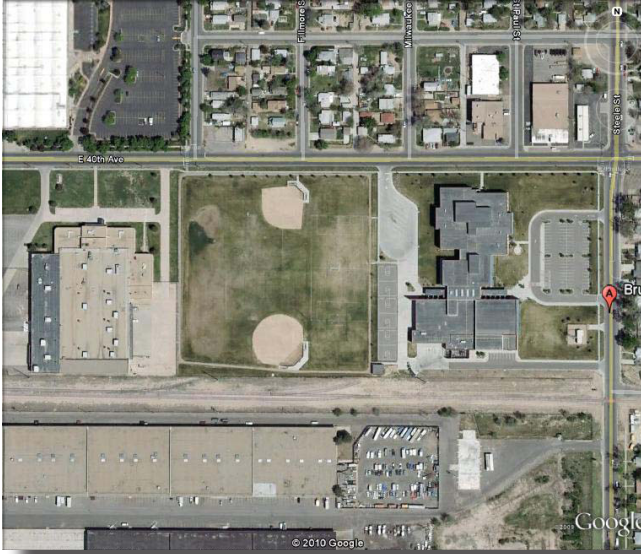
## 9. Bruce Randolph Middle School

- a. Location:  
Existing Middle School located at Steele St. and 45th Ave.
- b. General Character/Site Conditions:  
Intensely used sport field complex consisting of ball fields, soccer fields and football fields
- c. Turf/Plant Material Appearance:  
Extreme high use of turf areas.  
Extensive turf area wear.
- d. Additional Information:  
Field superintendent indicated there were no known problems pertaining to recycled water.

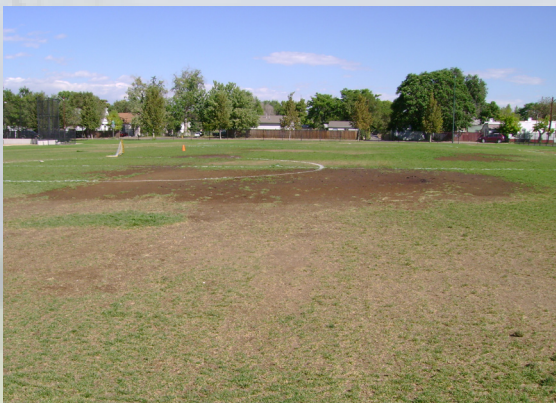
Extreme Turf Wear at  
Bruce Randolph Middle School

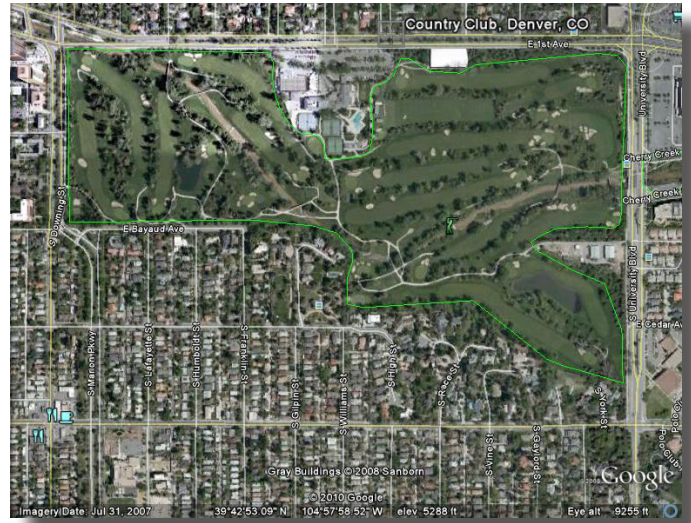
## 10. Denver Country Club

- a. Location:  
1st Ave. and University Blvd.
- b. General Character/Site Conditions:  
Finely manicured golf course.
- c. Turf/Plant Material Appearance:  
No known plant or turf abnormalities as a result of recycled water based on a phone conversation with the golf superintendent. Did not visit the site or meet with anyone from Denver Country Club.
- d. Additional Information:  
Site visit was not conducted. Soil analysis data was sent to PRZ Consulting for this effort.

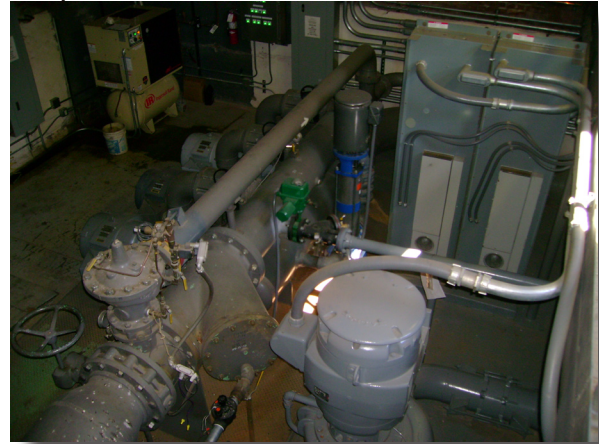
The observed and reported problems with these sites included a number of dead and dying trees and vast expanses of damaged turf areas. Superintendents also reported an increased amount of irrigation maintenance required for these sites ranging from clogged irrigation heads to pump seals replacement.

City Park Pump Facility is reported to require frequent maintenance for seals and replacing parts.

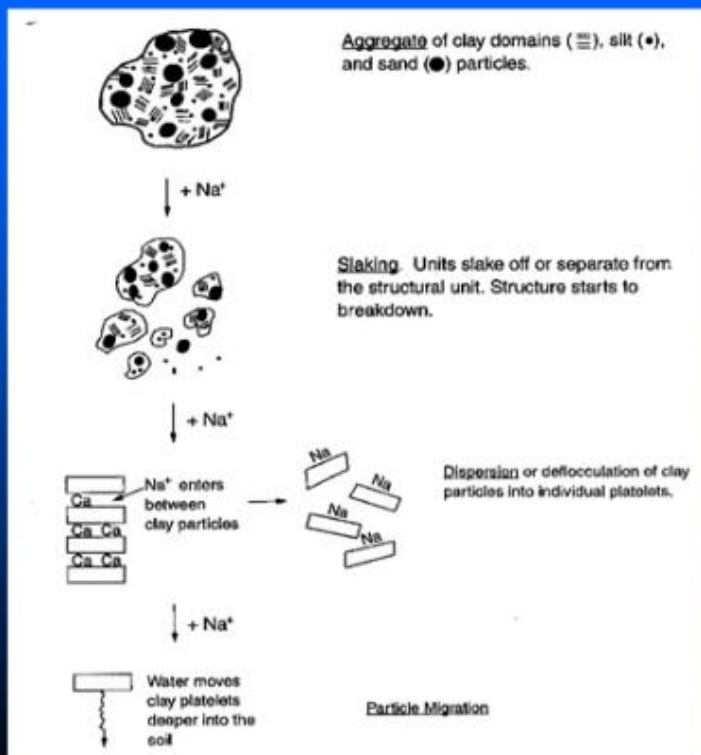
The slide on the next page prepared by CSU, shows how the sodium accumulation in the root zone over time breaks down the soil structure. This also has a dramatic affect on the plants growing in these conditions.

**This would be the the sodium effect on soil structure**

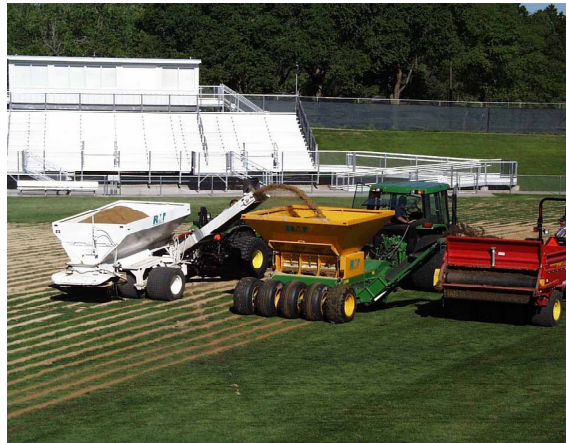
## Aeration Equipment

On "high use" fields, compaction can be a primary cause of turf damage. Higher clay content and plasticity index result in more compaction. Sodium accumulation slows down percolation and also contributes to the compaction.

Deep roots are critical to giving high use sports fields maximum wear-ability. Since roots only go as deep as oxygen exists and oxygen is carried by percolating water, compaction of the soil results in turf that can be damaged more quickly.

Aeration on a monthly basis in the wear areas can help prevent the compaction and associated sodium accumulation. The aerator below is an example of a machine that has both slicing tines (6" depth) for monthly use and fracturing tines (7" depth that fracture as deep as 10") for annual renovation or late fall or summer rest time before the leach and flush periods described above.

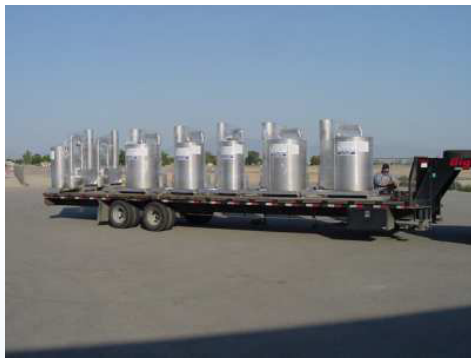
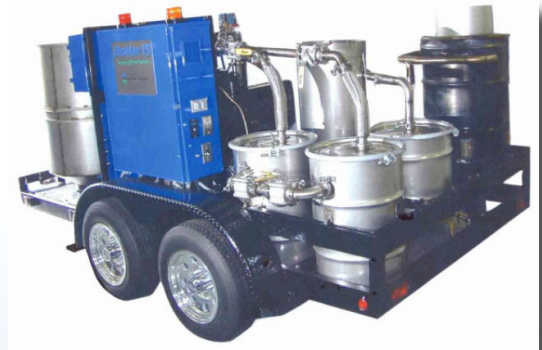
A sulfur burner lowers pH and converts bicarbonate in recycled water to CO<sub>2</sub> and H<sub>2</sub>O. The low pH (approximately 6.5) mimics rainwater, but the sulfurous gas it produces causes the negatively charged sulfates to attract, hold and move the positively charged sodium out of the root zone. This system gradually produces a healthier environment for all vegetation that is affected by sodium and also reverses damage initiated by the sodium through percolation and soil stability.

Sulfur Burners on Trailer for Scale

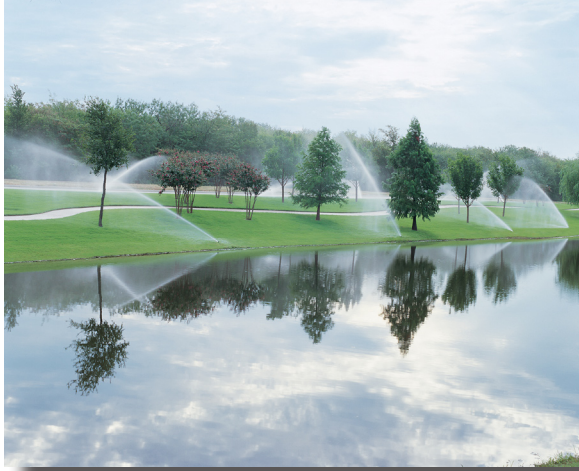
Conventional Park Spray Pattern

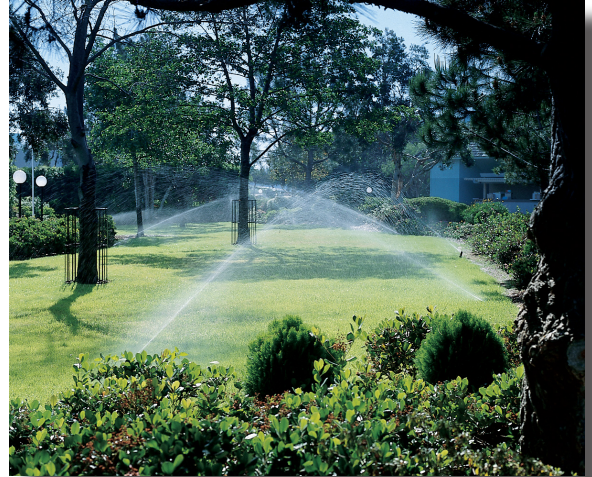
One solution is to use low trajectory spray heads and rotors to keep irrigation spray off of sensitive leaves. Low trajectory heads are available in spray and rotor configurations. They can be retrofitted with existing irrigation systems or may require a complete new irrigation system because of reduced "throw distances" of low trajectory heads.

Low Trajectory Spray Pattern
