Seattle Freeway Construction, Interstate Highway 5, 1960-1966

KENNETH A. JOHNSON

Washington State Department of Highways, Retired

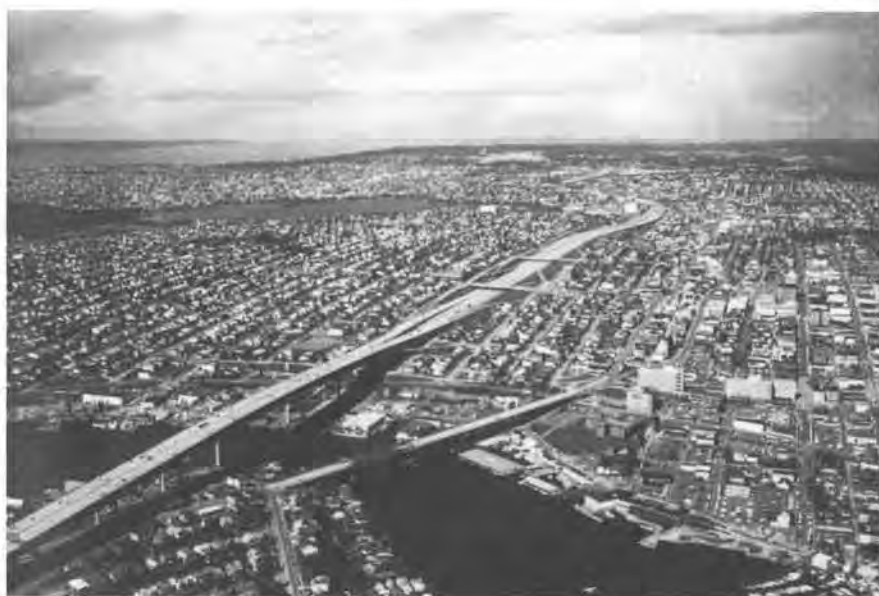
Aerial view to the north-northwest of the Interstate Highway 5 bridge over the Lake Washington Ship Canal, Seattle. Photograph by R. W. Galster, February 1971.

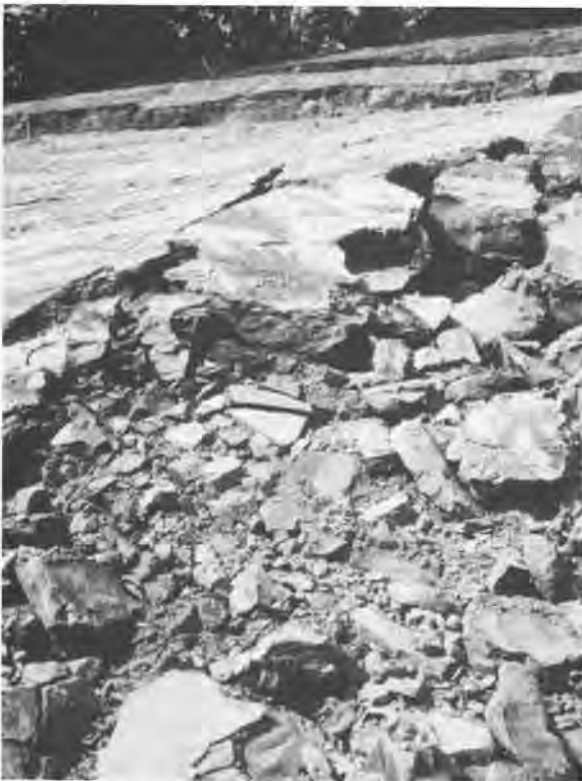
Figure 2. Hard blocks and chunks of clay in a landslide mass. Largest chunk in the upper middle part of the photograph is about 5 ft across.

The lacustrine deposits consist principally of unweathered silt, silty clay (CH, Unified Soil Classification System), and clay (CH), with representative Atterberg limits as tabulated below. The deposits are either massive or layered and in some places varved. The consistency of the material varies from very stiff to hard, and in the undisturbed state it exhibits a remarkably high strength. The *in-situ* properties of the material, however, are influenced by the existence of structural features consisting of joints and fissures and, generally, horizontal bedding planes. When disturbed, such as by ground movements, the fissured nature of the material creates a broken mass composed of hard blocks and chunks (Figure 2).

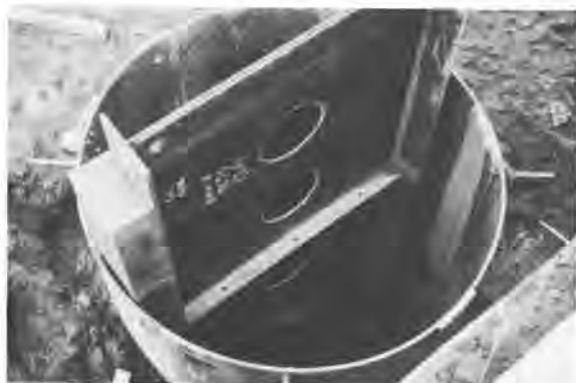
Figure 5. Cylinder pile (diameter 4 ft 9 in.) at the toe of an existing conventional wall. Steel beam is in place and ready for concrete pour.

the lowest failure plane required cylinders as long as 81 ft. The design loading was too great to permit the use of reinforcing steel, and therefore welded steel beams were employed as shown on Figure 5.

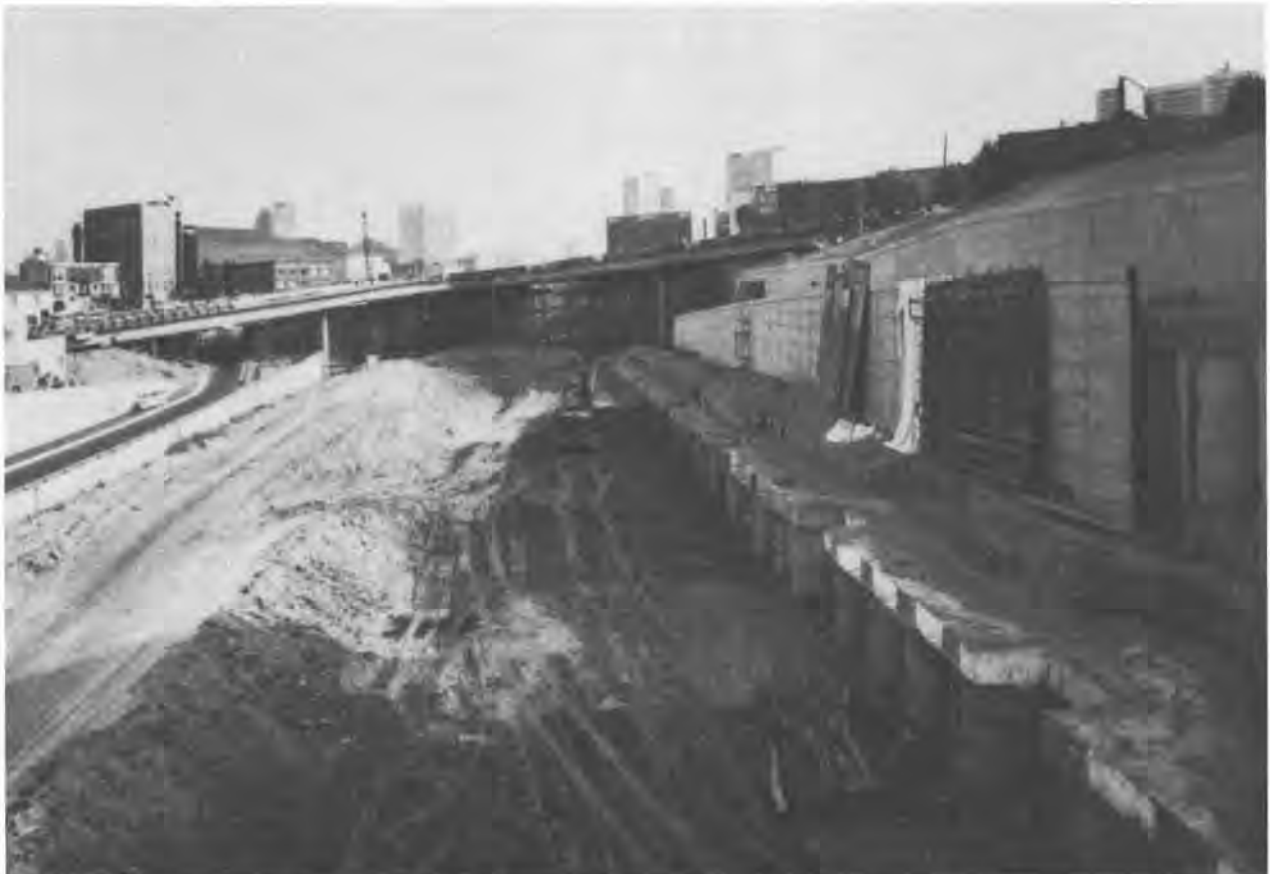
Figure 10. View north along the southbound lanes at the intersection of Boren Street and Pine Street. Two cylinder pile walls (10-ft diameter) were designed to accommodate the reversible lane under the southbound lane.

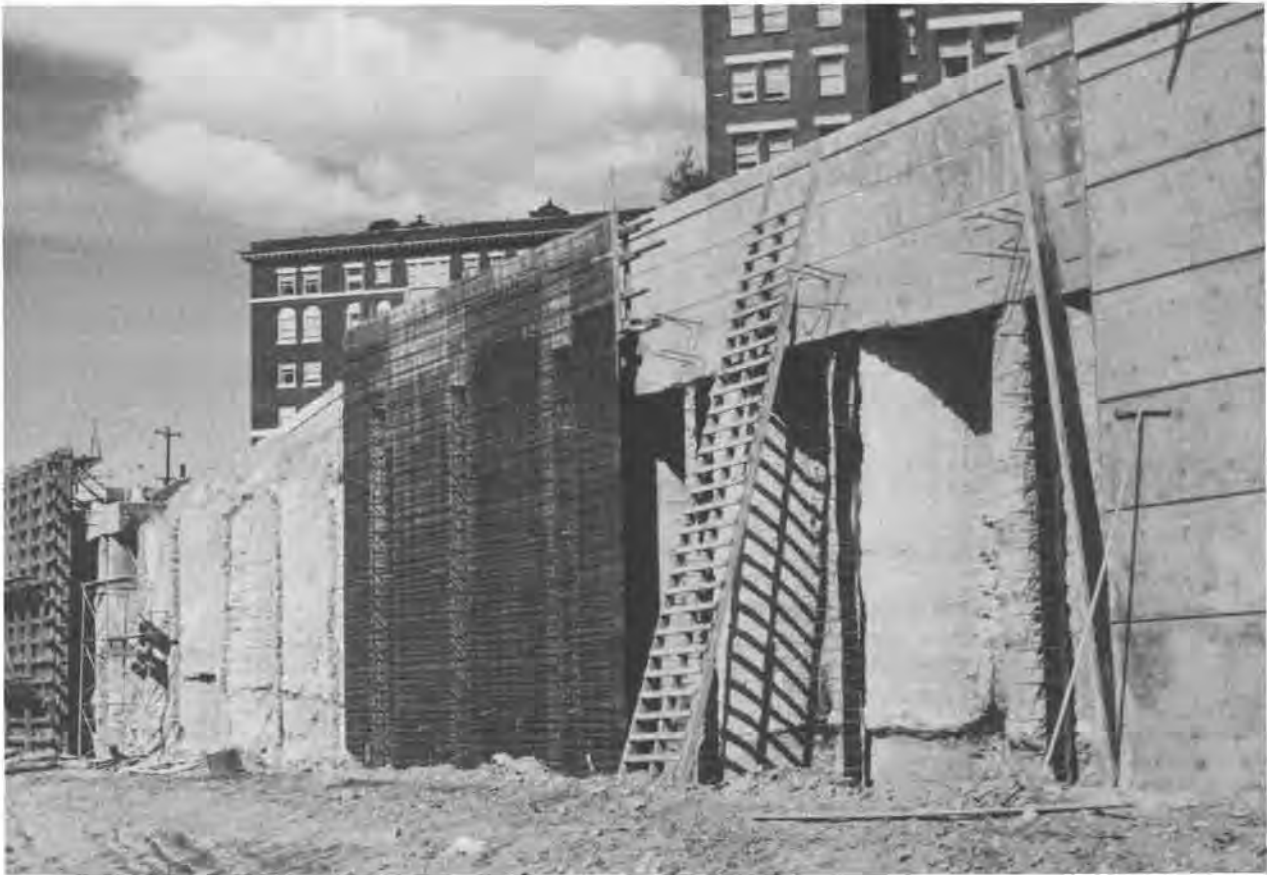
Figure 11. Cylinder piles (10-ft diameter) with permanent face walls under construction.

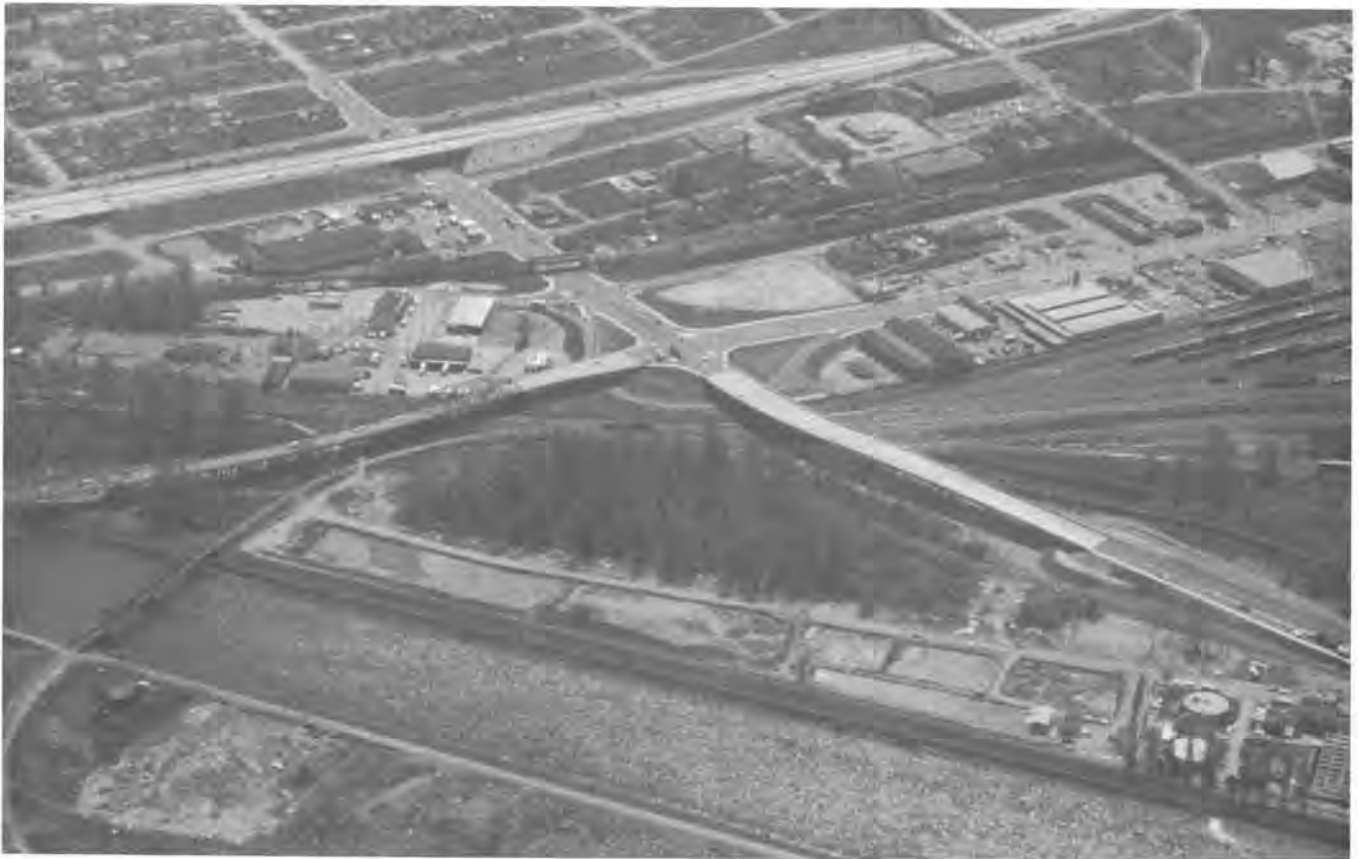
Figure 1. Intersection of Portland and Yakima avenues at the south embankment (center of this 1976 photo). North embankment is to the right, above the sewage treatment plant along the Puyallup River.

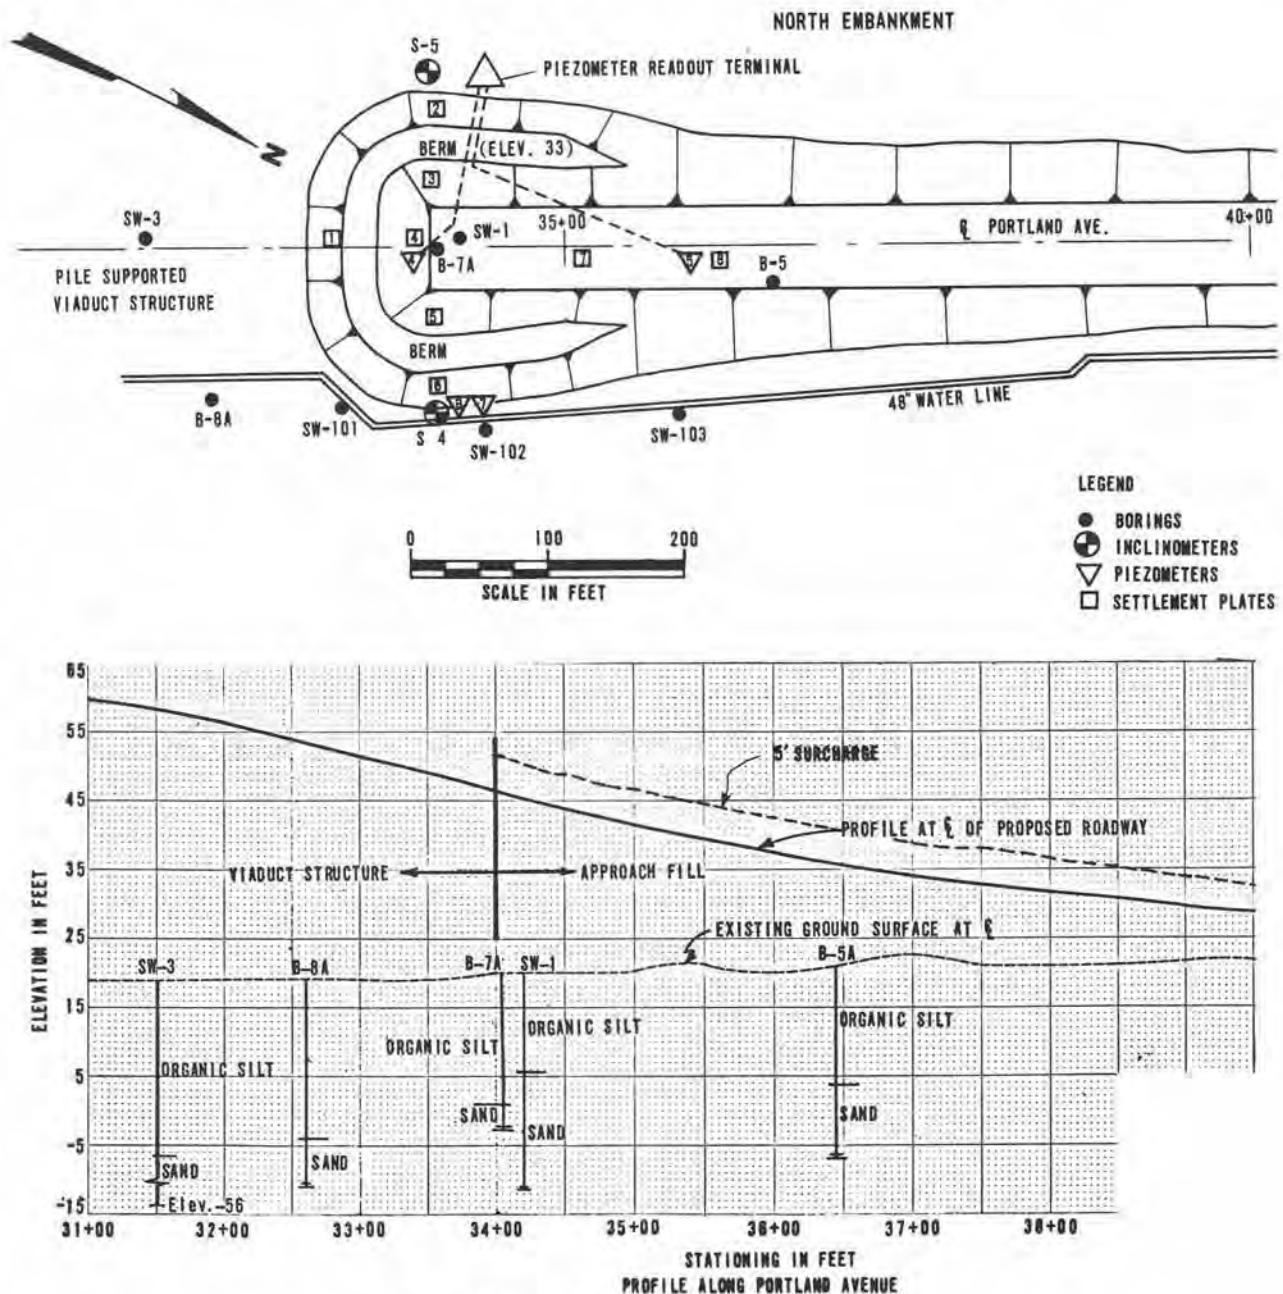
Figure 2. North embankment, plan and profile.

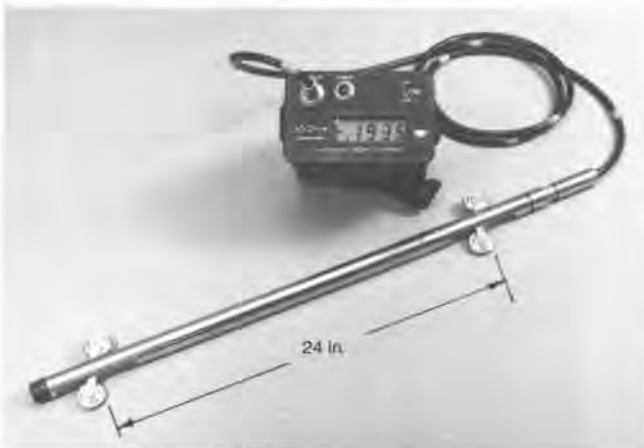
Figure 6. Digitilt Inclinometer (1987).

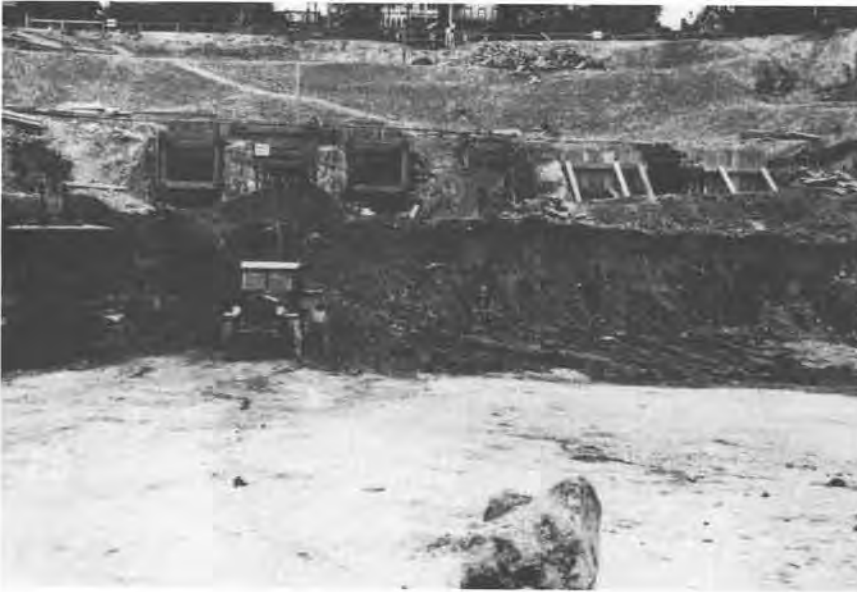
West portal drift excavations for tunnels through Mt. Baker Ridge, Seattle. These two double-lane tunnels were driven by the stacked drift method through glacially over-ridden hard clay. Note the large glacier-transported boulder in the foreground. 1939 photograph courtesy of Shannon & Wilson, Inc.

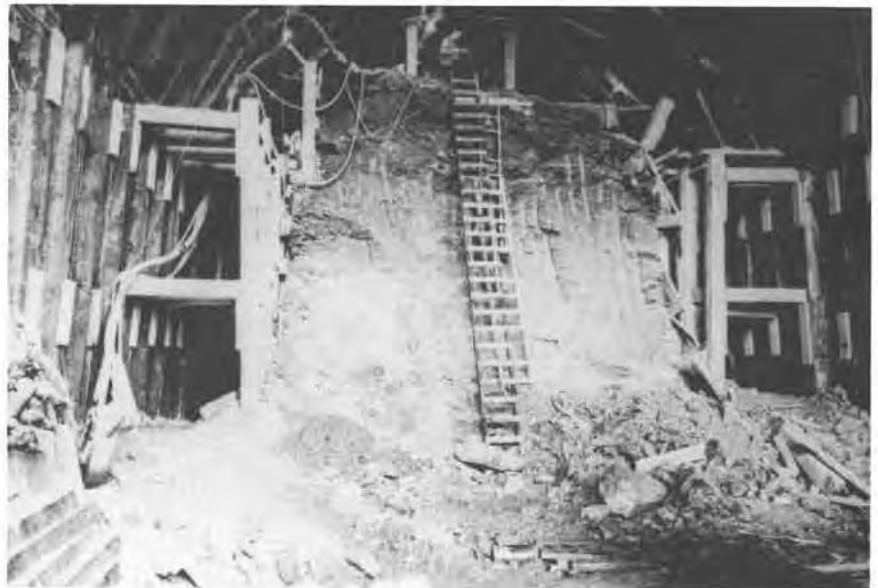
Stacked drift excavations for the early double-lane tunnels through Mt. Baker Ridge, Seattle. The small drifts were excavated to maintain the stability of the clay soils and reduce settlement of overlying structures. The clay core was used to support the forms for the concrete lining. 1940 photograph courtesy of Shannon & Wilson, Inc.

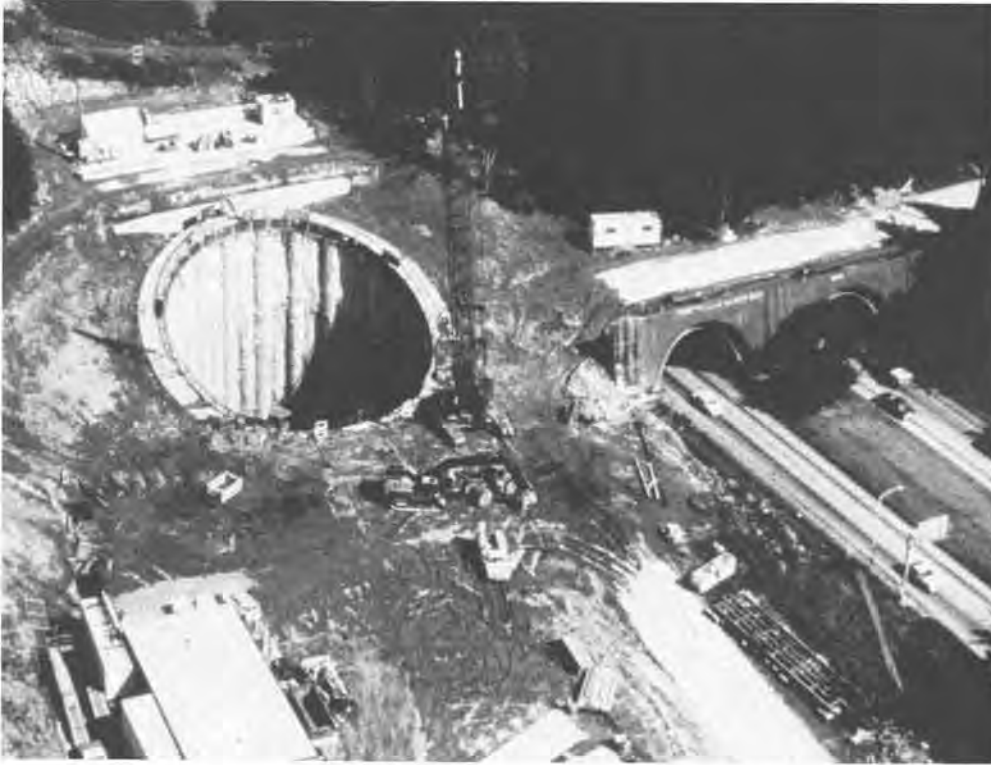
Figure 9. Aerial view of completed west access pit; existing tunnels on the right, stabilizing blocks above portal, construction yard to bottom.

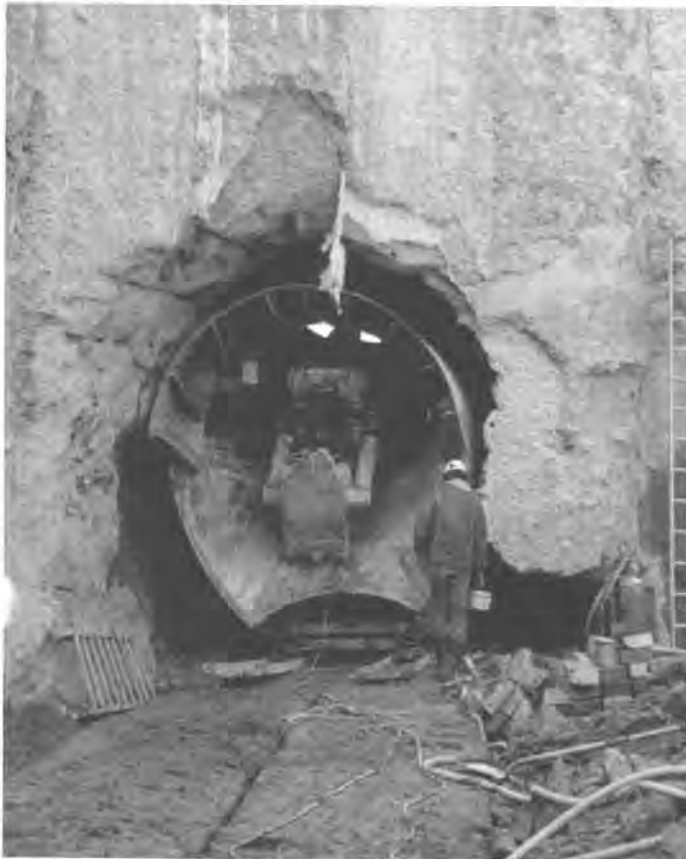
Figure 10. Breakout of drift #13 shield in east access pit.

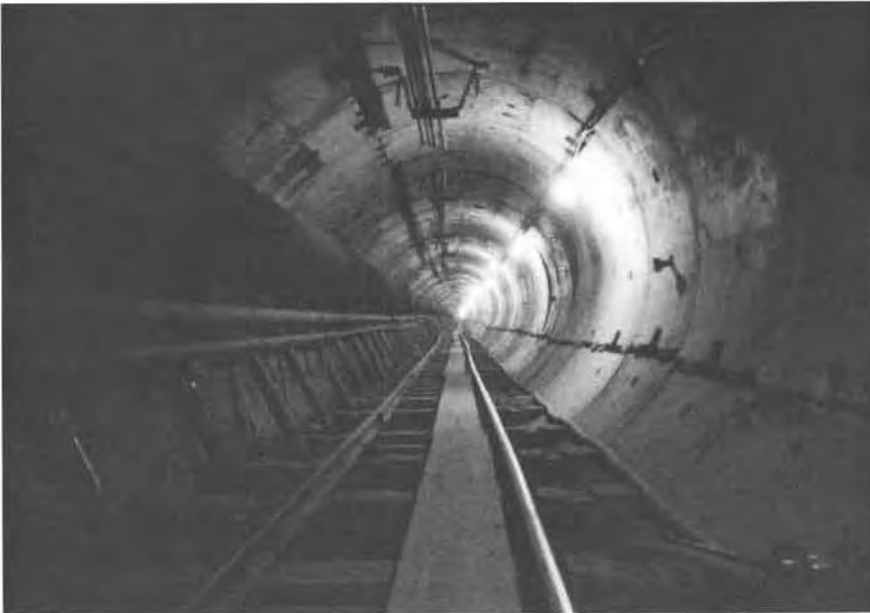
Figure 11. Temporary 5-in.-thick concrete segment lining for drift #3 with exterior lining of prior drift #1 on the left, wood wedges for liner expansion on the right, and grout lines in the crown.

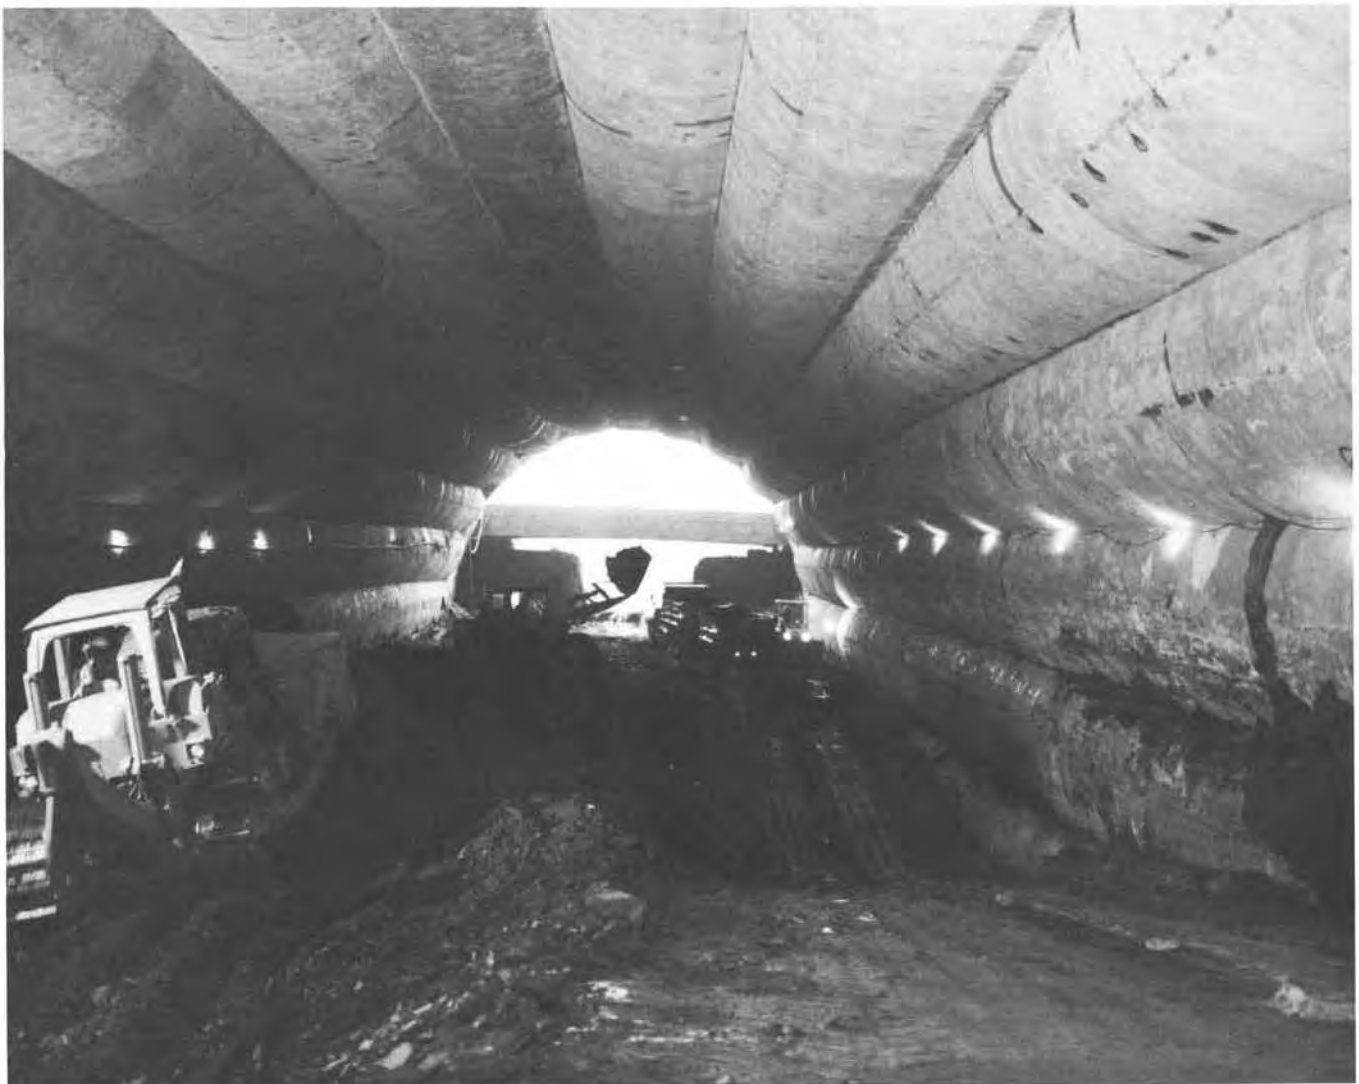
Figure 12. Excavation of bench #3 showing drift exterior and east access pit with upper level bracing.

Excavation of the soil core was started on August 5, 1985. Excavation was accomplished in five benches, each as much as 12 ft high. The top bench was excavated from both ends of the tunnel with front-end loaders. In subsequent lifts, the hard clays were ripped and stockpiled with dozers (Figure 12) and then placed in highway truck/trailer combinations driven through the tunnel from east to west. During peak excavation periods, as many as 20 trucks passed through the tunnel each hour.

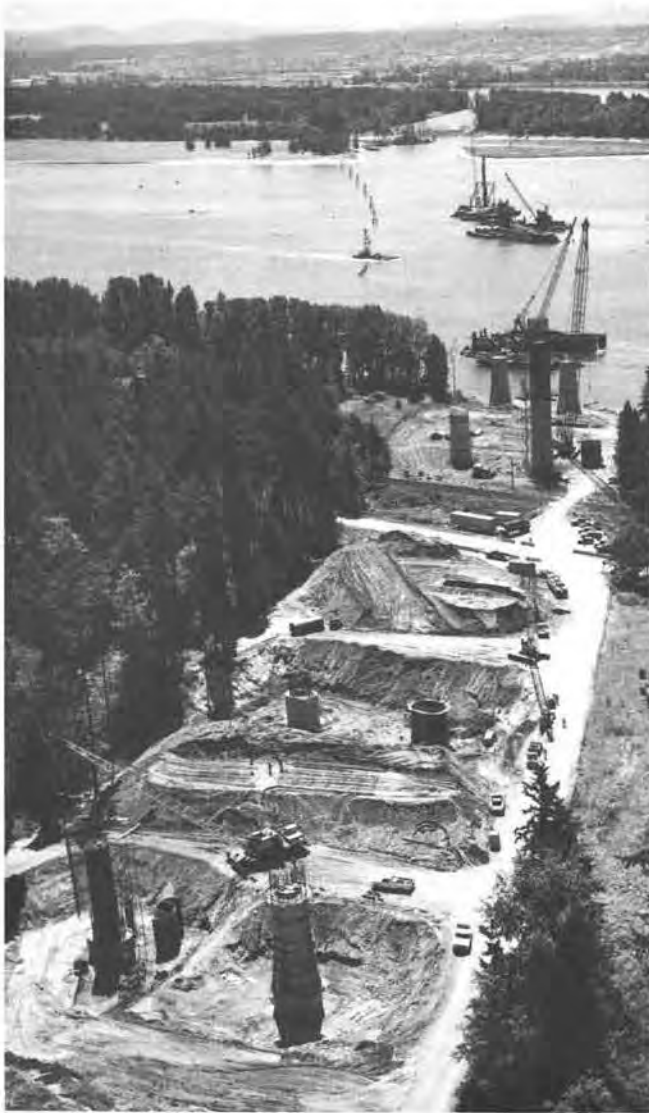
Bridge pier construction on the north (Washington) shore of the Columbia River, Glenn Jackson Bridge site in July 1987. Photograph courtesy of the Oregon Department of Transportation.

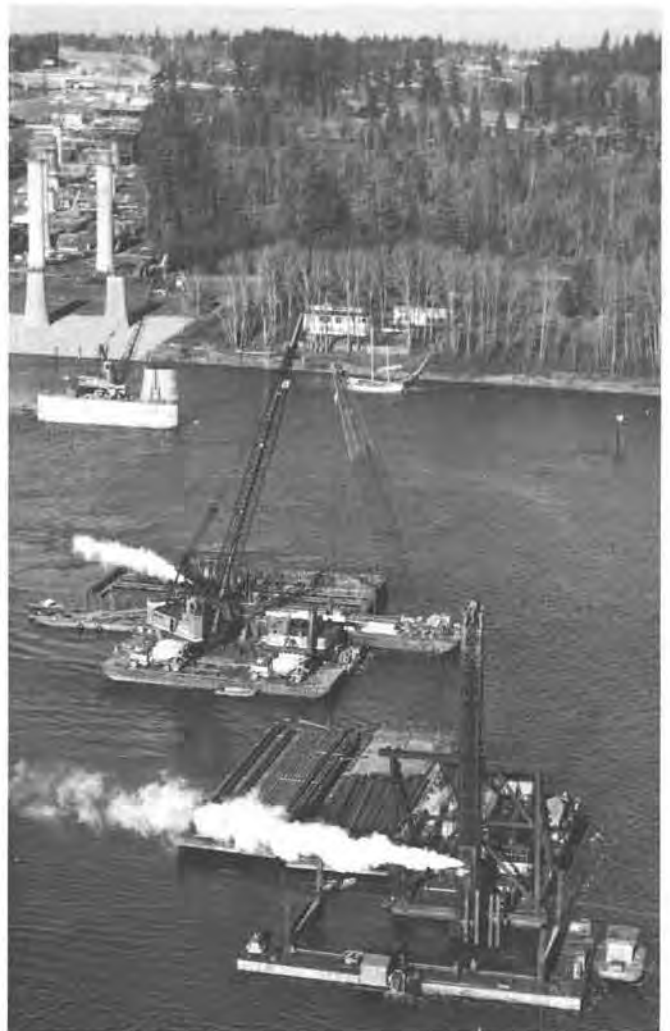
Pile driving for bridge piers at the Glenn Jackson Bridge site, 1978. Photograph courtesy of the Oregon Department of Transportation.

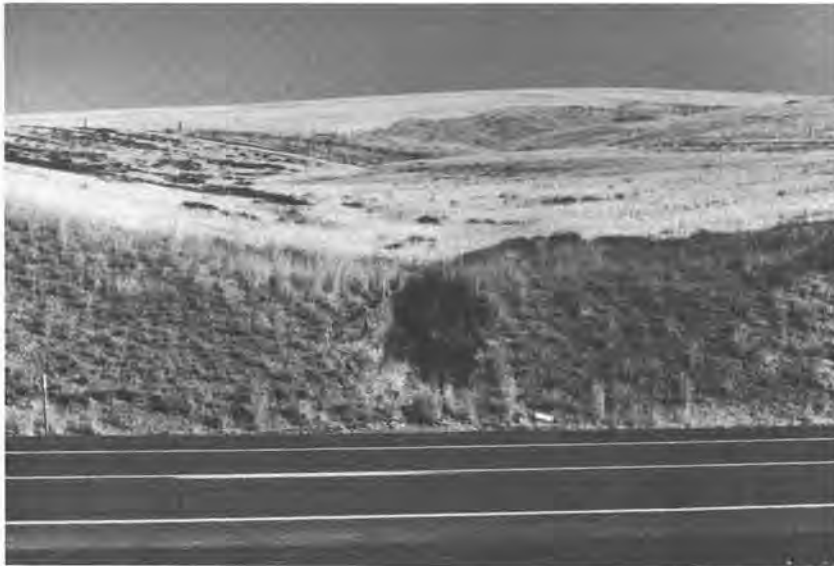
Figure 12. Erosion of loess by flow over the face of a cut (near La Crosse).

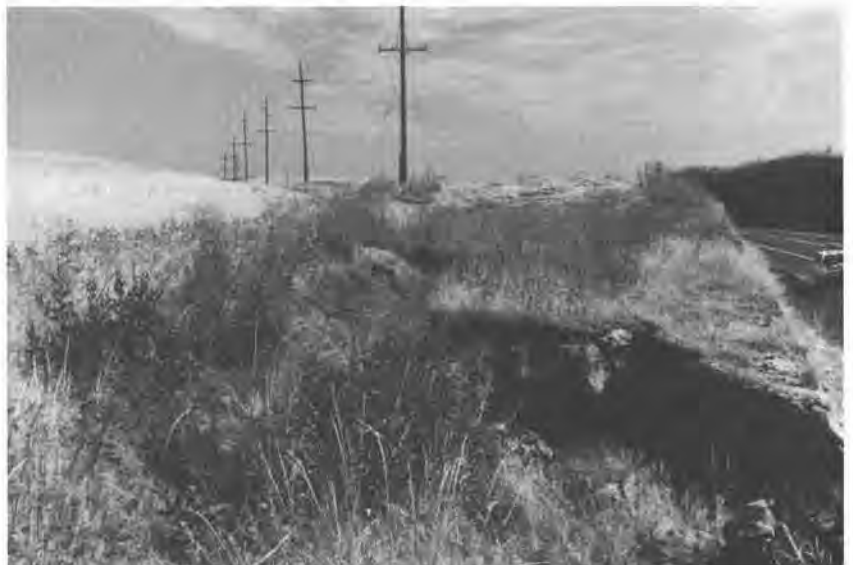
Figure 13. Gully erosion in a side ditch due to insufficient channel protection (U.S. Highway 12 near Walla Walla).

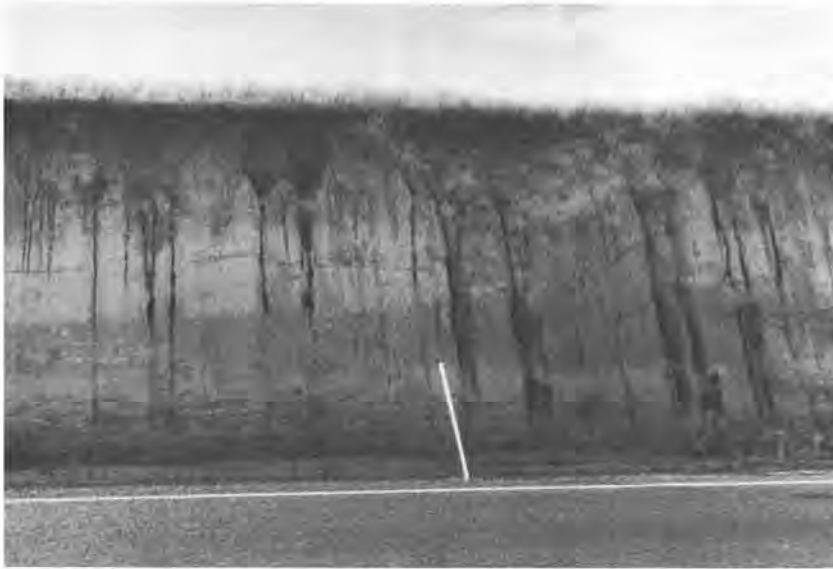
Figure 14. Erosion pipes developing into gullies on a 30-ft-high cut along U.S. Highway 12 near Walla Walla.

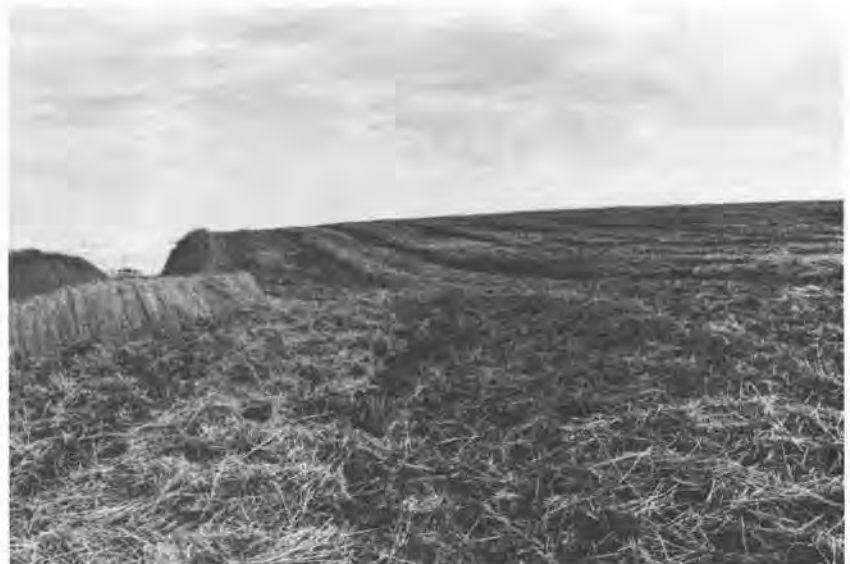
Figure 15. Low area at the center of the photograph is the runoff source causing the erosion shown in Figure 14. Cut slope is on the left.

In the cut shown in Figure 14, the majority of the erosion in the upper portion of the cut slope is due to piping. Below the pipes, gully erosion is beginning to develop. When the pipe enlarged to the point where the overlying material could no longer be supported, caving occurred, and the overlying vegetation was deposited in

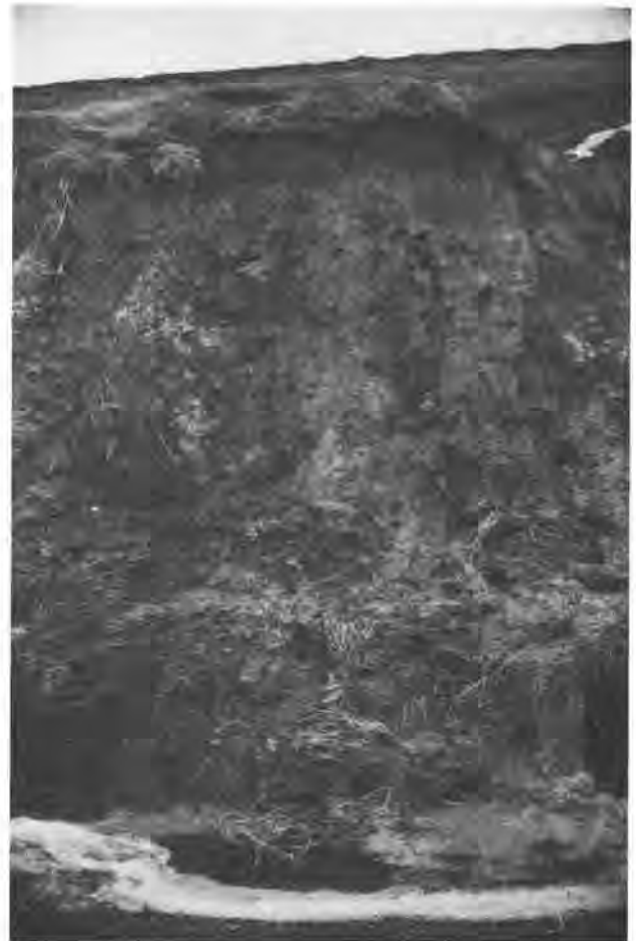
Figure 16. Small flow of soil and vegetation in a 15-ft-high cut slope along U.S. Highway 195 near Pullman.

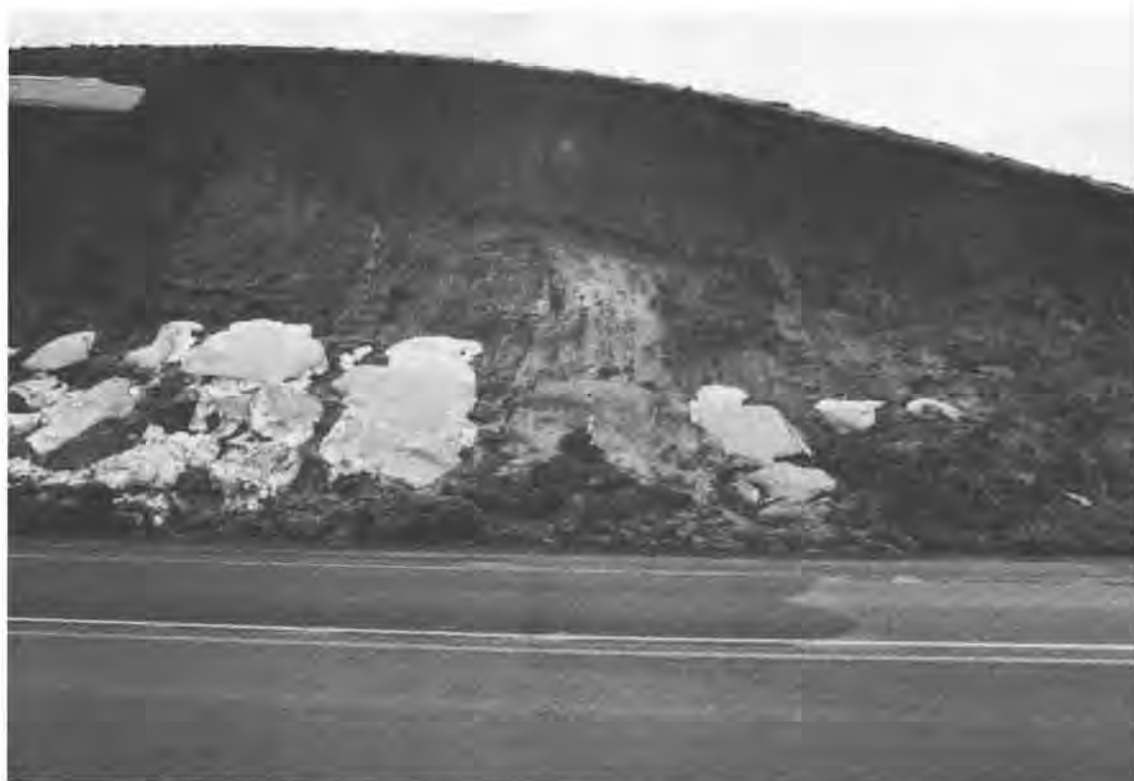
Figure 17. Failure of cut slope in clayey loess near Pullman. White areas are snow. Cut is about 30 ft high.

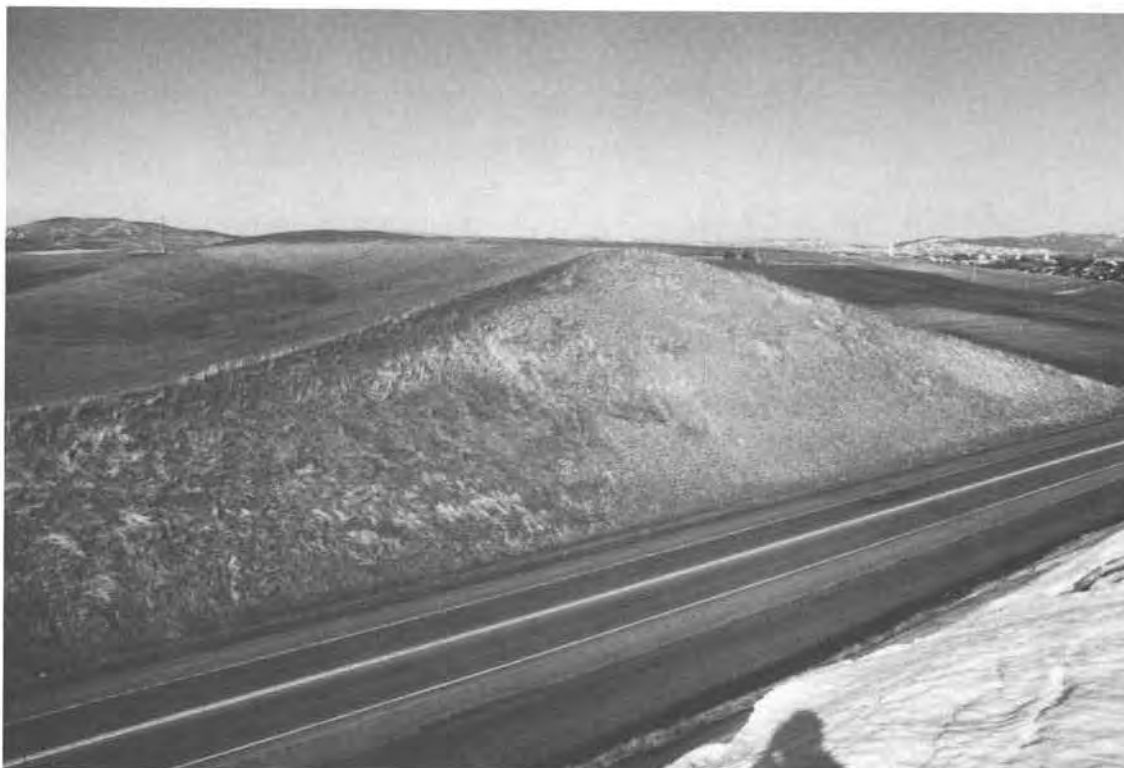
Figure 18. South-facing slope near Pullman shows little degradation. Cut is about 60 ft high.

other orientation. Figures 18 and 19 show south- and north-facing slopes (respectively) cut in clayey loess at 2H to 1V. Note that Figure 18 shows that some erosion has occurred in the area where small patches of vegetation and soil have slipped away. However, the north-facing slope (Figure 19) has experienced numerous shallow failures which have stripped the vegetation. Obscured by the snow drift are scarps from larger failures, which have occurred over the past several years, that have significantly steepened the crest of the slope. The result of the shallow slides is exposure of bare soil and rapid formation of erosion gullies, some of which range up to 1.5 ft in depth in the slope shown in Figure 19.

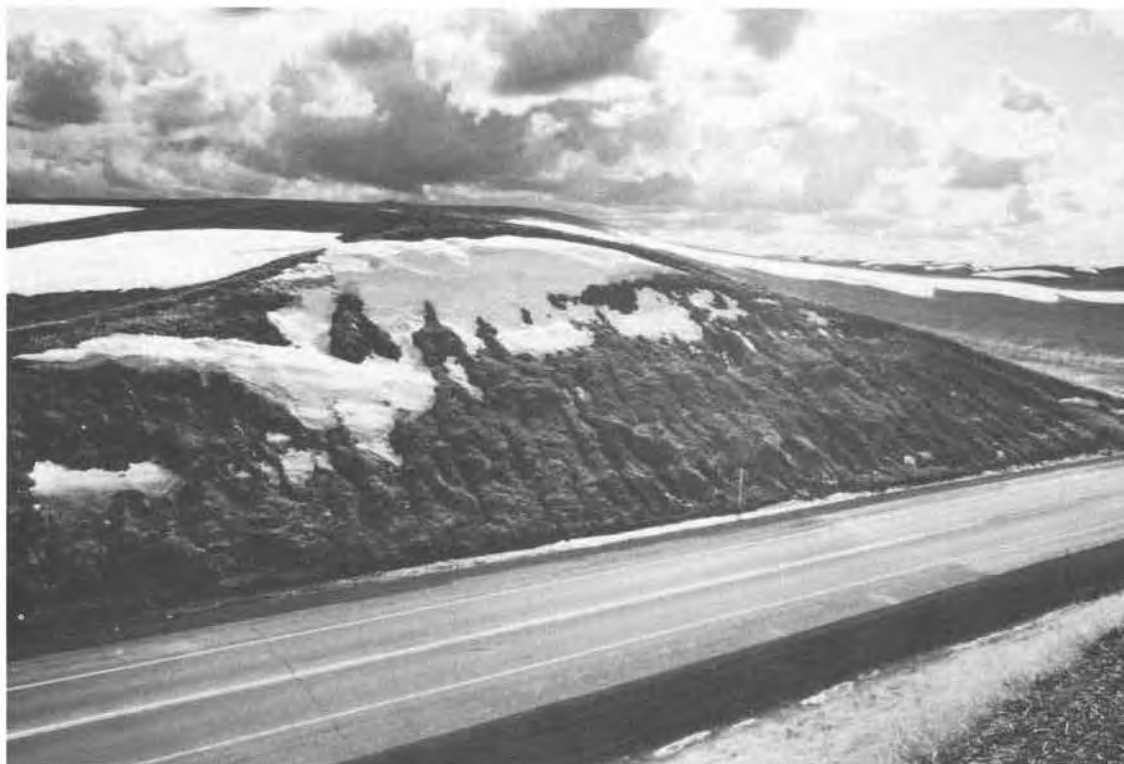
Figure 19. North-facing slope (counterpart of slope in Figure 18) exhibits slide scar and severe gully erosion.

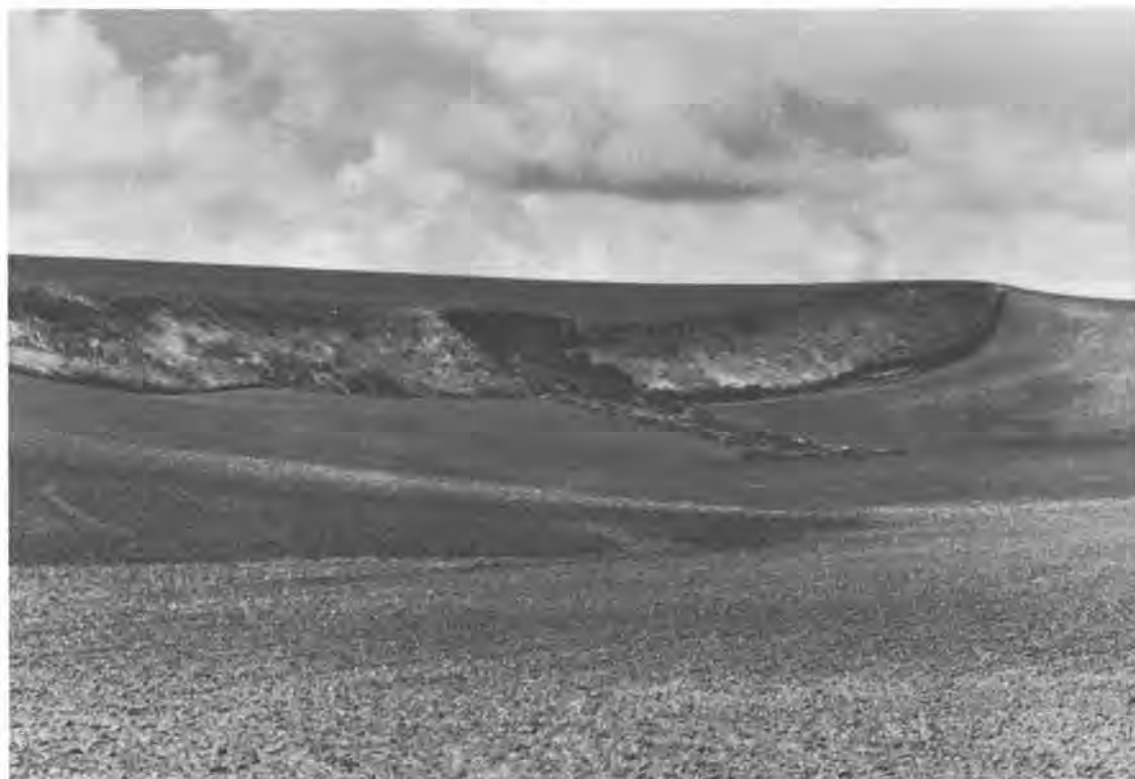
Figure 20. A slump/earthflow in clayey loess near Pullman.

The rotational failure observed during the spring of the field study was a slump/earth flow in a natural slope in clayey loess soils. The slope was inclined approximately 2H to 1V, the head scarp was approximately 15 ft high, and the failed material flowed about 50 ft from the toe of the scarp (Figure 20). The failure occurred where runoff and ground-water seepage from the surrounding field could be expected to collect and saturate the soils.

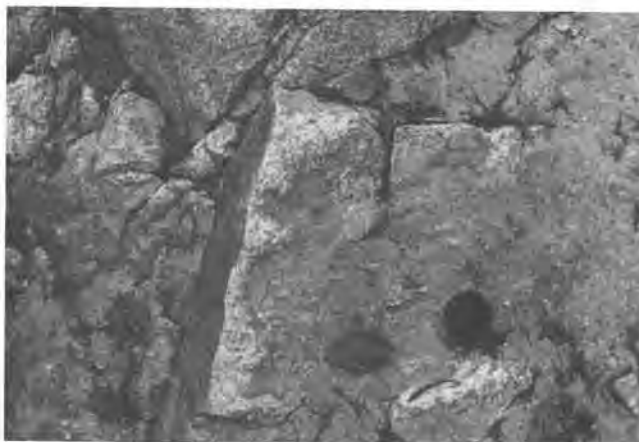
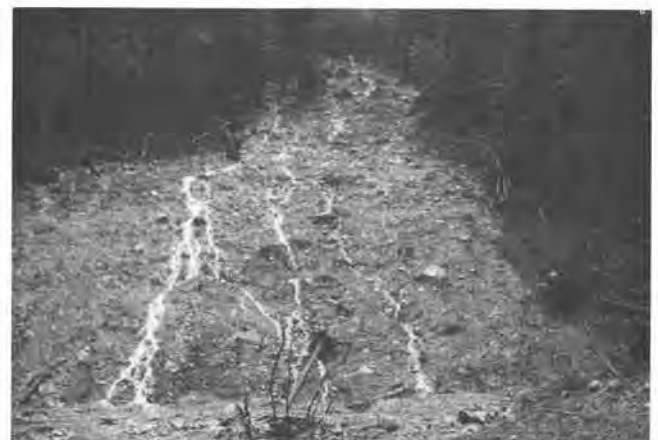
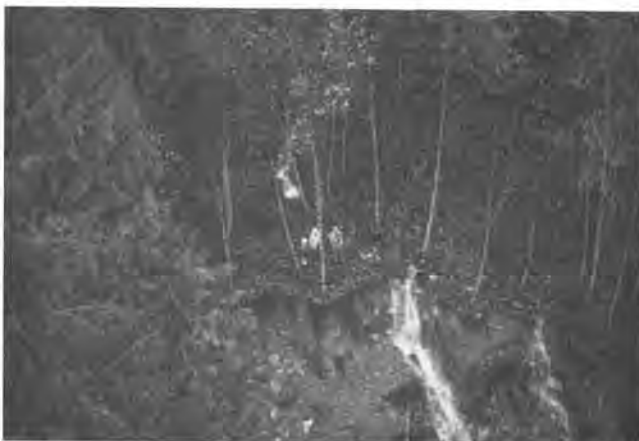
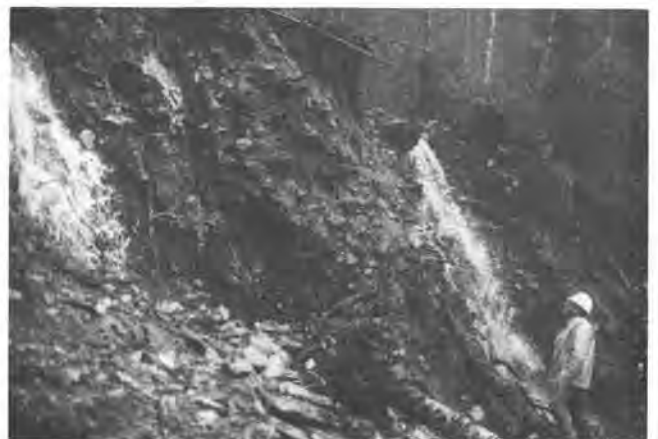
Figure 6. (a) Till lodged on meta-quartz diorite; (b) view from near the county road upslope toward the headscarp area. Note the shallow nature of the slide and the abundant surface runoff; (c) surface drainage at the head of the slide; (d) contact between the base of the road fill and pre-road ground surface located near center of photograph. Note the buried log in the right center of the photograph. Photographs by G. W. Thorsen, 1985.

Slope failure was estimated to have taken place at the contact between the weathered and unweathered till.

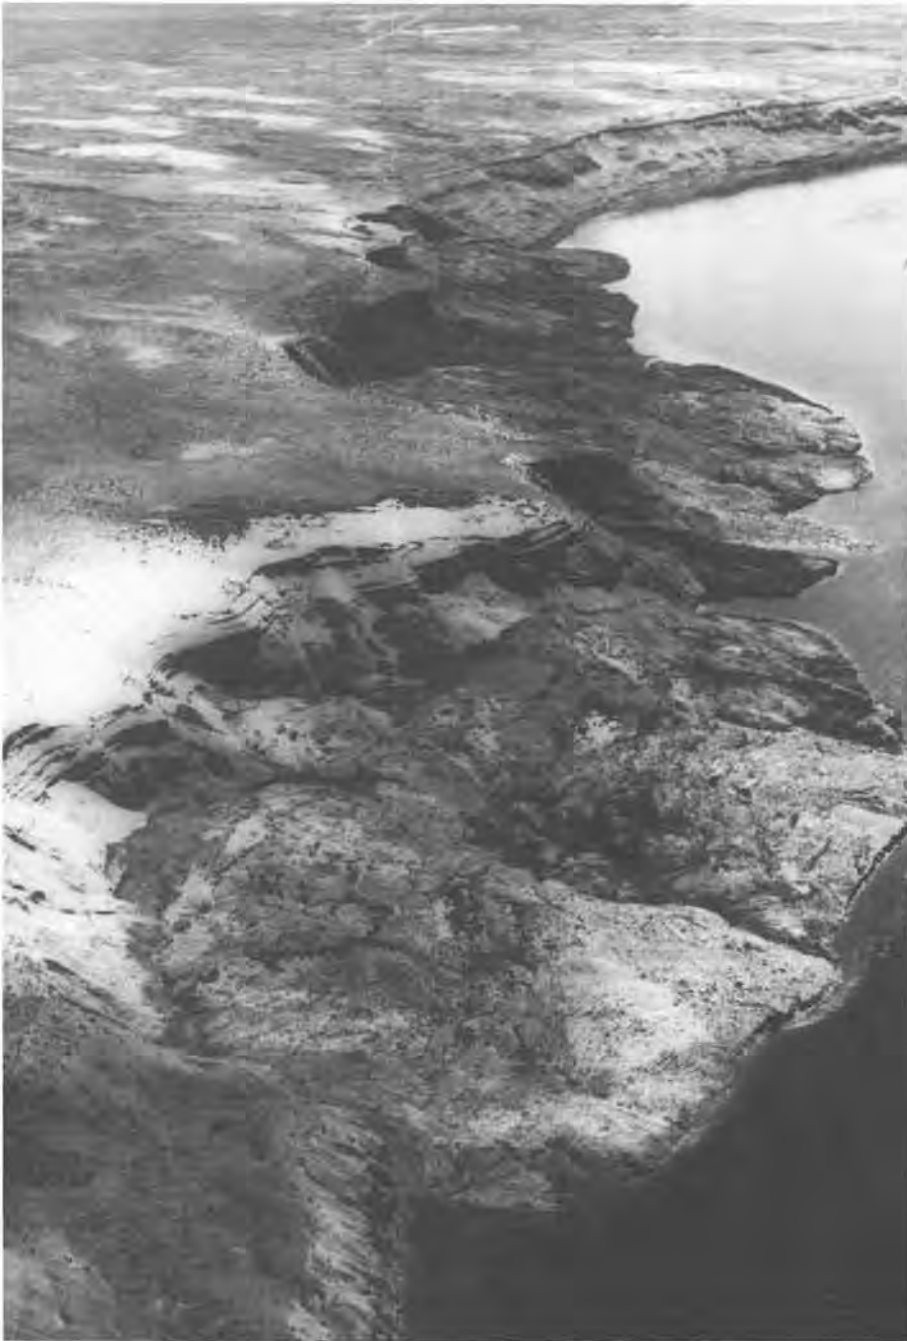
Figure 2. Locke Island landslides and northeast channel of Columbia River; view downstream. See Figure 3 for scale. Photograph by H. S. Holmes, U.S. Bureau of Reclamation, April 1985.

The total area of landsliding in the Locke Island area is about 68 ha; of this, 59 ha consists of active landslides (less than 15 yr old). The total volume of these active landslides is estimated at 12 million cu m. The slides generally started as deep-seated slump blocks; in descending the slope toward the river, they have been transformed into thick trains of earth-flow debris. The toes of individual landslides have progressed as much as one-third of the way (150 m) across the northeast channel of the river (Figures 2, 3, and 4).
