Seattle Freeway Construction, Interstate Highway 5, 1960-1966

KENNETH A. JOHNSON

Washington State Department of Highways, Retired

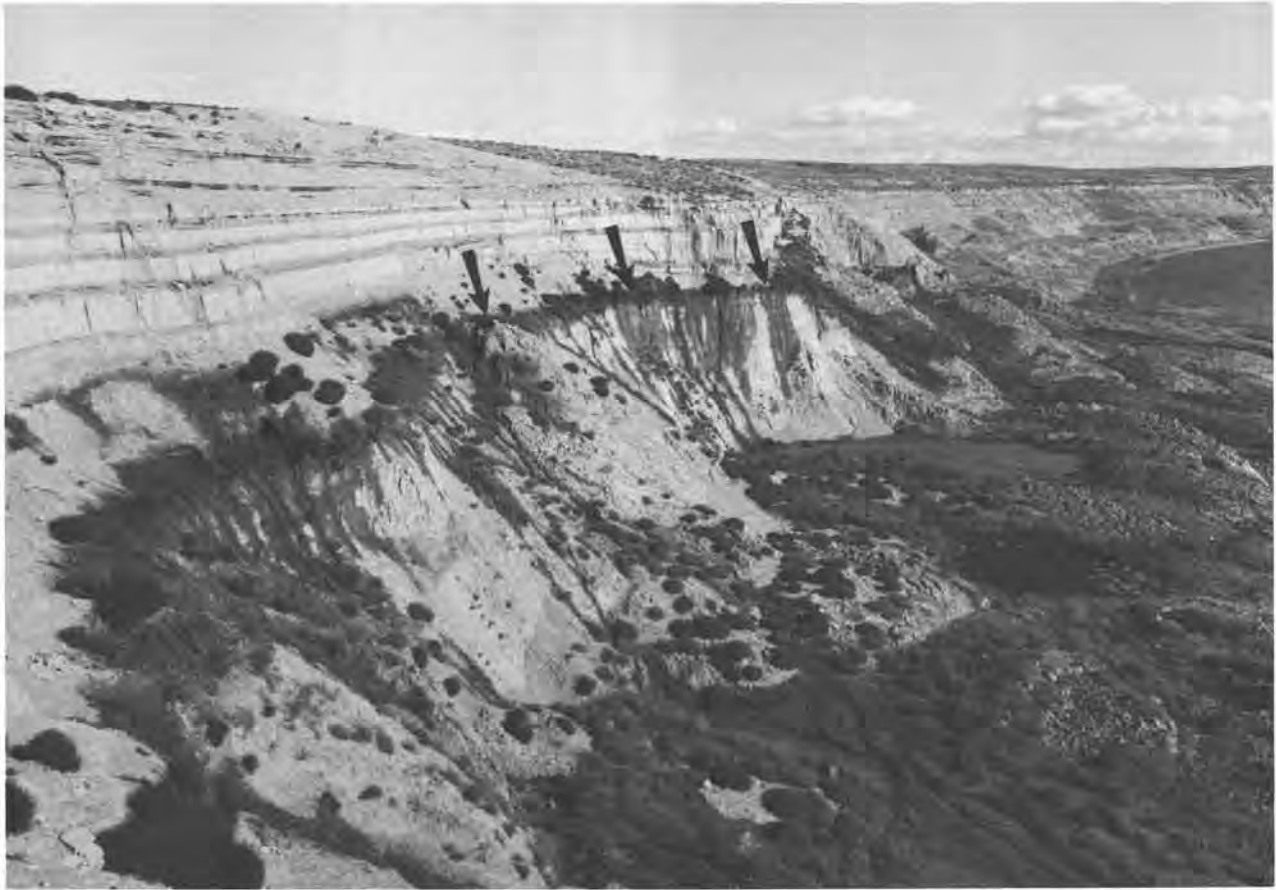
Figure 5. Seepage of irrigation waste water from the face of a 40-m-high head scarp of an active landslide in the Locke Island landslide area. Seepage (dark horizontal band on face of scarp) is concentrated at contact (arrows) between the Ringold Formation and overlying, more pervious Quaternary sediments.

vious layers within the formation. This seepage emerges from the bluffs as springs flowing from the landslide head scarps (Figure 5).

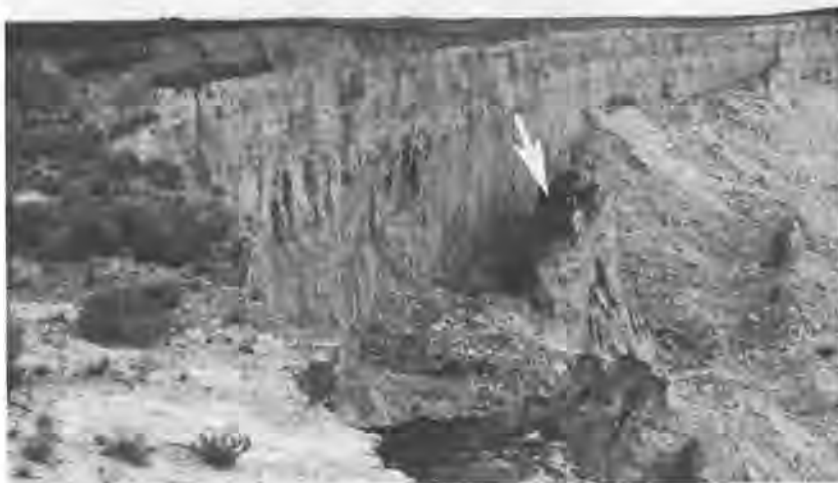
Figure 9. View to the south along the 20-m-high head scarp of the active Savage Island landslide, spring 1981. Note nearly intact Ringold Formation blocks that recently had calved from the head scarp. Older blocks have moved downslope and broken up. Note dark-colored alfalfa still growing on top of one block (arrow).

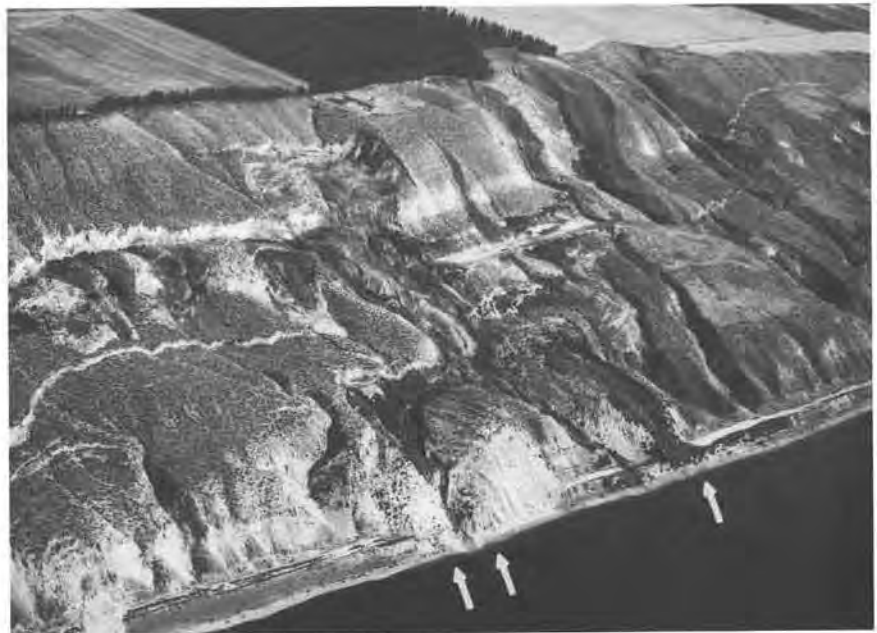
Figure 14. South end of the Johnson Island landslide area, showing the 0.5-km-long shear crack (white arrows) that formed along the upper face of the bluffs in 1981.

A 0.5-km-long shear crack (Figure 14) formed along the south end of the bluffs in 1981 on a part of the slope that had previously been inactive. The upper face of this separation forms the head scarp (as much as 3 m high) for a large, slowly creeping landslide that is evident lower in the slope mainly by a slight bulging of the downslope profile. Differential movement between the upper and lower sides of the crack has averaged 0.25 m/yr (slope measurement) in the 6 yr since the crack occurred.
