A SURVEY OF DEFENDED ENCLOSURES IN PEMBROKESHIRE, 2006-07: GAZETTEER OF ORDNANCE SURVEY GRID SQUARES SM70 AND SM80

RHIF YR ADRODDIAD / REPORT NO. 2007/01
RHIF Y PROSIECT / PROJECT RECORD NO. 54269

SITE GAZETTEER OF 10KM GRID SQUARES SM70 and SM80

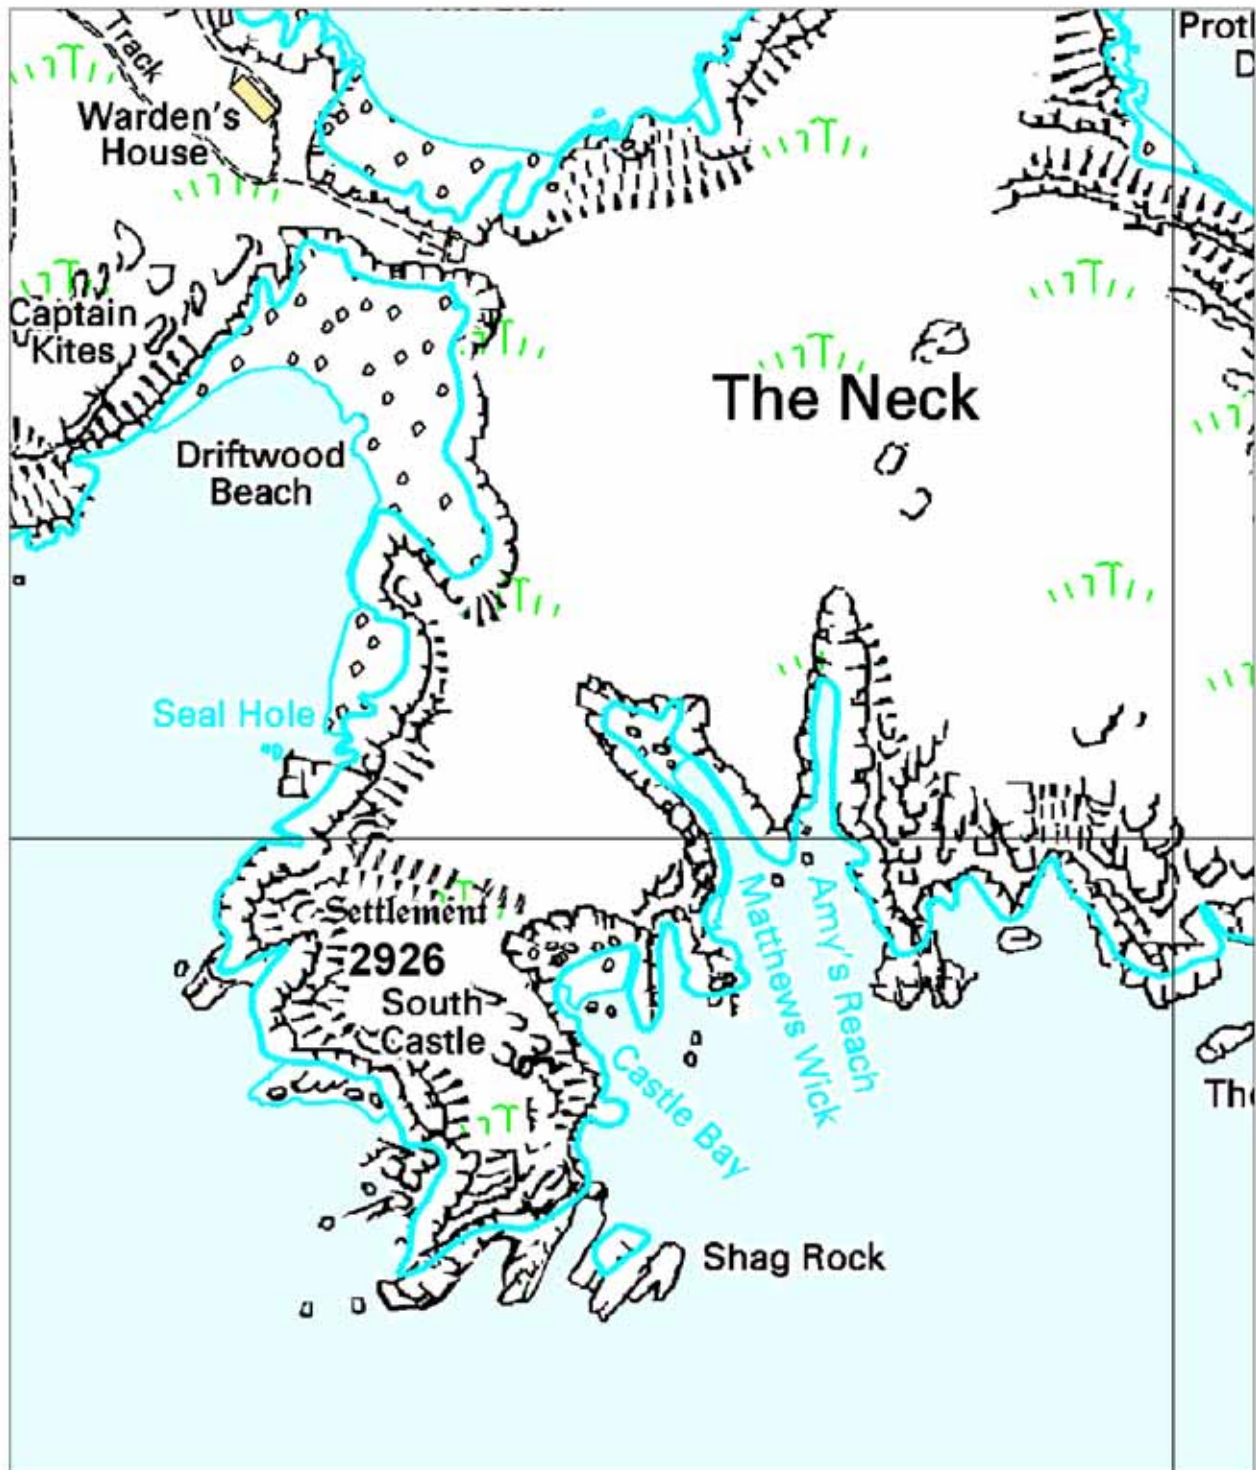
2926 SOUTH CASTLE

South Castle is a univallate coastal promontory fort located on Skomer Island. The site is well defended on the west, south and east sides by high sea cliffs. A c.105m long rampart runs across the neck of the promontory cutting it off from the rest of the island. The rampart consists of a bank and ditch with an external counterscarp bank. A simple gap through the rampart towards the eastern end marks the entrance. The interior is irregular in shape and measures approximately 130m N-S and 140 E-W. Vegetation consists of rough grass. Damage to the site is being caused by rabbits and burrow nesting birds.

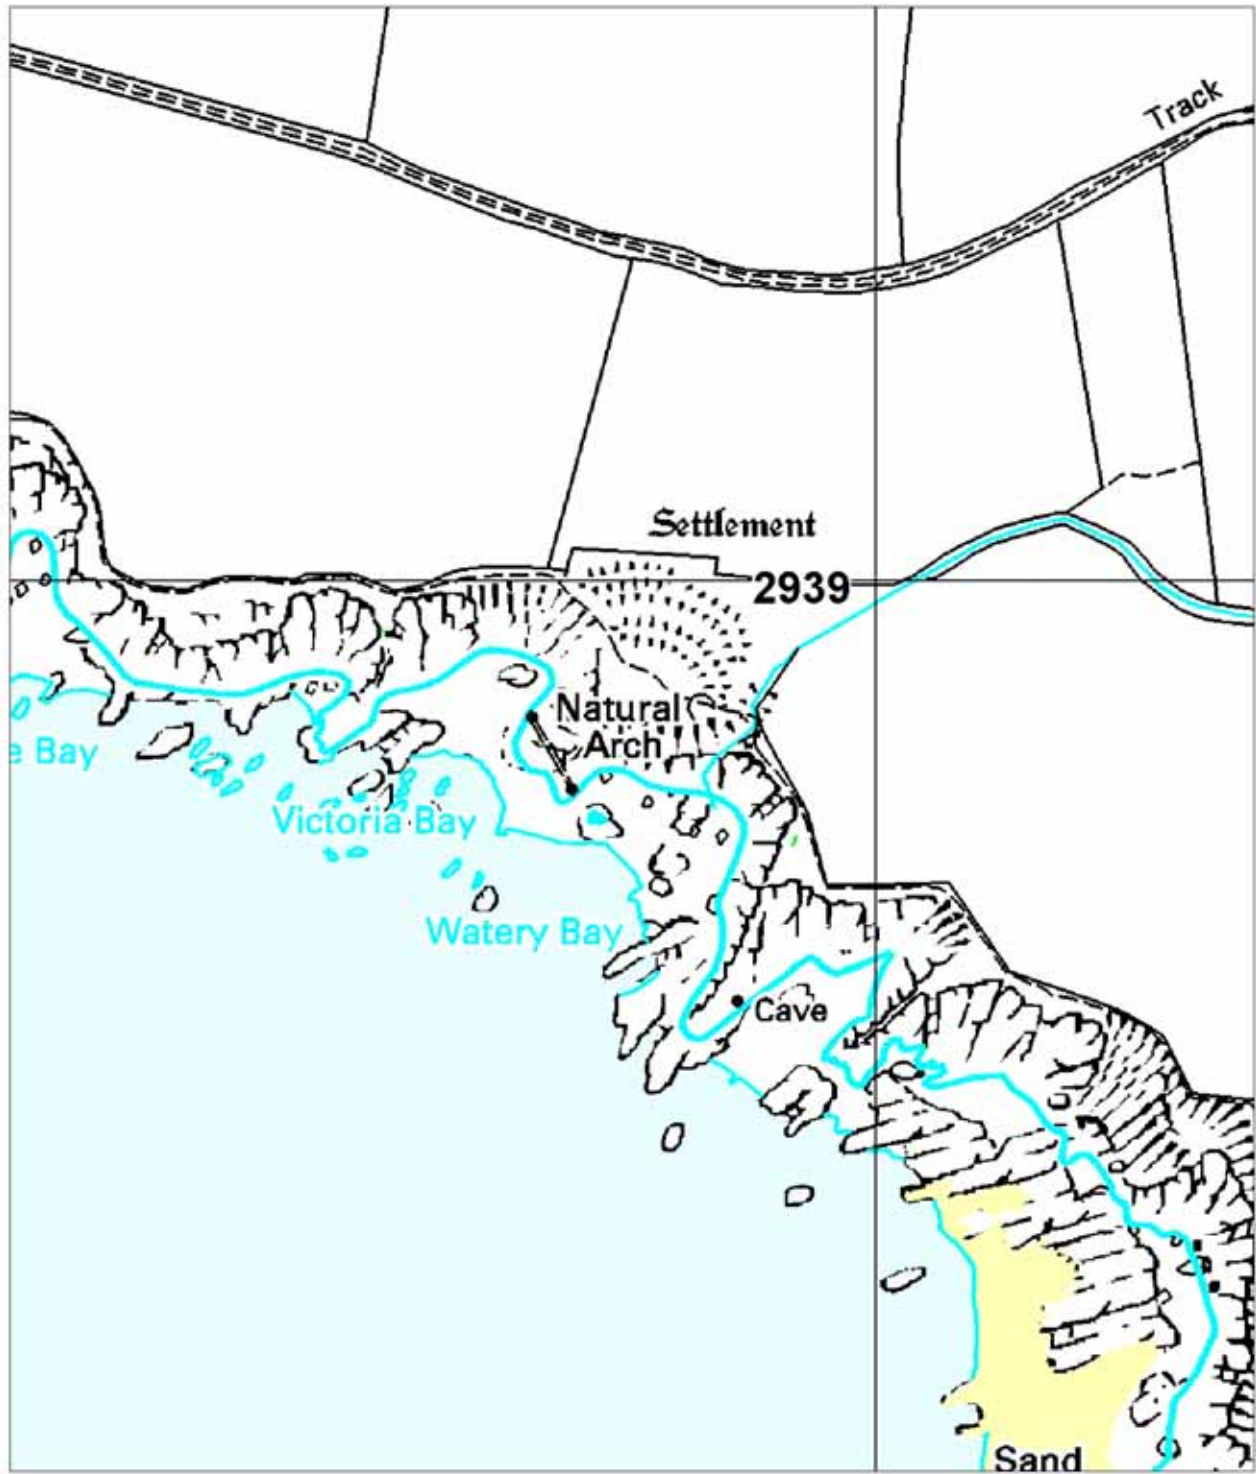
2939 MARLOES SOUND RATH

South Castle Rath is a multivallate coastal promontory fort. Its western and southern sides are protected by high sea cliffs, its northern and eastern sides are defended by three lines of curving bank and ditch. The inner bank is the most substantial and is flanked by an outer ditch, then a small central bank, a second ditch, a third bank and finally an outer ditch. The whole system is c. 115m long and 35m wide. A natural gully runs along the eastern side of the site; the defences stop short of this gully providing a simple entrance. A low bank curving along the cliff top on the east side of the interior seems to be part of the defensive circuit. The interior is level and measures 60m E-W and 45m N-S; it is assumed that some has been lost to the sea. The site is under rough grass with bramble and bracken over the banks.

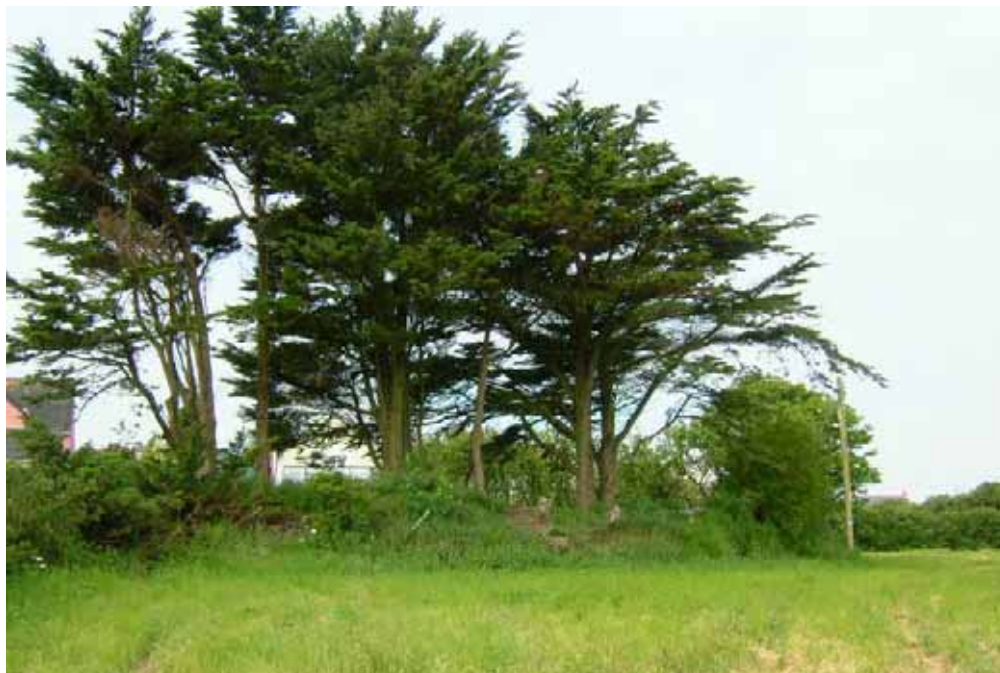
This small circular enclosure, c. 45m diameter internally, is now hardly recognisable owing to development and general degradation. It lies on land that is almost level at 40m above sea level. The enclosure has been divided into two halves by a boundary running approximately east to west, with Glebe House in the northern half and Foxdale House in the southern half. The earthwork defensive circuit of the enclosure is now hardly detectable as such, apart from to the east and northeast of Glebe House where the garden boundary consists of an earth and stone bank up to 3m wide and externally up to 2m high. Internally it is only 1m high. Immediately to the north of Glebe House and to the east of Foxdale the bank has been removed. To the south of Foxdale the defensive bank survives as a hedge bank. To the west of Glebe House and Foxdale the line of the defensive bank lies beneath a public road and had been removed by the end of the 19th century. Apart from a slight depression on the northeast side of the site there is no trace of a defensive ditch external to the defensive bank.

Ground photograph looking NW at defensive bank of enclosure 2959 from the outside.

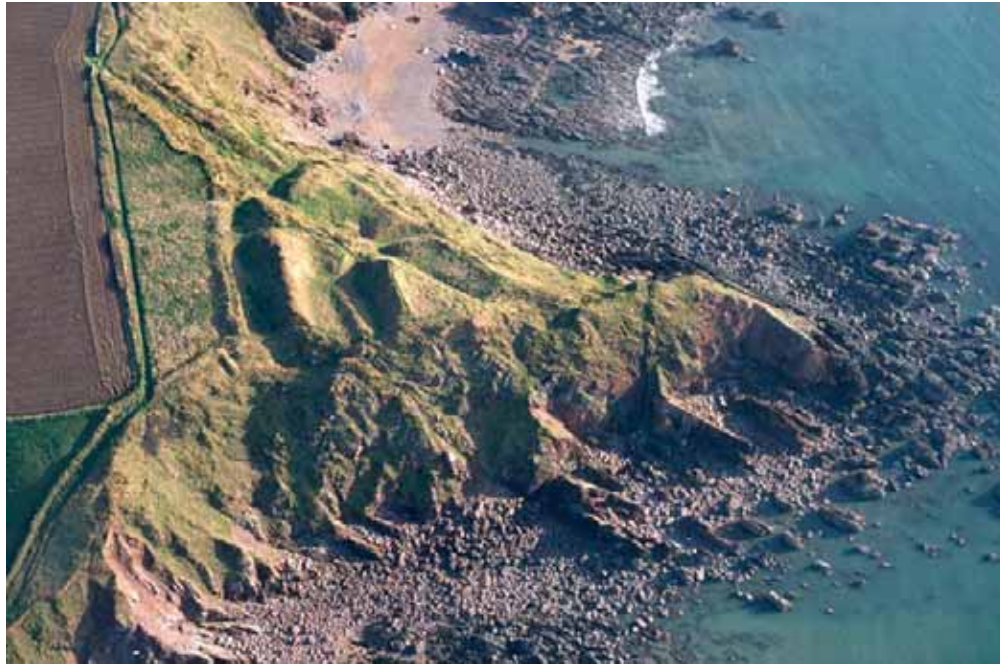
Great Castle Head is a coastal promontory fort that has suffered severe coastal erosion. The defences consist of two banks and ditches. The inner bank is c.4m high and 12m wide. Outside of it is a ditch c. 1m deep. A berm between 5m and 20m wide separates this ditch from the outer bank, which is c.3 high and 12m wide. There is an outer ditch, c.1m deep, to this bank. Erosion and excavation have shown the inner bank to be of earth construction with some stone retaining walls. A simple gap runs through the centre of the banks and ditches marking the entrance. The southern half of the site, including the defences, is now 7m lower than the remainder of the fort owing to massive rotational slumping. The interior area is now very small, triangular in shape, approximately 20m by 30m and is divided by the slumping. The site is under rough grass and bracken.

Aerial photograph of 2960. RCAHMW Crown Copyright ©
reference DI2006_1235.

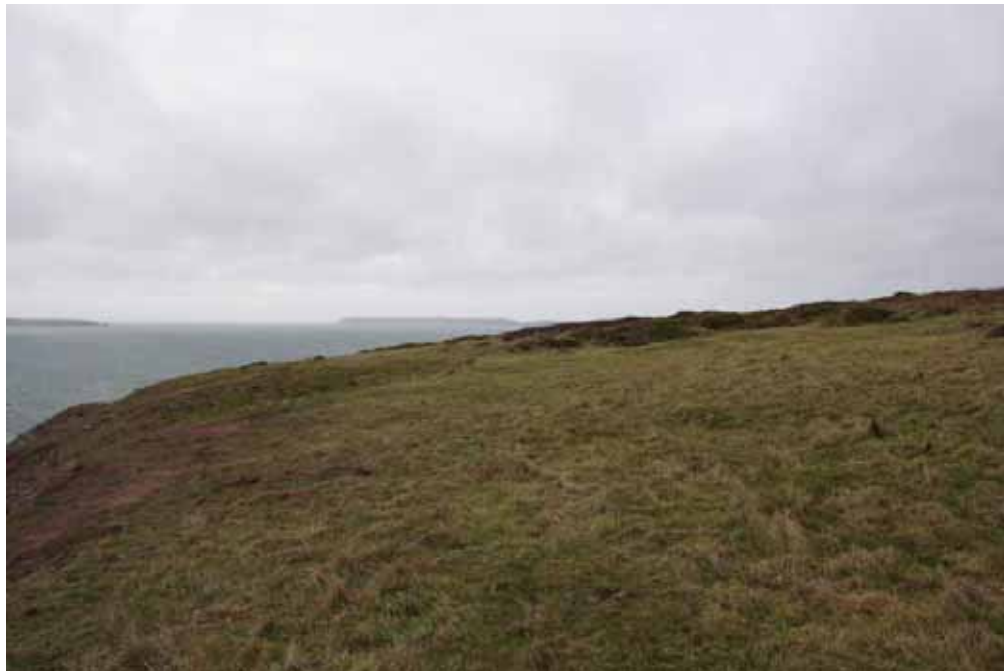
Little Castle Point is a small, univallate, lightly defended coastal promontory fort. It occupies a blunt promontory at 40m above sea level and is naturally defended by sea cliffs to the north, west and south. To the east land rises gently away from the site - a c.75m long curving rampart protects this side. The rampart consists of a 5m wide bank rising 0.6m above the interior and 1.5m above the ditch. The ditch is c.3m wide. Both the bank and ditch become slighter to their southern ends, with the bank fading entirely. A simple gap in the rampart on the southeast side marks the entrance. The slightly sloping interior has very slight undulations, but nothing that can be interpreted as house platforms. A WW2 military base (Kete Camp) lay to the east, with one installation immediately to the east of the fort. This is now demolished (as is the rest of the base) and the remains pushed into a high bank - there is also a spread of brick and rubble to the east of the defences, as well as a small pocket of brick rubble within the interior. However, a 1946 aerial photograph, reproduced on a display board on a nearby National Trust car park, shows that the military works did not encroach onto the fort. The northern end of the rampart is suffering some limited coastal erosion, and there is some evidence of slumping along the cliff margin to the north and south of the fort. There is also a little soil erosion to the south of the fort. Apart from these problems the site is in very good condition. The vegetation is mostly coastal grass, grazed by ponies, with gorse scrub over the most of the ramparts.

Ground photograph looking NW towards promontory fort 2962.

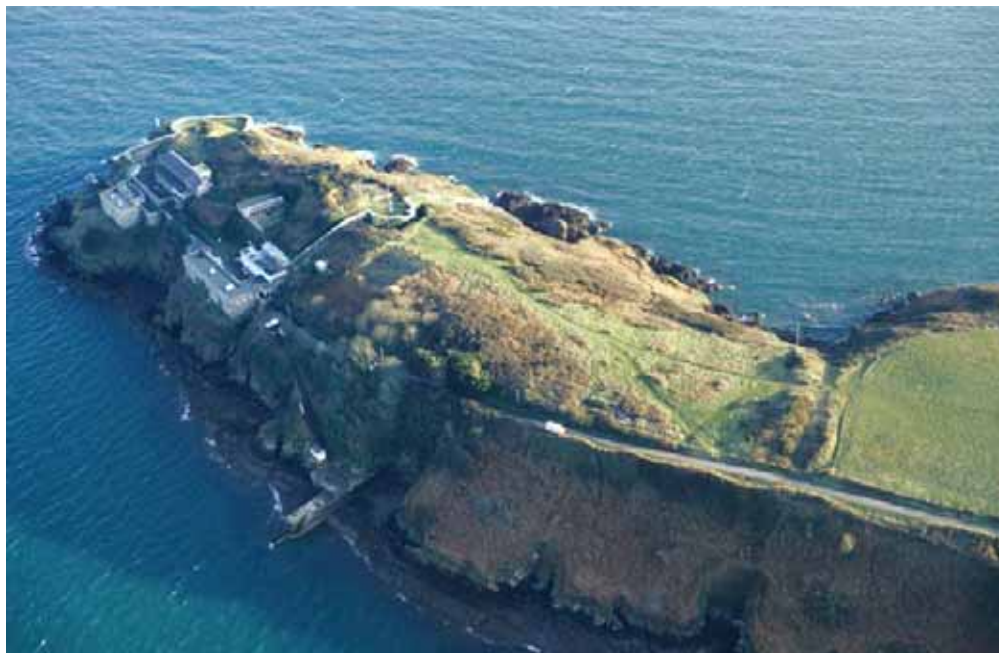
Dale Point is a univallate coastal promontory fort. A single bank and ditch run across the narrowest point of a long promontory enclosing an area 320m E-W and 120m N-S, making it one of the largest prehistoric forts in southwest Wales. The bank and ditch are about 90m long with a low counterscarp bank and with an entrance towards the south end. The bank stands about 2m above the interior and 3m above the base of the ditch. The counterscarp is about 0.4m high. The bank is somewhat mutilated: there is a modern entrance cut through it, the entrance area was not restored to its original state following excavation, and the south end of the bank is suffering from erosion.

Aerial photograph of 2986. RCAHMW Crown Copyright ©
reference DI2006_1245.

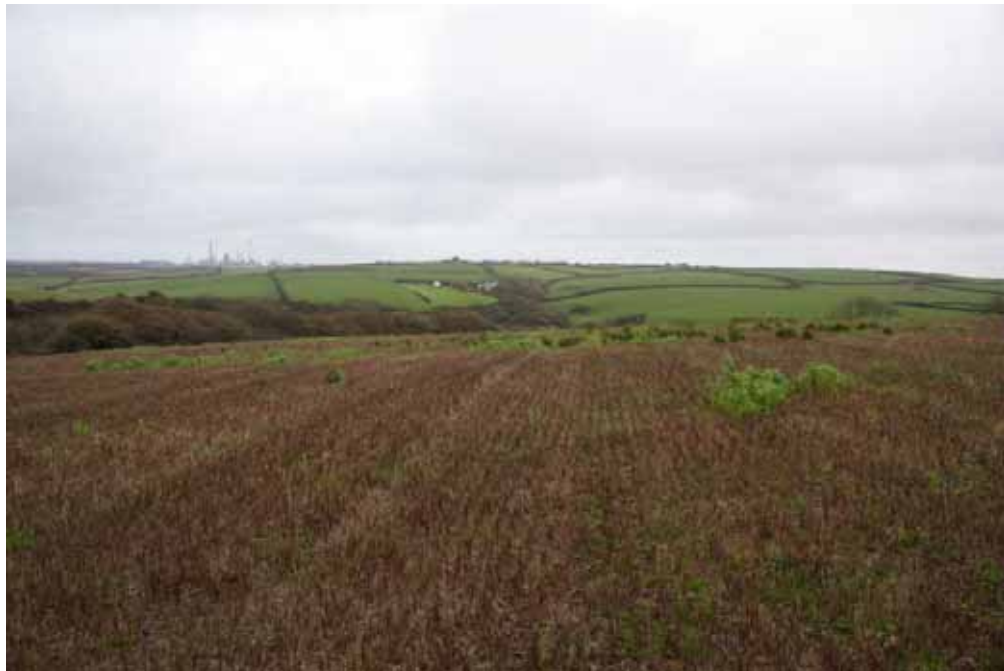
Brock's Castle is a small, univallate, sub-rectangular defended enclosure that was an upstanding earthwork until recently, but has now been levelled. It lies on a gentle northeast-facing slope at c.30m above sea level. It was described by the Ordnance Survey in 1966 as sub-rectangular approximately 50m across. The bank was highest on the up-slope, west, side where it stood up to 1.7m high. On the north side the bank faded to a scarp and was plough-levelled on the southeast side. There was a trace of shallow ditch outside the bank. The site has now been levelled and the only evidence for its presence is a hollow in the field c.30m across and 0.5m wide. The site is under arable cultivation.

Ground photograph looking E over site of levelled enclosure 3022.

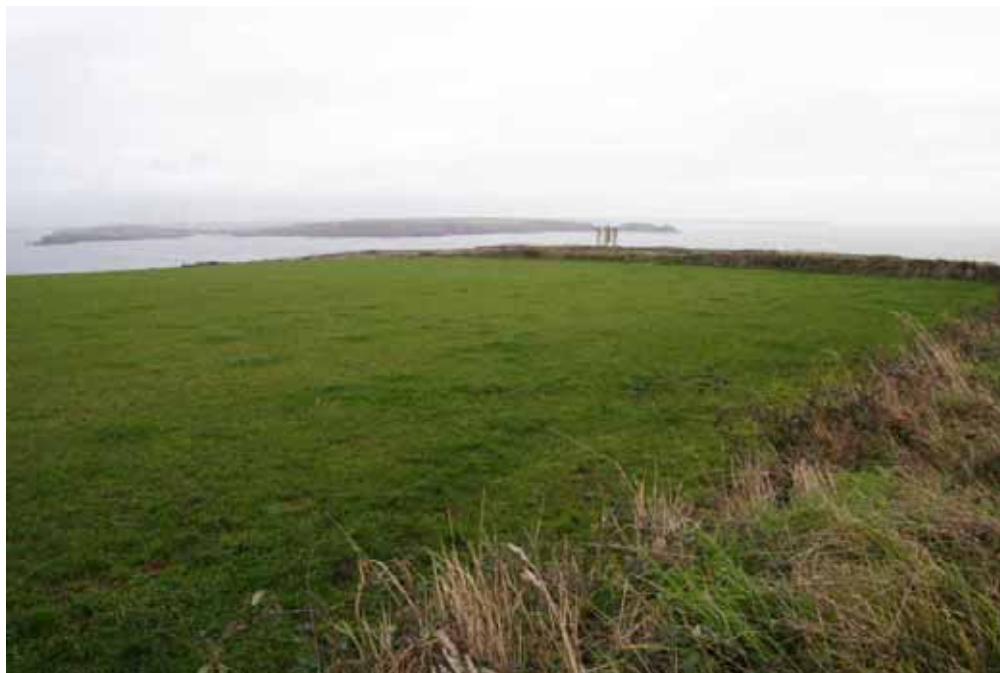
A small circular cropmark enclosure was identified on vertical aerial photographs by the Ordnance Survey. Field visits by the OS showed the enclosure was plough-spread, but had a stony scarp surviving up to 0.5m high, except on the south side where it was lower - the location of the presumed entrance. The enclosure was about 40m diameter. There is now no trace of this enclosure. It lies on a gentle southeast facing slope, 450m southwest of a rounded hilltop, at 57m above sea level overlooking the entrance to Milford Haven. The site is under improved pasture.

Ground photograph looking SE over site of cropmark enclosure 3053.

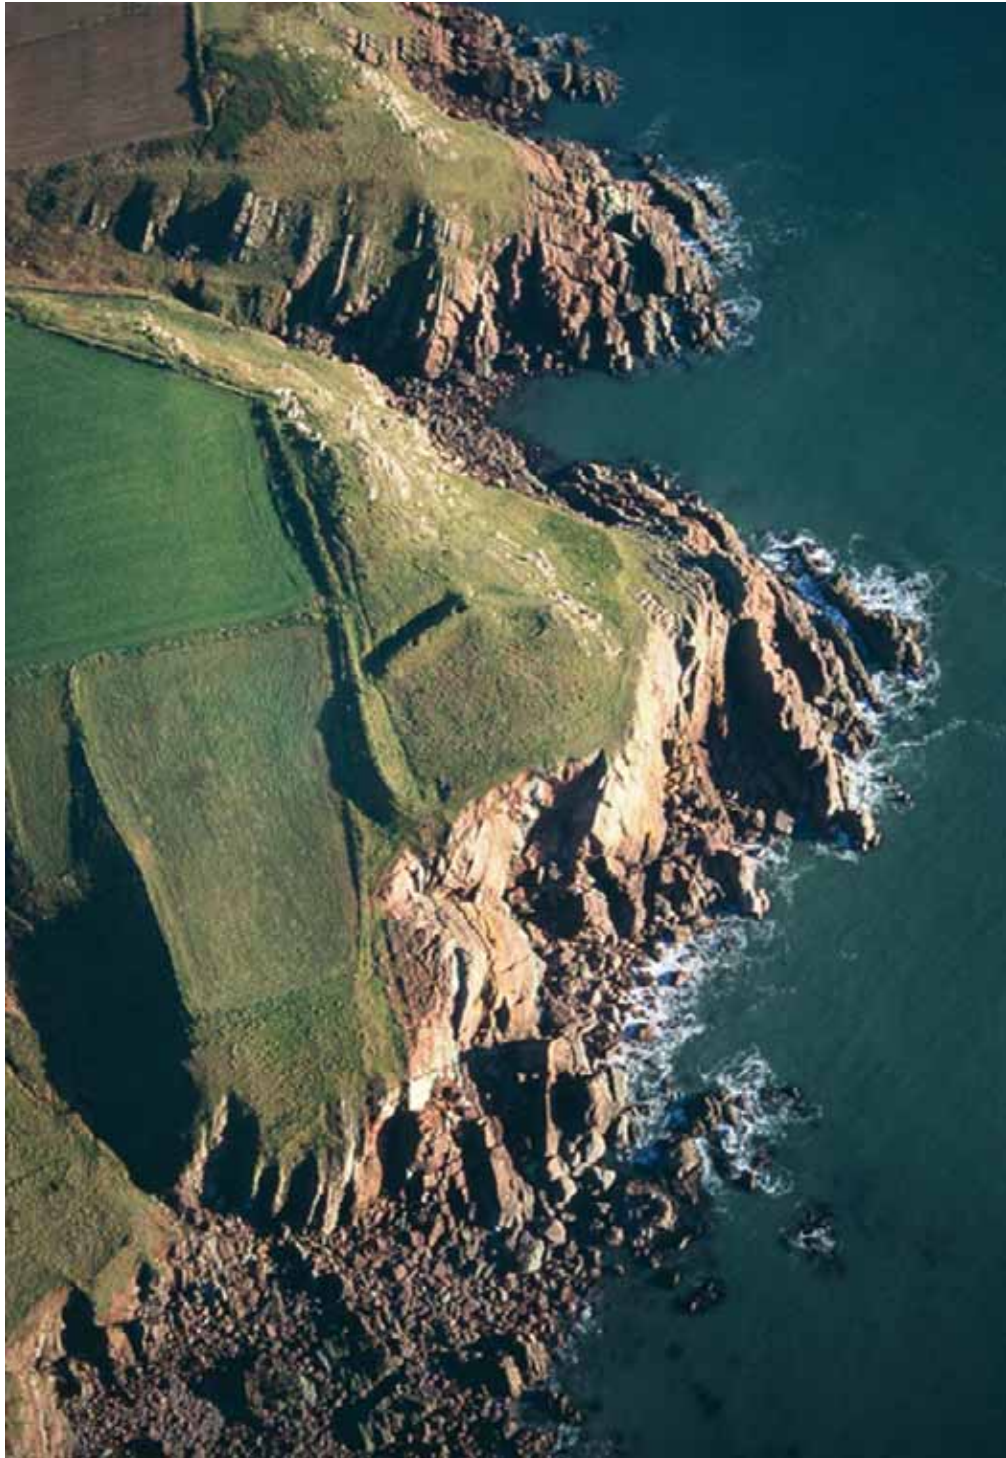
West Pickard Camp is a univallate coastal promontory fort occupying a blunt headland at c.40m above sea level. It is protected by sea cliffs to the west and south and by a c.105m long curving rampart to the north and east. The bank is 1.3m high internally and 3m externally above the ditch. On the east side the ditch is rock-cut. The entrance at the southeast angle of the rampart is a simple gap. A boundary bank runs along the defensive bank at its western end. The bank and ditch have been disturbed by 20th century military installations, including four depressions on the bank - probably weapons' pits. There is also an 8m circular gun emplacement (PRN 32765) on the east side of the interior. The rounded interior slopes gently down towards the sea and measures c. 52m E-W and 60m N-S. The site is under coastal grass. Some erosion is being caused where the Pembrokeshire Coastal Path crosses the ramparts, and coastal erosion is eating into the western side of the fort.

Aerial photograph of 3099. RCAHMW Crown Copyright ©
reference DI2006_1232.

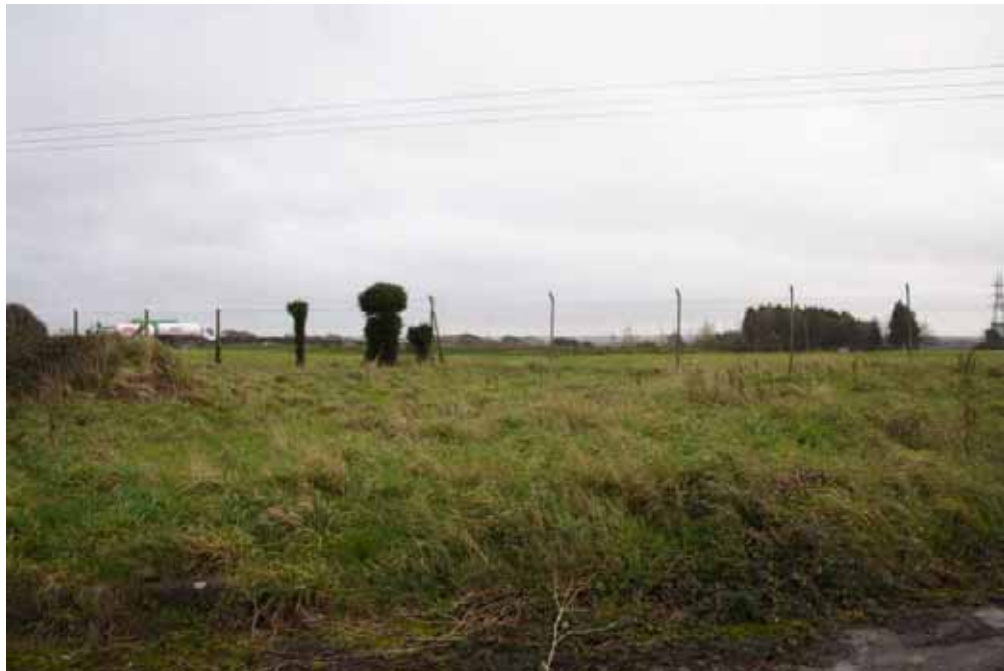
A possible small, circular, earthwork enclosure approximately 40m across with a possible southeast-facing entrance is visible on vertical aerial photographs. It is located on level ground at about 65m above sea level. This is not a certain site, and the low earthworks may be entirely natural. The site is now within the security compound of an oil refinery. The field in which the site lies is mostly used as a car park and minor installation. The site itself is in a unused part of the field and is under long grass. The location of the site was viewed only from the edge of the field, outside the compound and therefore its character and condition could not be assessed.

Ground photograph looking SE over site of former cropmark 12103.
