# A SURVEY OF DEFENDED ENCLOSURES IN PEMBROKESHIRE, 2006-07: GAZETTEER OF ORDNANCE SURVEY GRID SQUARES SN04 AND SN14

RHIF YR ADRODDIAD / REPORT NO. 2007/01 RHIF Y PROSIECT / PROJECT RECORD NO. 54269

#### SITE GAZETTEER OF 10KM GRID SQUARES SN04 and SN14

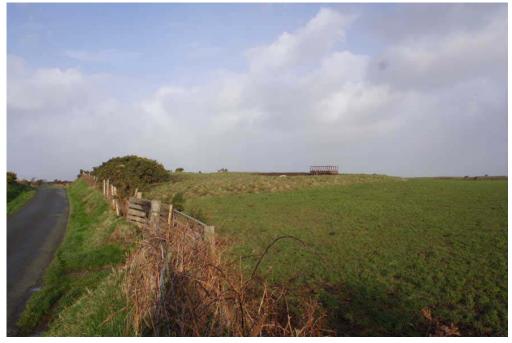
Y Gaer is a small, oval defended enclosure occupying slightly raised knoll on an undulating plateau at c.165m. Land falls away steadily to the northwest, west and southwest providing panoramic view in these directions. To the east the land rises very gently. The enclosure measures c.55m north-south and 40m east-west. It is defined by a low scarp to the north and west and by plough-reduced remains of a bank and ditch to the east and south. A simple entrance faces south. The interior is slightly dished. The enclosure is under long grass with gorse of the scarp slopes, but the field in which it lies is cultivated for barley.

Ground photograph looking N towards earthwork enclosure 1149.

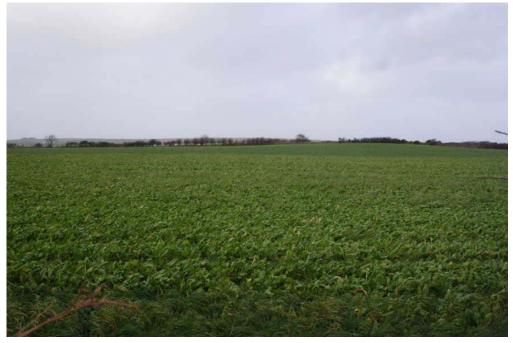
The enclosure lies on almost level ground at 160m above sea level. Immediately to the east and northeast the land rises a few metres on to a low ridge - the enclosure is overlooked from this ridge. In December 2006, the site was under a turnip crop. There were no earthworks or other surface evidence for the site.

Ground photograph looking N over site of cropmark enclosure 1152.

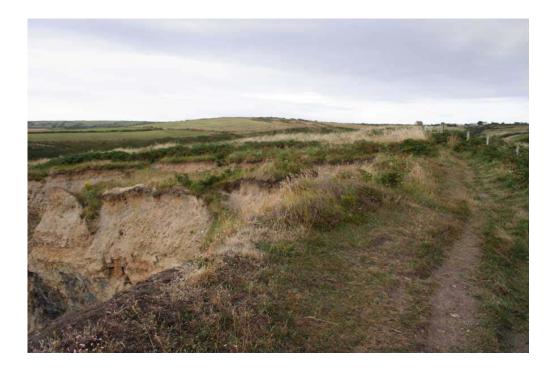
The site is located on shale bedrock overlain by glacial clays and gravels. The softer geological deposits have suffered severe erosion since the Royal Commission visited; the promontory described in 1925 is now a bay and the defensive bank has all but gone.

In August 2006, the landward portion of the site was overgrown with bracken and bramble and therefore the character and nature of any surviving defence was difficult to ascertain. However, it was clear that very little of the bank noted by the Royal Commission survived. A break of slope seems to be its last remnants. Virtually the whole of the interior of the fort has been lost to the sea, and the remainder is suffering severe rotational slumping. A post-hole is visible in the exposed face of one of these slumps. It is only a matter of years before all traces of this site are lost.

General view of eroding site 1157

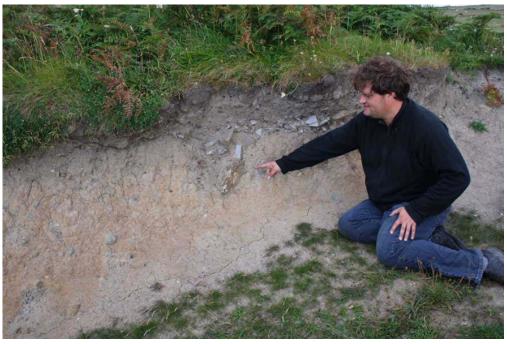
Ground photograph. Detail of post-hole eroding out of slumping.

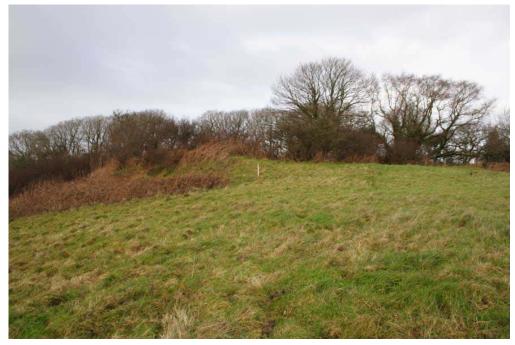
The site is covered with blackthorn scrub, brambles and bracken. The whole site is suffering severe disturbance from badgers.

Ground photograph looking NE at enclosure defences 1173.

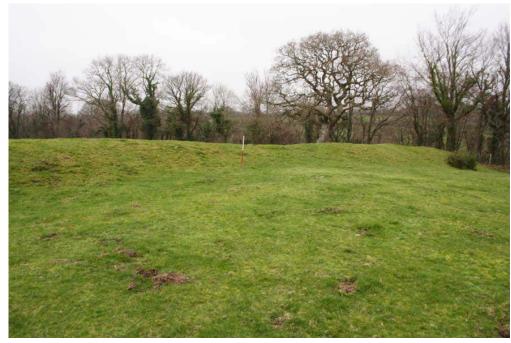
A univallate, inland promontory fort lying at c.50m above sea level. It is naturally defended on the north, west and east sides by steep, 10m-20m high, slopes. A 47m long, 1.2m high bank protects the easily approachable east side. The slopes and the bank define a roughly rectangular area c.110m east-west and 50m north-south. The site is under improved pasture with long grass and gorse on the bank. There is evidence of active badger burrowing in the bank and in parts of the interior. The Ordnance Survey in 1974 recorded that the bank was 1.7m high, in which case it has suffered some degradation over the past 30 years.

Ground photograph looking NW at defensive bank of 1175.

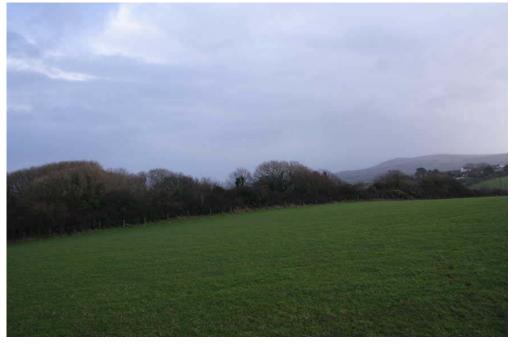
The Ordnance Survey noted two small quarries close to the enclosure - these were not seen in 2006 owing to the vegetation. Many badger runs were noted over the earthworks in 2006, but there did not appear to be any setts in the enclosure itself. Slight surface weathering over the banks revealed their earth and shalely-stone construction.

Ground photograph looking E towards site of enclosure 1587 in bushes.

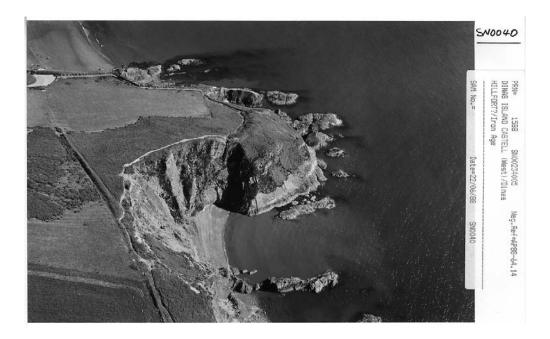
This site is shown on the 1st and 2nd edition Ordnance Survey 1:2500 maps as an earthwork bank with entrance running across the neck of a promontory and is named 'Castell'. The Pembrokeshire Archaeological Survey of 1908 could not find the site, and the Royal Commission of 1925 refer to slight remains of a bank. The Ordnance Survey reference card of 1964 notes the bank and a possible round structure in the centre of the 'fort'. However, later OS investigators and members of Cambria Archaeology in 1994 and 1996 considered the site to be entirely natural. When visited in August 2006 the site was very overgrown, but what is depicted on the early OS maps as an artificial bank is clearly a natural scarp. This is confirmed at its northern end where coastal erosion has stripped away soil showing it composed of bedrock. This site is therefore not an antiquity. The place-name does indicate the (?former) presence of a promontory fort in the vicinity.

Aerial photograph of 1588. Cambria Archaeology reference AP88-64.14.

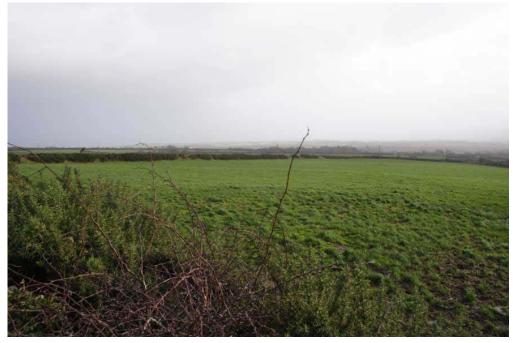
Castell-y-Garn is a small, oval, earthwork defended enclosure lying on a gentle south-facing slope at 145m above sea level. The slightly dished interior measures c.50m W-E and 42m N-S. It is defined by a spread bank, 10m-12m wide and up to 0.5m high above the interior. Externally the bank rises c.1m above the exterior of the enclosure on the N, W and E sides and up to 1.5m on the down-slope, S, side. A lower section of bank on the E side indicates the position of a simple entrance. There is no trace of an external ditch. In 2006 the enclosure was under improved pasture.

Ground photograph looking SE over earthwork enclosure 1597.

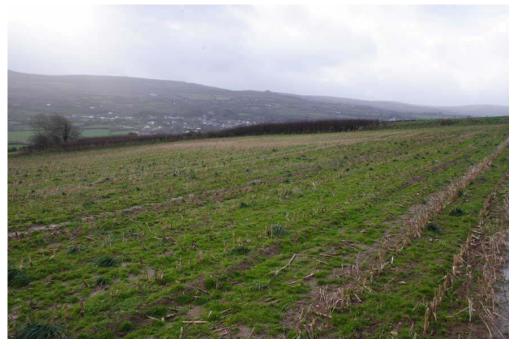
When visited in 2006 the site had been under a maize crop.

Ground photograph looking SW over site of low, earthwork enclosure 1612.

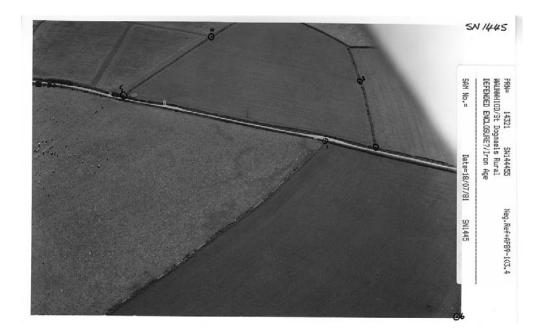
Aerial photographs show a crop-mark ditch of an oval, defended enclosure. The ditch encloses an area c.50m east-west by 45m north-south. There is an entrance on the east side with slight crop-mark ditches outside it - these may be part of a ditched track-way approaching the entrance, but they are faint and not clear. There are other, possibly related, fainter crop-marks nearby. The enclosure lies on a gentle southeast-facing slope at 195m above sea level, approximately 300m from a rounded summit at 205m. In 2006, the enclosure was under improved pasture. There were no earthworks or other surface evidence for the site.

Aerial photograph of 14321. Cambria Archaeology reference AP89-103.4.

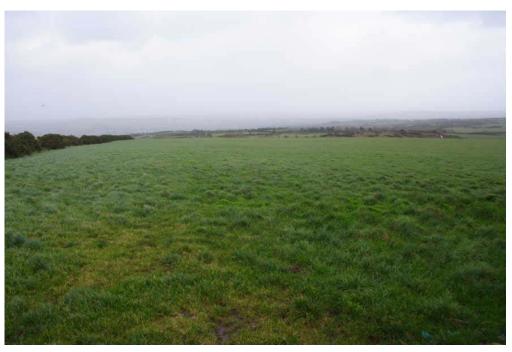
Ground photograph looking E over site of cropmark enclosure 14321.

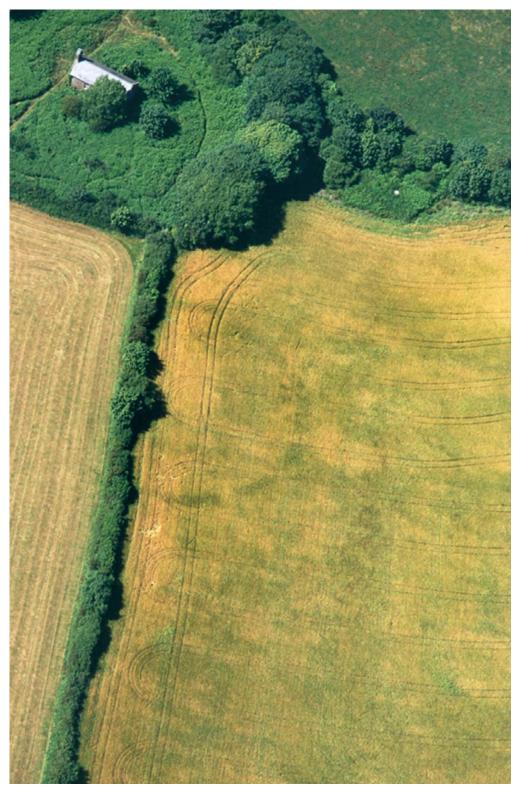
An aerial photograph taken in 2005 shows a crop-marked ditch of a circular defended enclosure. The enclosure lies on roughly level ground at 130m above sea level c.50m southeast of Bayvil Church. The aerial photograph shows a c.4m wide ditch enclosing an area c.60m diameter. A hedge-bank divides the site in two, with two-thirds of the crop-mark enclosure showing in barley on the eastern side - the field to the west was under pasture in 2005 with no visible crop-mark. There seems to be gap in the ditch on the southeast side possibly indicating an entrance. There are other, less well defined, gaps, the result of perhaps of geological anomalies or differential crop growth. However, there is the possibility that this is a segmented ditched enclosure, and therefore not Iron Age.

Aerial photograph of 62206. RCAHMW Crown Copyright  $\ensuremath{\mathbb{C}}$  reference DI2006\_1279.

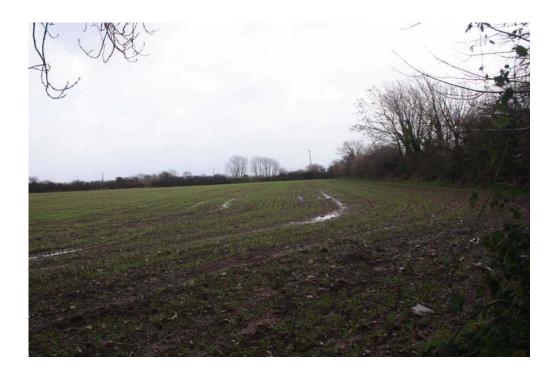
In December 2006 the east field was under maize stubble, the west field under improved pasture. There was no surface evidence for this site.

Ground photograph looking SE over site of cropmark enclosure 62206.

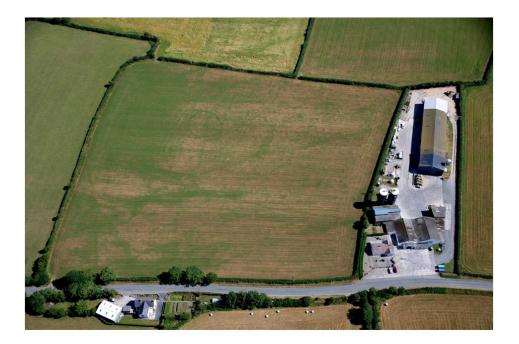
Aerial photographs taken in 2006 show what seems to be a small, sub-circular enclosure with a concentric annexe. A crop-marked ditch defines the enclosure. The ditch is c.2m-3m wide and defines an area c.35m diameter. There may be a northwest-facing entrance through the ditch, but this is not clear. A very thin crop-mark ditch is concentric to the inner enclosure approximately 45m from it. This is visible on the west and north sides only - it probably lies beneath hedge-banks to the south and east. It defines a concentric annexe c.140m diameter. The site lies on level ground at 155m above sea level. In 2006 the site was under improved pasture. There were no earthworks or other surface evidence for the site.

Aerial photograph of 62207. Cambria Archaeology reference AP\_2006\_3904

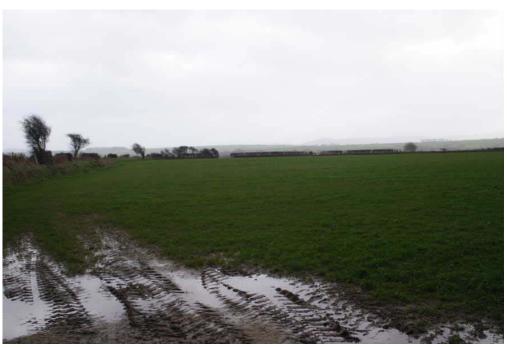
Ground photograph looking S over site of cropmark 62207.
