## Appendix M

### City of San Marcos, Texas State University, and Texas Parks & Wildlife Department Reports/Documents

# Images of the October 2015 Flood Event

Biology Field Crew  
Habitat Conservation Plan, San Marcos

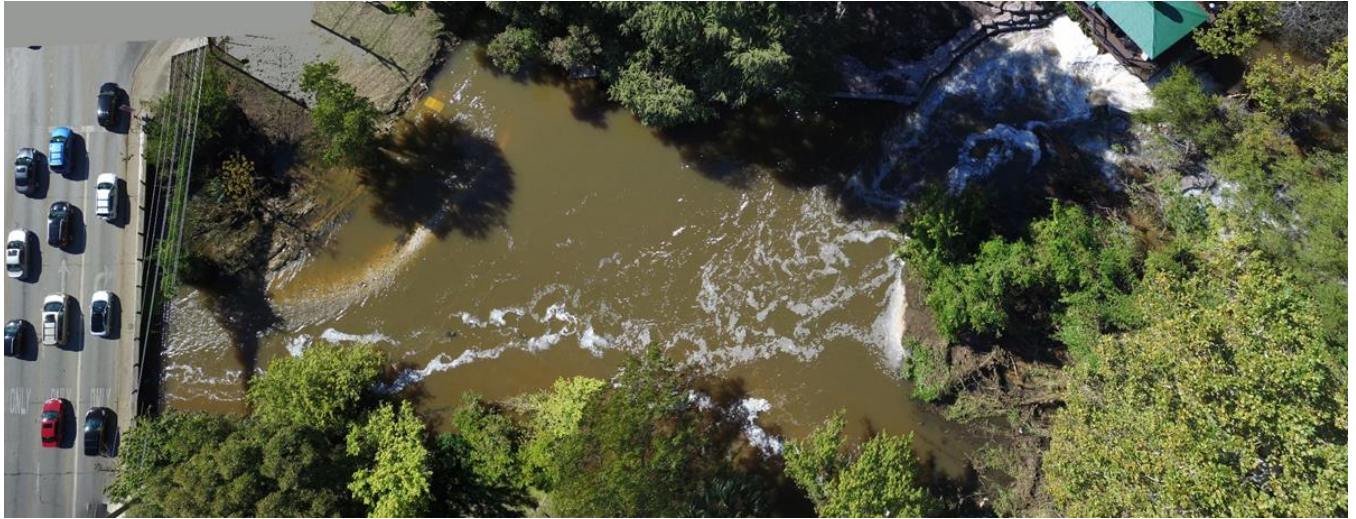
*Figure 1 A mosaic of headwaters on November 3rd, 2015.*

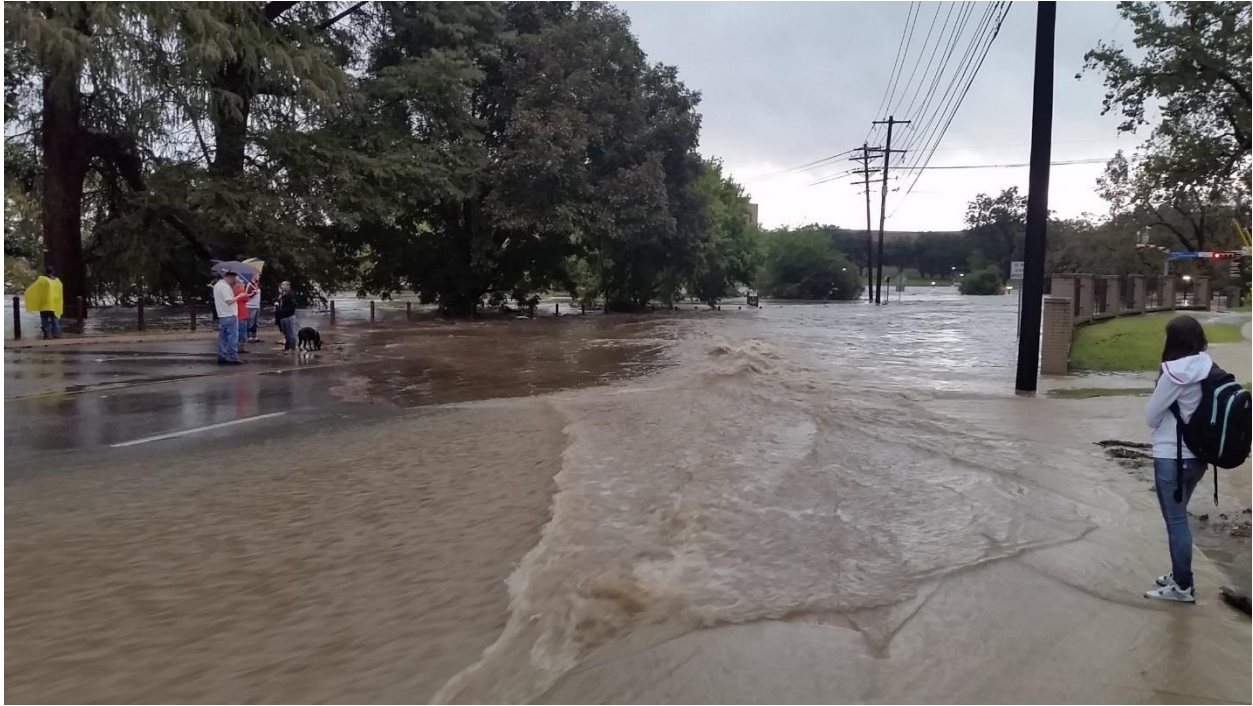
Figure 2 View of Sessom Dr. on October 30th, 2015.

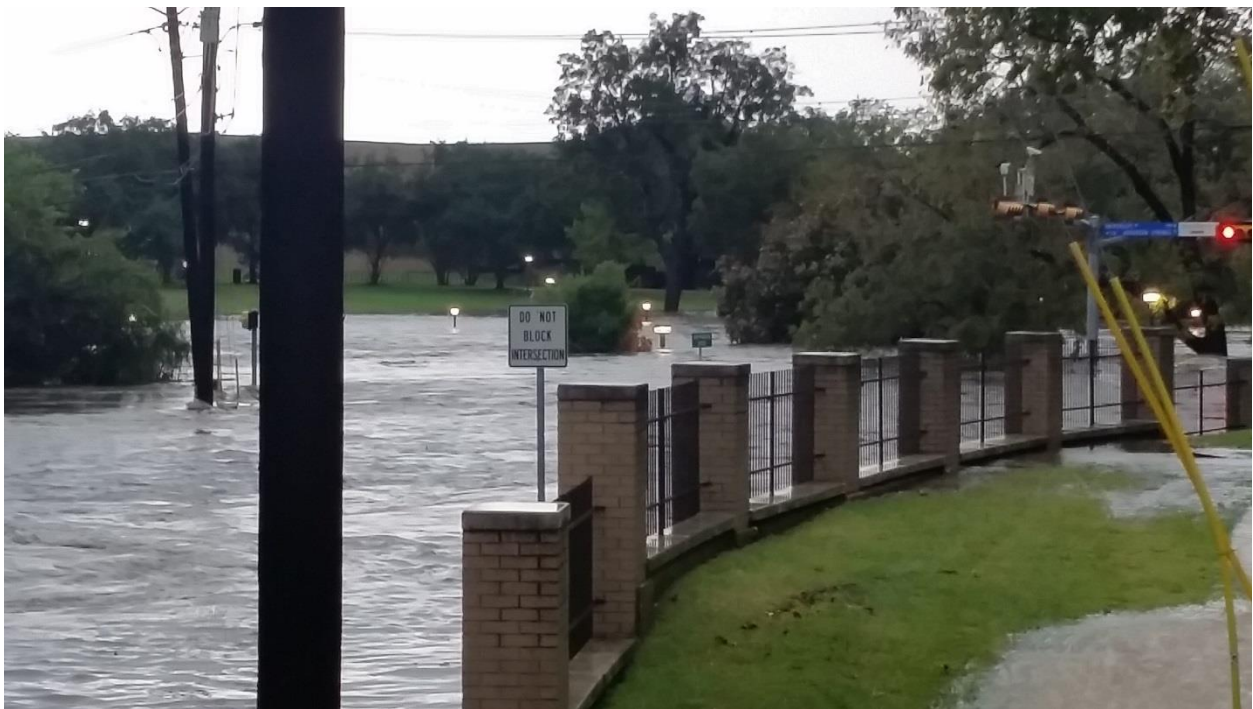
Figure 3 Image of Sessom Dr. and Aquarena Dr. intersection on October 30th, 2015.

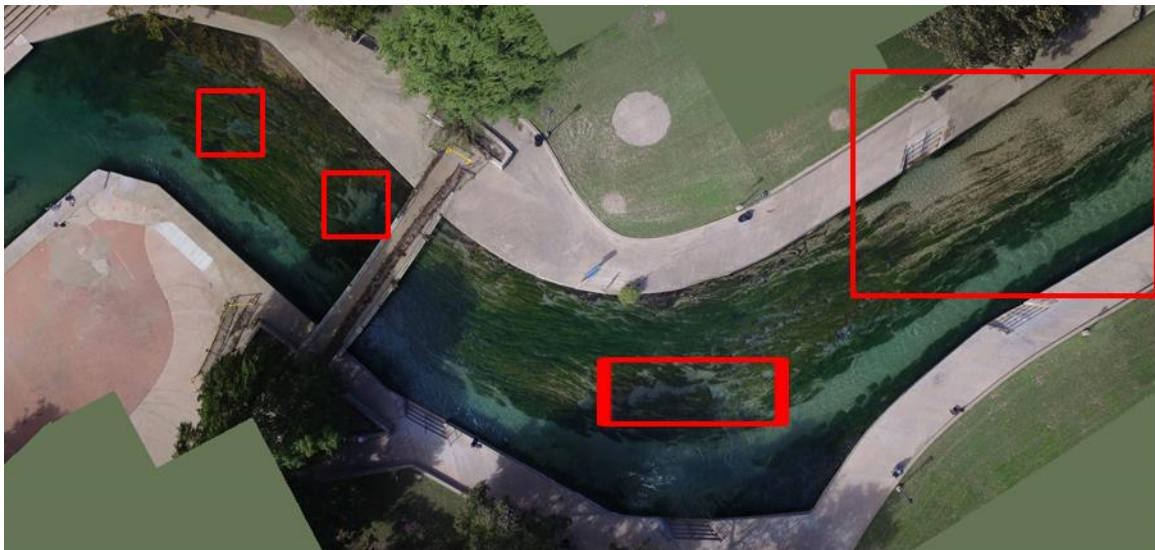
Figure 18 Sewell Park at the first walking bridge, November 9<sup>th</sup>, 2015. Areas of vegetation loss have been highlighted in red.

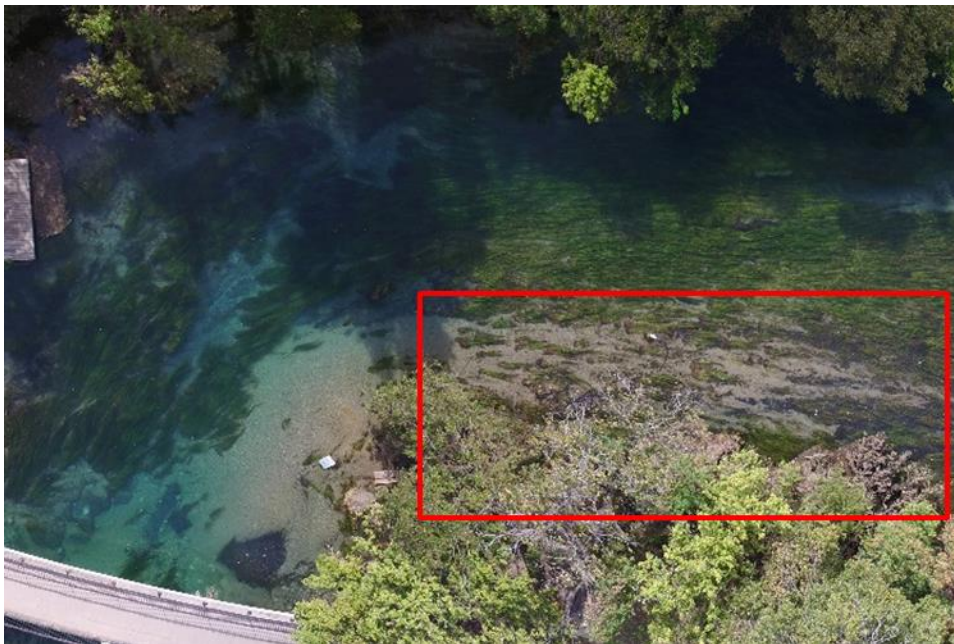
Figure 22 Image of Site 1, further down the bend, taken November 9th, 2015. The location of the previous image is highlighted in red.

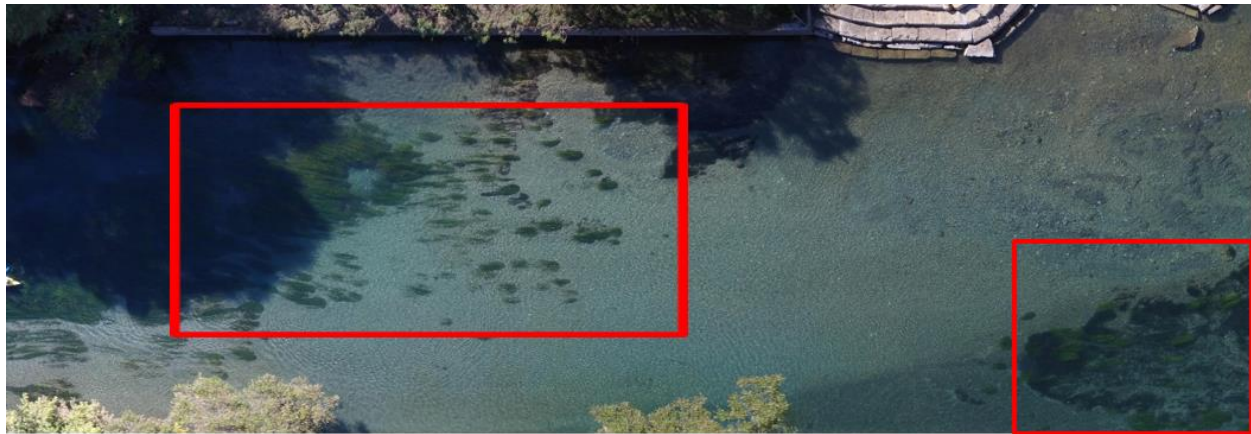
Figure 24 City Park at Lion's Club, November 9th, 2015. Lost vegetation is highlighted in red.

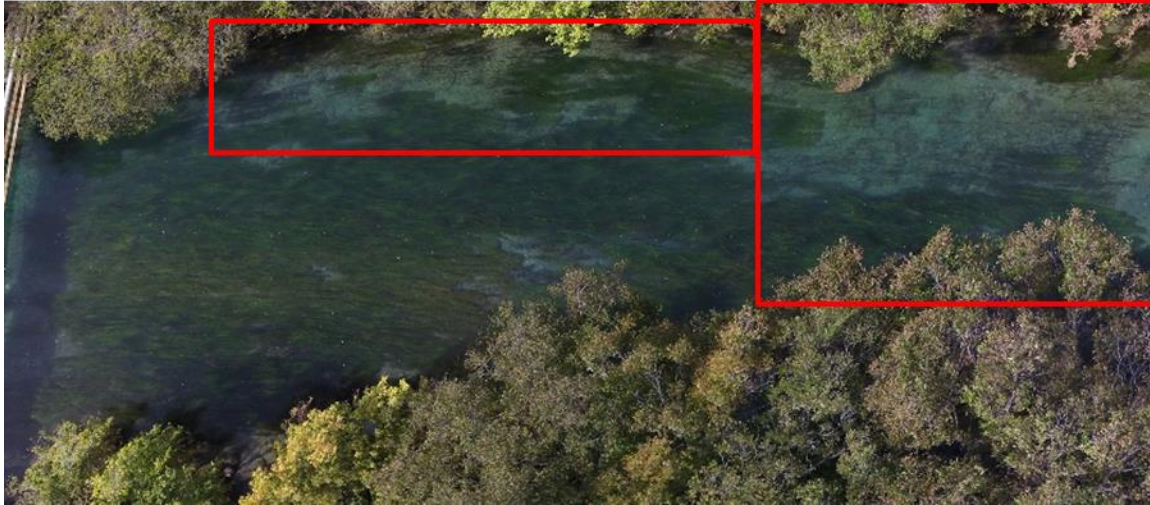
Figure 27 City Park upstream from the walking bridge, November 9th, 2015. Lost vegetation is highlighted in red.

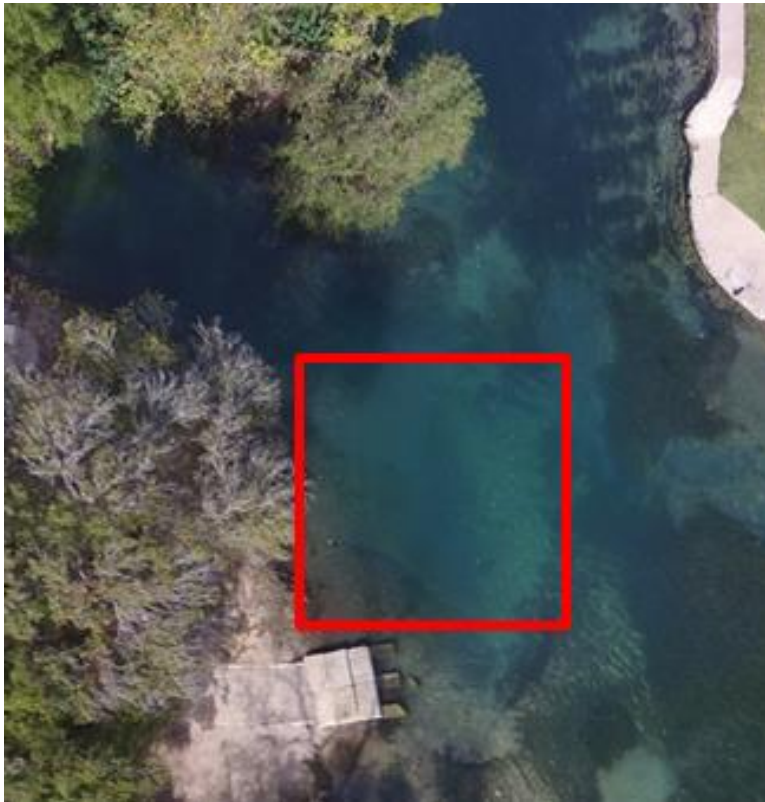
Figure 28 Image of Purgatory Creek taken November 12, 2015. A pre-flood image of this area was not available. However, the area that experienced vegetation loss has been highlighted in red.

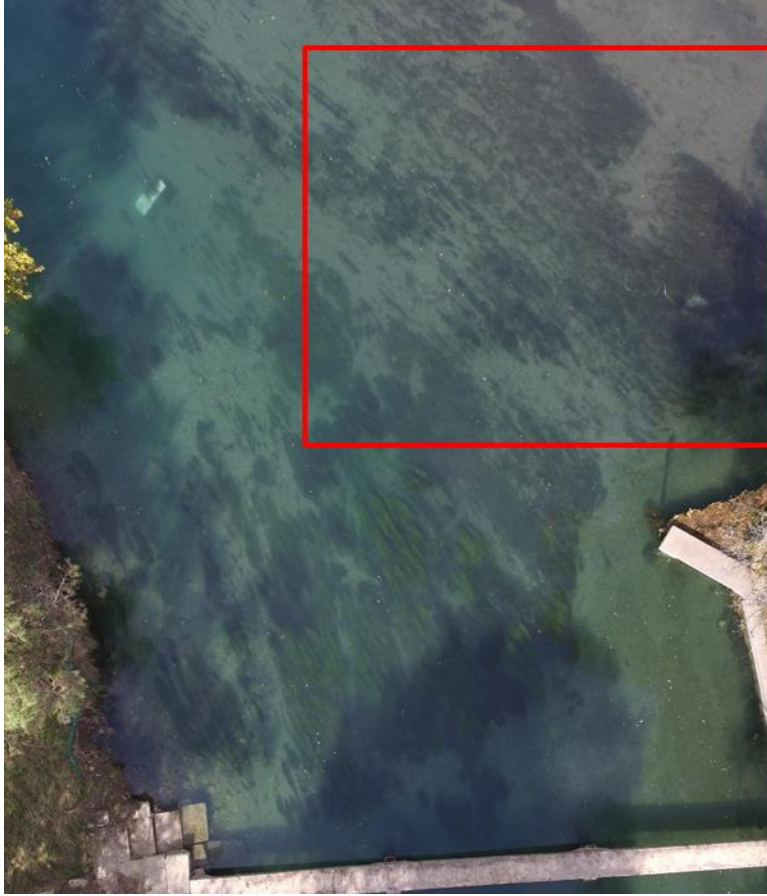
Figure 33 Image of Cypress Island taken November 9th, 2015. The area highlighted is now mostly silt, with a significantly less dense occurrence of *Hydrilla verticillata*.

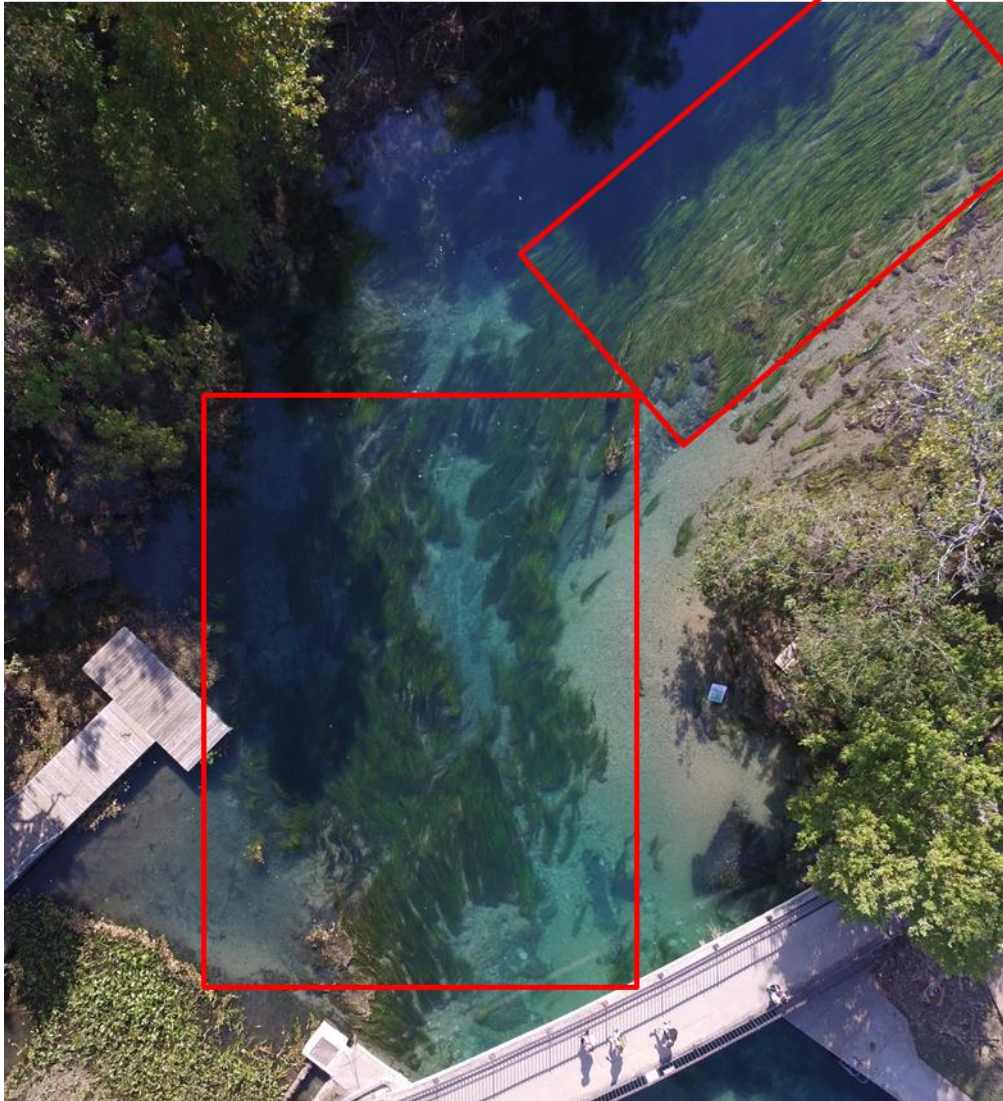
A pre-flood aerial image of non-loss areas at Site 1 is not available at this time. However, the areas that did not experience loss are outlined in the post-flood image below.

*Figure 38 Image of Site 1 taken November 9th, 2015. It is important to note that within the section marked on the left, there is some degree of thinning within the stands of *Zizania texana*. However, a larger percentage of the vegetation remains than was lost.*

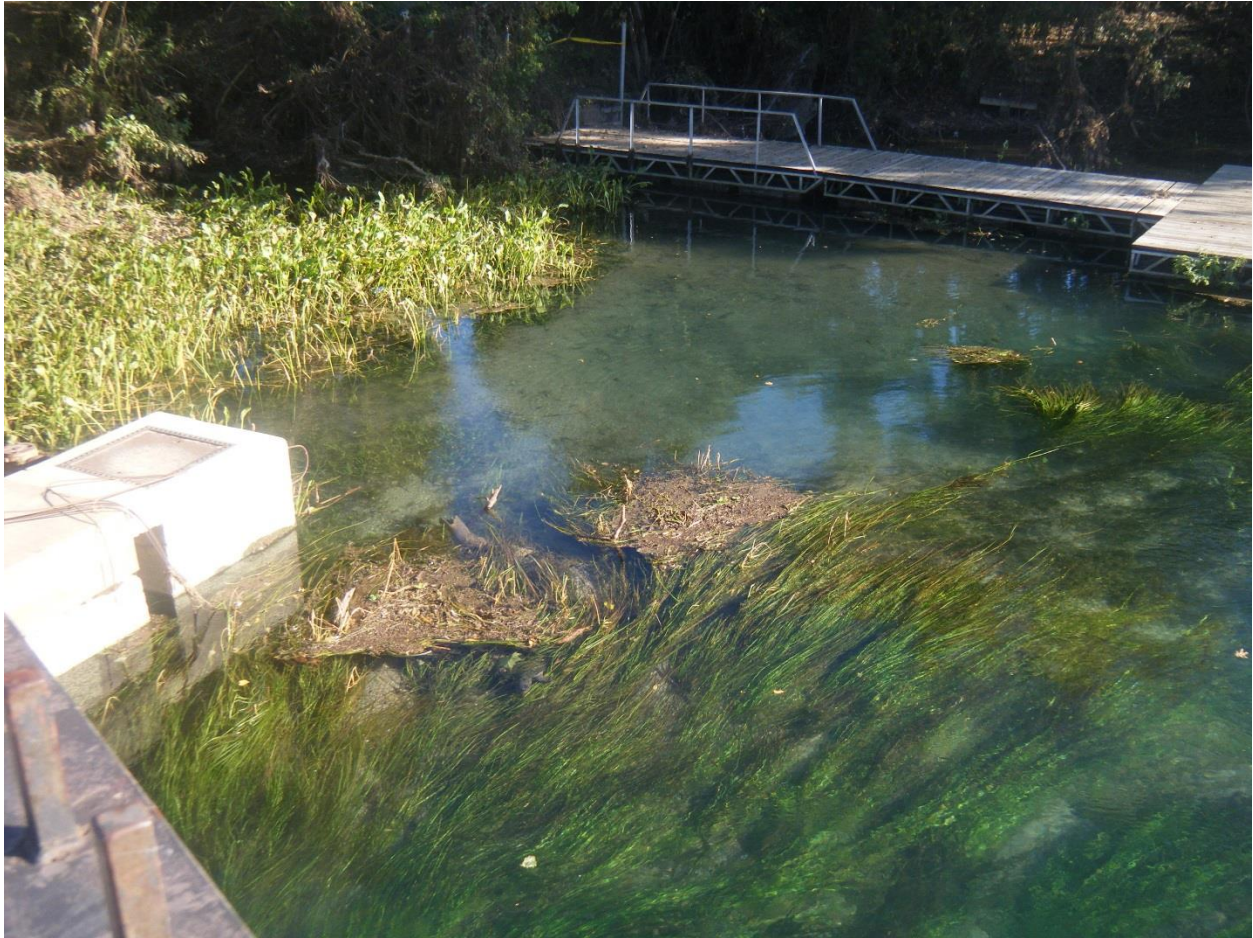
Sagittaria planted in 2014 at the dock in Sewell Park notably persisted through the November 2015 flood (Figure 1 and 2).

Figure 2 Sagittaria at Sewell Park dock, November 2015. Though the dock was moved by the flood, the Sagittaria covers the same area.

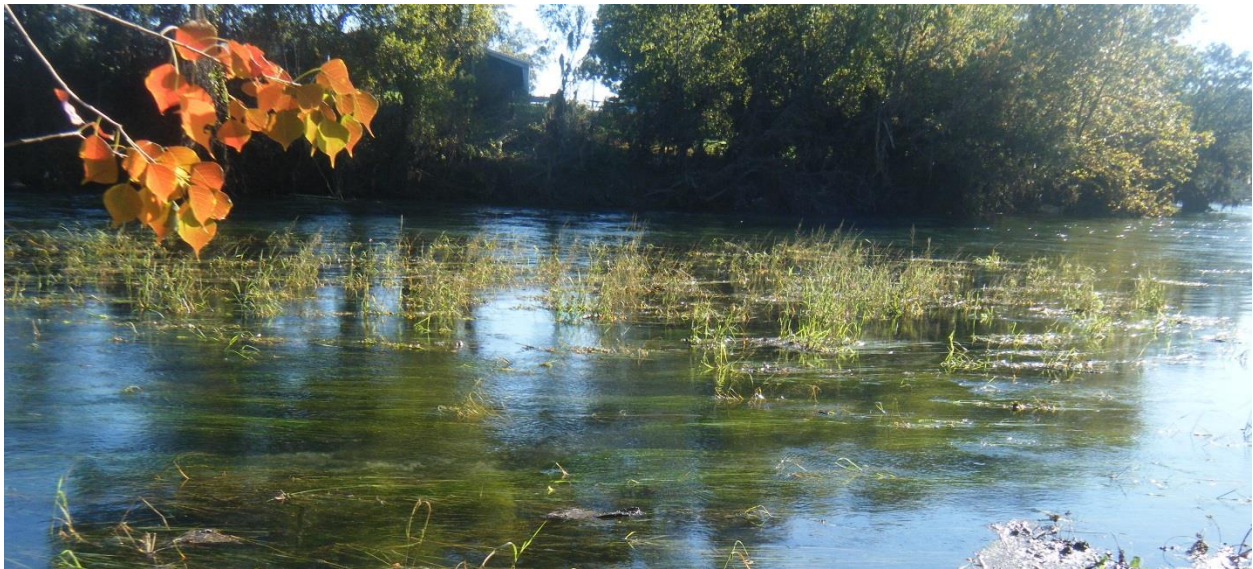
Although some *Zizania texana* (Texas wild rice) at Site 1 was lost to sediment deposition in the November flood (see document “Images of November 2015 Flood”), Texas wild rice still constitutes the greatest amount of aerial coverage for vegetation in this work-site (Figure 3 and 4).

*Figure 4 Zizania texana at Site 1, November 2015. Texas wild rice closer to the bank is currently non-emergent, yet abundant.*

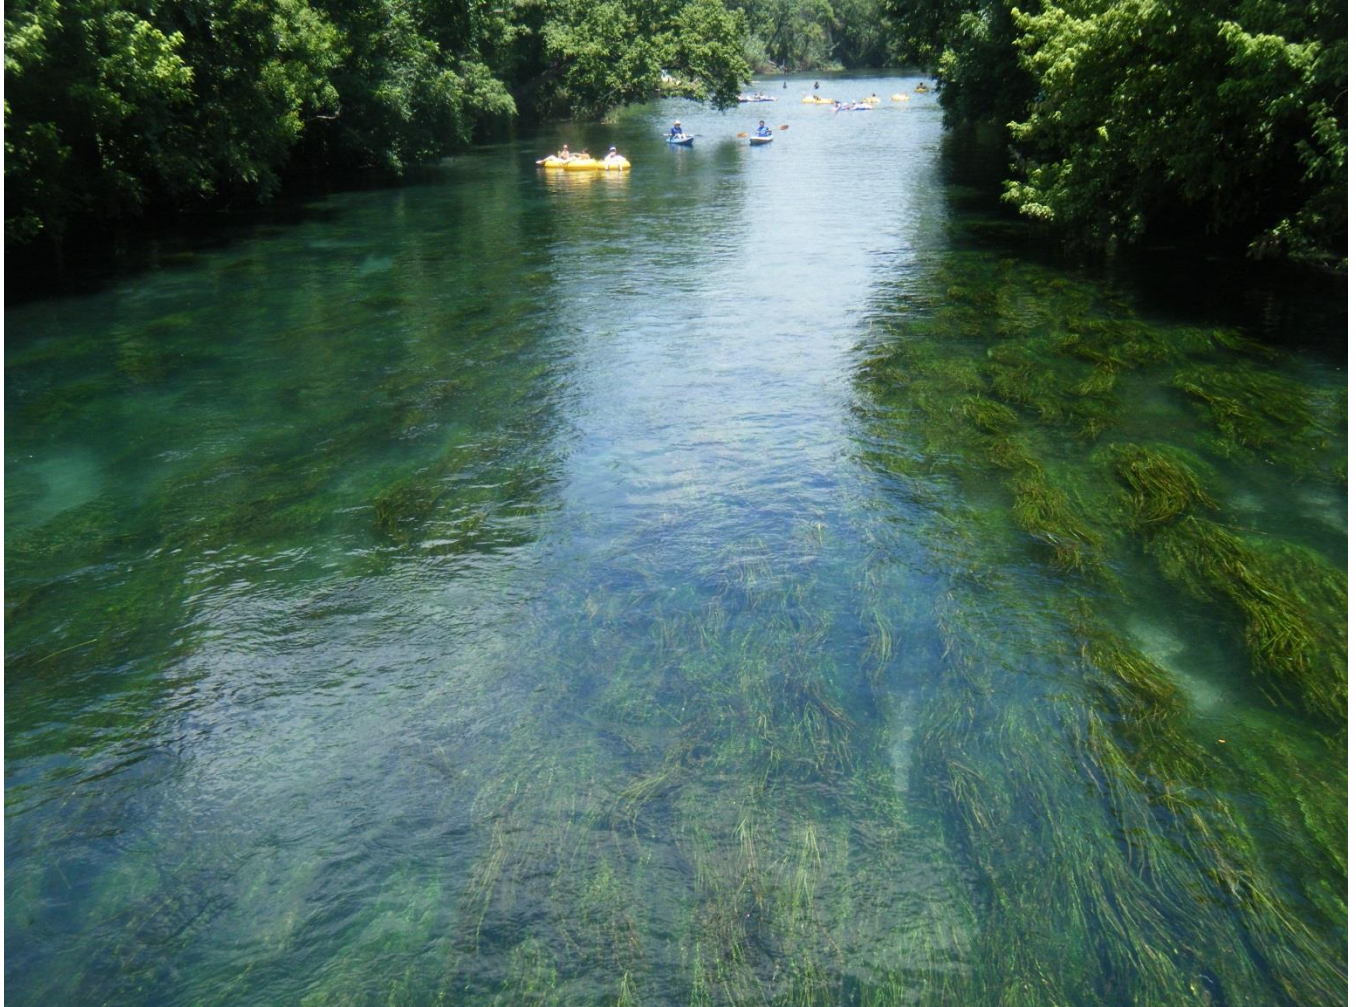
Texas wild rice at city park expanded from 2014 - 2015, particularly near the walking bridge and along the right bank of the river, as seen in the Figures 5-7.

Figure 6 City Park from the walking bridge, April 2015. *Zizania texana* has expanded considerably throughout the area, particularly along the banks.

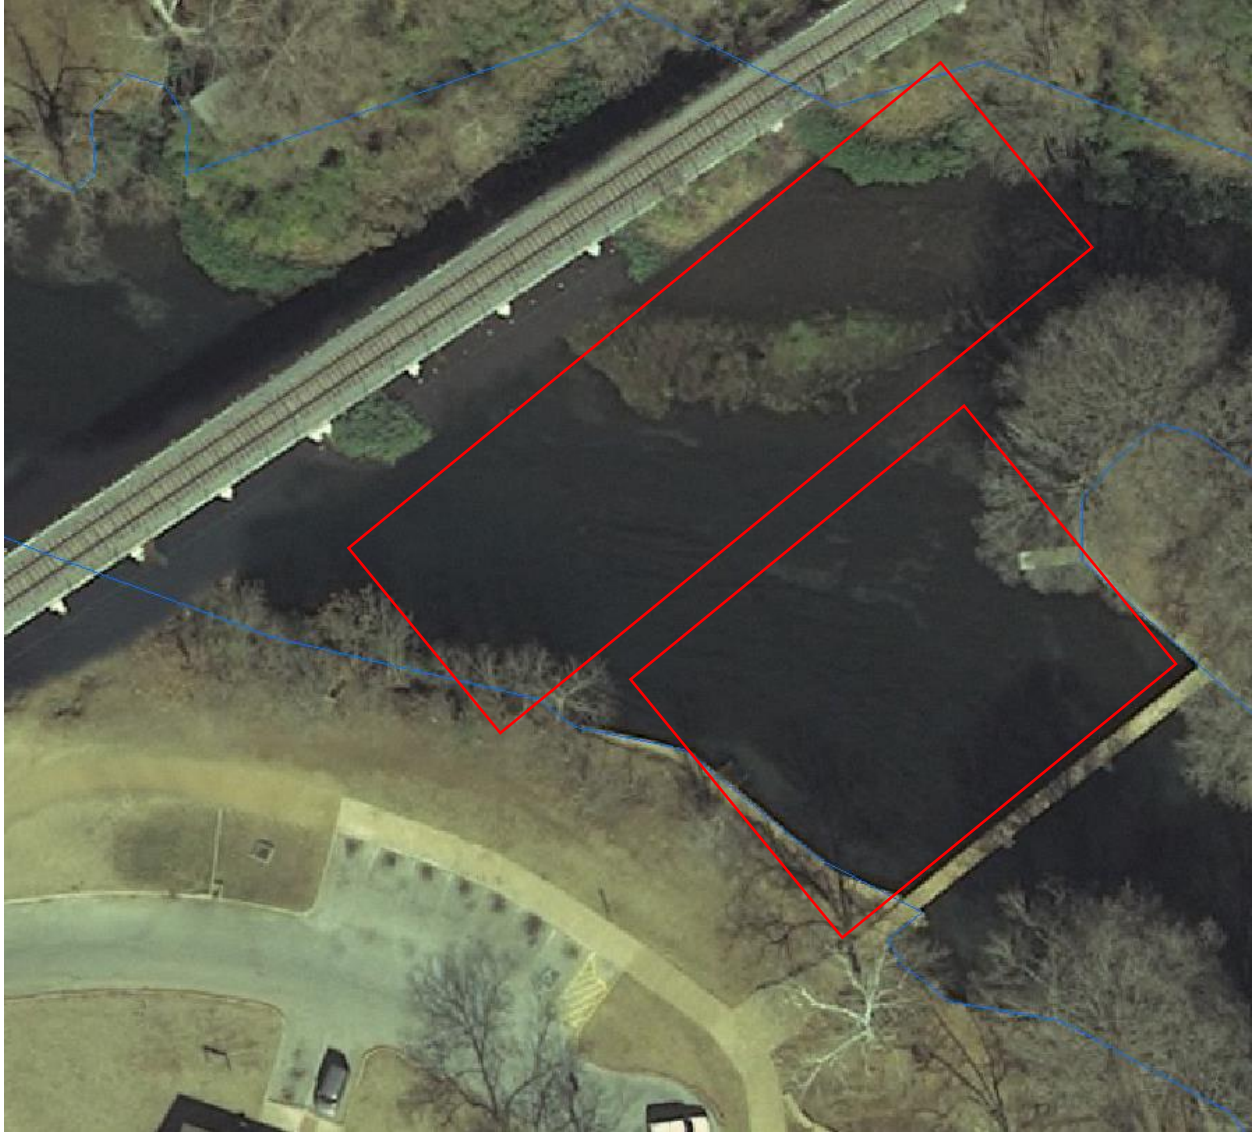
Cypress Island, located just upstream of Rio Vista Dam, became a work site for Texas State during 2015. An aerial image of Cypress Island from 2013 shows the area filled with dense masses of *Hydrilla verticillata* with very little, if any, stands of Texas wild rice (Figure 8). As of October 2015, *Hydrilla verticillata* coverage was reduced by 850.7m<sup>2</sup> with many stands of Texas wild rice, as well as other native plant species now present (Figure 9).

*Figure 7 Cypress Island, 2013. Areas of dense Hydrilla verticillata have been highlighted in red. Imagery is provided by NAIP Satellite Imagery captured in 2013.*

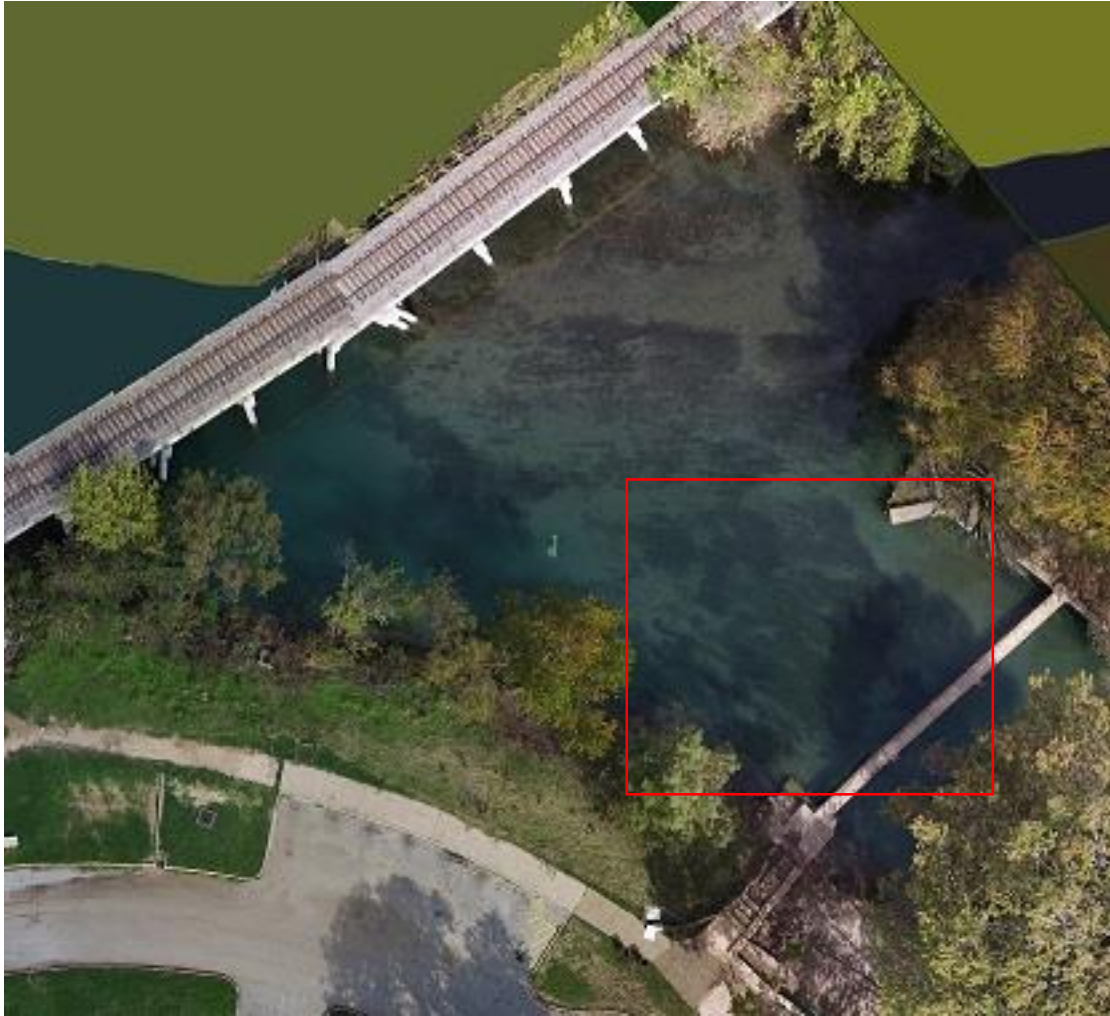
*Figure 8 Cypress Island in November, 2015. The main area by the bridge, which now consists of Texas wild rice and star grass, is highlighted in red.*

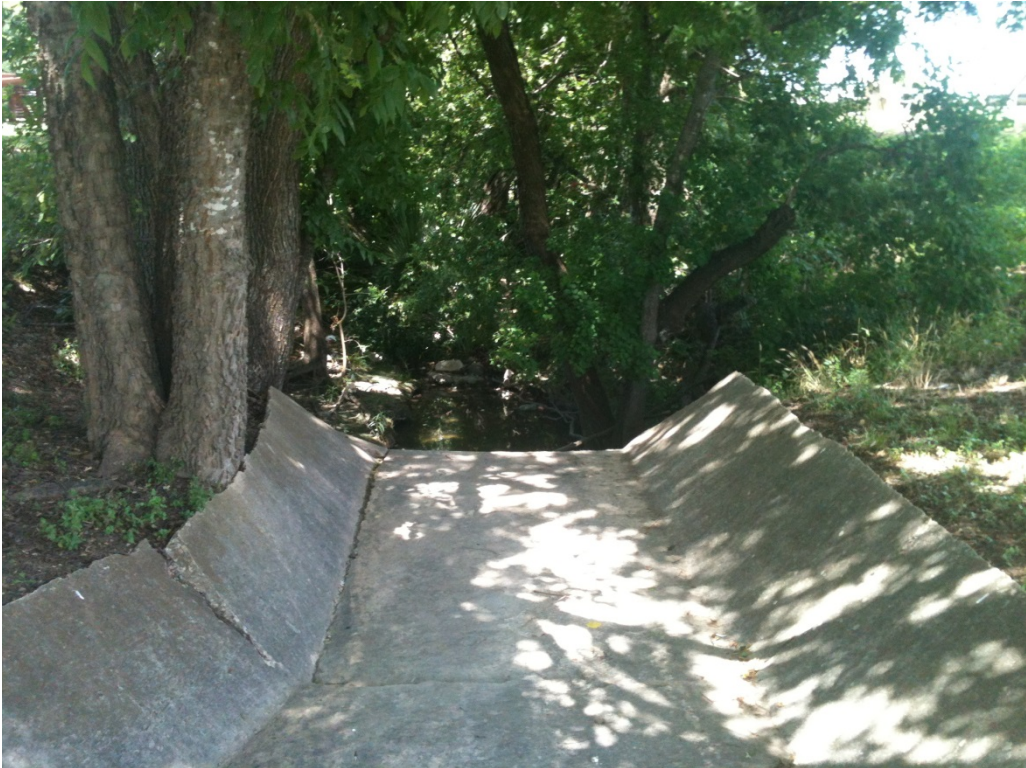
**Figure 2-2 Existing Storm Sewer Outfall Looking Upstream**

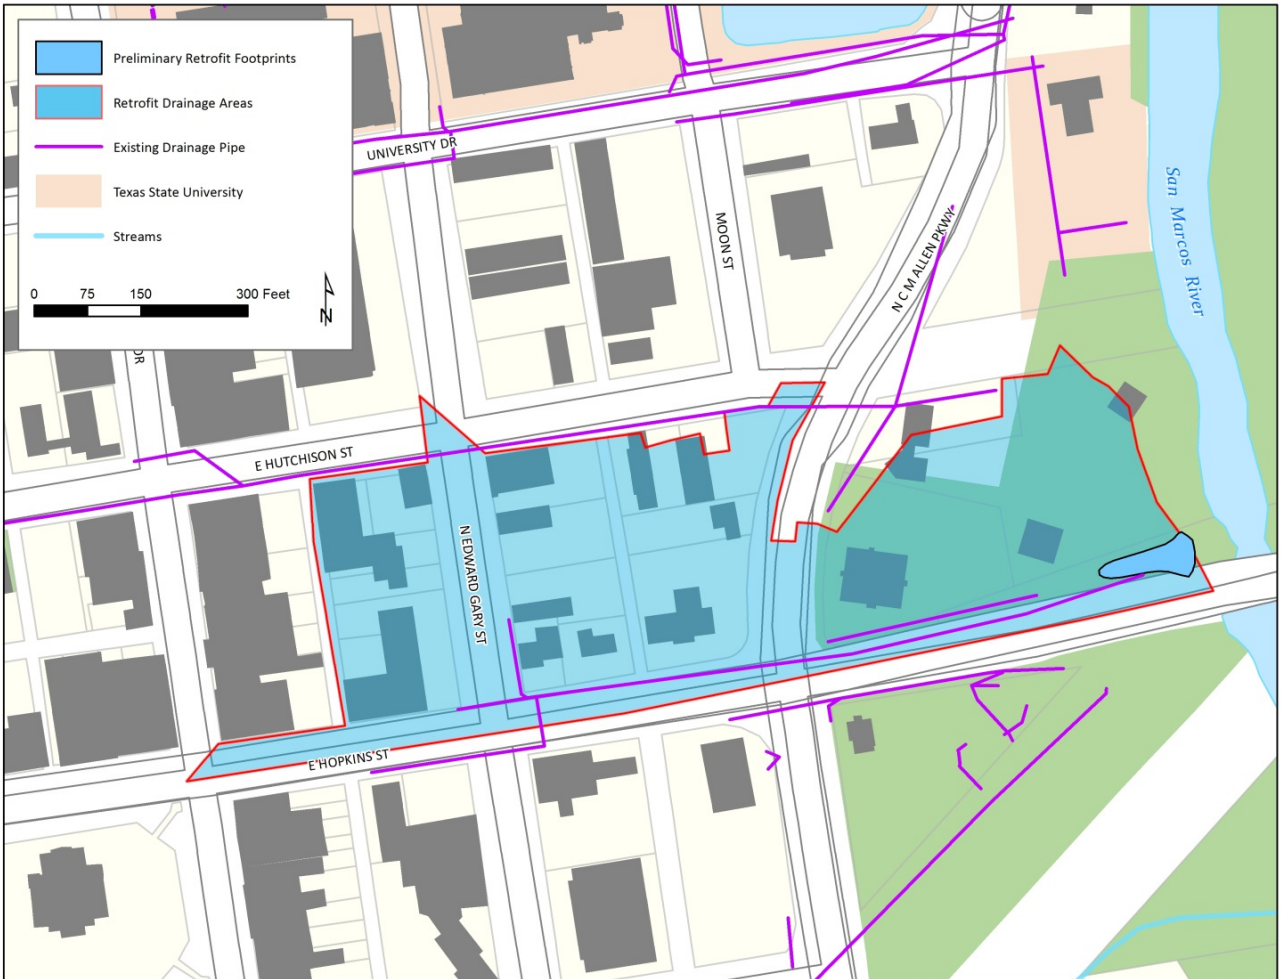
An in-line, extended detention basin is recommended in this location as it will make the best use of available space for stormwater treatment. A biofiltration facility with stacked detention might also be feasible but would have a smaller water quality volume, be more expensive to construct/maintain, and with close proximity to the river may experience issues with filtration media scour during flood events. Figure 2-5 depicts the drainage area, location and potential footprint of this BMP.

**Figure 2-5 Hopkins Drainage Channel Pond 1 near San Marcos Plaza**

With an estimated surface area of approximately 4,650 square feet and estimated average depth of 4 feet, a water quality capture volume of 18,600 cubic feet would be available. Modeling shows a BMP of this approximate size and a 48-hour drawdown time would treat 80% of all runoff conveyed to it over the course of a typical year and remove approximately 6.4 lbs of Total Phosphorus (TP) at an estimated capital cost of \$57,000. The annualized cost per pound of TP removed (including operation and maintenance) would be (\$2,250 / lb TP), which is competitive compared to others evaluated but smaller scale in terms of pollution removal. For example, the project suggested at the wastewater treatment plant is estimated to remove approximately 140 lbs of TP per year at \$911 per lb.

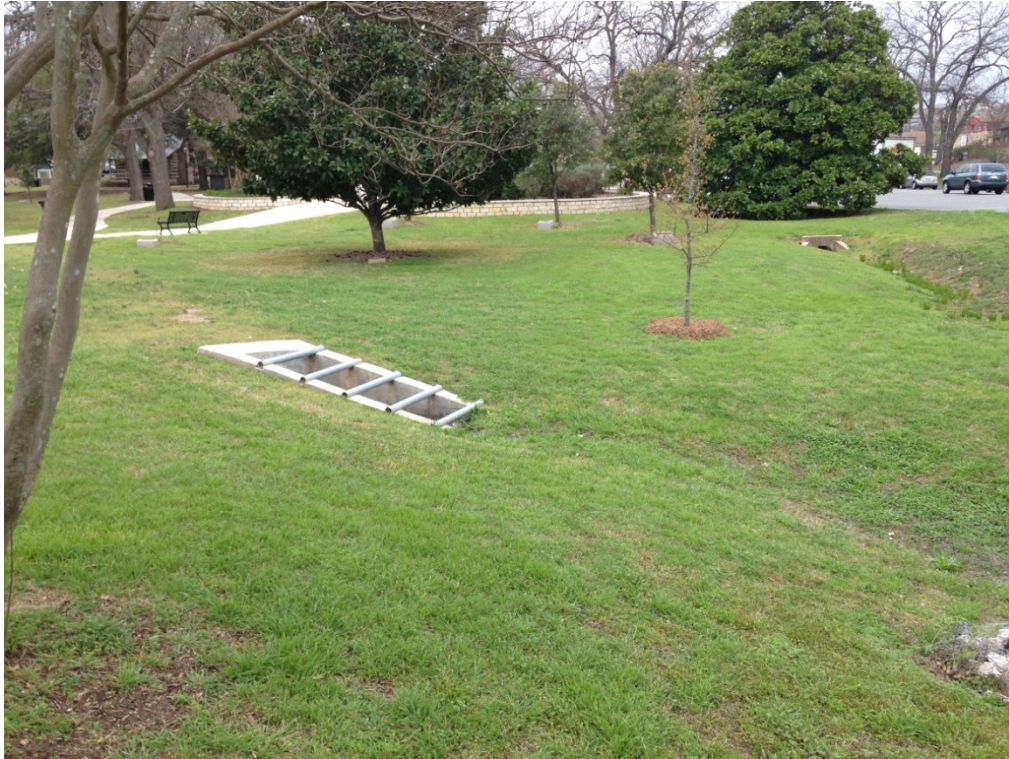
A drainage channel flows in an easterly direction through Veramendi Park, adjacent to Hopkins Street to the south. The grass-lined channel contains three storm sewer outfalls, one of which is below-grade and does not drain well. Erosion issues were also observed in the channel along with a gabion-style grade control structure and concrete flume that were likely installed to control these problems (see Figures 3-1 through 3-4). The drainage area of approximately 15 acres was delineated in GIS using City of San Marcos data (topography, storm sewer data, aerial photographs) and then field-verified during a rain event. Impervious cover was estimated in GIS to be 9.9 acres (or 66%) using City of San Marcos impervious cover data supplemented with aerial photography. In 2014, a trail was constructed across the downstream portion of the channel with a corrugated metal pipe conveying wet weather flows beneath to the San Marcos River. Based on NRCS Soil Maps and a site visit, Type D soils appear to exist in this area that drain slowly so infiltration-type BMPs are not recommended without an underdrain.

**Figure 3-1 Two Storm Sewer Outfalls and Proximity to Veramendi Park Amenities**

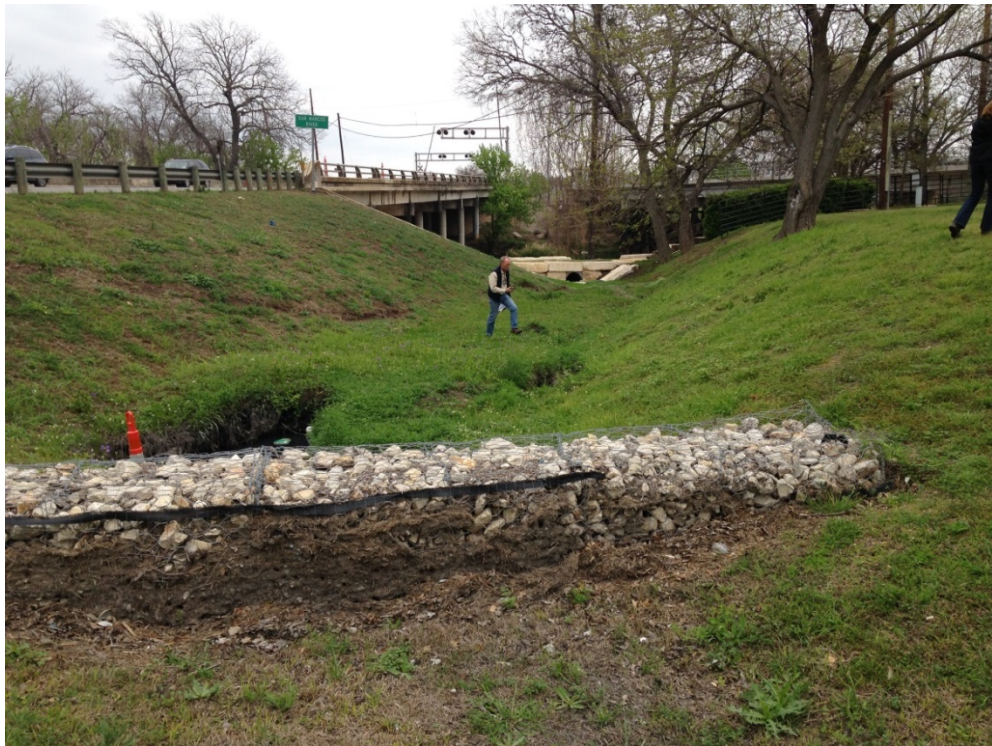
**Figure 3-2 Gabion Grade Control Structure, Trail, Steep Slopes, Trees, Hopkins Street Bridge**

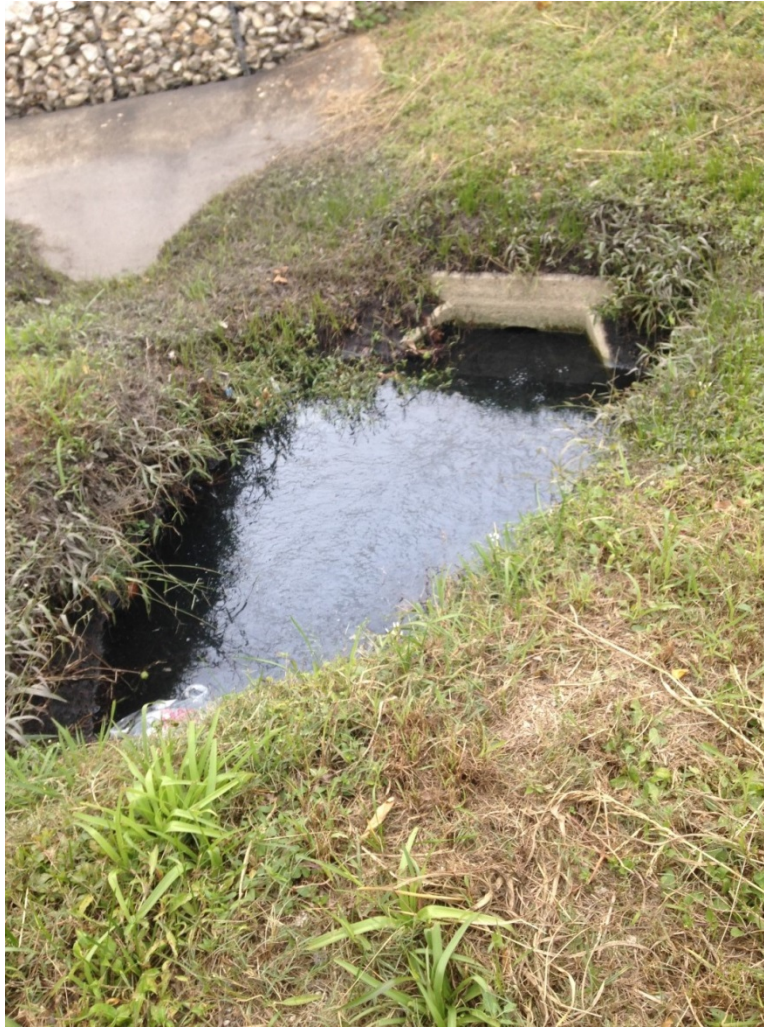
**Figure 3-3 Third Storm Sewer Outfall Below Grade and Drainage Issue**

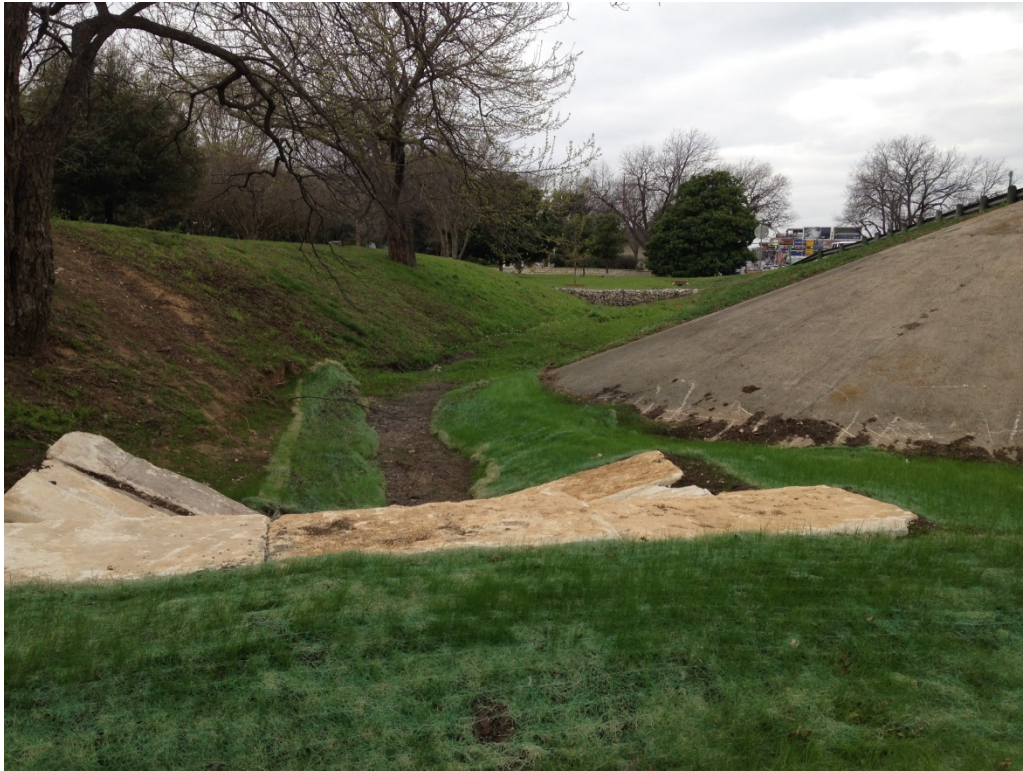
**Figure 3-4 Erosion on Left Bank (Looking Upstream)**

With an estimated surface area of approximately 8,015 square feet and estimated average depth of 4 feet, a water quality capture volume of 32,060 cubic feet would be available. Modeling shows a BMP of this approximate size and a 48-hour drawdown time would treat 87% of all runoff conveyed to it over the course of a typical year and remove approximately 18 lbs of TP at an estimated capital cost of \$98,000. The annualized cost per pound of TP removed (including operation and maintenance) would be (\$953 / lb TP), which is very cost effective compared to others evaluated but smaller scale in terms of pollution removal. For example, the project suggested at the wastewater treatment plant is estimated to remove approximately 140 lbs of TP per year at \$911 per lb. In addition to a water quality benefit, this project would resolve the erosion and drainage issues that currently exist.
