**Access Road to Nelson
Location 7965
(Sandy Peak)
Doggerup Road
Shire of Manjimup**

**Public Environmental Review
Assessment No 1836
Appendices 1 to 9**

Appendix 2 – Engineering Assessment, MPM Development Consultants

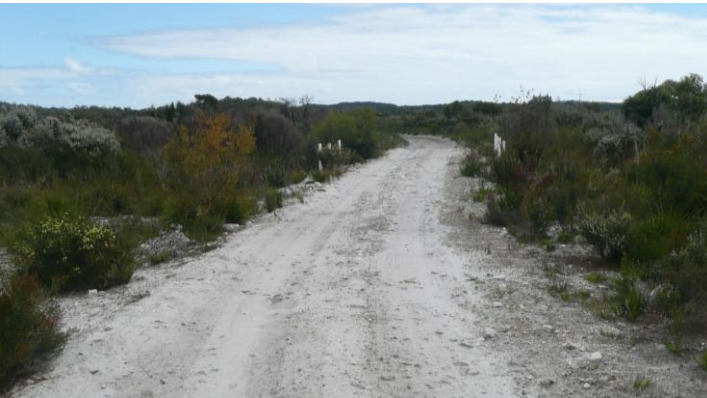
Photograph 1, shown here is of the nearby Summertime Track and provides an indication of the type of construction proposed for Doggerup Rd. The limestone material is placed on top of the existing ground surface without the formation of defined roadside drains. Note is also made here regarding how the approach to water crossings is made, where an existing water crossing is located beneath the guide posts in the photograph.

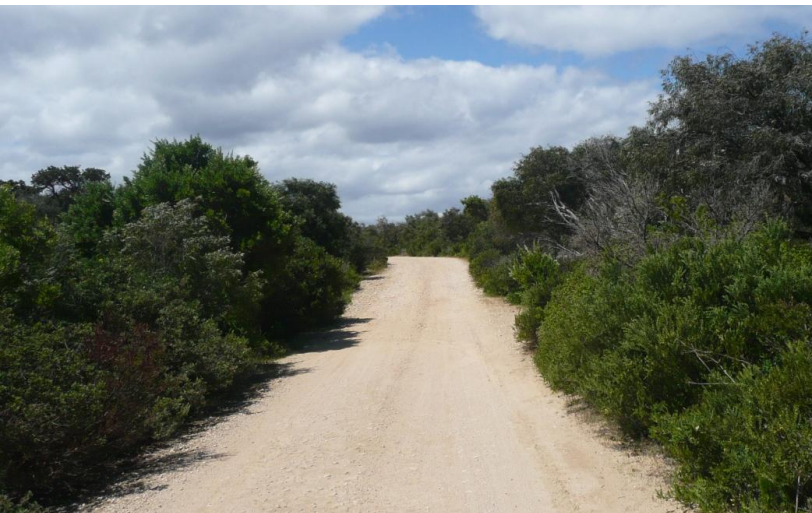
Photograph 2, shown here is D'entrecasteaux Road within the Windy Harbour townsite. A 3.0m wide limestone track with the vegetation regrowth occurring right up to and even overhanging the track. It should be noted that the track is constructed to take higher traffic volumes than that proposed for Doggerup Rd and has minimal track width, no defined drainage and the track elevated above natural surface level by the actual track pavement.

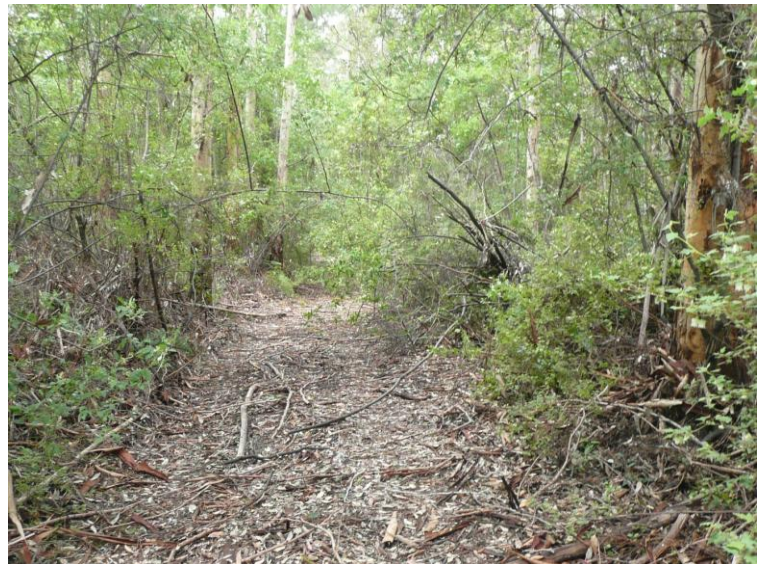
Photograph 4 is another general track condition view, but it highlights the large potential habitat trees. The existing track alignment is shown to already avoid these trees and the proposed track alignment would also be varied to ensure all potential habitat trees remain and any clearing is absolutely minimised. This photo is also taken in the area where there is evidence of the previous gravel pavement, as highlighted in Photograph 5 below.

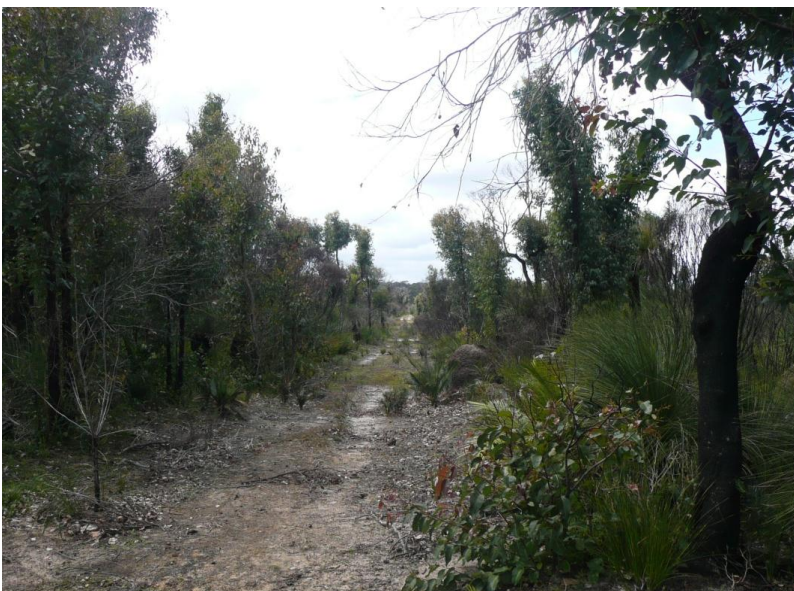
Photograph 7, shown here provides a general existing track view through the Jarrah area and clearly indicates an existing track and the extent of existing clearing. The photograph also provides an indication of the crossfall on the existing natural surface.

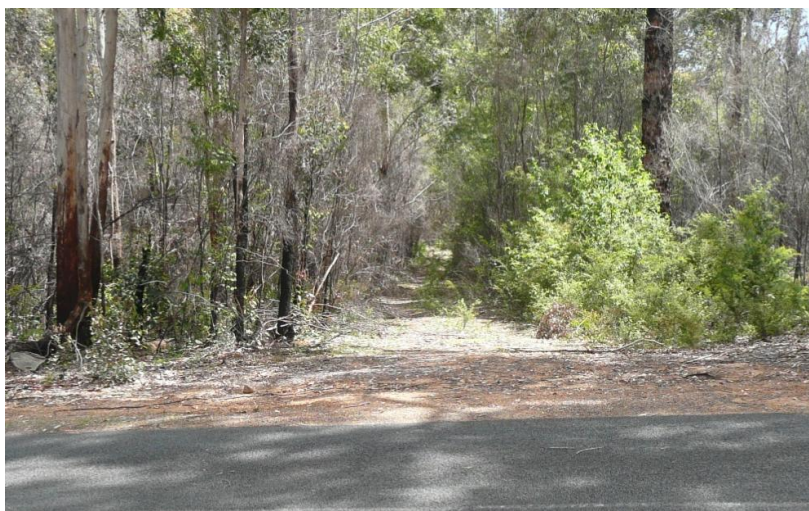
Photograph 8, shows the existing and proposed intersection point with Windy Harbour Rd, a cleared 3.0m width is not currently available however only minor regrowth clearing would be required and minimised to ensure the minor access nature of Doggerup Rd is maintained. It is envisaged that the Doggerup Rd would be deemed by the Shire of Manjimup as a closed public road with access only permitted by DEC and the owners of Loc 7965. The method of restricted access could be discussed further with DEC however an option may be to install a DEC management gate, as per Wheatley Coast Rd and photograph 22, following.

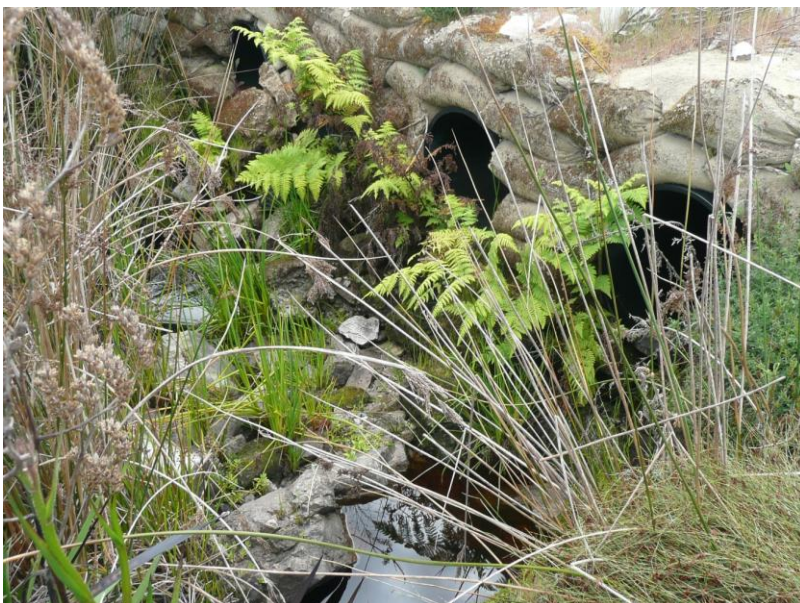
Photograph 9 here shows the existing water crossing on the nearby Summertime Track. The crossing shows multiple culverts with concrete filled sandbags as scour protection.

It is proposed to construct the required water crossings in an identical manner to that of existing tracks and roads within the area.

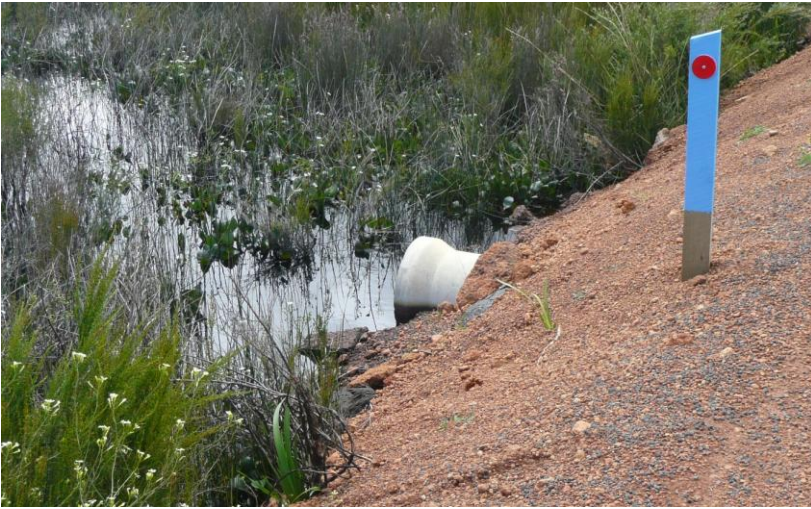
Photograph 10, shows an existing culvert crossing installed by the Shire of Manjimup on Windy Harbour Rd. Note is made of the use of reinforced concrete pipework and the Main Roads standard guidepost as a vehicle notification of the crossing.

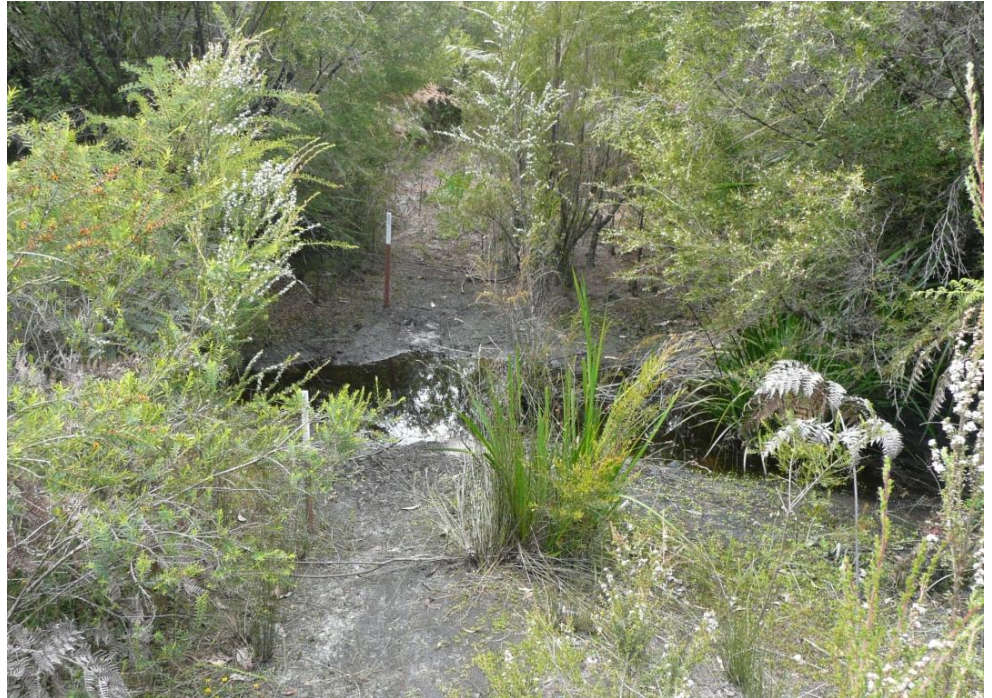
The first water crossing is located at the edge of the Karri forest and just into the tea tree shrubland as can be seen in photograph 11. The catchment contributing to the crossing appears to be small both on site and upon review of the general aerial contours of the area. The water crossing as shown in photograph 11 was flowing at the time of the October inspection as considerable rainfall was received the day before, however flow depth was only approximately 30mm. The survey stakes, as seen in the photograph were placed in winter 2010 to provide an extent of surface water and/or water flow therefore flow could be expected to be upto 150mm deep. As can be seen by the reflection in the water in the photograph, flow velocity was very low mainly due to the limited slope in the drainage channel. It is expected that a single 300mm diameter pipe culvert would be sufficient to handle the majority of flows for this water crossing, however a detailed catchment design for culvert sizing will be carried out prior to construction being undertaken, using the principles as outlined in Australian Rainfall and Runoff.

The pipework would be laid at a very flat grade approximately 1 vertical to 350 horizontal; this grade will permit flow but will not create velocity and potential scour issues.

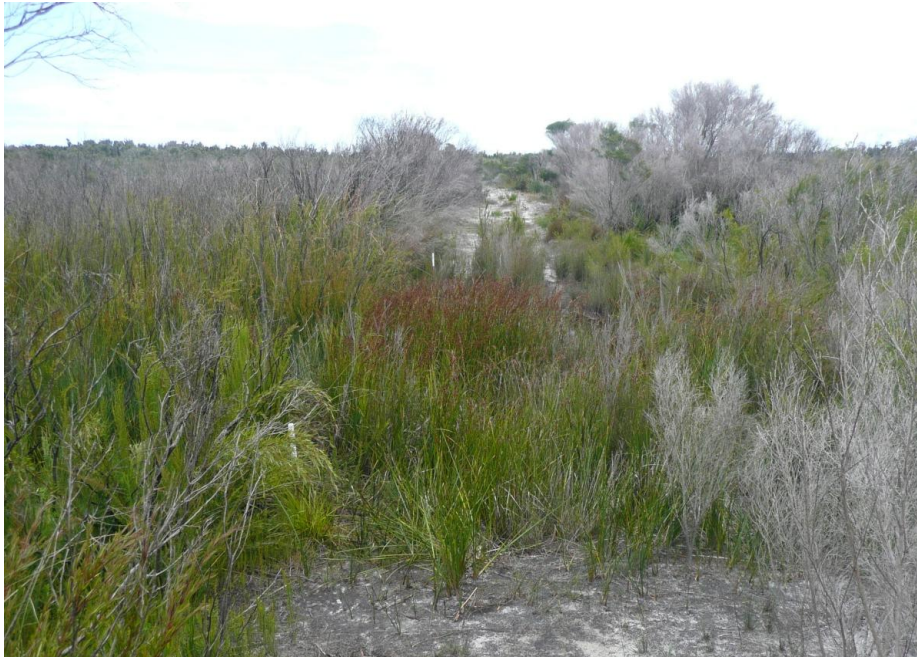
The second water crossing is located past the edge of the Karri forest and within the sedgeland / reed swamps as can be seen in photographs 12 and 13. The catchment contributing to the crossing appears to be reasonable both on site

and upon review of the general aerial contours. The water crossing as shown in photographs 12 and 13 wasn't flowing at the time of the October inspection, however the depth of the crossing was approximately 150mm and there is an existing culvert. The culvert was submerged but is estimated at being around 200mm in diameter. Again, the photographs show the survey stakes that were placed in winter 2010 showing the extent of surface water and/or water flow, however as can be seen the winter area of water is not greatly increased.

It is expected that at least two 300mm diameter pipe culverts would be required to convey the majority of flows for this water crossing, however a detailed catchment design for culvert sizing will be carried out prior to construction being undertaken, using the principles as outlined in Australian Rainfall and Runoff.

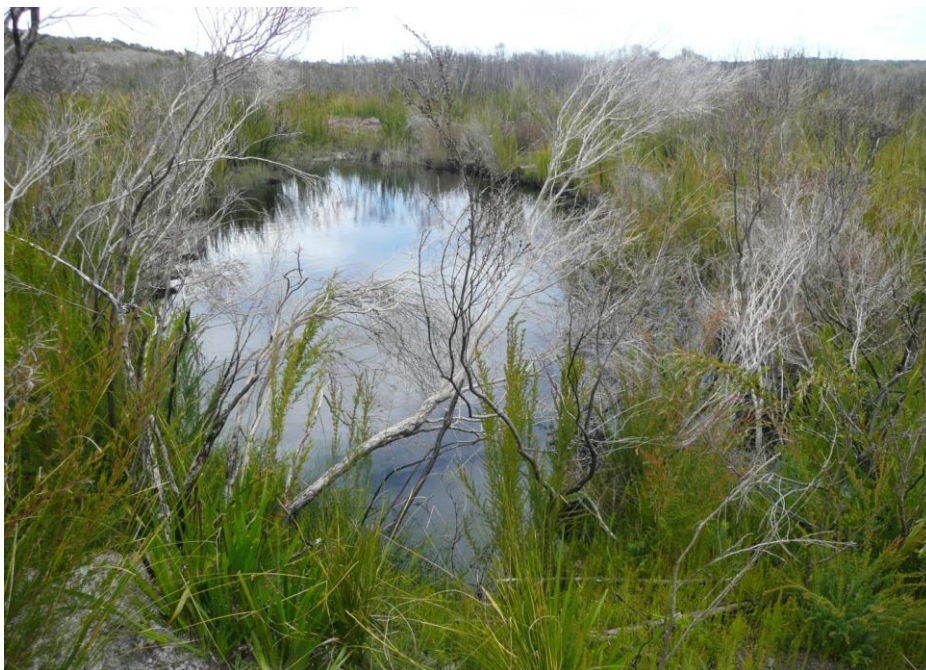
The second water crossing also has a small ponded area located directly south of the track crossing point, this is shown as photograph 13. The ponded area appears to be at a slightly higher elevation than the actual channel crossing and it appears to be a previously excavated area. It is not proposed to further disturb this

appear as regrowth around the water body has occurred.

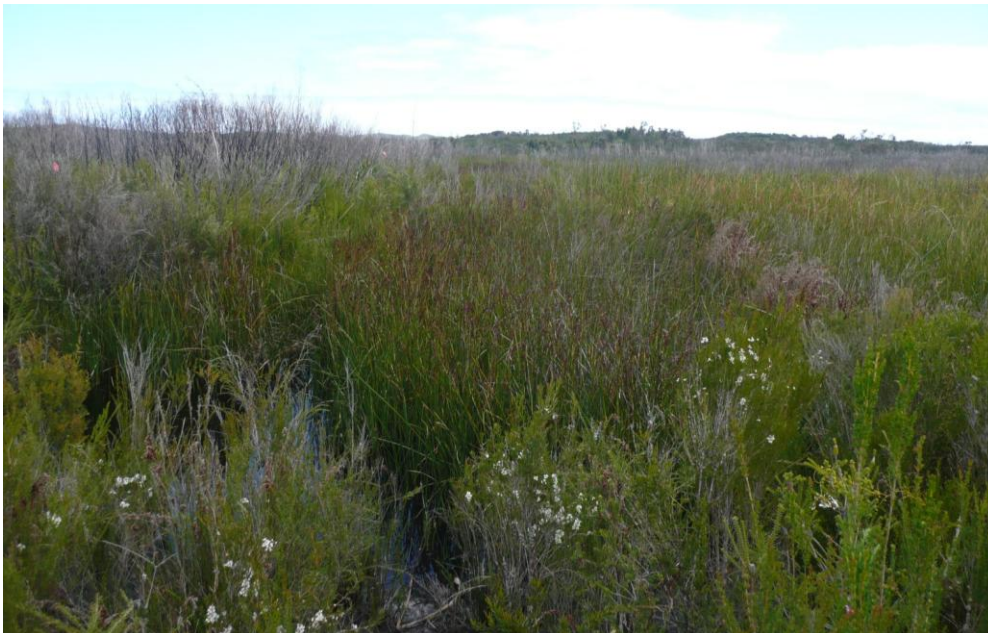
Photograph 14, above shows the view looking west from the start of the water crossing / wetland area the edge of the sedgeland vegetation and the pink marking tape line show the approximate location of the track.

In addition to the culverts placed at each low point it is proposed to install additional culverts at regular spacing's across the full width of the wet area, this will ensure that when surface flows occur they minimise the concentration of flows at particular points and ensure that the surface water flows are spread across the whole water crossing in a

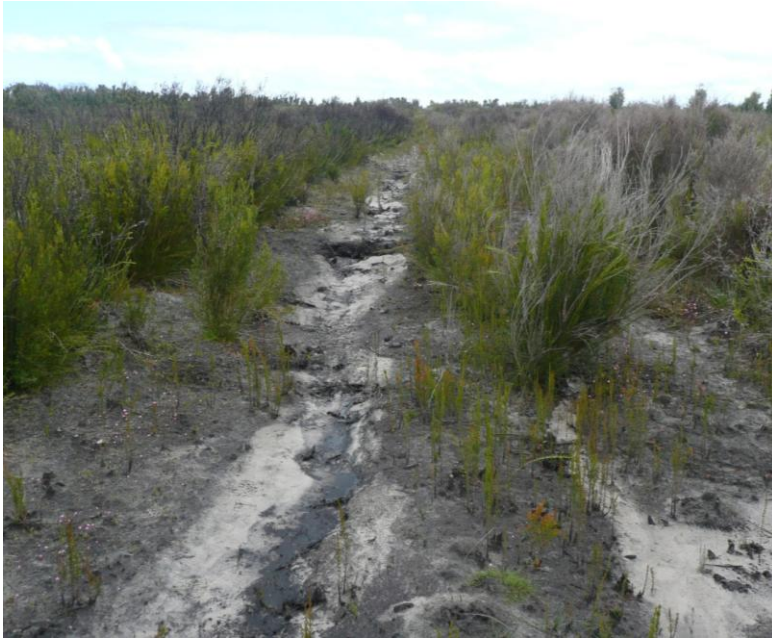
Photograph 16, shows an area of the existing track west of water crossing 2, and shows the slope of the natural surface rising out of the low point of the water crossing. Small areas of scour are clearly visible in the photograph down a line that would approximate the wheel location of a vehicle. This photograph shows two pertinent points, the first is that leaving the track as is will cause significant scour of the sandy surface. This sand will eventually makes its way to the water crossing point and potentially cause a blockage or diversion of the surface water flow plus the covering of the surrounding vegetation. The second point the photograph shows is that

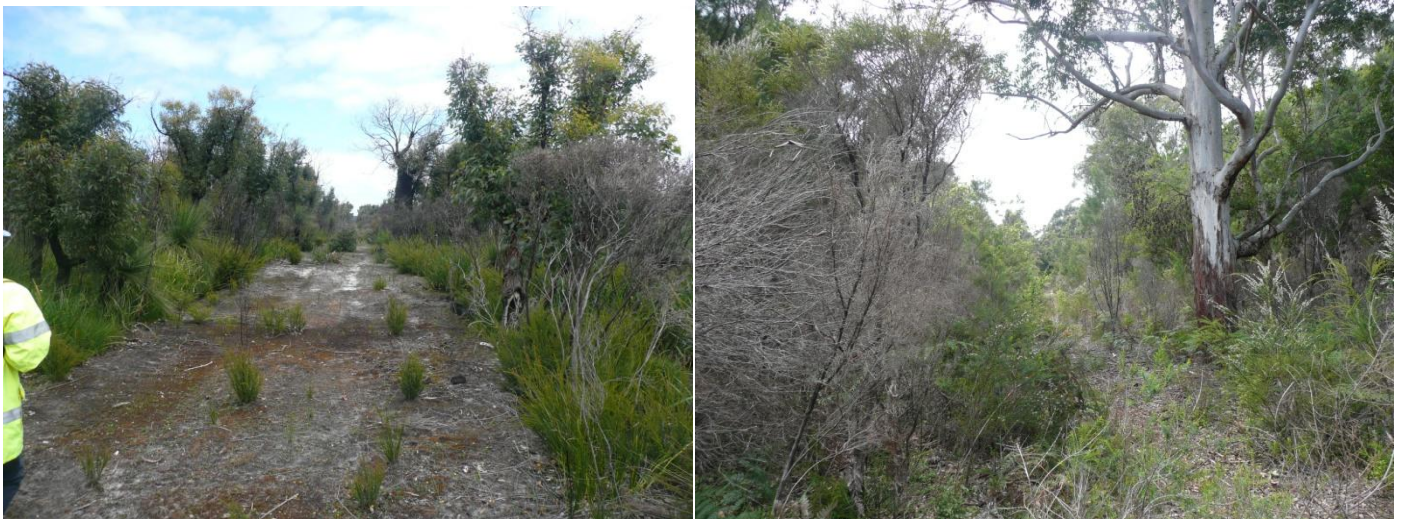
Potential habitat trees were noted at multiple locations along the length of the full length of the track, two examples are shown here in photographs 17 and 18, with a mature jarrah and karri shown in respective photos. The proposed track alignment would be varied to ensure the maximum separation between the track pavement and any habitat tree is achieved. The separation distance would vary at each potential habitat tree due and weighed up against potential clearing on the opposite side of the track, however indicative measurements on site indicate that an absolute minimum separation of pavement edge to a habitat tree would be 1.0m.

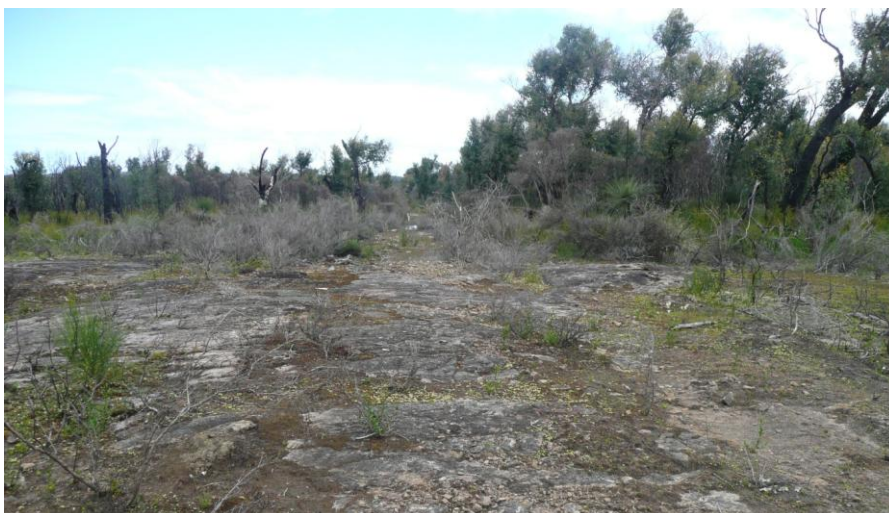
There exists several points along the track length where rocky granite outcrops occur, as shown here in photograph 19. As shown in Figure 4 below it is proposed to install the limestone track base directly on top of the granite, in order to negate the need to bring in heavy earthmoving machinery, remove the rock and potentially damage areas and vegetation adjacent the rocky outcrops.

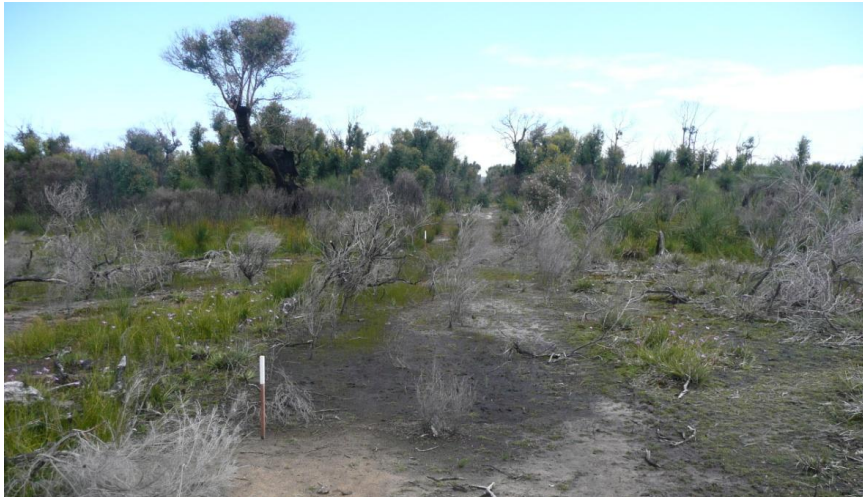
Photograph 20 shows a potential area where a passing lane could be provided relatively easily. The passing lanes would provide trafficable widths of 6.0m where vehicles could easily pass. Passing areas will be located where previous clearing has been undertaken or where minimal vegetation removal will be required.

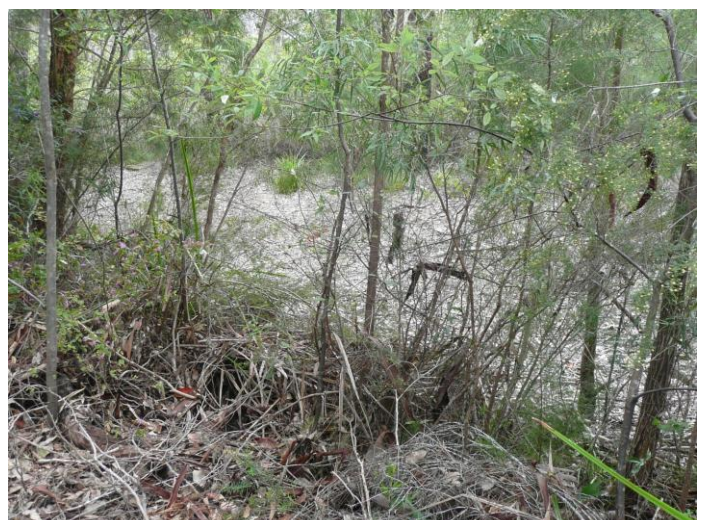
Photograph 21, below shows an area off to the side of the existing track where previous clearing has occurred and limited regrowth has happened, these areas provide ideal areas for passing lanes or widening of the track.

Areas such as the location shown in photograph 21 would be larger than the area required for a passing lane and would be one of the areas where rehabilitation would occur.

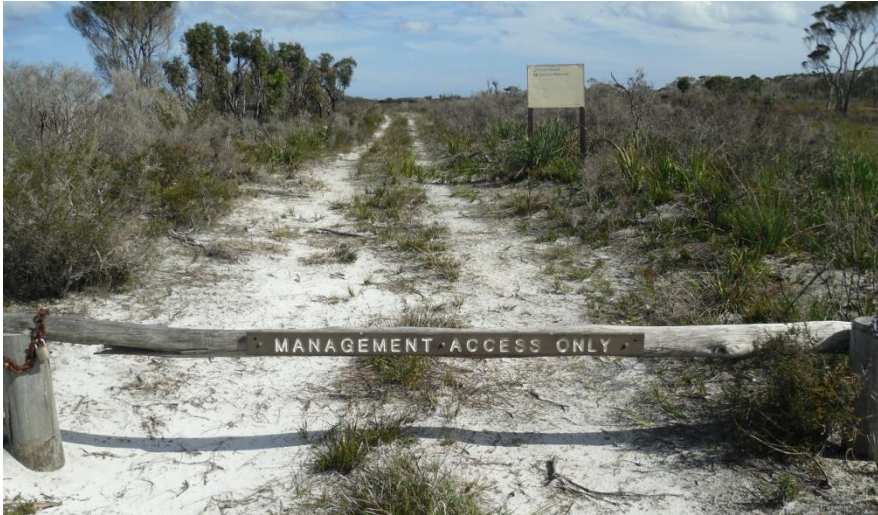
It is proposed that a gate be installed approximately 10.0 to 20.0m inside the road reserve from Windy Harbour Rd, the gate could be a simple DEC Management gate as shown below in photograph 22 or a solid fire access gate that is used to restrict vehicle access to strategic fire breaks. Either option would involve providing the owners of Loc 7965 with a key or providing a second interlinked lock that the Loc 7965 owners could maintain and use.

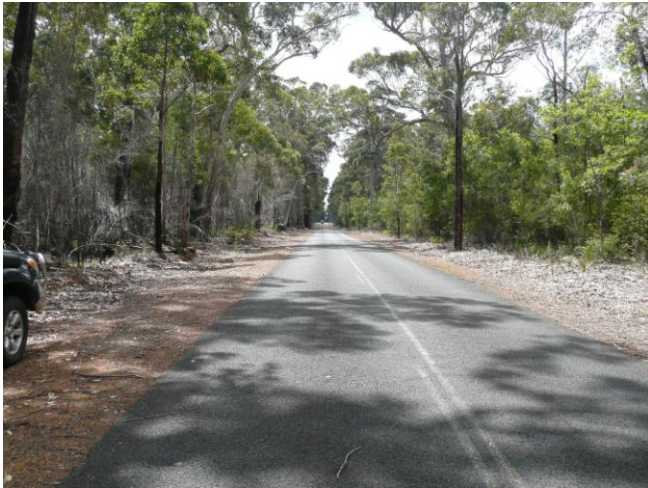
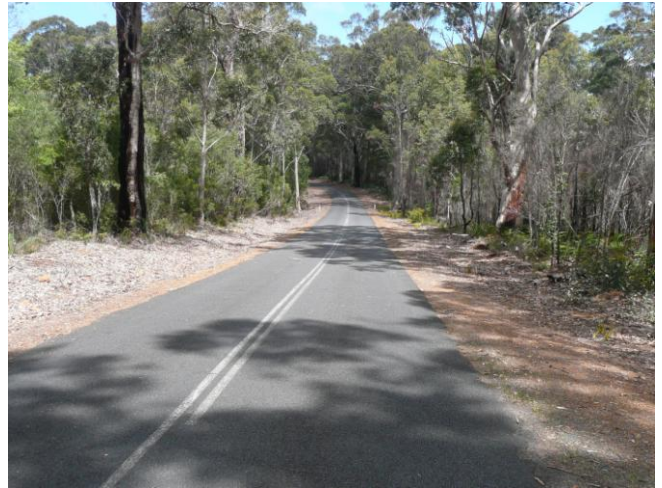
Photographs 23 and 24, indicate the available sight distances for a vehicle entering Windy Harbour Rd from the Doggerup Rd track, both the north and south sightlines in the respective photos appear adequate to meet the requirements of Austroads design criteria for intersections.

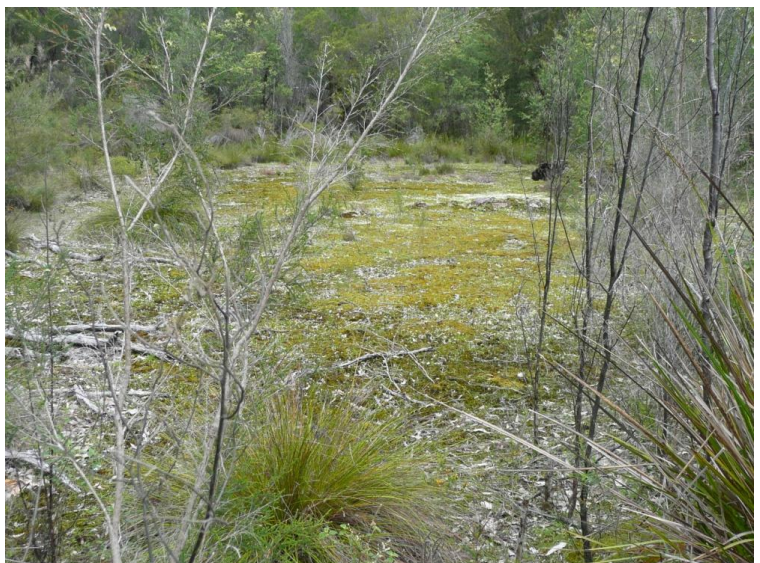
Areas devoid of ground cover and vegetation exist due to previous partial road construction clearing by the Shire in the 1960's and will be used as turnaround /lay down areas for construction vehicles during the works and then rehabilitated with plantings and removed vegetation at the completion of the construction works. This will enable the existing road reserve to be left in a better state than the existing. Photograph 25

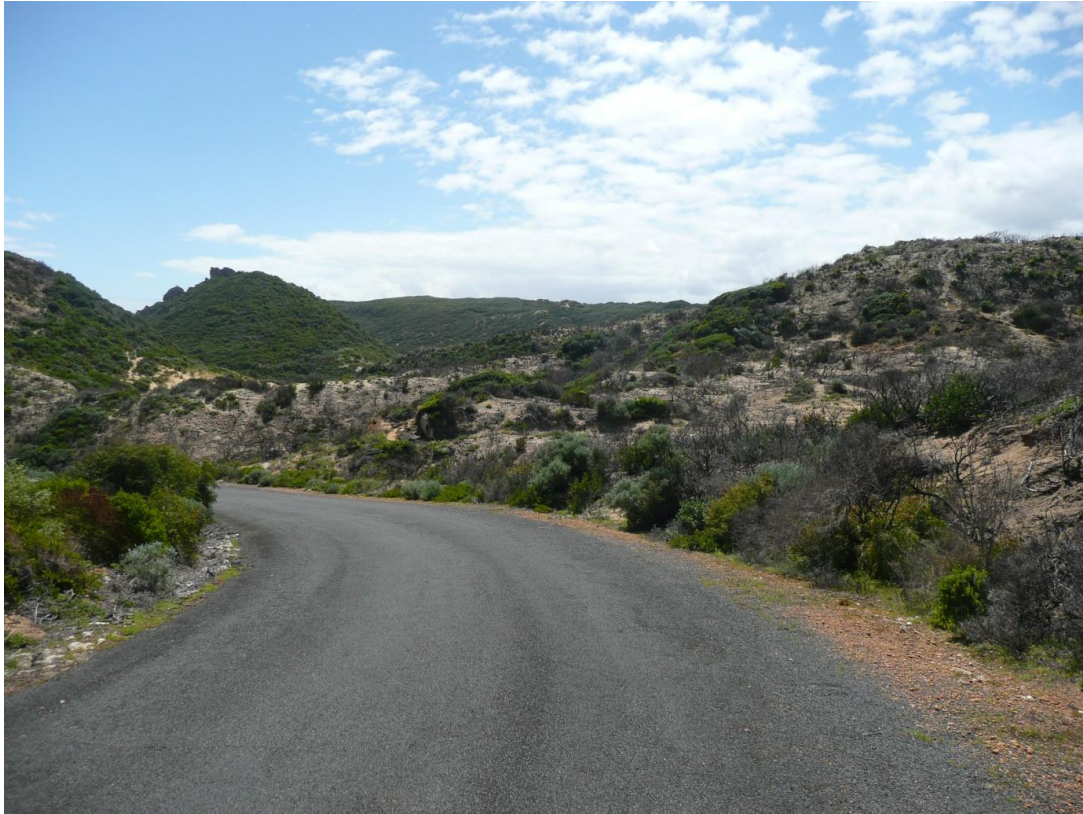
Photograph 26, potential intersection point for track from Salmon Beach Rd

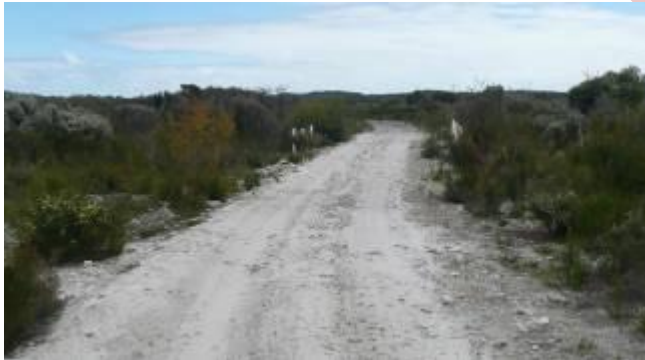
Photograph 1- Nearby Summertime Track provides an indication of the type of construction proposed for Doggerup Road.

The roadbase material is placed on top of the existing ground surface without the formation of defined roadside drains. Wetland/water crossings are formal water crossing (culverts and pipes) and are located beneath the guide posts in the photograph.

Please refer to Photograph 1 and 2 outlining similar constructed tracks within the local vicinity of the project site.

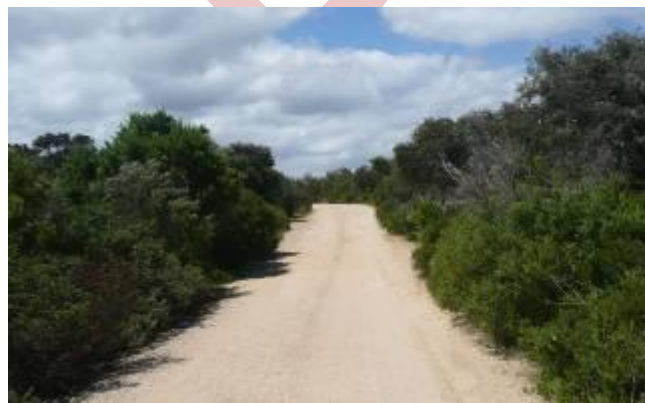
Another similar constructed track is the D'Entrecasteaux Road within the Windy Harbour Townsite. This is a 3.0m wide all weather limestone track with the vegetation regrowth occurring right up to and even overhanging the track. It should be noted that the track is constructed to take higher traffic volumes than that proposed for Doggerup Road and has minimal track width, no defined drainage and the track elevated above natural surface level by the actual track pavement. Please refer to Photograph 2 below.

Photograph 2 - D'Entrecasteaux Road within the Windy Harbour townsite.

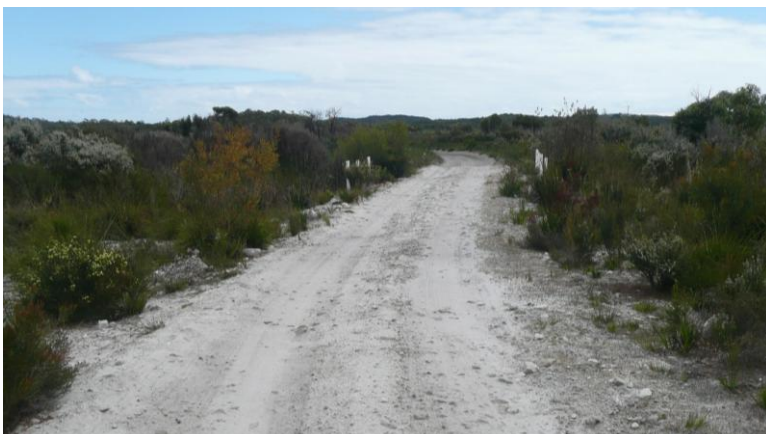
Photograph 1- shown left is of the nearby Summertime Track and provides an indication of the type of construction proposed for Doggerup Road. The limestone material is placed on top of the existing ground surface without the formation of defined roadside drains. Note is also made here regarding how the approach to water crossings are made, where an existing water crossing is located beneath the guide posts in the photograph.

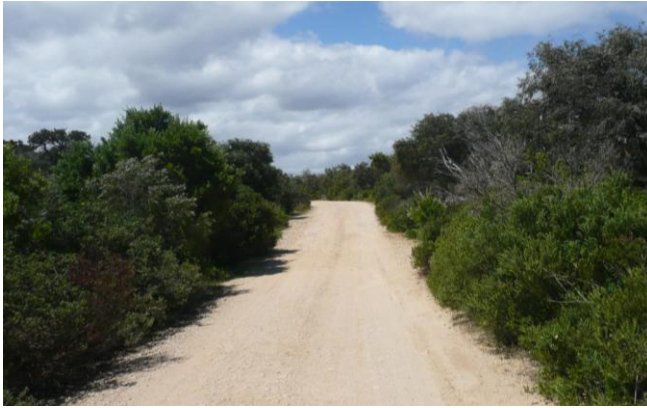
Photograph 2 - D'Entrecasteaux Road within the Windy Harbour townsite. A 3.0m wide limestone track with the vegetation regrowth occurring right up to and even overhanging the track. It should be noted that the track is constructed to take higher traffic volumes than that proposed for Doggerup Rd and has minimal track width, no defined drainage and the track elevated above natural surface level by the actual track pavement.

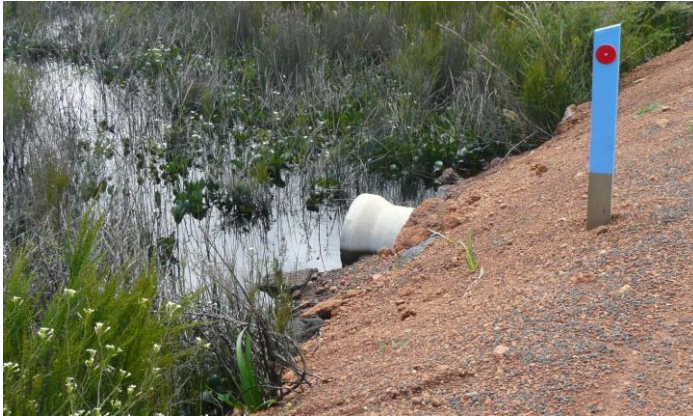
Photograph 3 - Shows an existing culvert crossing installed by the Shire of Manjimup on Windy Harbour Road. Note is made of the use of reinforced concrete pipework and the Main Roads standard guidepost as a vehicle notification of the crossing.

Please refer to Photograph 3 and 4 below showing constructed culvert examples in similar terrain.

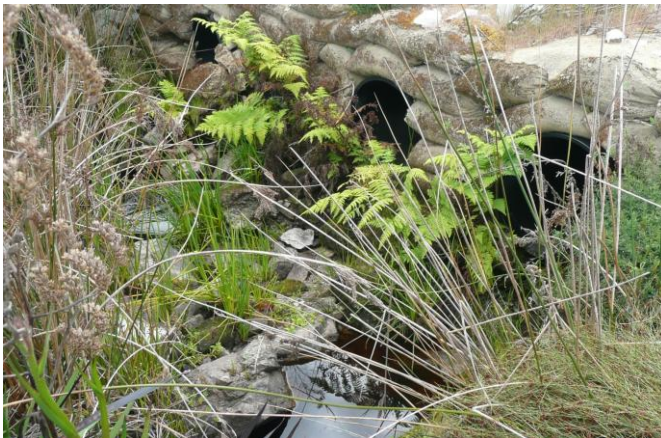
Photograph 4 - Shows the existing water crossing on the nearby Summertime Track. The crossing shows multiple culverts with concrete filled sandbags as scour protection.

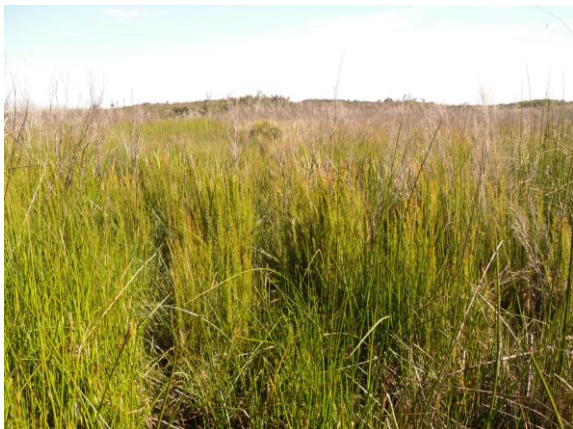
Photograph 5 – View of intermittent swamp
116°037'E 34° 791' (Eastern swamp)

The Subject site is located within the "Shannon River" Hydrographic Catchment Basin and the "Gardiner River" Local Catchment (SLIP 2010). The subject site is the upper watershed of the Blackwater Creek which is to the south east of the subject area. Blackwater Creek flows to the Gardiner River. Further to the north of the subject area the watershed is towards the Doggerup Creek system. Contour mapping shows that the subject site does not drain to the Doggerup Creek but to the Gardiner River watershed. The Road Reserve traverses 2 seasonal swamps, and minor creeks. These areas are winter wet, and summer dry. Please refer to Photographs 5, 6, 7 and 8 below.

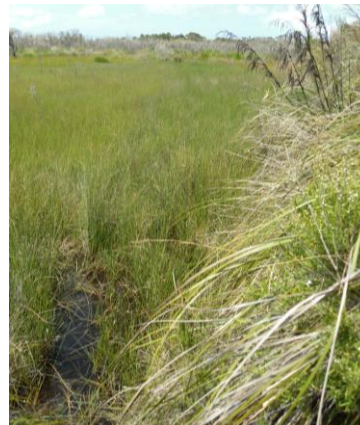
Photograph 6
– View of
intermittent
swamp
116°037'E 34°
791' (Eastern
swamp).

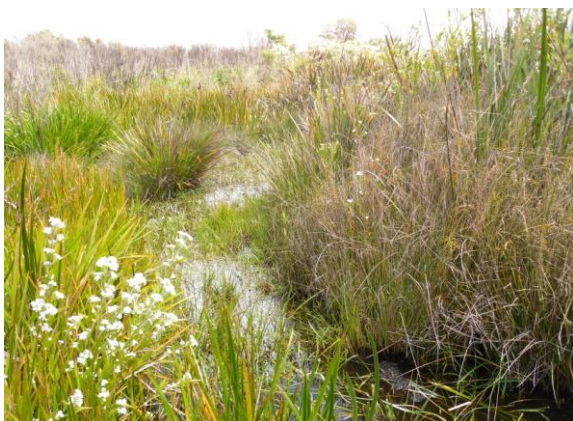
Photograph 7– View of intermittent swamp
116°034'E 34° 789' (Western swamp)

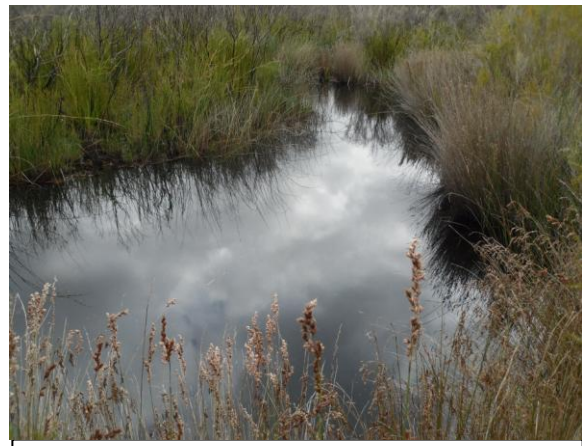
Photograph 8 – View of creek adjacent to
Karri/Jarra in the east.

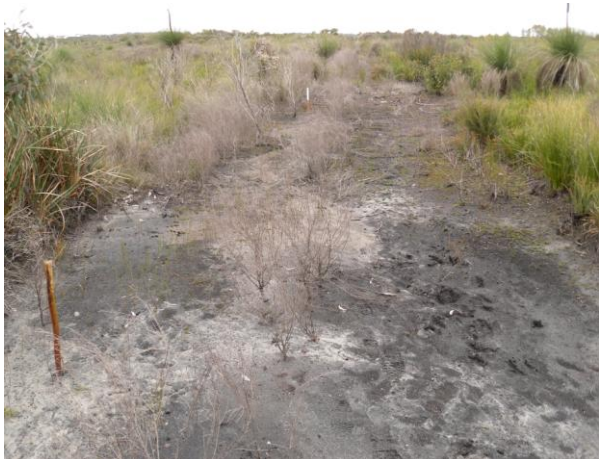
Photograph 9 – view of wet area in late winter, Winter water cover was to extent of pegs.

Preliminary site assessment over winter and spring indicates that the creeks and swamps are dependent on surface catchment and rainfall with water draining rapidly after rain events. Surface water area monitoring was commenced in August 2010 marking extent of water cover over the road reserve. Please refer to Photographs 9 and 10 below.

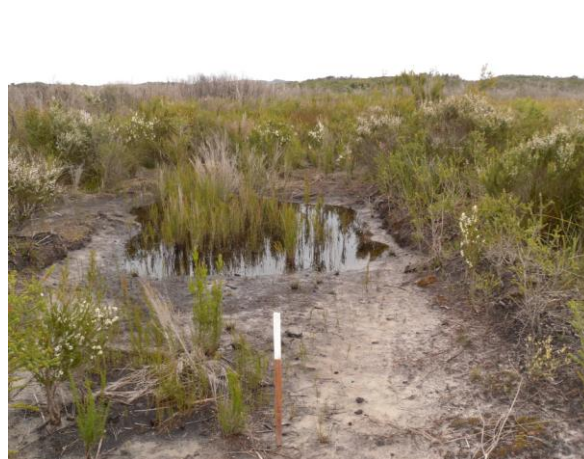
Photograph 10 – some pooling occurs from previous disturbance of road/clearing.

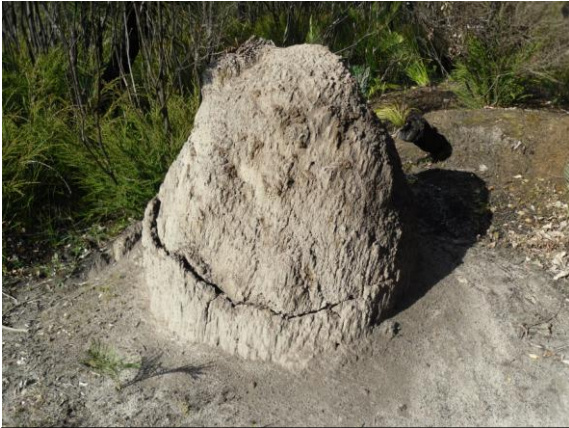
Photograph 11 – View of termite mound showing grey sands adjacent to granite outcrop.

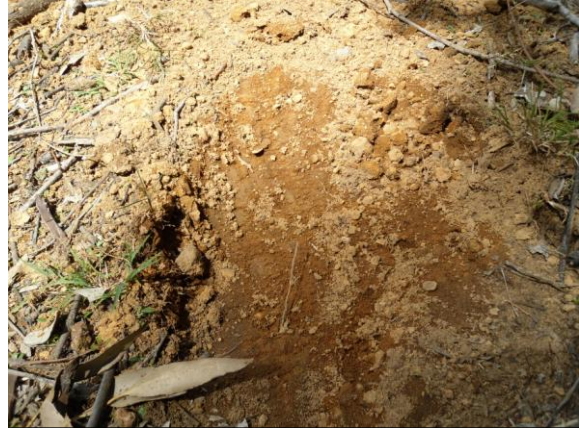
Photograph 12 – View of loamy soil from scratching most probably from echidna in Karri forest area.

Desktop Assessment indicate that Acid Sulfate Soils have a high to moderate (50-69%) risk in the 254BrBWp Map unit, being from Estuarine/lagoonal origin. Acid Sulfate Soil Risk Mapping is shown in Appendix D. Site investigation indicates the site is Loams over clay in the east (Karri Forest areas) grading to sands over granite through the central area and deep sands in the west (grading to dune systems). Please refer to Photographs 11, 12 and 13 over the page and soil profile sampling sheets Appendix C.

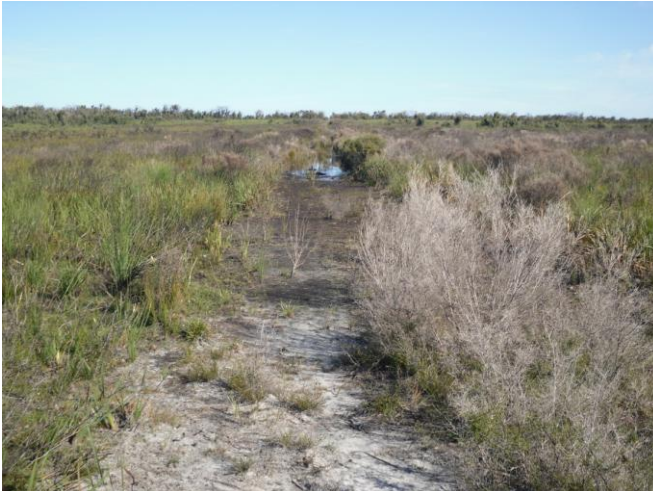
Photograph 13 - Peats/sands over granite in low lying areas. These areas have surface water movement (winter watershed) during peak rainfall periods, drying in summer conditions to isolated pools. Depressional areas exhibit silts accumulating on surface from horizontal water movement. Photograph central along road reserve.

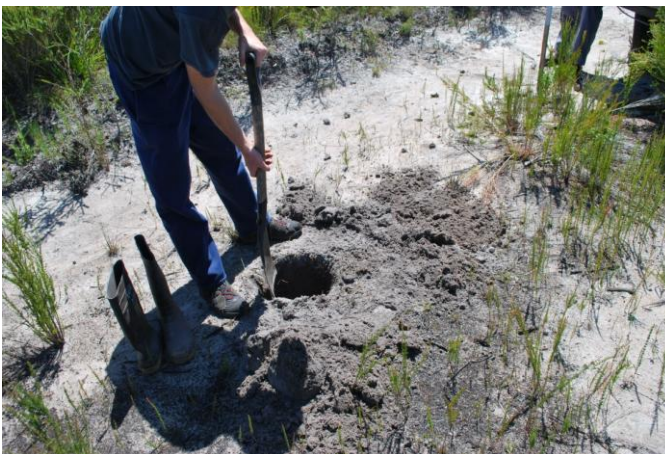
Photograph 14 – Deep Grey sands exist in the eastern portion of the subject area. Vegetation consistent with occasional groundwater sources adjacent to road reserve (*Taxandria juniperina*). No peats encountered along road reserve in this soil type.

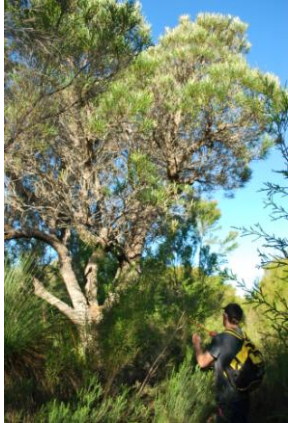
<u>Location GPS</u>	<u>Site description</u>	<u>Sample and Depth(mm)</u>	<u>Soil description</u>	<u>Site Photographs</u>
Loc 4 0410852 6150067	Habitat #37	S1 - 150 S2 - 250	Dark grey sand Dark grey sand

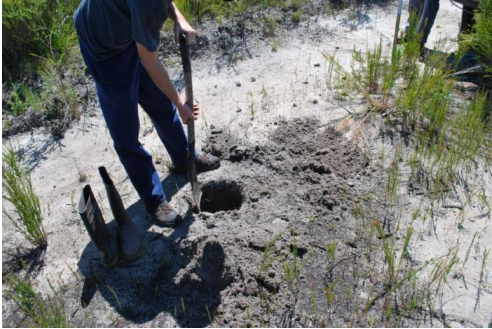
Loc 5 04122058 6149735	Eastern edge of wetland 2	S1 - 250 S2 - 500	Light brown sand, moist organic matter. Brown moist sand.

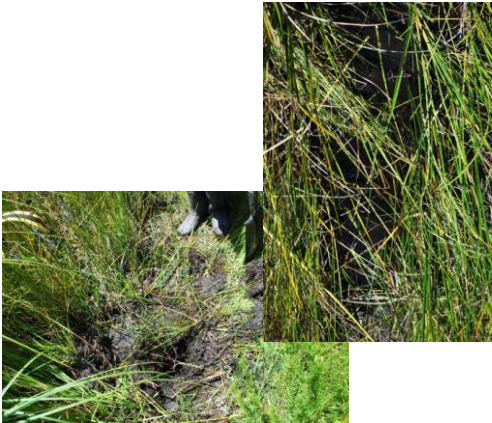
<u>Location GPS</u>	<u>Site description</u>	<u>Sample and Depth(mm)</u>	<u>Soil description</u>	<u>Site Photographs</u>
Loc 7 0411969 6149729	Middle of wetland 2 (east)	S1 - 250 S2 - 400	Dark brown silty sandy peat, organic matter Dark brown/black silty peat, wet, organic matter. Water table 300mm Minnows sighted. 20 paces west, thick wet peat to 500mm. surface flow north to south.

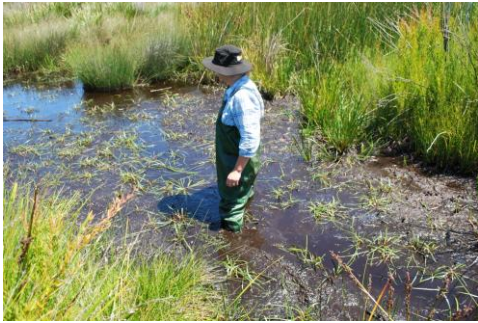
Loc 8 0411942 6149727	In mud hole	S1 - 250 S2 - 500	Dark brown silty sandy slop Dark brown silty sandy slop, organic matter. 10cm of water cover, clear flowing north to south.

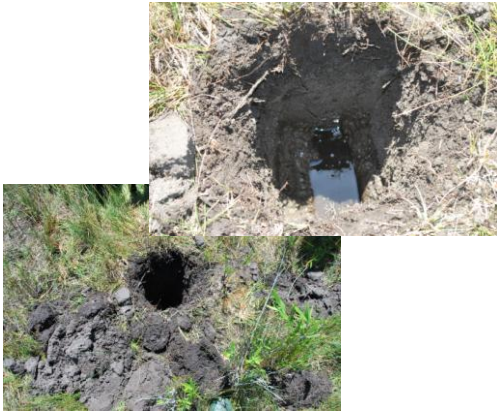
Loc 9 0557593 6120639	West end of wetland 2	S1 - 250 S2 - 500	Dark grey slightly wet sand, organic matter. Grey wet sand. Water table 500mm No open water.

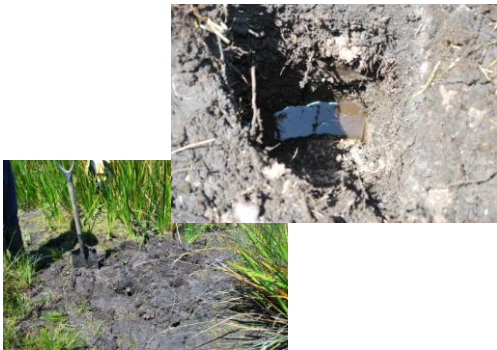
Loc 10 0411600 6149921	Wetland 3, 10m from east side	S1 - 250 S2 - 500	Brown wet peat Brown wet sand Water table 500mm No surface water in reeds. Deepest part 15cm, silt settled over sand. Minnows sighted. Running slowly north to south.

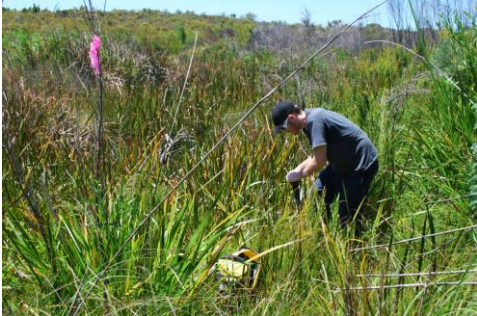
<u>Location GPS</u>	<u>Site description</u>	<u>Sample and Depth(mm)</u>	<u>Soil description</u>	<u>Site Photographs</u>
Loc 11 0411575 6149922	West side of wetland 3	S1 - 250 S1 - 500	Wet dark brown sand Wet brown coarse sand No water table

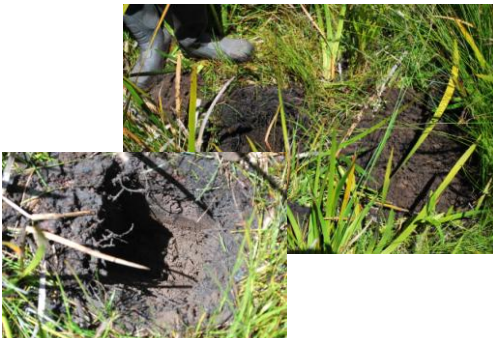
Loc 12 0413798 6149700	Wetland 1 Inundated area to west of creek crossing	S1 - 250 S2 - 500	Grey moist sand Dark grey moist sandy silt Water table 400mm

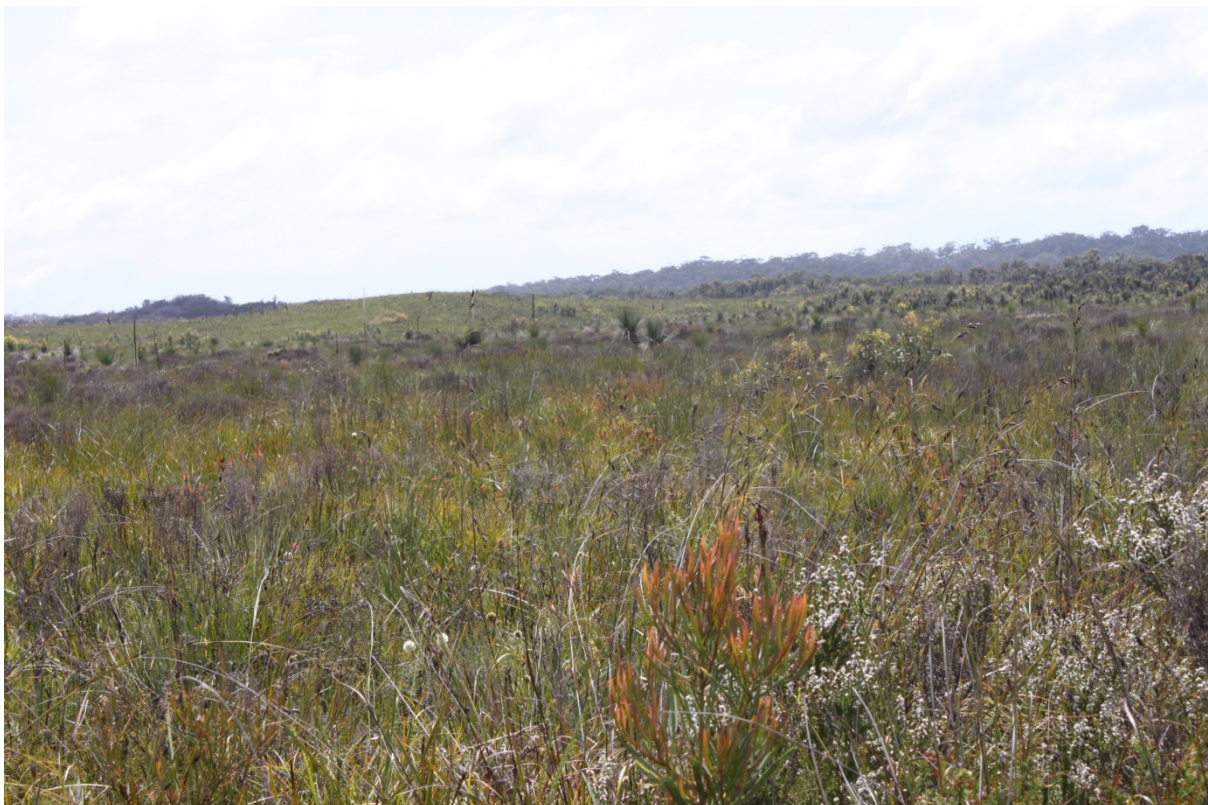
Figure 5: Dunes to the west and north of the road reserve act to direct water flow to the south and east, towards the Gardner River

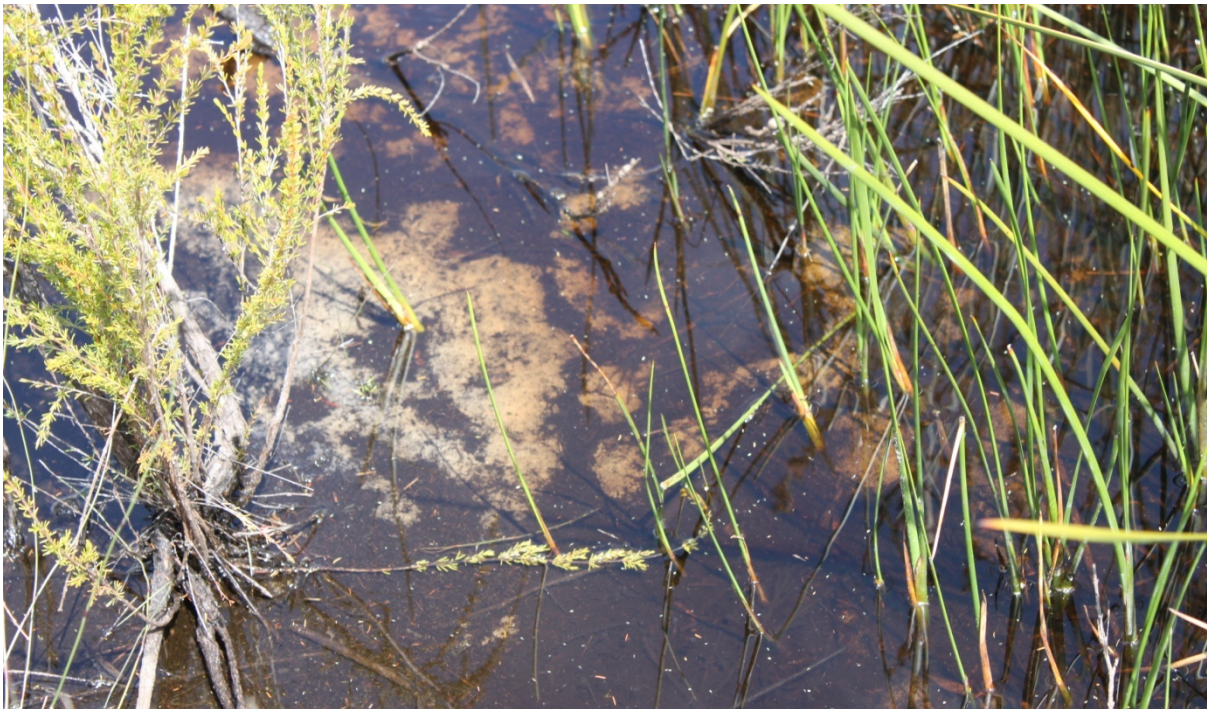
Figure 8: Wetland base is sandy soils with fine layers of organic material

The wetlands within the project site primarily occur over sandy soils with fine layers of organic material, as shown in Figure 8; however some peat is present within deeper portions of the large wetland areas (Figure 9). The water is very coloured due to the presence of tannins from vegetation and is consistent with other wetlands within the region.
