**Access Road to Nelson
Location 7965
(Sandy Peak)
Doggerup Road
Shire of Manjimup**

**Public Environmental Review
Assessment No 1836
Appendices 1 to 9**

Appendix 2 – Engineering Assessment, MPM Development Consultants

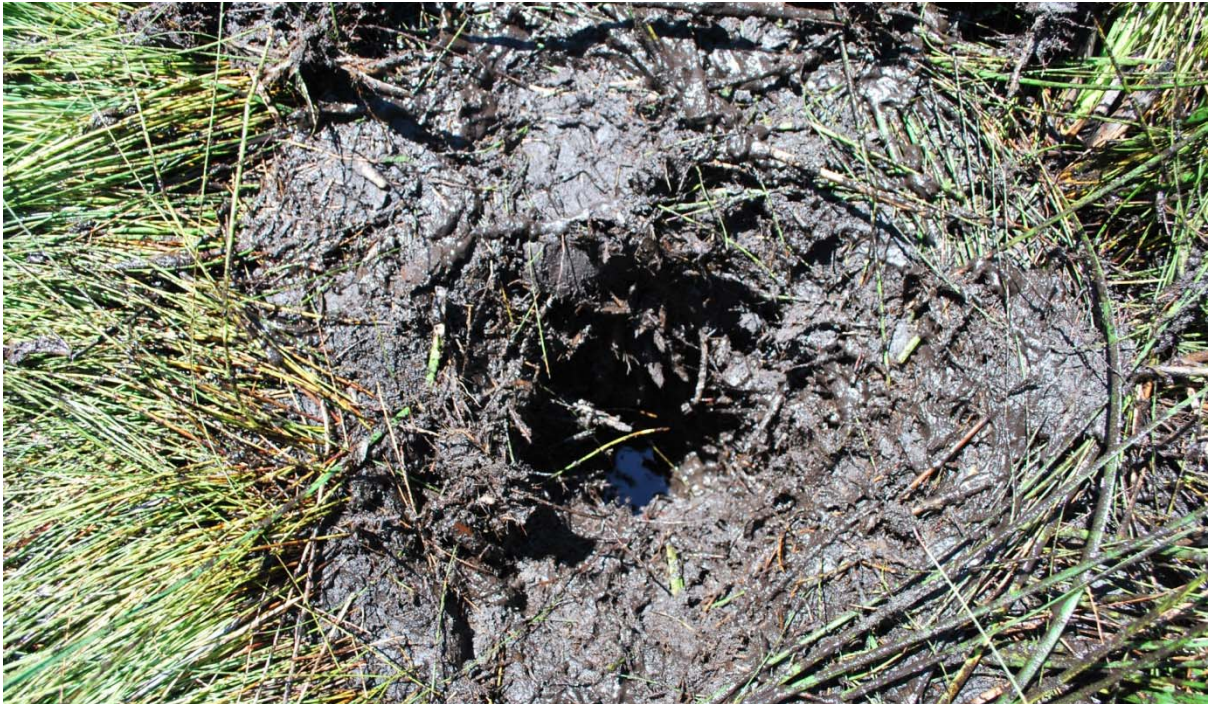
Figure 9: Peaty material in deeper wetland areas (Photo: K. Kinnear)

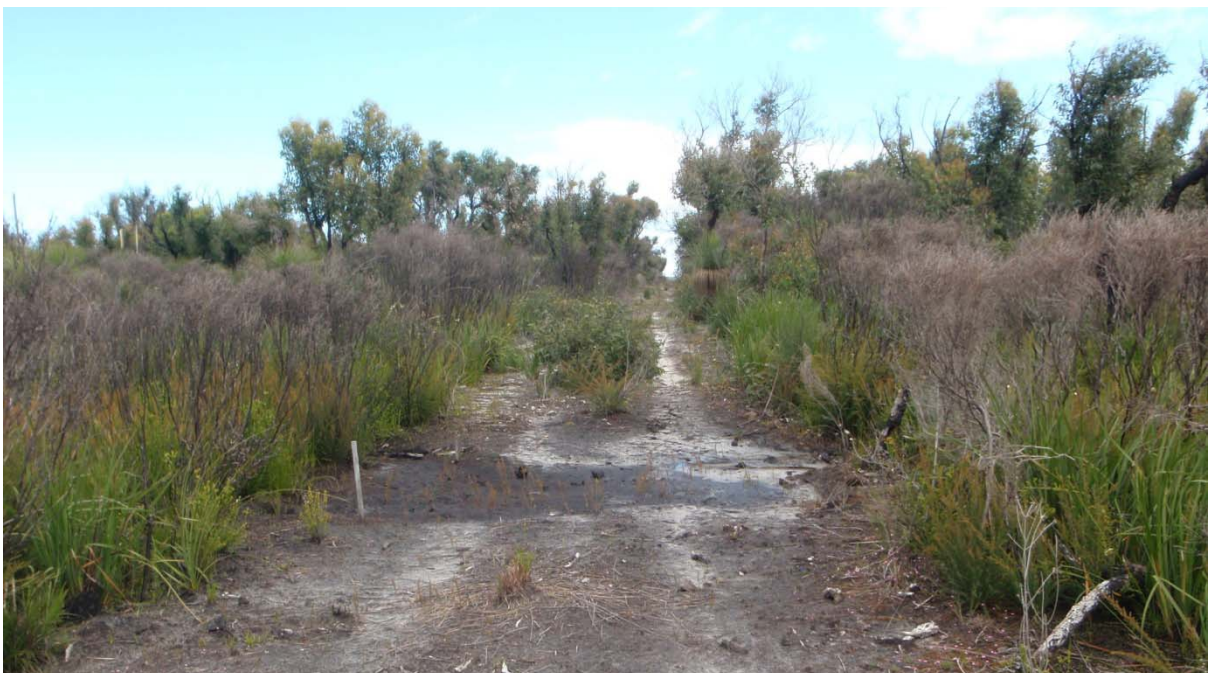
A number of wet areas within and around the Doggerup Road reserve area occur in depressions within the cleared road reserve (Figure 10). The creek line at the western end of the karri is known to have been modified by the Shire of Manjimup during road building activities some 30+ years ago (Bio Diverse Solutions, 2010). It is unknown whether other winter wet depressions within the road reserve are natural wetland areas or associated with the current presence and condition of the road reserve. It should be noted that the depressions generally include little or no vegetation and no fauna other than the occasional tadpole was observed.

Figure 10: Winter Wet Depression within Doggerup Road Reserve

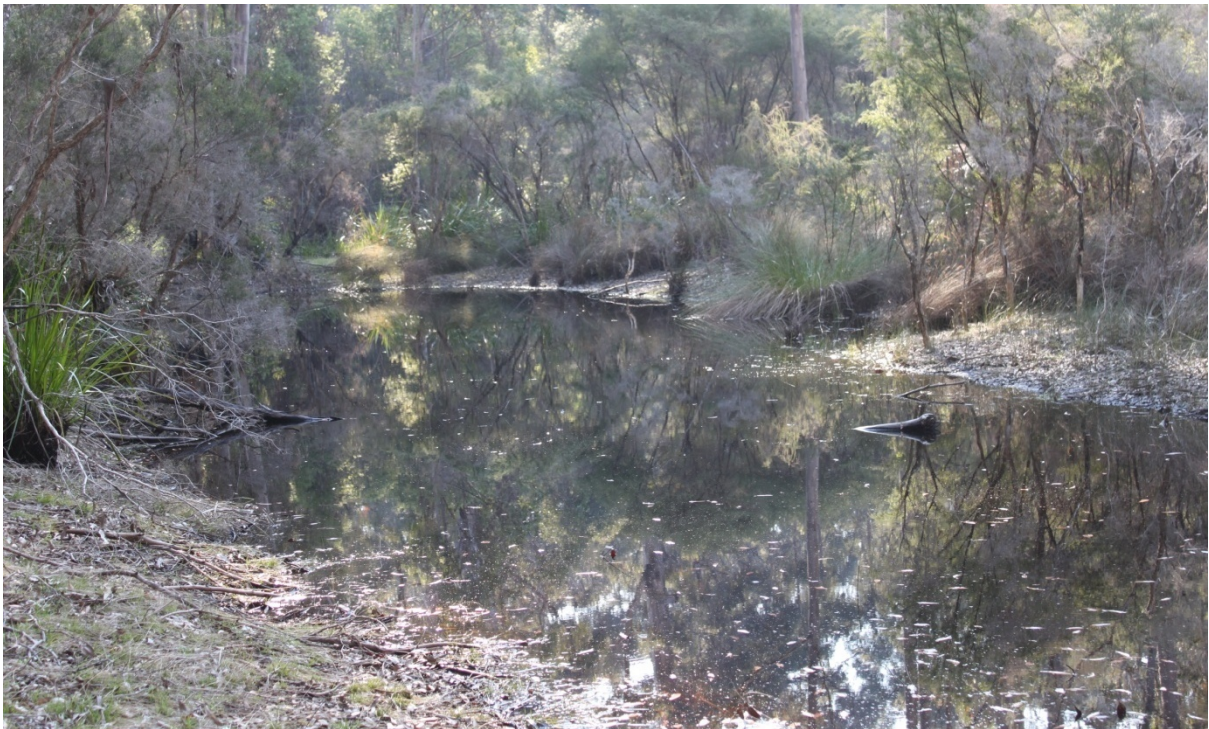
Figure 11: Winter Wet Borrow Pit

A borrow pit adjacent to the road reserve near Windy Harbour Road has also become winter wet (Figure 11). At present, vegetation within the wet areas is primarily grasses with few sedges and rushes (Figure 12).

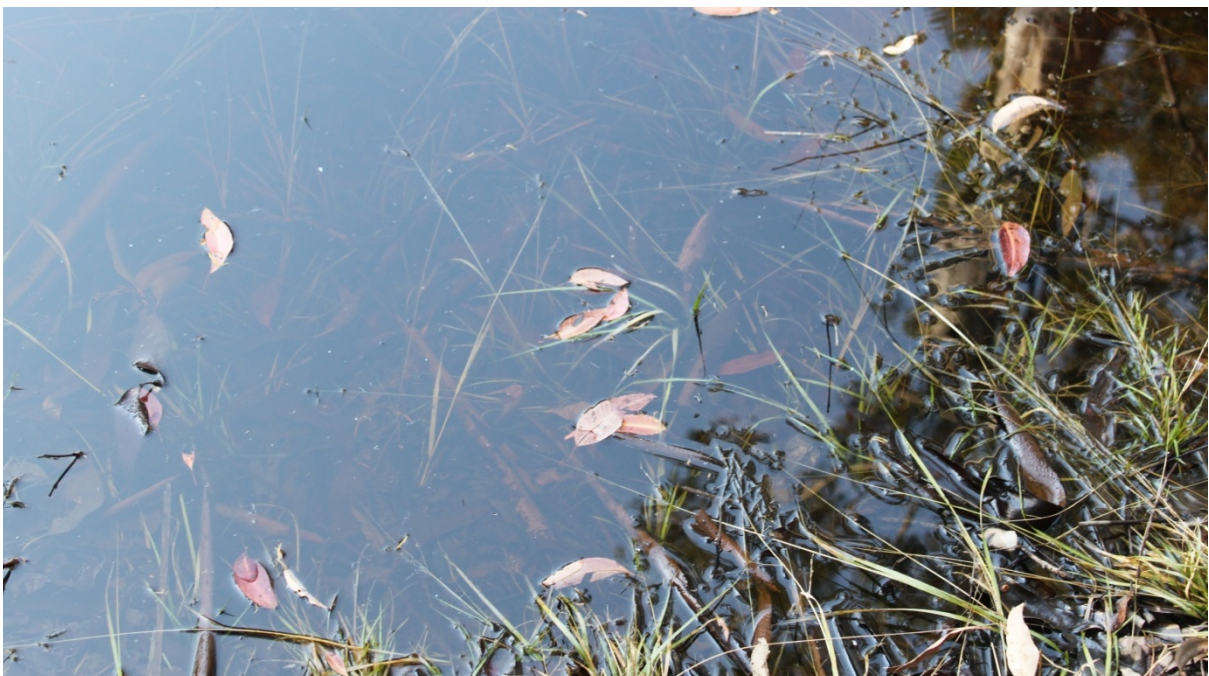
Figure 12: Inundated Grasses in Borrow Pit

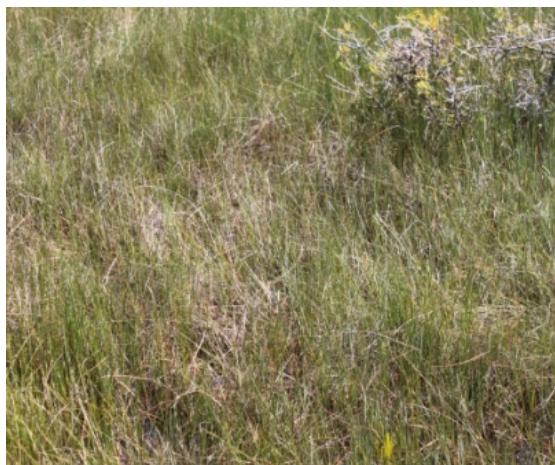
Figure 13: Grasses and sedges within wetland areas, showing little open water

The two larger wetland areas are best described as flooded meadows or sedge marshes fed by narrow creeks. They contain little or no open water, with sedges or rushes covering the majority of the wet areas (refer Figures 13, 14).

- no birds or other larger fauna species were apparent within the wetland areas, and
- no wetland bird species were noted during the site visit, with the significant presence of sedges and rushes and lack of open water (refer Figures 13, 14) possibly acting as a deterrent.

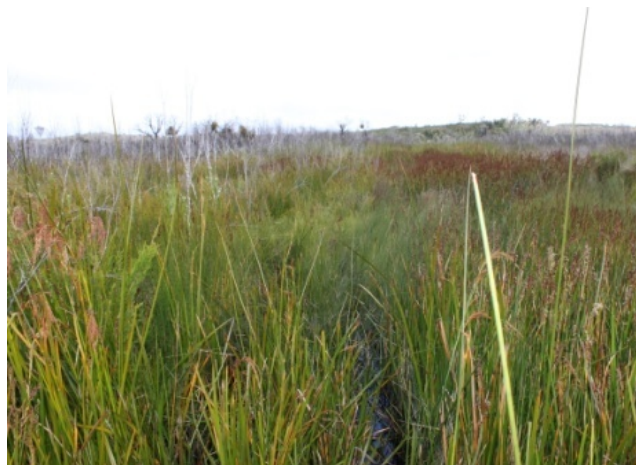
Figure 14: Sedge marshes with little or no open water

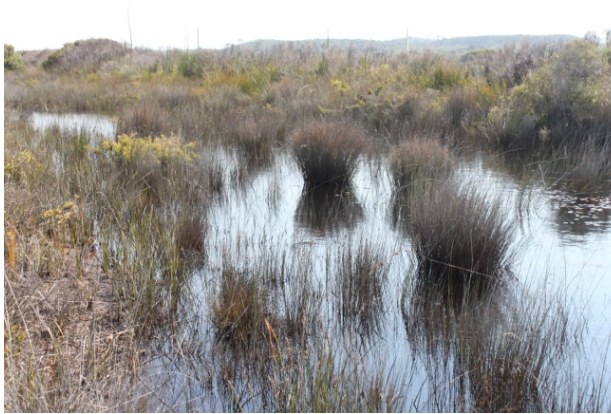
Figure 16: Wet area to west of Windy Harbour Road

Areas that can be described as wetlands within the immediate vicinity were noted adjacent to Windy Harbour Road to the south of Doggerup Road reserve (refer Figures 16 and 17). It is not known if the areas are borrow pits associated with the road construction or were naturally subject to seasonal inundation prior to the construction of the road. Similarities to the Doggerup Road reserve wetland locations include:

- similar heath-type vegetation and typical wetland species,
- brown coloured water from tannins associated with the presence of native vegetation,
- sandy soils, and
- little or no aquatic fauna was apparent at any of the wet areas accessed.

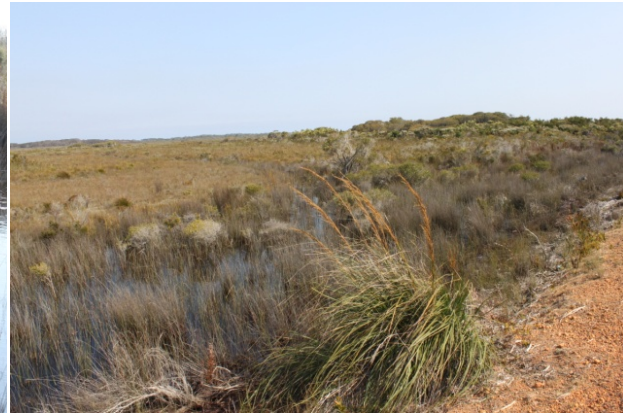
Figure 17: Wet area to east of Windy Harbour Road

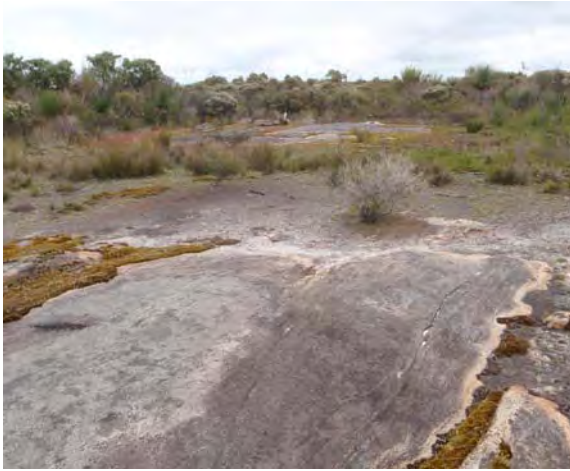
Exposed granite area in the *Eucalyptus marginata* Low Woodland unit.

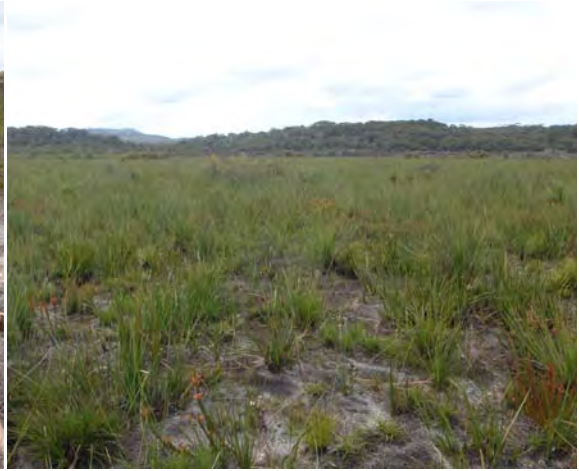
A recently burnt area of Open Heathland on the east side of the survey area.

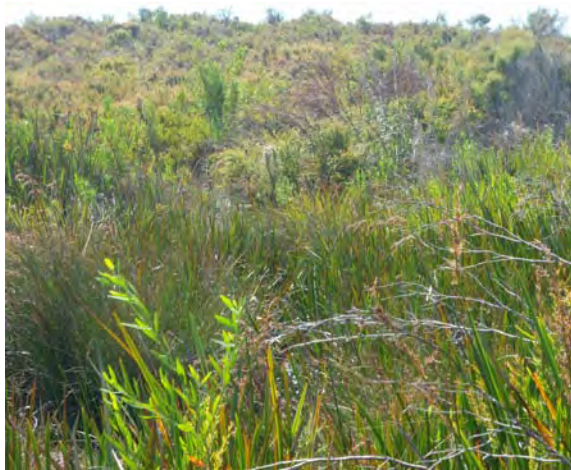
Closed Tall Scrub area.

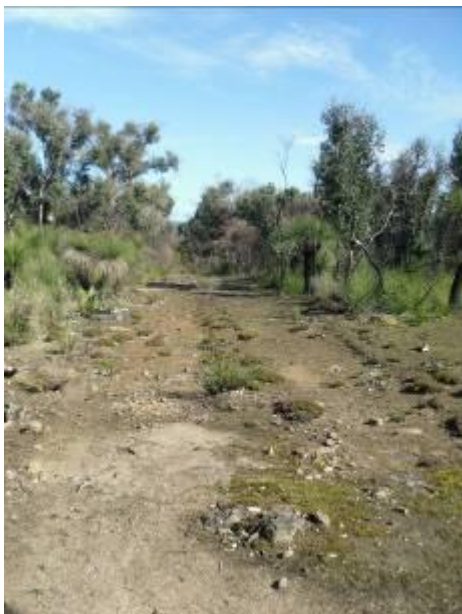
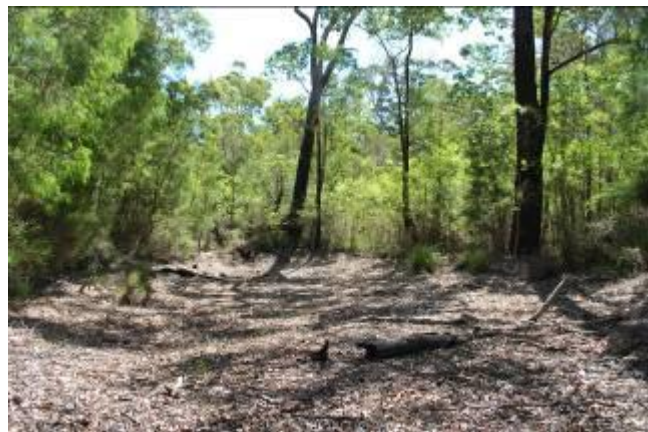
Photograph 1 right – View of cleared track through low open woodland.
Photograph 2 above – View of borrow pit from road construction and formation by the Shire in the karri forest area of the subject site.

The site has been previously disturbed by the formation of the road and drainage (and borrow pits) by the Shire of Manjimup from Windy Harbour Road and from previous clearing disturbance the full length of the 6.5km track. Please refer to Photographs 1 and 2 below.

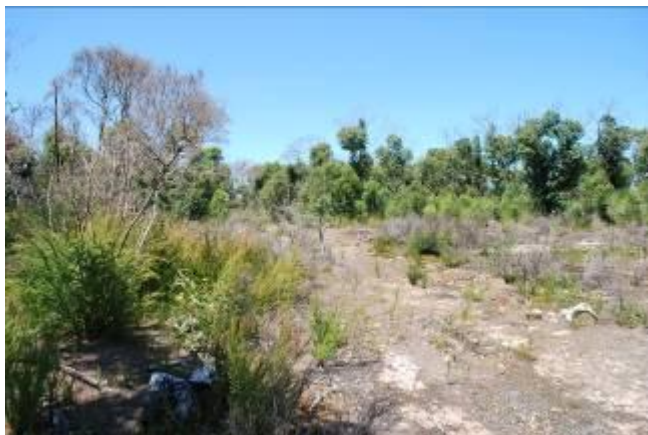
Photograph 3 – View of fire 3-4 year old burnt area in low open *E.marginata* woodland showing regeneration.

The western end of the track has sustained fire and is varying stages of regeneration, please refer to Photographs 3 and 4 below.

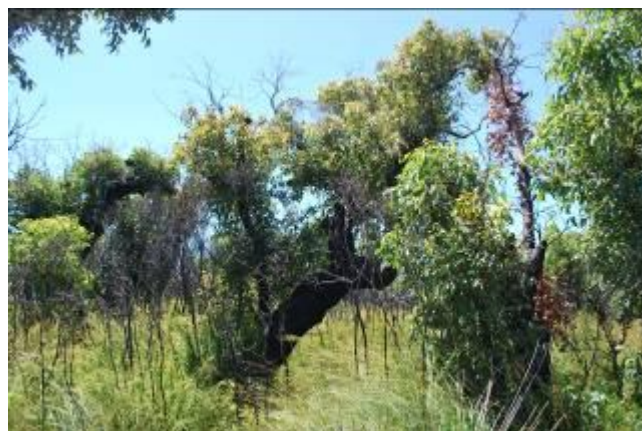
Photograph 4 – View of *E.marginata* species with coppice regeneration.

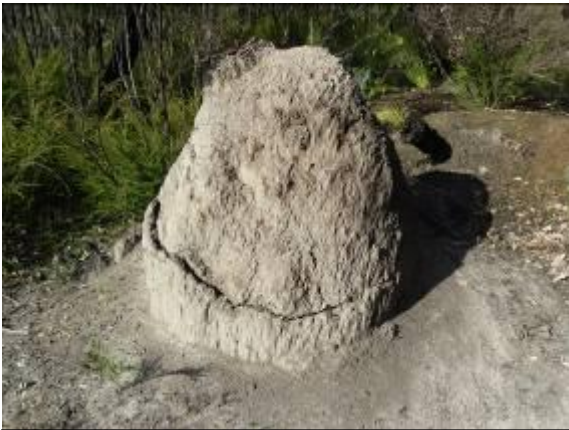
Photograph 5 – View termite mound showing grey sands adjacent to granite outcrop.

Preliminary site investigation indicates the site is Loams over clay in the east grading to sands over granite and deep sands in the west. Please refer to Photographs 5 and 6 over the page.

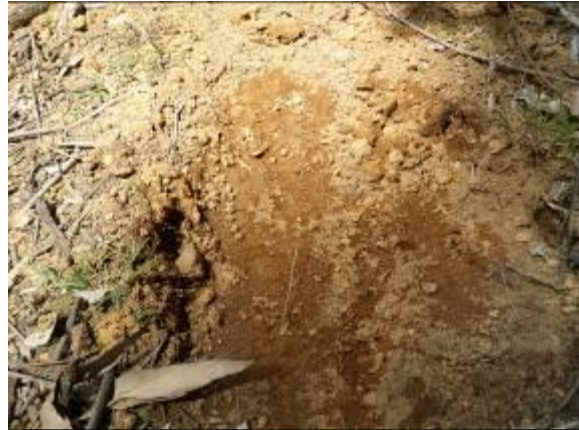
Photograph 6 – View of loamy soil in the karri forest area from scratching most probably from an echidna.

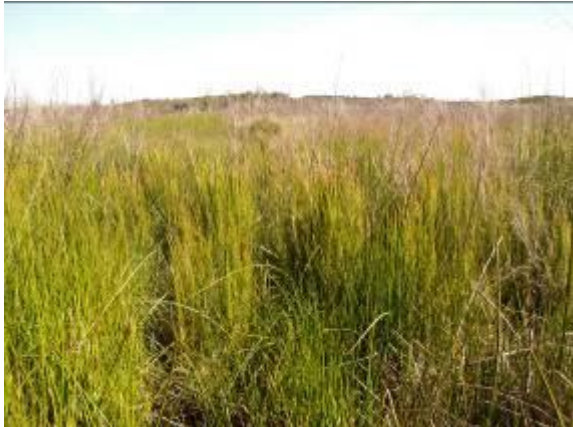
Photograph 7 – View of intermittent swamp 116°037'E 34° 791' (Eastern swamp)

The Subject site is located within the “Shannon River” Hydrographic Catchment Basin and the “Gardiner River” Local Catchment (SLIP 2010). The subject site is the upper watershed of the Blackwater Creek which is to the south east of the subject area. Blackwater Creek flows to the Gardiner River. Further to the north of the subject area the watershed is towards the Doggerup Creek system. Contour mapping shows that the subject site does not drain to the Doggerup Creek but to the Gardiner River watershed. The Road Reserve traverses 2 seasonal swamps, and minor creeks. These areas are winter wet, and summer dry. Please refer to Photographs 7, 8, 9 and 10 below.

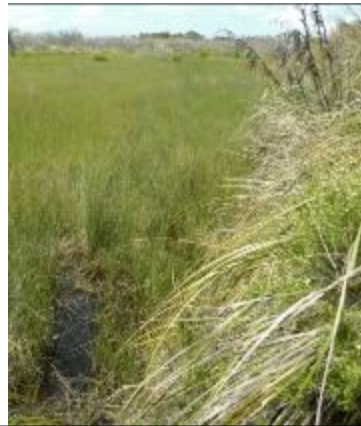
Photograph 8 – View of intermittent swamp 116°037'E 34° 791' (Eastern swamp).

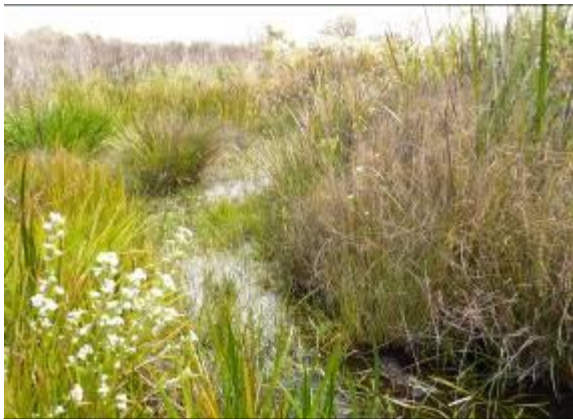
Photograph 9 – View of intermittent swamp 116°034'E 34° 789' (Western swamp)

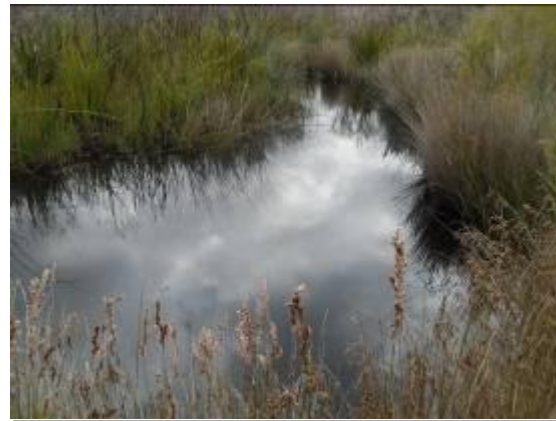
Photograph 10 – View of seasonal creek adjacent to Karri/Jarrah in the east.

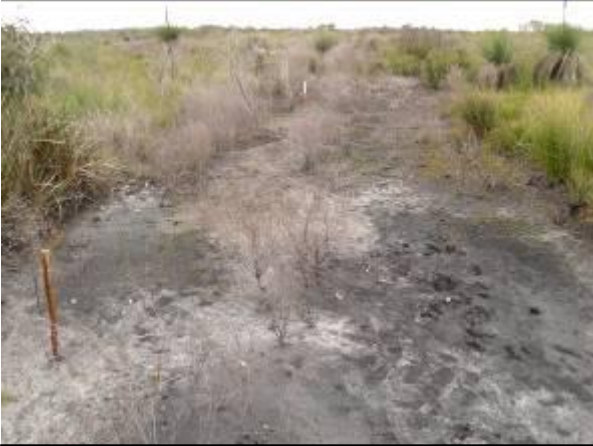
Photograph 11 – View of wet area in Spring 2010, Winter water cover that year was to extent of pegs.

Site assessment over spring (2010) and winter (2011) indicates that the creeks and swamps are dependent on surface catchment and rainfall with water draining rapidly after rain events. Surface water area monitoring commenced in August 2010 marking extent of water cover over the road reserve and project footprint. Please refer to Photographs 11 and 12 over the page.

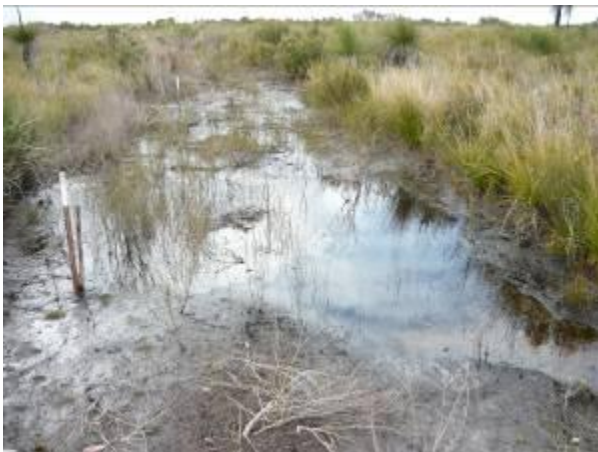
Photograph 13– View of wet area in late winter 2011, Winter water cover was still to extent of pegs placed in 2010. (Compare to Photograph 11).

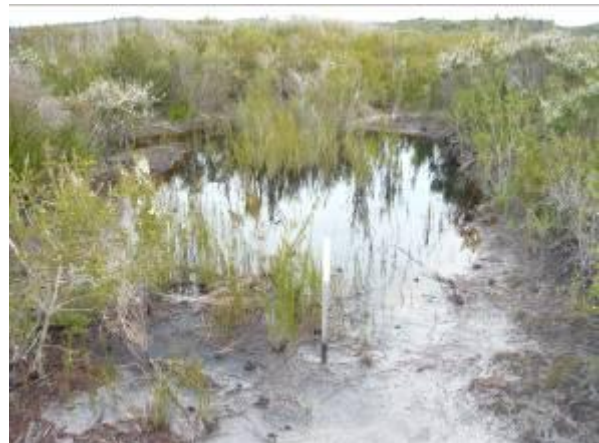
Photograph 14 – View of wet area in late winter 2011, Winter water cover was still to extent of pegs placed in 2010.(Compare to Photograph 12)

All seasonal creek areas were dry to damp upon inspection under late summer conditions (March 2011), and Winter 2011 monitoring revealed that surface water extent had not breached higher than 2010 levels. Please refer to 2011 winter monitoring photos below comparing sites pegged in 2010 (Photographs 13 and 14).

The surface water monitoring to date indicates that the surface hydrology waters are rapidly draining with temporary pools forming during precipitation events. The extent of surface water cover in 2011 (wet winter season) compared with 2010 (un-seasonally dry winter) indicates that surface water patterns are not variable between seasons. Surface water monitoring is continuing through to 2012.

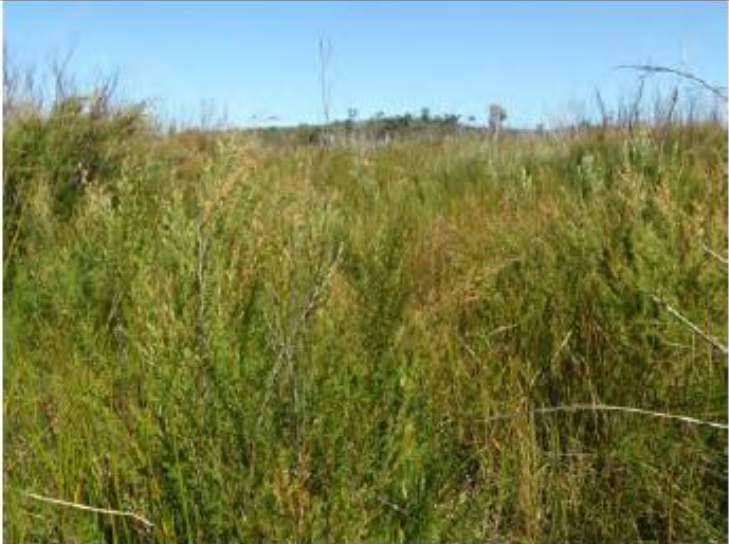
Closed Tall Scrub in the largest wetland area of the survey.
Tf	Old, established dunes with a Low Open Forest of <i>Taxandria flexuosa</i> and <i>Banksia ilicifolia</i> with and understorey of Tall Open Scrub of <i>Jacksonia horrida</i> , <i>Acacia Cyclops</i> and <i>Macrozamia reidleyi</i> .

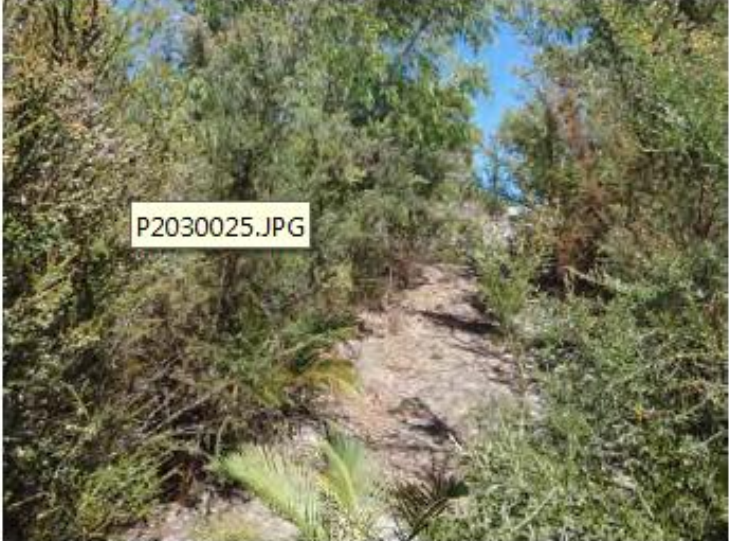
<i>Jacksonia horrida</i> Tall Open Scrub.

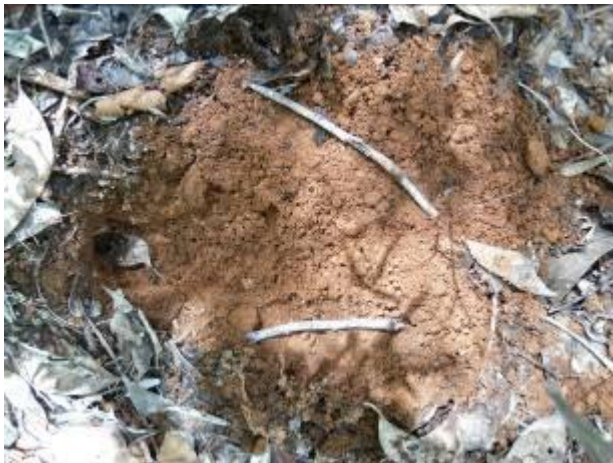
Photograph 13 – View of diggings by a Quenda, near H59 tree in Karri forest.

The walked transect searches yielded 2 sites where signs of Quenda were found (Photograph 13 over the page). The 2 sites (H59 & H58) contained sparse concentrations of recent diggings where

the animals had been foraging for possible worms or larvae. During the site assessment their diggings were distributed mainly around the edges of the Road Reserve in the Very Good to Disturbed (in centre of cleared track) habitat areas.
