## 12. Biodiversity

### 12.1 Terrestrial fauna habitat

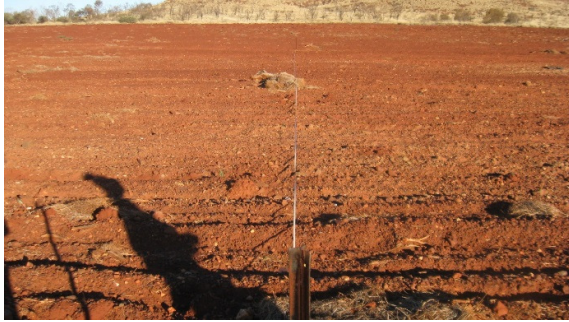
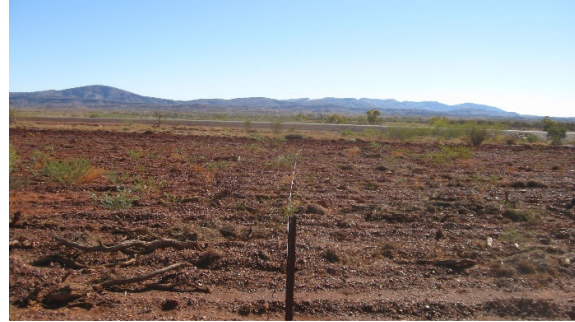
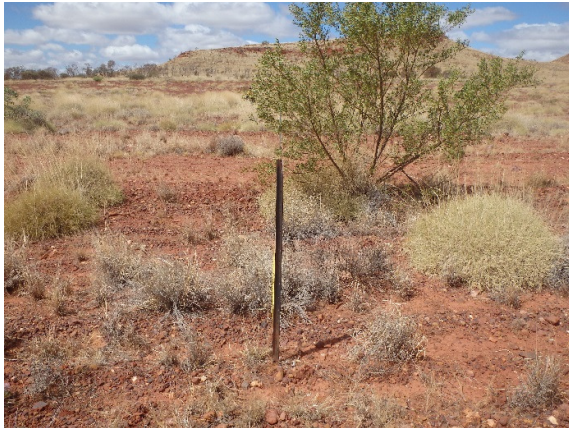
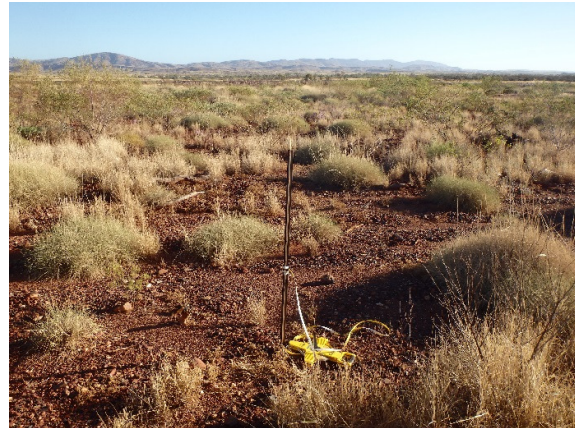
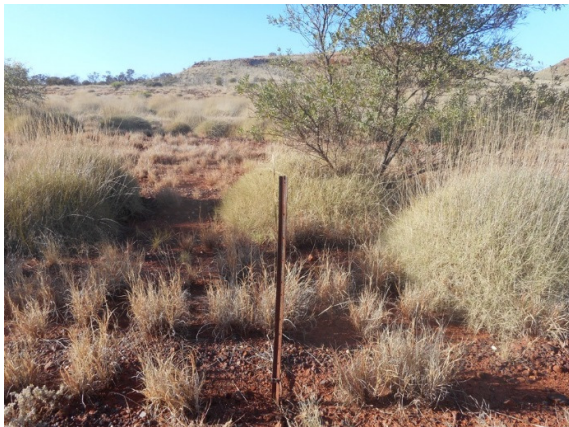
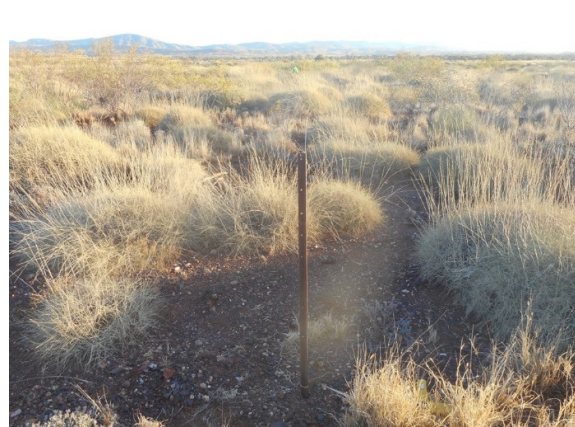
WQR borrow pits (2010 – <1 year)

WQR borrow pits (2014 – 5 years)

WQR borrow pits (2017 – 8 years)

Figure 23: Borrow Pit rehabilitation over time at Brockman 4

Borrow pits along WQR were rehabilitated in 2009. Rehabilitation details are largely unknown; however they generally appear ripped without seeding, with topsoil returned directly. Monitoring locations were installed in 2010 at 31 different borrow pits. These sites were monitored in 2010, 2011, 2012, 2014 and 2017 (Figure 23). The rehabilitation is compared to local undisturbed reference sites. The rehabilitation has generally established well, with a range of native perennial species present. Vegetation parameters are approaching the corresponding reference sites. Buffel Grass is present at some of the borrow pits in low to moderate densities. Weeds in rehabilitation are managed under the company's *Weed Management Strategy* which has control measures such as periodic spraying and equipment hygiene procedures.

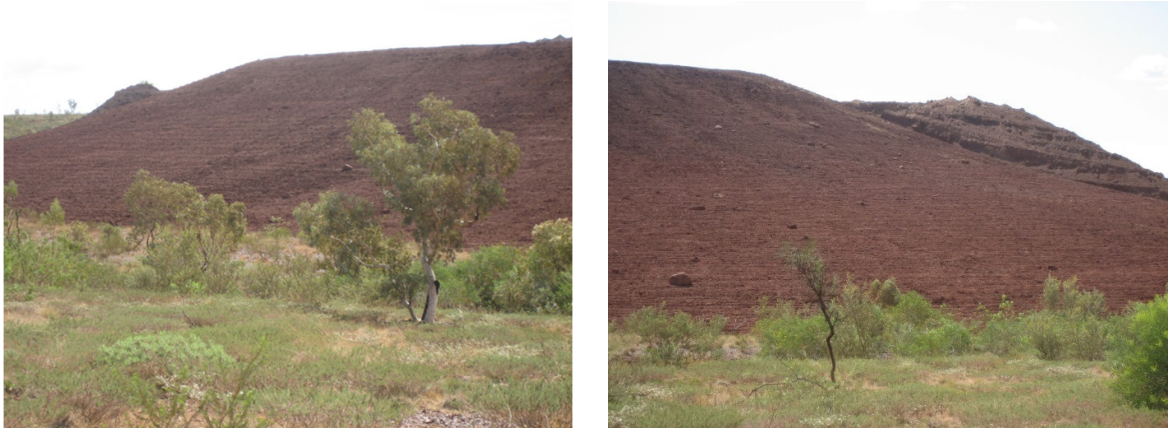
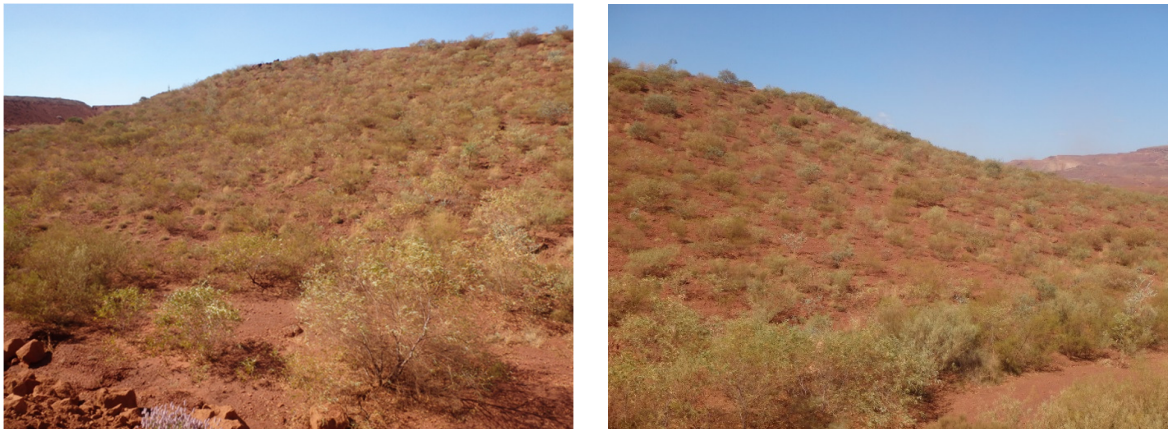
Lens C Dump (2007 – <1 year)

Lens C Dump (2014 – 7 year)

**Figure 24: Waste dump rehabilitation over time at nearby Brockman 2**

The Lens C Waste Dump at nearby Brockman 2 was completed in 2007. The single lift dump was reshaped into a concave slope, and received both topsoil and seed. Concave slopes are unusual in Rio Tinto Pilbara operations, which normally favour the batter/berm configuration. One monitoring location was installed in 2008, and subsequently monitored in 2009, 2010, 2012, 2013, 2014 and 2016 (Figure 24). The rehabilitation is compared to local undisturbed reference sites. The rehabilitation has established well, with parameters comparable to corresponding reference sites. Spinifex is starting to develop to supplement the other various native perennial species present. No weeds were present at last assessment. Some minor gullying had occurred, however all showed evidence of being stable or stabilising since last monitored.

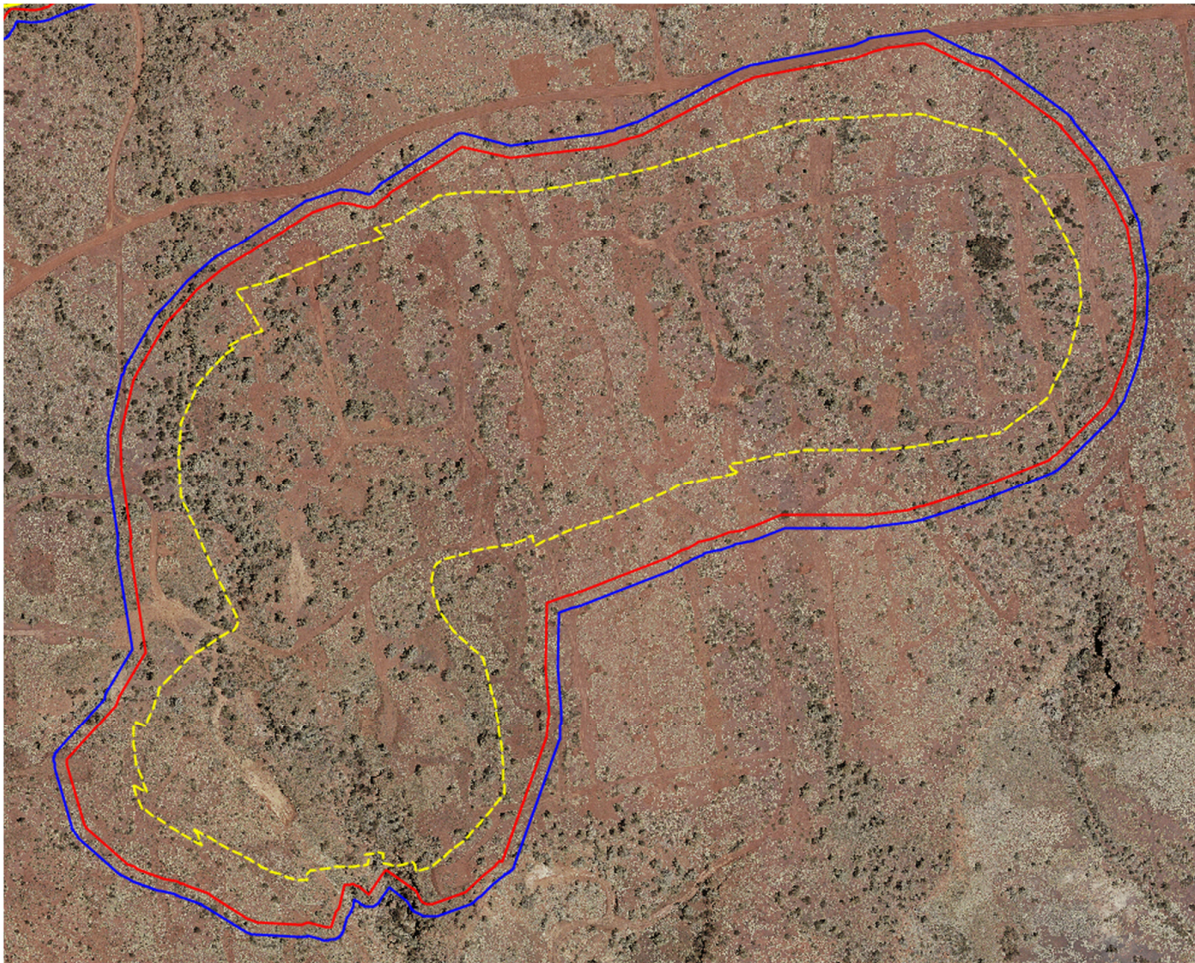
**Figure 33: Example of abandonment bund placement (blue), outside the ZOI (red) and the pit crest (yellow)**

Conceptual locations for abandonment bunds have been established based on the preliminary ZOI around each pit (Figure 33). Further refinement is required to allow for backfill, overlapping bunds and access requirements. Abandonment bunds may be one or a combination of – natural landforms, earthen/rock bund walls, rows of large rocks, fences, ditches etc. Proposed plans for post closure access will be developed and finalised prior to closure after discussion with key stakeholders.
