GABANINTHA VANADIUM PROJECT

EP ACT S38 REFERRAL: SUPPORTING
INFORMATION

Part B: Appendices

REV C
INTEGRATE SUSTAINABILITY PTY LTD

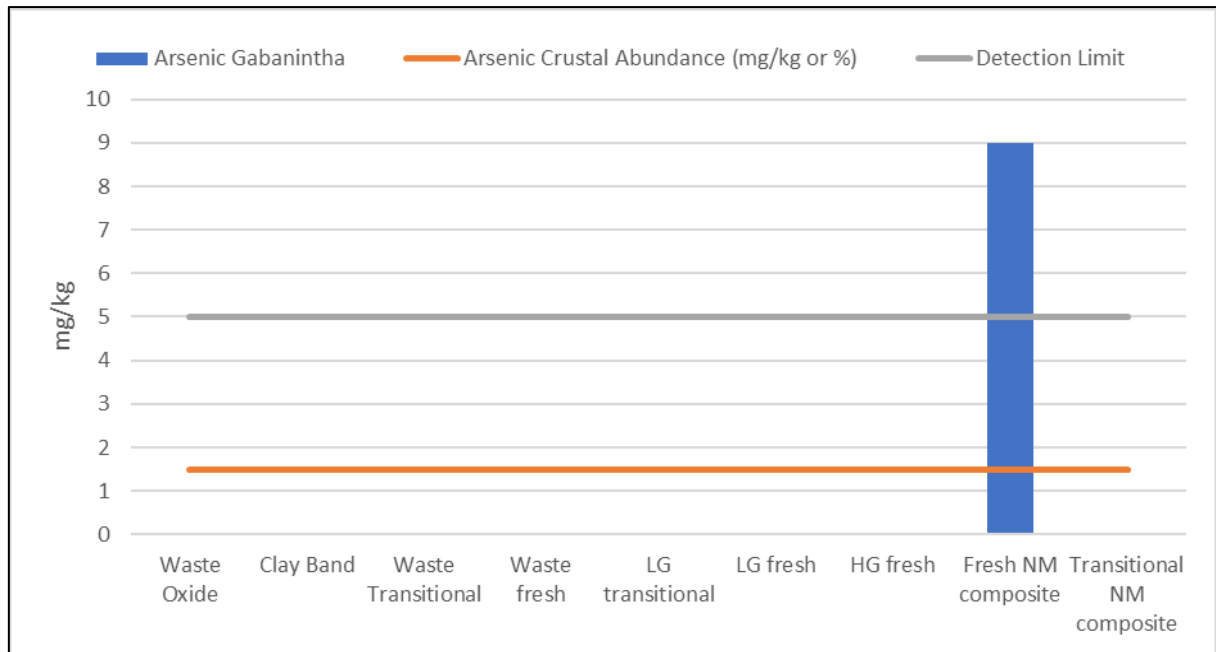
Figure 1: Arsenic Levels at Gabanintha
 HG – High Grade; LG – Low Grade; NM – Non-magnetic

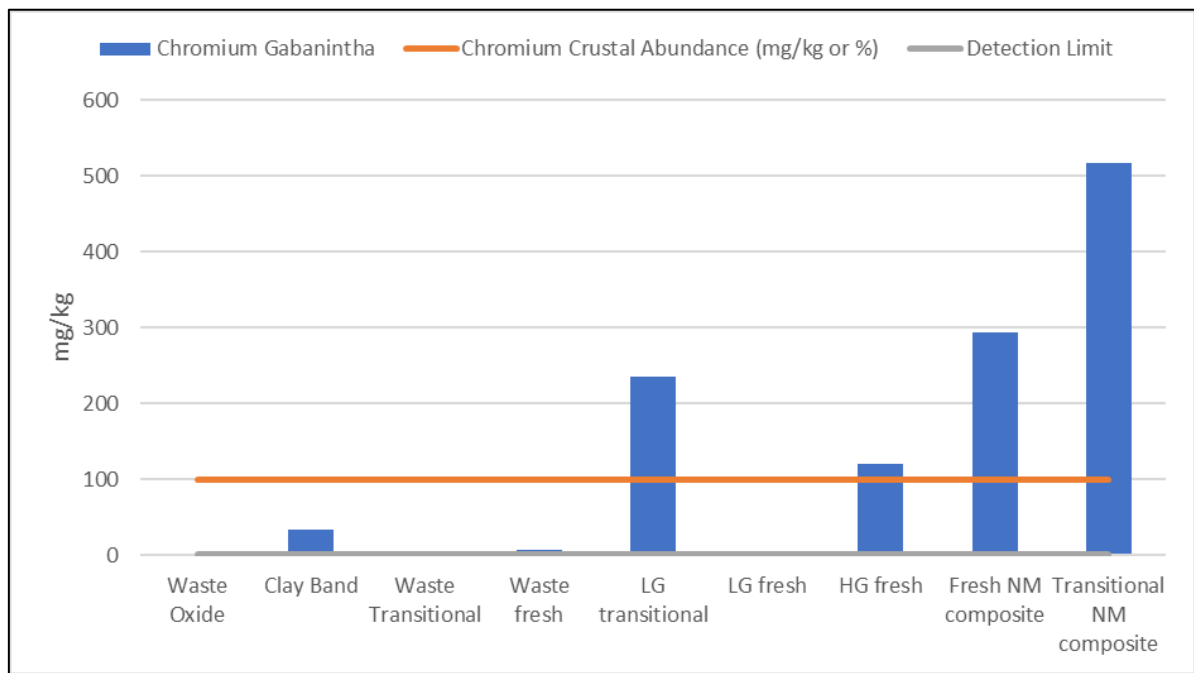
Figure 2: Chromium Levels at Gabanintha
 HG – High Grade; LG – Low Grade; NM – Non-magnetic

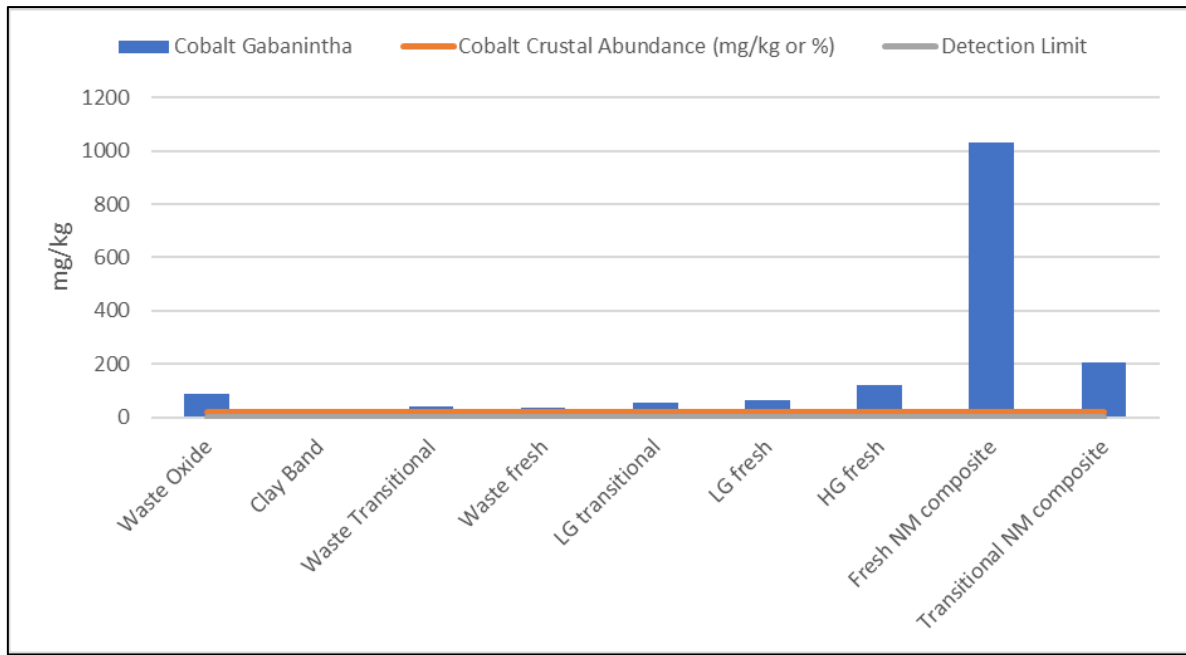
Figure 3: Cobalt Levels at Gabanintha

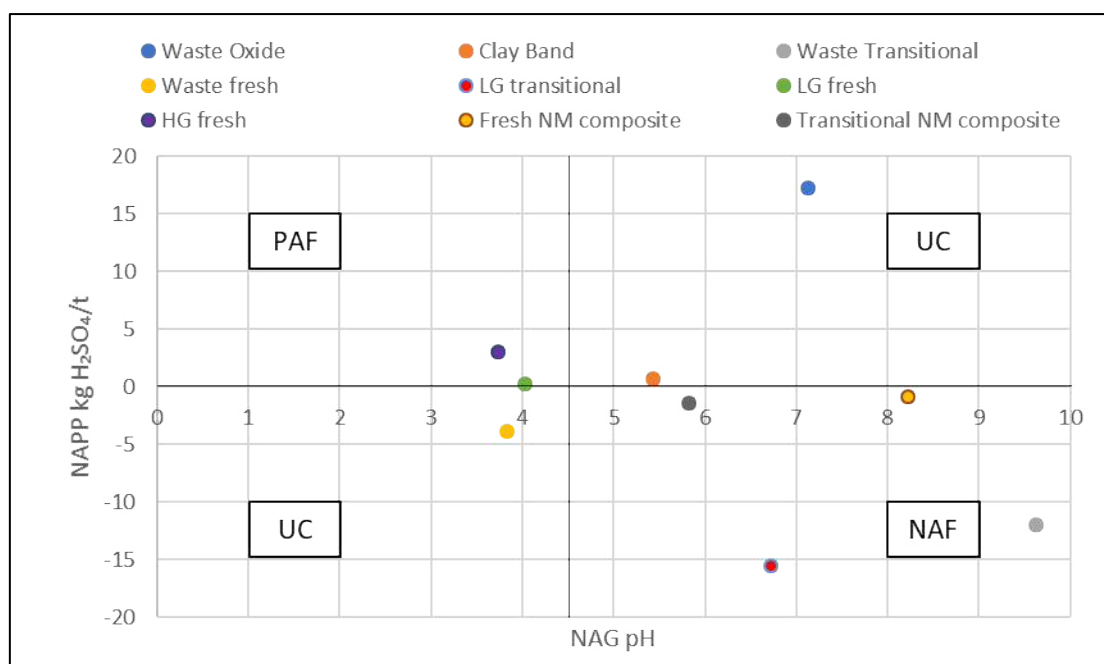
Figure 4: Plot of NAPP Versus NAG pH
 HG – High Grade; LG – Low Grade; NM – Non-magnetic

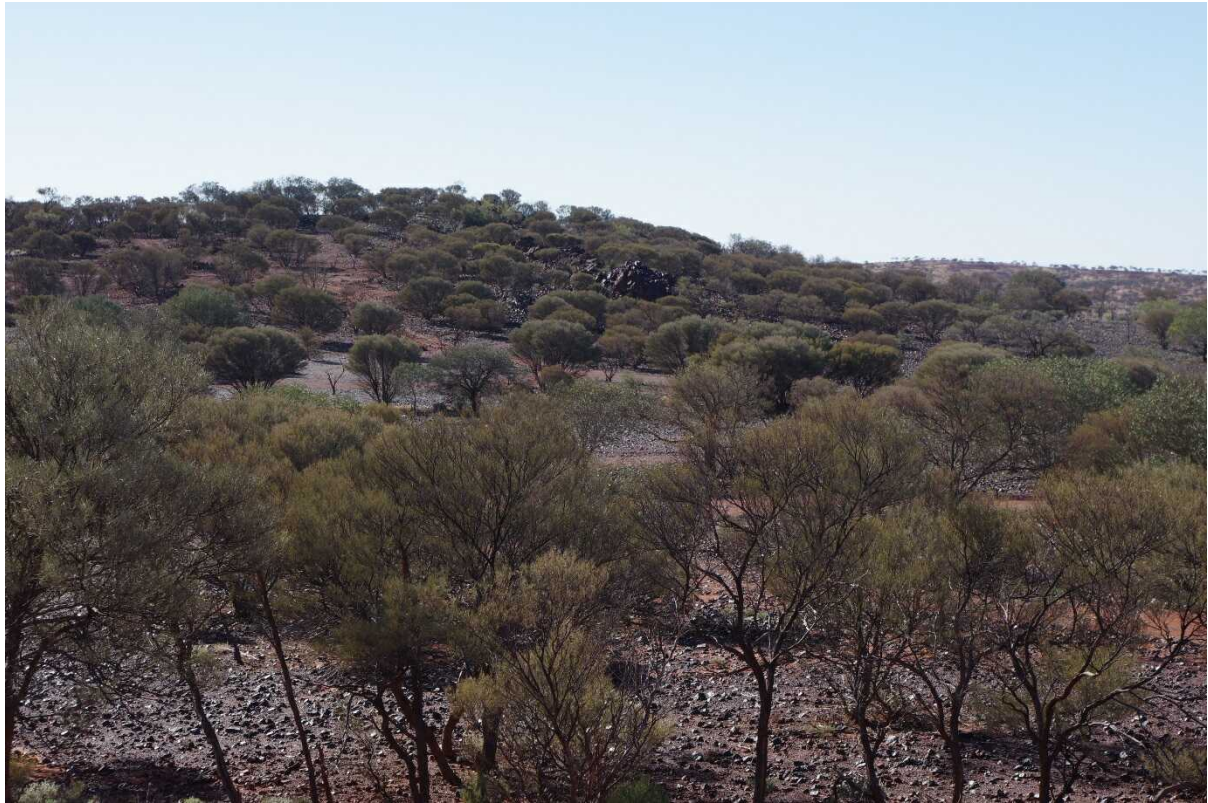
Photo 1 Landscape at the north site pit area

Generally, the elevated areas around the pits have gravelly, heavily armoured soils and rock outcrops on moderate to steep slopes. Landscape and soils at the two pit locations are shown in Photo's 1 and 2. These areas have low infiltration capacity and generate high runoff rates during rainfall events. Flow generally occurs as shallow overland flow. Shallow defined streams develop in places, defined mainly by topographic valleys. These streamlines tend to form on the hills around the centre of the pits and dissipate on wash plains downstream.

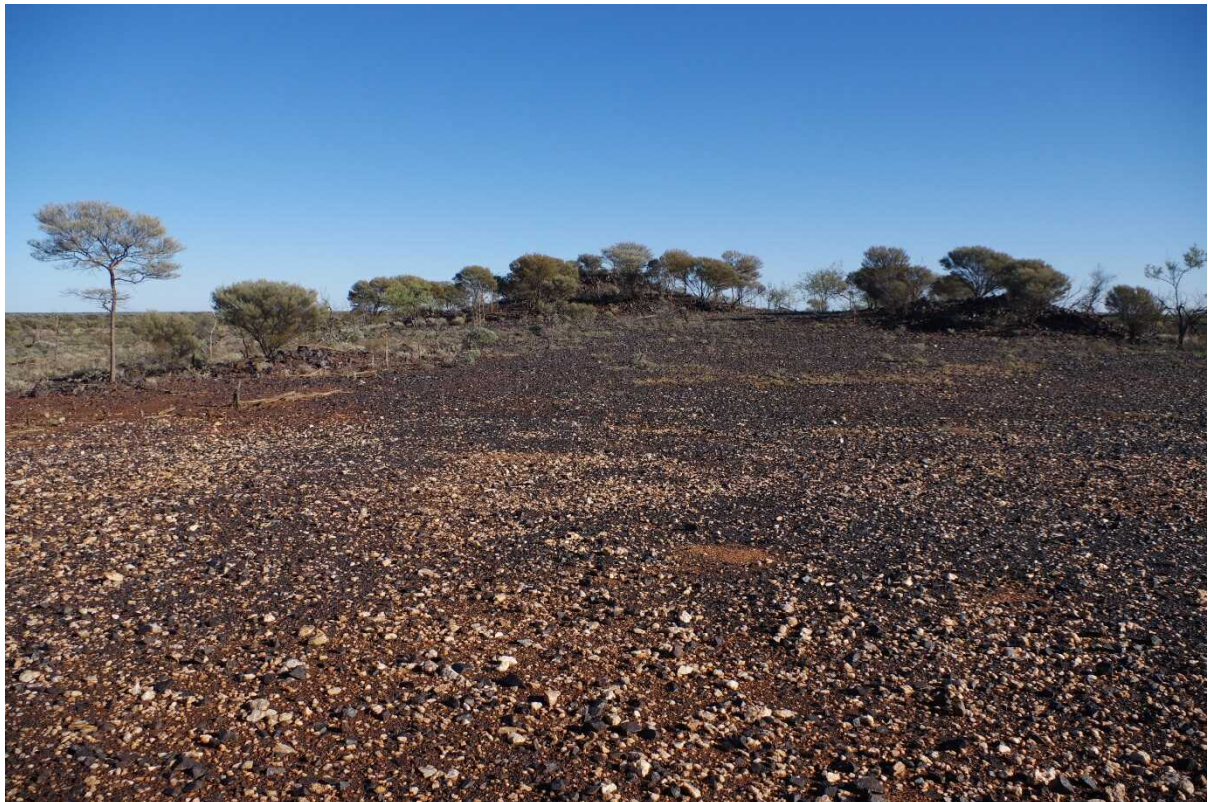
Photo 2 Landscape and soils at the south pit area

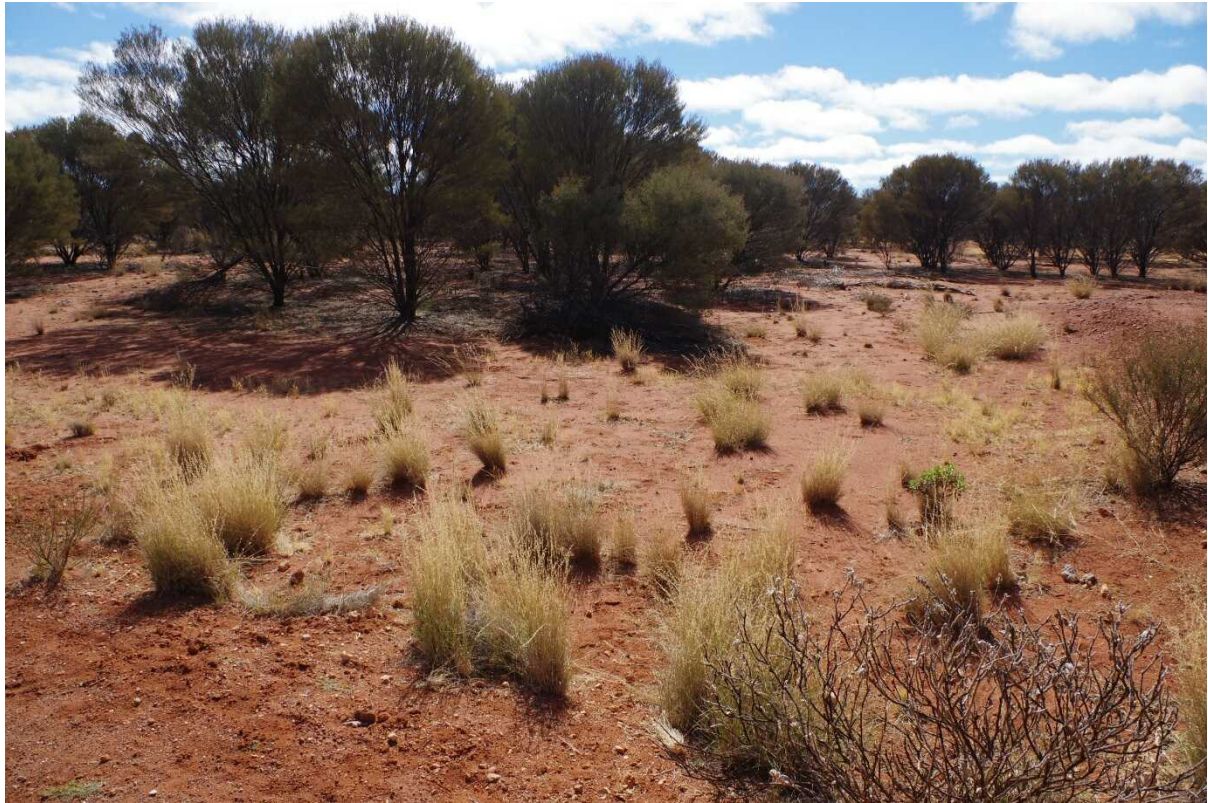
Photo 3 Landscape in the catchment valley north of the site

The landscape in the main catchment valley north of the site is shown in Photo 3. This area has broad flat wash plains with low infiltration and shallow overland flow during runoff events. Small drainage lines tend to form where flow concentrates. Defined streams don't tend to persist through the catchment, rather forming then dissipating depending on local land grade and flow concentration.

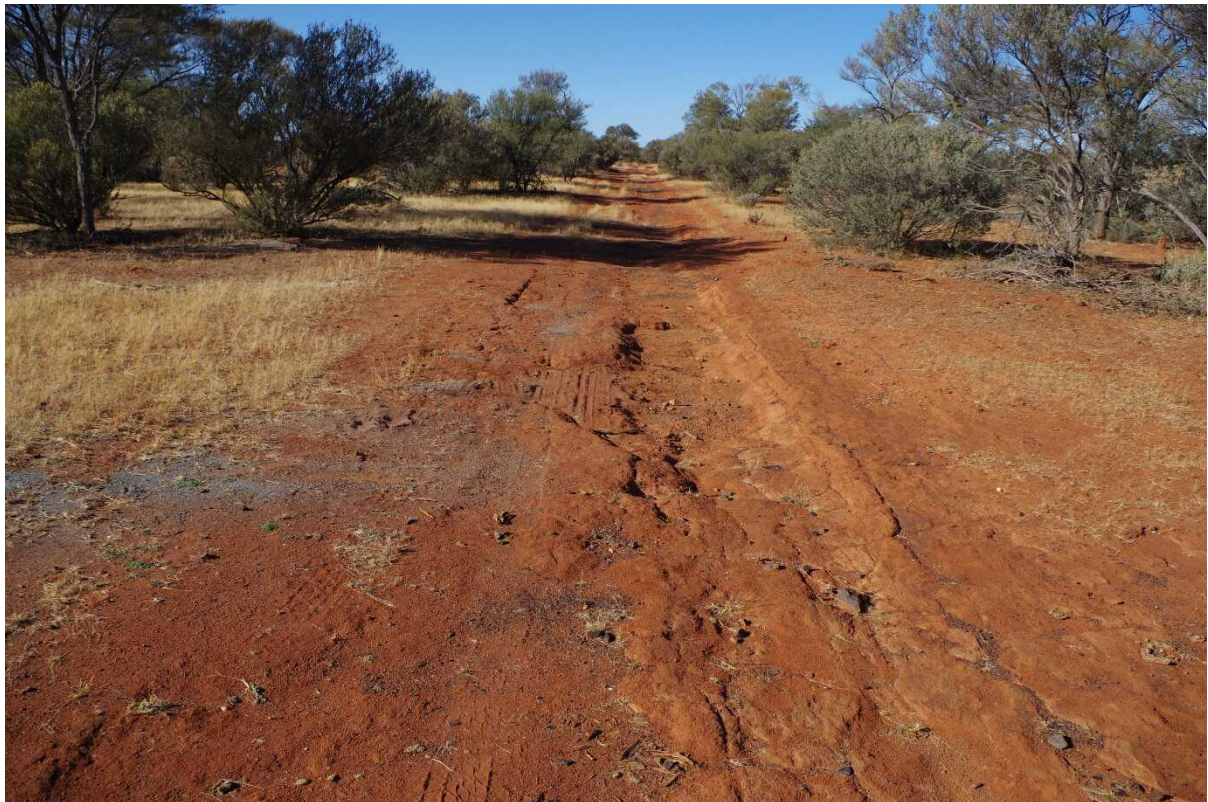
Photo 4 Scour resulting from flow concentration along a track near the south site

Artificial concentration of flows, such as along tracks or at the outfall of drains, can lead to scour. Photo 4 shows scour developing along a track near the south pit.

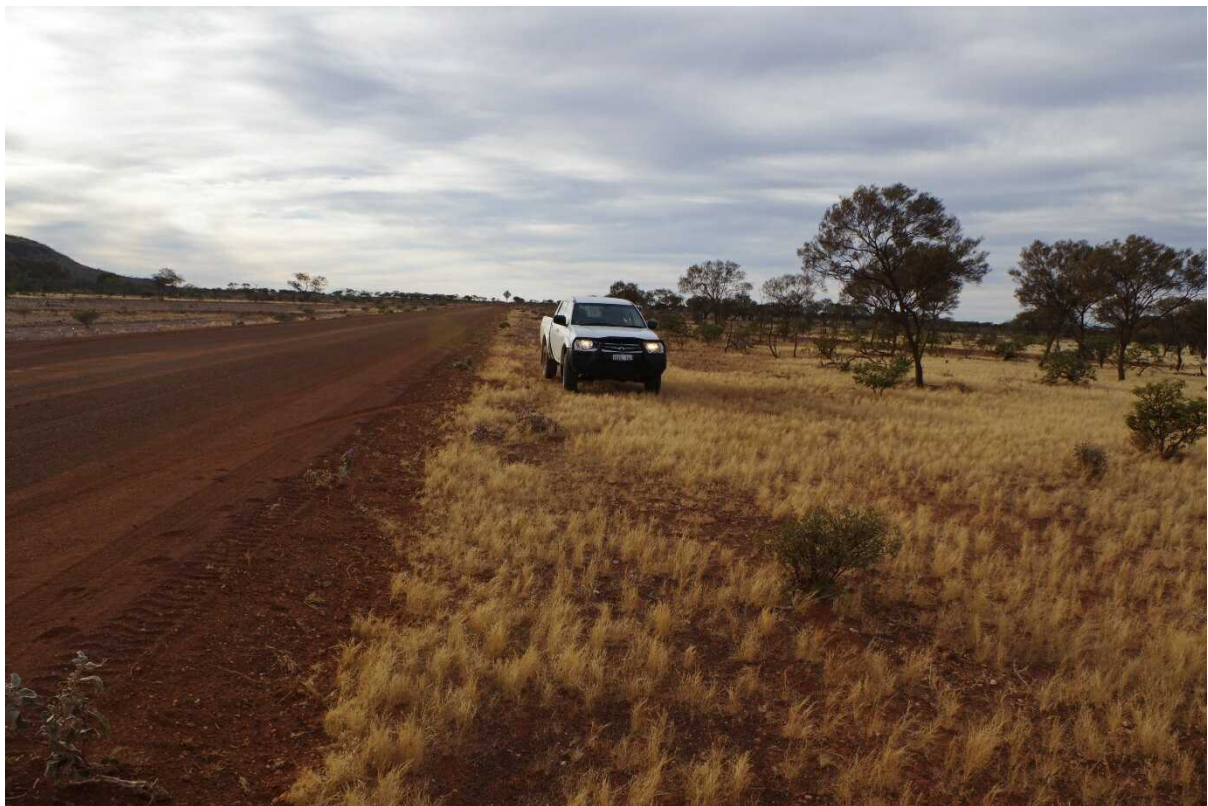
Photo 5 Effect of modified overland flow path at a road on pasture growth

Photo 5 shows effects of modified flow paths on pasture growth along the Meekatharra-Sandstone Road between the north and south sites. The road formation in this area is raised which tends to increase ponding upstream of the road. Road-side drains can have a similar effect (Photo 6). The pasture stand is less vigorous immediately downstream of the road or drain where overland flow is reduced.

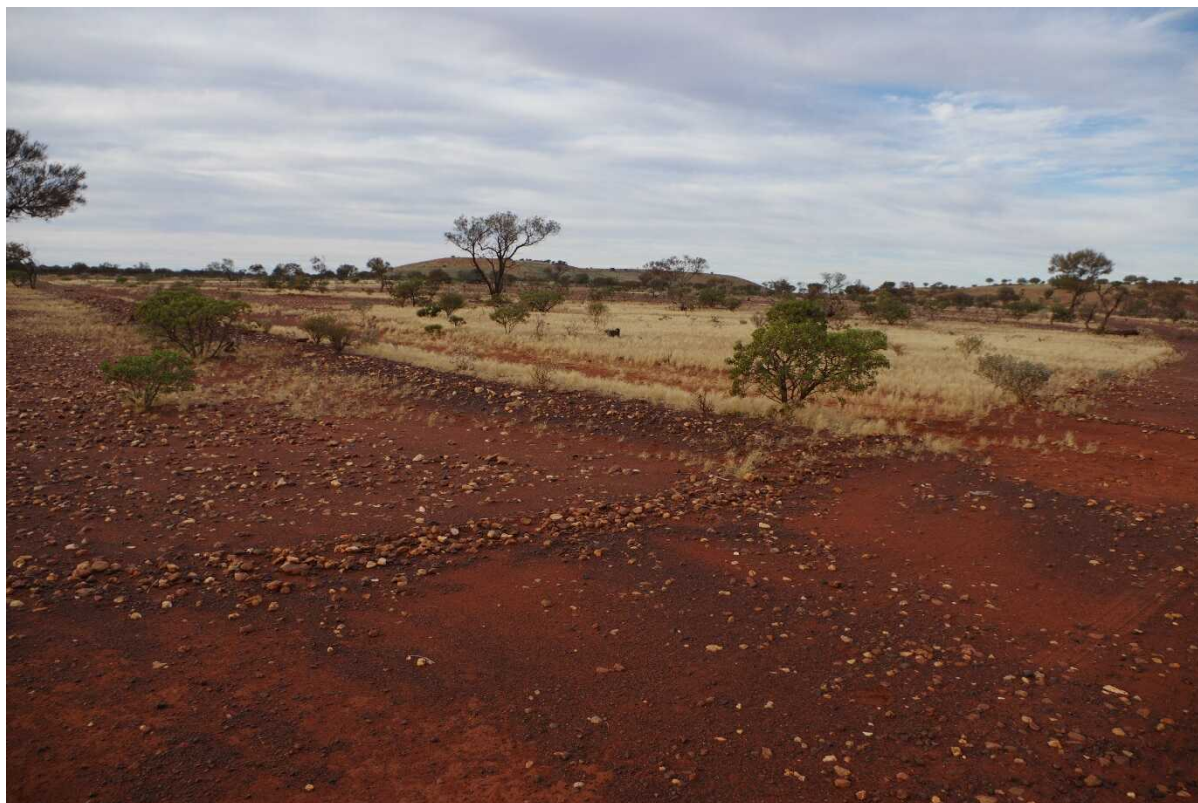
Photo 6 Effect of a road-side drain on pasture growth

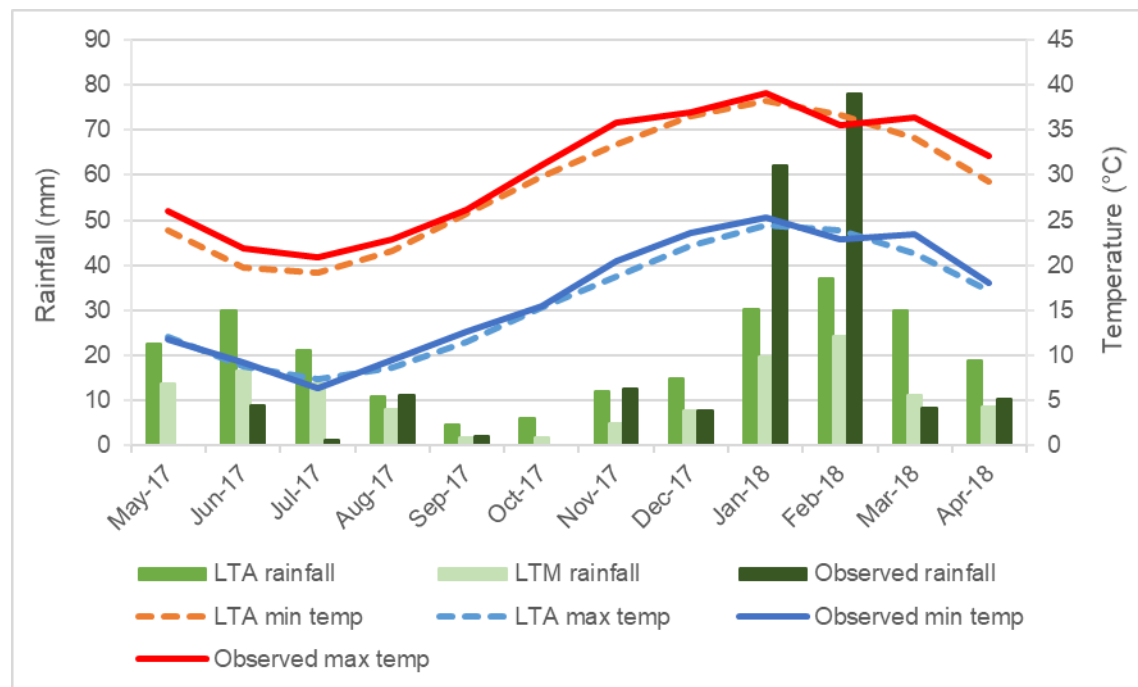
Figure 2.1: Climate data for Meekatharra Airport (BoM, 2018), comparing long-term average (LTA) monthly rainfall (mm) and temperatures (°C), Long-term median (LTM) rainfall (mm), observed average monthly rainfall (mm) and temperatures (°C).

Long-term climatic data is not available for the Study Area itself; however, long-term climatic data (BoM, 2018) is available from the Bureau of Meteorology weather station at Meekatharra Airport (Station 7045), 35.24 km north of the Study Area, which provides an indication of climatic conditions experienced at the Study Area (Figure 2.1).
